BUCHANAN HOUSE **Sun Street, Hitchin**

Archaeological Evaluation

Archaeological Evaluation Report

Report No.284

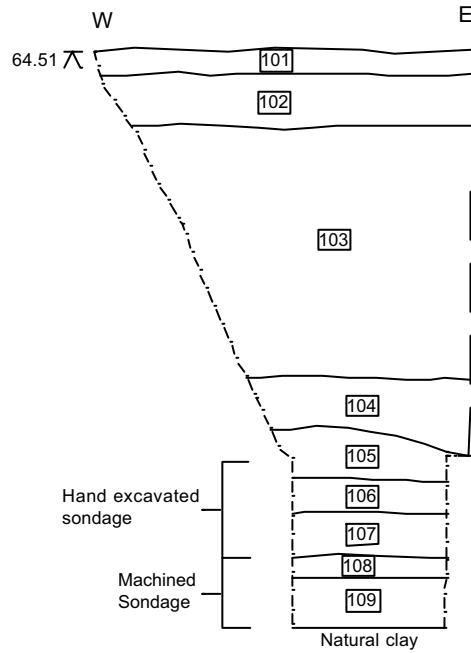
South facing section, NW corner of trench

2.11 The stratigraphy in the trench consisted of a layer of modern concrete [101] over a mixture of levelling aggregate and crushed CBM fragments [102]. Beneath this lay a soft, mid greyish brown, slightly sandy silty clay overburden [103], which contained artefacts of 19th/20th century date, including, pottery, peg tile, and glass. This sealed a layer of firm, light greyish brown, silty clay [104], with frequent chalk inclusions, and moderate small flecks of CBM. Beneath this alternating layers of firm, light grey, silty chalk with frequent greenish mottling, and firm, very dark greyish brown, silt, were observed [105] – [109]. Layer [106] yielded a small, abraded, and undiagnostic fragment of late post-medieval peg tile. These layers have been interpreted as flood deposits from the River Hiz, the present line of which flows less than 60m to the east of the site.

Context	Type	Description	Dimensions (m)
101	Layer	Hard standing concrete.	0.10m thick
102	Layer	Mixed aggregate and crushed CBM, levelling layer.	0.20m thick
103	Layer	Soft, mid greyish brown, slightly sandy silty clay.	1.00m thick
104	Layer	Firm, light greyish brown, silty clay.	0.30m thick
105	Deposit	Firm, light grey, silty chalk with occasional greenish mottling. Flood deposit.	0.20m thick
106	Deposit	Firm, very dark greyish brown, silt. Flood deposit.	0.12m thick
107	Deposit	Firm, light grey, silty chalk. Flood deposit.	0.17m thick
108	Deposit	Firm, light grey, silty chalk with frequent greenish mottling. Flood deposit.	0.10m thick
109	Deposit	Firm, black, peat like silt. Flood deposit.	0.20m thick

3.2 The alternating layers of silt observed in the base of the trench are consistent with flood deposits. Their presence on the site is not surprising as the River Hiz flows within 60m to the east of the site.

3.3 The evaluation has demonstrated that the undisturbed natural geology lies at approximately 2.30m below the present ground surface, which appears to have been artificially raised, possibly as a protection against flooding.
