DOVE HOUSE **Town Street, Thaxted, Essex**

HN532

Archaeological Monitoring & Excavation Report

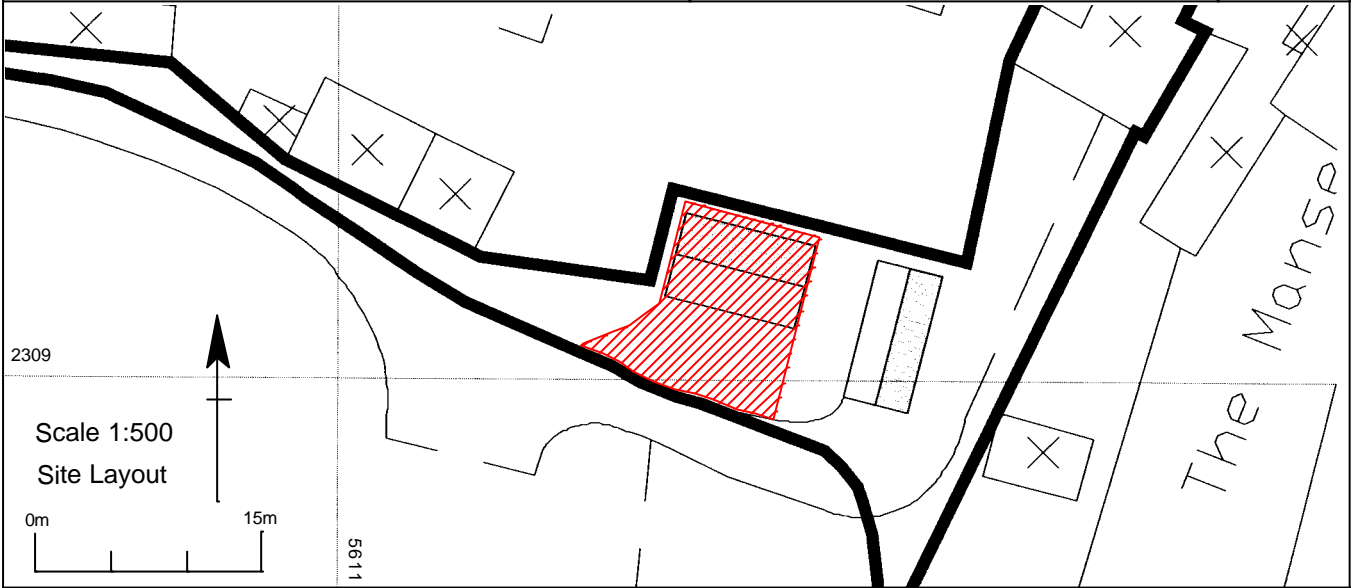
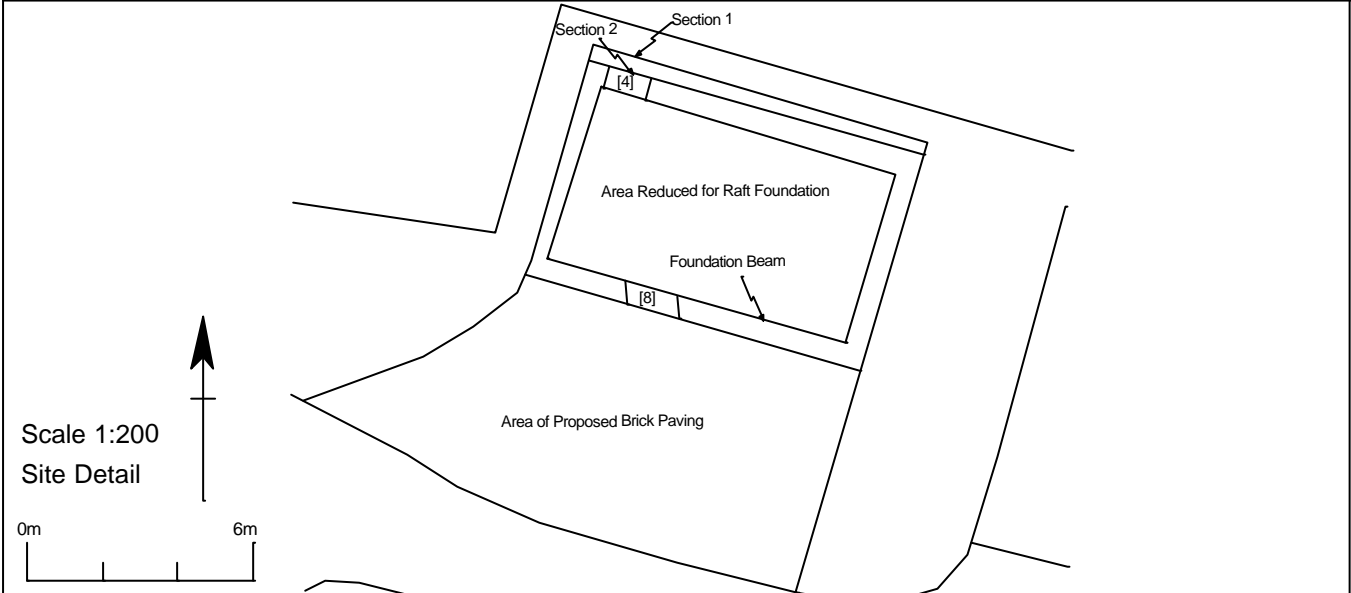
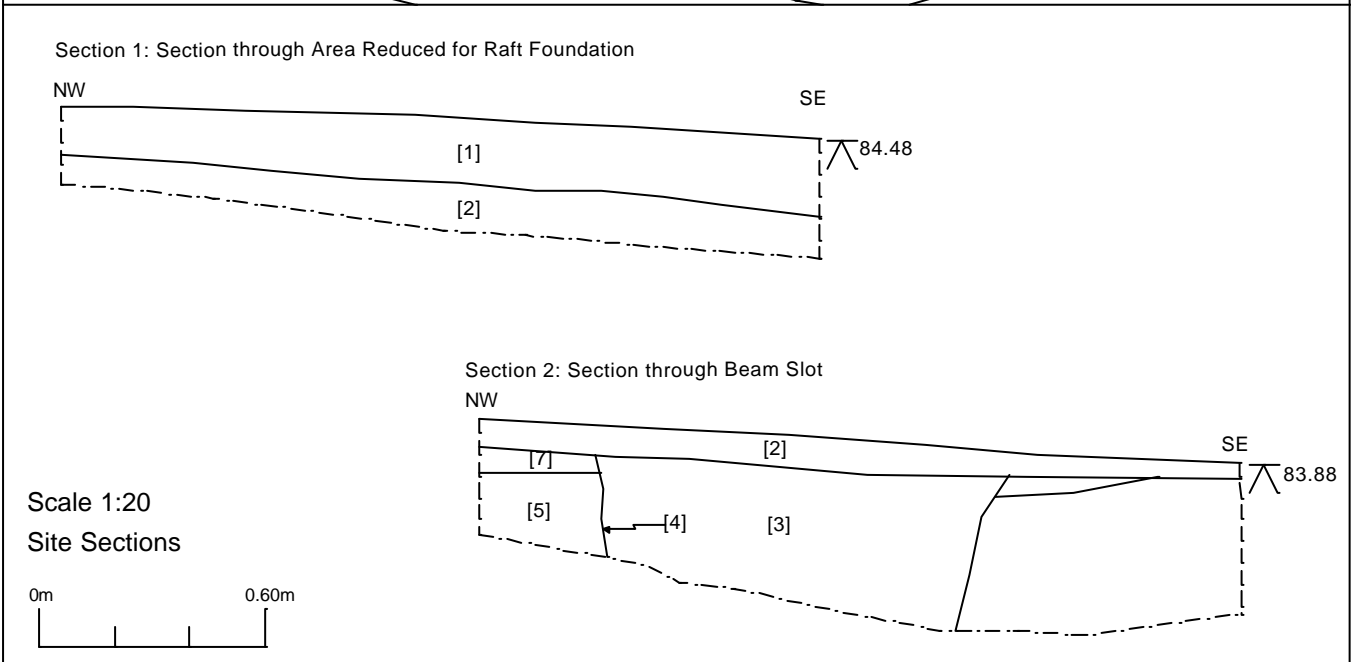
Figure 2 Identified Features and Deposits

2.13 Two features were exposed during this process. In the northern strip, linear feature [4], potentially a ditch, contained fragments of post-medieval tile and pottery. The base of the feature was not reached. It may be a boundary or drainage ditch.

2.14 The surface of a second linear feature, [8], was identified in the southern strip. It is possible this feature represents a continuation of ditch [4]. No artefacts were recovered from this feature.
