RECTORY FARM Meesden, Herts.

HISTORIC BUILDING RECORD & ARCHAEOLOGICAL MONITORING REPORT

Project ref.: HN980
Planning ref.: 3/11/1535/FP
HER consultation number: 302/11

Report no.736

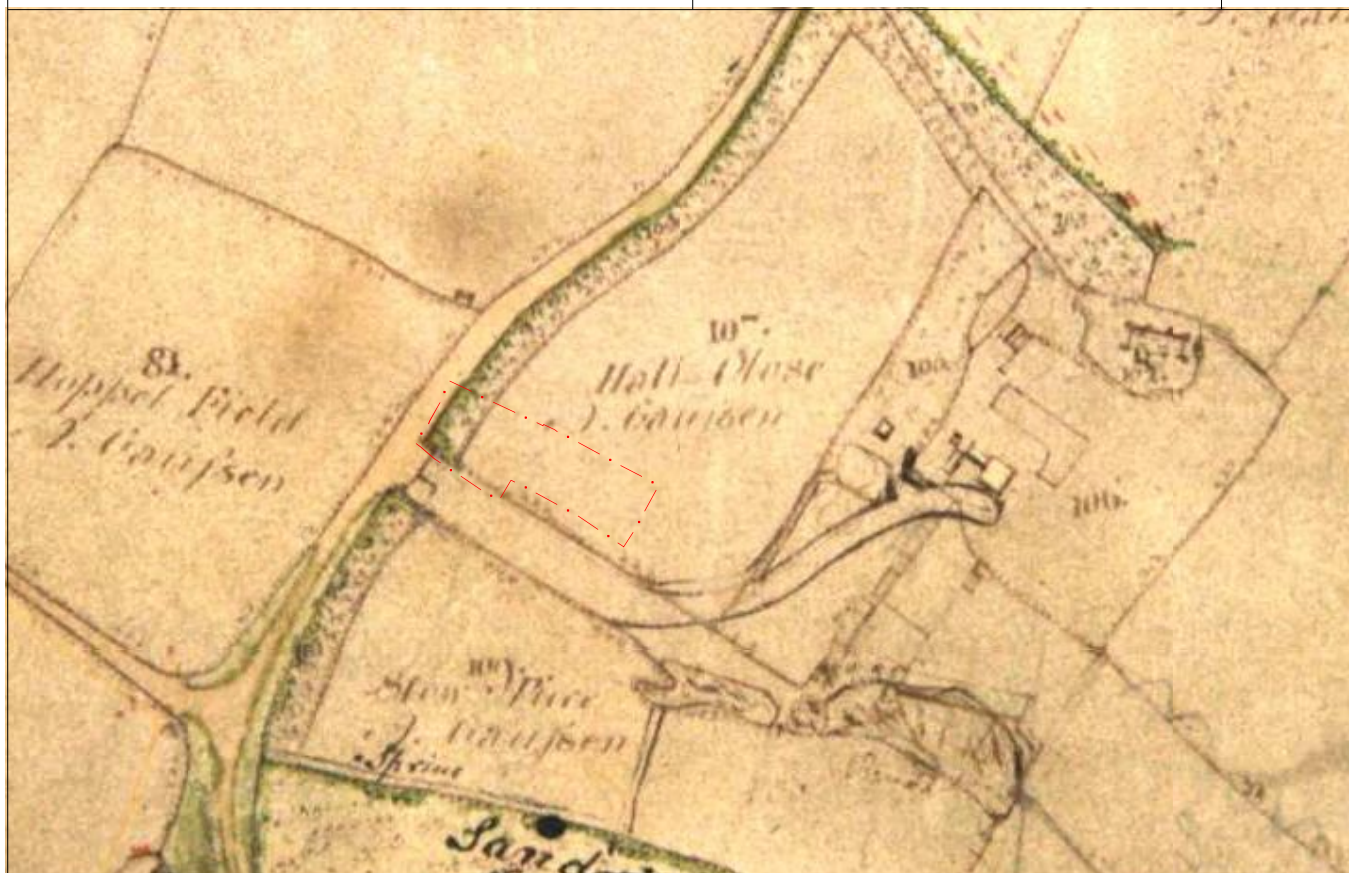
Figure 2

2.7 The earliest detailed map available for Meesden is *A Map or Plan of the Parish of Meesden in the County of Hertford* (HALS 26872A), dated 1815 (Figure 2). This map shows the Rectory and church, with the driveway to the Rectory shown as a later addition. However, the area now occupied by Rectory Farm is shown as an open field, labelled Hall Close, and is flanked on the west by a narrow plantation of trees.

A Map or Plan of the Parish of Meesden in the County of Hertford, 1815

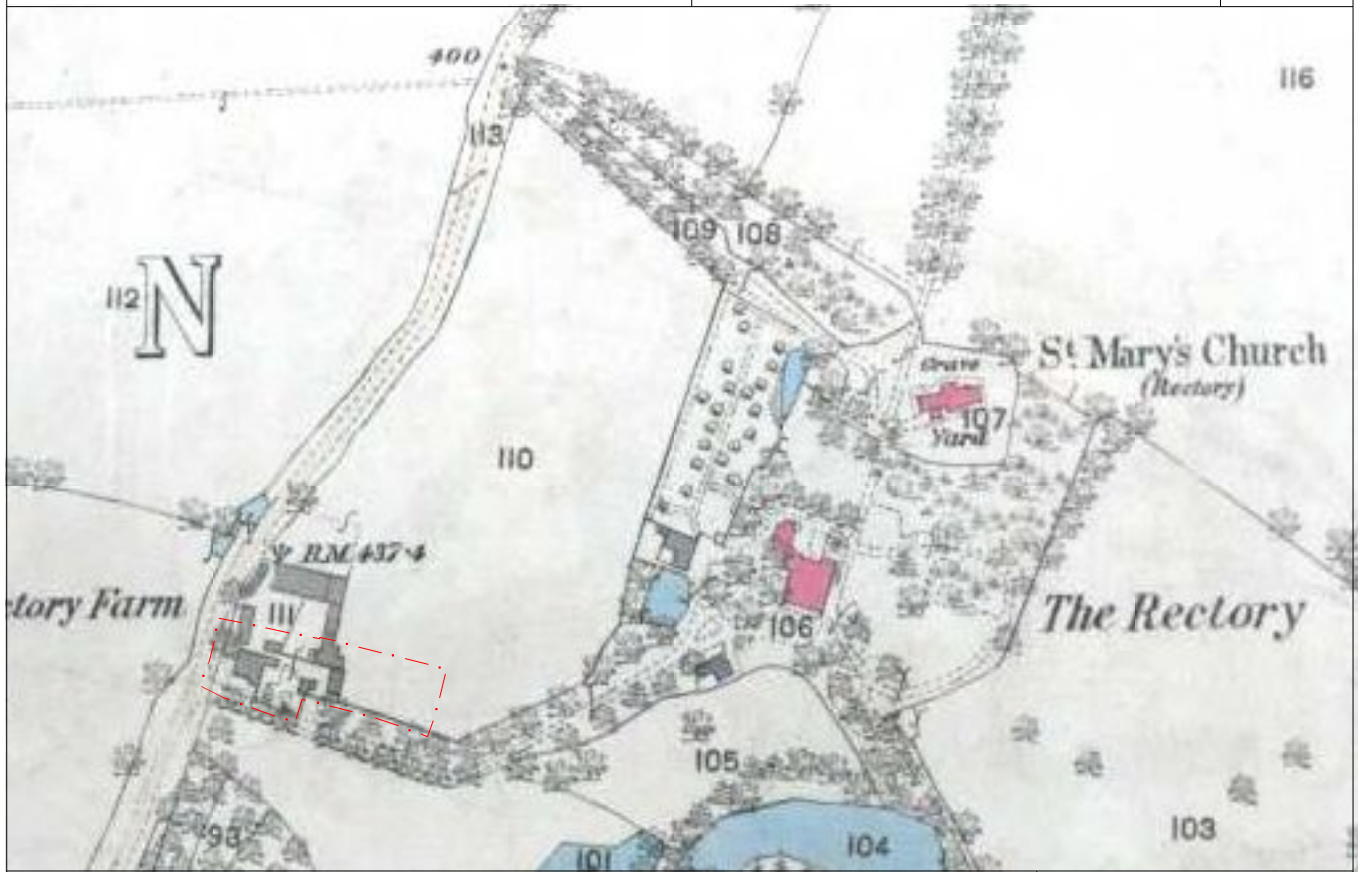
Figure 4

2.9 The OS 1st edition 25” County Series, dated 1878, shows that the remainder of the plantation had been cleared and that various changes had been made to the buildings (Figure 4). Building 7 has been extended to the east (with the creation of Building 8), and Building 2 appears to have been extended to the north. A narrow building has been erected in the north-west corner of the yard, in the area now occupied by Building 9, and a small building is shown to the east of the house, in the general location of Building 5. The house also appears to have been enlarged, with infilling to the south-west corner and an extension to the south elevation.

1st edition OS map, 25" scale, 1878

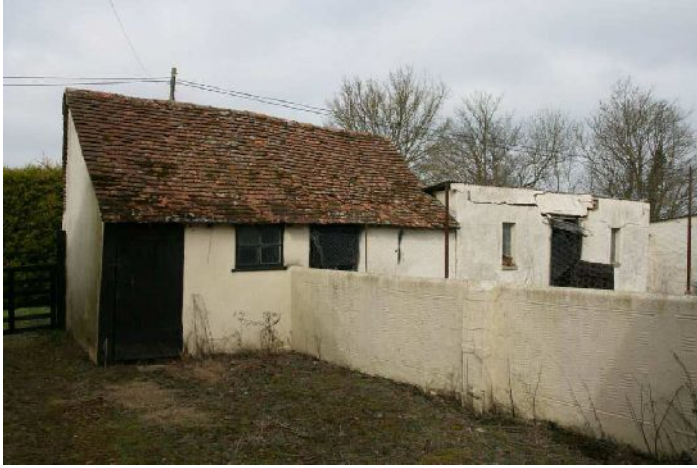
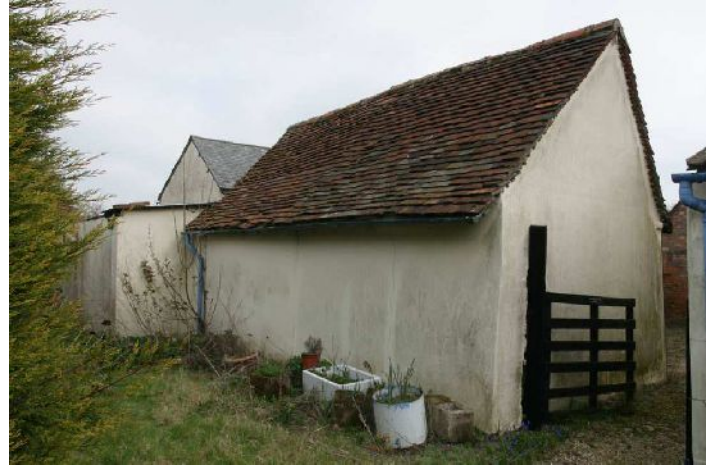
3.6 Building 2 is a two-cell stable and wood/coal store aligned north-south with a pitched clay-tile roof, measuring 5.85 x 3.20m (Figures 11 & 12; Plates 25 & 26). It abuts Building 3 which lies to the north. The elevations have all been rendered and local information indicates that the previous owner of the property had been a plasterer who was responsible for rendering the majority of the buildings on the property.

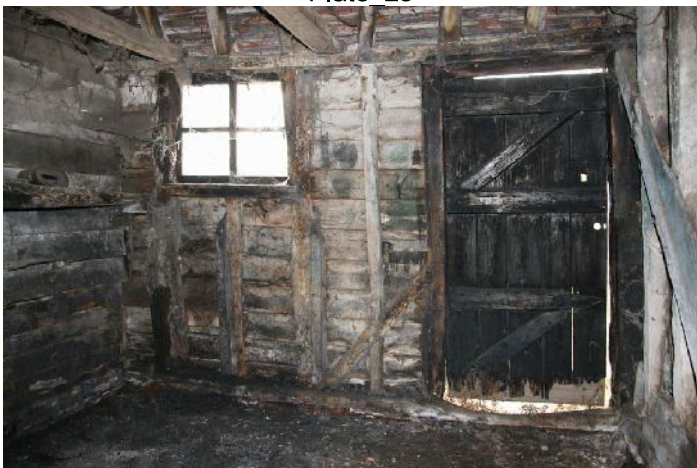
Plate 30

3.8 The southern cell measures 2.6m long by 3.00m wide on the interior, the height from the floor to the top of the wall plate is 1.77m, and to the ridge is 3.39m. A sole plate survives in the southern elevation of the southern cell, this being much decayed and resting on a pad formed of a single layer of red bricks laid as headers (Plate 29). Waney-edged softwood studs, on 14-inch centres, link the sole plate and waney-edged southern tie-beam, and a nailed primary brace crosses the eastern half of the elevation. There is no sign of a similar brace to the west. Behind the studwork, sawn softwood weatherboarding is visible, each board of 7-inch width. Above the tie-beam, the gable is formed of a collar and studs on 16-inch centres (Plate 30).

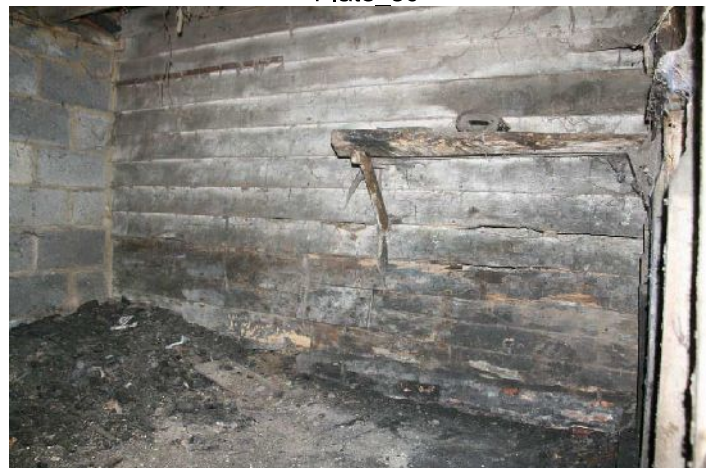
Plate 31

3.9 A sole plate also survives in the eastern elevation, which has badly weathered waney-edged studwork, also on 14-inch centres and a diagonal primary brace at the southern end, interrupted by the later addition of a doorway and a window (Plate 31). Softwood weatherboarding is also visible behind the studwork in this elevation.

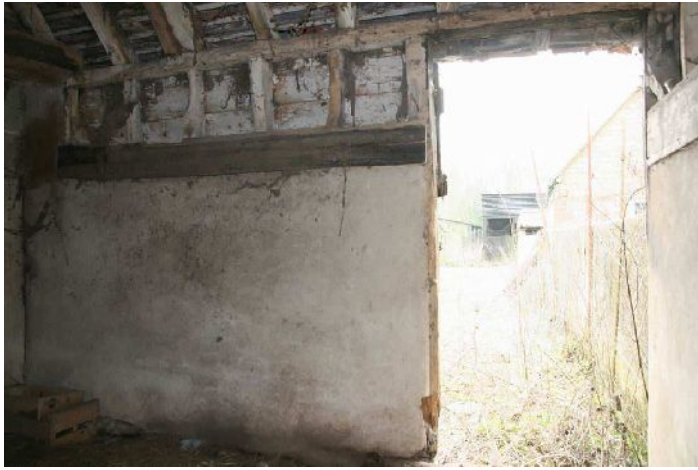
Plate 32

3.10 The studwork in the eastern elevation of the southern cell has been replaced by cement blocks, and the partition that separates the northern and southern cells is covered in softwood weatherboarding (Plate 32).

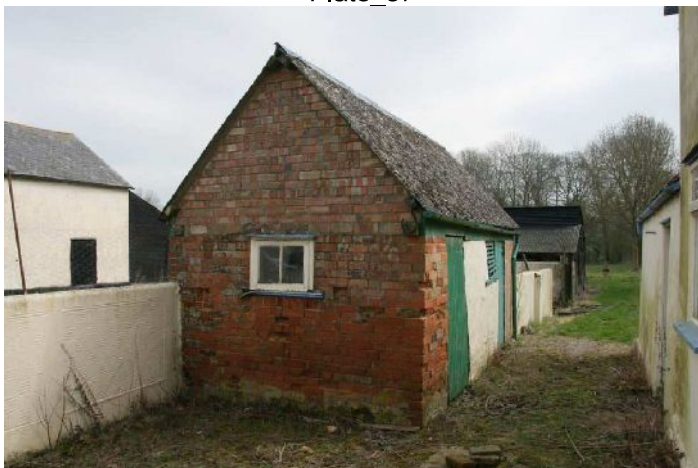
Plate_39

- The western gable end is formed of hand-made red brick laid in Flemish bond with a lime mortar, the bricks measuring $8\frac{3}{8}$ " x 4" x $2\frac{1}{2}$ " (the lengths of the bricks actually varying between 7" and 9") (Plate 39). A single light, top-hinged window of two panes occupies the centre of the elevation. Above the level of the eaves, all has been rebuilt in Fletton bricks in poor quality cement mortar. An OS benchmark was noted 0.787m above the existing ground level and 0.71m north from the south-west corner (value 134.03mAOD).

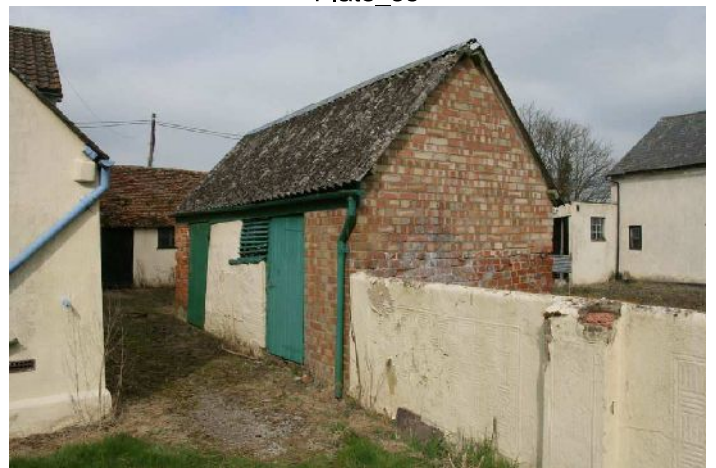
Plate_40

- The south elevation has two doors giving access to the east and west cells, both doors being modern boarded, ledged and braced (Plate 40). To the west of the western door, the structure is of brick, contemporary with the western elevation. Between the two doors, a brick plinth supports a panel of cob which has been rendered and painted, with a window opening at its eastern end below the eaves (Plate 41). This has a wood and metal mullion bisecting the opening with each half being further bisected by a metal strut. Horizontal wooden slats have been nailed in front of this. To the east of the eastern door, the elevation is formed of modern Fletton bricks laid in a random pattern with cement mortar.

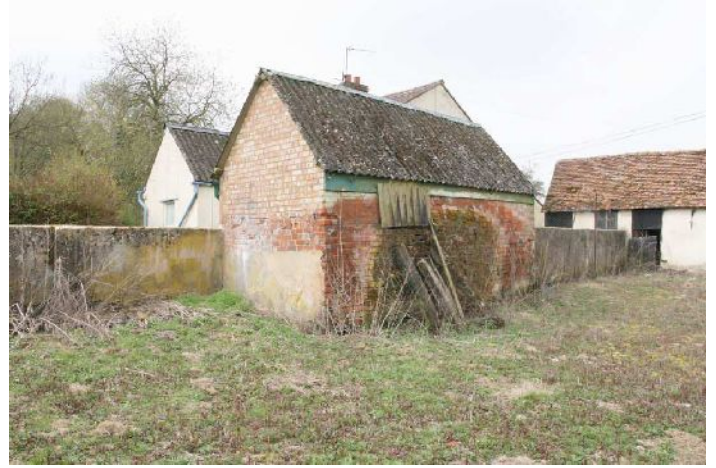
Plate 42

- The north elevation is formed of hand-made red brick laid in Flemish bond with a lime mortar, the dimensions of the bricks being similar to those in the west elevation (Plate 42). A window opening to the east of the elevation lights the eastern cell, but is masked by a corrugated fibreglass panel.

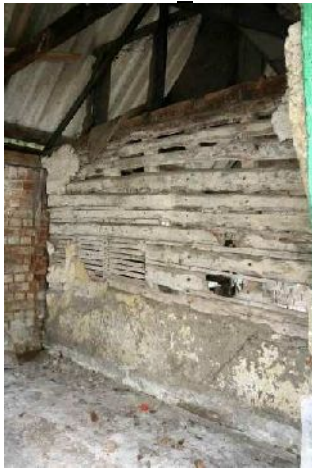
Plate 43

3.15 The eastern interior elevation is a stud partition, faced with nailed lath and plaster, separating the two cells (Plate 43). The plaster continues round to the southern elevation where the cob is exposed in places (Plate 44). The northern elevation bows outwards exposing the junction with the partition (Plate 45).

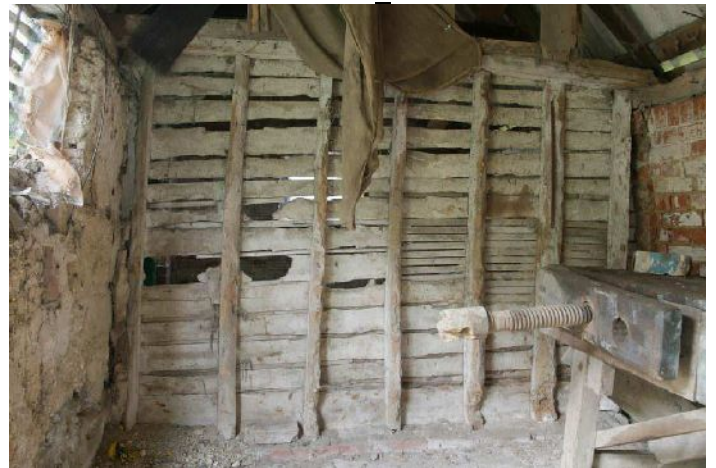
Plate 46

3.16 The eastern cell measures 2.81 long by 2.34 wide, with a concrete floor. The dividing partition, which forms the western interior elevation, has studs on 14-inch centres, all of narrow scantling and waney-edged. The partition sits on a brick sill which probably replaces a timber sole plate (Plate 46). The northern elevation has a window opening in a similar style to that already noted in the southern exterior elevation (Plate 47).

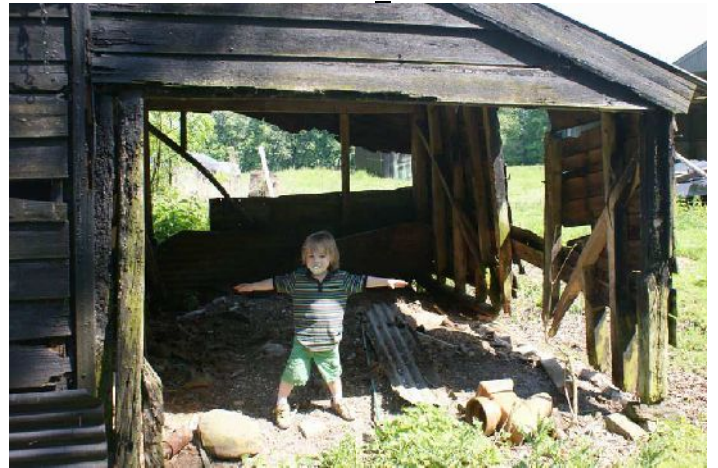
Plate_52

3.22 The lean-to extension to the east measured approximately 4 x 2.5m and was open to the south, suggesting its use as a cartlodge (Plate 52). It had a pent roof of corrugated iron sloping down to the east. Much of the weatherboarding in the north and east elevations had come away and much of the studwork in the north elevation was also missing. The studs in the east elevation appear to have been more substantial, but the sole plate had decayed completely.

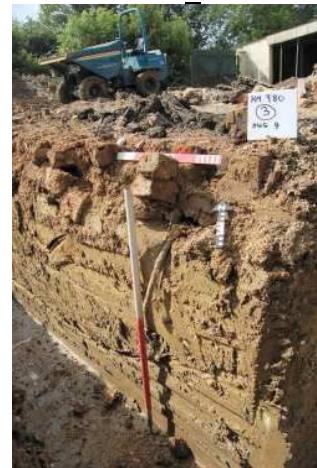
Plate_54

4.6 Cutting into overburden (001) and lying on the upper surface of natural clay (002) were the footings (003) for the former Building 4 (Figure 15; Plate 54). These were composed of unfrosted red brick bonded with soft sandy lime mortar.

4.9 The brick fragment from overburden (001) was from a handmade, unfrosted brick, probably local and dating to the 19th century. The whole brick recovered from (003) was of the same, form and fabric as the fragment in (001) and was also identified as a locally made 19th century house brick.
