SALTMORE FARM BARNs **Hinxworth, Herts.**

Historic Building Record

Report no.274

February 2005

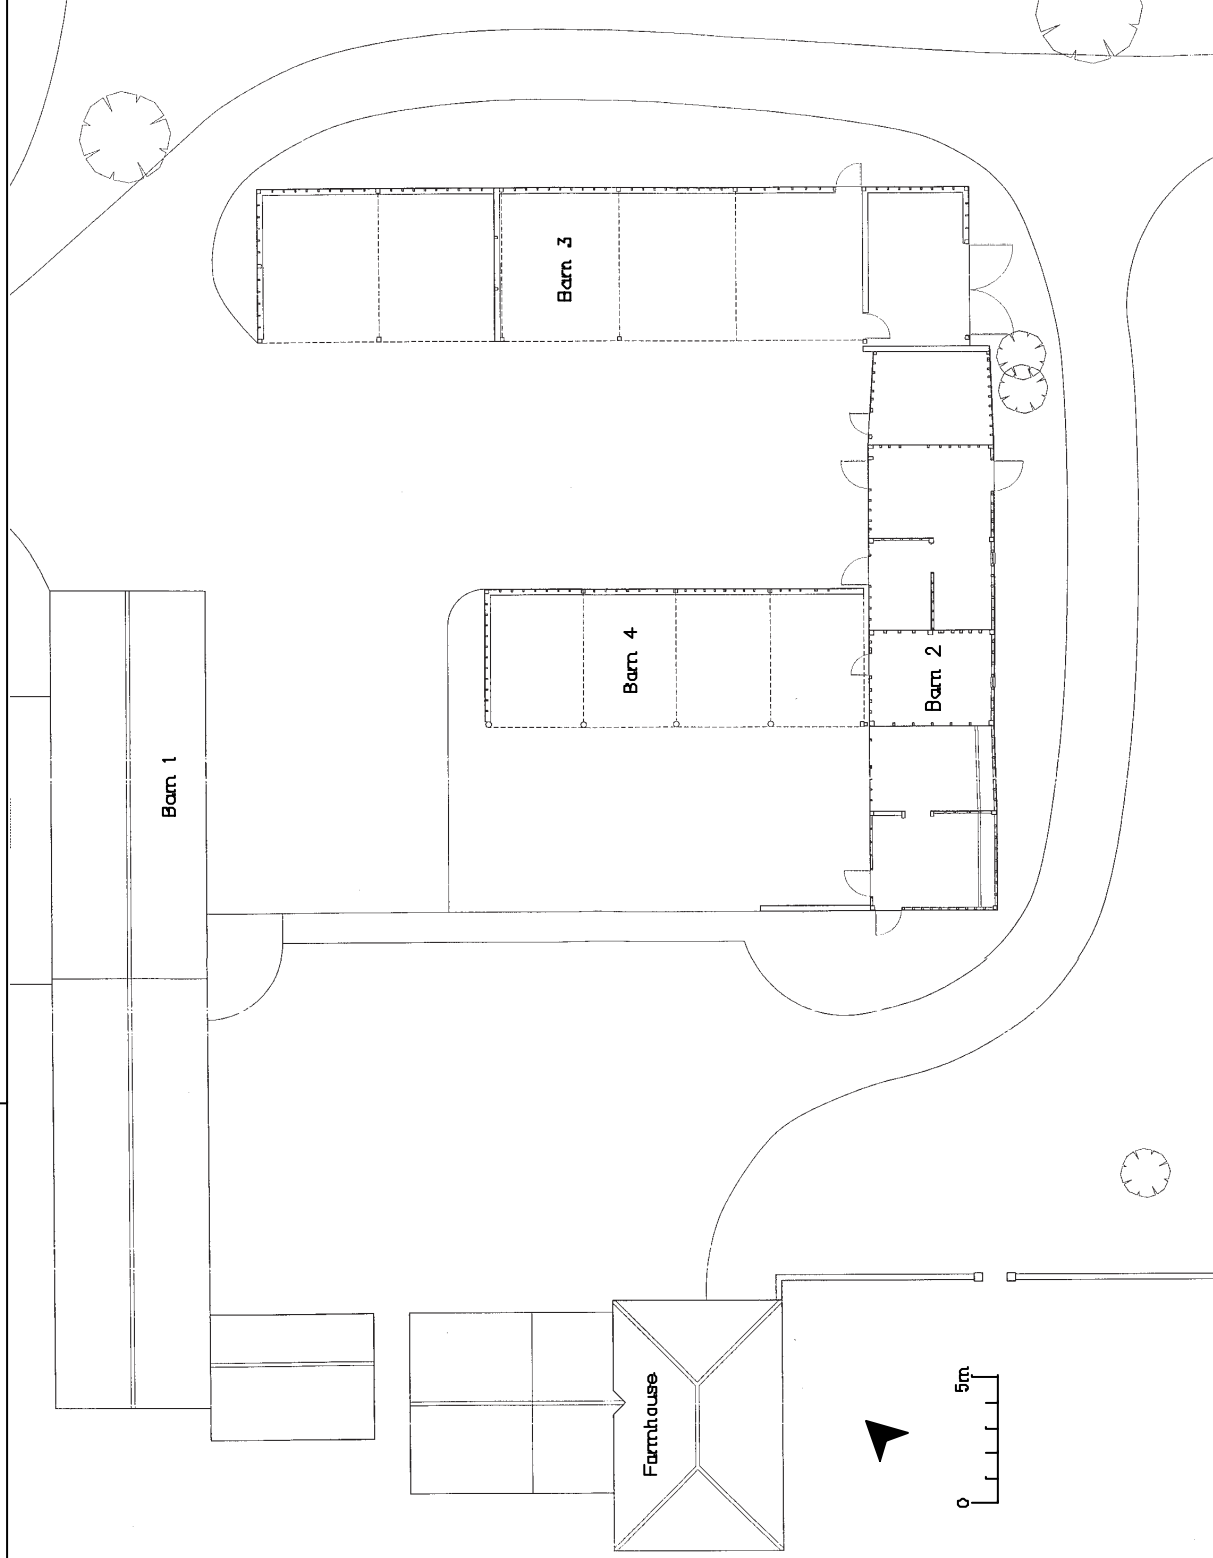
Figure 2

2.1 The site consists of five ranges of buildings, including Saltmore Farmhouse, set around and within a courtyard (see Figure 2). The farmhouse, which forms the south-western range, and Barn 1, which forms the north-western range, do not form part of the present planning application and are, therefore, excluded from the study. Barn 2, is a timber framed structure which forms the south-eastern range of the courtyard, Barn 3 is a modern machinery shed which forms the north-eastern range, and Barn 4 is a modern machinery shed which runs across the courtyard parallel with Barn 3.

Site Layout

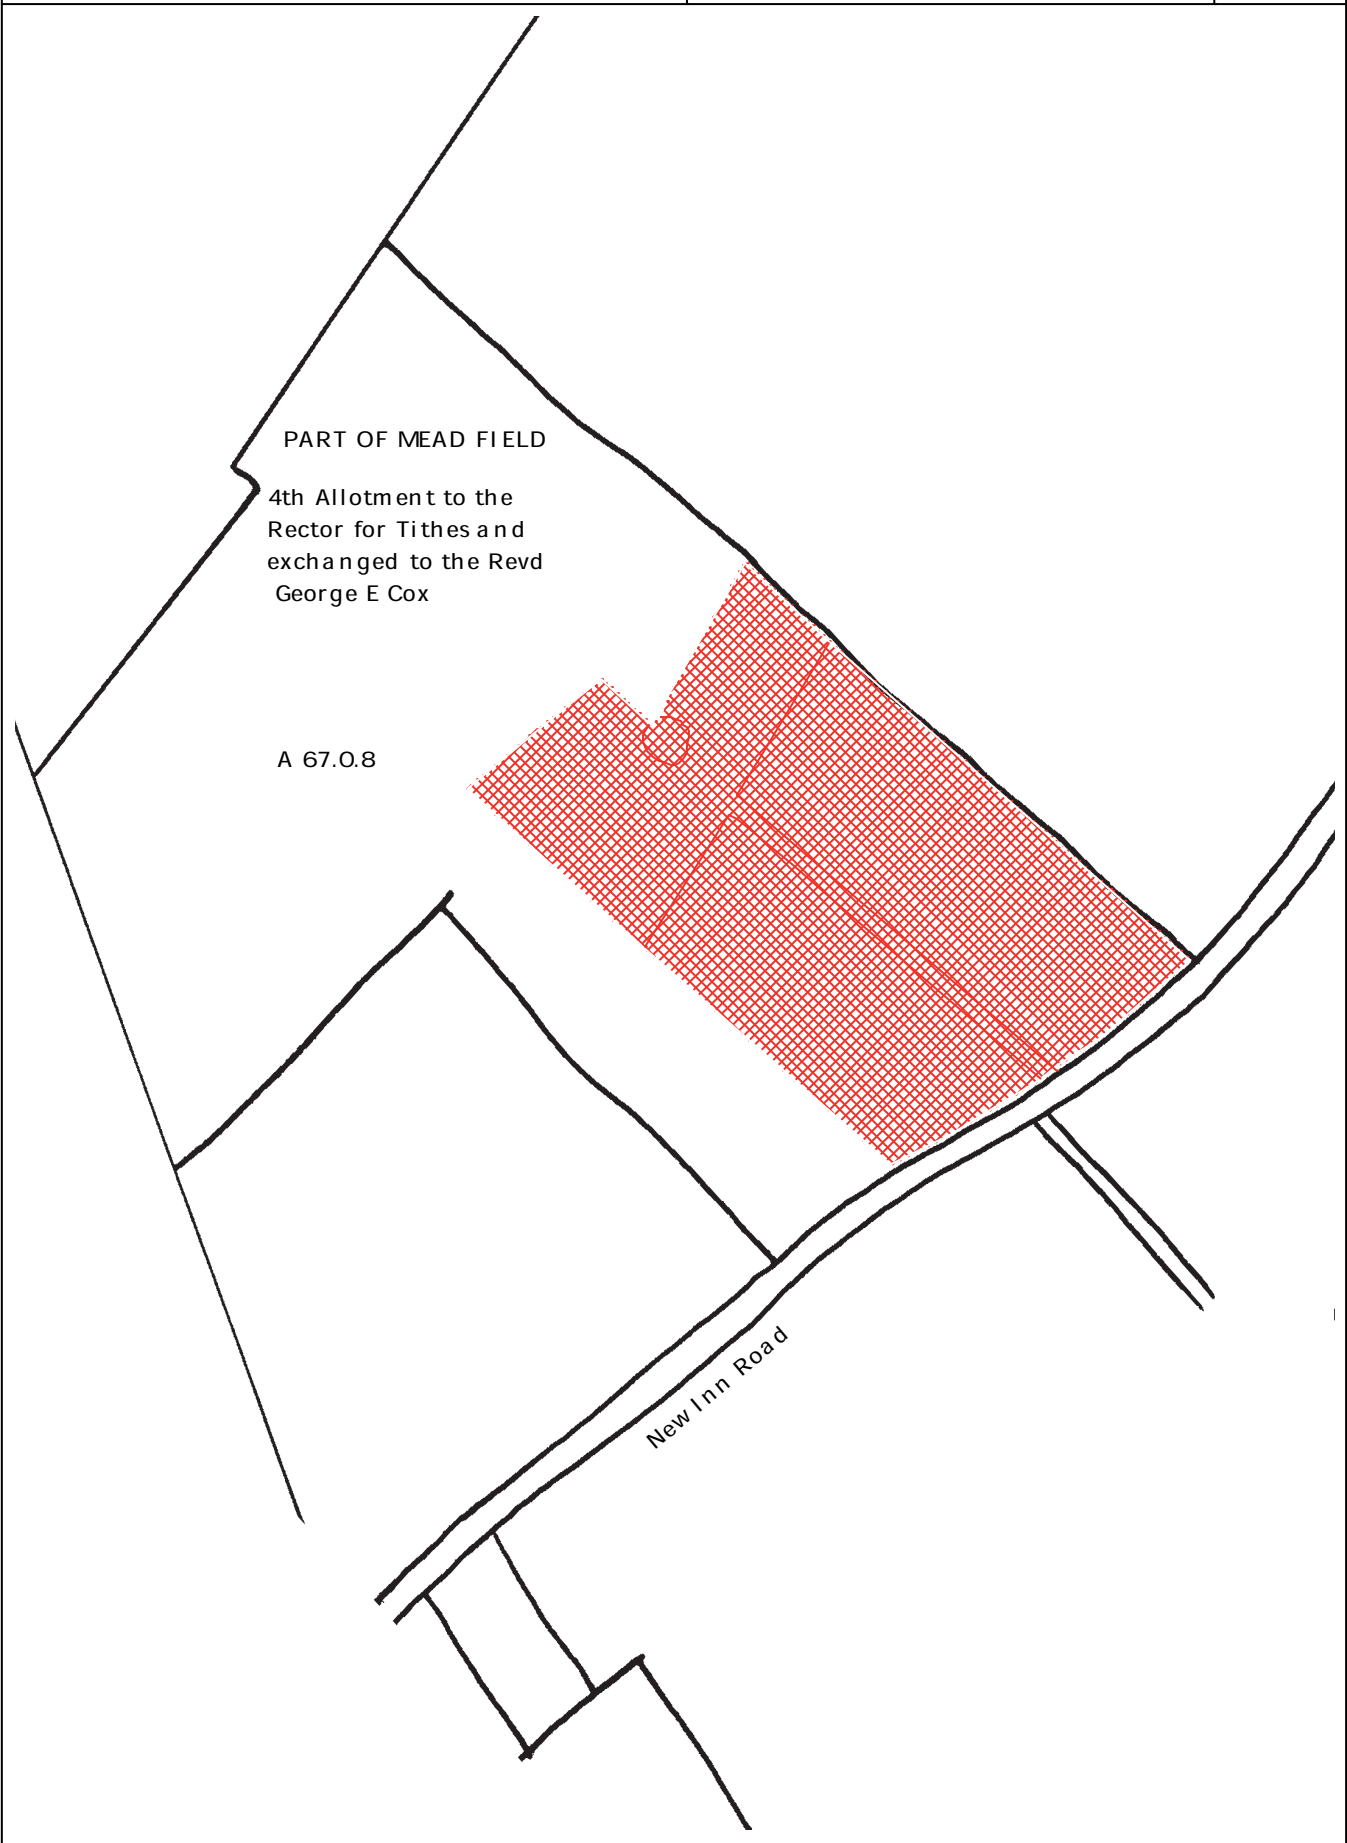
Figure 3

2.2 The earliest map consulted was the Hinxworth Inclosure Map of 1802 which shows the site as falling within a large L-shaped field, being part of Mead Field, and measuring 67 acres, 0 roods, and 8 perches (see Figure 3). No buildings are shown in the present location of Saltmore Farm.

Inclosure Map, 1802
(study area shown hatched)

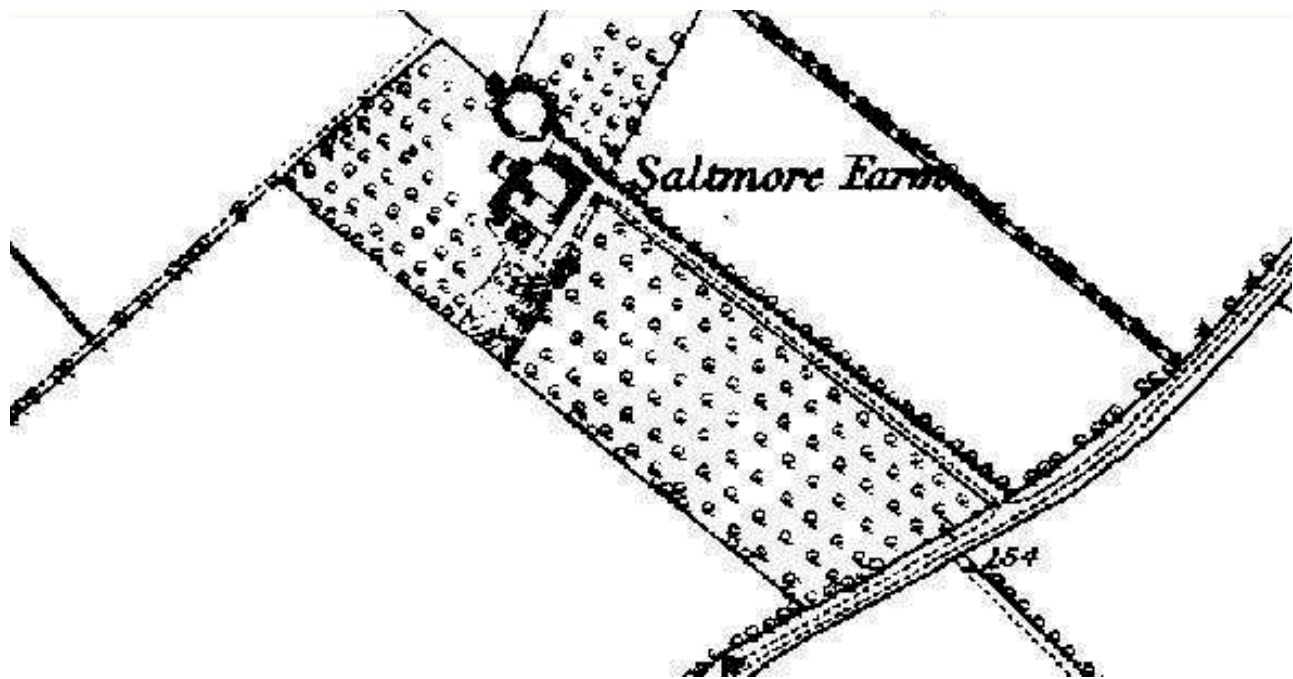
Figure 4

2.3 The 1st edition Ordnance Survey of 1882 shows the present site to be well established, with a pond to the north, and orchard occupying the field to the south (see Figure 4). The farmhouse is in existence together with Barn 1 and Barn 2. A building, which has an apparent porch on the north-eastern elevation and may be a threshing barn, is shown in the present location of Barn 3. The drive gives access to New Inn Road to the south-east.

Ordnance Survey, 1882

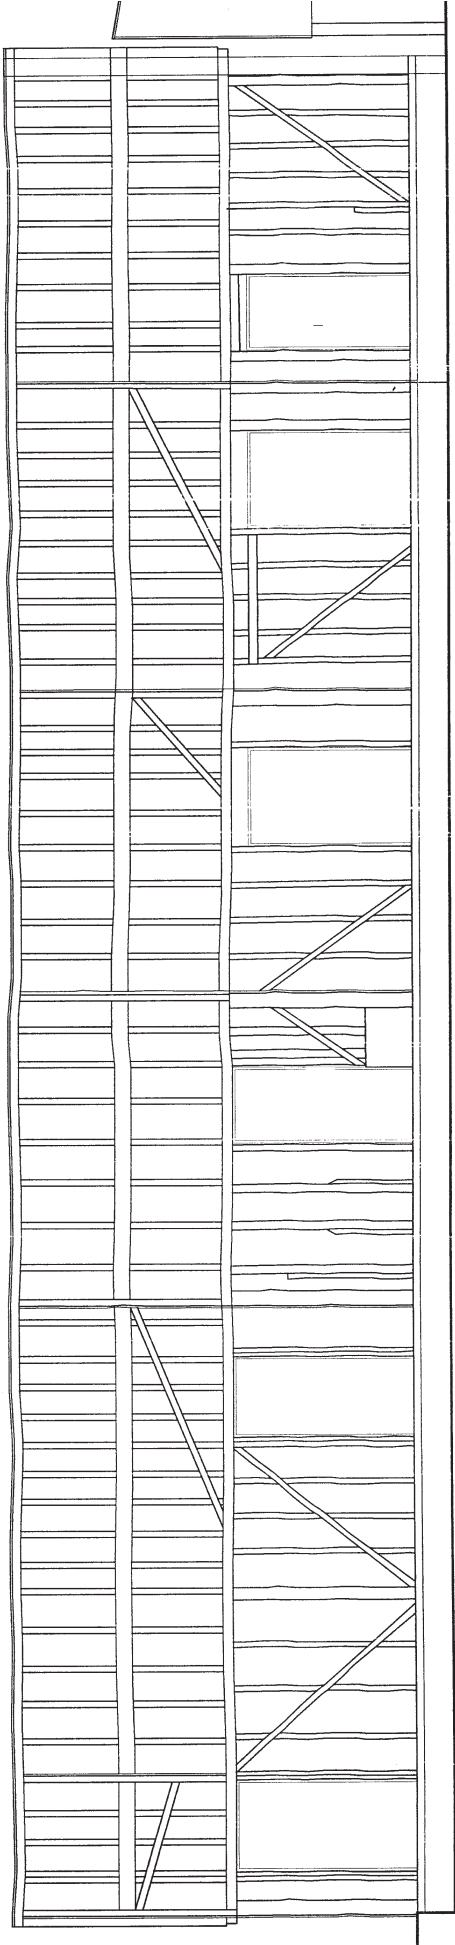
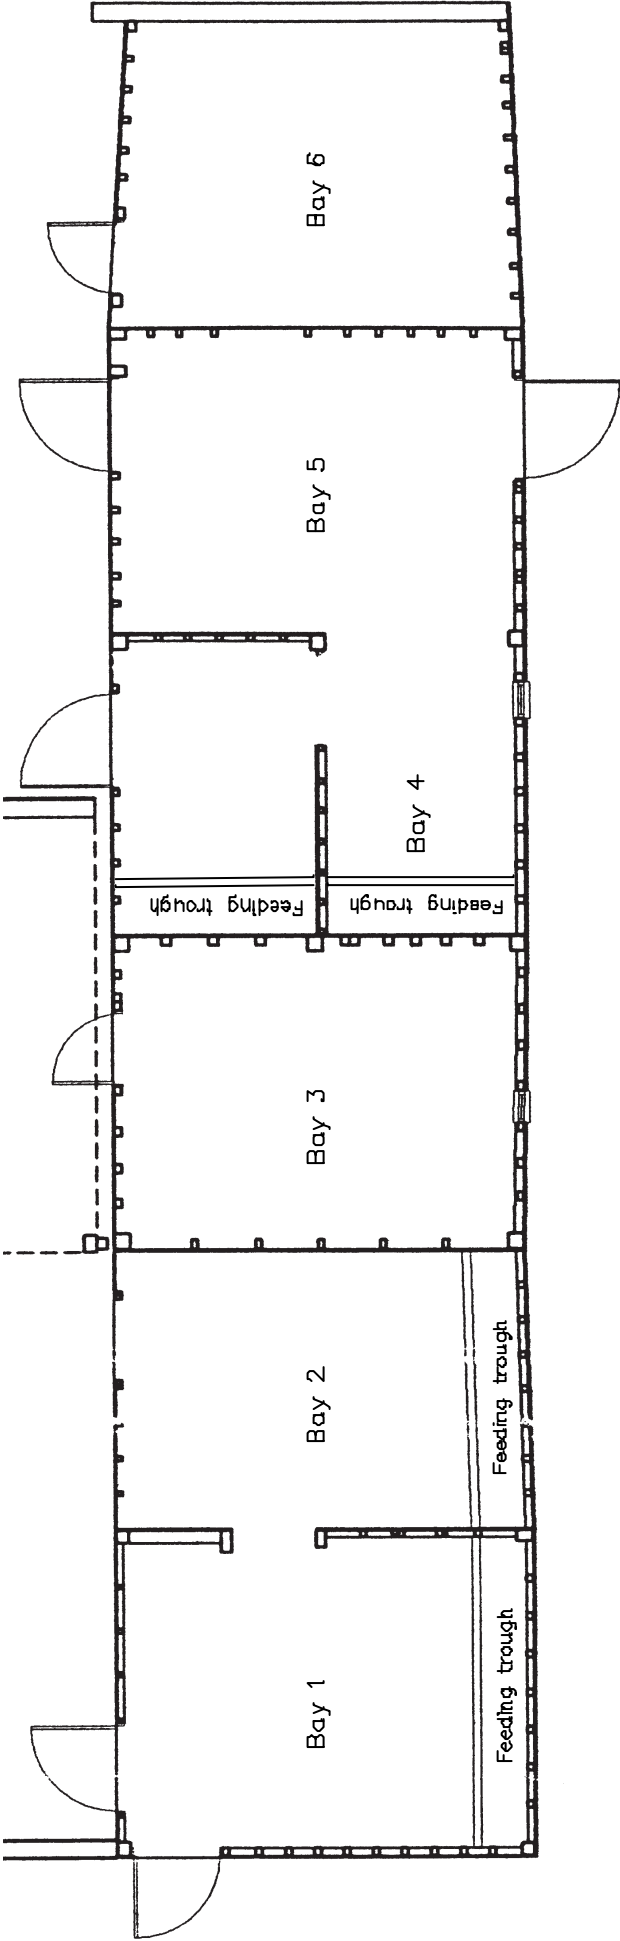
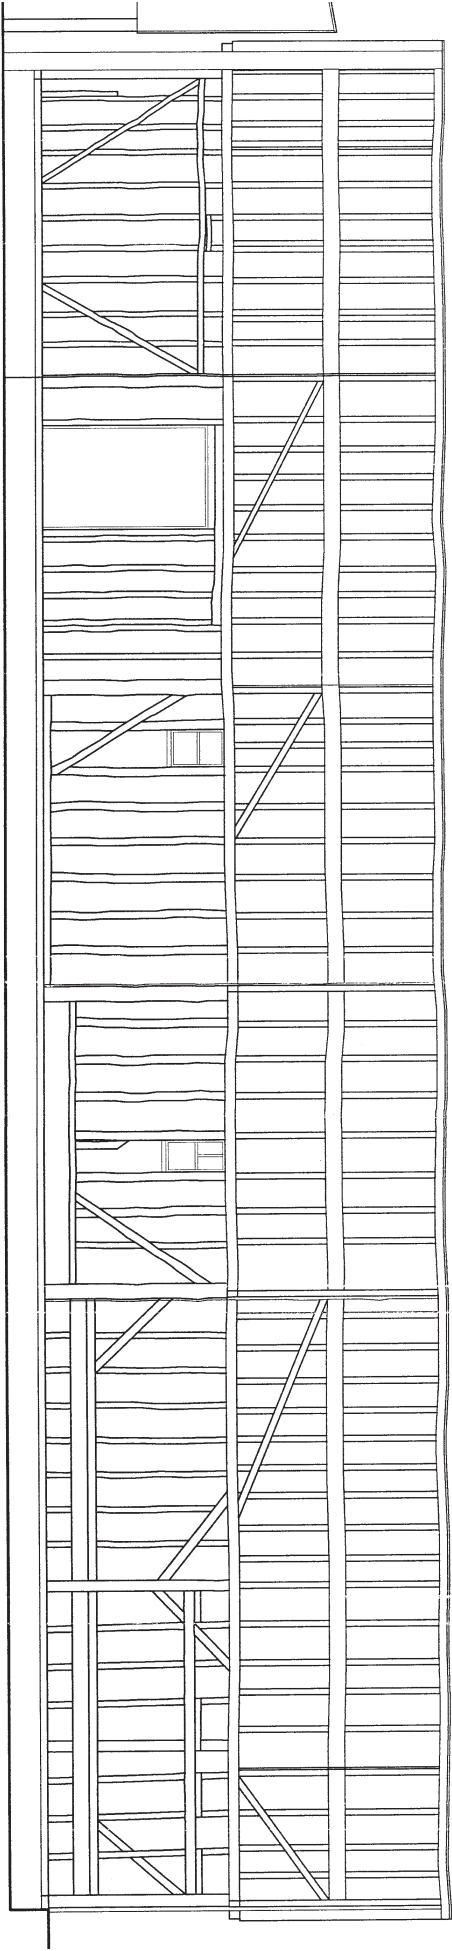
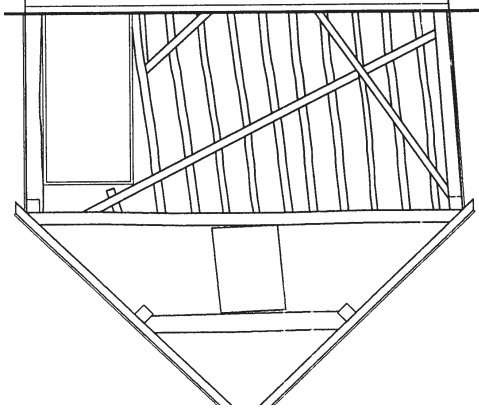
Figure 8

2.5 Barn 2 is a single storey timber-framed structure, measuring 22.5m (73'10") long by 5m (16'5") wide, and 5m (16'5") high from sole plate to apex (see Figure 8). The elevations are weatherboarded using elm in places, replaced by later softwood, over simple softwood framing with primary bracing. The sole plate rests on a red brick foundation with repairs using Cambridge white bricks. The roof is of clay tile and corrugated iron on replaced modern softwood rafters and purlins.

2.6 The barn is divided into six bays which represent different stages of construction. Bays 1 and 2 appear to be the earliest part of the structure, although close examination was not possible due to the instability of the framework. The principal posts are not jowled, and the queen struts to the roof trusses appear to be lapped and nailed suggesting a later 18th century date, at earliest. A partition and doorway divides Bay 1 from Bay 2, and feeding troughs are located against the south-eastern elevation. Doorways give access to the bays from the courtyard.

Barn 2:
Plan and interior elevations

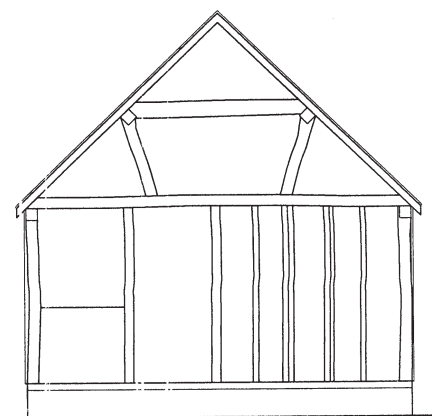
Bay 1 - 2

2.7 Bay 3 has been added on to Bay 2 using a splayed scarf joint to link the wall plates. The partition between the bays is faced with good quality pine attached on the inside of Bay 2. An

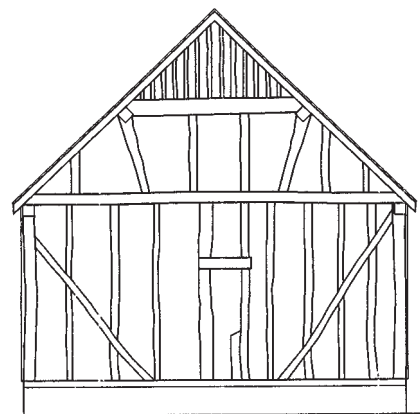
Bay 3 - 4

2.8 Bay 4 may be contemporary with Bay 3 but this could not be ascertained for certain. It is divided into two stalls across its width, each partitioned area having a feeding trough at its south-west end. An opening above the tie beam in the north-eastern partition suggests the former existence of a hay loft, which may be confirmed by the presence of a detached loft ladder stored in this bay. The wavy struts to the roof truss are indicative of a decline in carpentry skills. The floor appears to be earth. A door gives access to the courtyard.

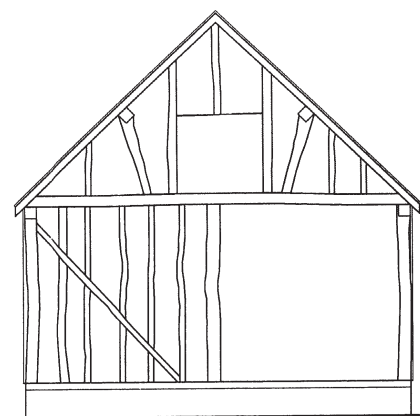
Bay 4 - 5

2.9 Bay 5 is a single-bay extension to the barn. The partition between Bays 4 and 5 is weatherboarded in wide (9-10") planks of softwood. Doors give access both to the courtyard and to the south-east. The floor is formed of brick.

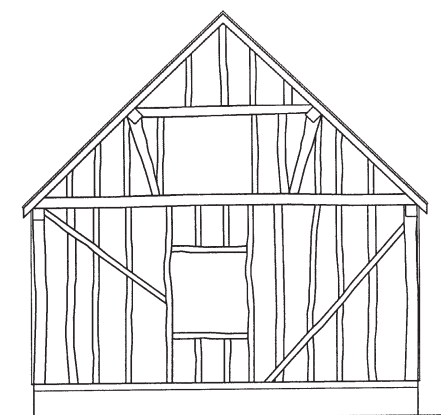
Bay 5 - 6

2.10 Bay 6 is a single-bay extension to the barn. The partition between Bays 5 and 6 is weatherboarded in wide (9-10") planks of elm. The gable end of the extension appears to be the end wall of another structure, possibly one of the predecessors to Barn 3, and is formed of Cambridge white bricks, bonded in lime mortar for the first 11 courses, with cement mortar above this level. A door gives access to the courtyard. The floor is of earth.

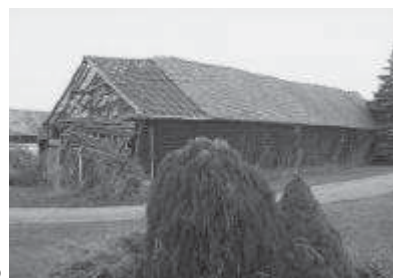
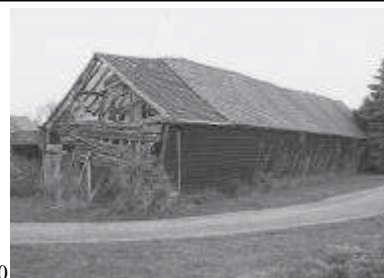
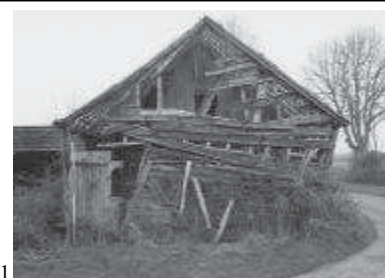
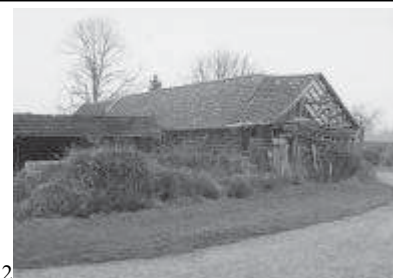
1/7	1/8	1/9	
Farmhouse, NE & SE elevations	General view, SW end of farmyard	Barn 2, SE & SW elevations

1/10	1/11	1/12	
Barn 2, SE & SW elevations	Barn 2, SW elevation	Barn 2, NW and SW elevations

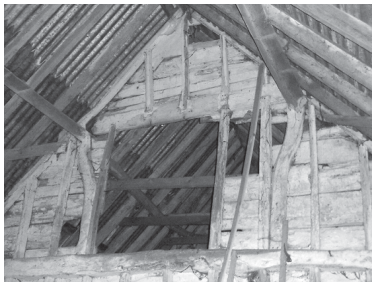
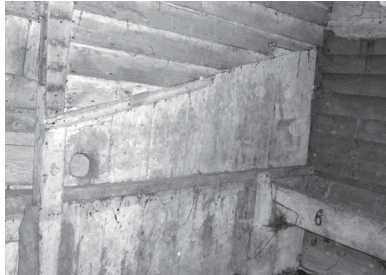
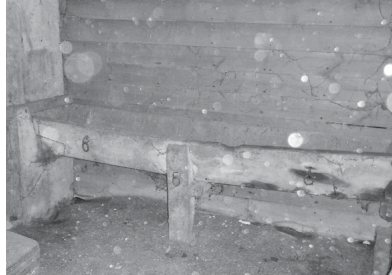
DP01: Upper SW facing partition Bay 5	DP02: Stall partition Bay 4	DP03: Trough Bay 4 (NW)

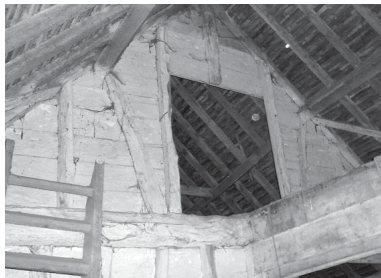
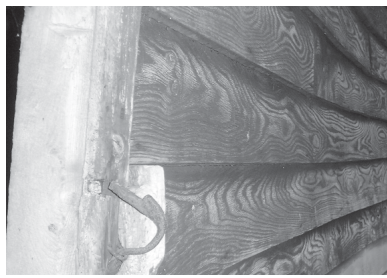
DP04: Hayloft in Bay 4	DP05: Stall partition in Bay 4	DP06: Elm weatherboard Bay 5 (NW elevation)

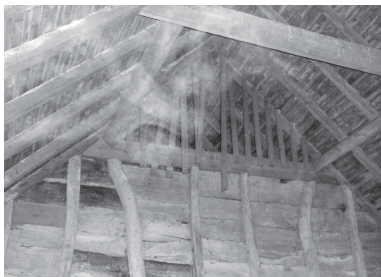
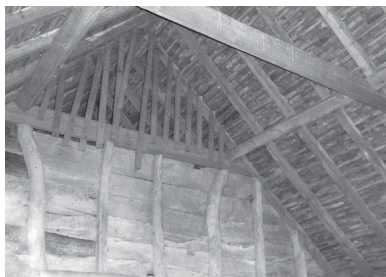
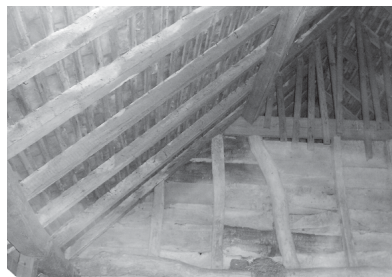
DP07: Upper SW facing partition Bay 3	DP08: Upper SW facing partition Bay 3	DP09: Upper SW facing partition Bay 3

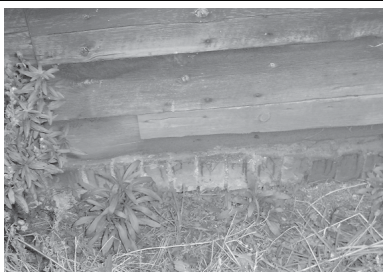
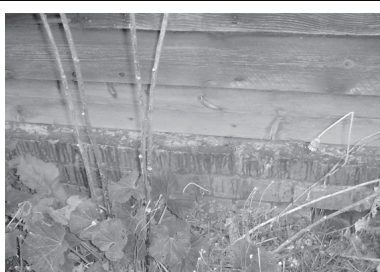
DP13: Brick foundation to SE elevation Bay 2	DP14: Brick foundation to SE elevation Bays 3-4	DP15: Brick foundation to SE elevation Junction Bays 4-5	
Digital Photos
