St MARY'S CHURCH Albury, Herts.

Archaeological Monitoring Report

Prepared on behalf of Albury Parochial Church Council

Report no.315

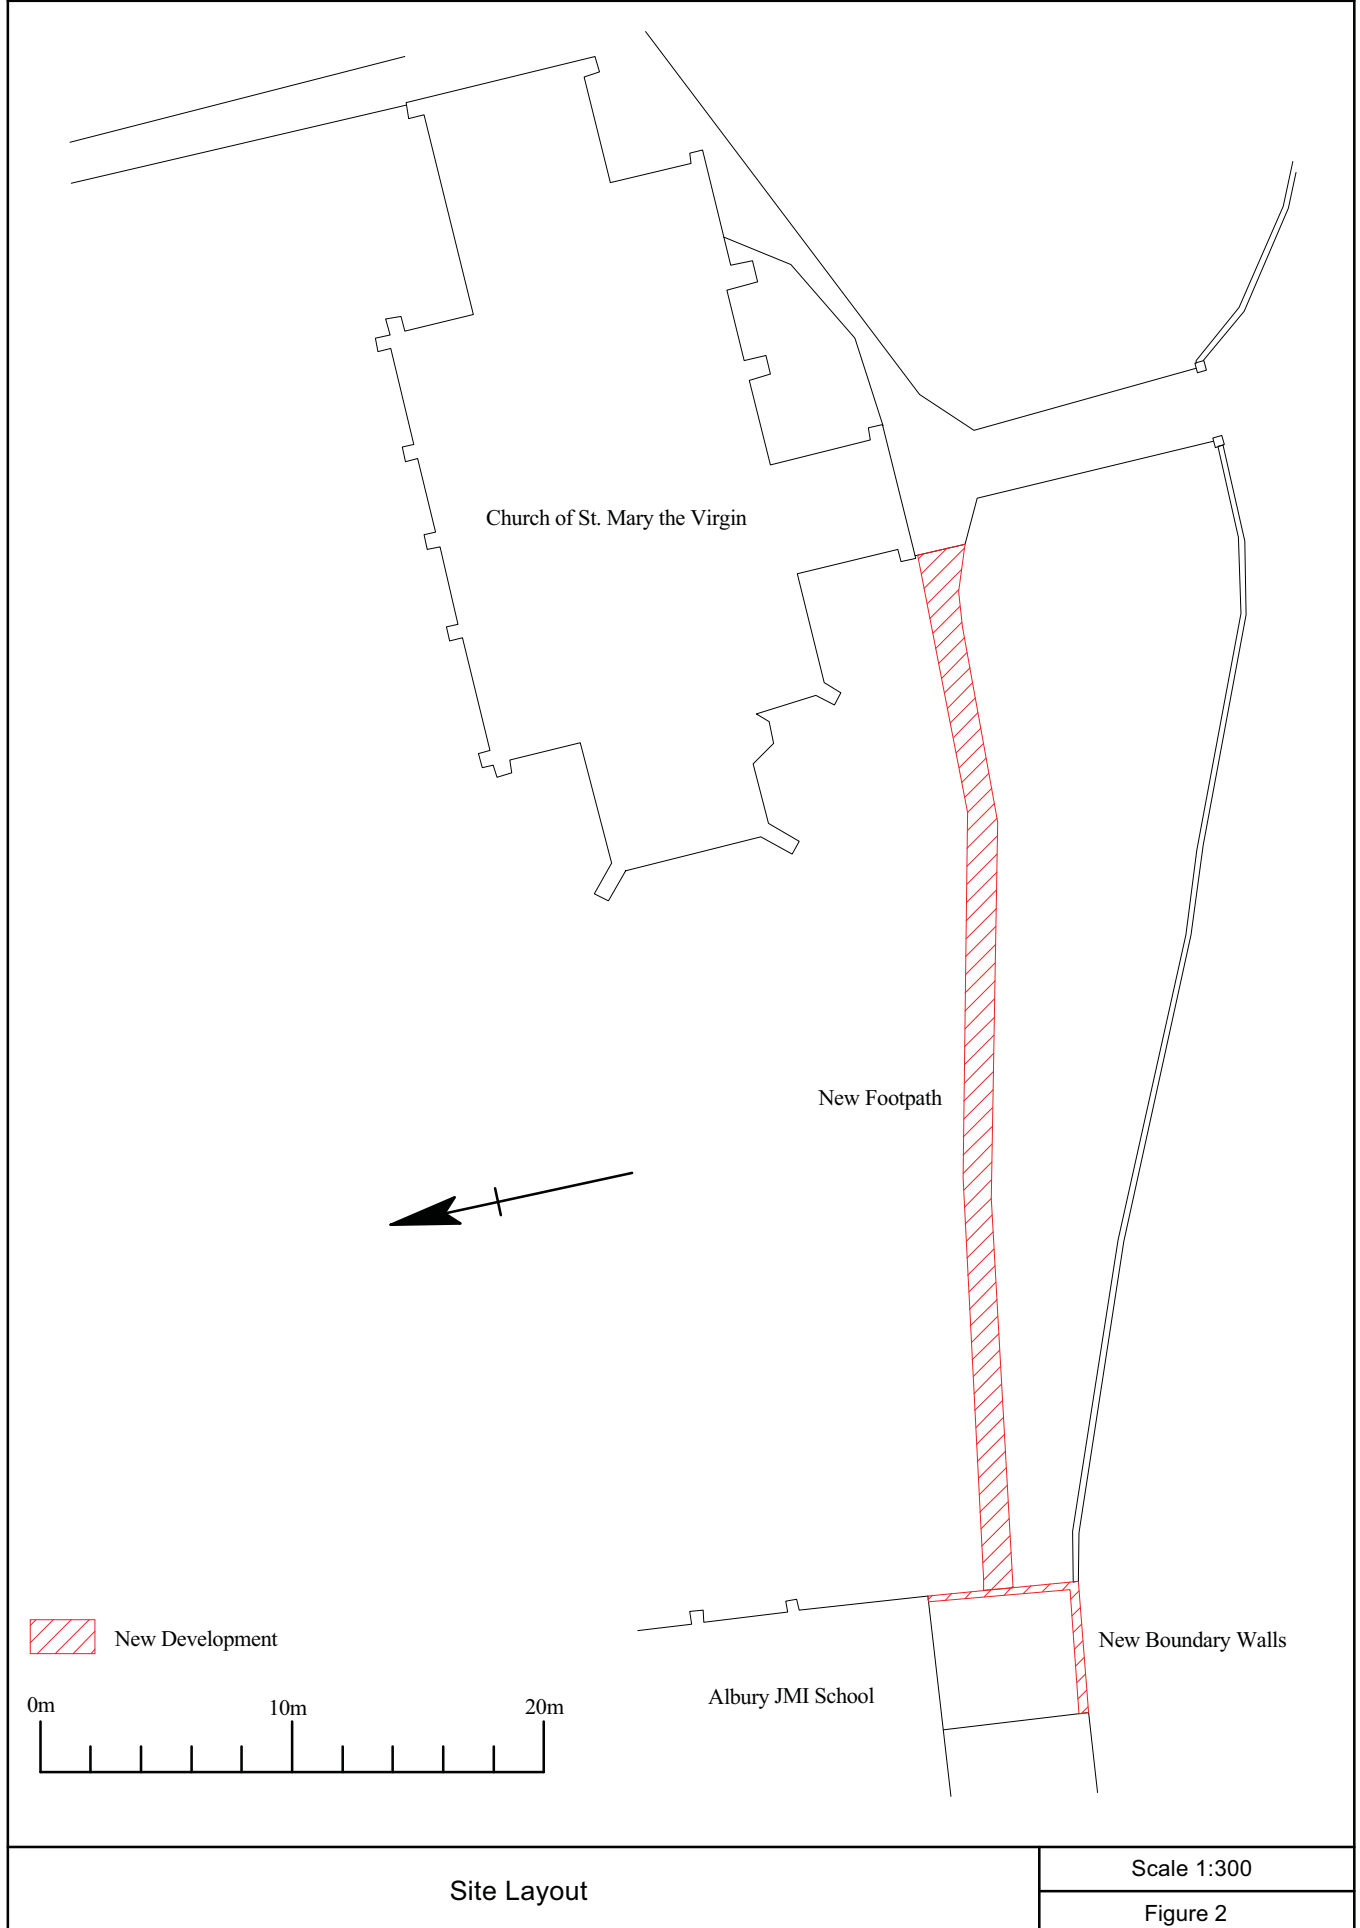
Figure 1	Site location
Figure 2	Site layout
Plate 1	Decorated Medieval Floor Tile

1.2 The site, centred on NGR TL 43527 24731, is located between the church and Albury School to the west. The development proposes the construction of a new path across the churchyard and a raised boundary wall.

2.7 The ground was reduced for the footpath to between 0.10m-0.20m below the current ground level and to a width of 1.30m. A patch of greyish brown gravel was observed below the topsoil close to the church and may be the remains of a path from the church porch to the tower door. A modern soakaway was also observed during excavation.

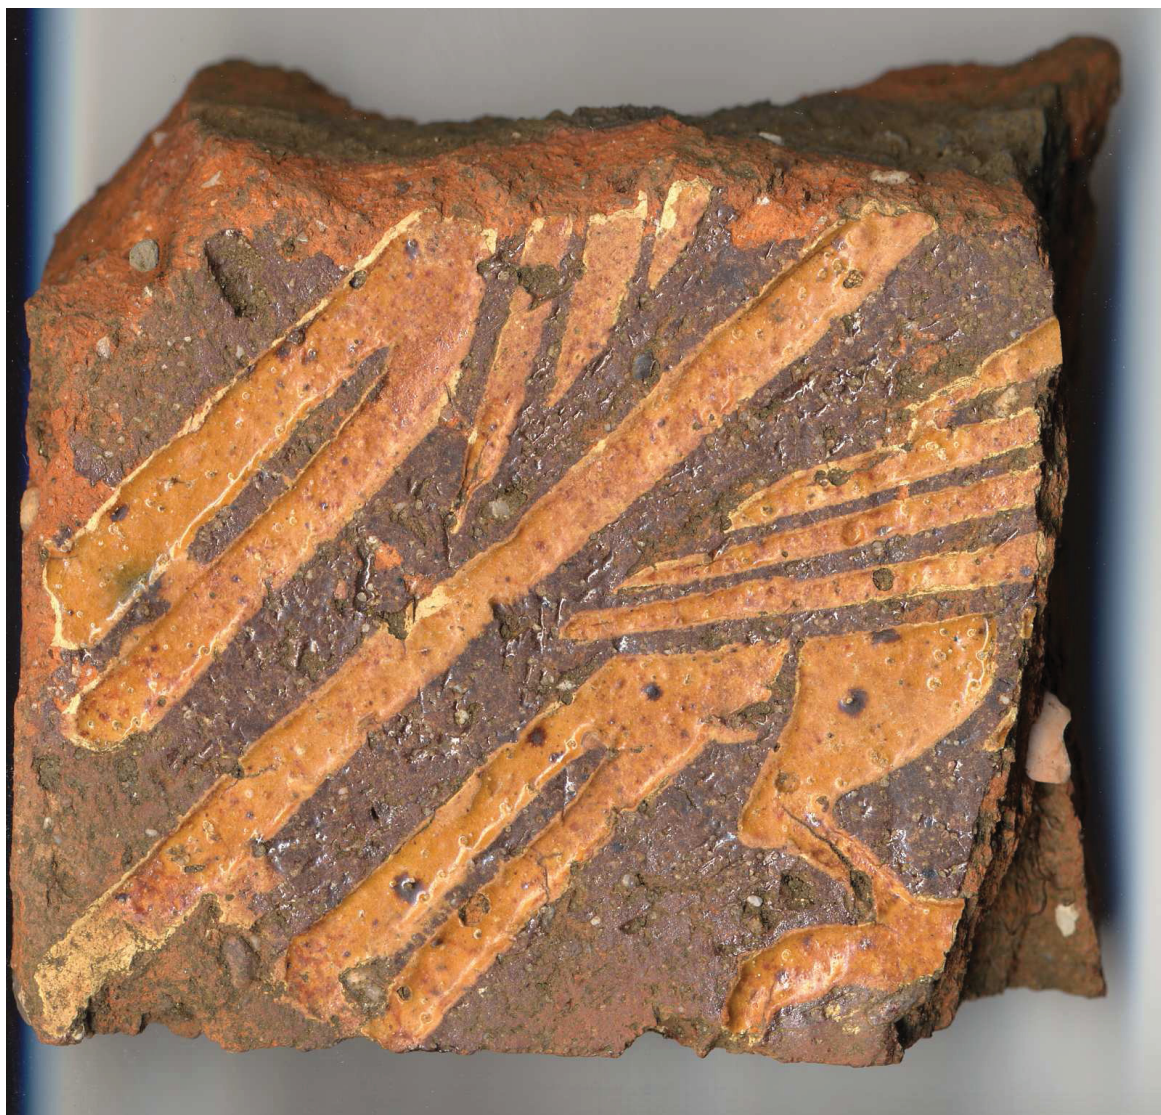
Plate 1

2.16 The decorated tile measured 52 x 61 x 22 mm and weighed 125g. The bird design on the tile is likely to have been created by stamping the design onto a plain unfired tile. This would then have been filled with a clay slip, and the tile covered with a lead glaze and fired. This type of decorated floor tile was popular between the 13th and 16th centuries.

Decorated medieval floortile

2.8 Two floor tiles, medieval in date, were recovered from within the topsoil during this process. One of the tiles was decorated with an inlaid bird design (Plate 1).

2.15 Two medieval floor tiles, were recovered unstratified from within the topsoil during the new footpath construction. Both appear to be of the same period. One of the tiles was decorated with an inlaid bird design. The plain tile measured 66 x 48 x 39 mm and weighed 165g.
