## **PEACE CLOSE** **Goffs Lane, Cheshunt, Herts.**

### *Archaeological Monitoring Report*

*Prepared on behalf of Aldwyck Housing Association*

Report no.327

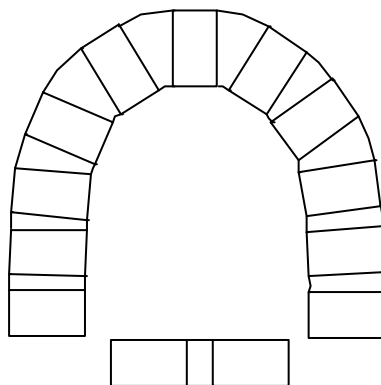
**2.16** Arched brick culvert [04] was observed in the northernmost footings trench, running on a north-west – south-east alignment. The culvert measured 0.5m wide by 0.5m deep, and was constructed of

unfrogged red bricks bonded with lime mortar. The base of the culvert was formed by a course of bricks two courses wide by one course deep. The bricks measured approximately 220 x 100 x 60mm (8.5 x 4.5 x 2.5 inches), and have been dated to the early 18<sup>th</sup> century. The culvert is likely to be associated with the former northern wing of the Great House.

*Profile of Brick Culvert [04]*
