**'APPLEGARTH'**  
**53 Stocks Road, Aldbury, Herts.**

HN528

*Historic Buildings Record*

Report no.301

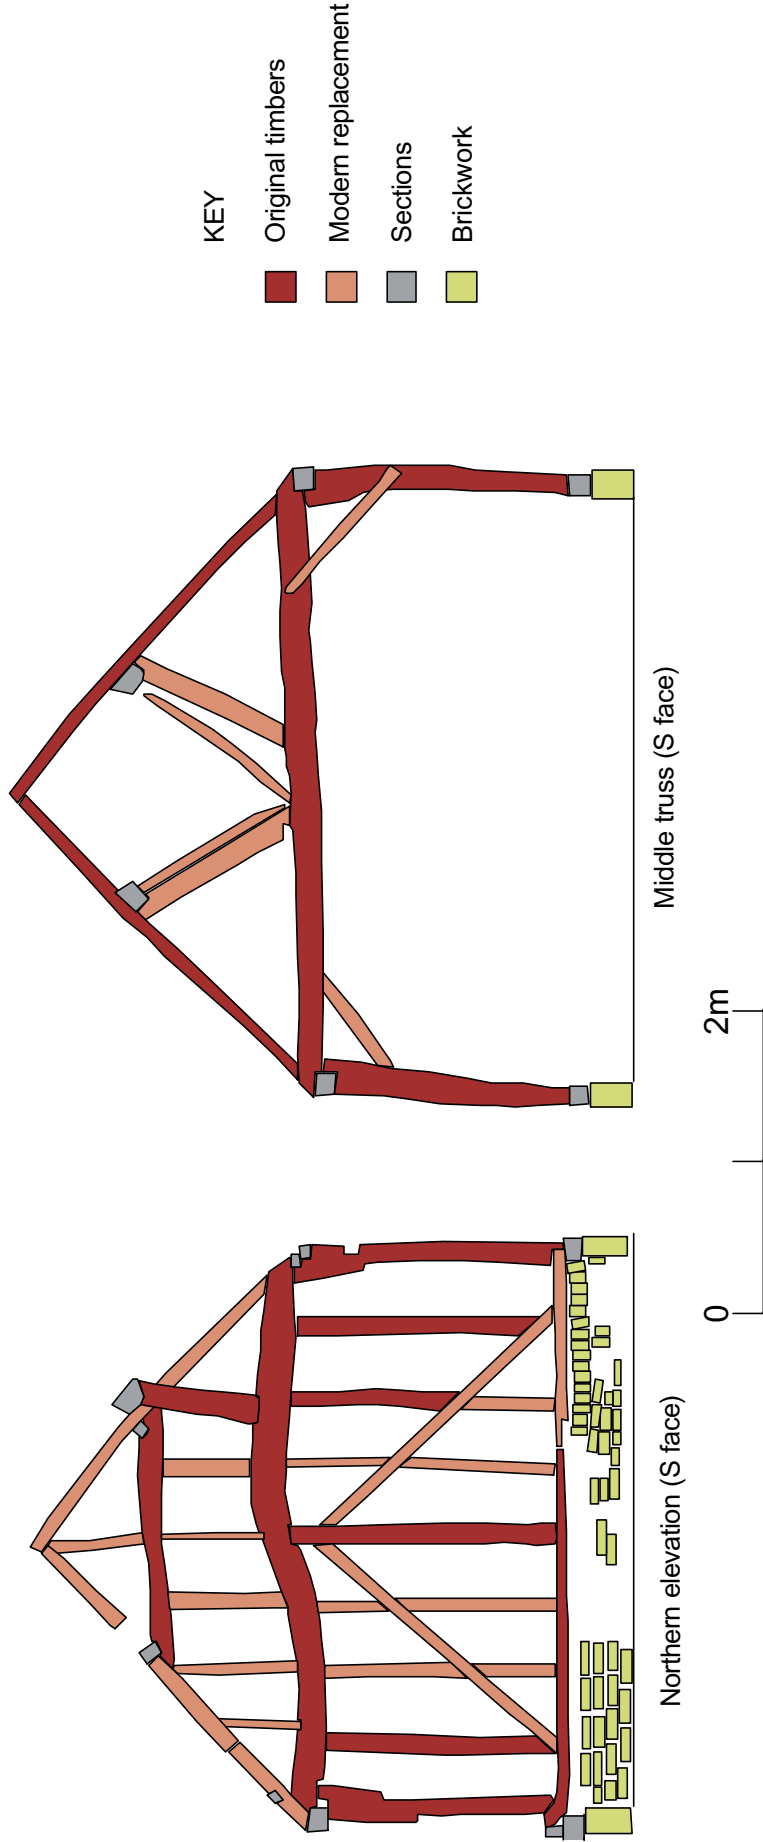
Barn Sections

**2.6** The northern end wall of the structure has jowled and stopped principal posts, and the middle roof truss has raking queen struts (Figure 10). The tie beam is probably original, on original posts, but the queen struts are replacements. A single carpenter's mark was noted on the principle rafter above the tie beam on the western side (Plate 5).

**2.16** Although the barn has been much altered over time, much of the basic frame, including the principal posts, wall plates, and the central truss of this two bay structure are likely to be original. From these it is possible to suggest a date of c. 1600 for the barn’s construction, based on the stopped jowls and the raked queen struts. Such a date would fit with the documentary sources which indicate that there was a house on the property in 1598.

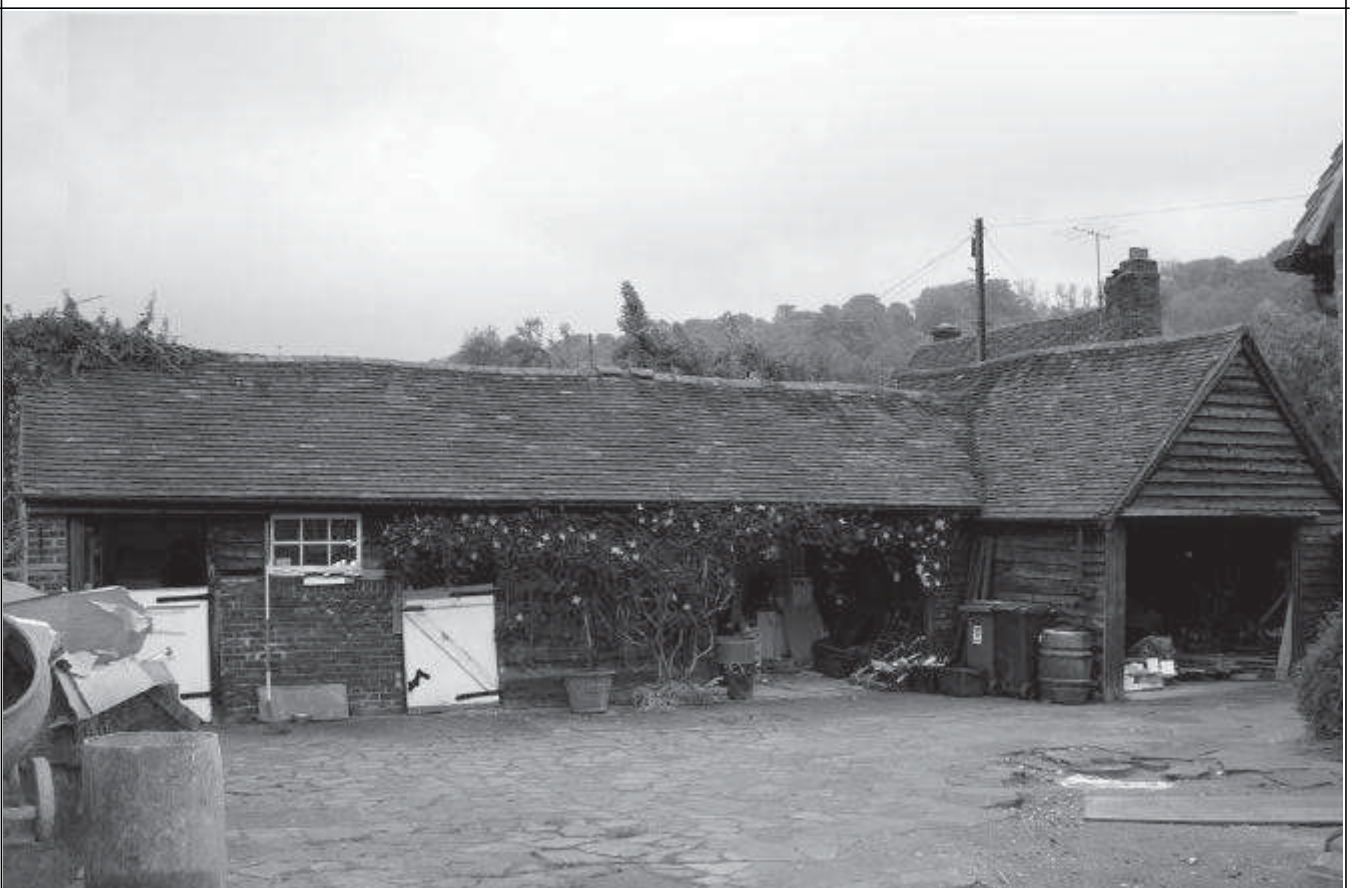
Plate 2: Barn and stable block looking NE

**2.1** The site consists of a dwelling house of at least 17<sup>th</sup> century date, with a 19<sup>th</sup> century northern extension, and a separate barn, stables and greenhouse to the north (Plate 1). The house, which is Grade II listed, lies outside the present planning application and is, therefore, excluded from the study. The barn, stables and greenhouse have planning consent for conversion to residential use (Plate 2).

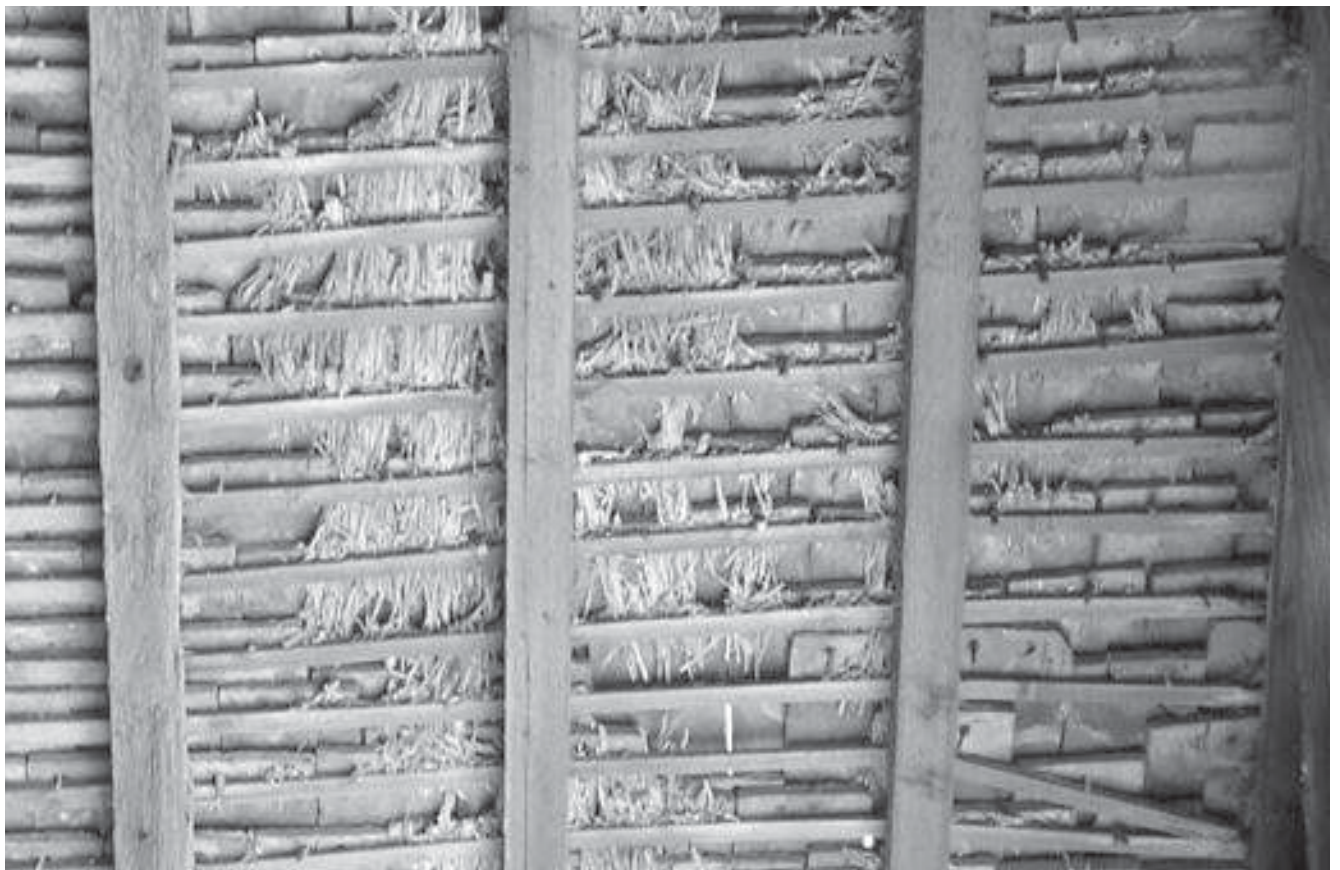
Plate 6: Straw 'torching' in barn roof

**2.7** The roof purlins consist of split tree trunks, roughly debarked, which may be original, though the rafters have been largely replaced. It is likely that the roof was originally thatched, but now consists of clay tiles, the older parts of which are pegged with wood, and bedded on straw ‘torching’ (Plate 6).

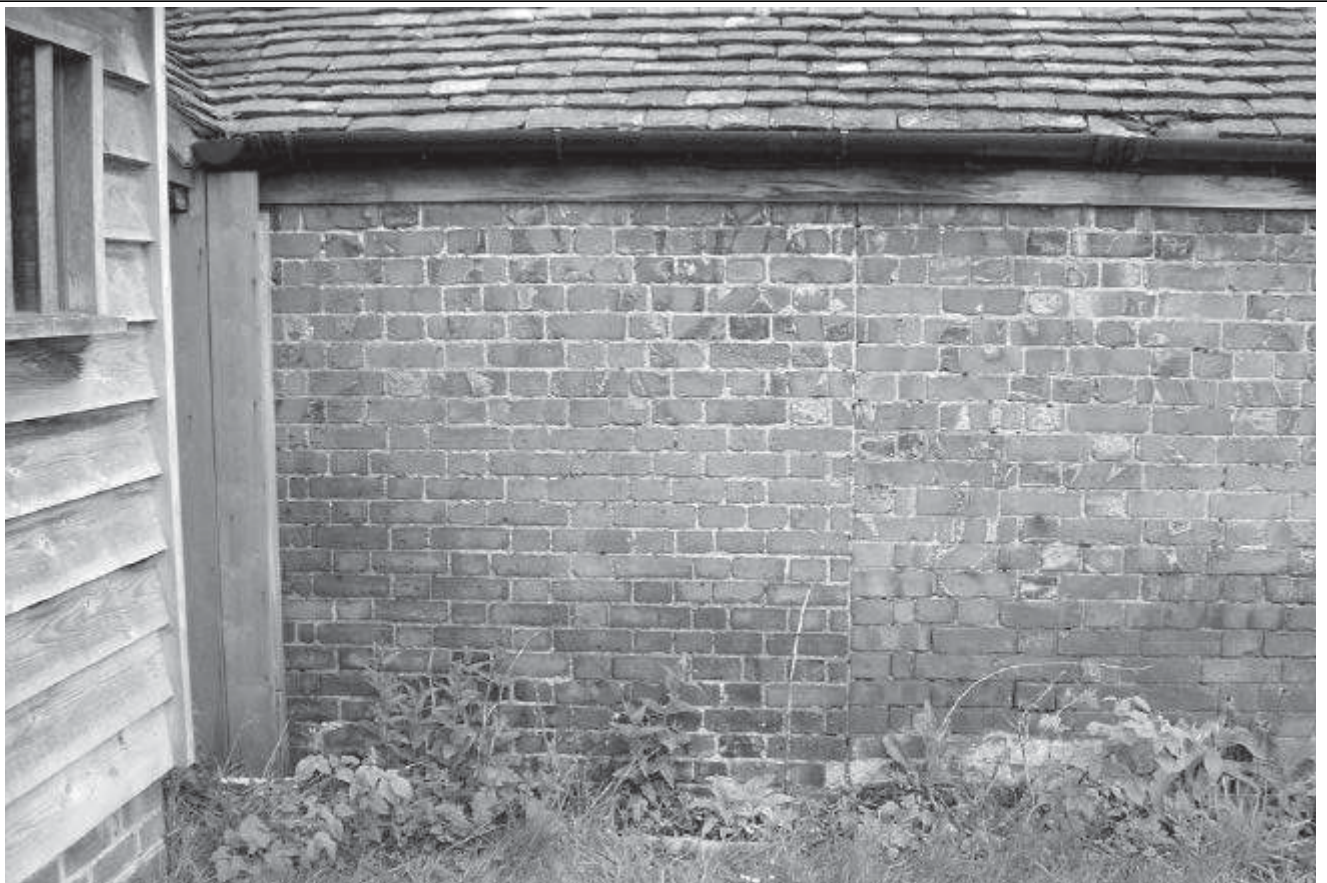
Plate 8: Stables, blocked through way

**2.11** The northern elevation and the western gable are in a mixture of normal and vitrified brick in Flemish bond with a lime mortar. At the western end of the northern elevation an entrance or through way has been blocked in similar brick, slightly out of alignment (Plate 8). The through way is defined by a buttress on the internal elevation. The roof is of clay tile.

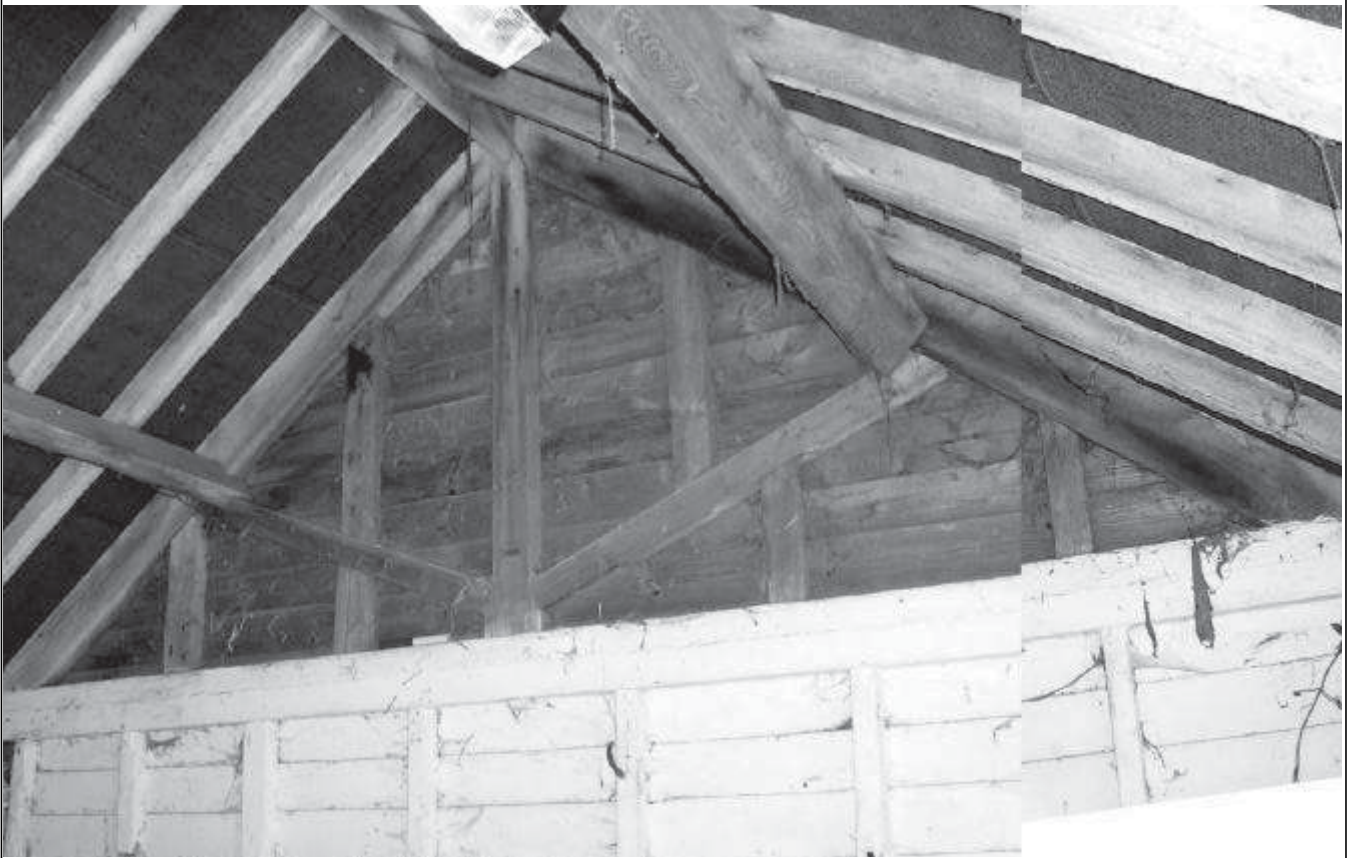
Plate 9: Stables: roof truss

**2.13** The roof trusses appear to be pre-formed and are likely to be late Victorian in date (Plate 9). The purlins and rafters are of sawn softwood.

**2.17** The stables are of a later Victorian type, with manufactured roof trusses and cast iron stanchions supporting an originally open front elevation. The cartographic evidence suggests that the present building replaced an earlier east-west extension to the barn between 1884 and 1899, although the evidence of the only available version of the 1884 Ordnance Survey map is unclear.
