FORMER JENYNS SCHOOL **The Street, Braughing, Herts.**

Historic Buildings Record

Report no.314

November 2005

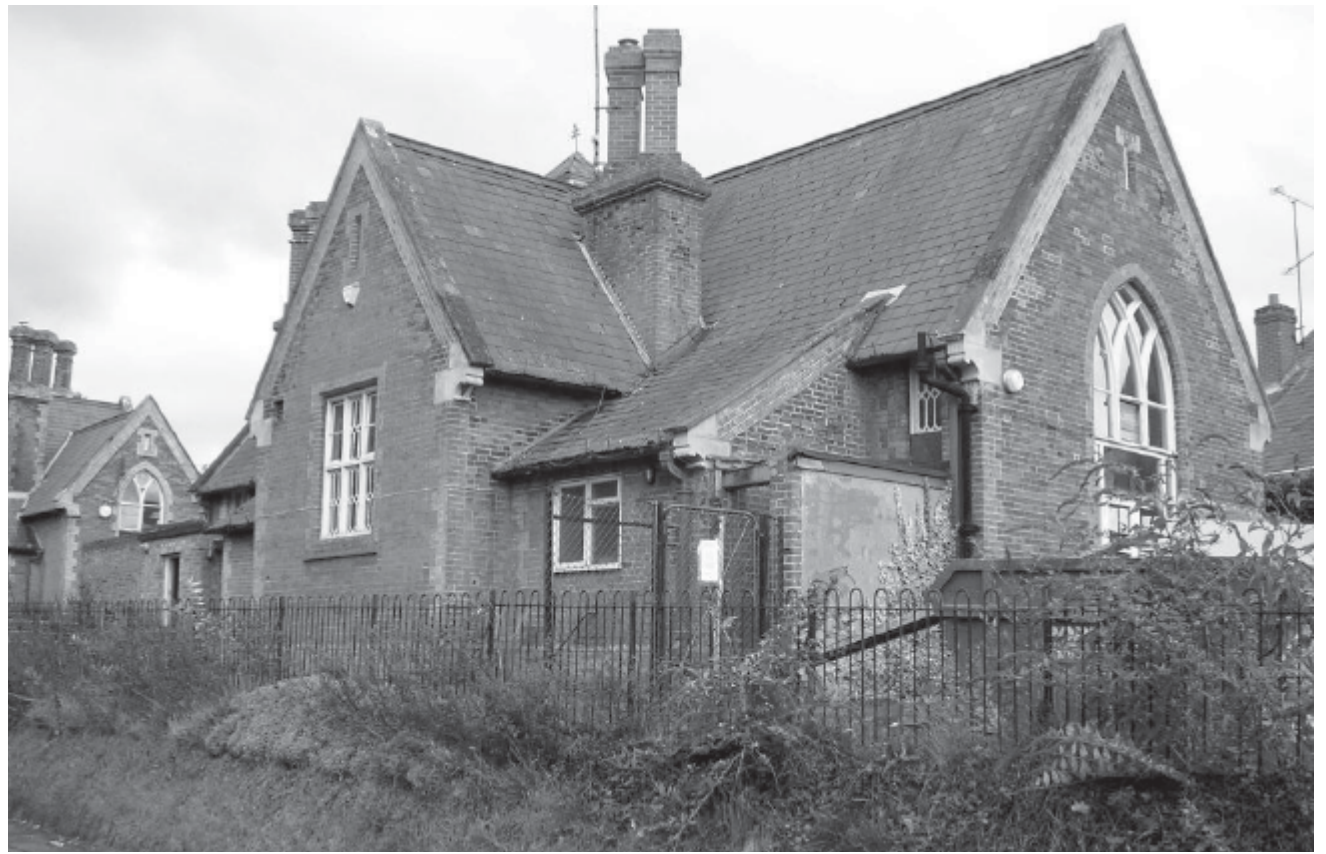
Plate 1: Building 1, northern and western elevations

2.4 A twin-flue chimney aligned east-west occupies the angle between the main building and the northern extension. The breast, which is dressed in white bricks laid in a pattern of long and short work, has a cornice formed of simple brick offsets, surmounted by diagonally set stacks which appear to have been renewed (Plate 1).

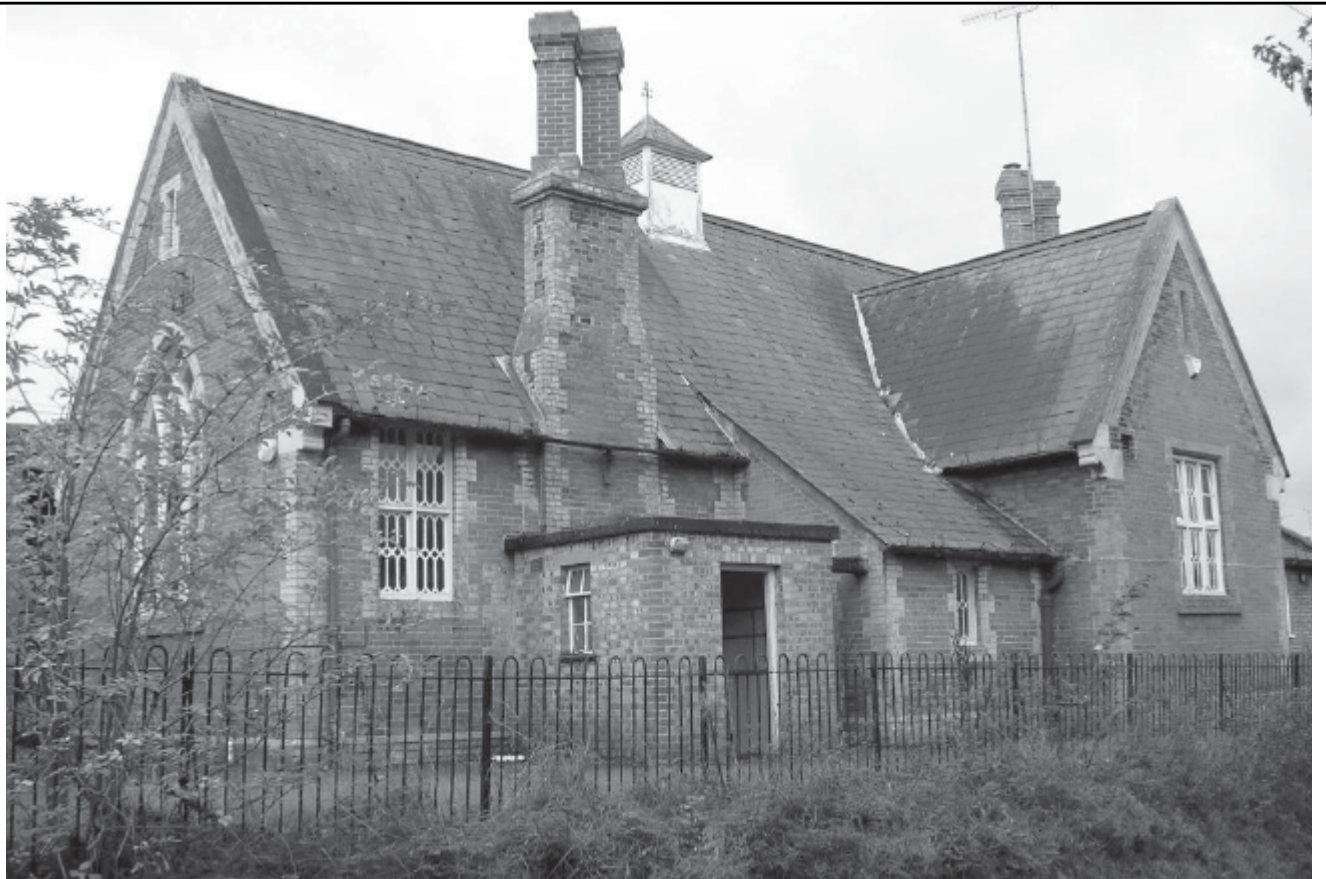
Plate 2: Building 1, northern and eastern elevations

2.5 A further twin-flue chimney occupies the middle of the eastern end of the northern elevation. It exhibits similar decoration but the breast is hipped above the level of the eaves (Plate 2).

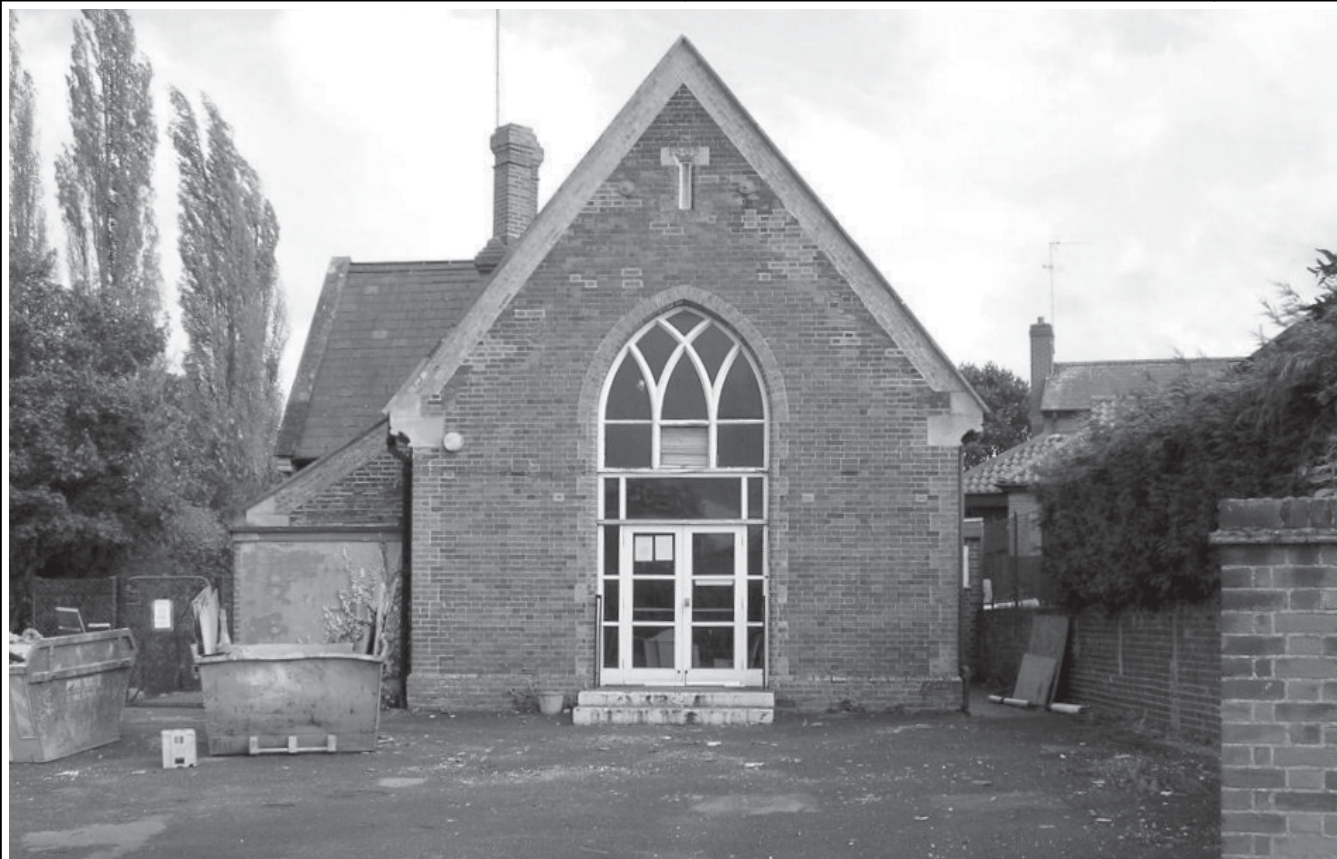
Plate 3: Building 1, western gable end

2.7 The western exterior elevation exhibits decorative long and short quoins in white bricks, laid flush in blocks three bricks high (Plate 3). At the base of the wall is a chamfered string-course, also in white bricks. The gable springs from a moulded limestone corbel topped by a chamfered block of limestone, the northern pair having been renewed. The coping to the gable is in limestone resting on a four brick high band of white bricks, laid to follow the roof line.

2.8 Below the ridge, a tall and narrow vent can be seen. The lintel is in limestone with the date 1868 carved in relief, but the opening is otherwise dressed in white bricks. It is flanked by two circular tie-rod plates.

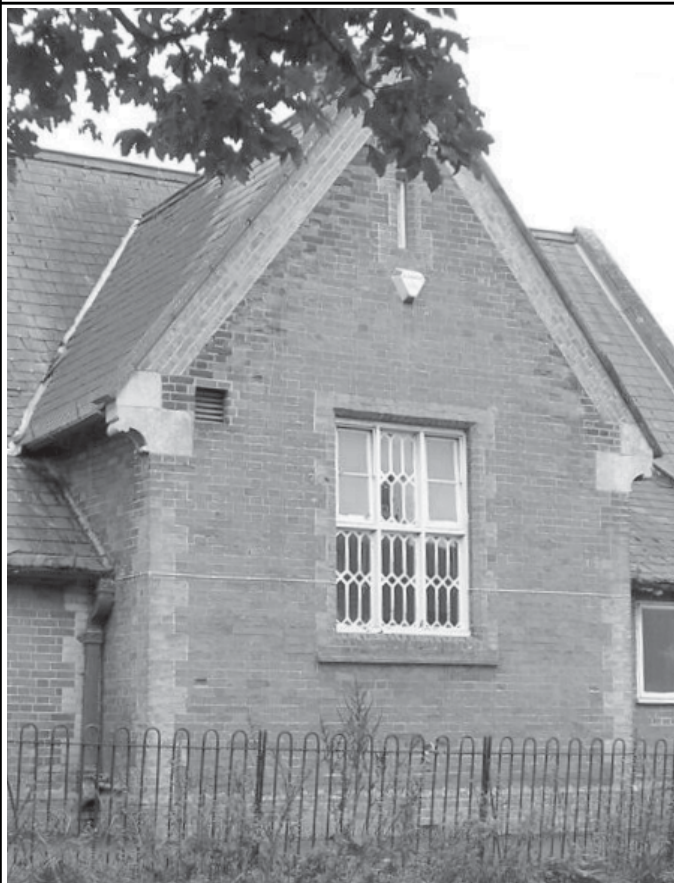
Plate 4: Building 1, central extension

2.10 The gable end of the central extension is built in similar fashion to the western gable end, with the exception that the window is square headed, and divided into six panels, each formed of small decorative panes in elongated hexagon and diamond pattern (Plate 4).

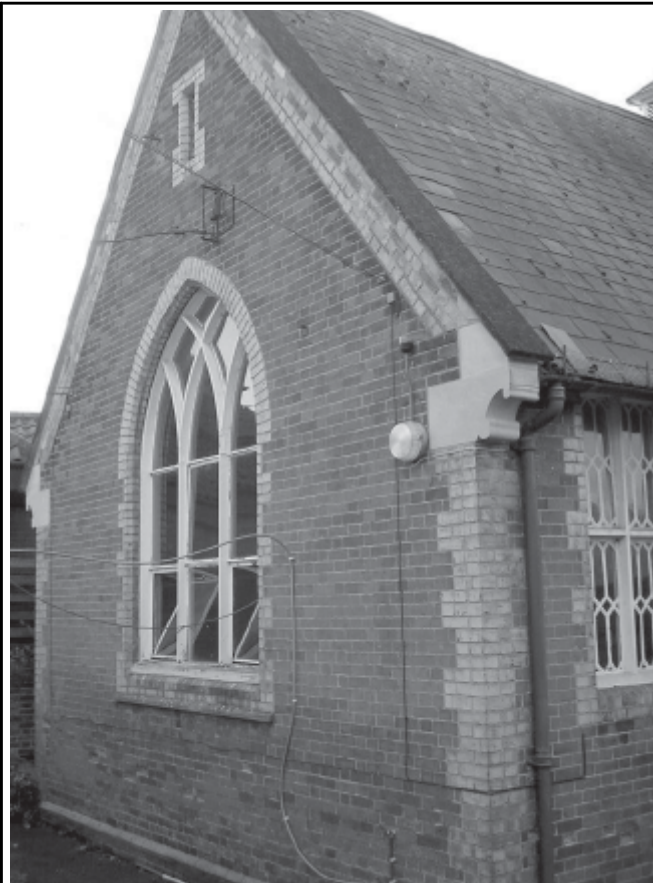
Plate 5: Building 1, eastern gable end

2.15 The eastern gable end is a mirror of the western gable end, reflecting what this would have looked like before it was remodelled. The window may be a later replacement. The lintel to the vent beneath the ridge is in white brick rather than the limestone block seen on the west (Plate 5).

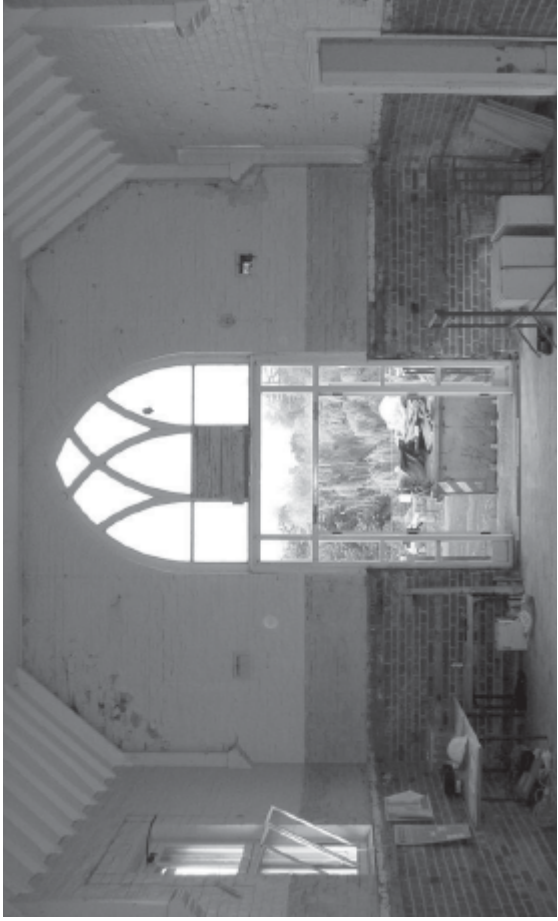
Plate 6: Building 1, Classroom 1, western elevation

2.17 The western classroom is an open hall, originally panelled to 1.5m (5') in height. The western elevation has a large pointed arched window opening which has later been remodelled to create a glazed entrance way of the same width (Plate 6).

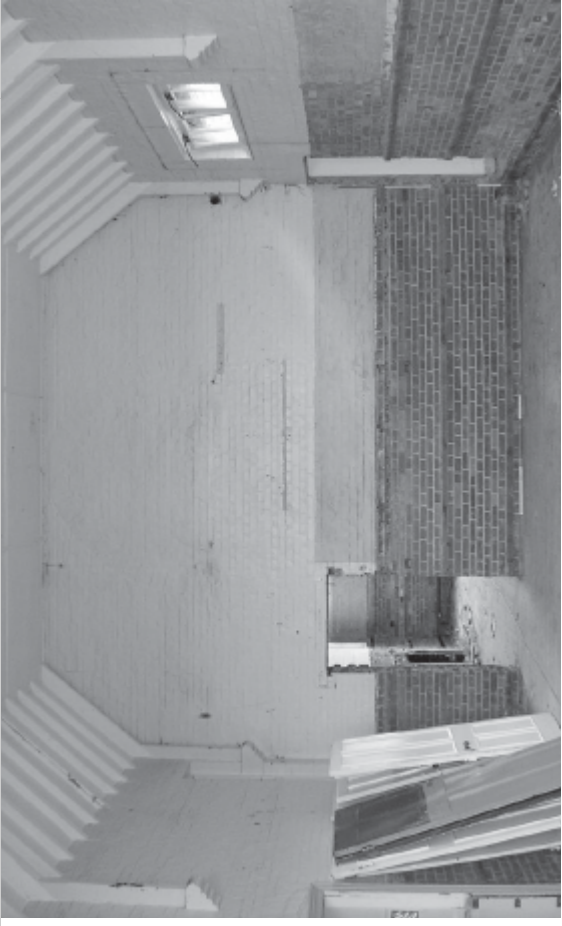
Plate 7: Building 1, Classroom 2, eastern elevation

2.18 The eastern elevation has a blocked pointed arched opening which is likely to form the site of an earlier window similar to that found in the western elevation. An doorway into Classroom 2 has been cut in the northern half of this elevation. The lintels are wood, suggesting an earlier twentieth century date (Plate 7).

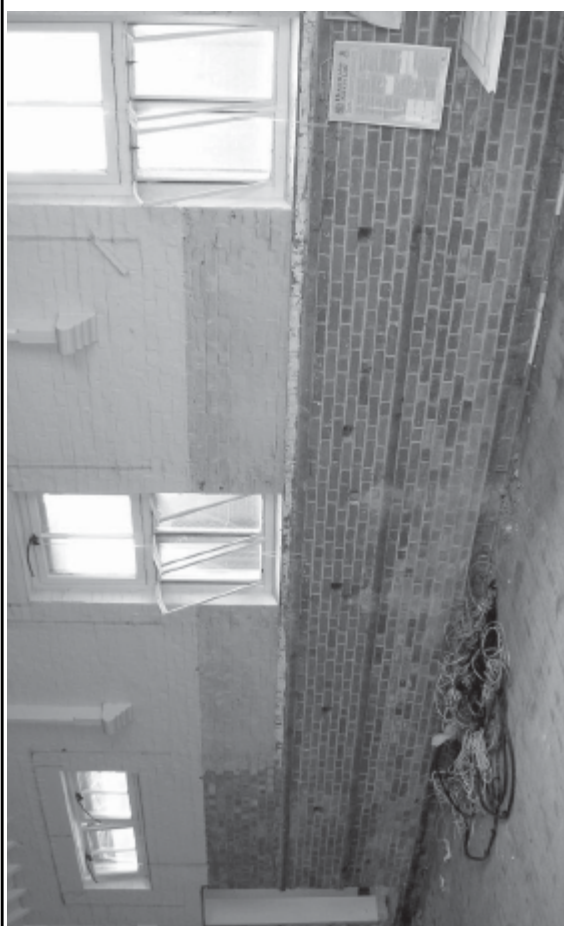
Plate 9: Building 1, Classroom 1, southern elevation

2.20 There are three windows along the southern elevation, each of 2 lights. The top light of the western two windows is hinged at the base and pivots on a geared rail. The 2 lights of the eastern window are side by side, the opening having been remodelled to accommodate the construction of a lavatory block in the 1960s or '70s. All these windows appear to be replacements, probably contemporary with the extension. At the far eastern end of the elevation, a doorway has been inserted to give access to the lavatory block.

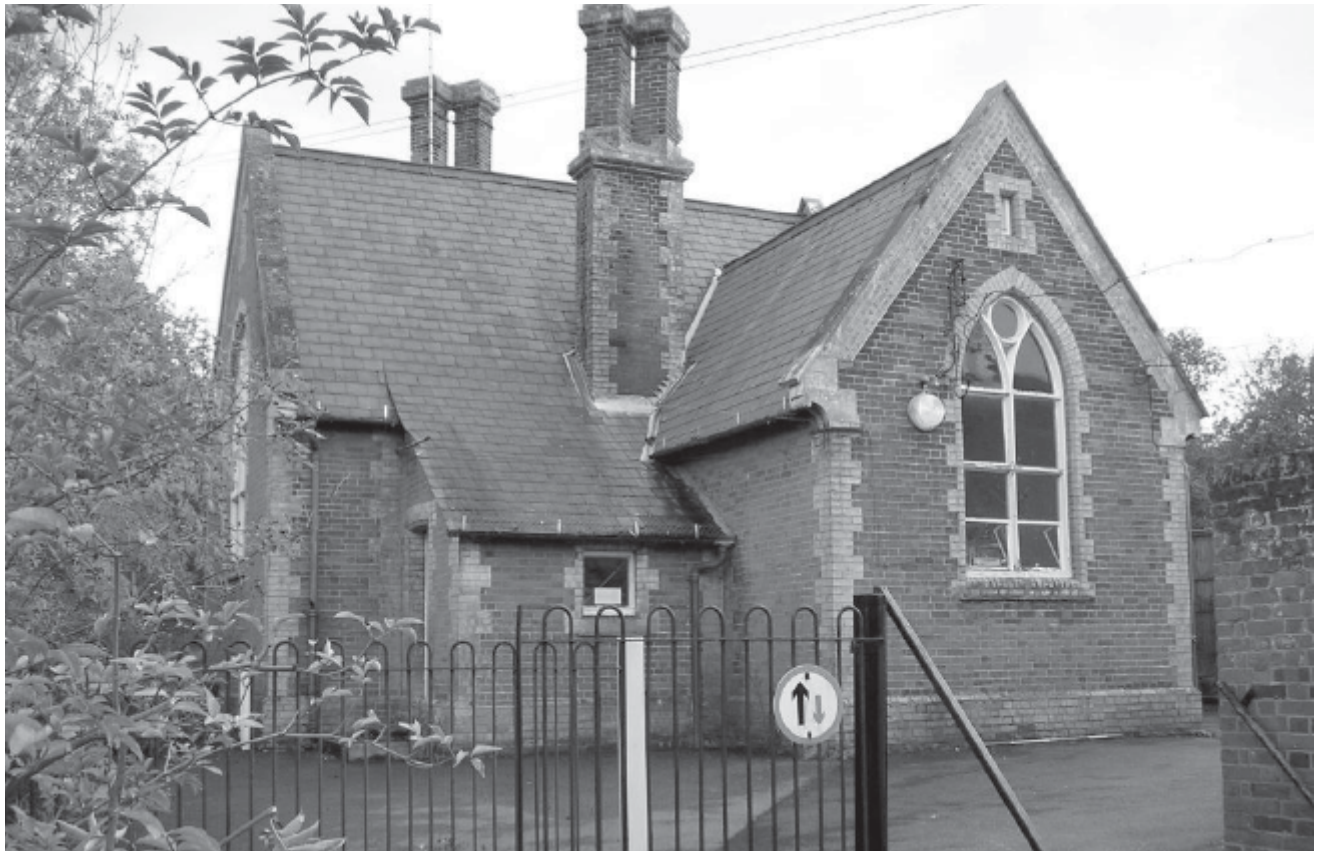
Plate 10: Building 2, western elevation

2.29 The classroom is a gabled structure aligned north-south with a nearly full-height gabled extension occupying the southern half of the western elevation, and a half-height extension with a cat-slide roof occupying the northern half of the same elevation (Plate 10).

2.33 The gable end of the western extension is broadly similar in style and construction to that seen elsewhere, with the exception that the window in the large, pointed arched opening is two panes wide and subdivided by wooden glazing bars in a Y-formation, which recall tracery, with a roundel set in the crook of the Y (Plate 10).

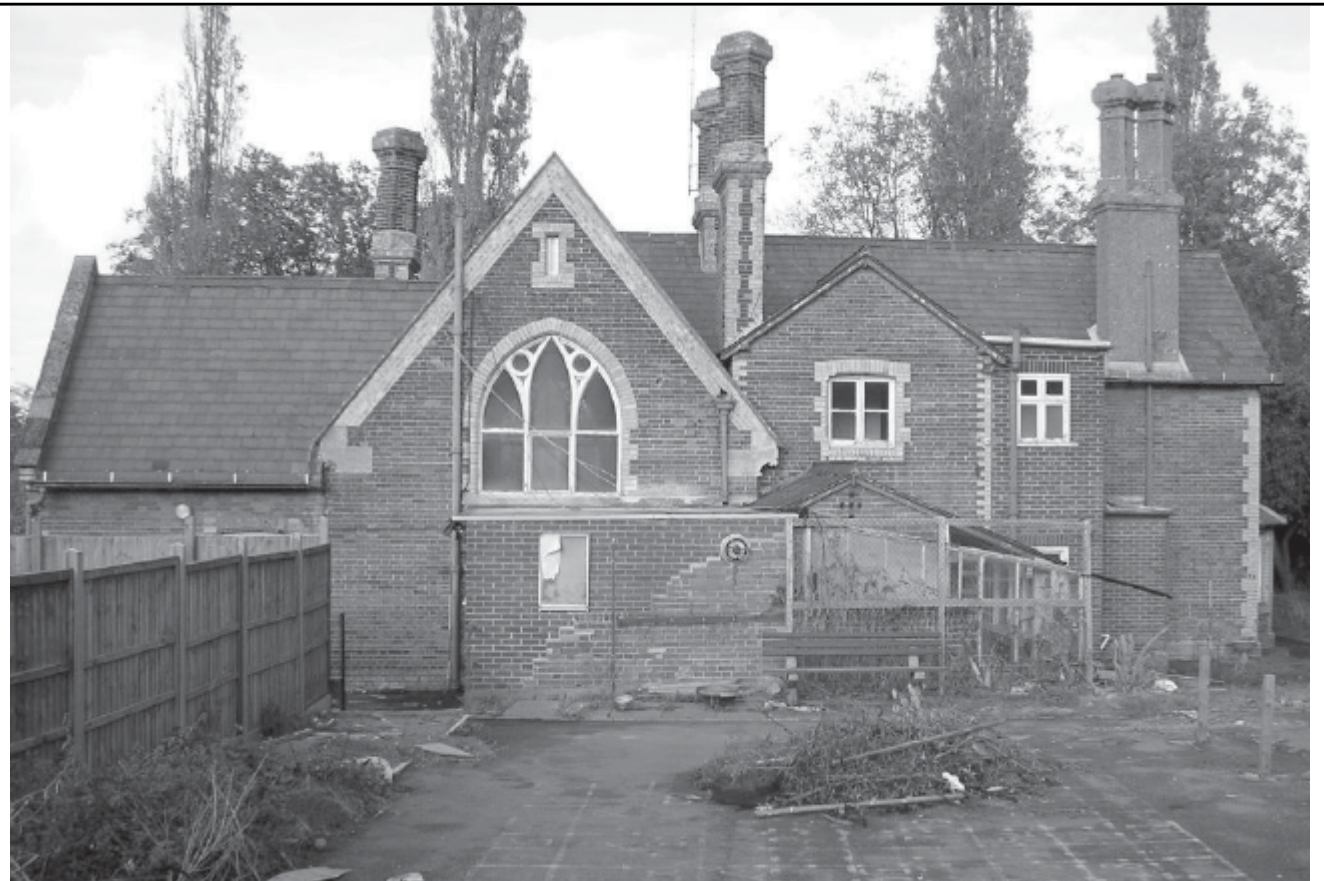
Plate 11: Building 2, southern elevation

2.31 A similar chimney cuts through the ridge of the roof of the master's house, where it joins the classroom, and a further chimney serves the southern extension of the master's house at its junction with the classroom (Plate 11).

2.39 The southern gable end of the classroom is the mirror of the northern gable end, with the exception that the lower half of the window has been remodelled to accommodate a flat-roofed brick built lavatory block, of 1960s or '70s date, which has been added to this elevation (Plate 11).

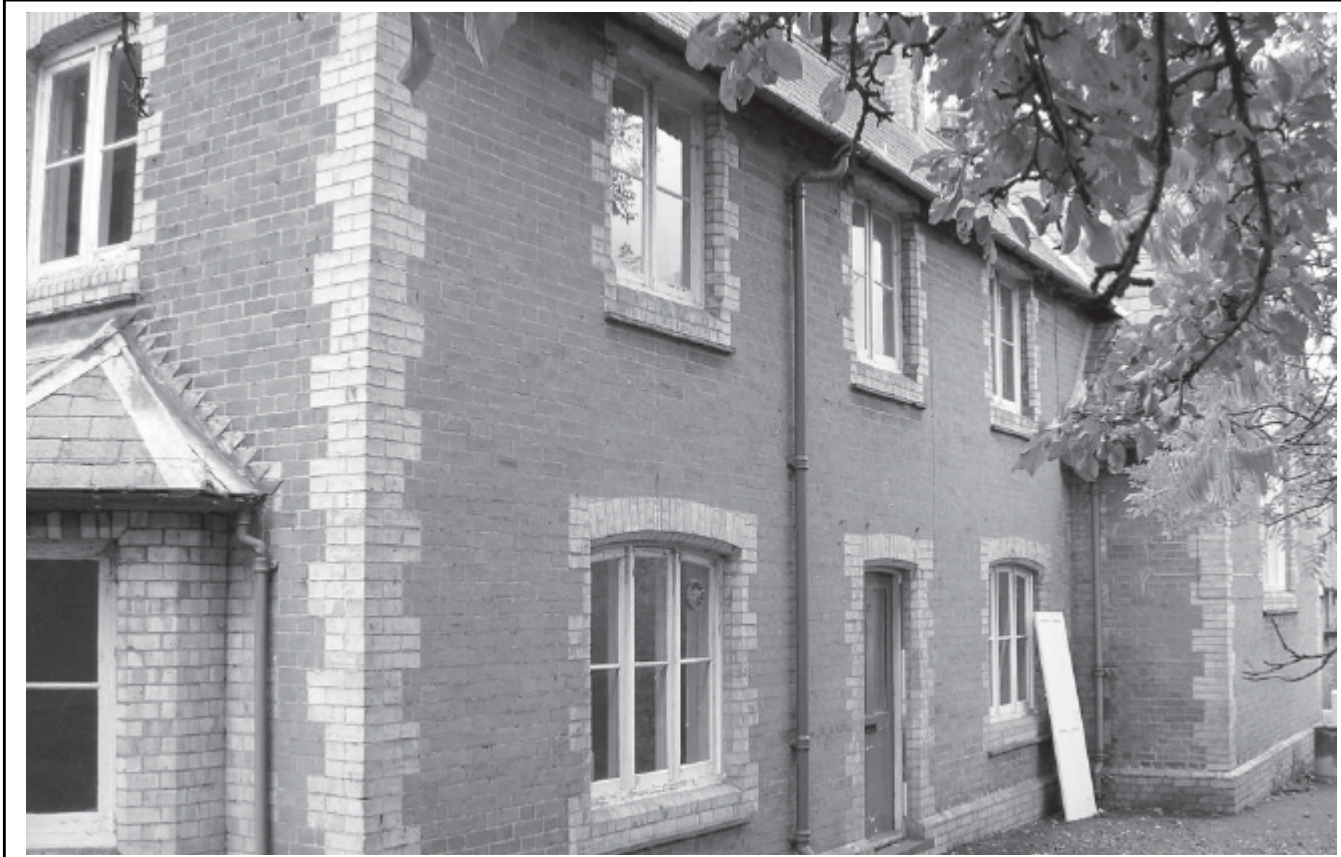
Plate 12: Building 2, master's house, northern elevation

2.36 To the east of this is the front elevation of the master's house, having similar decorative quoins, window and door dressings, and chamfered string course to those seen elsewhere (Plate 12). In the centre of the ground floor is the front door of four panels, the upper two glazed, with a stone threshold, and an iron boot scraper set in the ground to the left (Plate 13). The doorway is flanked by two window openings, each having a shallow segmental head and stop-chamfered jambs. The wooden window frames are of three lights with a central side-hung casement. The upper storey has three window openings in line with the lower openings, these being square headed. The window frames are of two lights with a single side-hung casement.

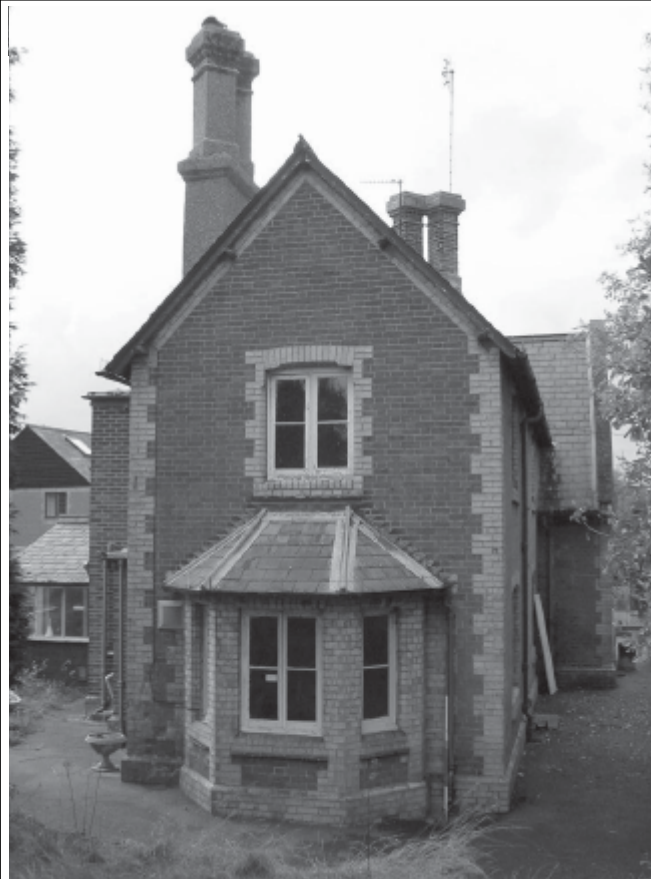
Plate 14: Master's house, western elevation

2.37 The eastern elevation of the master's house has a canted bay window on the ground floor, with a slate roof (Plate 14). The window openings have square heads, and the jambs are chamfered and in white brick. The middle window frame is of two lights with a single side-hung casement. The side windows are of single lights. The upper storey has a single central window opening with a shallow segmental head, cut away in the middle, and stop-chamfered jambs. The window frame is of two lights with a single side-hung casement.

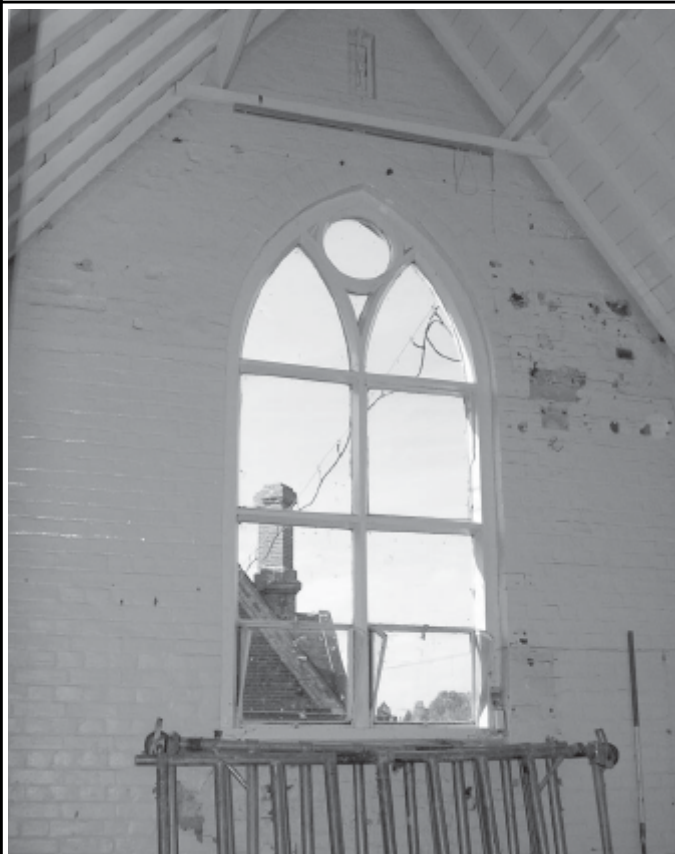
Plate 15: Building 2, ante-room window

2.42 This is a small classroom, most recently used as an office. There is a pointed arched window in the western elevation (described above) with an opening louvred vent above (Plate 15). The entrance door is in the southern elevation. There is a doorway through to the adjacent classroom at the southern end of the eastern elevation, with a shallow curved relieving arch over. A small rectangular opening, approximately 0.30m (1') wide by 0.90m (3') high, in the middle of the upper half of the eastern elevation. A chimney breast occupies the angle between the northern and eastern elevations with a chamfered stone chimney piece.

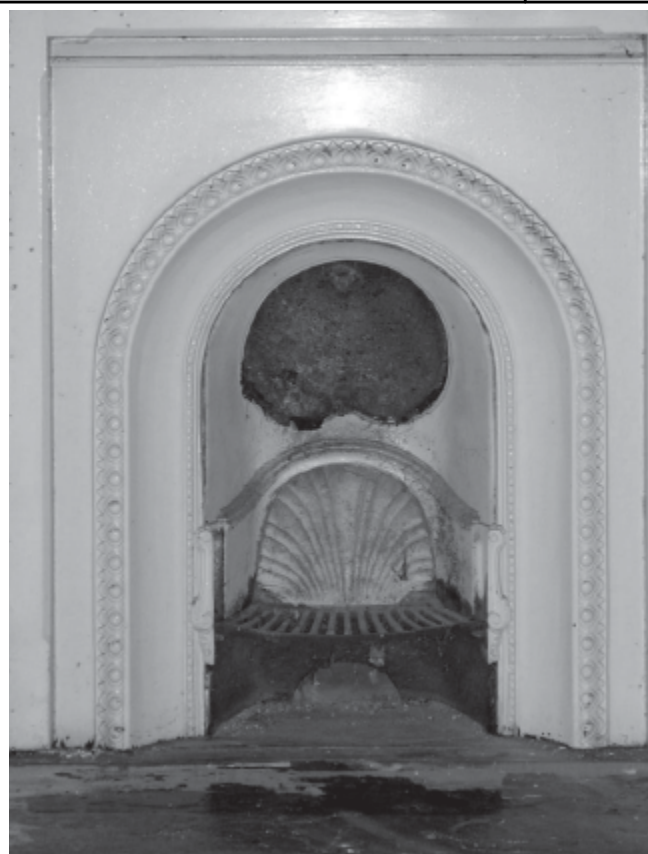
Plate 17: Master's house, fireplace, east front bedroom

2.53 Upstairs a modern extension provides a bathroom at the top of the stairs on the left. There are three bedrooms, each with its own chimney breast. The fireplace in the north-east bedroom survives in situ (Plate 17). There is a further grate, removed from elsewhere also stored in the room.

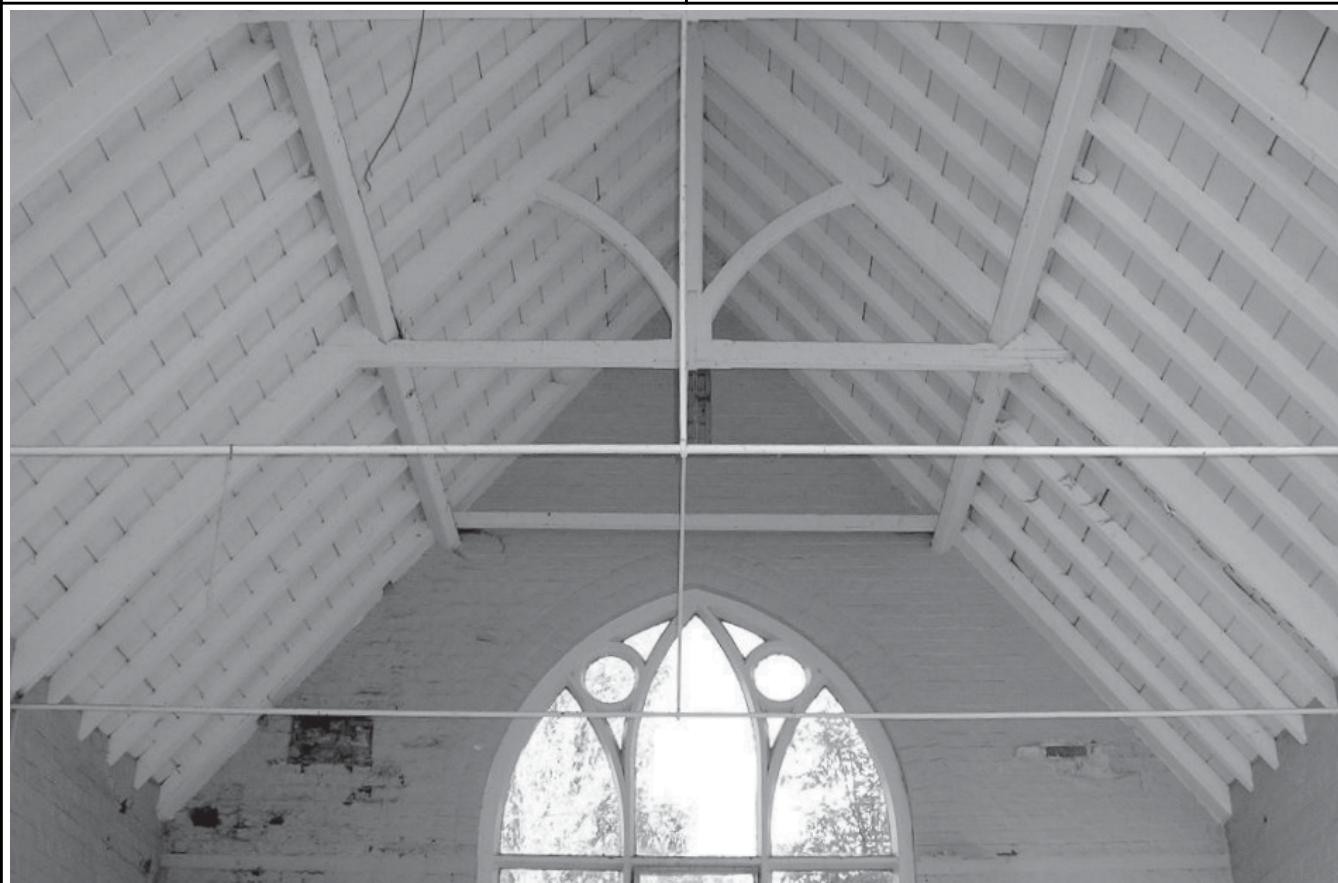
Plate 16: Building 2, classroom ceiling

2.49 The ceiling is similar to that of the ante-room, with the exception that the trusses have a king post in addition to curving struts. There are three trusses in all, beneath each of which a round section tie-bar is suspended (Plate 16).
