**Former Dairy
LOCKLEY FARM
Welwyn, Herts.**

Historic Building Record

Report no.487

July 2008

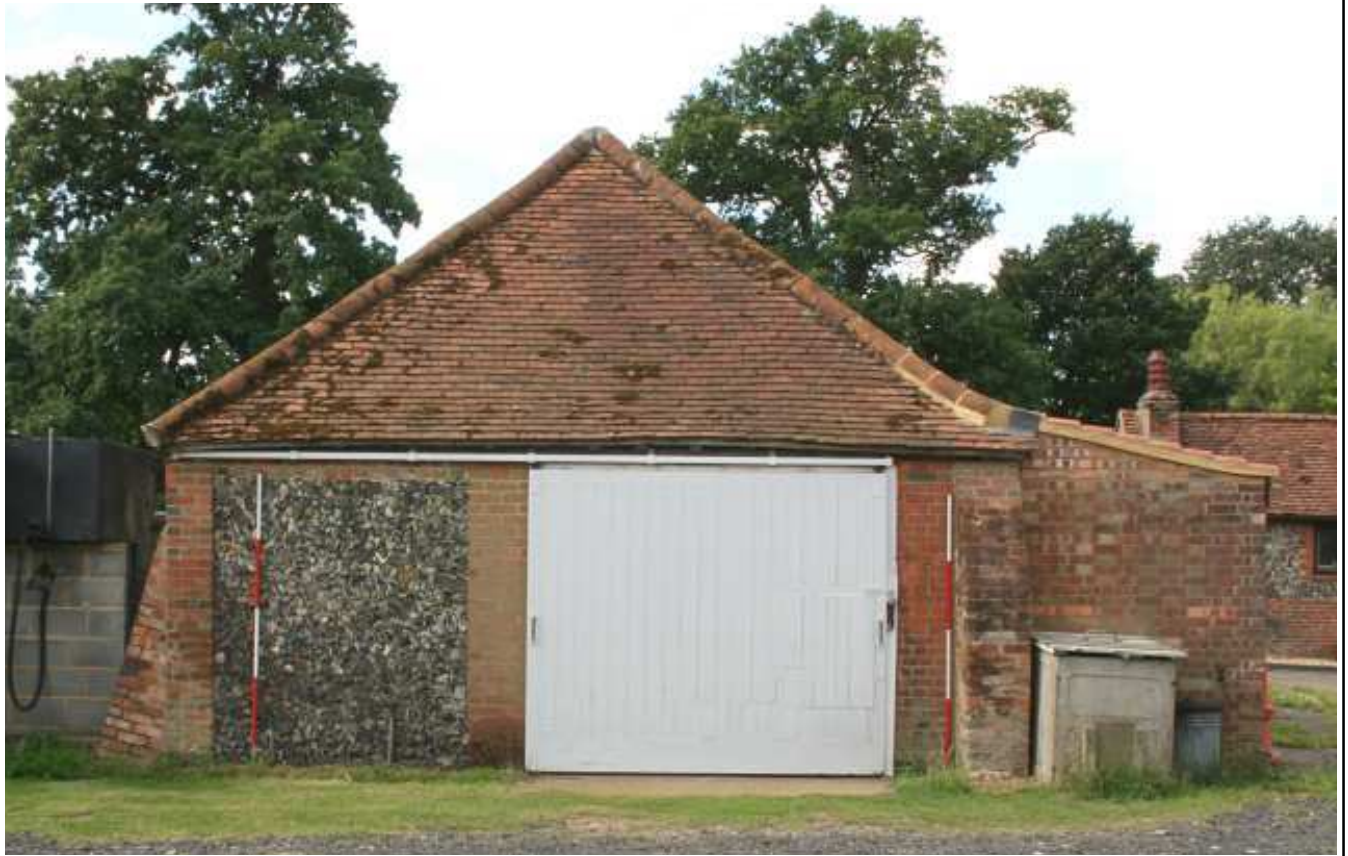
Plate 1: Exterior. North elevation

3.5 Red brick piers with flint panels bonded with sandy lime mortar. The panels have no plinth but are capped by two courses of red brick. Most of the flint work has a cut face. The piers are built using red bricks that measure 22cm x 6³/₄cm x 10¹/₂cm (9" x 2³/₄" x 4"). Two graffito marks were noted on the eastern corner pier: a double cross and an upside down 'V'.

3.7 Between the central pier and the west buttress is a large opening with a timber boarded sliding door, somewhat repaired, but thought to be an original feature. The two metal handles at each end of the door, and the metal runner above the door, are embossed with the manufacturer's name, *King, Hitchin*.

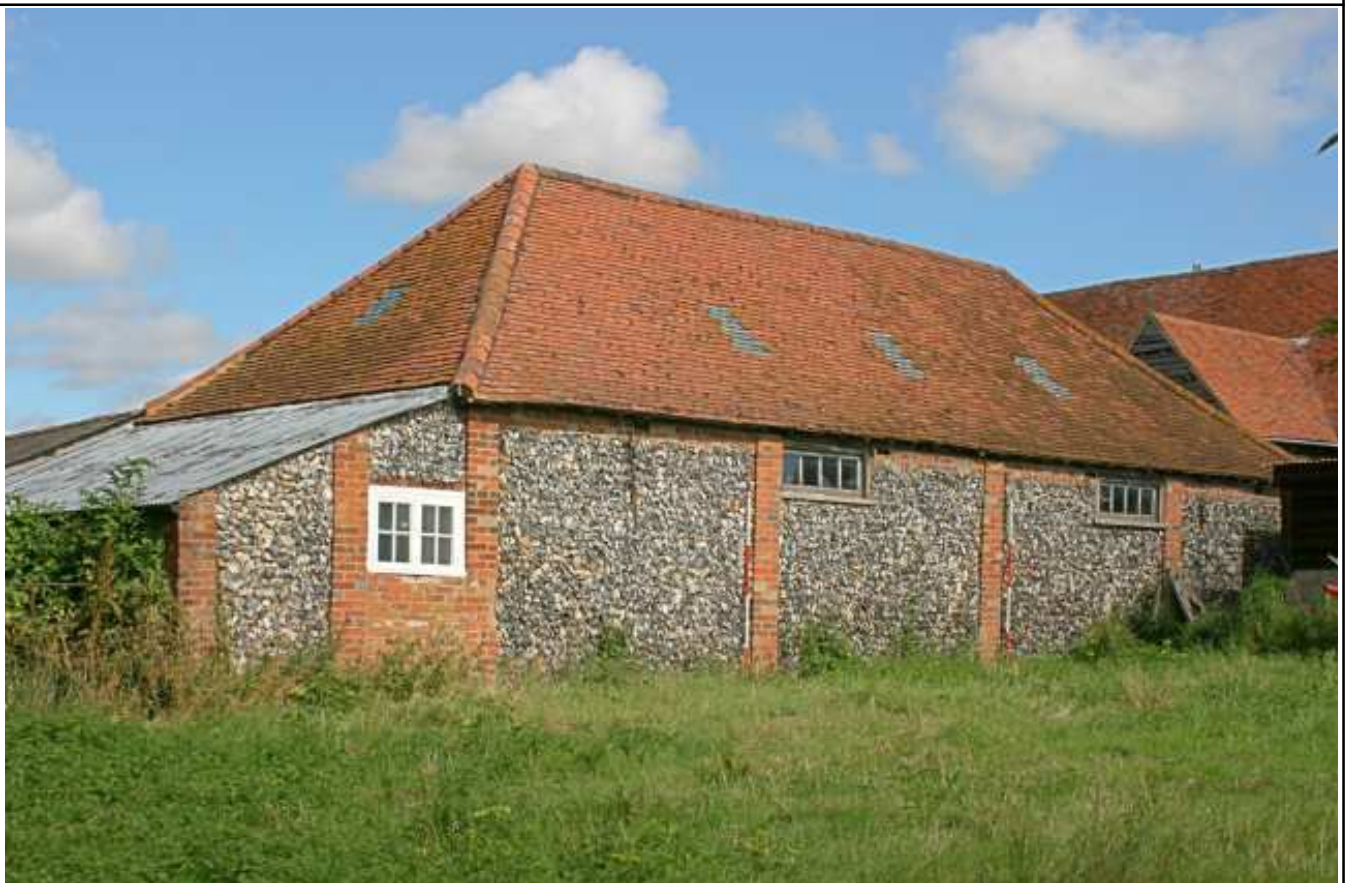
Plate 2: Exterior. East elevation

3.8 Red brick piers with flint panels bonded with sandy lime mortar. Five brick piers built using red bricks that measure 22cm x 6¾cm x 10½cm (9" x 2¾" x 4"). Four flint panels with no plinth but capped by two courses of red brick; most of the flint work has a cut face. Sloping buttress at the north end (see above). Two wide, recessed, timber hopper windows, each of four panes with timber sills, located under the eaves within the two central flint panels. Both abut a brick pier and are thought to have been inserted later. Metal air vents lie centrally above each flint panel set into the brick capping. On top of the east elevation is a wall plate, and at its mid-length is a bridled scarf joint.

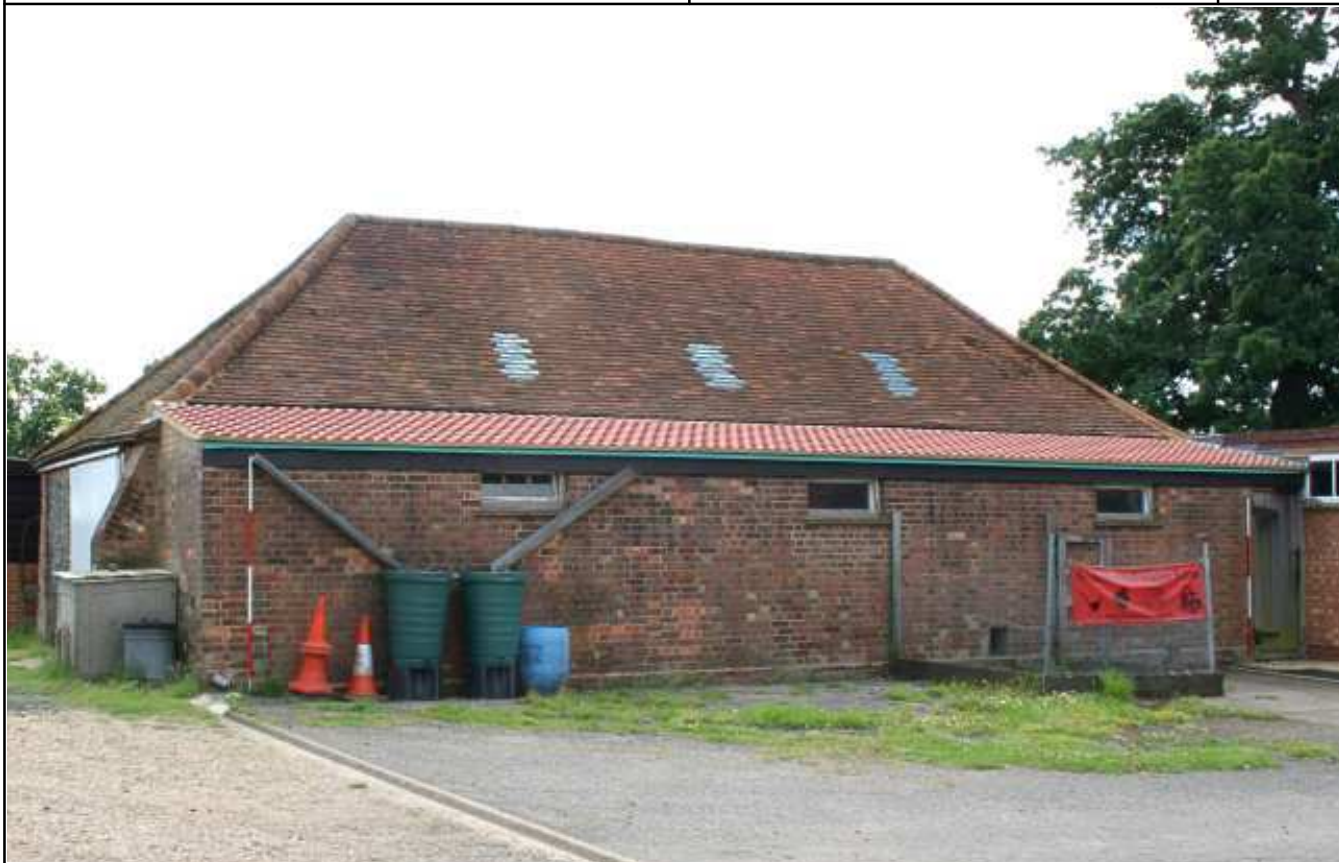
Plate 3: Exterior. West elevation

3.10 Built in dark fletton bricks, which came into general use in the first quarter of the 20th century, partly in Flemish bond. A thick layer of cement above the second visible row of bricks marks a damp-proof course.

3.11 Three, evenly spaced, wide, recessed, timber hopper windows with clay tile sills are located under the eaves. Two have a single pane, and one at the north end is of three panes. At the south end is a doorway with a deep step up into the dairy. It has a latched boarded door that is thought to have been re-used from elsewhere on the farm. Against the exterior west elevation is a small, modern, wire chicken pen. Some bricks at the base of the wall have been removed to create a small hatch.

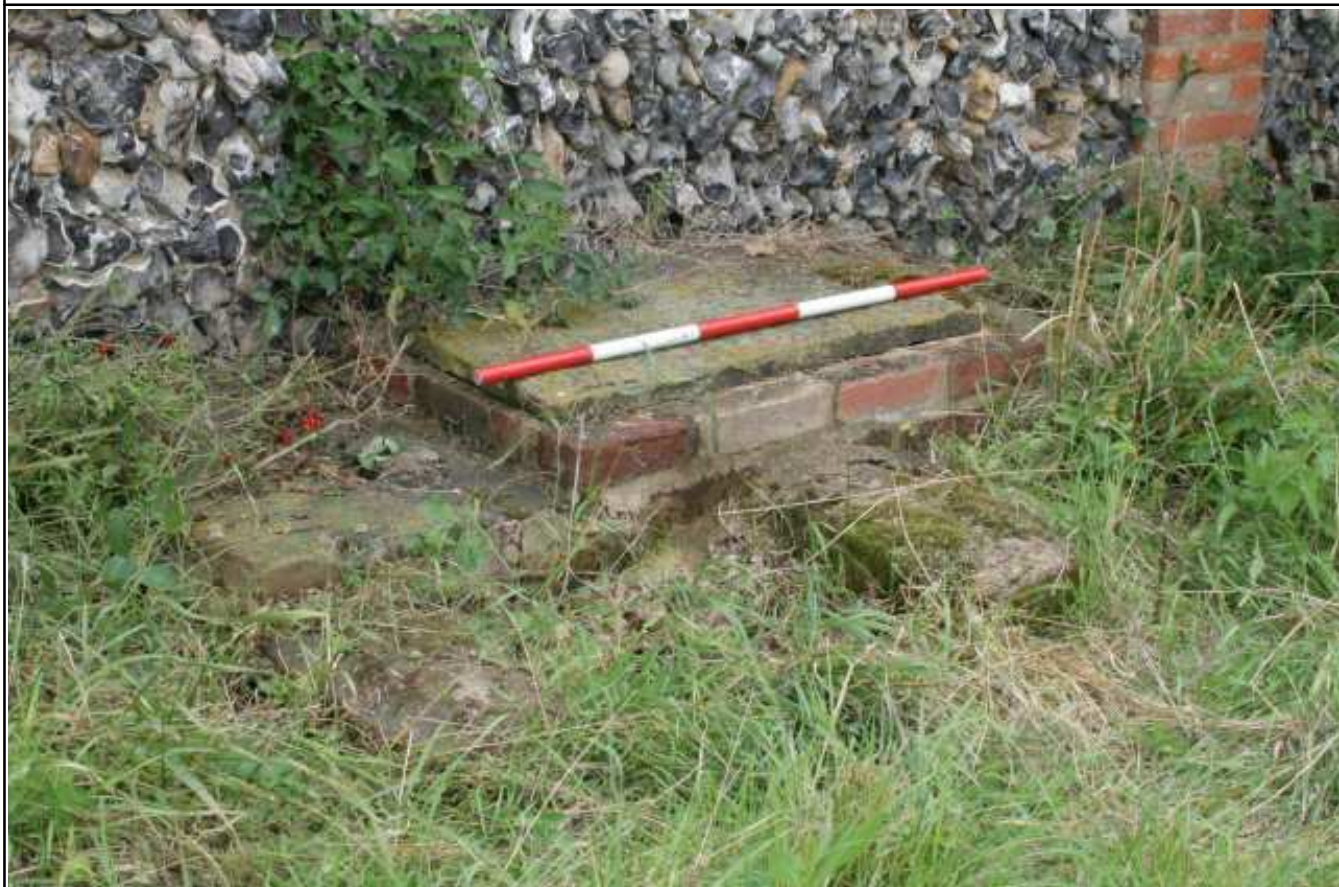
Plate 4: Exterior. East elevation, drain

3.4 Adjacent to the north end of the main dairy building is a small, square, concrete-panel store with a timber lid and a small hatch to the lower north face. It is typical of a design associated with coal-bunkers, and may have been used to store coal, sand or salt. East of this is a small, concrete lined drain. At the south end of the east elevation is a large raised drain with a concrete cap.

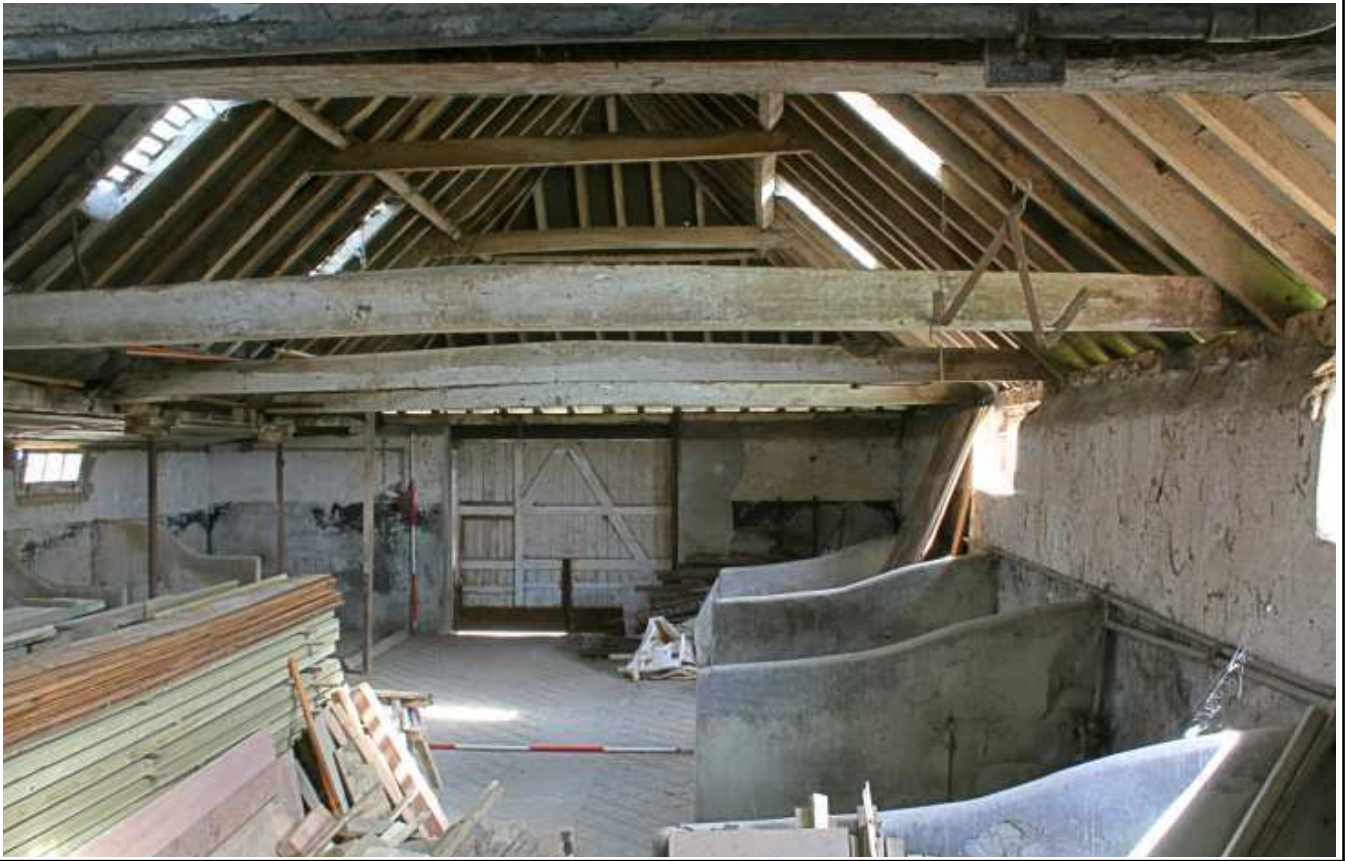
Plate 5: Interior. View looking north

3.13 The milking parlour's interior is one large open space of five bays with an exposed roof truss and a concrete laid floor. Towards the west side of the dairy, marking the original extent of the building, a pine wall plate runs north to south, supported by five, evenly spaced, tubular metal stanchions. At its mid length is a bridled scarf joint.

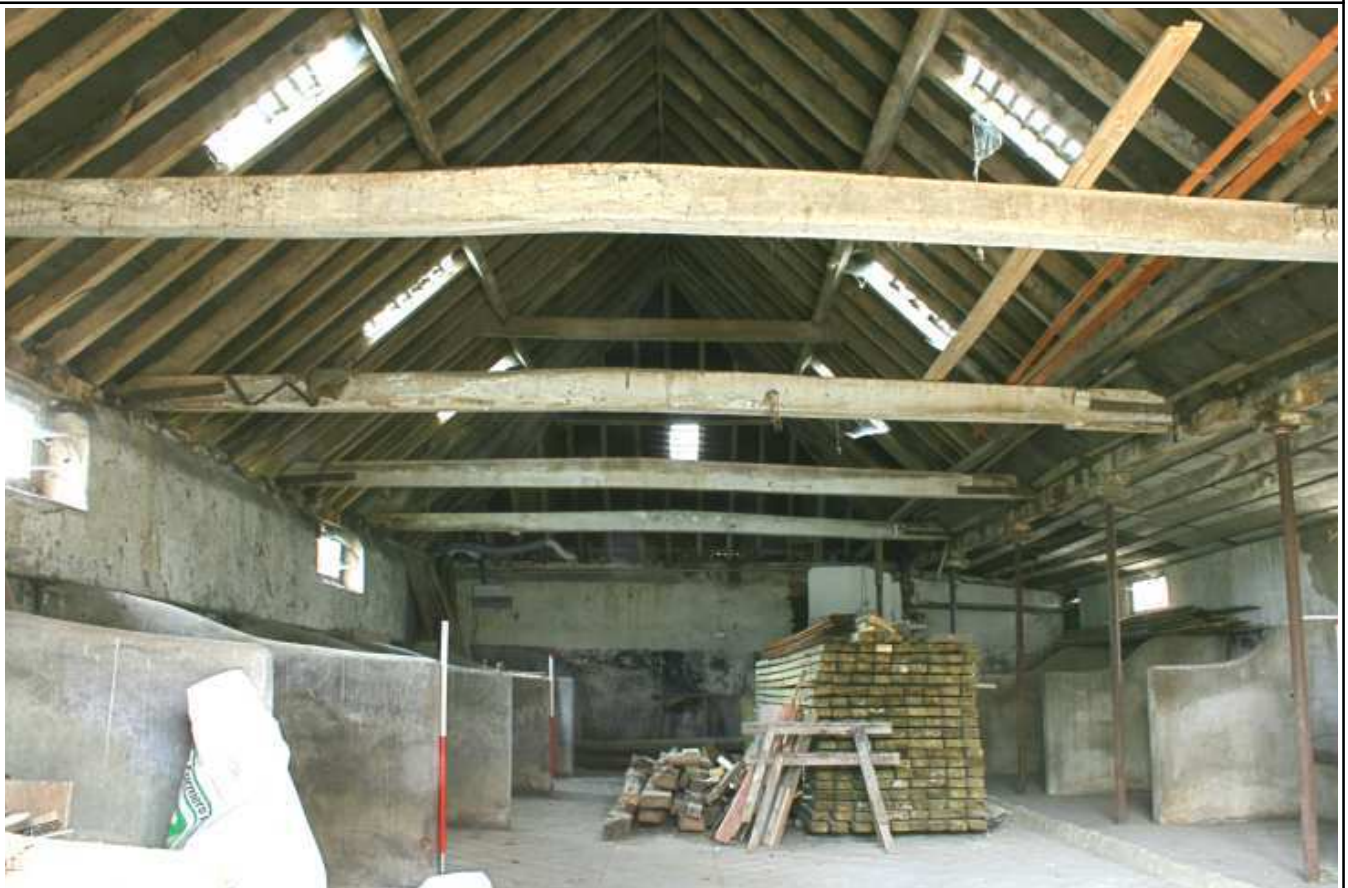
Plate 6: Interior. View looking south

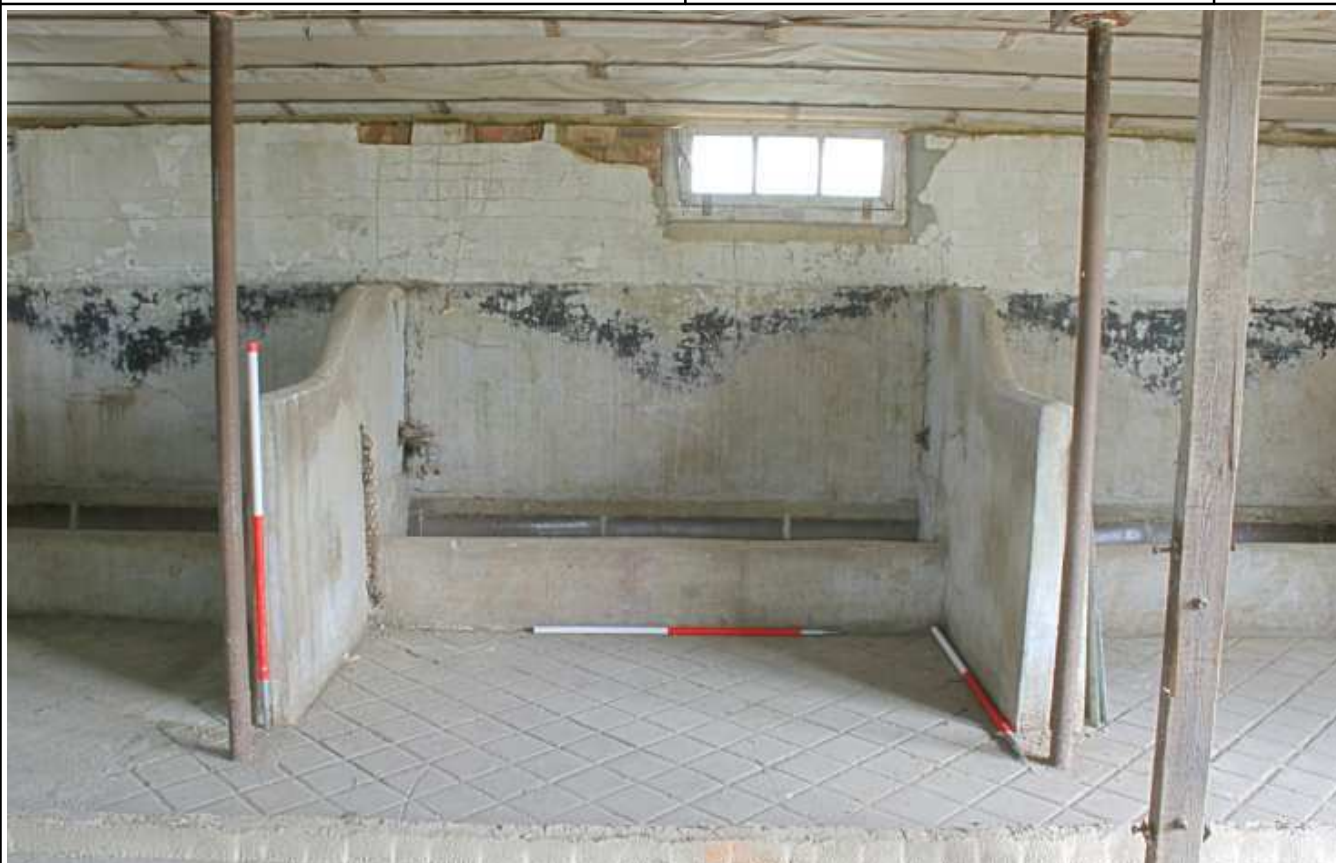
Plate 7: Interior. Stall 2 looking west

3.14 There are eleven, evenly spaced, milking stalls, nos. 1 – 5 to the west side and nos. 6 – 11 to the east side. The stalls are separated by pre-cast concrete panels, five to each side. Those along west side have a more prominent profile than those on the east side, and although taller in height, they are 30cm shorter in length. In each of the eleven stalls, between the pre-cast concrete panels, is a pre-cast concrete feed trough. The troughs along both sides of the parlour are roughly the same dimensions and style, but those to the west are lined with brown glazed curved tiles, while those to the east are lined with white glazed curved tiles. The trough in Stall 4, along the west side, has been truncated to allow for the insertion of a small hatch that leads into the chicken pen on the west exterior, noted above.

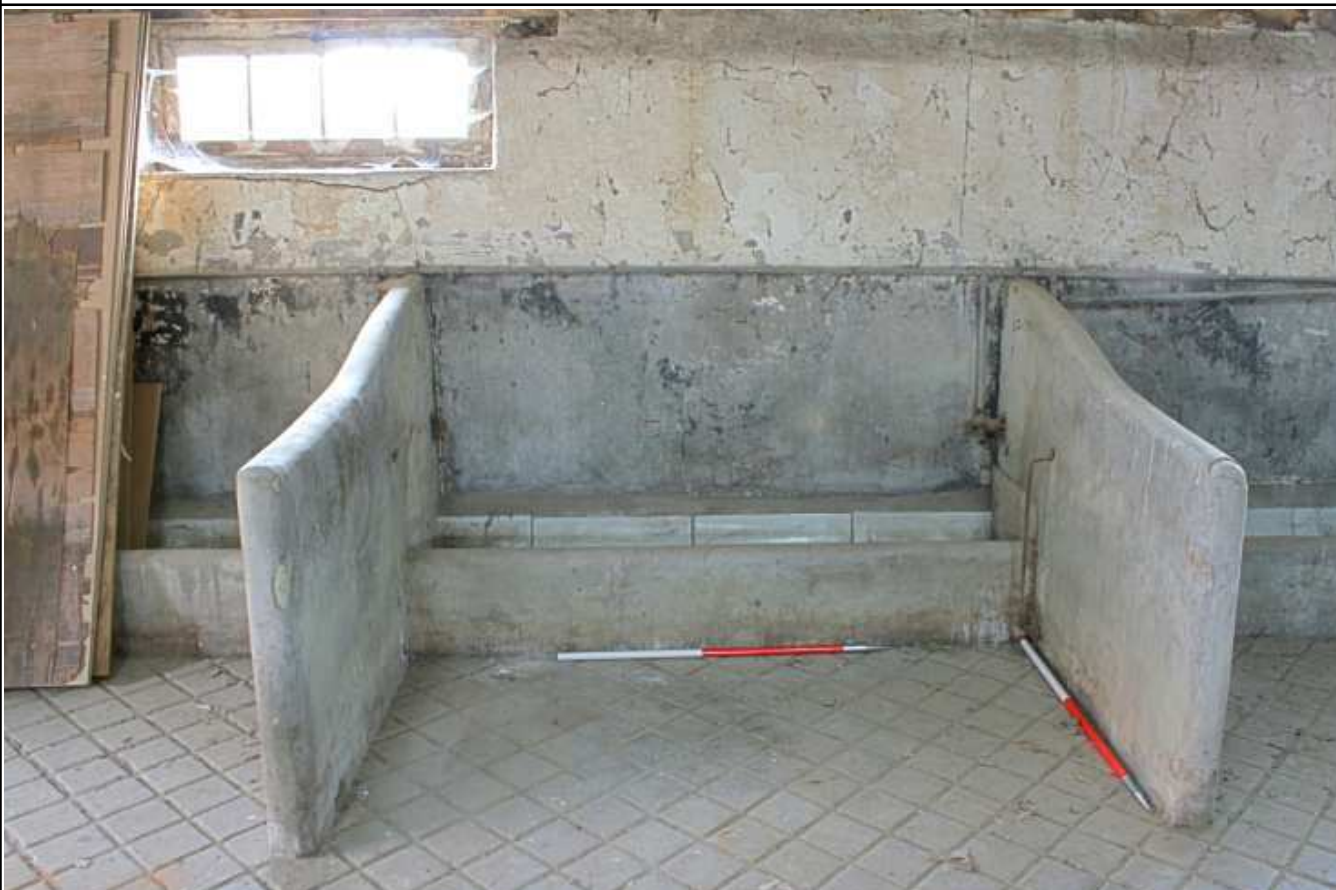
Plate 8: Interior. Stall 9 looking east

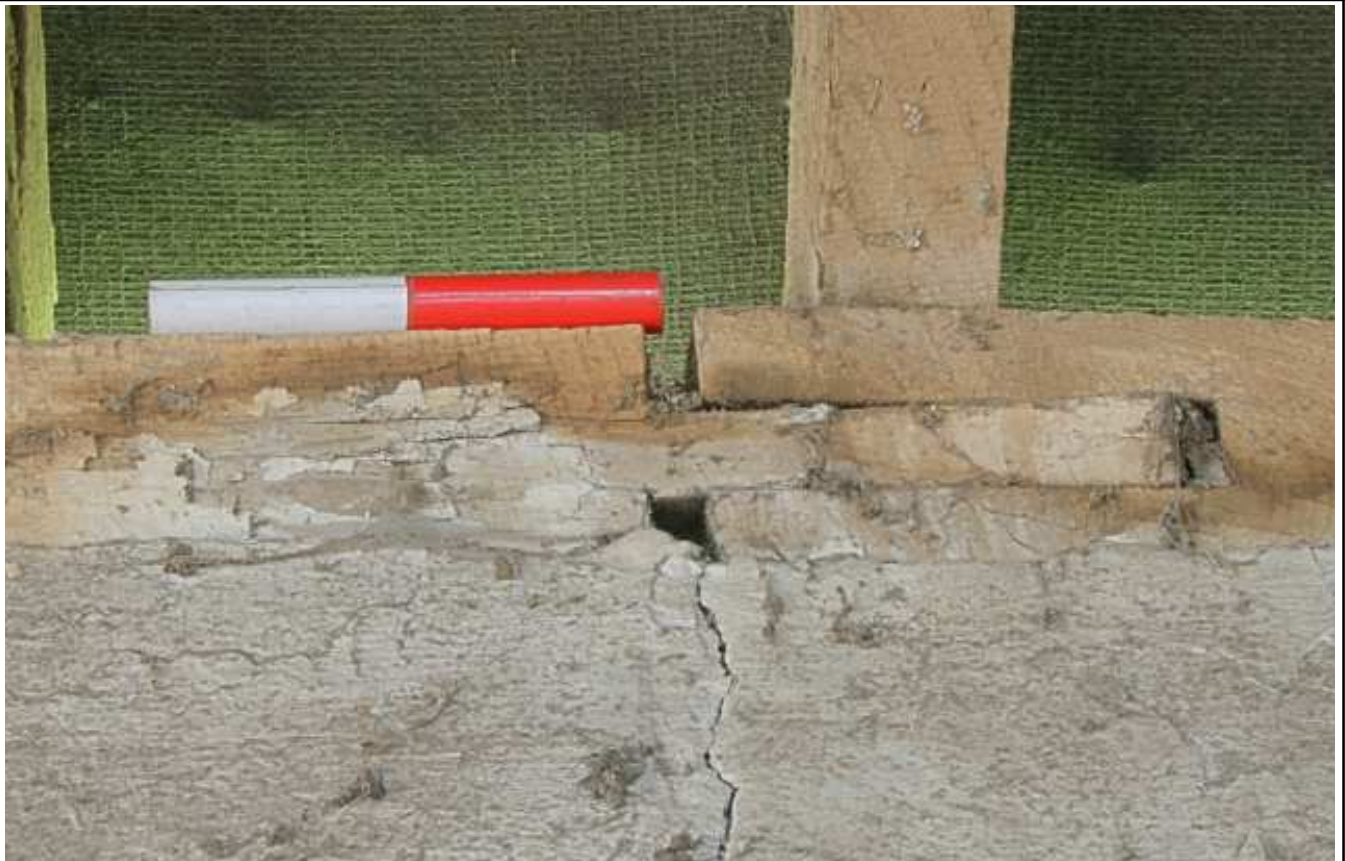
Plate 9: Interior. East elevation, wall plate joint in stall 8

3.17 Brick wall, lined with render. Pine timber wall plate with a bridled scarf joint at its mid-length. Two wide, timber hopper windows under the eaves in the second and fourth bays, each of four panes and thought to have been inserted.

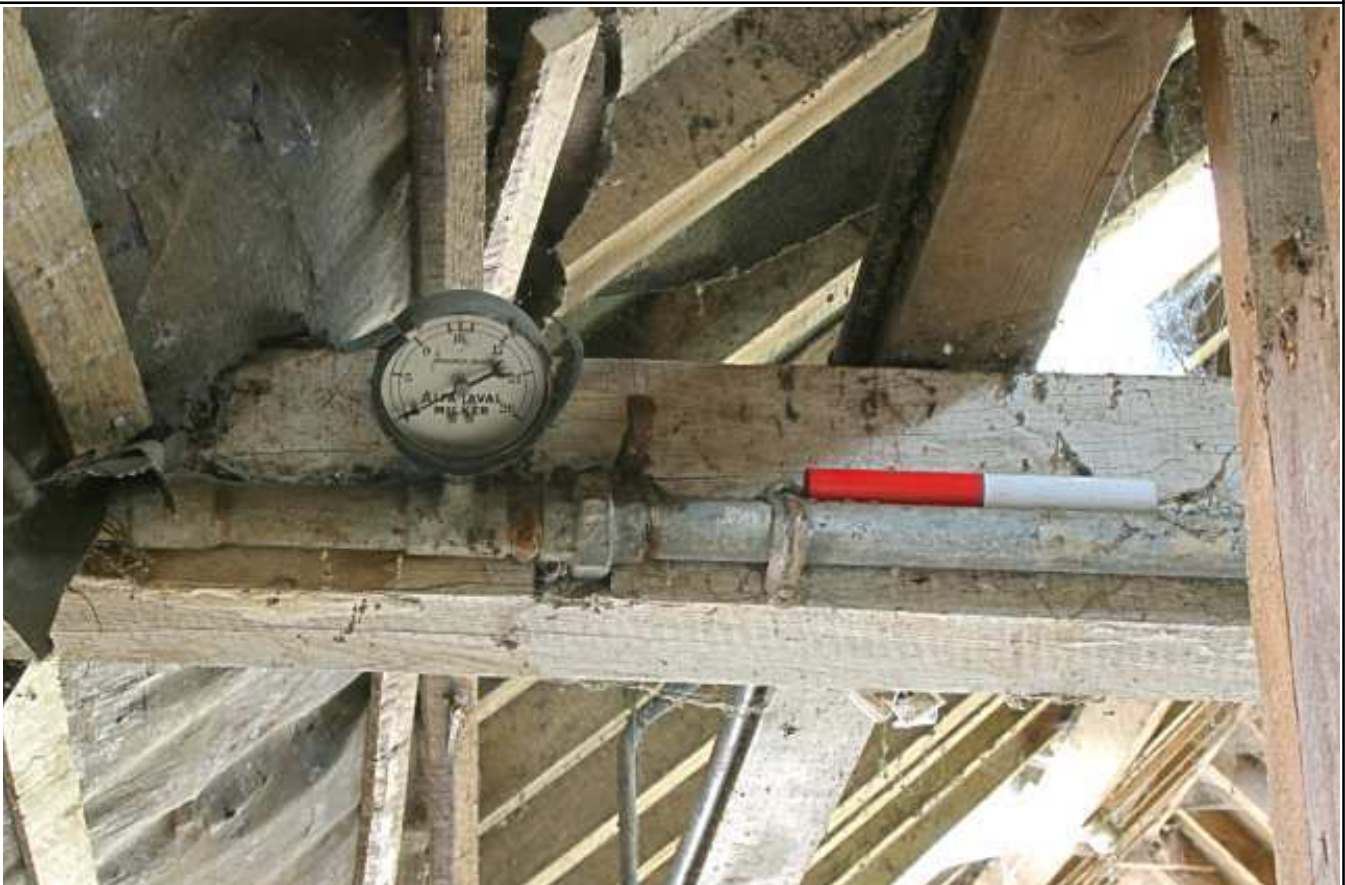
Plate 10: Interior. Tiebeam in stall 5, north face. Dial showing 'Alfa-laval milker'

3.15 Within the building are the remains of metal piping used for the collection of milk. This has mostly survived towards the south end of the dairy and includes a vacuum dial for an ‘Alfa-laval milker’ on the south face of the tiebeam in Stall 5 to the west side. On the second, third and fourth tiebeam along the east side are three, heavily rusted, metal brackets which formerly supported milk pipes that hung down into the stalls and are thought to be contemporary.
