ELMDON BURY
Elmdon, Essex

Archaeological Monitoring Report

Outdoor Riding Arena
ELMDON BURY
Elmdon, Essex.

Archaeological Monitoring and Excavation Report

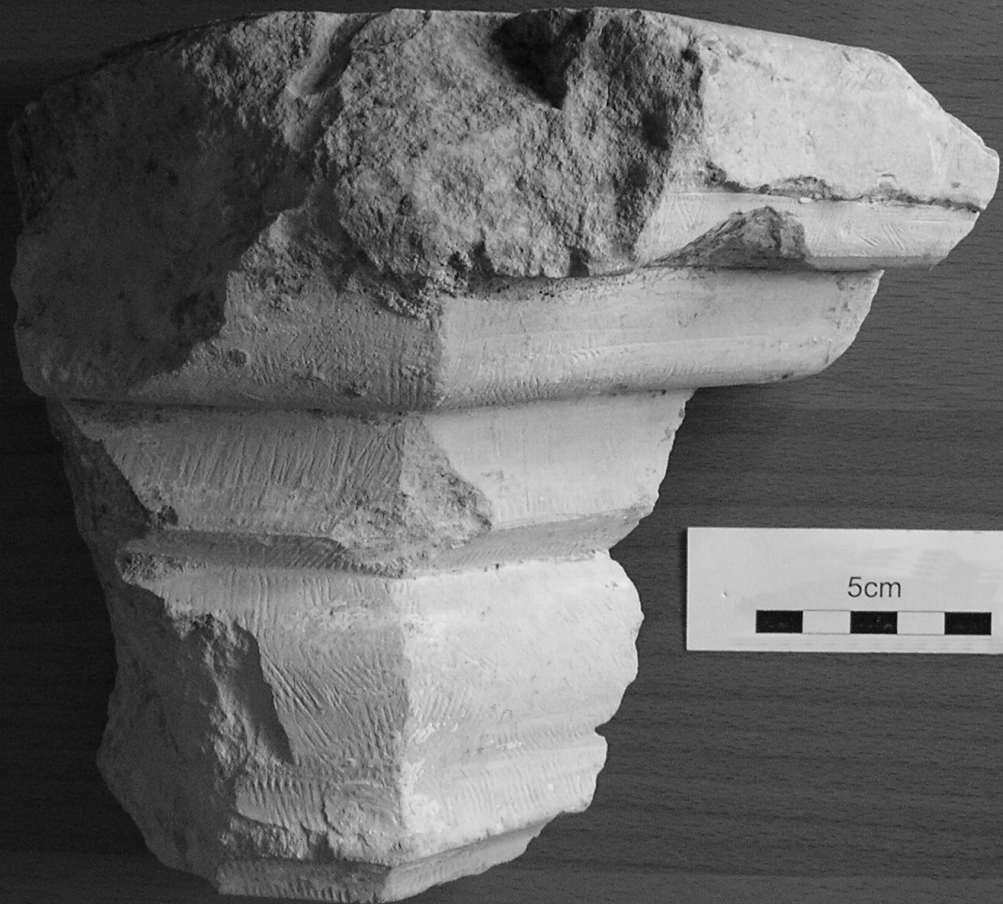
The cover photograph shows the column capital from ditch [01]
