## **EDMONTON SPORTS & SOCIAL CLUB** **Church Street, Edmonton, London N9**

*Archaeological Monitoring Report*

HN537

Report no.349

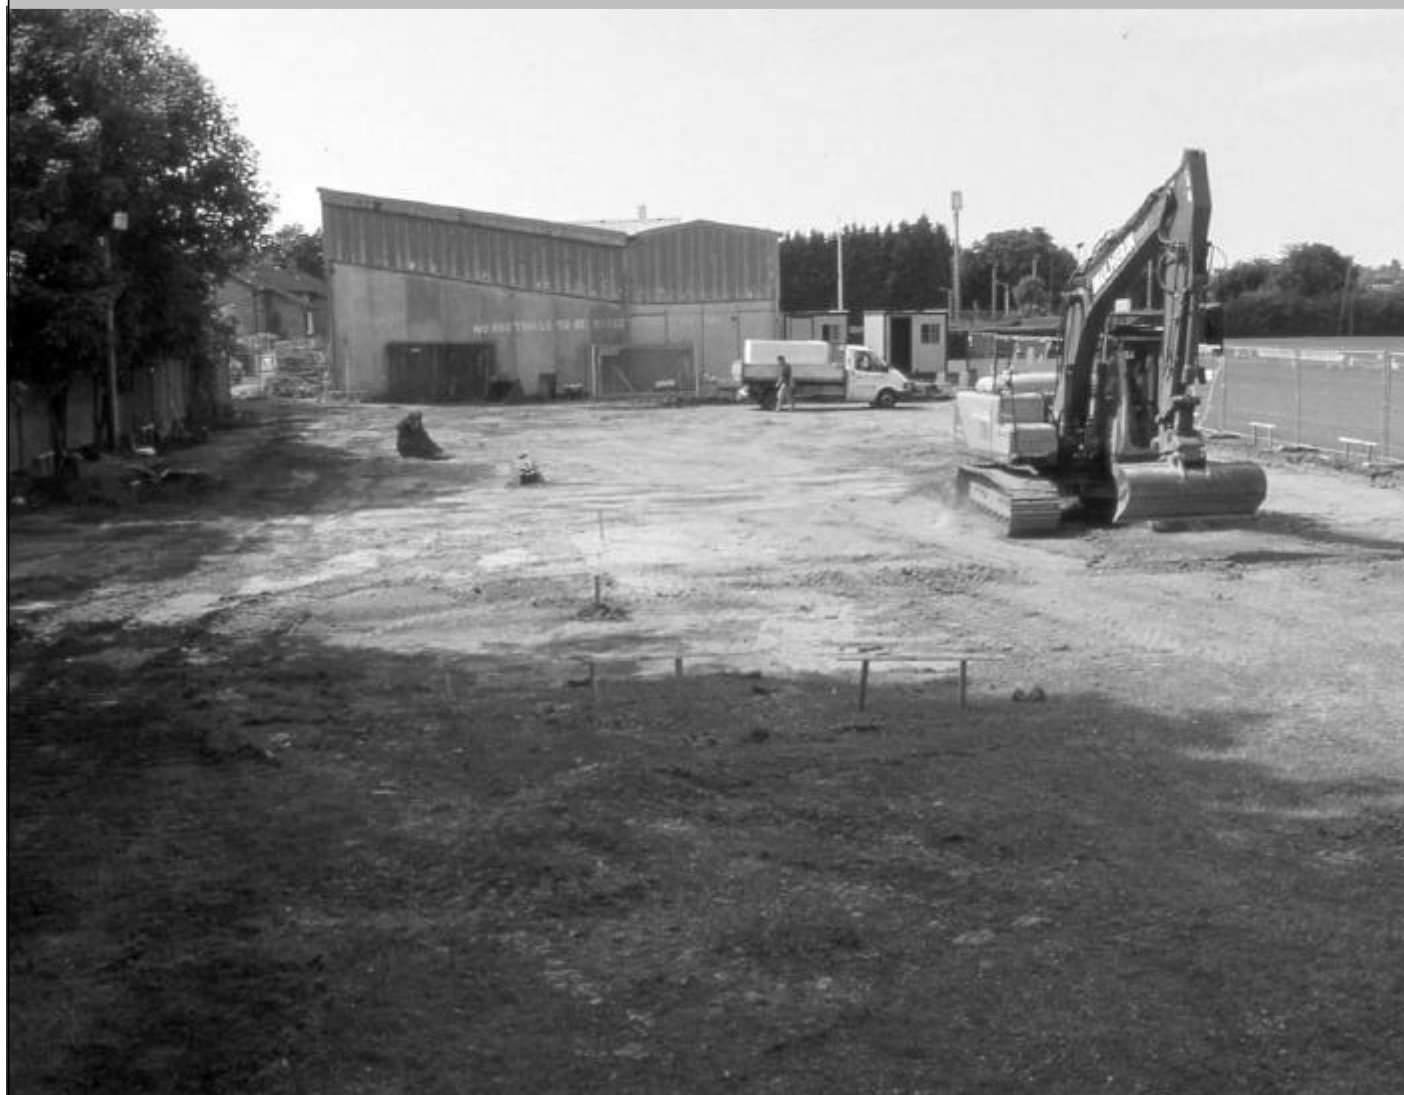
*The cover photograph shows a view of the site looking north-west*

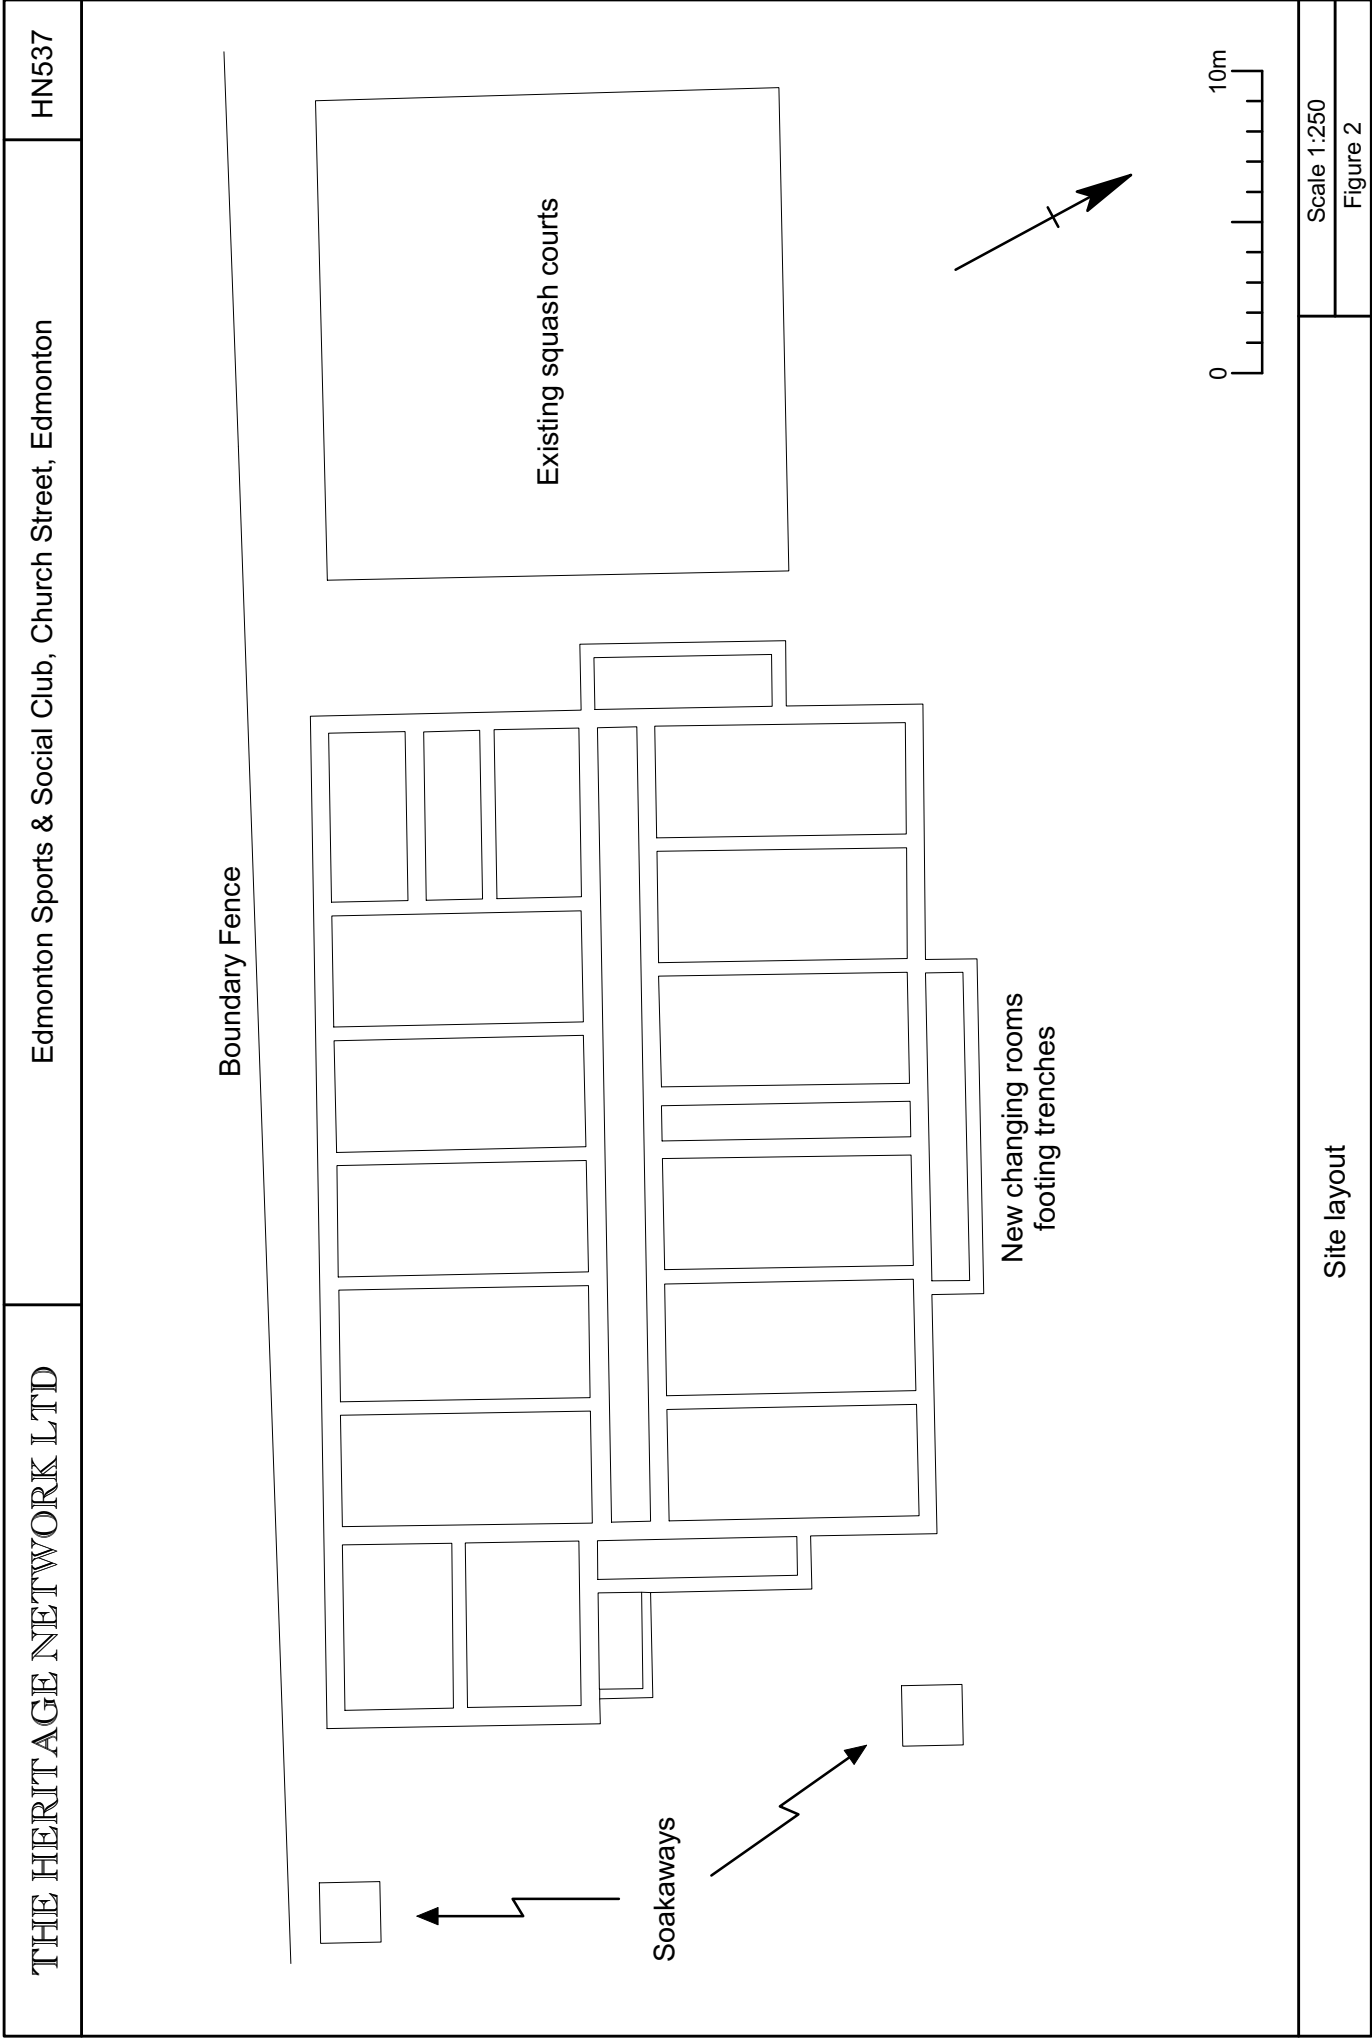
Figure 2

Site layout

**1.2** The study area is focused on a proposed new changing room block located to the ESE of the existing clubhouse and squash courts, centred on NGR TQ 33300 94040 (see Figure 1).

**2.8** A modern service trench was observed running along the southern site boundary, the trench contained power cables for the floodlights which run along this boundary.

**2.10** The footings trenches were excavated to a width of 0.60m. The internal trenches measured 1.2m in depth, whilst the external were excavated to 1.8m.

**2.11** At the request of the building inspector the external footings in the south-west corner of the new building were excavated to a greater depth of 3.50m. Natural gravel ballast was observed at this depth below the natural drift geology of very firm, yellowish brown (10YR 5/6), sandy clay.

**2.13** Two soakaways were excavated, both measured 2m square and were excavated to a depth of 3.0m. The stratigraphy observed within the soakaway was identical with that observed in the footing trenches.

**2.14** A single drainage trench was monitored, it ran along the north-east front of the building on a north-west – south-east alignment. The trench was excavated to a maximum depth of approximately 0.60m.
