**New Dining Hall  
NORTHWOOD PREP SCHOOL  
Moor Park, Hertfordshire**

HN1004

***ARCHAEOLOGICAL  
EVALUATION REPORT***

## New Dining Hall NORTHWOOD PREPARATORY SCHOOL Moor Park, Rickmansworth, Hertfordshire

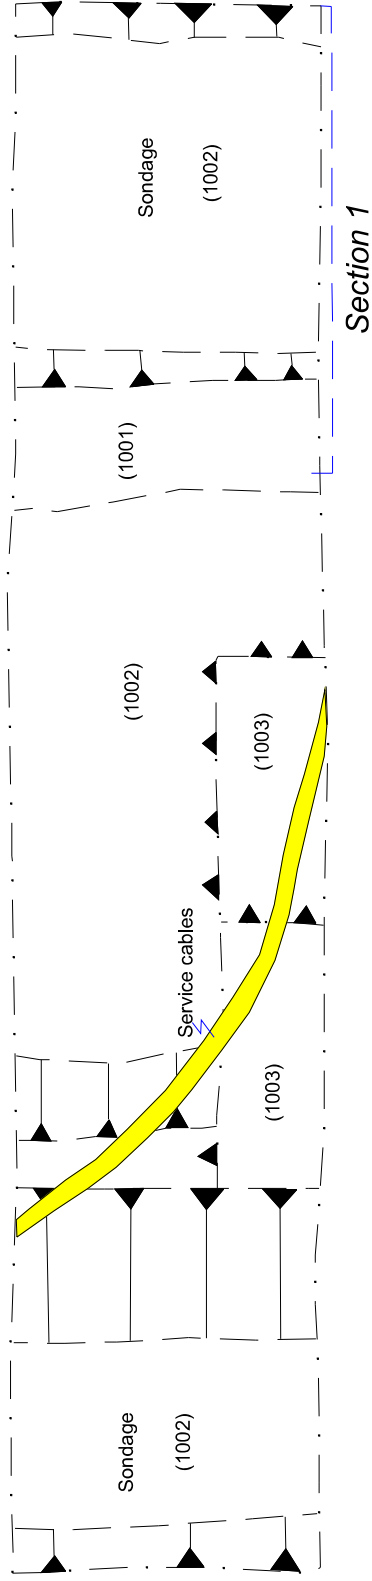
Plan of Trench 1

**2.24** Trench 1 was located in the southwest of the site, within the footprint of the proposed building (Figures 2-4, Plates 7 & 8). It was orientated east-west and measured 10.0m in length, 2.0m in width and was excavated to a depth of up to 1.9m.

**2.25** The topsoil in Trench 1 consisted of 0.1m of a friable greyish brown clay/silt with sand (1003), with moderate sub-angular gravel to 10mm in diameter. This sealed a 1.1m thick layer of pale brown silty clay (1001) that contained occasional concrete and brick and tile fragments, interpreted as an imported levelling deposit. Within this, two modern service cables were revealed running diagonally across the trench from northwest to southeast, at a depth of c.0.2m. They were left in situ (Figure 3).

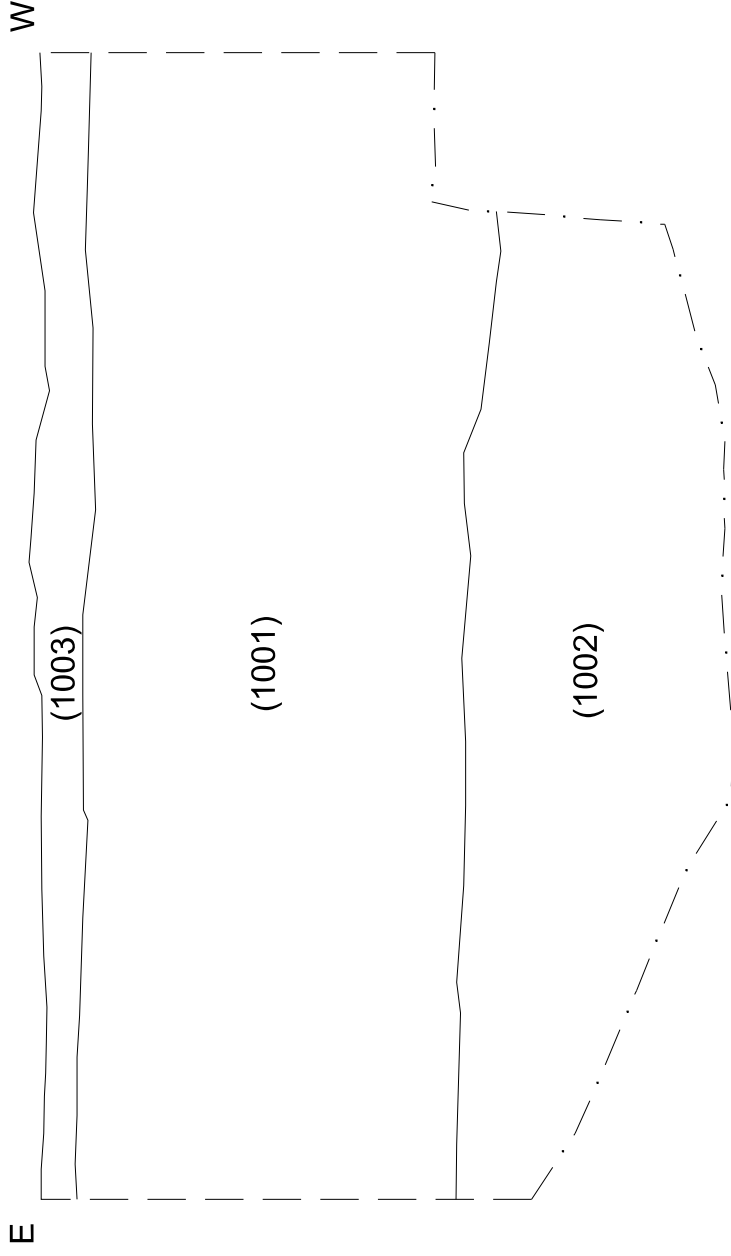
Section 1, north facing

**2.26** Beneath the levelling deposit was a 0.70m thick deposit of dark greyish brown sandy silty clay (1002) with brick and tile fragments, that extended beyond the limit of excavation. This deposit was thought to represent a buried agricultural/horticultural earth. A sample of the brick and tile fragments, and a fragment of glass were collected from this deposit.

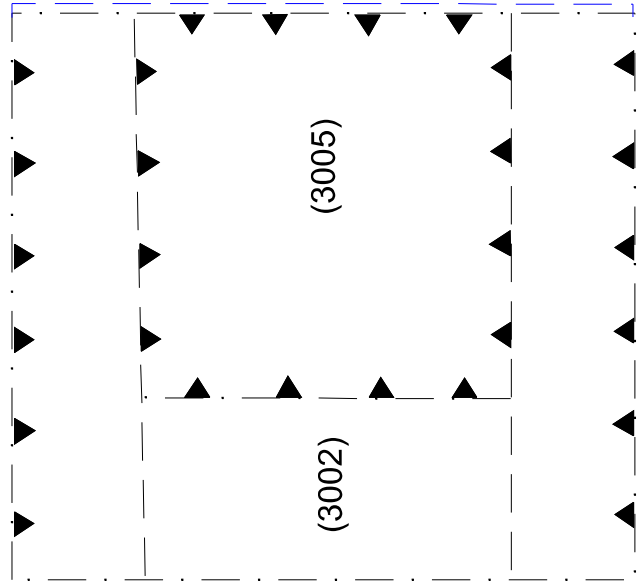
Trench 3 Plan

**2.34** Trench 3 was located towards the middle of the footprint of the proposed buildings (Figure 5, Plate 10). It was 3m square and was excavated to a depth of 2.2m.

**2.37** Beneath the buried earth was a deposit of grey clay (3003) with moderate large brick fragments and frequent small brick and tile fragments, 0.2m thick. This may represent a spread of demolition debris from a post-medieval brick structure, which sealed the natural horizon consisting of hard greyish brown silty clay (3005).

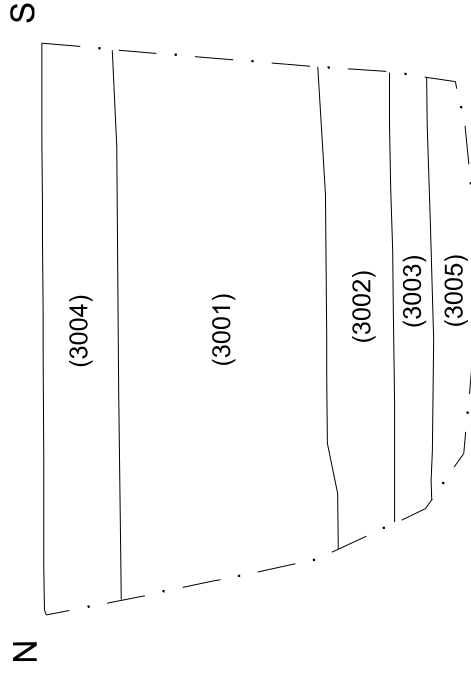
Trench 3 Section,  
looking west

**2.35** The topsoil in Trench 3 consisted of 0.1m of a friable greyish brown clay/silt with sand (3003), with moderate sub-angular gravel to 10mm. This sealed a 0.3m thick layer of cement asbestos fragments that was damped down, bagged and removed by the groundworks contractor. Beneath this was a pale brown sticky silty clay (3001) that contained occasional concrete and brick and tile fragments, and moderate sub-angular gravel to 10mm diameter, interpreted as an imported levelling deposit.

**2.36** Beneath the levelling deposit was a 0.30m thick deposit of dark greyish brown sandy silty clay (3002) with brick and tile fragments, that extended beyond the limit of excavation. This deposit was thought to represent a buried agricultural/horticultural earth and contained brick and tile fragments similar to those collected from Trench 1.

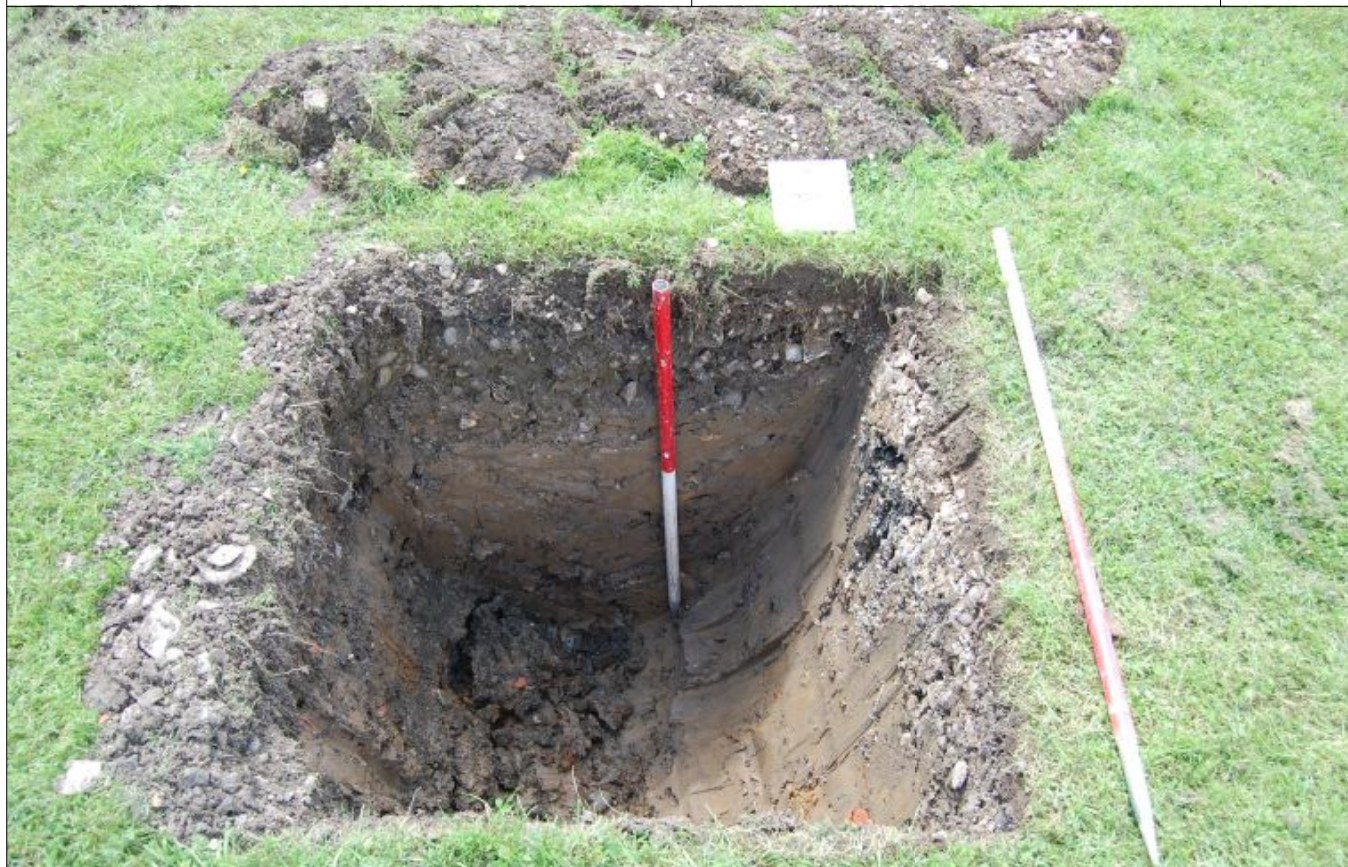
Plate 1: TP1 looking south

**2.10** Test-pit 1 was located approximately in the middle of the grassed area (Figure 1). It measured 1m x 1m and was 1m in depth.

**2.11** The stratigraphy in TP1 consisted of friable (10 YR 4/1) 'Dark Grey' sandy clay silt topsoil with occasional rounded stones and frequent asbestos fragments, to a depth of c.0.3m. Further excavation revealed modern made ground below the topsoil, consisting of 'Brown'(10 YR 4/3) firm mixed silty clay, with occasional modern brick fragments and occasional rounded stones >0.7m thick (Plate 1). One residual post-medieval brick fragment was uncovered from within the fill. No archaeology was seen and the natural substratum was not reached.

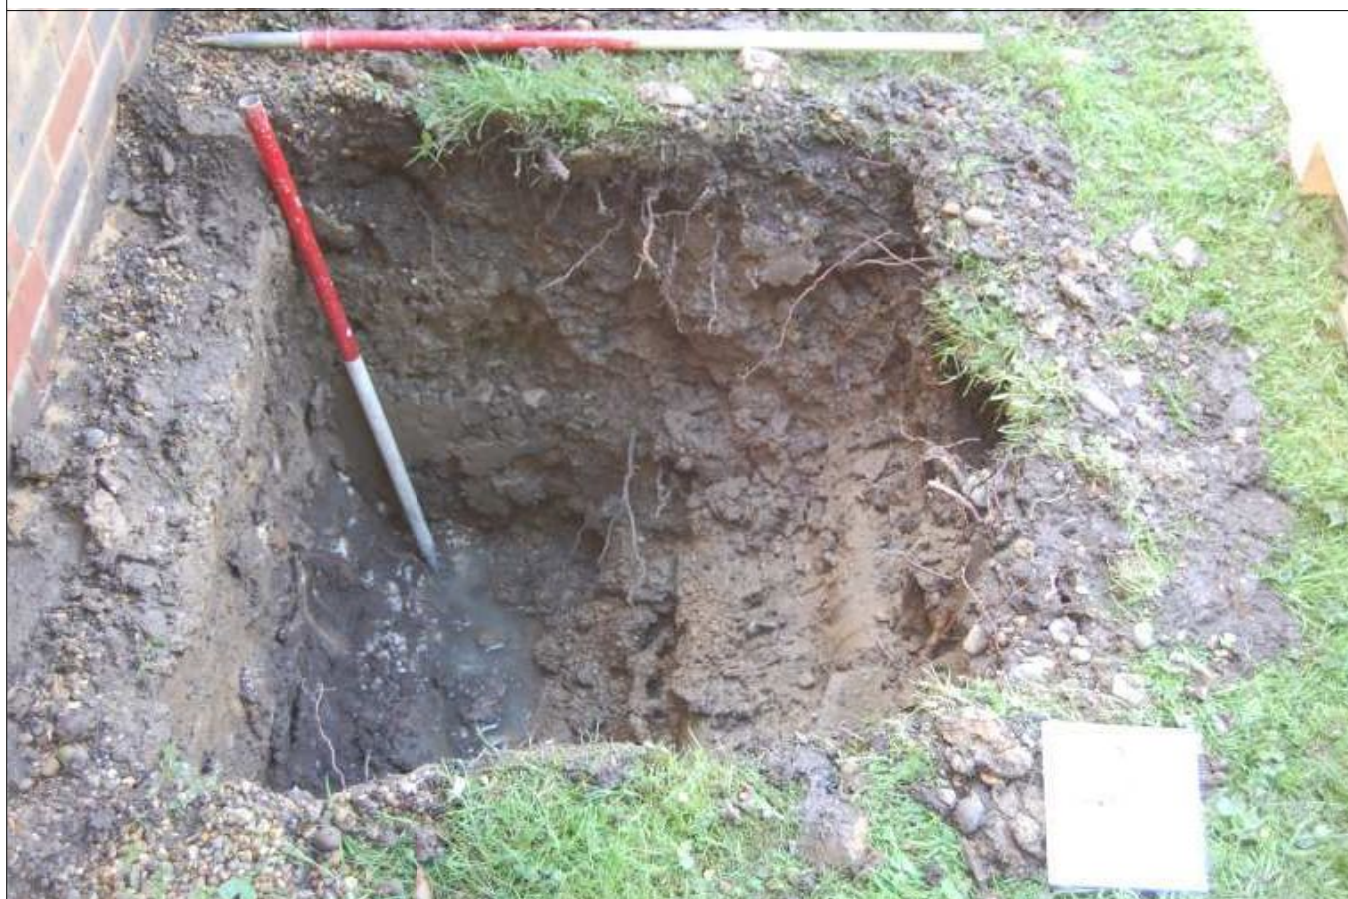
Plate 2: TP2 looking west

**2.12** Test-pit 2 was located on the southern edge of the site, abutting the school building (Figure 1). It measured 1m x 1m x 1m in depth.

**2.13** The stratigraphy also consisted of friable (10 YR 4/1) 'Dark Grey' sandy clay silt topsoil with occasional rounded stones and frequent asbestos fragments, to a depth of c.0.3m (same as Test Pit 1). Further excavation revealed modern made ground below the topsoil, consisting of 'Brown'(10 YR 4/3) firm mixed silty clay, with occasional modern brick fragments and occasional rounded stones >0.7m thick. Cutting into this layer a modern service trench/drain was seen and the concrete foundations of the building (Plate 2). No archaeology was seen and the natural substratum was not reached.

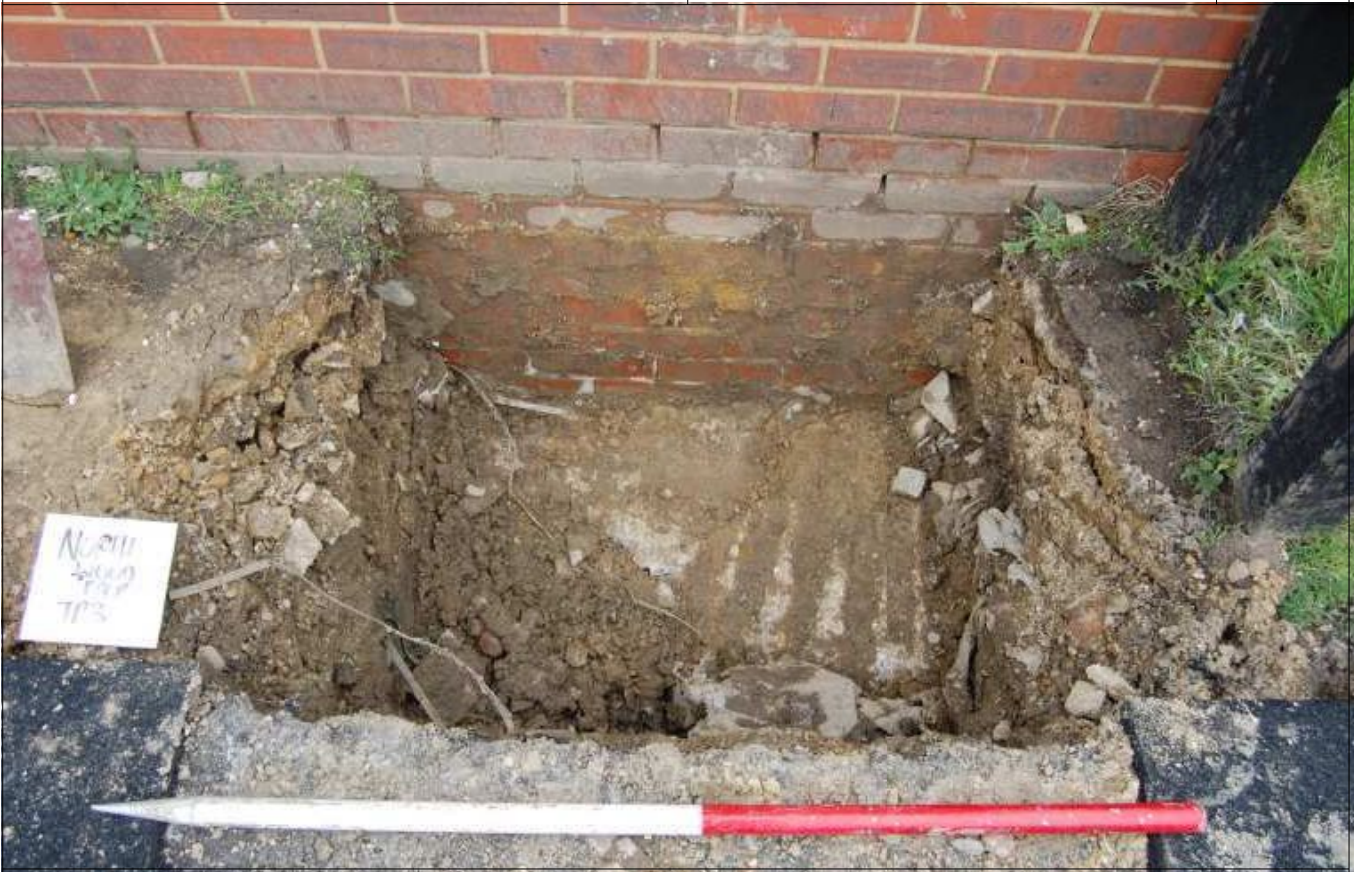
Plate 3: TP3 looking north

**2.14** Test-pit 3 was located on the north western edge of the site abutting the school building (Figure 1 & Plate 3). It measured 1m x 1m in area and was 0.45m deep.

**2.15** The stratigraphy consisted of a firm (10 YR 4/3) 'Brown' silty clay layer, which contained frequent concrete fragments, occasional modern metal objects and occasional bits of plastic. Below this layer, at a depth of 0.45m, the concrete foundations of the building were revealed (Plate 3) and no deeper excavation was possible.

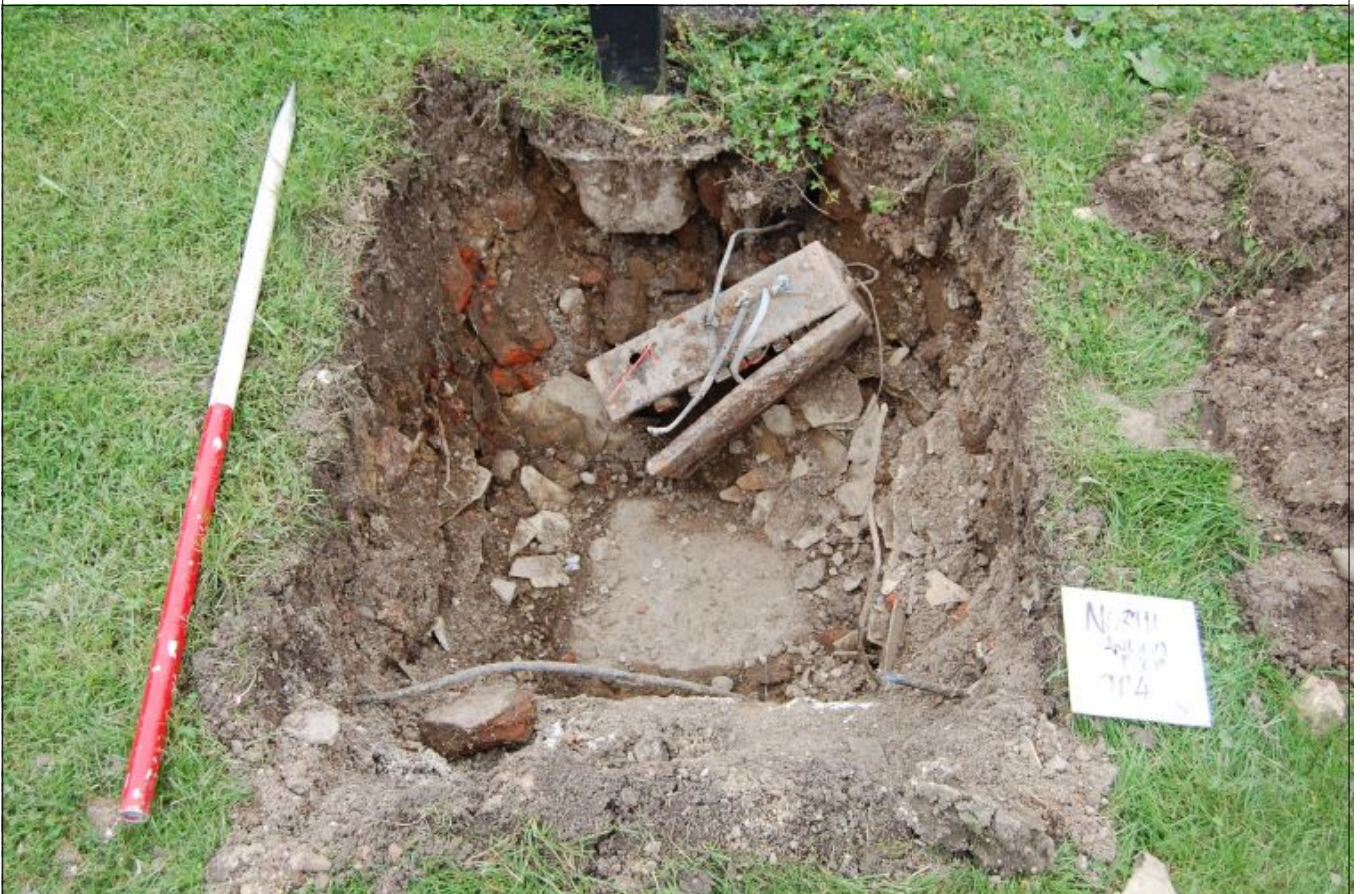
Plate 4: TP4 looking west

**2.16** Test-pit 4 was located immediately to the east of the existing rubberised playground surface (Figure 1 & Plate 4) and measured 1m x 1m x 0.4m deep.

**2.17** The stratigraphy consisted of friable (10 YR 4/1) ‘Dark Grey’ sandy clay silt topsoil with occasional rounded stones and frequent asbestos fragments, to a depth of c.0.3m. Immediately below the topsoil a modern demolition layer was revealed, consisting of modern brick and concrete rubble, plastic and old broken electrical parts. Below this layer, at a depth of 0.4m, was a modern concrete surface and a concrete ‘lip’ (Plate 4).

**2.18** Based on an aerial photograph held by the school, this appears to form a farmyard surface which was in existence in 1984, prior to the construction of the junior school.

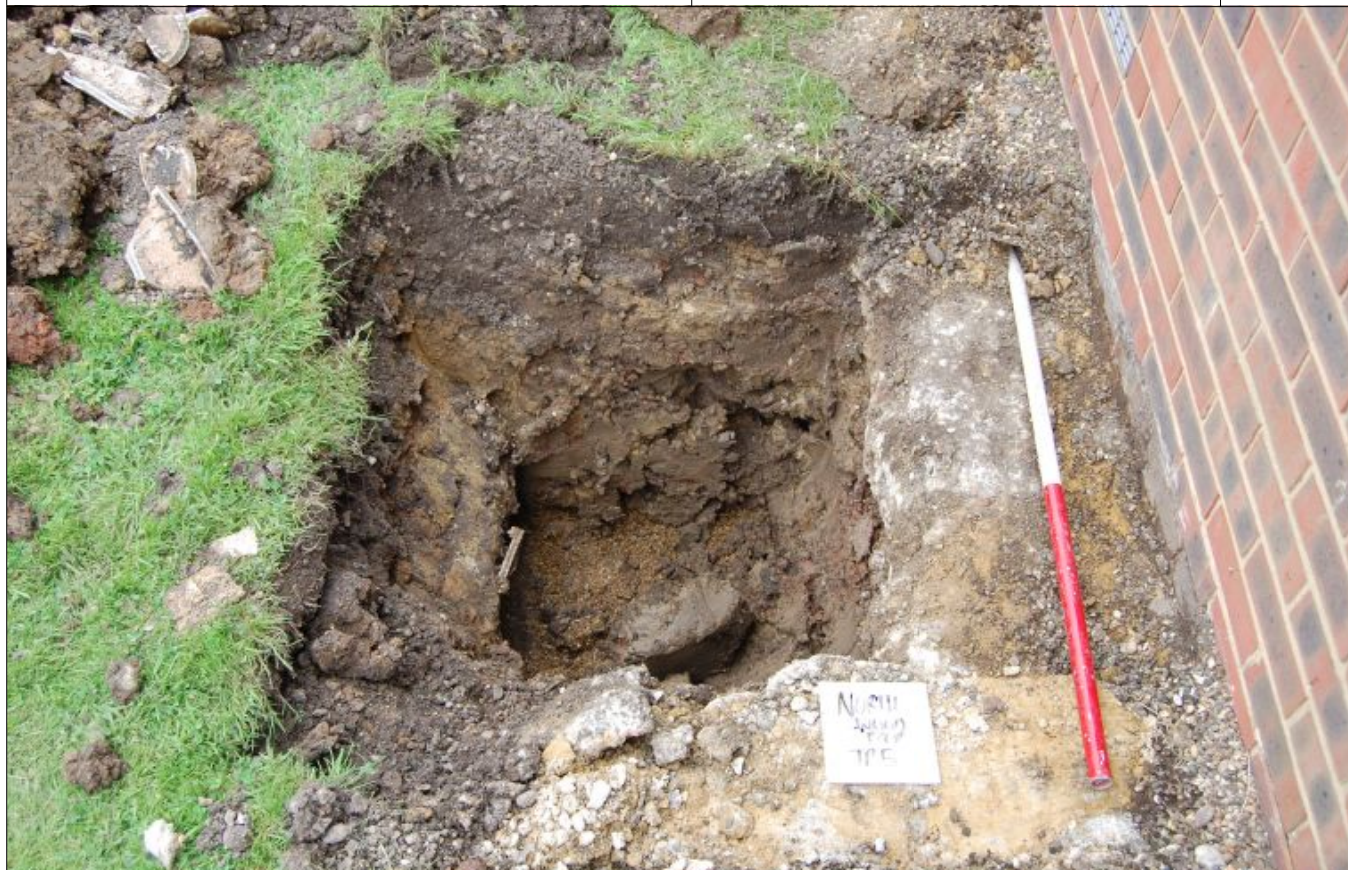
Plate 5: TP5 looking east

**2.19** Test-pit 5 was located on the southern edge of the site, in the south western corner, abutting the school building (Figure 1). It measured 1m x 1m x 1m in depth.

**2.20** The stratigraphy consisted of friable (10 YR 4/1) ‘Dark Grey’ sandy clay silt topsoil with occasional rounded stones and frequent asbestos fragments, to a depth of c.0.3m. Further excavation revealed modern made ground below the topsoil, consisting of ‘Brown’(10 YR 4/3) firm mixed silty clay, with occasional modern brick fragments and occasional rounded stones >0.7m thick. Cutting into this layer was a modern service trench/drain and the concrete foundations of the building (Plate 5). No archaeology was seen and the natural substratum was not reached.

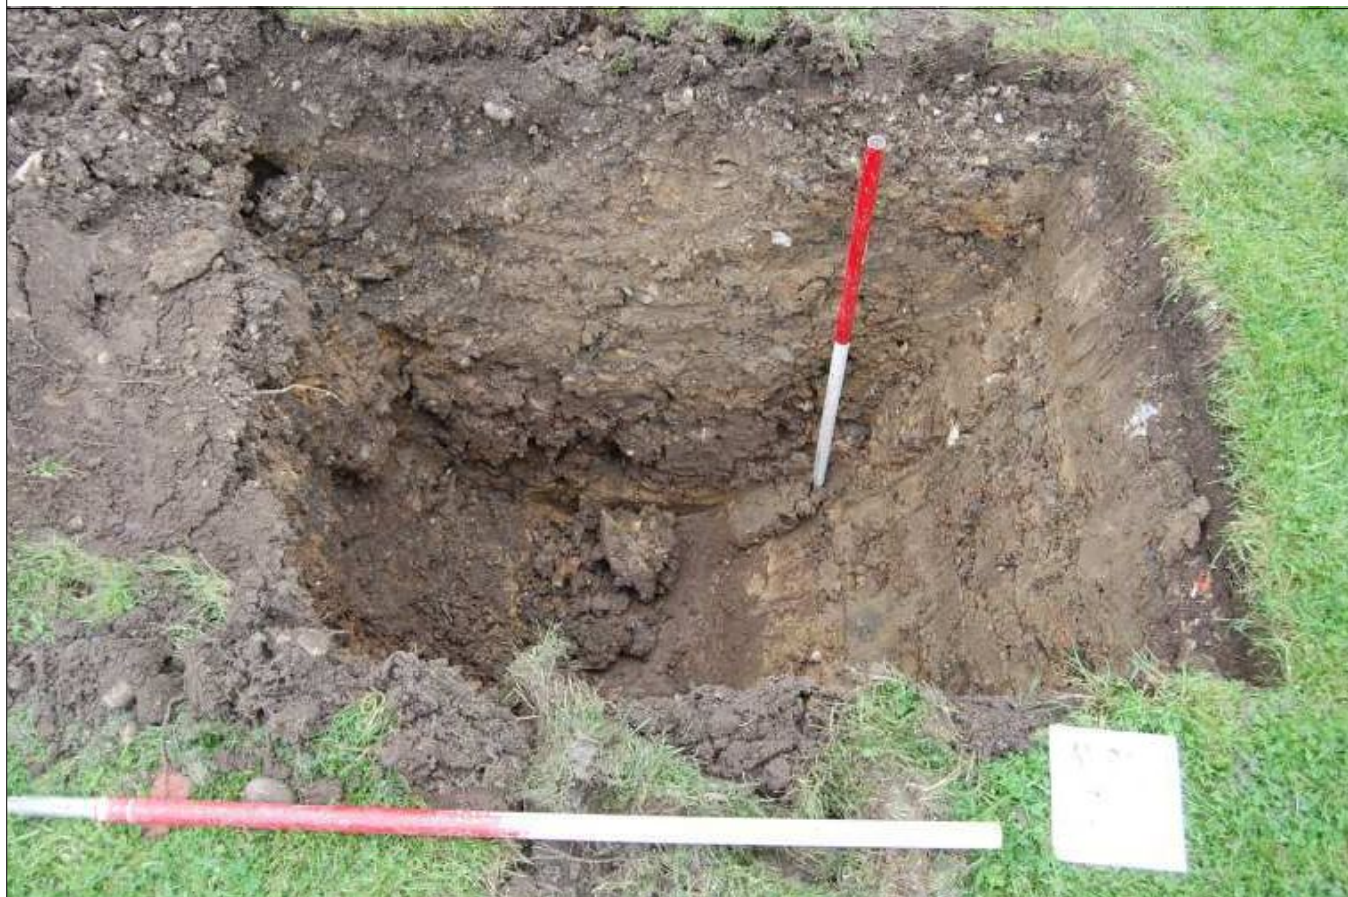
Plate 6: TP6 looking south

**2.21** Test-pit 6 was excavated in the location of the proposed evaluation trench, towards the western end of the proposed building footprint (Figure 1 & Plate 6). The topsoil was the same as that seen in the majority of the other test pits and it overlay 0.9m of modern made ground, similar to that observed in Test pits 1, 2, 4 & 5.

**2.22** Feature (603) consisted of soft ‘very dark grey’ (10 YR 3/1) clay silt with tiny fragments of brick or tile (Plate 6). It was exposed at a depth of 1.2m and measured >1m x >0.6m x unknown depth, extending beyond the limit of excavation.

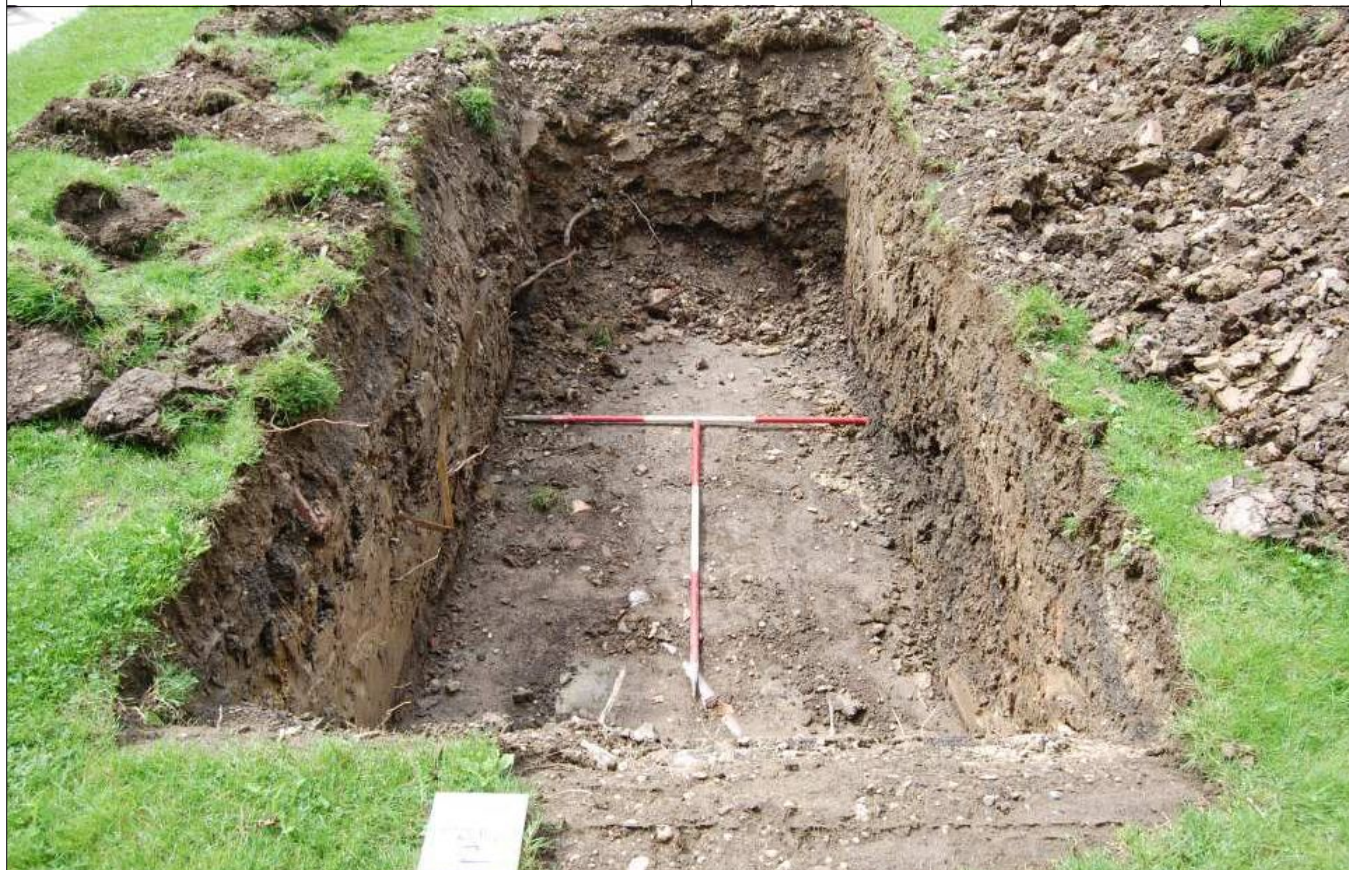
Plate 9: Trench 2, looking east

**2.28** Trench 2 was located in the southeast of the site, within the footprint of the proposed building (Plate 9). It was orientated east-west and measured 4.5m in length, 1.85m in width and was excavated to a depth of 1.6m.

**2.29** The topsoil in Trench 2 consisted of 0.1m of a friable greyish brown clay/silt with sand (1003), with moderate sub-angular gravel to 10mm in diameter. This sealed a 1.2m thick layer of pale brown silty clay (2001) that contained occasional concrete and brick and tile

**2.30** Beneath the levelling deposit was a 0.30m thick deposit of dark greyish brown sandy silty clay (2002) with brick and tile fragments, that extended beyond the limit of excavation. This deposit was thought to represent a buried agricultural/horticultural earth and contained brick and tile fragments similar to those collected from Trench 1.

**2.32** A broken 0.15m diameter ceramic drain pipe was found at a depth of 1.6m, in a c.0.6m wide pipe trench that had been dug into the agricultural earth. The pipe and its construction trench were sealed by the levelling deposit (2001). The pipe was dry, and was left in situ.
