**104 HIGH STREET
Meldreth, Cambridgeshire**

***ARCHAEOLOGICAL
EVALUATION REPORT
& BUILDING APPRAISAL***

Project ref.: HN1018
LPA refs.: S/1656/11 & S/0958/10/F
Event No: ECB 3859

Archaeological Evaluation
&
Historic Building Appraisal

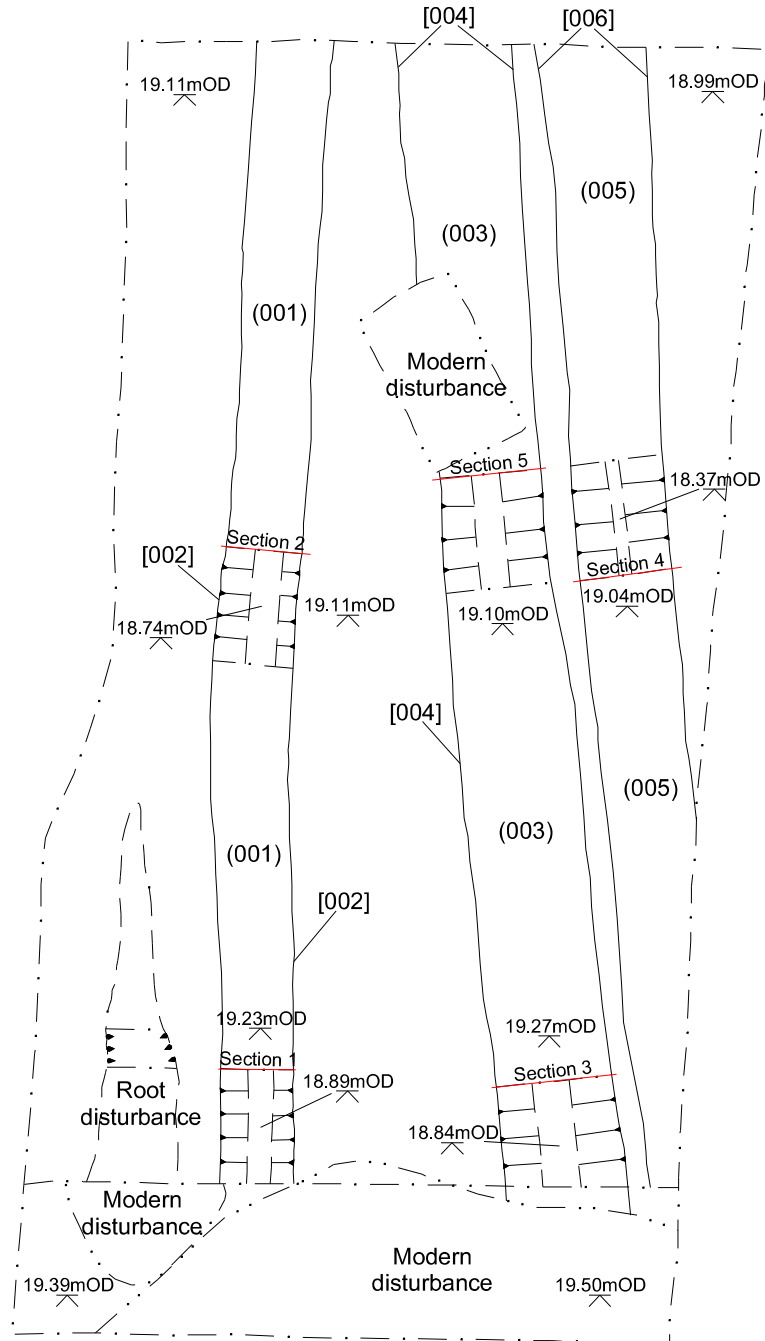
Figure 3

Plan of excavated area

2.10 Cutting into the natural were three approximately parallel ditches [002], [004] and [006], which all had sloping sides and flat bases. They were all filled with grey brown sandy clayey silt (001), (003) and (005). Pottery dating to between the 9th and 12th centuries was recovered from fills (001) and (003).

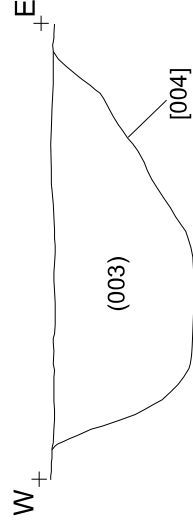
Section 3, south facing

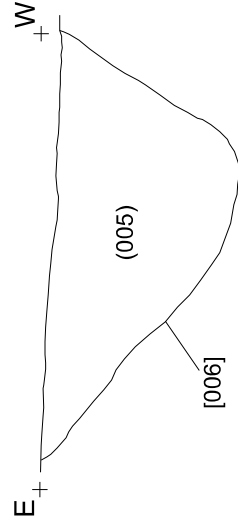
Section 4, north facing

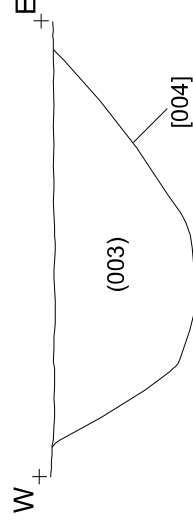
Section 5, south facing

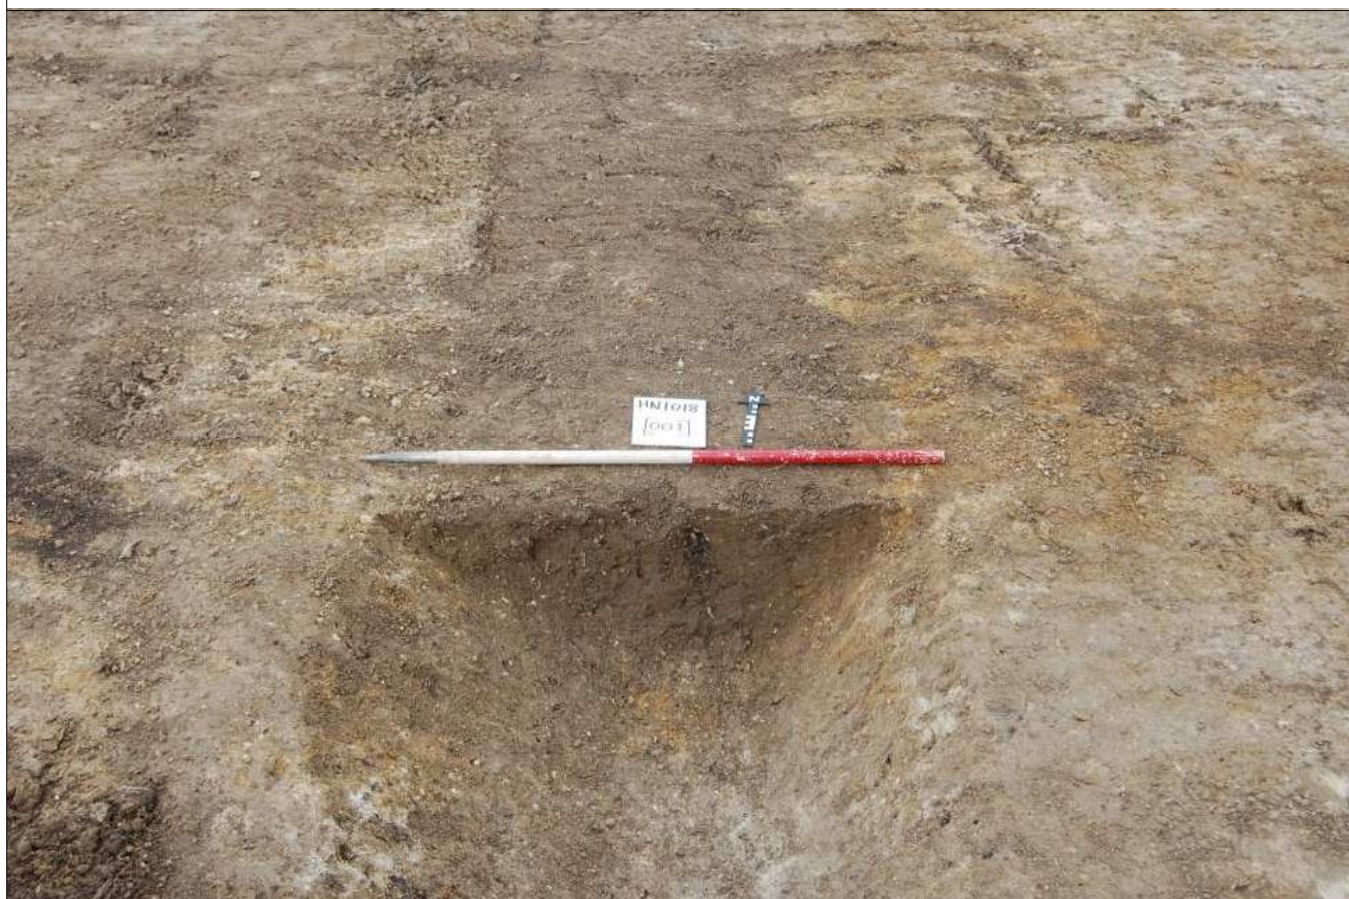
Plate 2: Section through ditch [002], looking north.

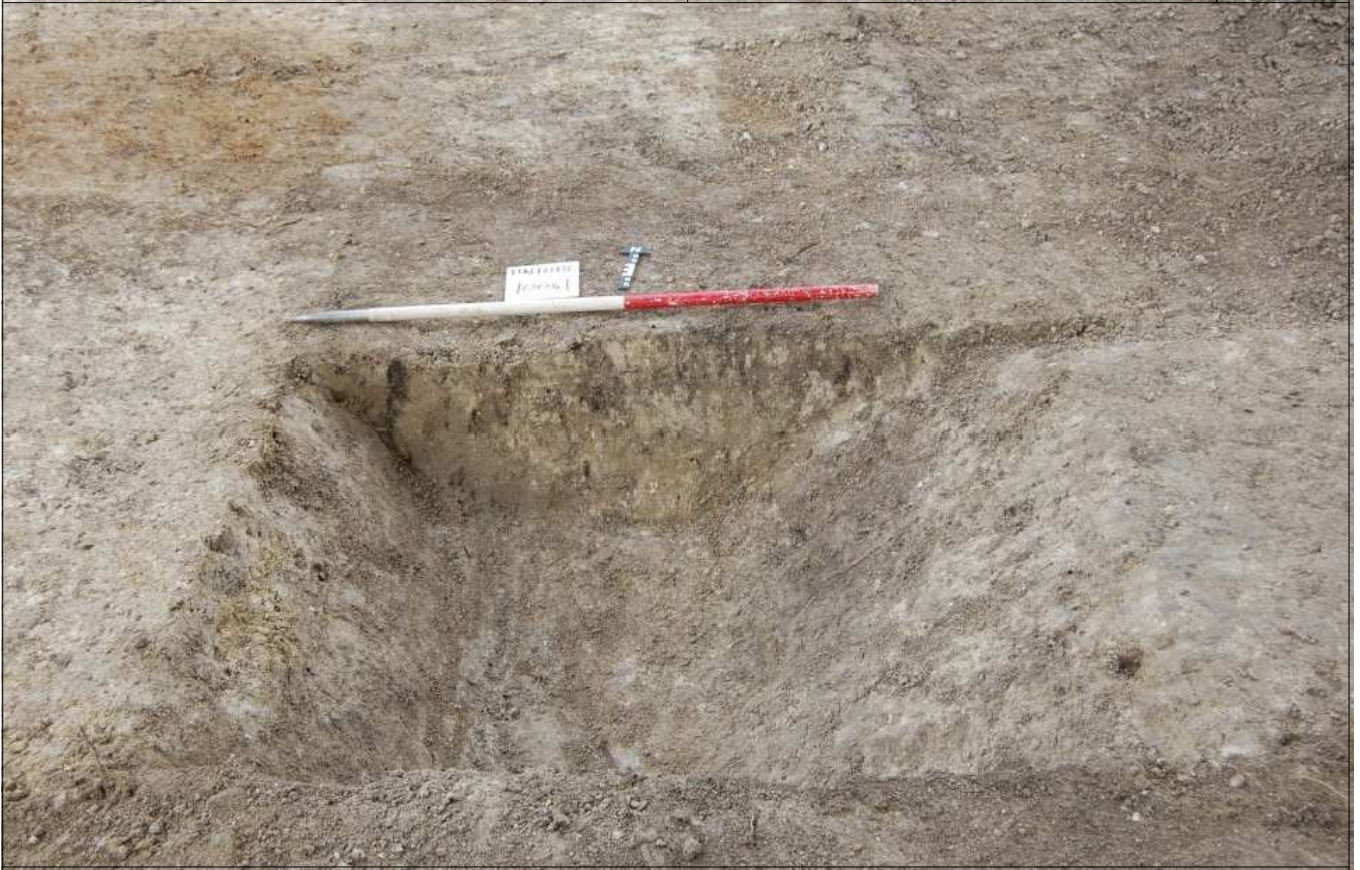
Plate 3: Section through ditch [004], looking north.

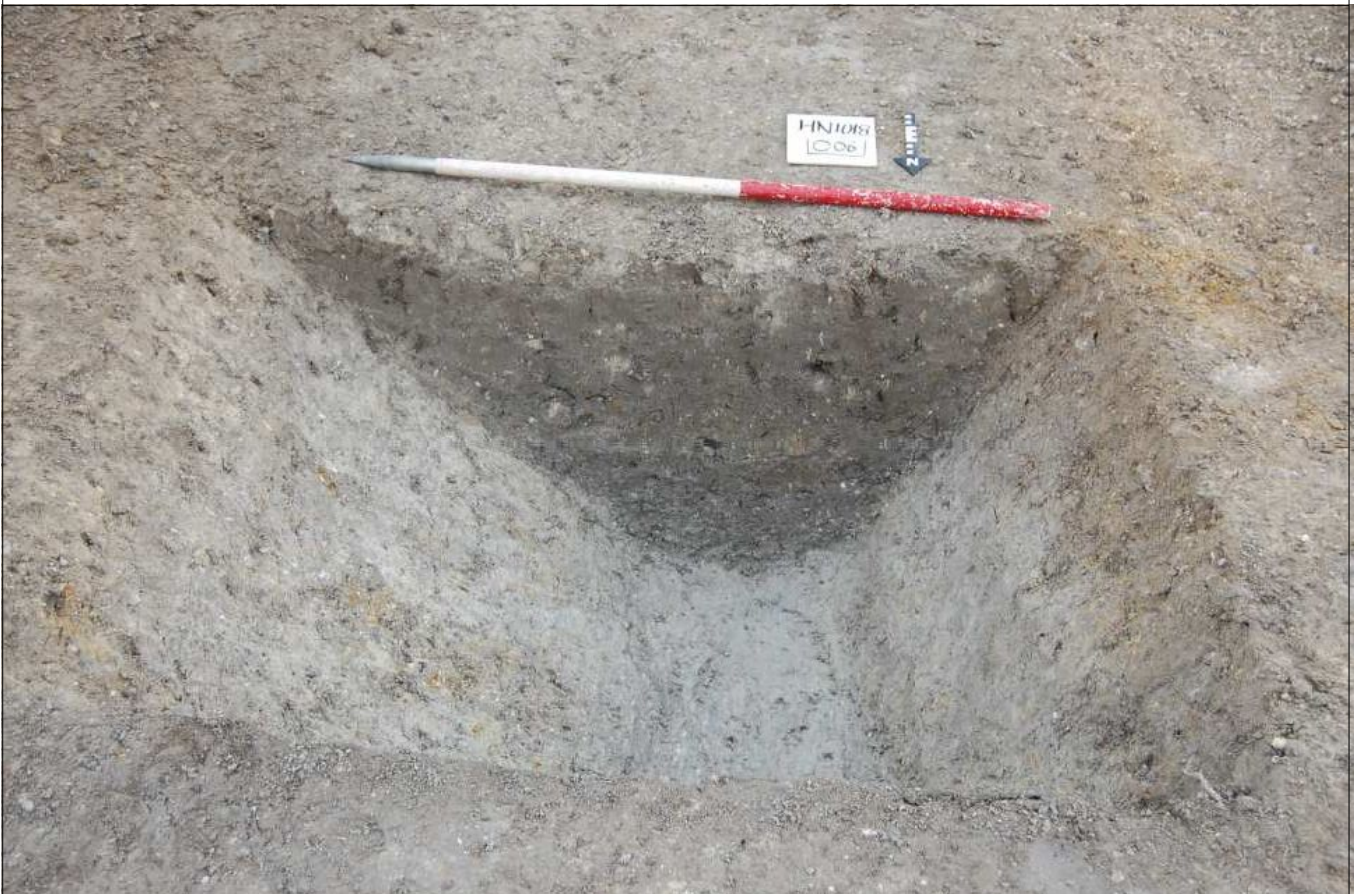
Plate 4: Section through ditch [006], looking south.

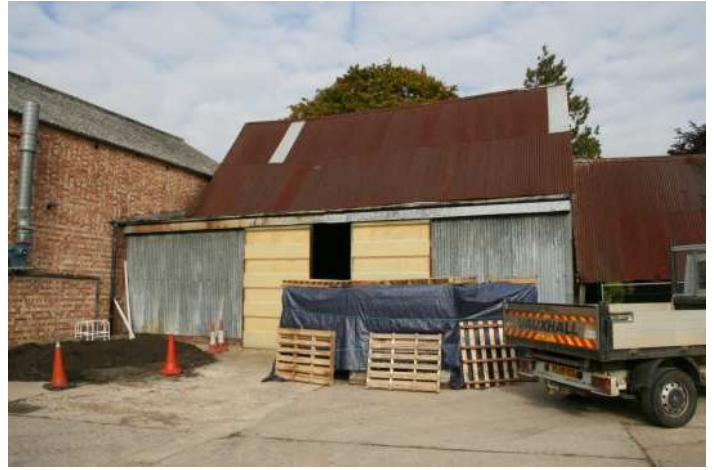
HN1018_002A

4.2 Barn 1, to the west, is a three bay timber framed barn with a pitched corrugated iron roof and modern softwood weatherboarding to the east, west and north elevations. The south elevation is occupied by a modern corrugated iron pent-roofed lean-to (Frames 2, 9, & 10).

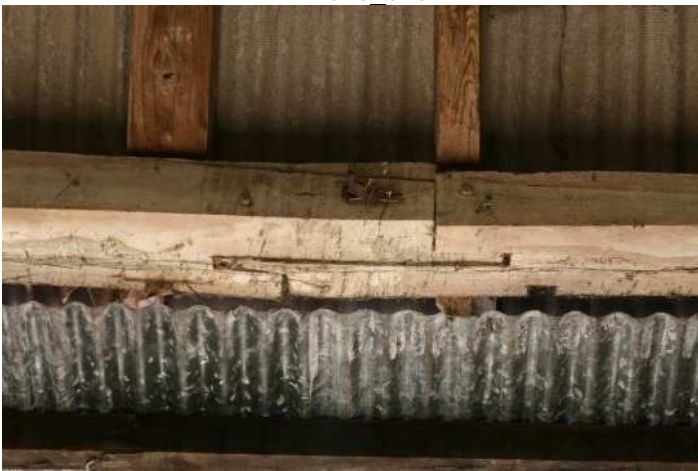
HN1018_027A

4.3 The barn is of post-and-truss construction, the principal posts, which are of narrow scantling (0.13m wide instead of an expected 0.20m), having square stepped gunstock jowls (Frame 31). Each bay has a centre post running between the wall and sole plates, flanked by staggered mid-rails (Frame 15). The studwork, which appears to be largely original and of hardwood (oak, with possibly some ash and elm) is of narrow scantling and waney-edged, with primary bracing above the mid-rails and also below, at the corners of the building. The tie-beams and their curving braces are also waney-edged. The wall plate in both northern and southern elevations is in two halves joined by face-halved and bladed scarf joints (Frames 27 & 28).

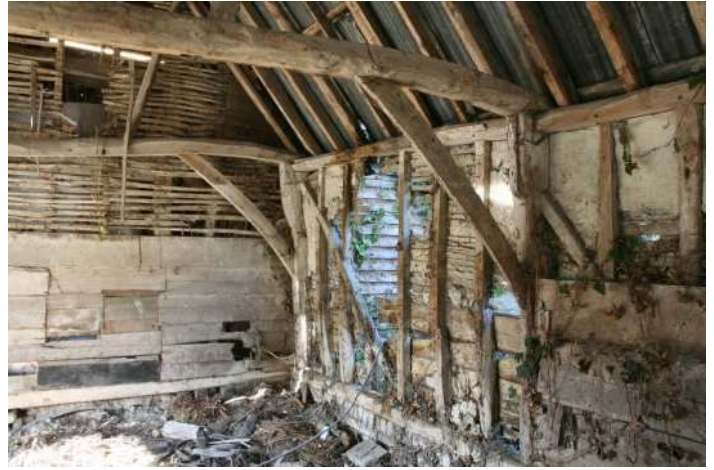
HN1018 034A

4.10 The barn shows a mixture of styles, Bay 1 being of post-and-truss construction (Frames 34 & 35) and Bays 2 to 4 being box-framed. The principal posts at the four corners of Bay 1 have gunstock jowled heads, each with diagonally cut steps. Curved braces run between the principal posts and the tie-beam, with queen struts bracing the principal rafters. The northern sole plate to Bays 1 -3 sits on a plinth of Cambridge white bricks and the wall-plate runs through all three bays, with pegged hardwood studs, infilled with straw strengthened plaster, closing the elevation. The southern wall plate has mortice holes in its bottom face indicating that this elevation was originally closed.

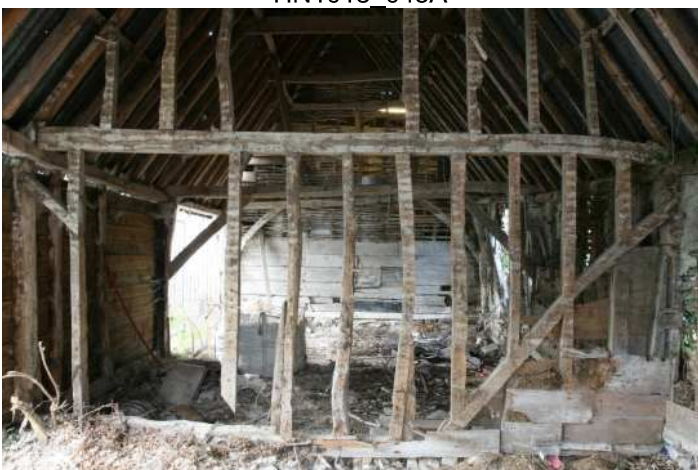
HN1018_047A

4.11 Bays 1 and 2 are linked and a partition separates Bays 2 and 3, its sole plate resting on a plinth of Cambridge white bricks (Frames 47 & 48). The partition was formerly faced with lath and plaster to the roof. A further partition separates Bays 3 and 4, its western face having been weatherboarded to the level of the tie beam, as demonstrated by surviving nails (Frames 41 & 42). Surviving nails show that the weatherboarding extended to the northern elevation, to within 0.40m of the eaves, above which was plastered. In Bay 4, the western partition was previously plastered to the roof (Frames 51 & 52). A side-halved scarf or lap joint in the northern wall plate located just beyond the partition (Frame 54), and a rise in the level of the sole plate indicates an earlier terminus to the structure, and suggests that Bay 4 is a later extension. A splayed scarf joint in the same wall-plate in the middle of the northern elevation serves to confirm this (Frame 55).
