HOW GREEN MEADOW Buntingford, Hertfordshire

HN1024

ARCHAEOLOGICAL MONITORING REPORT

Archaeological Monitoring Report

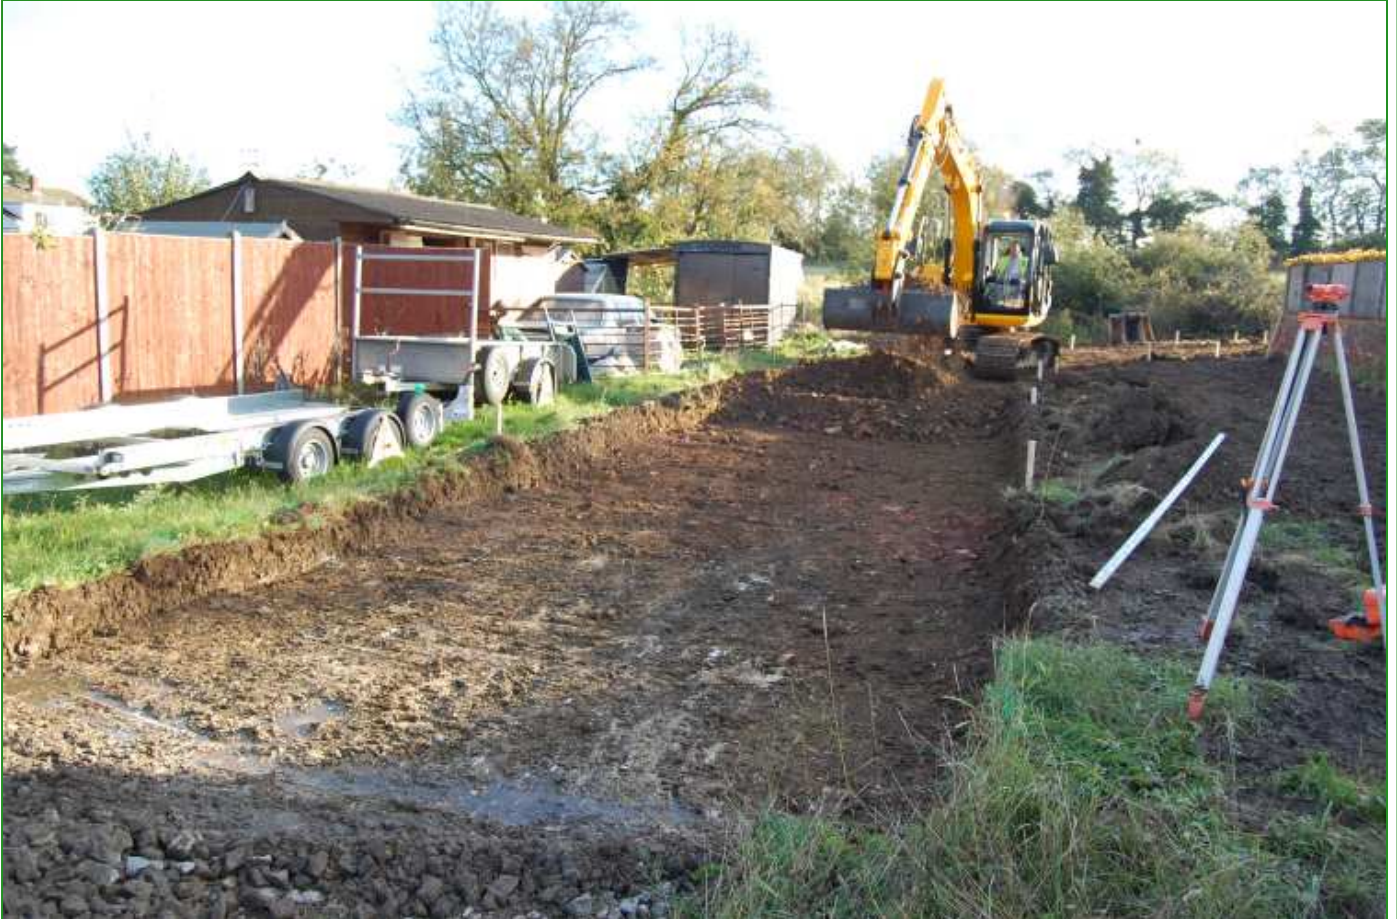
The cover photograph shows the stripping of the access road looking north-east

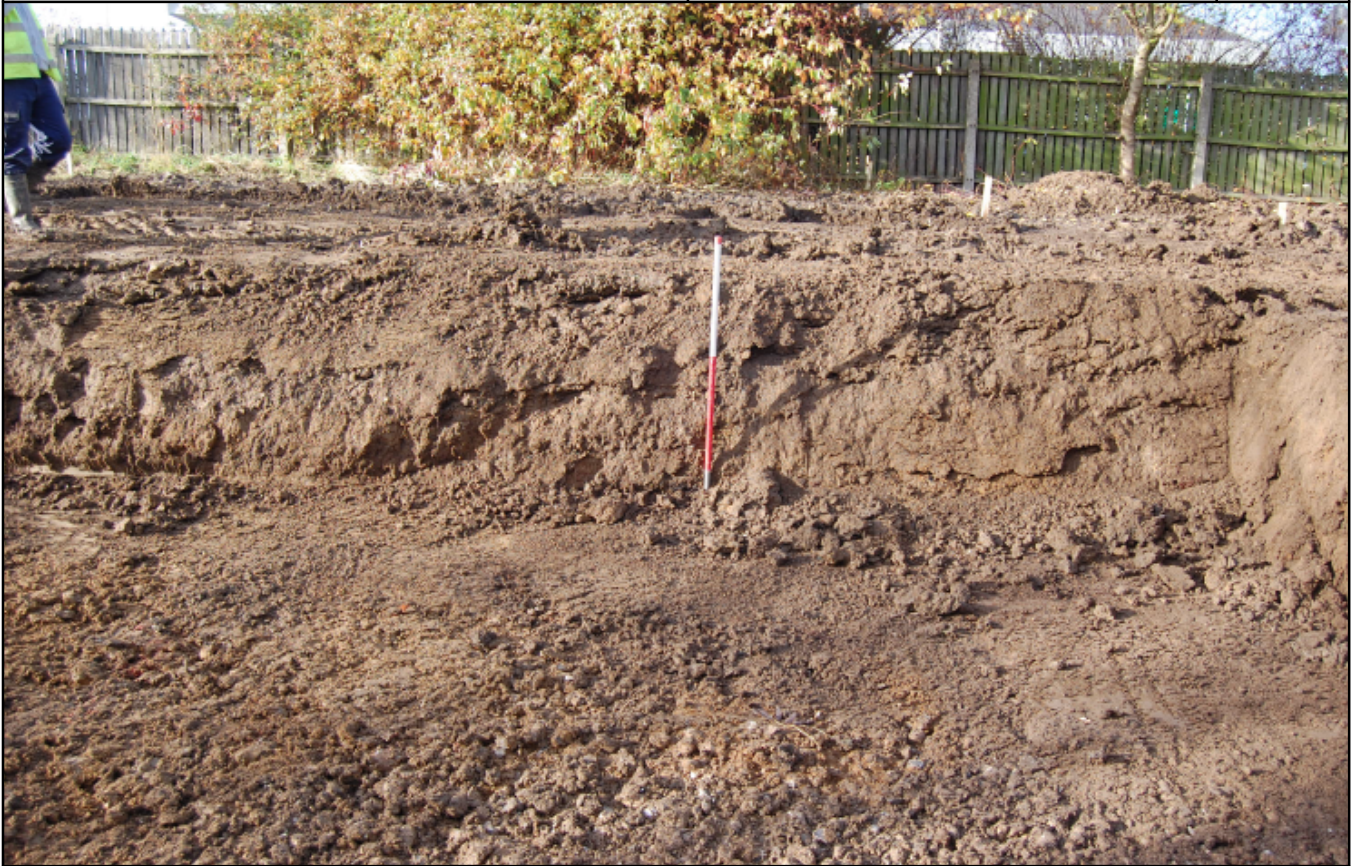
Plate 1: General stratigraphy on the site

2.12 The stratigraphy encountered across the site consisted of a highly mixed topsoil layer, approximately 0.30m in depth. This consisted of mixed clay, sand and gravel, which varied in colour from pale yellowish grey to dark greyish brown (Plate 1). Artefacts of late post-medieval and modern date, including brick, tile and glass fragments, were present in this layer, but not collected. Below this was a layer of mixed made ground, over 0.70m in depth, containing modern brick, plastic and metal fragments. The underlying natural was not exposed by the groundworks.

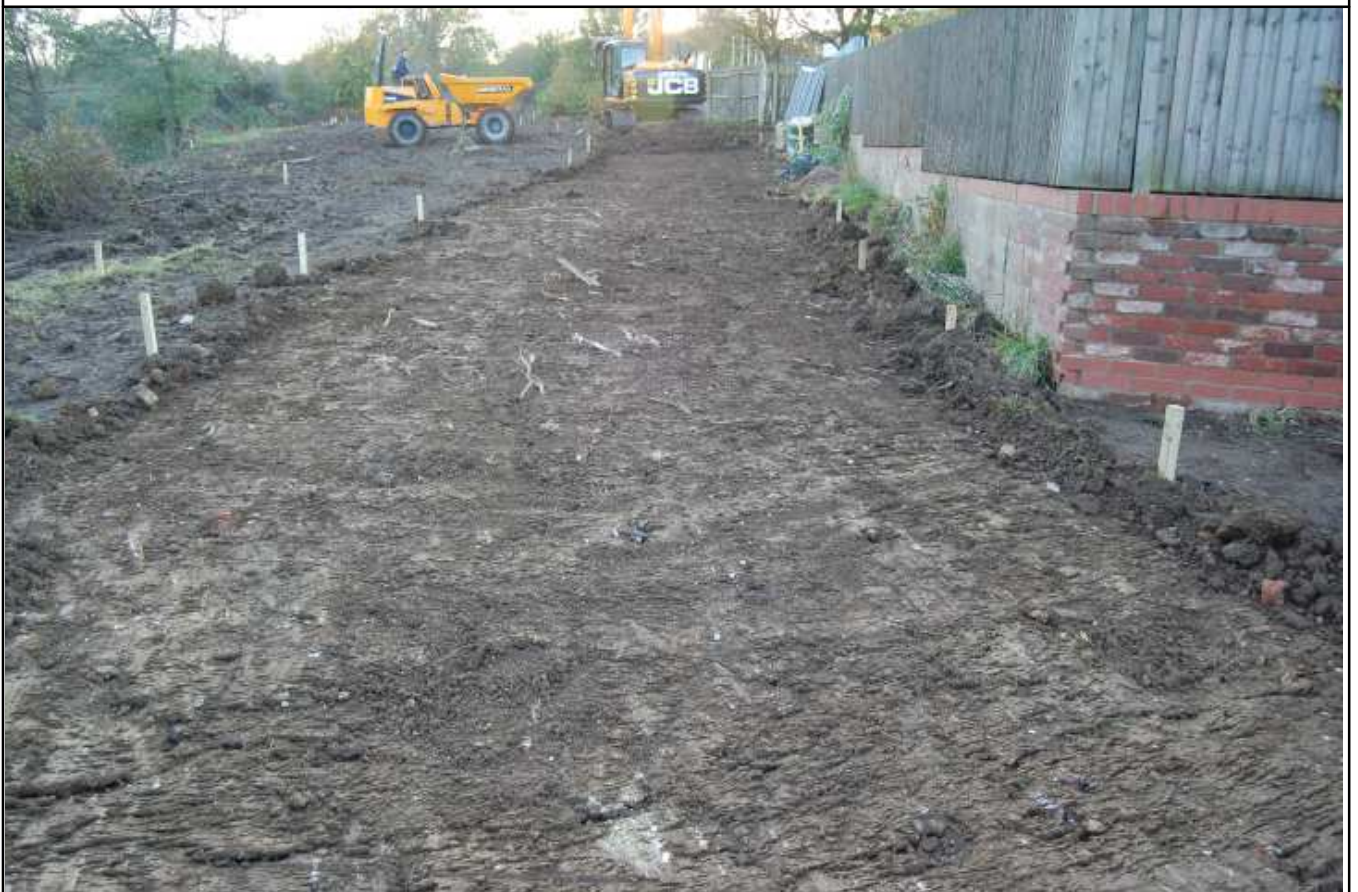
Plate 2: Access road, looking W

2.13 The access road covered an area of approximately 455m² and ran on a curving course following the northern boundary to meet the B1038 Baldock Road (Figure 2). It was reduced by 0.10m at the western end, increasing to 0.40m at the north-eastern end.

2.14 The stripping did not breach the overburden and no features, deposits or finds of archaeological significance were encountered in this area.

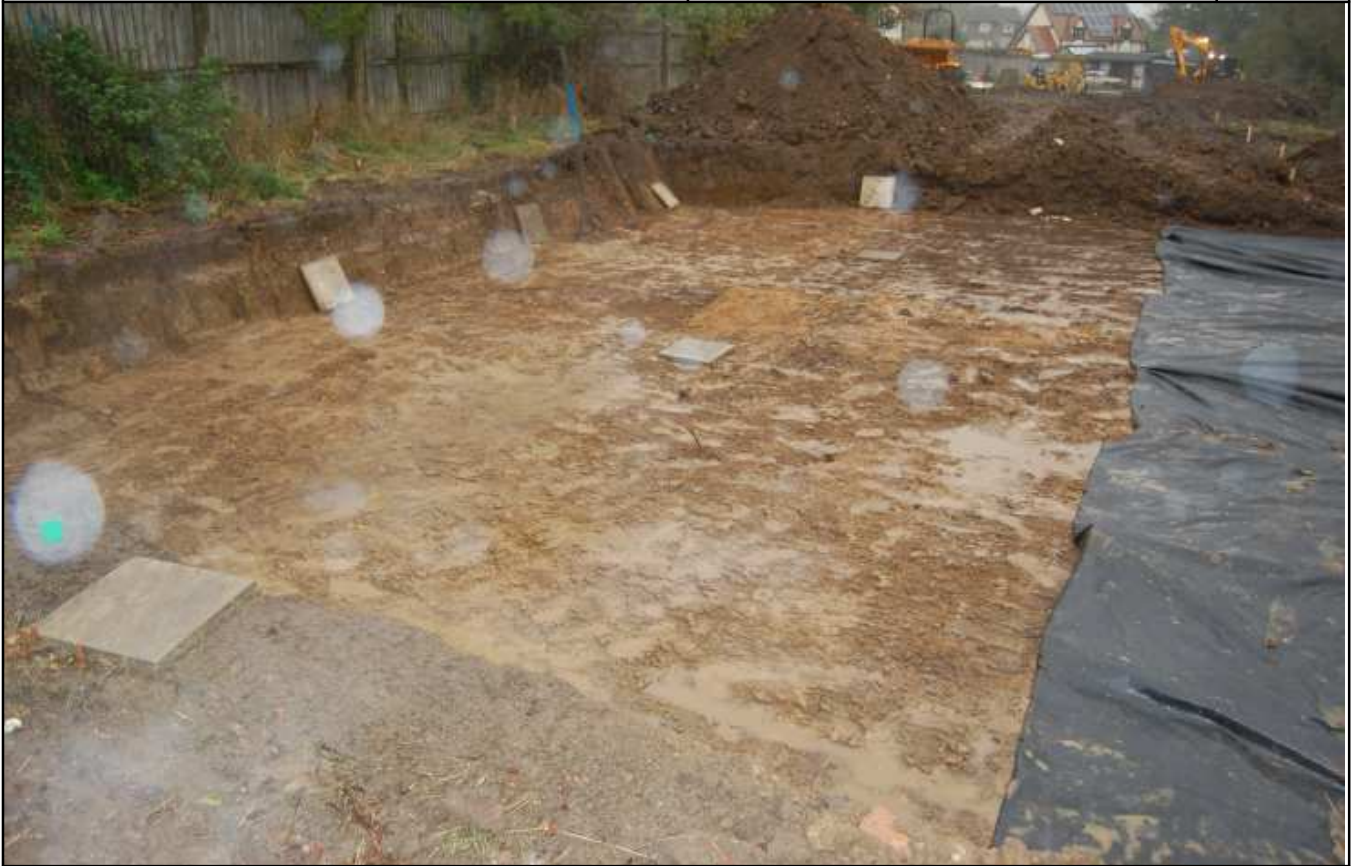
Plate 3: Plot 1, looking N

2.15 Plot 1 was located at the western end of the site and covered an area of approximately 102.50m² (Figure 2). The ground level was reduced by 0.30m in the south-eastern corner, increasing to c.1m in the north-western corner (Plate 3). A separate garage, measuring approximately 5.70m x 5.70m was located 6m to the east. This was reduced by approximately 1m (Plate 4).

2.16 The stripping did not breach the overburden and no features, deposits or finds of archaeological significance were encountered in this area.

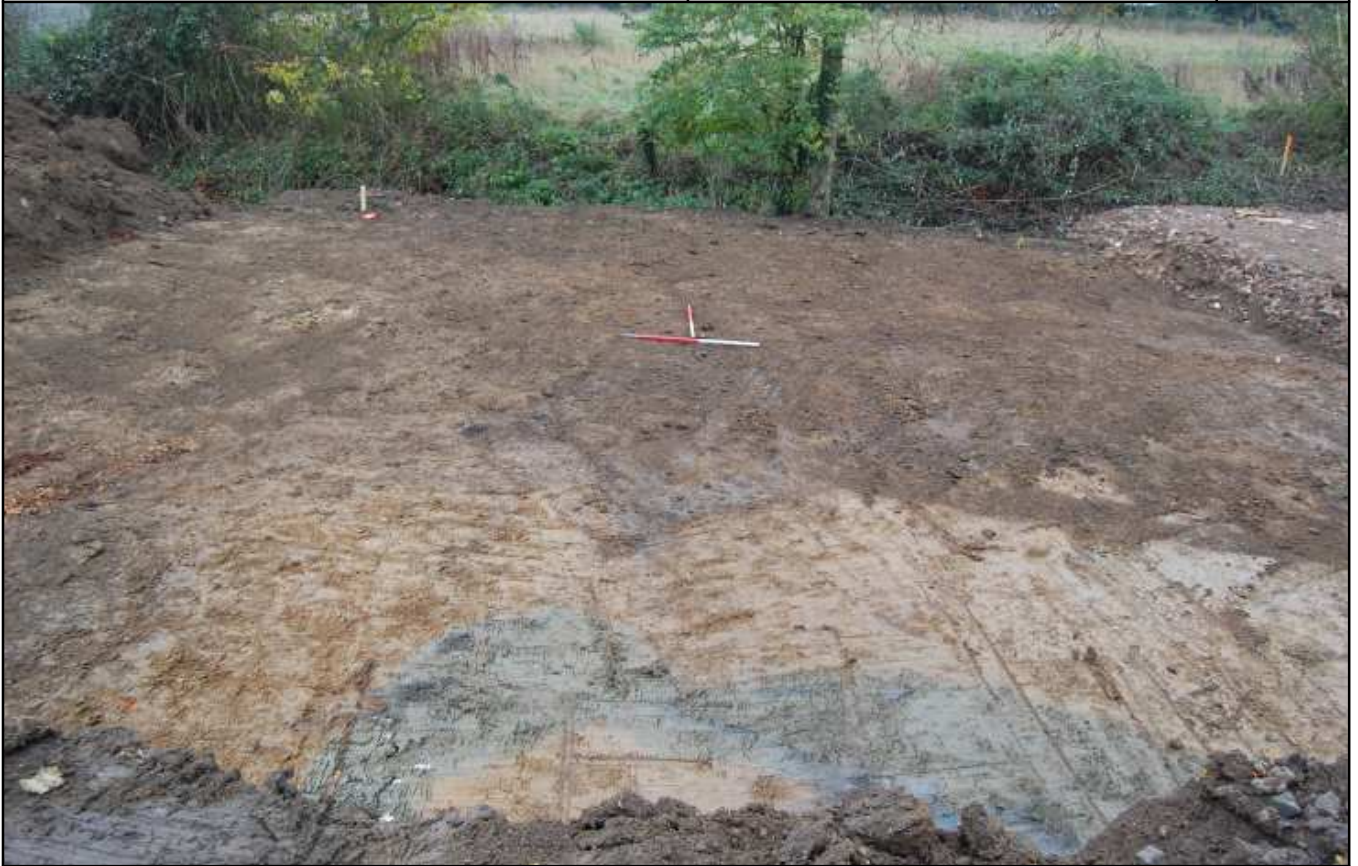
Plate 5: Plot 2, looking S

2.17 Plot 2 was located to the east of Plot 1 and covered an area of approximately 137.70m², including a linked garage to the west (Figure 2). The ground level was reduced by 0.10m in the south-eastern corner, increasing to 1.20m in the north-western corner (Plate 5). The garage footprint was excavated to a depth of 1m.

2.18 The stripping did not breach the overburden and no features, deposits or finds of archaeological significance were encountered in this area.

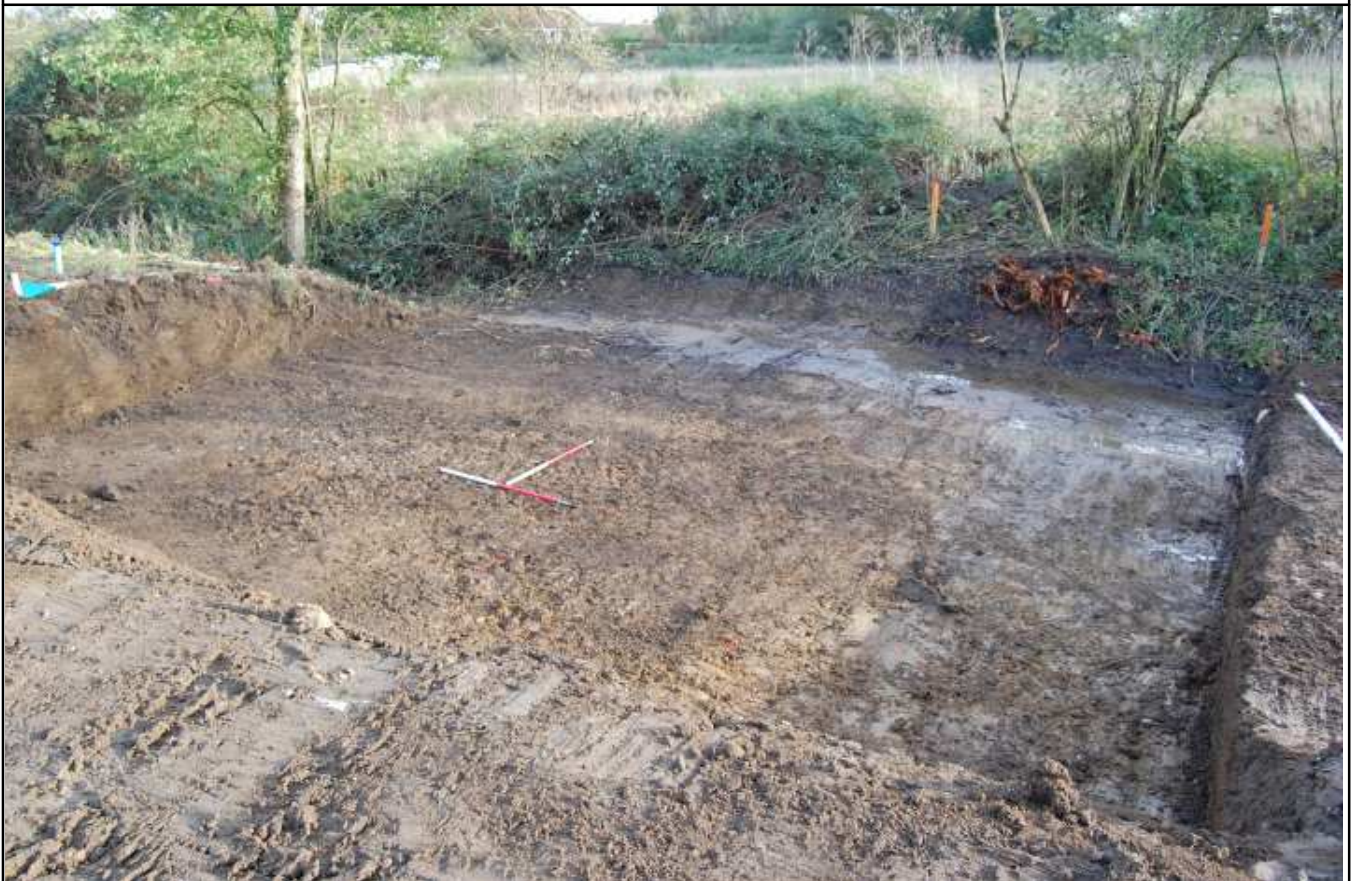
Plate 6: Plot 3, looking SE

2.19 Plot 3 was located in the south-eastern corner of the site and covered an area of approximately 99m² (Figure 2). The ground level was reduced by 0.10m in the south-eastern corner, increasing to 1.20m in the north-western corner (Plate 6). The garage footprint was excavated to a depth of 0.60m.

2.20 The stripping did not breach the overburden and no features, deposits or finds of archaeological significance were encountered in this area.
