**52A - 56 HIGH STREET  
Watford, Herts.**

HN1025

***ARCHAEOLOGICAL  
EVALUATION REPORT***

Project ref.: HN1025  
Planning refs.: 06/01335/FULM & 10/00121/EXT  
HER Enquiry ref.: 224/12

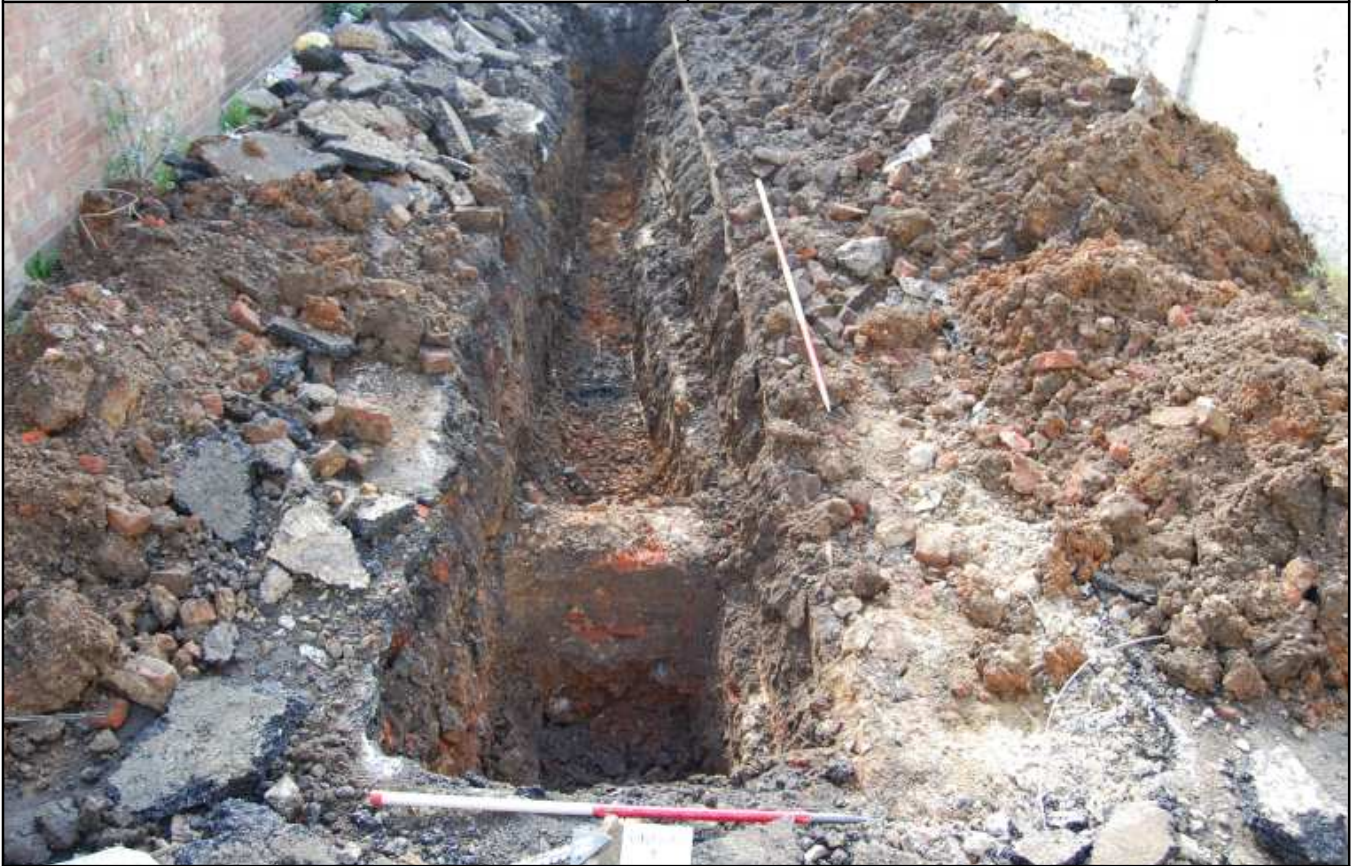
Plate 1: Trench 1, looking west.

**2.8** Trench 1 was located at the northern extent of the yard and was orientated north-east to south-west (Plate 1). The trench measured 10m in length by 0.45m in width, and was machine excavated to a maximum depth of c.1.5m. The trench was moved from the alignment proposed in the Project Design to avoid undermining existing walls and was reduced in width to avoid existing services and foundations.

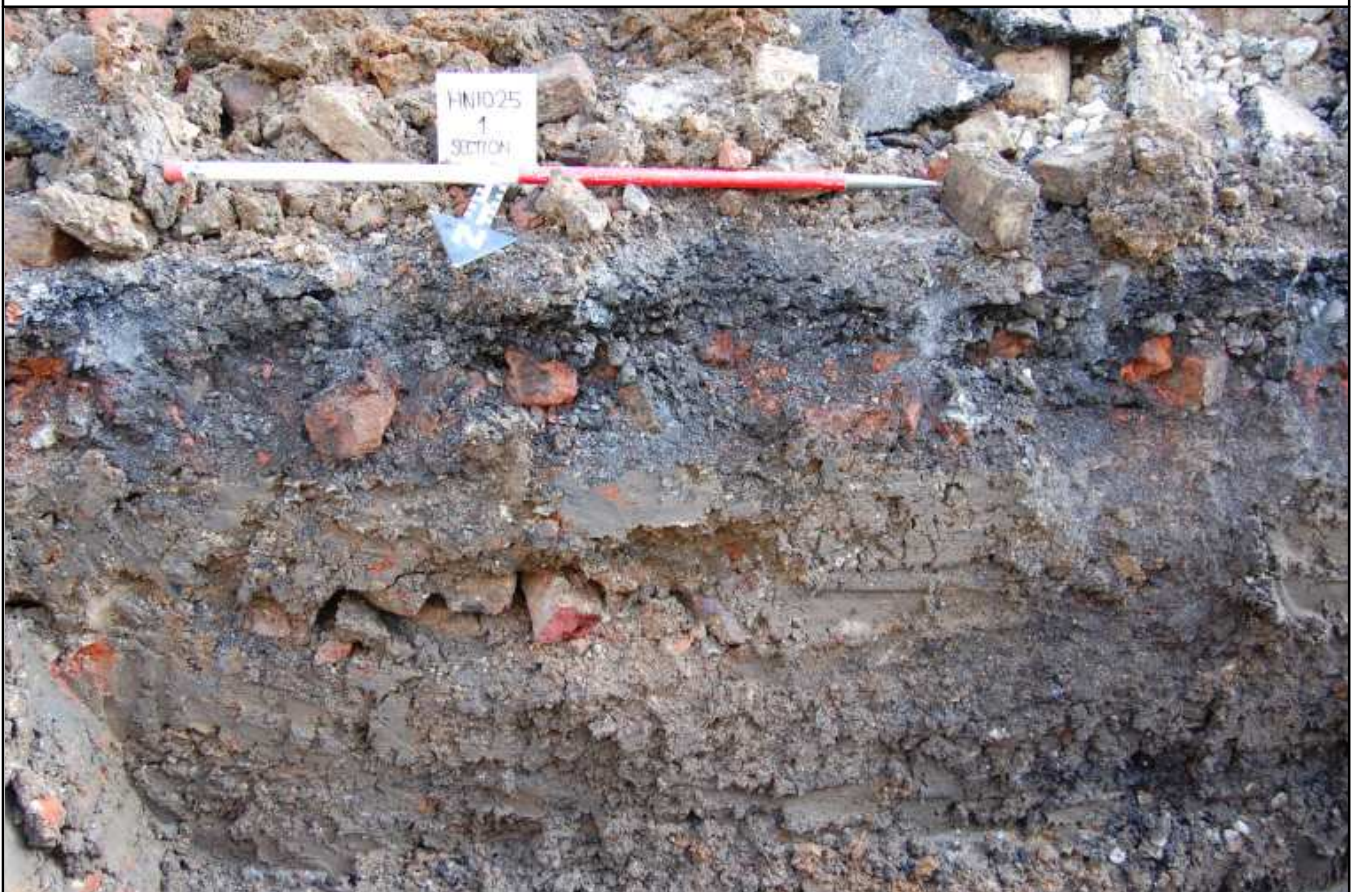
Plate 2: Trench 1, indicative section, showing overburden, looking south.

**2.9** The stratigraphy in Trench 1 (Plate 2) comprised a layer of dark grey (10YR 4/1) tarmac, 0.2m thick, above made ground formed of dark brown (10YR 3/3) loose heavily mixed sandy silty clay, 1.0m thick, which contained moderate brick rubble. This overlay the natural substrate of yellowish brown (10YR 5/8) sticky silty clay.

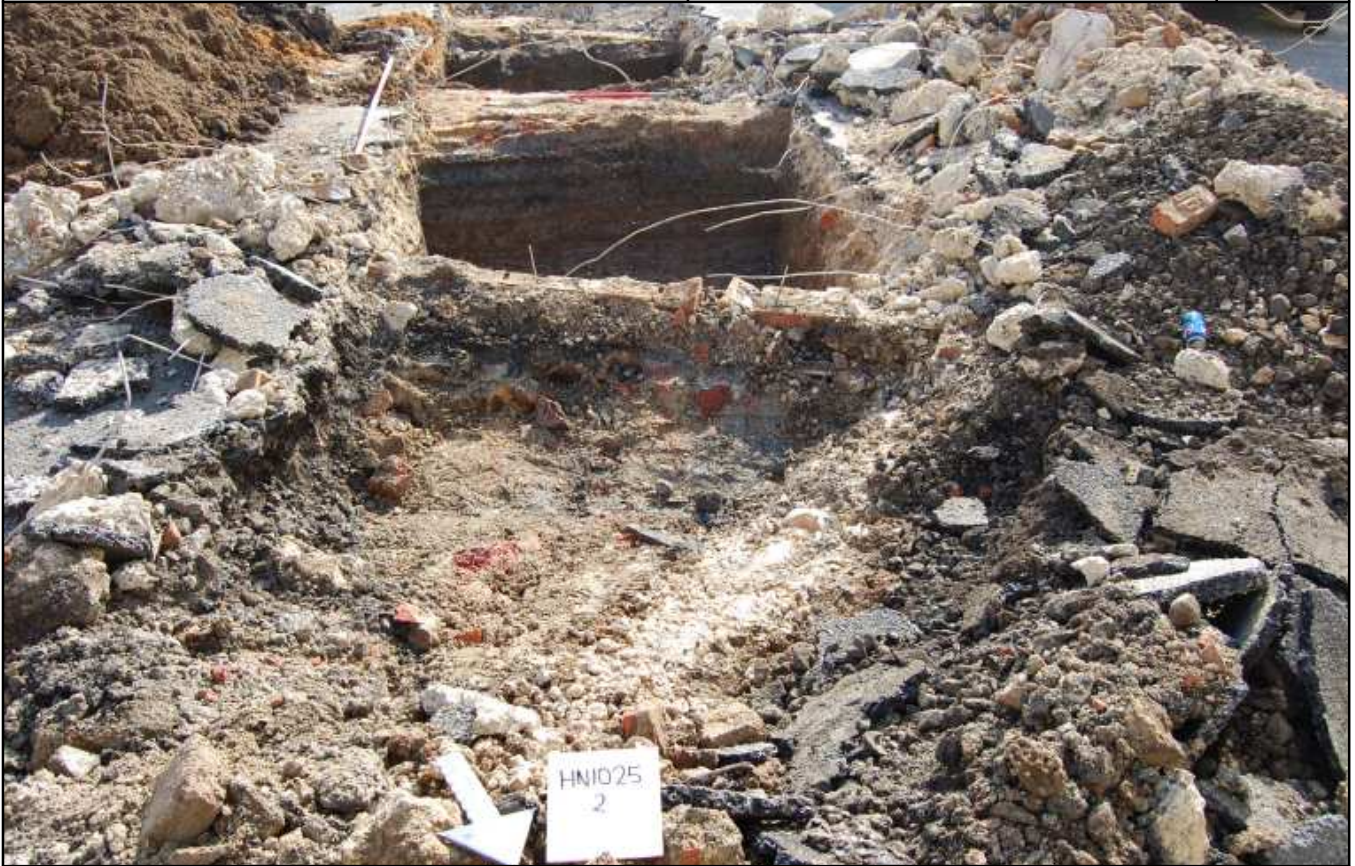
Plate 3: Trench 2, showing modern walls across trench, looking south.

**2.12** Trench 2 was located to the south of Trench 1, towards the western extent of the site and was orientated north-south (Plate 3). It measured 9.8m long by 2.2m in width and was excavated by machine down to a depth of c.1.0m.

**2.14** The trench demonstrated heavily disturbed ground and contained three concrete wall foundations running across the trench.

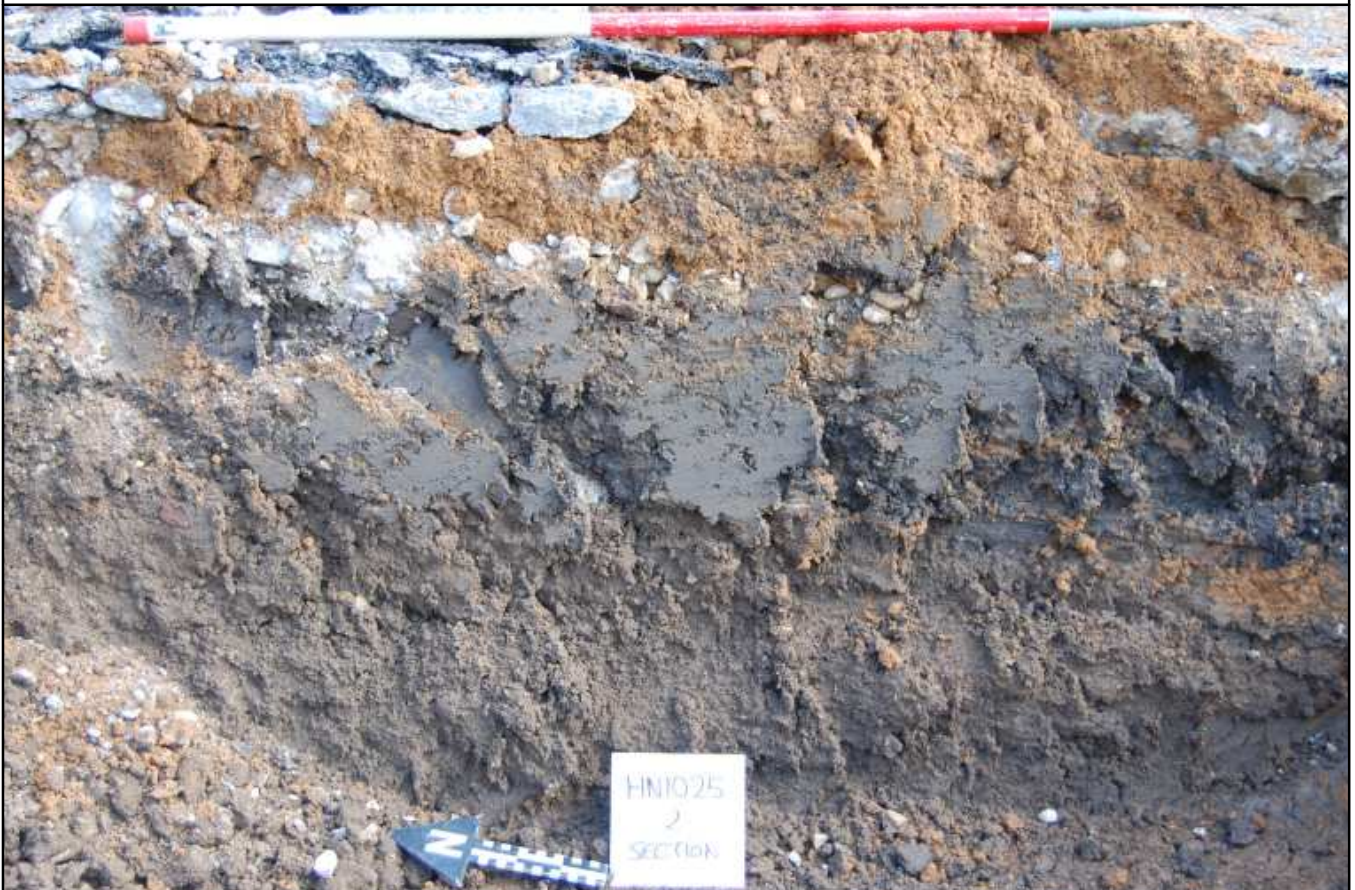
Plate 4: Trench 2, indicative section showing overburden, looking east.

**2.13** The stratigraphy in Trench 2 (Plate 4) comprised a layer of dark grey (10YR 4/1) tarmac, 0.05m thick, above a layer of light grey (10YR 7/1) concrete, 0.25m thick. This overlay made ground formed of very dark brown (10YR 2/2) sticky silty clay, 0.45m thick, which contained occasional charcoal and brick rubble. This in turn overlay a subsoil of yellowish brown (10YR 5/4) sticky sandy silty clay with occasional small sub-angular flint,

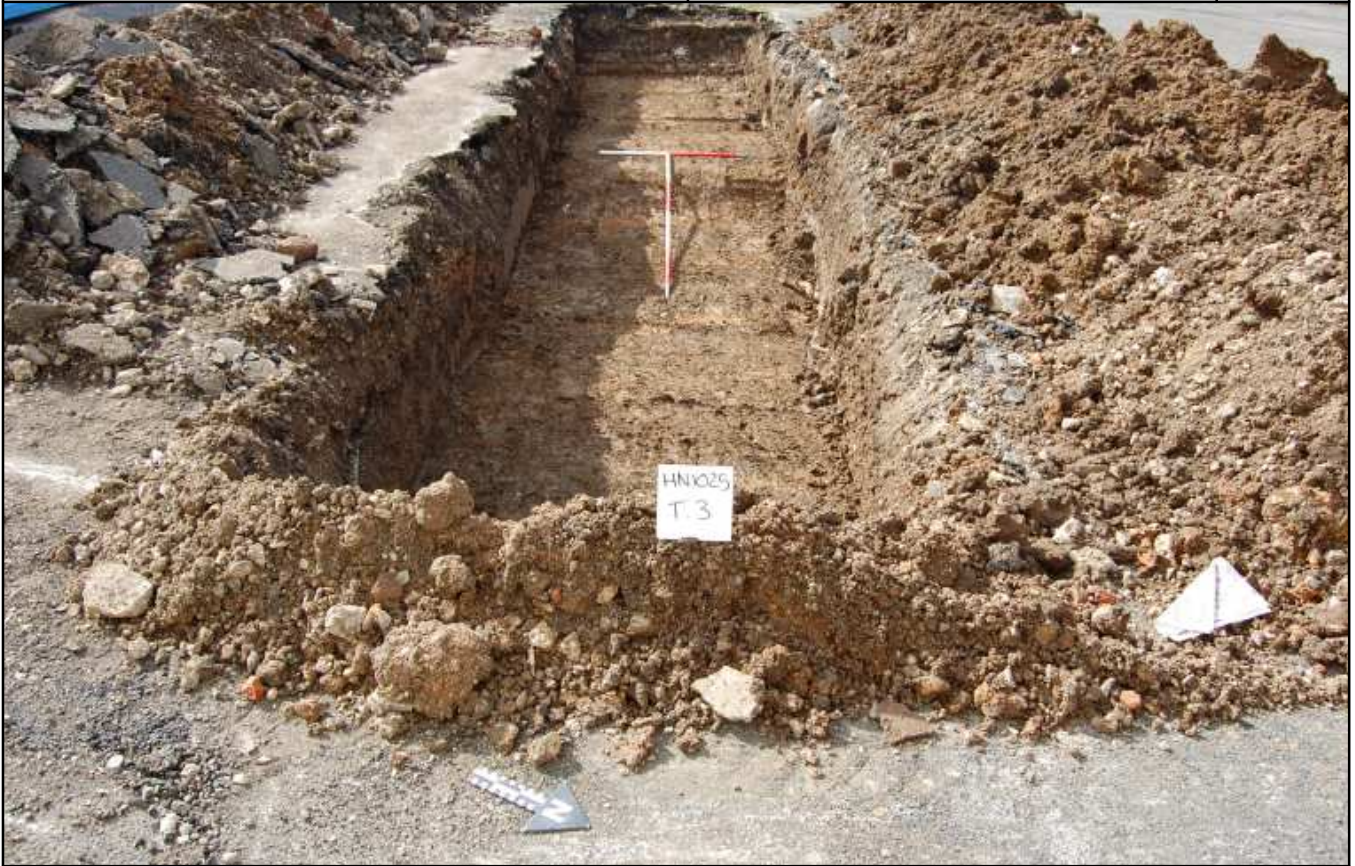
Plate 5: Trench 3, looking southwest.

**2.17** Trench 3 (Figure 3, Plate 5) was located to the south-east of Trench 2, towards the southern extent of the site and was orientated north-east to south-west. It measured 9.5m in length by 2.0m wide and was excavated by machine to a depth of 0.95m. The trench was moved from the alignment proposed in the Project Design to avoid known services.

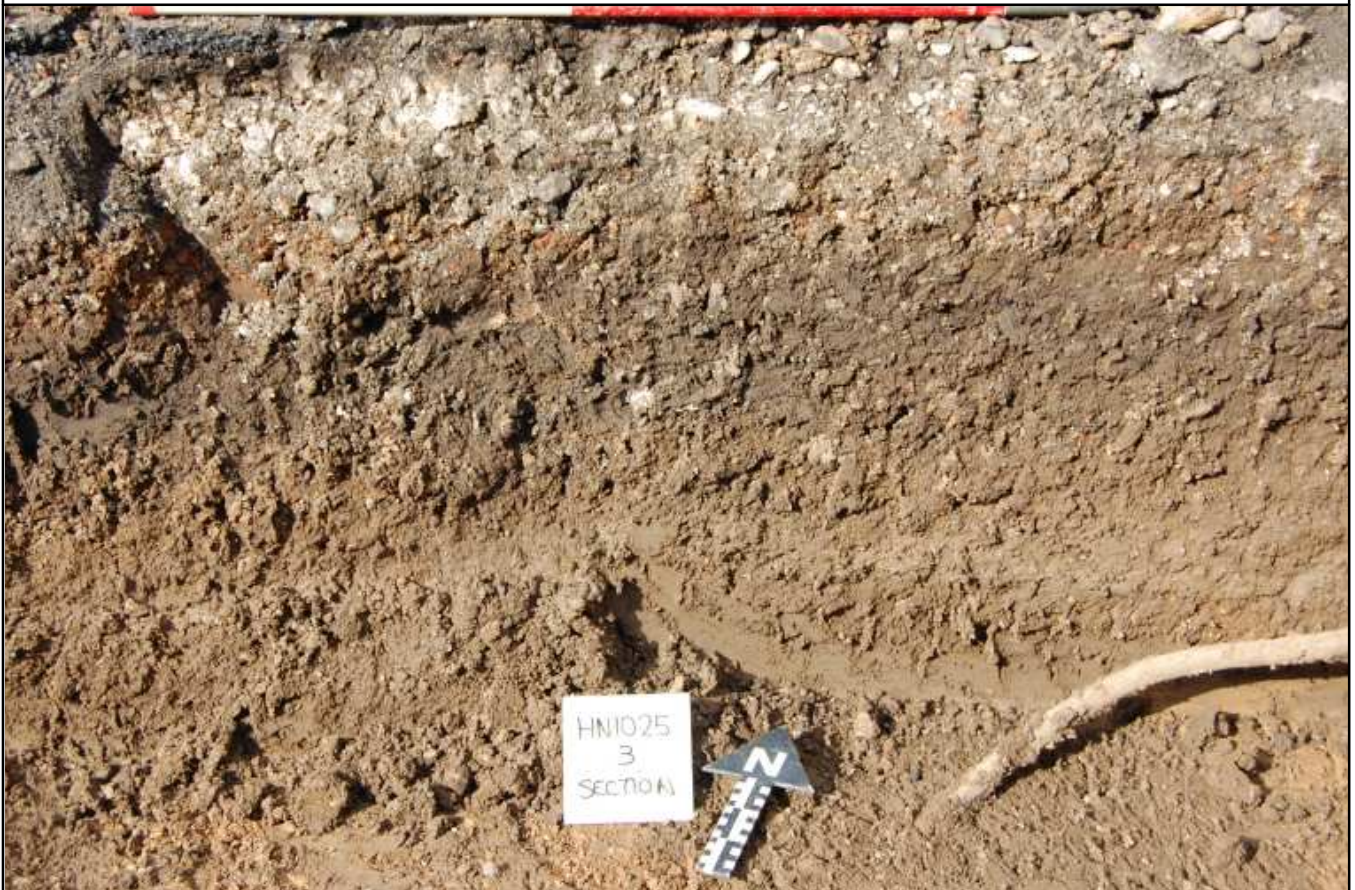
Plate 6: Trench 3, indicative section, showing overburden, looking northwest.

**2.18** The stratigraphy in Trench 3 (Plate 6) comprised a layer of dark grey (10YR 4/1) tarmac, 0.05m thick, above a layer of brown (10YR 4/3) loose sandy silty clay made-ground with frequent small sub-angular flint and brick rubble, 0.25m thick. This in turn overlay a second layer of made ground of very dark brown (10YR 2/2) sticky silty clay, 0.3m thick, which contained occasional charcoal and brick rubble and the natural substrate of yellowish brown (10YR 5/8) sticky silty clay with frequent gravel, >0.05m thick.

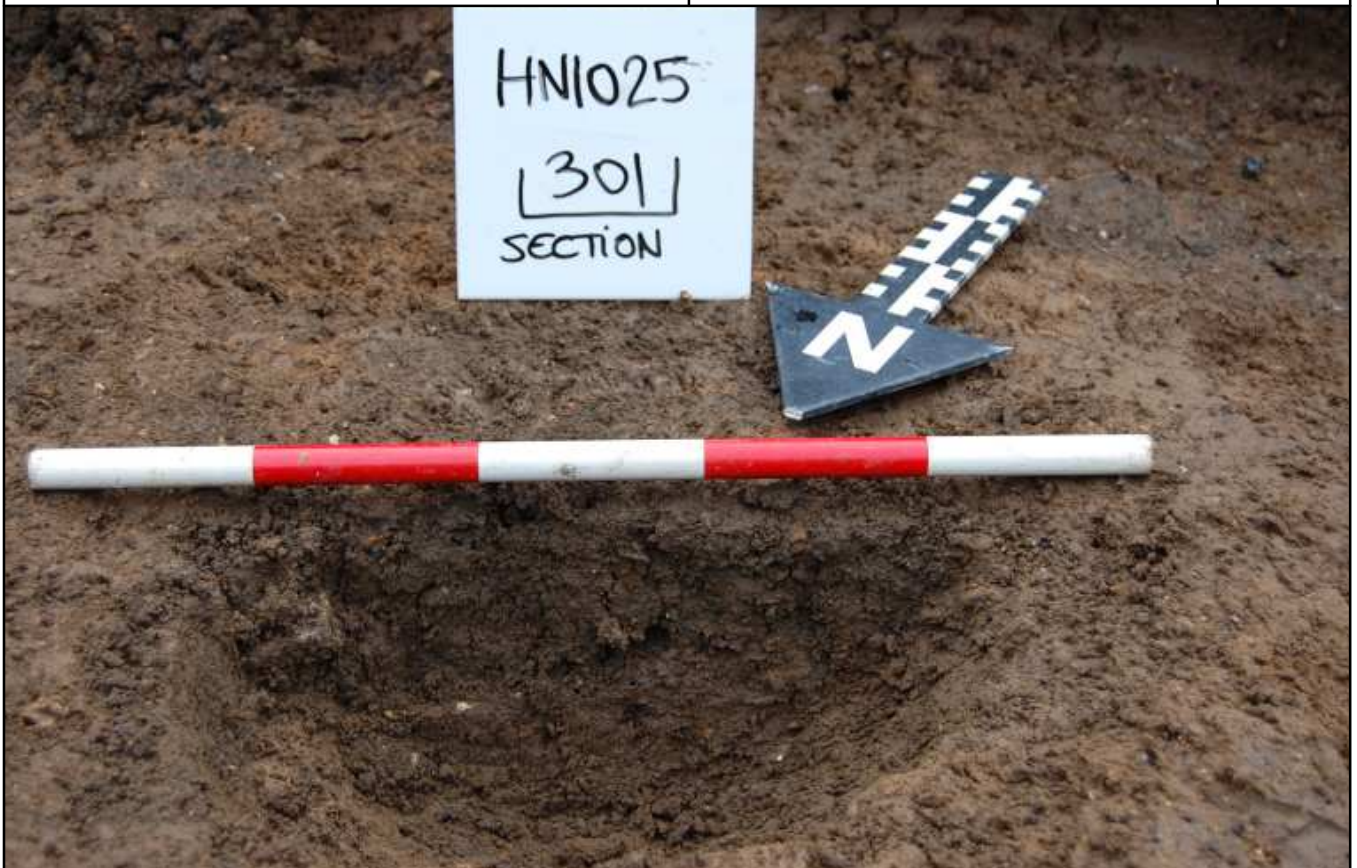
Plate 7: Pit [301], looking southeast.

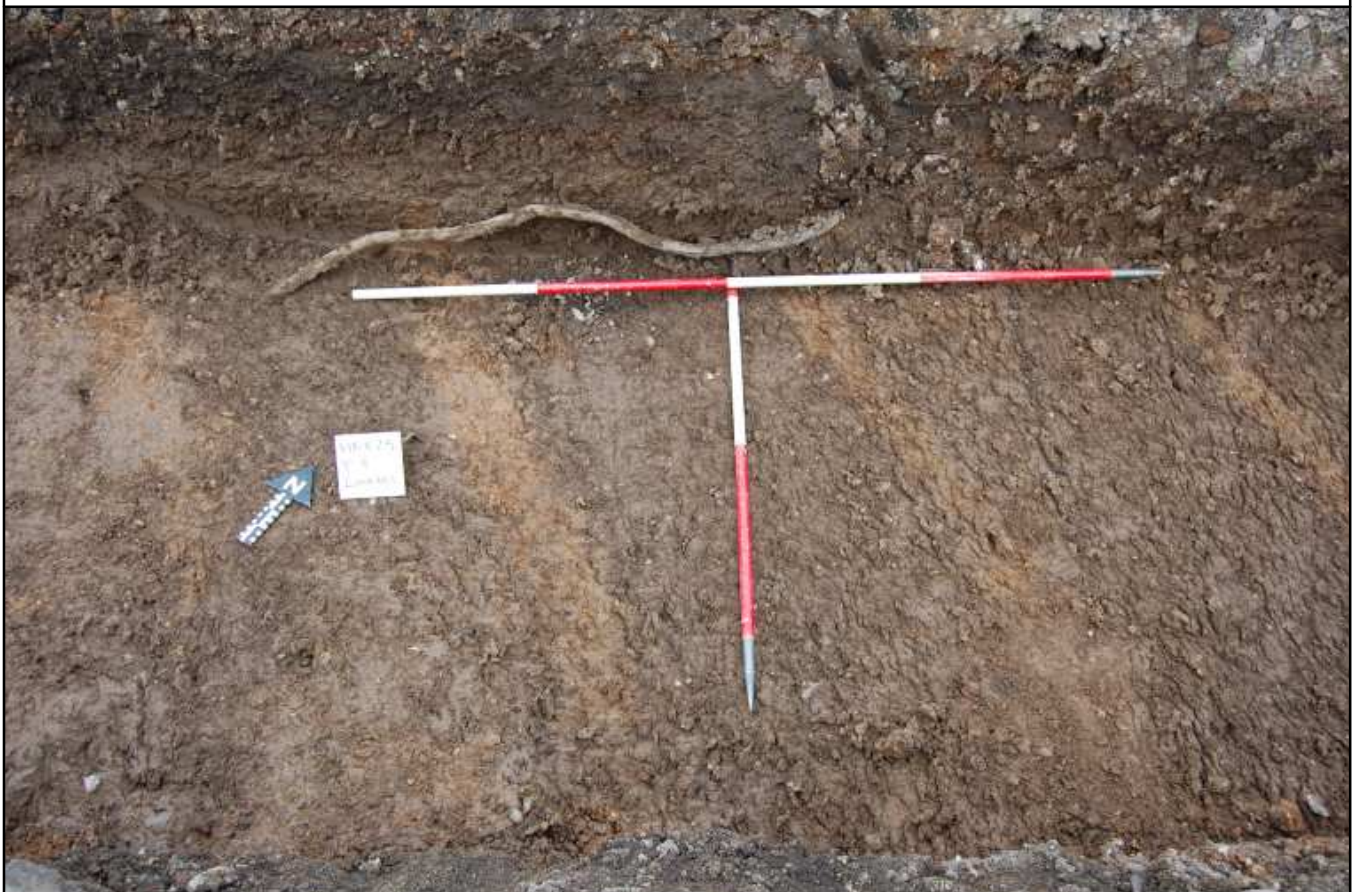
Plate 8: Trench 3 linears, pre-excavation, looking northwest.

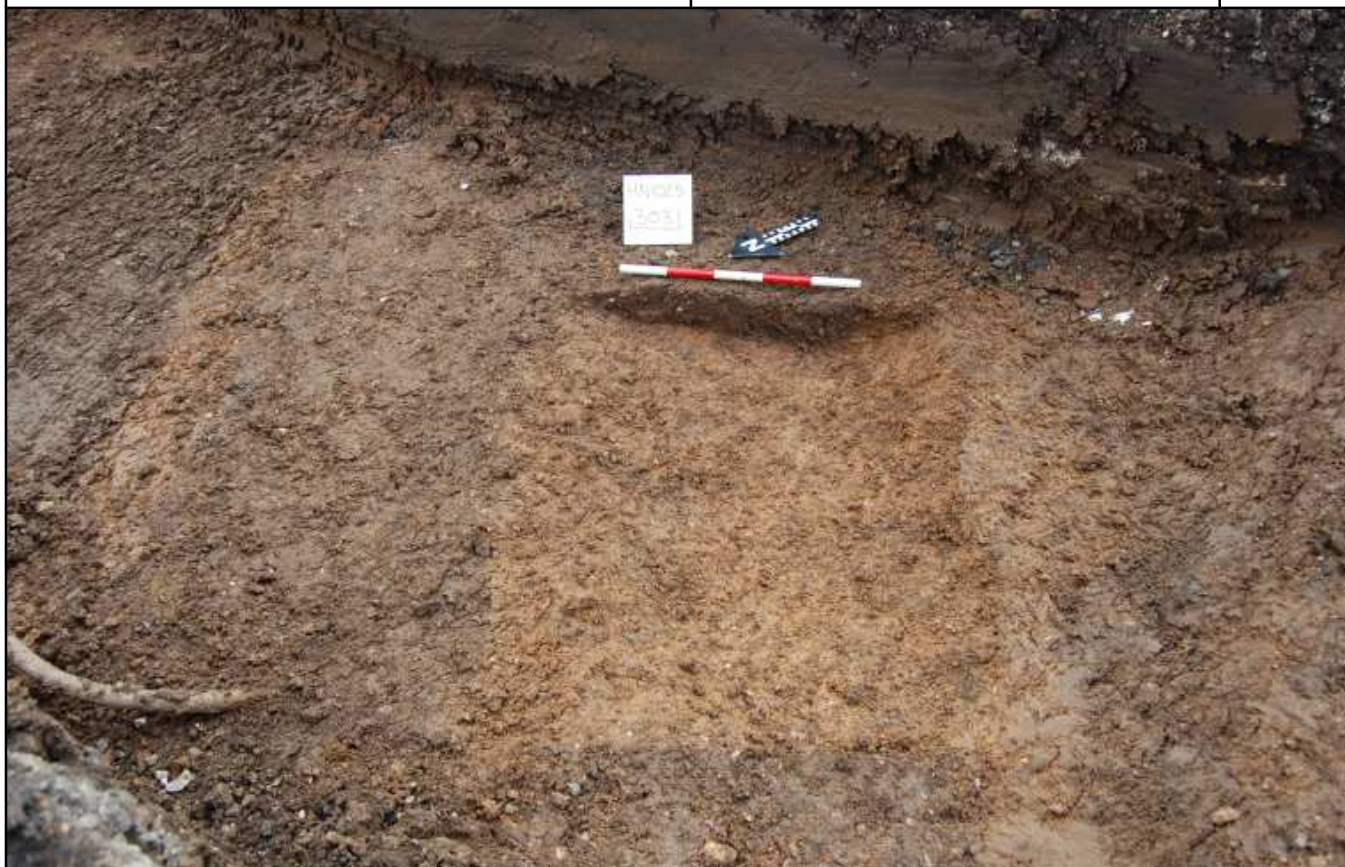
Plate 9: Ditch [303], looking southeast.

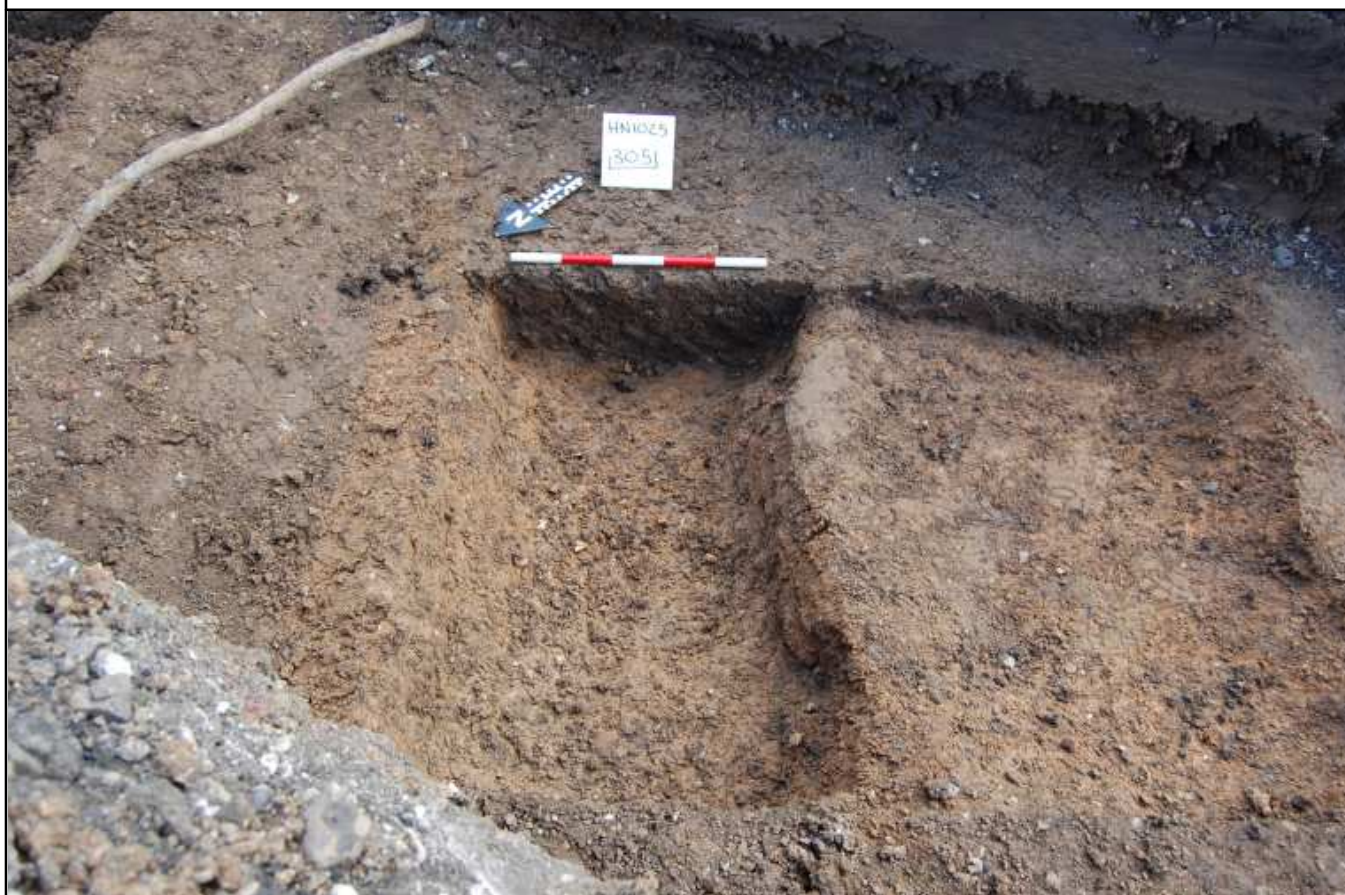
Plate 10: Ditch [305], looking southeast.

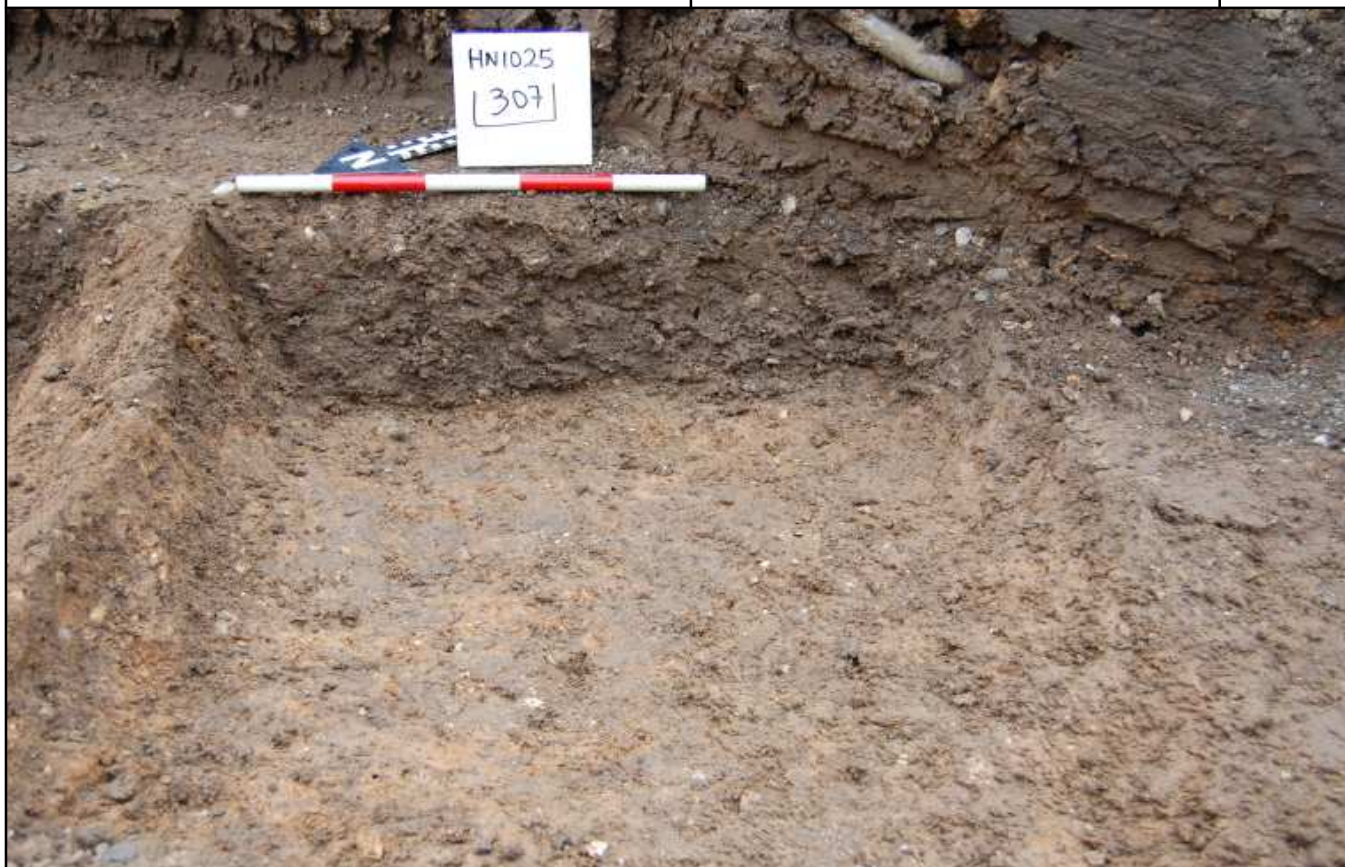
Plate 11: Ditch [307], looking southeast.

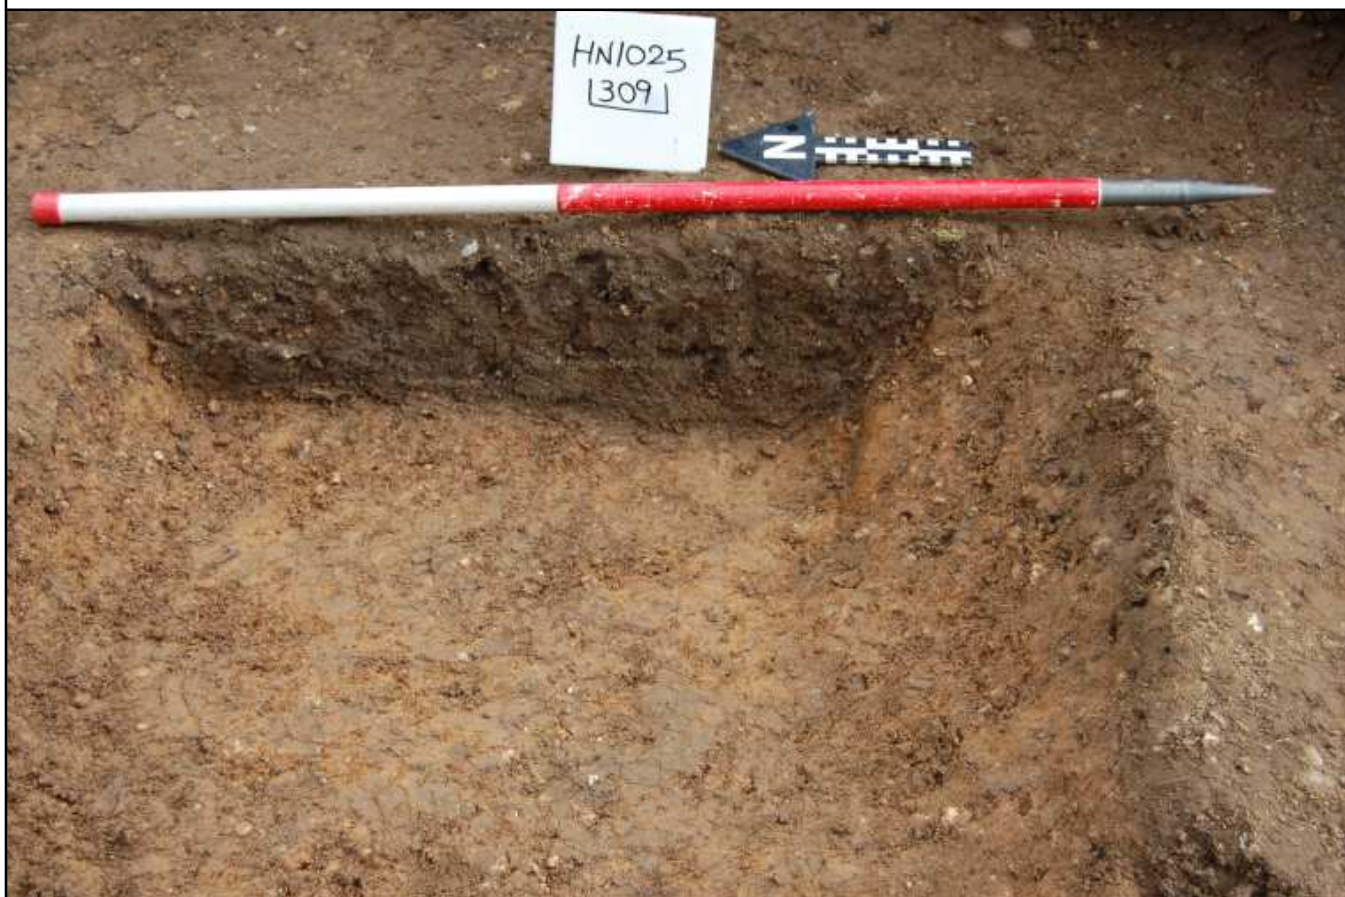
Plate 12: Ditch [309], looking east.

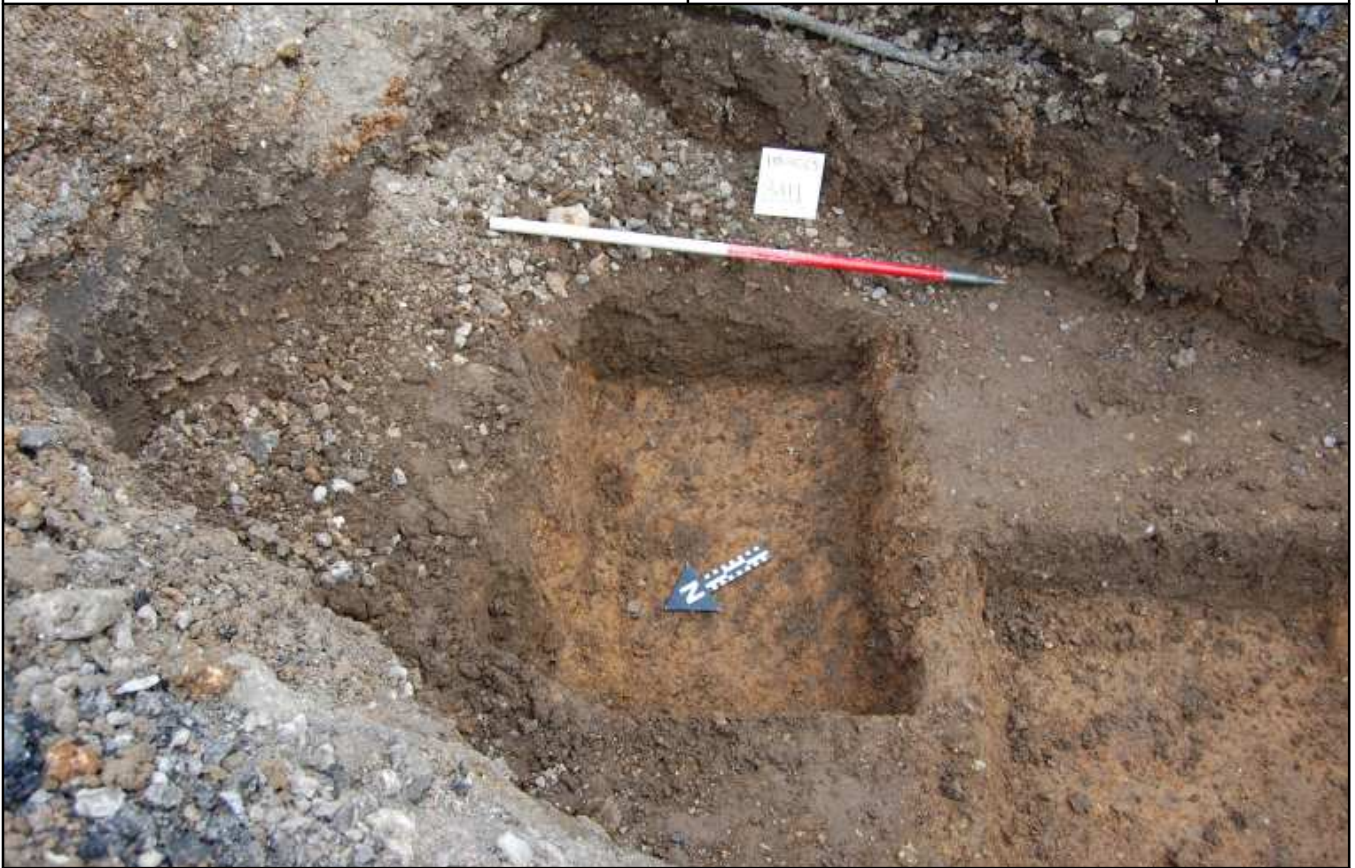
Plate 13: Ditch [311], looking southeast.

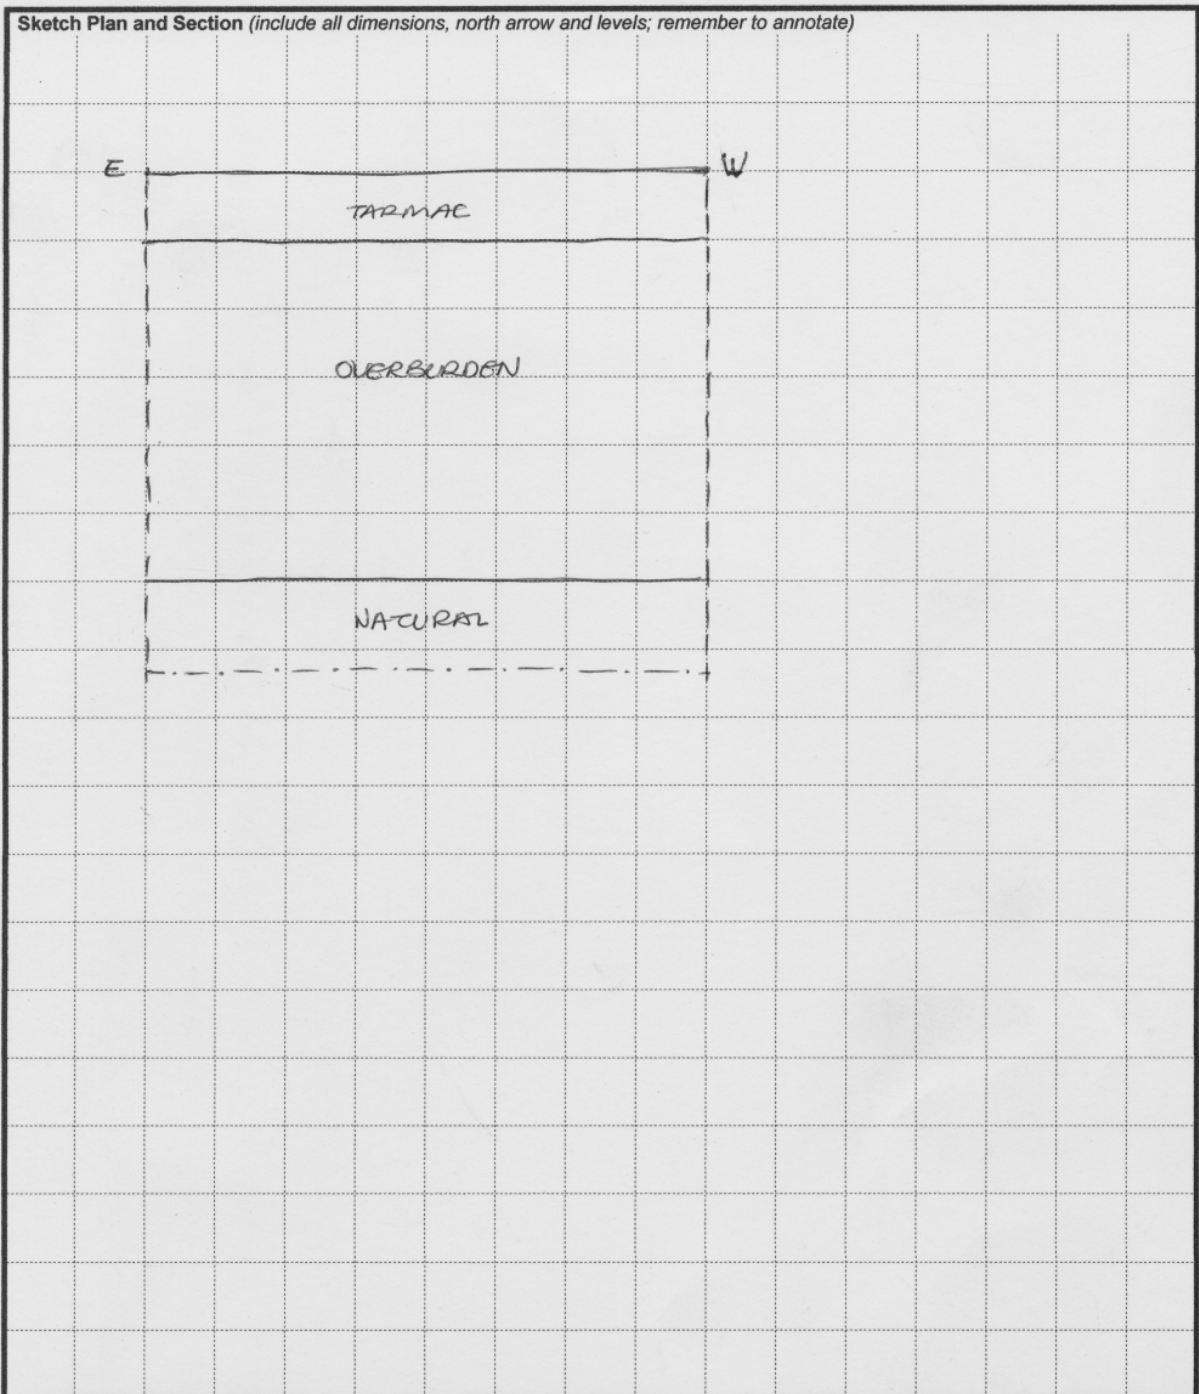
<b>Discussion and interpretation</b>	
INDICATIVE SKETCH SECTION TRENCH 1.	
Scale	1:20
Signature	
Date	30/9/14
Checked	
Sheet	1 of 1

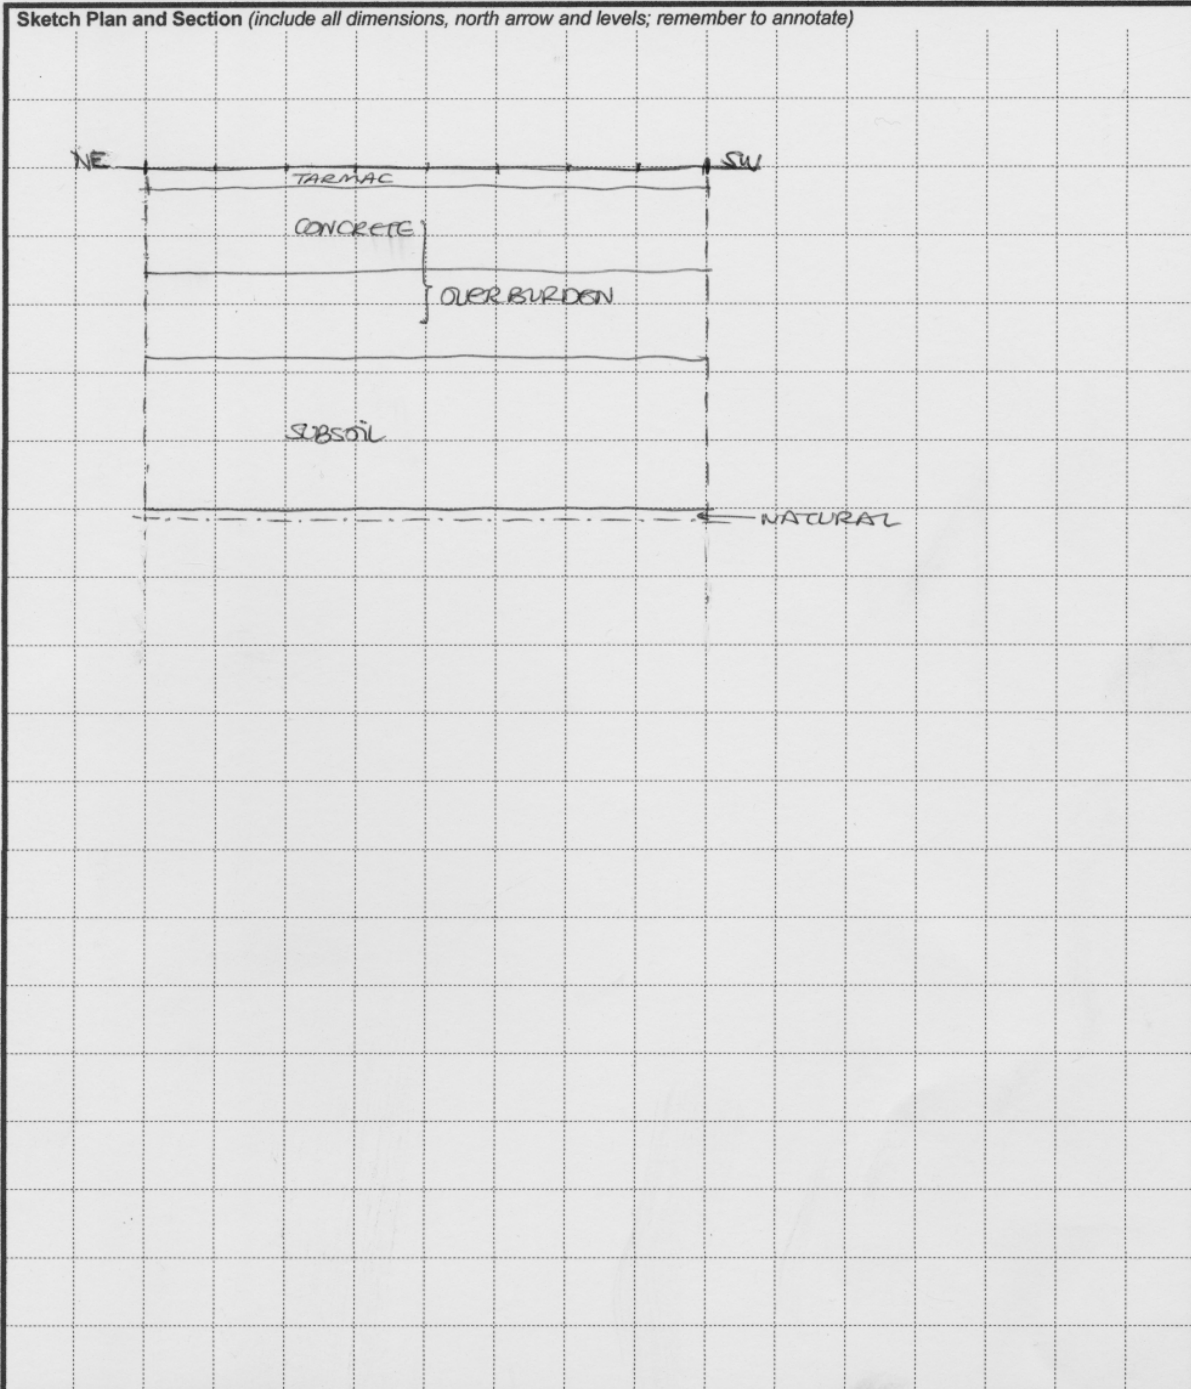
Discussion and interpretation			
INDICATIVE SKETCH SECTION TRENCH 2.			
Scale	1:20		
Signature	_____		
Date	30/9/14		
Checked	_____		
Sheet	9	of	1

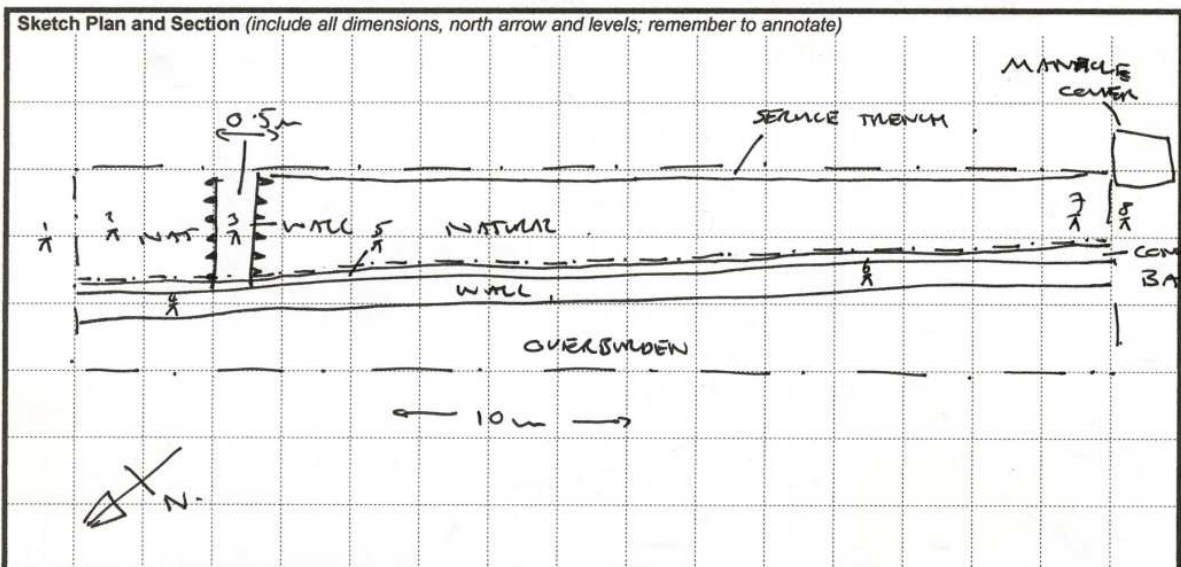
TRENCH 1 IS LOCATED IN A FORMER CAR PARK AT REAR OF PROPERTY UNDER TARMAC THE TRENCH WHICH IS ORIENTED NE-SW REVEALED A CONCRETE LINED WALL FOUNDATION WITH BRICK CONCRETE ON TOP. THIS UNFORTUNATELY RAN THE ENTIRE LENGTH OF THE TRENCH DOWN THE MIDDLE. ADDED TO THIS ONE SIDE OF THE TRENCH HAD A SERVICE RUNNING DOWN IT AND AN EXISTING WALL ON THE OTHER SIDE, SO ONLY A NARROW 0.5M WIDE SLOT COULD BE EXCAVATED. THIS REVEALED A LARGE QUANTITY OF O/S OVER NATURAL. TRENCH WAS BLANK

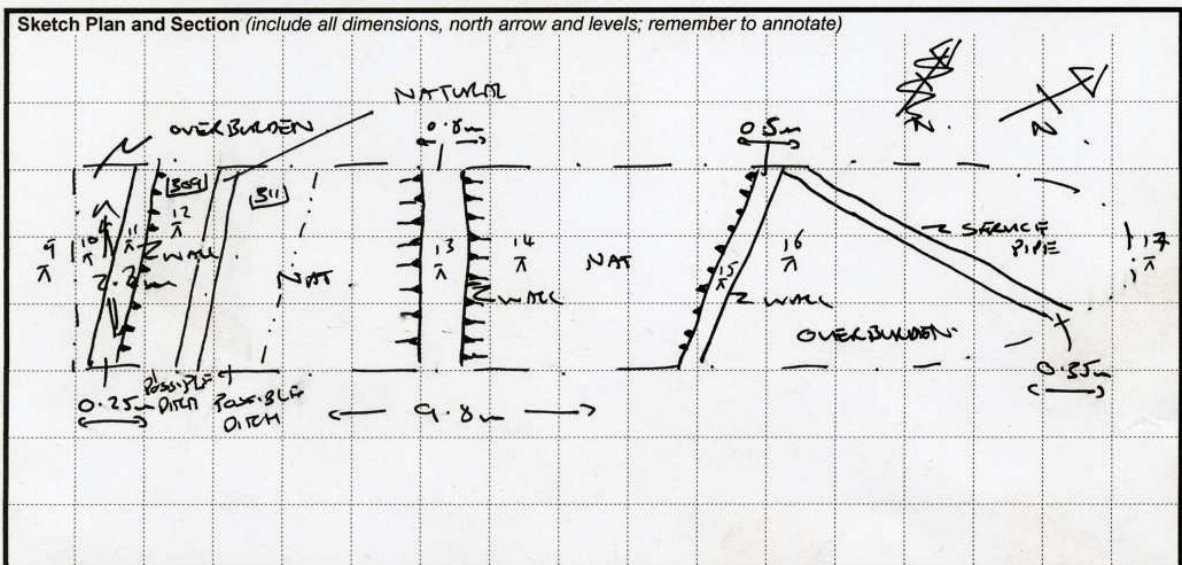
TRENCH 2 IS LOCATED IN A FORMER CAR PARK AT REAR OF PROPERTY. UNDER TARMAC ALIGNED N/S IT REVEALED BELOW TARMAC, REINFORCED CONCRETE, OVER A THICK LAYER OF ~~OS~~ THIS OVERLAY A SUBSOIL, OVER NATURAL HOWEVER, WHOLE AREA/TRENCH HAS BEEN DISTURBED BY MODERN BUILDING AS TRENCH REVEALED 3 CONCRETE WALL FOUNDATIONS RUNNING ACROSS THE TRENCH (RECENTLY E-W) CAPPED BY BRICK COURSE ALSO 3 SERVICED - 2 METAL + 1 CERAMIC BUT DIRT WAS REVEALED  
TRENCH = BLANK.
