Hatfield Road Estate, Witham, Essex

HN1029

Report No. 758

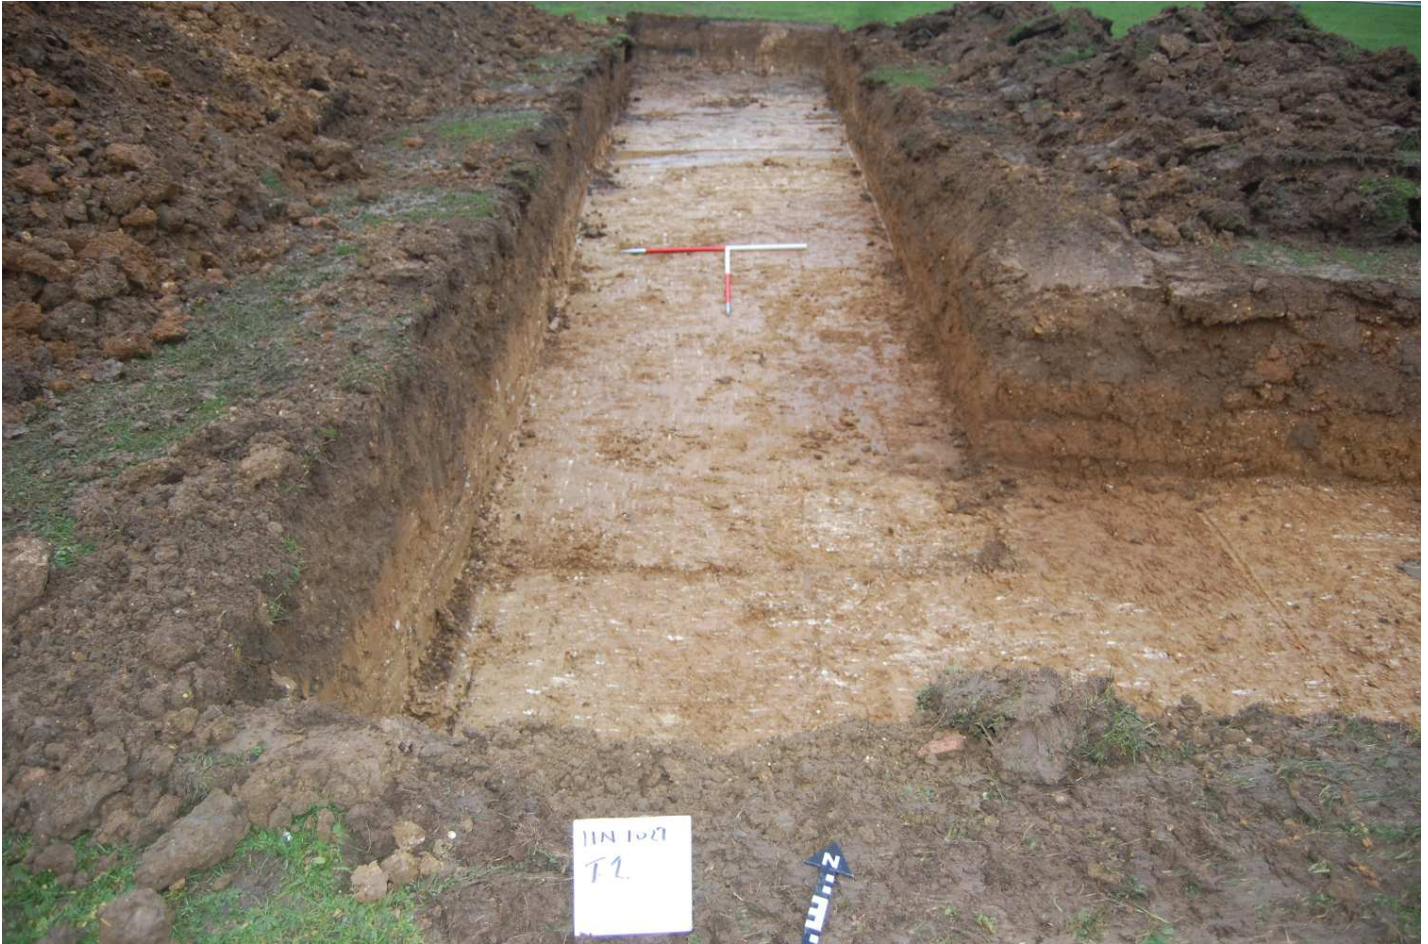
Length (m):	10	Width (m):	2	Maximum Depth (m):	0.80	Orientation	NW-SE	
Level at N End of Trench (mOD)		Top	11.60	Level at S End of Trench (mOD)		Top	11.43	
		Base	10.99			Base	10.62	
Context	Type	Description	Dimensions (m)					
			Length	Width	Depth

-	Topsoil	Turfed dark greyish brown (10YR 4/2) clayey sandy silt with occasional gravel.	10	2	0.05			
-	Layer	Modern overburden. Yellowish brown (10YR 5/4) clayey silt with occasional gravel inclusions.	10	2	0.25			
101	Cut	Sub circular cut with steep sides and shallow concave base. Tree bole. Continues in TR2 as [201]	2	0.7	0.6			
102	Fill	Yellow brown (10YR 5/6) clay silt with flecks of CBM. Fill of [101] same as (202)	2	0.7	0.6			
103	Layer	Dark greyish brown (10YR 4/2) clayey silt with occasional gravel	10	2	0.10			
104	Layer	Yellow brown (10YR 5/6) clay. Slightly lighter than (102)	10	2	0.10

Plate 01 - Siward Road, Tr1, looking N

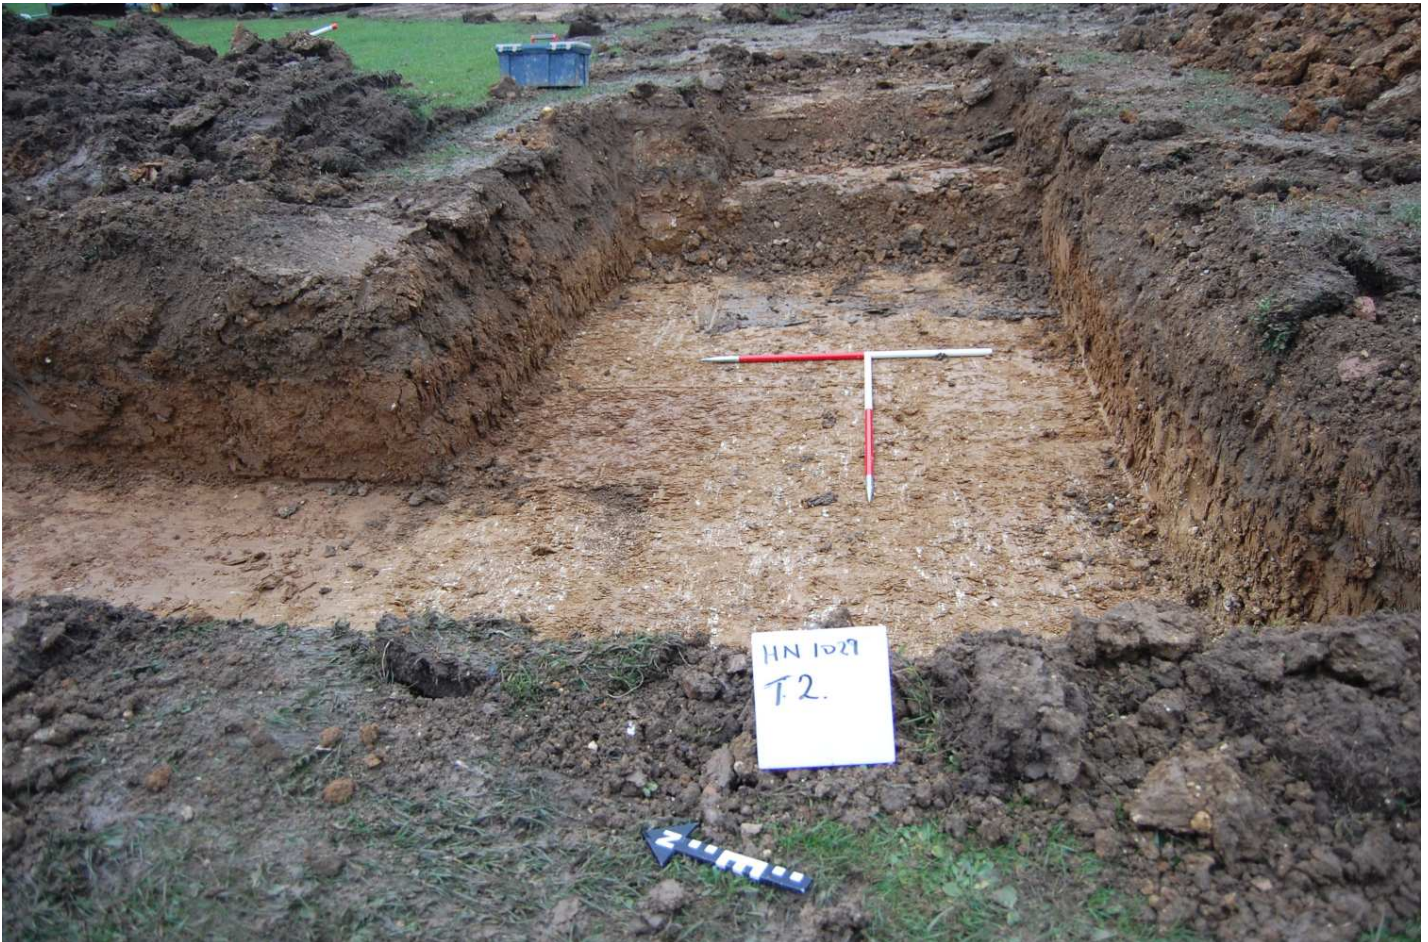
Length (m):	5	Width (m):	2.2	Maximum Depth (m):	0.80	Orientation	NE-SW	
Level at N End of Trench (mOD)		Top	11.33	Level at S End of Trench (mOD)		Top	11.49	
		Base	10.57			Base	10.60	
Context	Type	Description	Dimensions (m)					
			Length	Width	Depth

-	Topsoil	Turfed dark greyish brown (10YR 4/2) clayey sandy silt with occasional gravel.	5	2.2	0.05			
-	Layer	Modern overburden. Yellowish brown (10YR 5/4) clayey silt with occasional gravel inclusions.	5	2.2	0.25			
201	Cut	Sub circular cut with steep sides and shallow concave base. Tree bole. Continues in TR1 as [101]	1	1	0.6			
202	Fill	Yellow brown (10YR 5/6) clay silt with flecks of CBM. Fill of [201] same as (102)	1	1	0.6			
203	Layer	Dark greyish brown (10YR 4/2) clayey silt with occasional gravel	5	2.2	0.10			
204	Layer	Yellow brown (10YR 5/6) clay. Slightly lighter than (202)	5	2.2	0.10

Plate 02 - Siward Road, Tr2, looking E

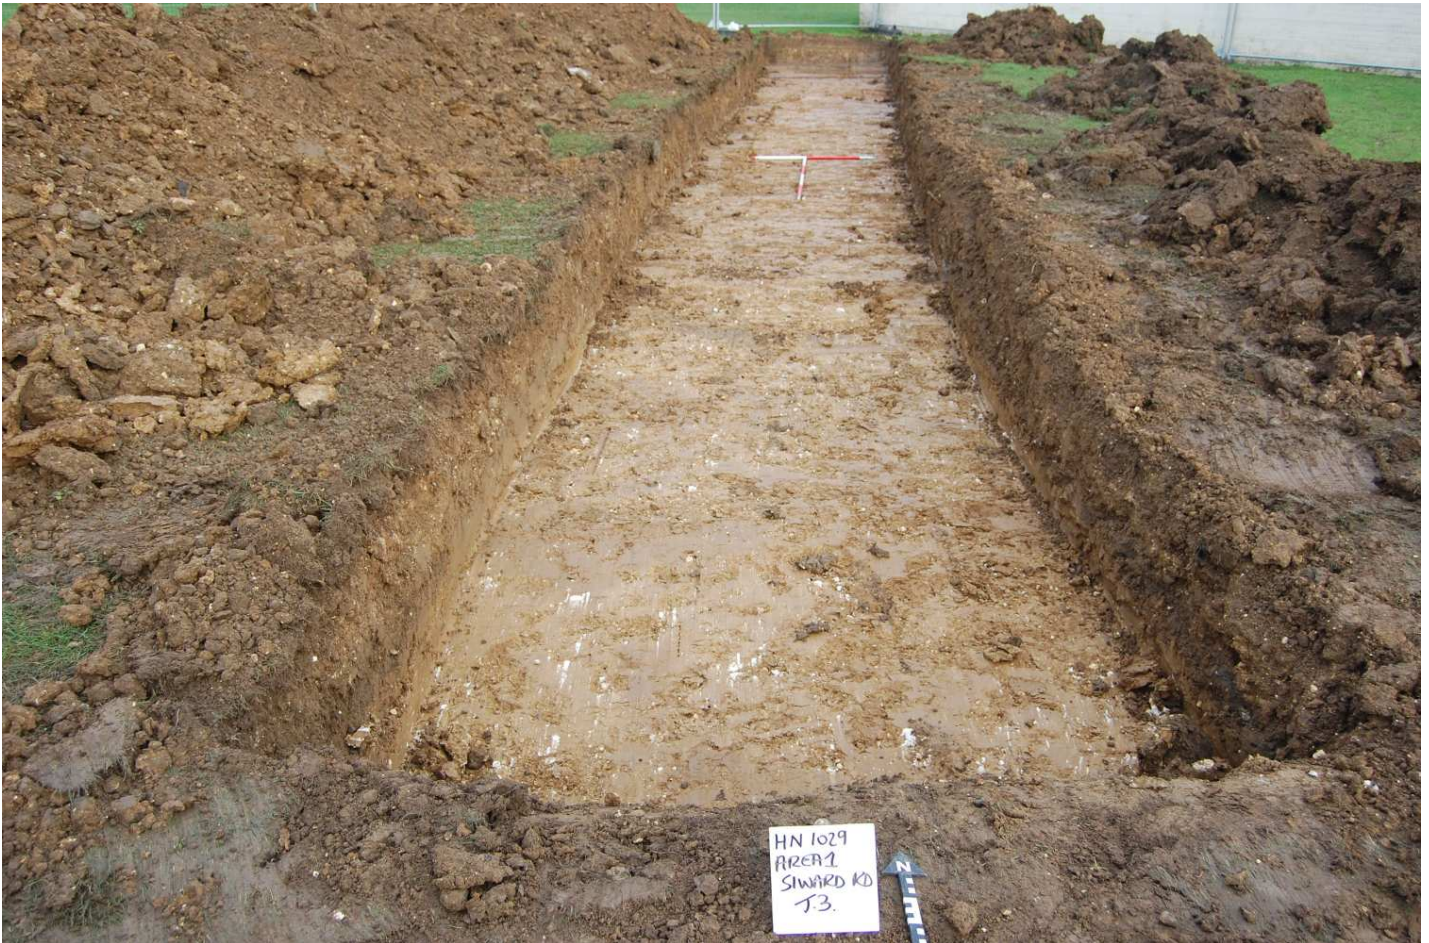
Length (m):	20	Width (m):	2.1	Maximum Depth (m):	0.60	Orientation	N-S
Level at N End of Trench (mOD)		Top	11.12	Level at S End of Trench (mOD)		Top	11.33
		Base	10.58			Base	10.84
Context	Type	Description	Dimensions (m)				
			Length	Width	Depth		
-	Topsoil	Turfed made ground. Dark brown (10YR 3/3) clayey sandy silt. Modern wooden stake observed.	20	2.1	0.6		
-	Natural	Yellow brown (10YR 5/6) clay with flint and chalk.	20	2.1	>0.6

Plate 03 - Siward Road, Tr3, looking N

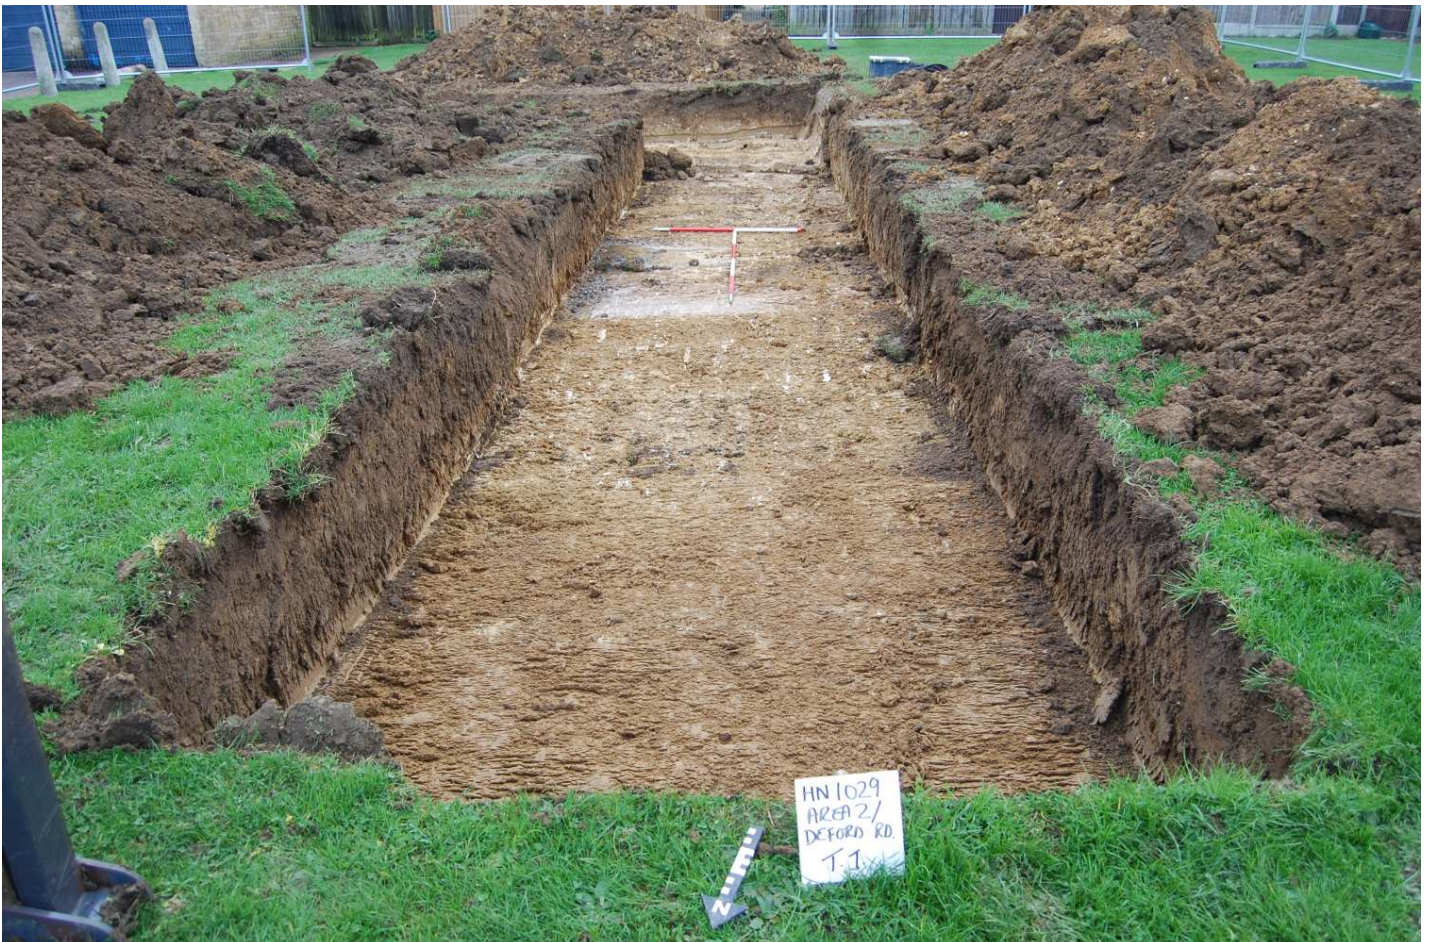
Length (m):	10	Width (m):	2	Maximum Depth (m):	0.65	Orientation	NW-SE
Level at N End of Trench (mOD)		Top	10.21	Level at S End of Trench (mOD)		Top	10.03
		Base	9.64			Base	9.44
Context	Type	Description	Dimensions (m)				
			Length	Width	Depth		
-	Topsoil	Dark greyish brown (10YR 4/2) clayey sandy silt with gravel inclusions.	10	2	0.10		
-	Subsoil	Dark brown (10YR 4/3) clayey sandy silt with occasional gravel and chalk inclusions.	10	2	0.35		
-	Natural	Yellow brown (10YR 5/6) clay with flint and chalk.	10	2	>0.45

Plate 04 - Deford Road, Tr1, looking S

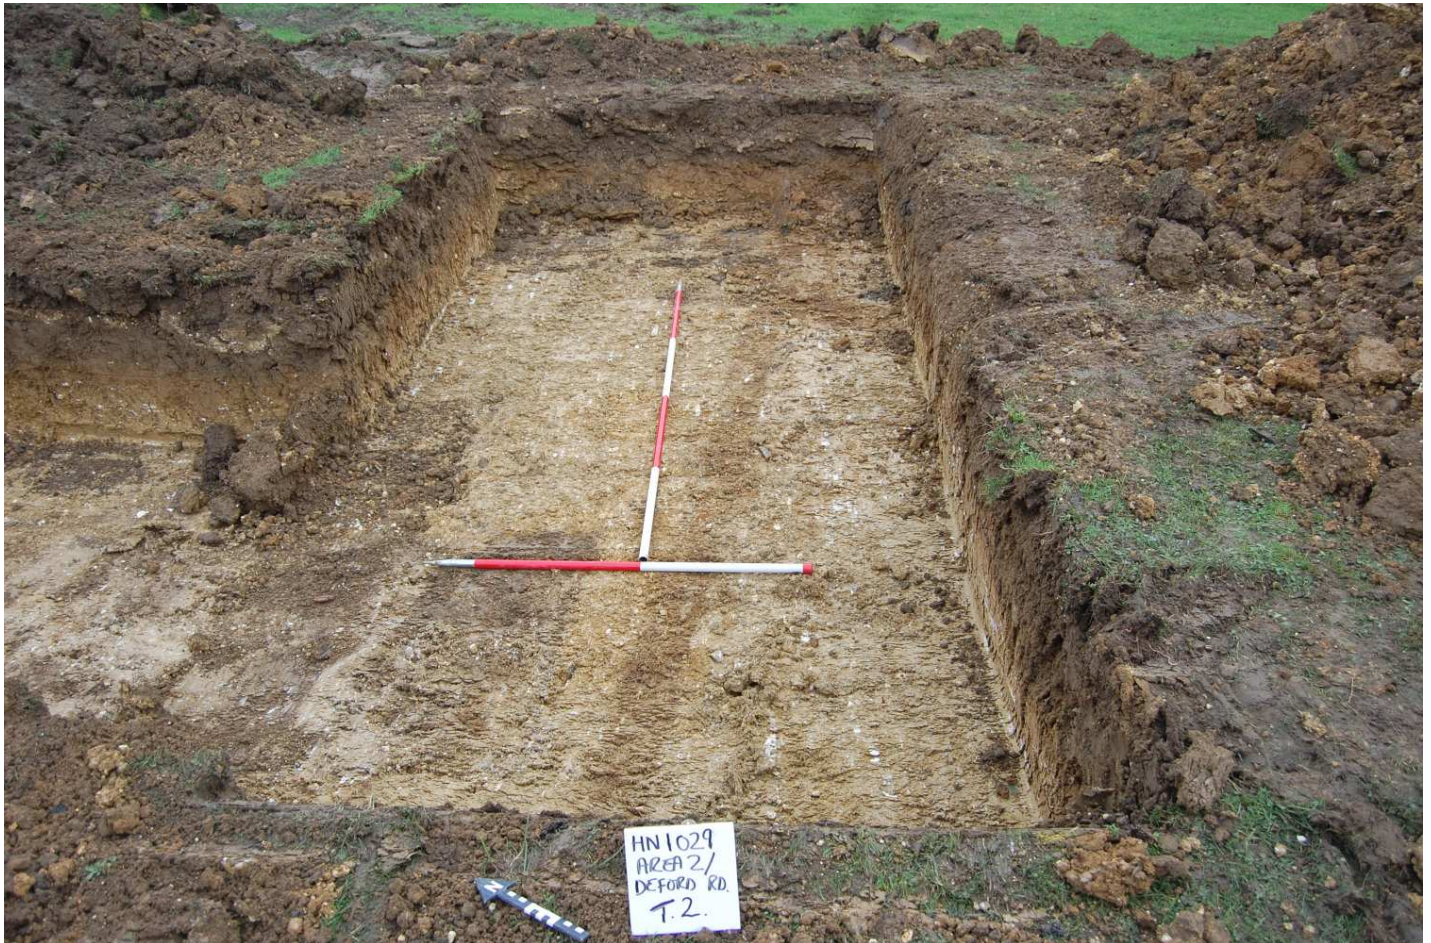
Length (m):	5	Width (m):	2.15	Maximum Depth (m):	0.65	Orientation	NE-SW
Level at N End of Trench (mOD)		Top	10.03	Level at S End of Trench (mOD)		Top	10.01
		Base	9.44			Base	9.44
Context	Type	Description	Dimensions (m)				
			Length	Width	Depth		
-	Topsoil	Dark greyish brown (10YR 4/2) clayey sandy silt with gravel inclusions.	5	2.15	0.10		
-	Subsoil	Dark brown (10YR 4/3) clayey sandy silt with occasional gravel and chalk inclusions.	5	2.15	0.35		
-	Natural	Yellow brown (10YR 5/6) clay with flint and chalk.	5	2.15	>0.45

Plate 05 - Deford Road, Tr2, looking E

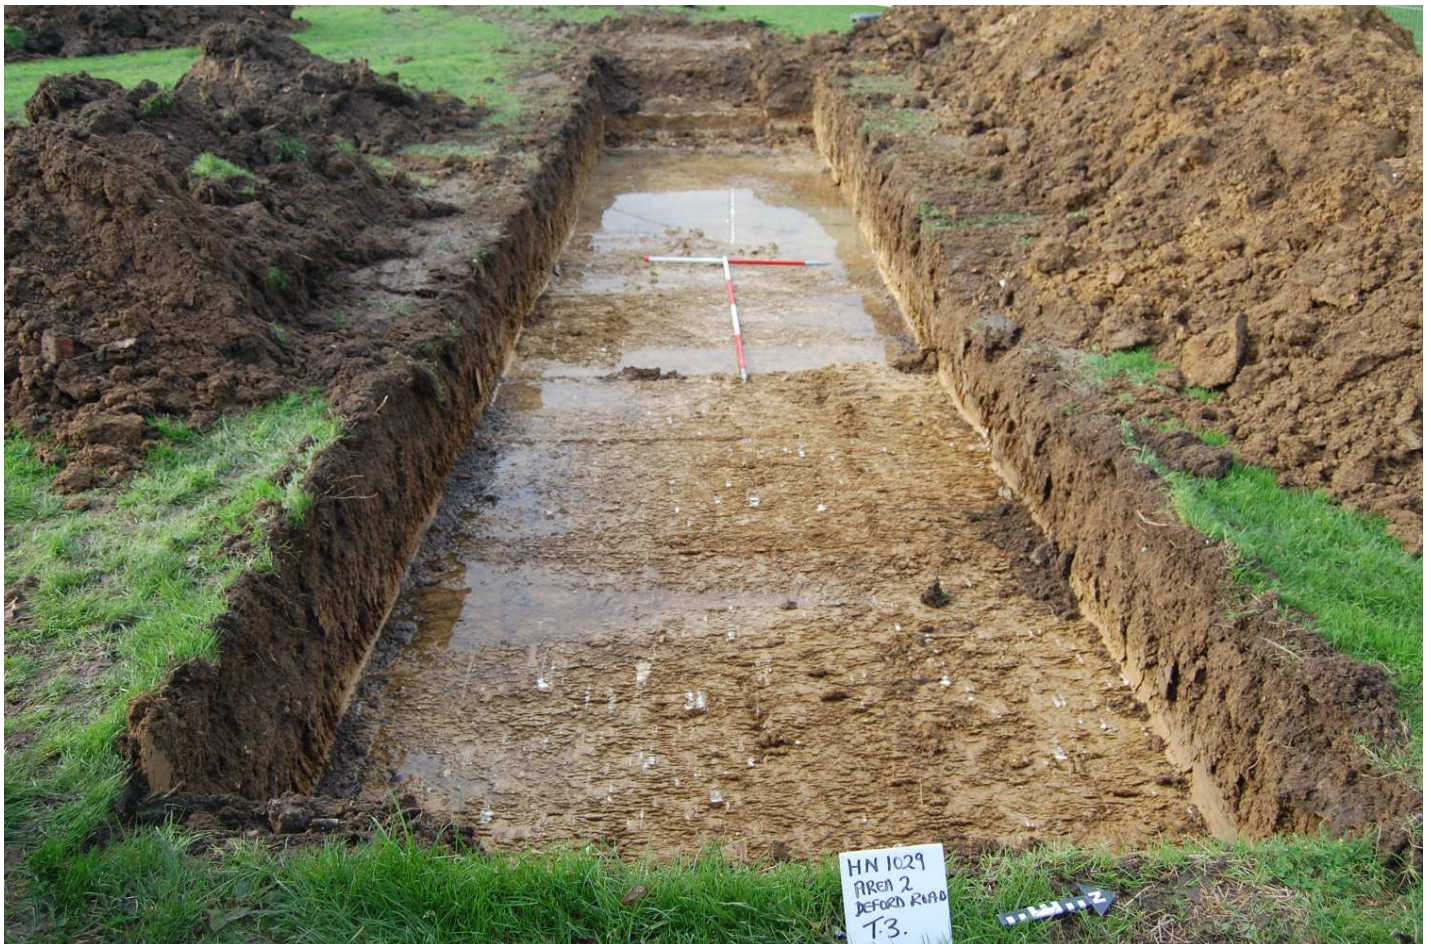
Length (m):	10	Width (m):	2.2	Maximum Depth (m):	0.65	Orientation	E-W	
Level at E End of Trench (mOD)			Top	10.09	Level at W End of Trench (mOD)		Top	10.06
			Base	9.52			Base	9.37
Context	Type	Description	Dimensions (m)					
			Length	Width	Depth			
-	Topsoil	Dark greyish brown (10YR 4/2) clayey sandy silt with gravel inclusions. Modern rubbish observed	10	2	0.10			
-	Subsoil	Dark brown (10YR 4/3) clayey sandy silt with occasional gravel and chalk inclusions. Fragment of CBM observed	10	2	0.40			
-	Natural	Yellow brown (10YR 5/6) clay with flint and chalk.	10	2	>0.50

Plate 06 - Deford Road, Tr3, looking W

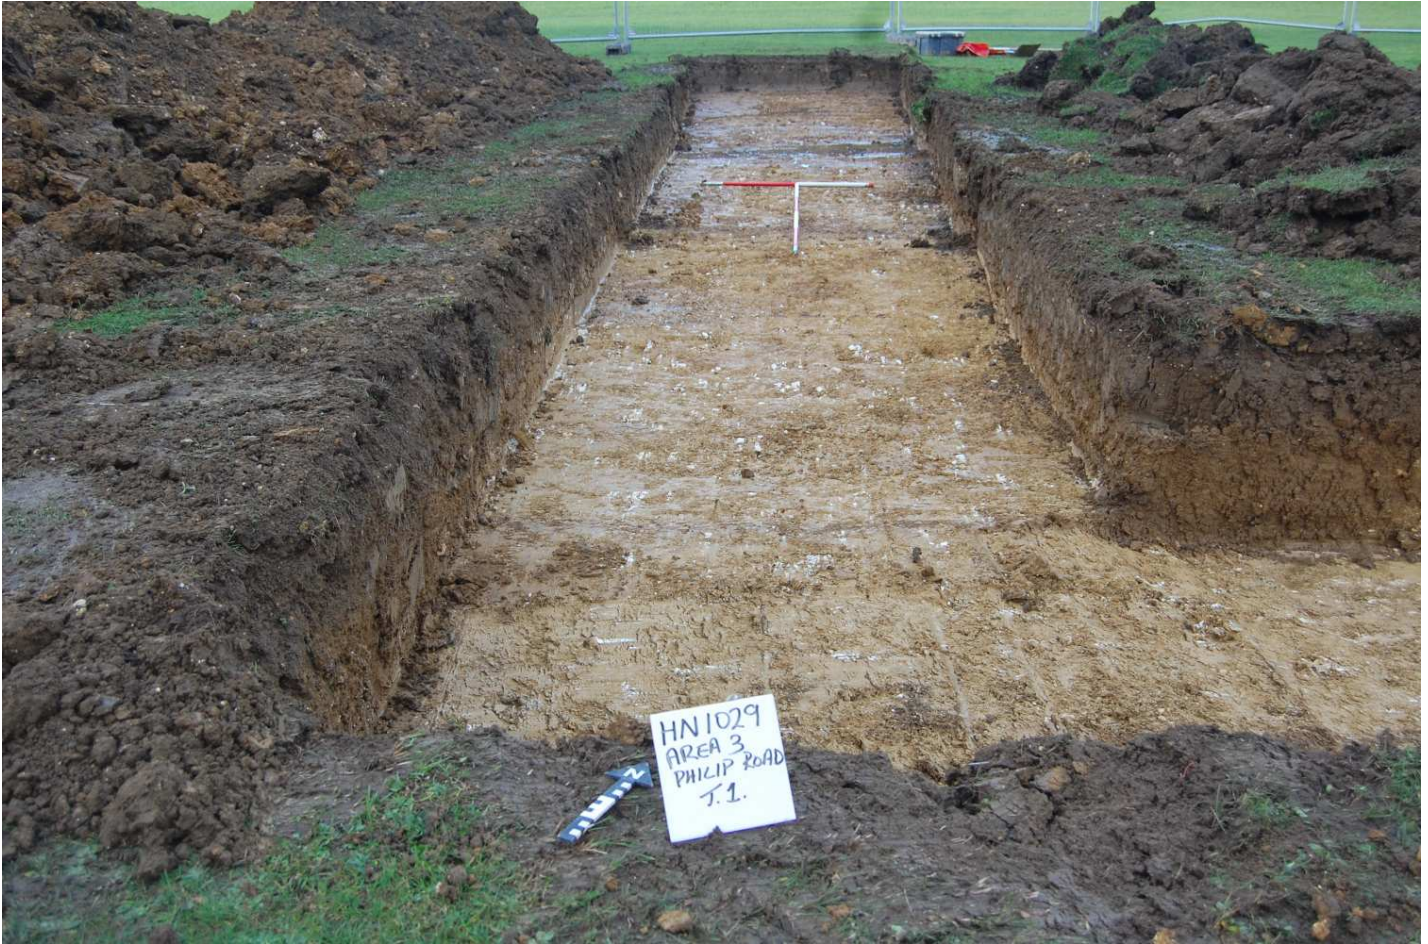
Length (m):	10	Width (m):	2	Maximum Depth (m):	0.55	Orientation	NW-SE	
Level at N End of Trench (mOD)			Top	8.70	Level at S End of Trench (mOD)		Top	8.64
			Base	8.32			Base	8.05
Context	Type	Description	Dimensions (m)					
			Length	Width	Depth

-	Topsoil	Dark greyish brown (10YR 4/2) clayey sandy silt with gravel inclusions.	10	2	0.10			
-	Subsoil	Dark brown (10YR 4/3) clayey sandy silt with occasional gravel and chalk inclusions.	10	2	0.30			
101	Cut	Irregular oval, with steep sides and a shallow concave base. Probable root activity.	0.4	0.4	0.13			
102	Fill	Yellowish brown (10YR 5/4) clay silt with occasional chalk fragments. Fill of [101]	0.4	0.4	0.13			
103	Cut	Irregular, with steep sides and a shallow uneven concave base. Orientated NE-SW. Root activity.	0.4	0.4	0.10			
104	Fill	Yellowish brown (10YR 5/4) clay silt with occasional chalk fragments. Fill of [103]	0.4	0.4	0.10			
105	Cut	Irregular, with steep sides and a shallow uneven concave base. Root activity.	0.3	0.3	0.05			
106	Fill	Yellowish brown (10YR 5/4) clay silt with occasional chalk fragments. Fill of [105]	0.3	0.3	0.05

Plate 07 - Philip Road, Tr1, looking N

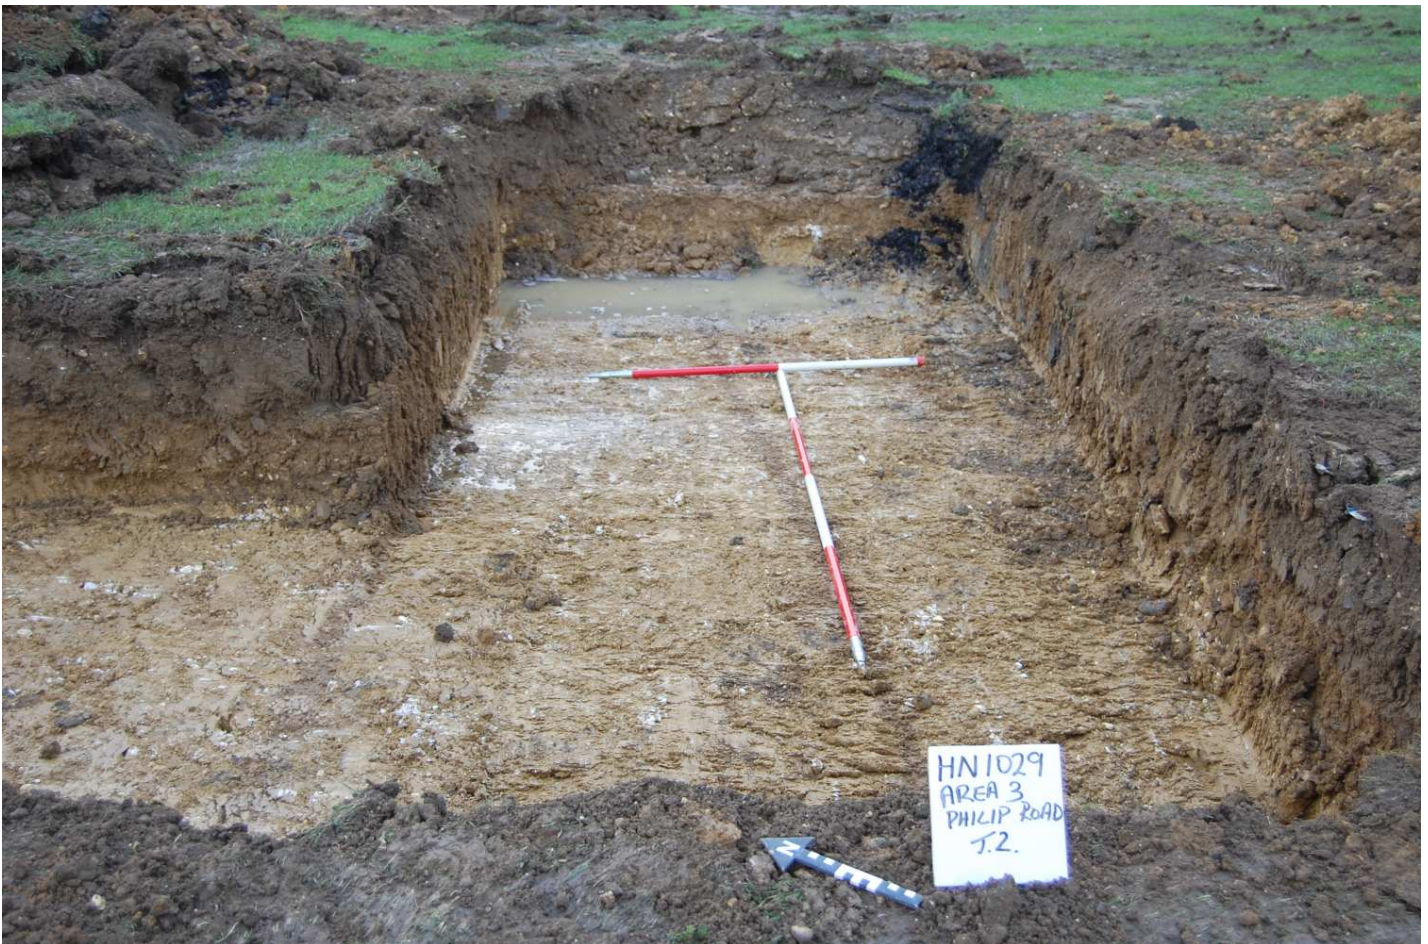
Length (m):	5	Width (m):	2	Maximum Depth (m):	0.75	Orientation	NE-SW		
Level at N End of Trench (mOD)			Top	8.55	Level at S End of Trench (mOD)			Top	8.65
			Base	7.93				Base	8.00
Context	Type	Description	Dimensions (m)						
			Length	Width	Depth				
-	Topsoil	Dark greyish brown (10YR 4/2) clayey sandy silt with gravel inclusions.	5	2	0.10				
-	Subsoil	Dark brown (10YR 4/3) clayey sandy silt with occasional gravel and chalk inclusions.	5	2	0.30				
-	Natural	Yellow brown (10YR 5/6) clay with flint and chalk.	5	2	>0.40

Plate 08 - Philip Road, Tr2, looking E

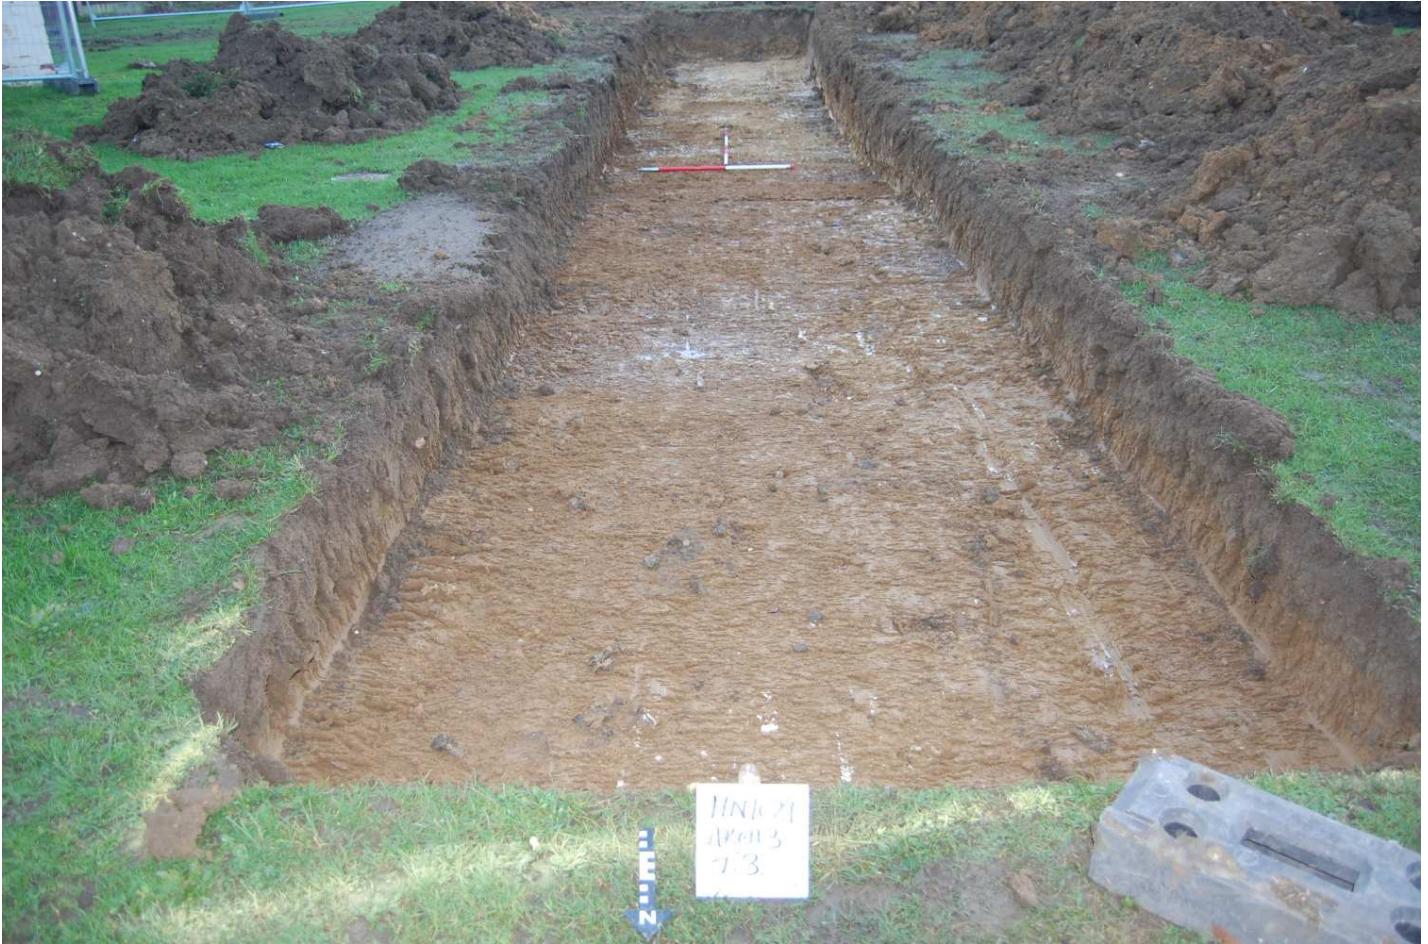
Length (m):	15	Width (m):	2	Maximum Depth (m):	0.60	Orientation	N-S		
Level at N End of Trench (mOD)			Top	8.34	Level at S End of Trench (mOD)			Top	8.56
			Base	8.03				Base	7.90
Context	Type	Description	Dimensions (m)						
			Length	Width	Depth				
-	Topsoil	Dark greyish brown (10YR 4/2) clayey sandy silt with gravel inclusions.	15	2	0.10				
-	Subsoil	Dark brown (10YR 4/3) clayey sandy silt with occasional gravel and chalk inclusions.	15	2	0.30				
-	Natural	Yellow brown (10YR 5/6) clay with flint and chalk.	15	2	>0.40

Plate 09 - Philip Road, Tr3, looking S

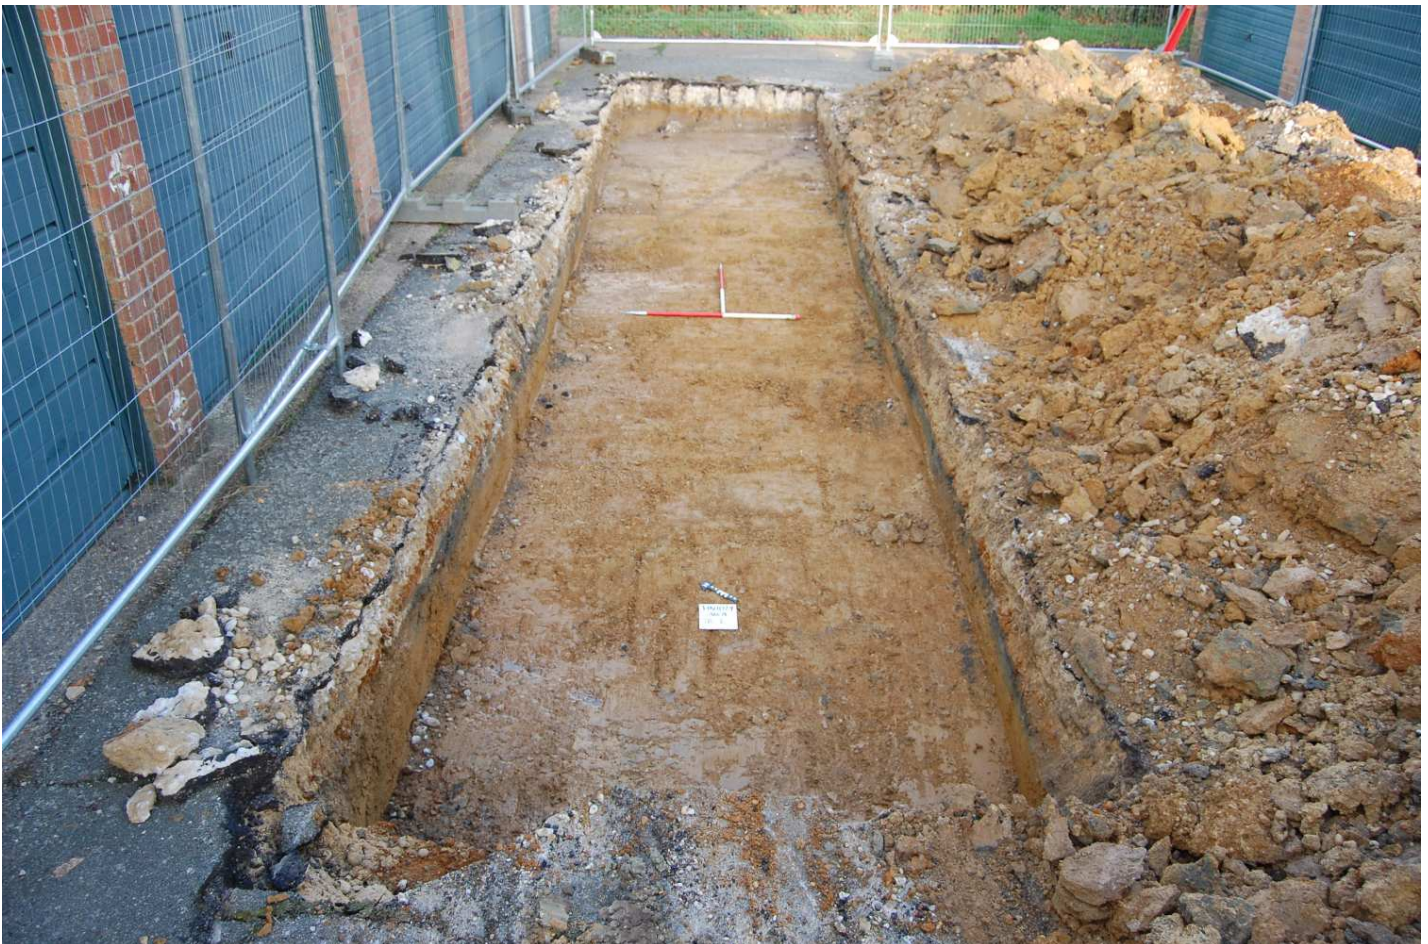
Length (m):	10	Width (m):	2	Maximum Depth (m):	0.50	Orientation	NE-SW		
Level at N End of Trench (mOD)			Top	5.13	Level at S End of Trench (mOD)			Top	5.07
			Base	4.65				Base	4.40
Context	Type	Description	Dimensions (m)						
			Length	Width	Depth				
-	Surface	Tarmac	10	2	0.06				
-	Layer	Concrete	10	2	0.20				
-	Layer	Sand	10	2	0.05				
-	Subsoil	Dark brown (10YR 4/3) clayey sandy silt with occasional gravel and chalk inclusions. Diesel contamination observed.	10	2	0.20				
-	Natural	Yellow brown (10YR 5/6) clay with flint and chalk.	10	2	>0.50

Plate 10 - Turstan Road, Tr1, looking NE

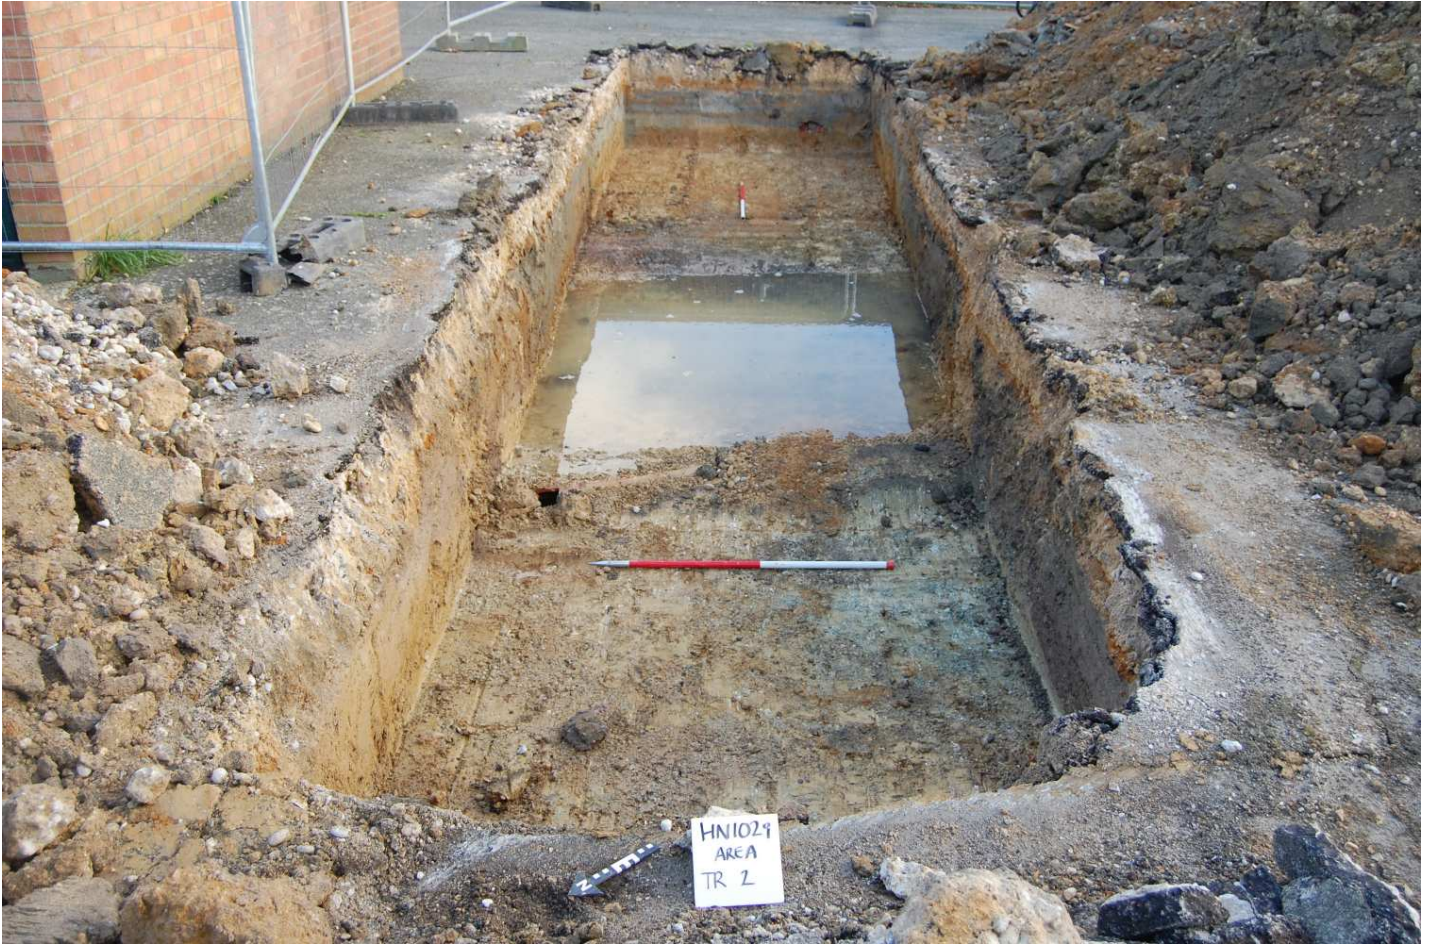
Length (m):	10	Width (m):	2	Maximum Depth (m):	0.90	Orientation	NW-SE	
Level at N End of Trench (mOD)			Top	4.85	Level at S End of Trench (mOD)		Top	4.98
			Base	4.10			Base	4.18
Context	Type	Description	Dimensions (m)					
			Length	Width	Depth			
-	Surface	Tarmac	0	2	0.06			
	Layer	Concrete	10	2	0.20			
-	Layer	Sand	10	2	0.05			
-	Layer	Dark brown (10YR 4/3) clayey sandy silt with occasional gravel and chalk inclusions. Redeposited clay.	10	2	0.45			
-	Natural	Yellow brown (10YR 5/6) clay with flint and chalk.	10	2	>0.75

Plate 11 - Turstan Road, Tr2, looking S
