ST JOHN THE BAPTIST CHURCH Aldenham, Herts.

HN1030

ARCHAEOLOGICAL MONITORING REPORT

Archaeological Monitoring Report

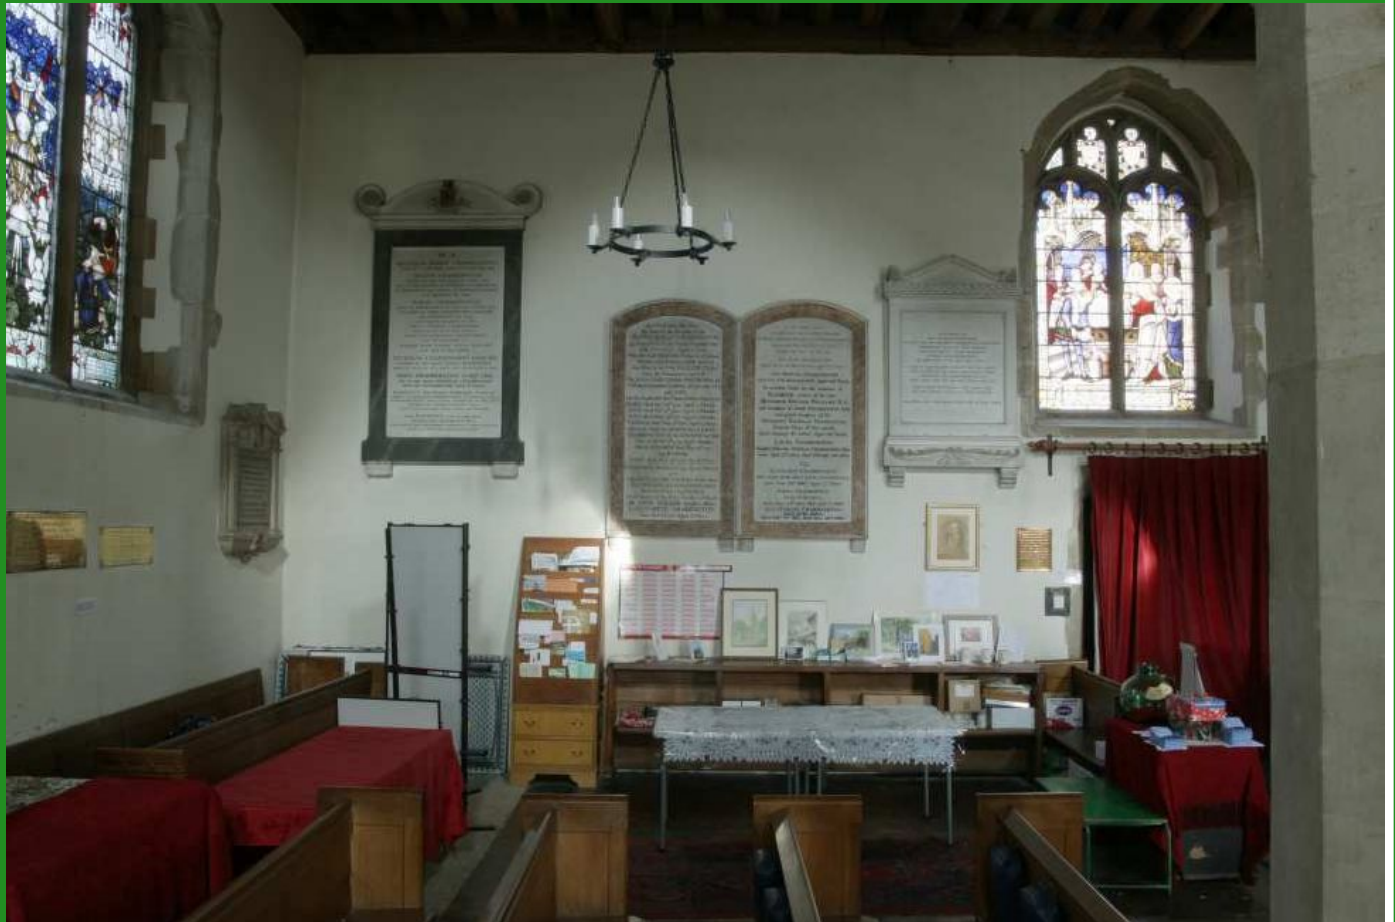
The cover photograph shows the Charrington Memorial prior to relocation, looking north

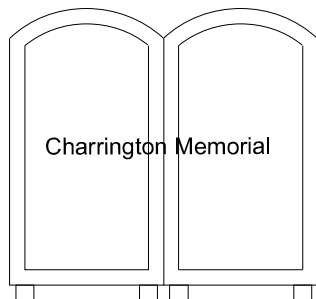
Original location

Proposed location

2.8 The memorials were located in the north-western corner of the north aisle, to the west of the window and between two other memorials (Figure 2; Plate 1). The height above ground of the Charrington memorials meant that they would be obscured by the proposed new kitchenette enclosure and it was decided that they should be re-sited at a higher level on the same wall.

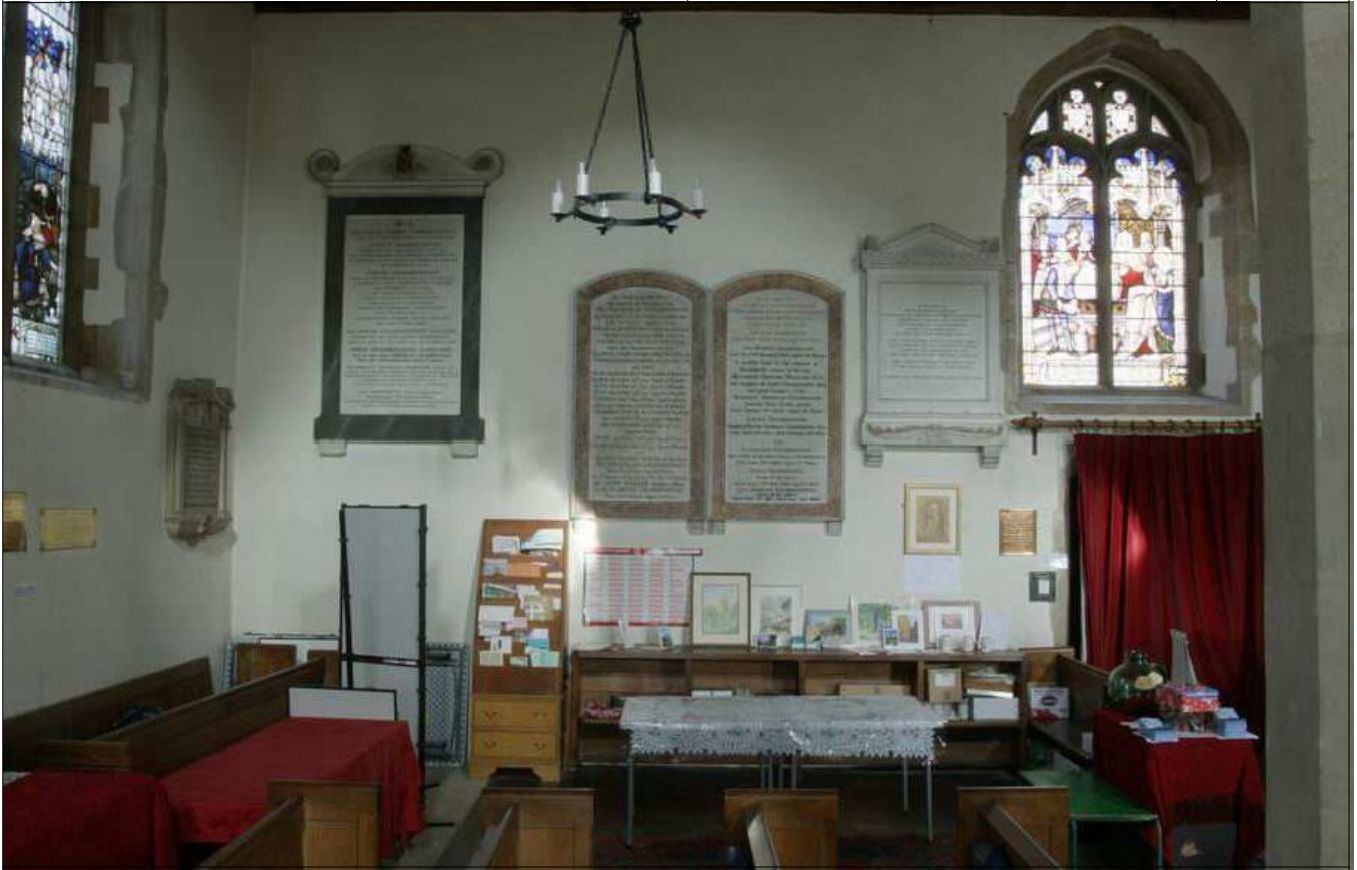
Plate 1: The Charrington memorials before removal, looking north

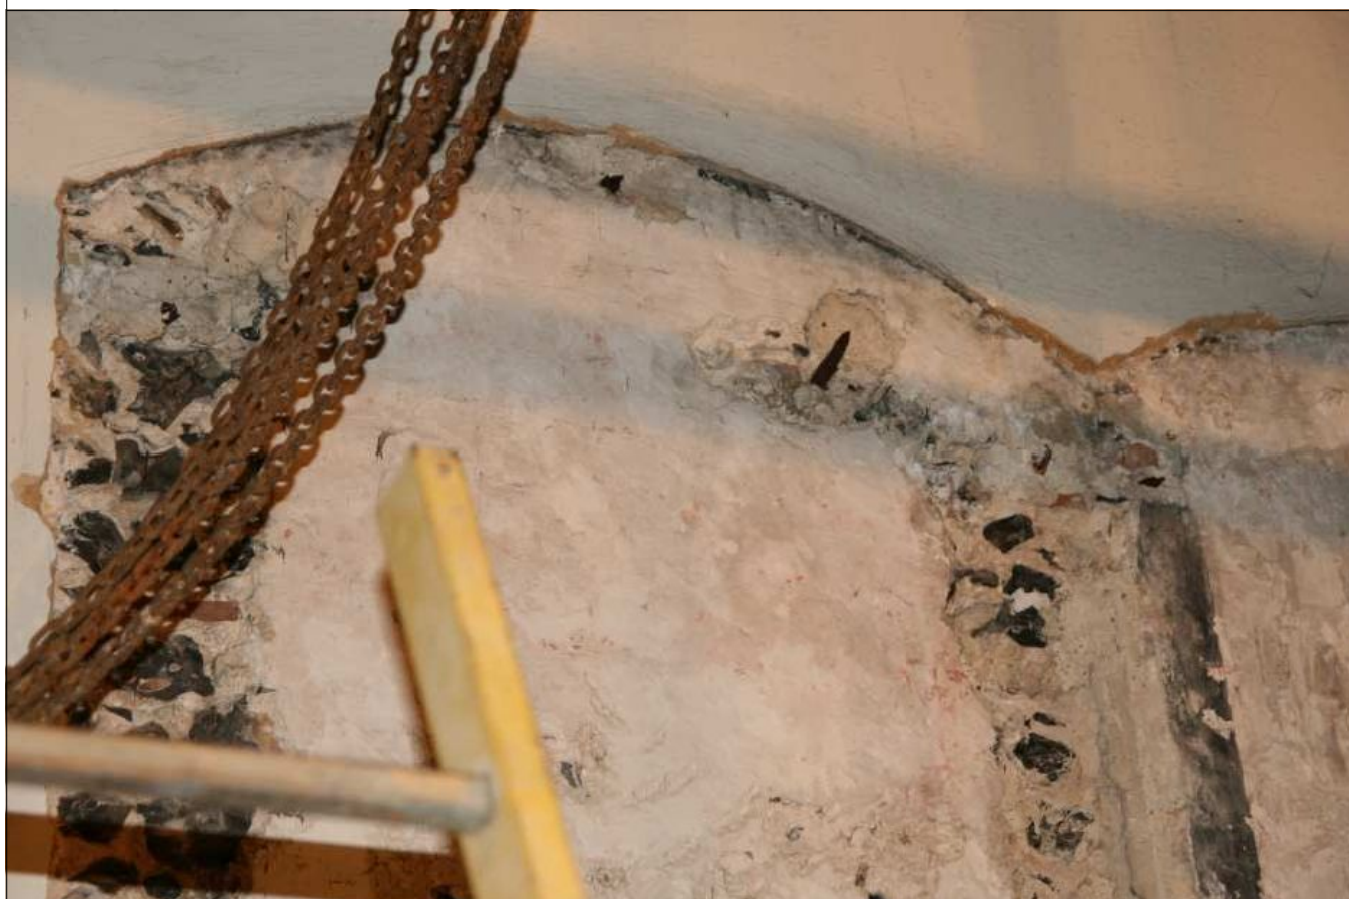
Plate 4: Detail of the exposed flintwork below the left hand memorial

3.7 The removal of the memorial did not reveal any hidden architectural features. The flintwork to the north wall was only exposed below the edges of the left hand tablet.

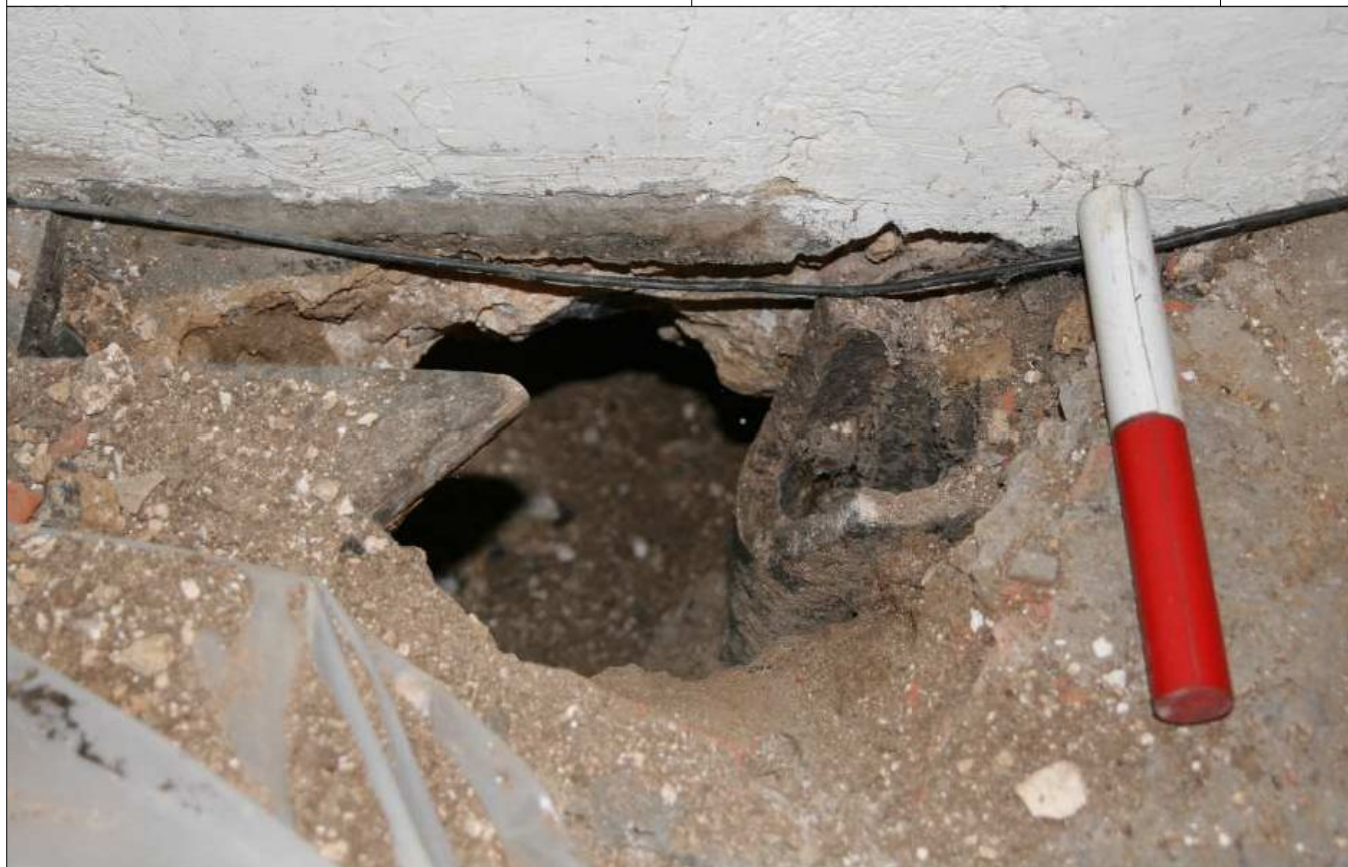
Plate 6: Access hole 1, from the interior

2.12 Two access holes were knocked through the north wall of the church, to feed drainage and services to the new kitchenette (Figure 2). The first was located at 0.37m to the west of the splay to the north door. The hole measured 0.30m x 0.15m on the interior, extending to 0.45m in depth. A vertical ceramic pipe was exposed on its eastern side, providing access for an earlier, defunct service (Plate 6). On the exterior the cut was 0.60m west of the door splay and measured 0.40m in width by 0.60m in depth (Plate 7). The hole was cut through the foundation of the mid 15th century north wall, which is formed of closely packed flint in a strong lime mortar.

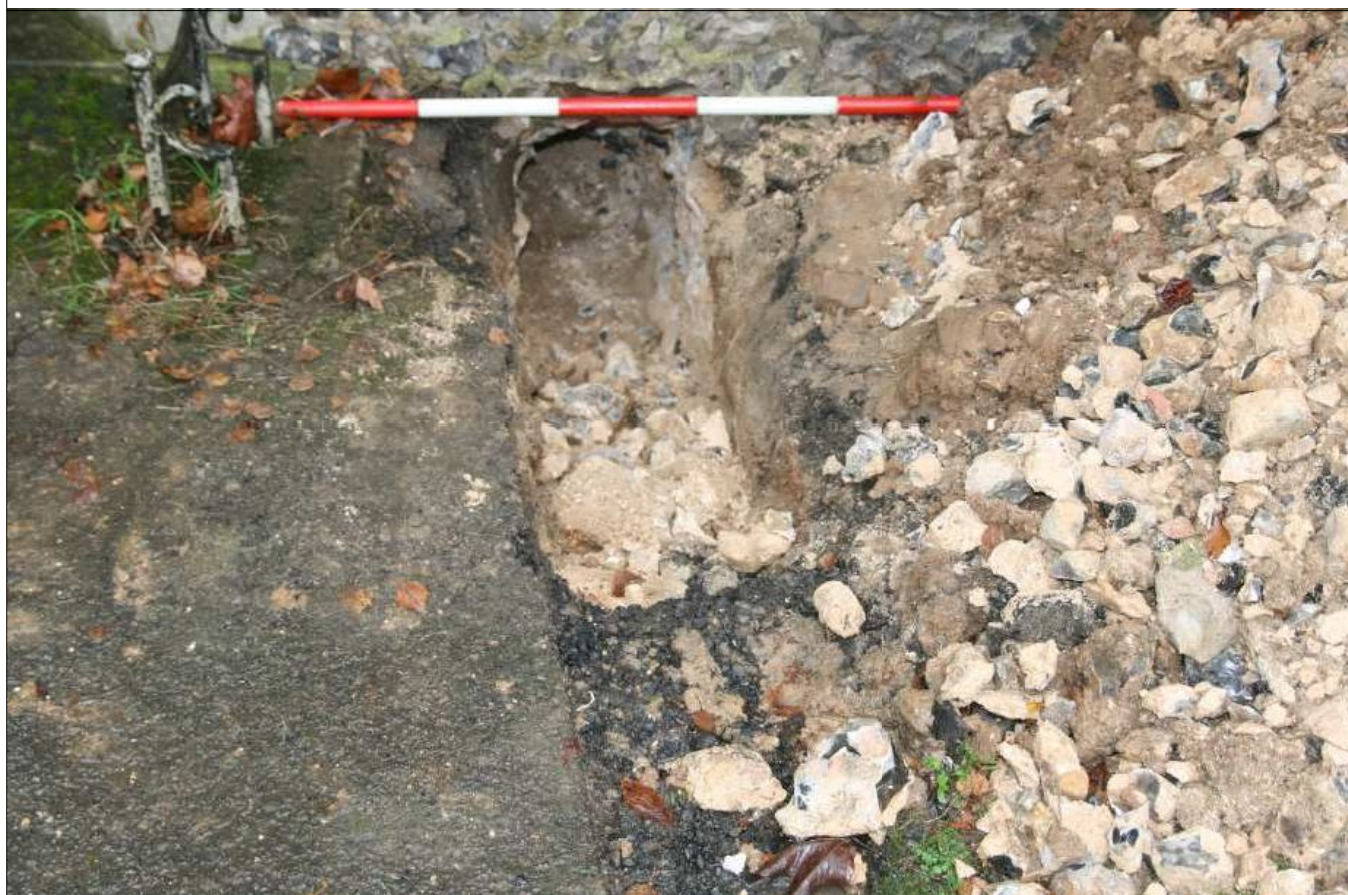
Plate 7: Access hole 1, from the exterior

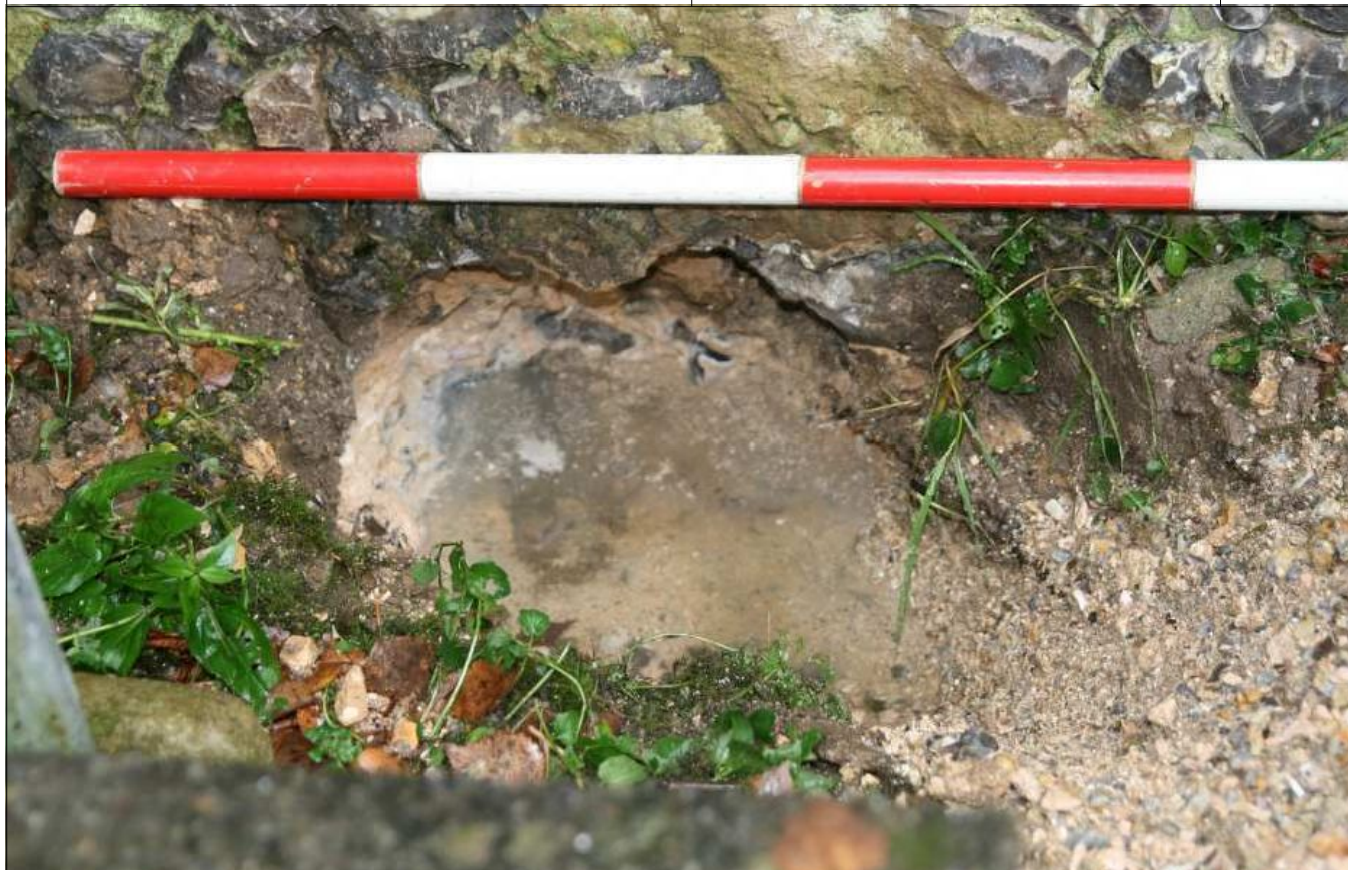
Plate 8: Access hole 2 from the exterior, looking south

2.13 The second hole was located at the eastern end of the north wall, at 0.15m to the west of the buttress adjacent to the Church Room. It measured 0.35m in width, 0.20m in height and 0.30m in depth and was cut into the foundation to the north wall, which is as described above (Plate 8).

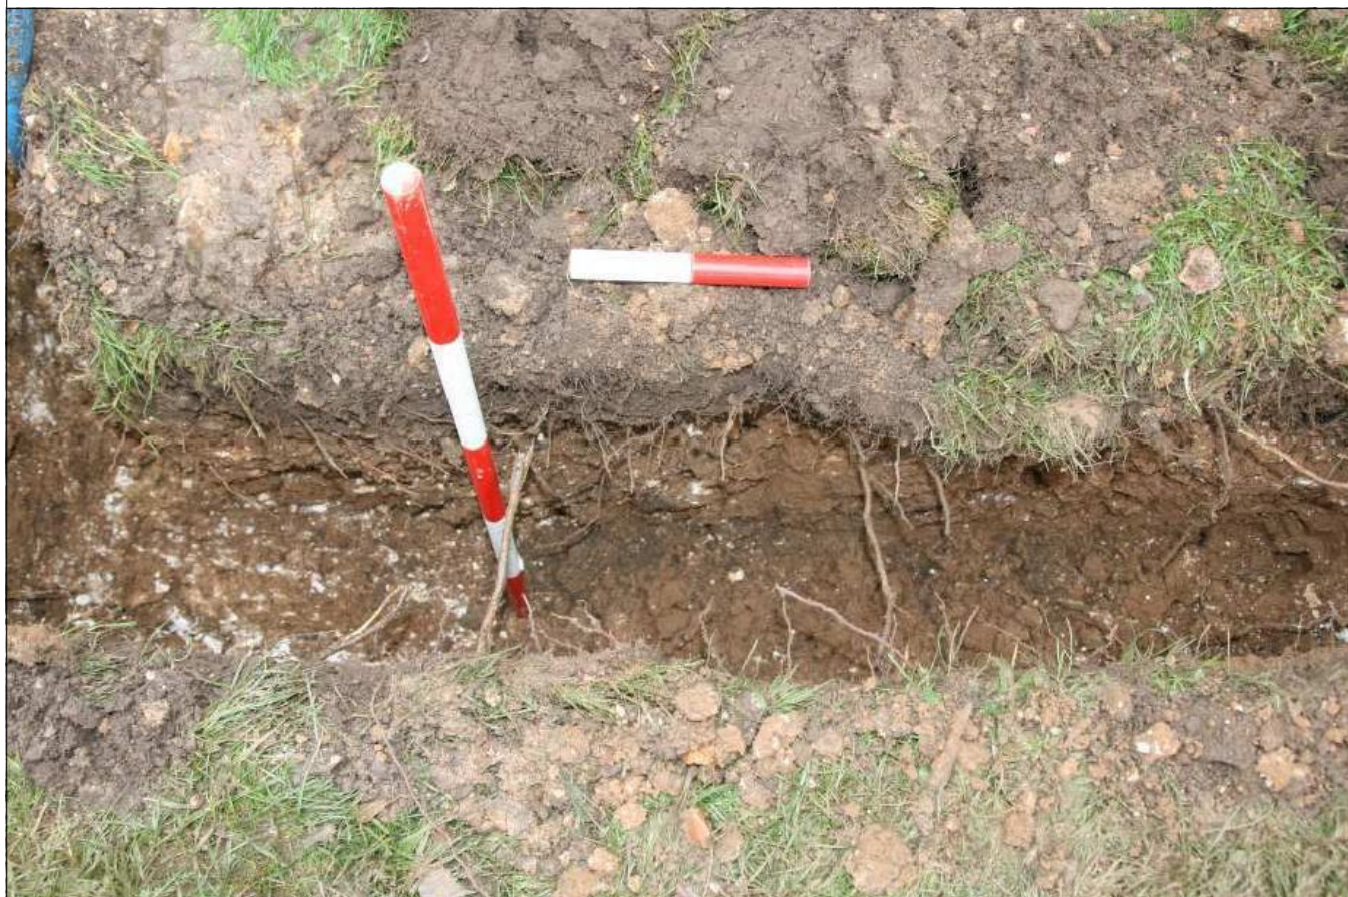
Plate 9: Stratigraphy revealed in Trench 1 sections

2.15 A trench for a new water main ran north from the south-eastern corner of the Church Room around the building (Figure 3). The trench measured 0.30m in width and 0.75m in depth. The stratigraphy revealed in the sections consisted of a layer of mid-brown silty clay graveyard soil, with frequent chalk fragments and occasional flints, under turf (Plate 9). The underlying natural substratum was not encountered.

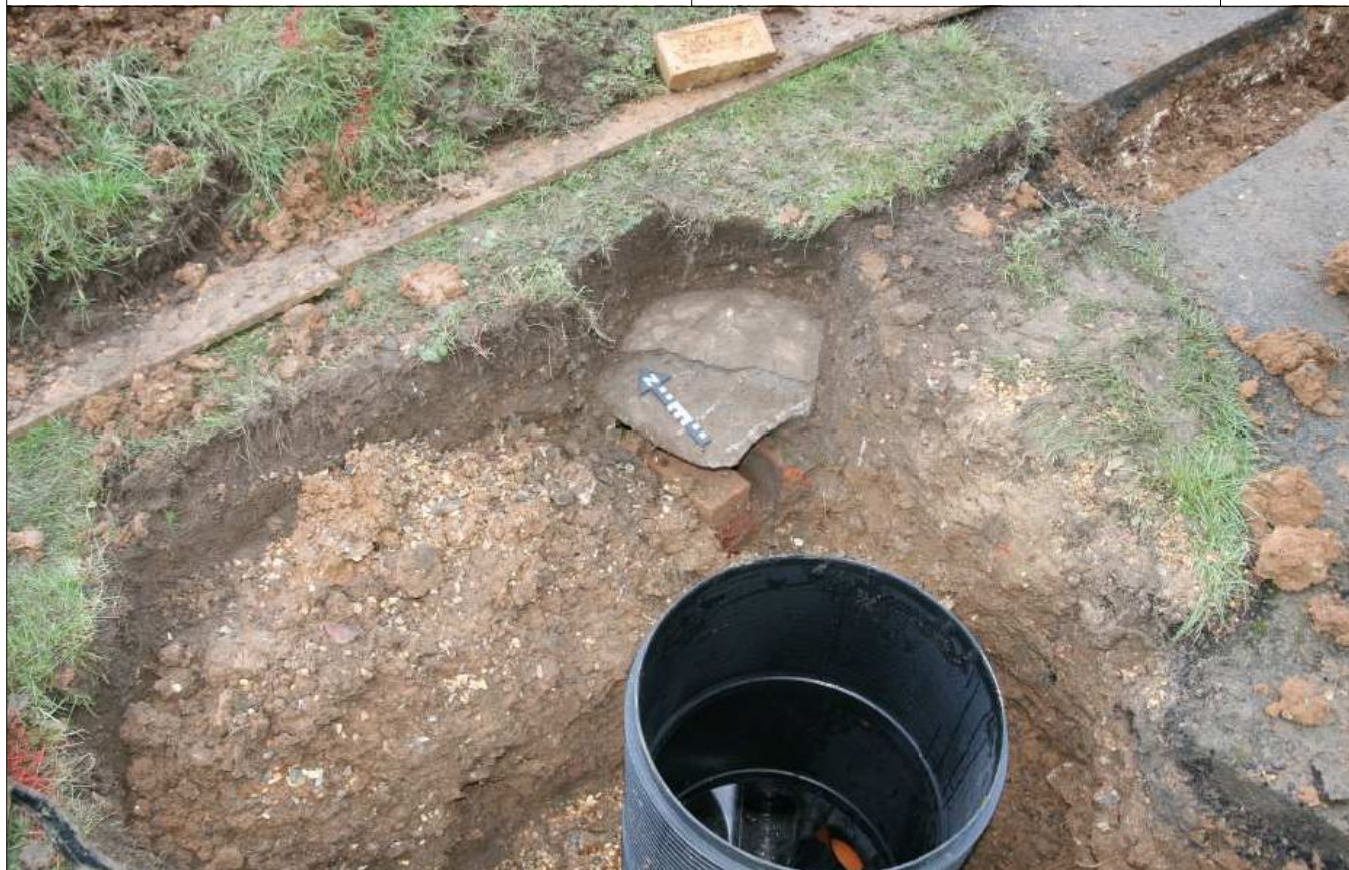
Plate 10: Buried grave slab in manhole pit

2.19 The excavation for the manhole had clipped the north-eastern corner of a buried grave slab sealing a brick grave (Plate 10). The inscription on the stone reads [...AS & SON and [J]OHN CONINGS...] (Plate 11).

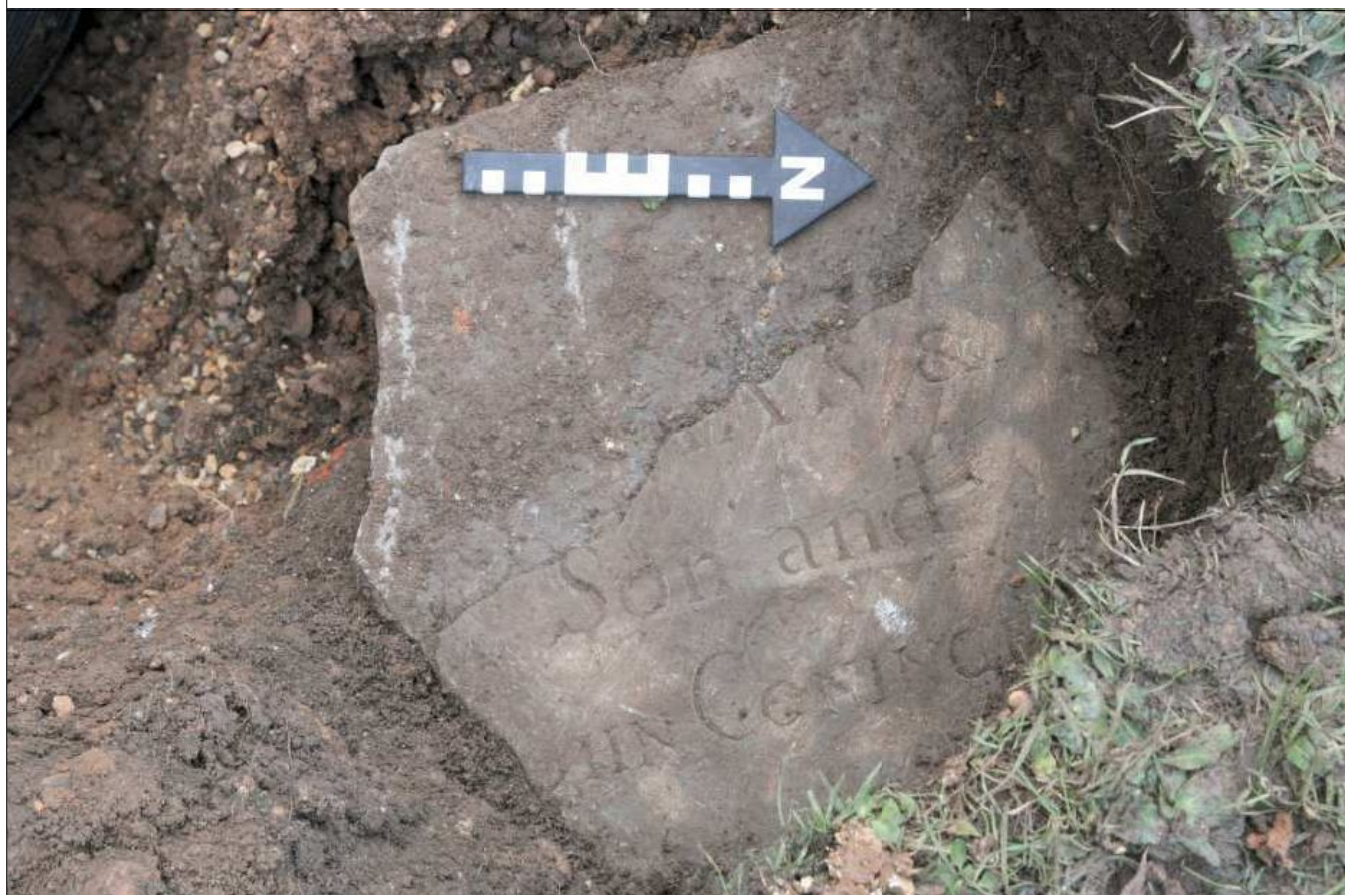
Plate 11: Detail of the buried grave slab

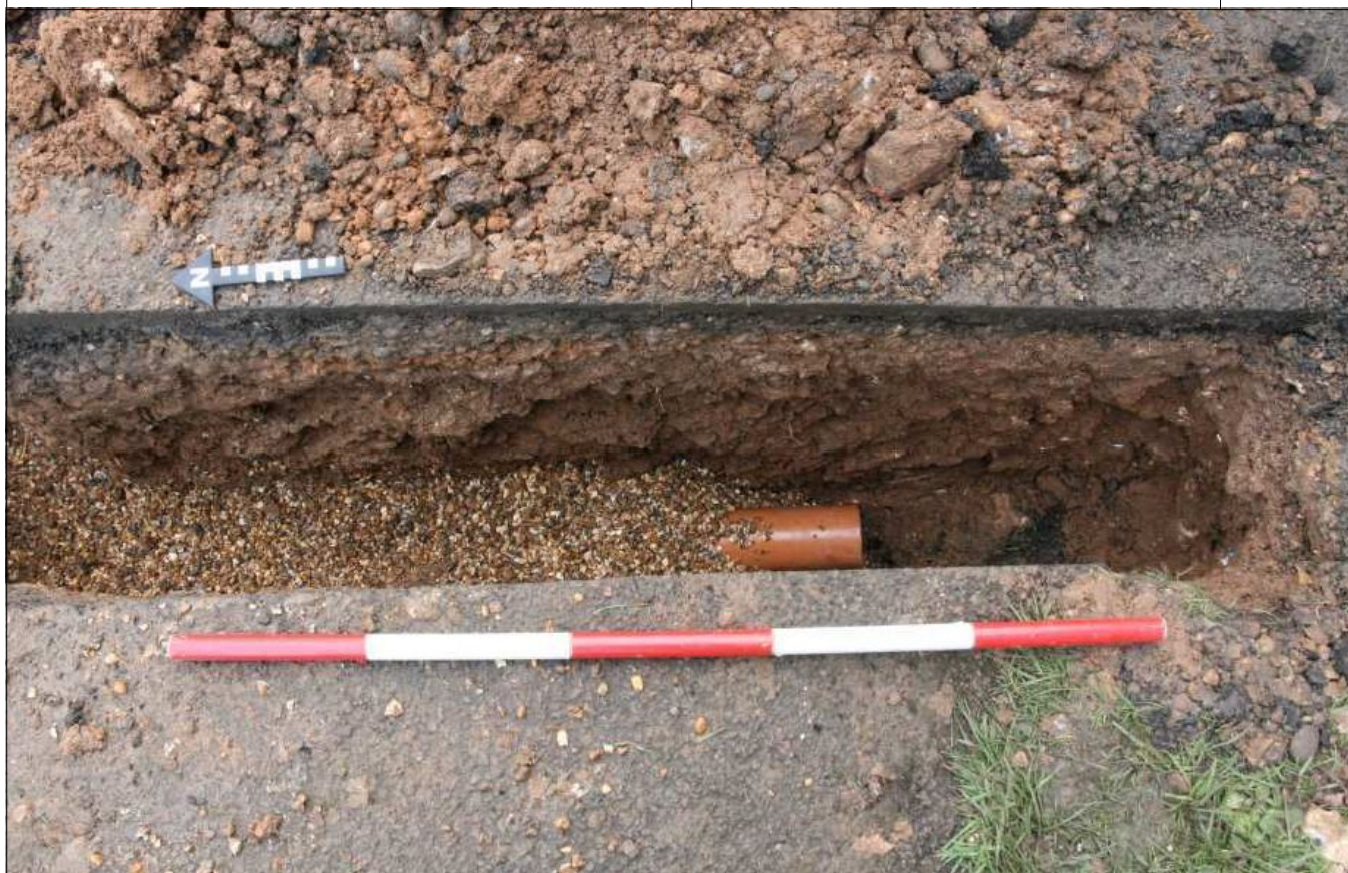
Plate 12: Trench 2, looking east

2.20 The trench measured 0.25m in width and was excavated to a depth of 0.80m. The sections revealed a layer of tarmac above cemetery soil (Plates 12 & 13). Some fragments of human bone were visible at the impact depth, these were left in situ. No archaeological features, deposits or finds were present in the trench.

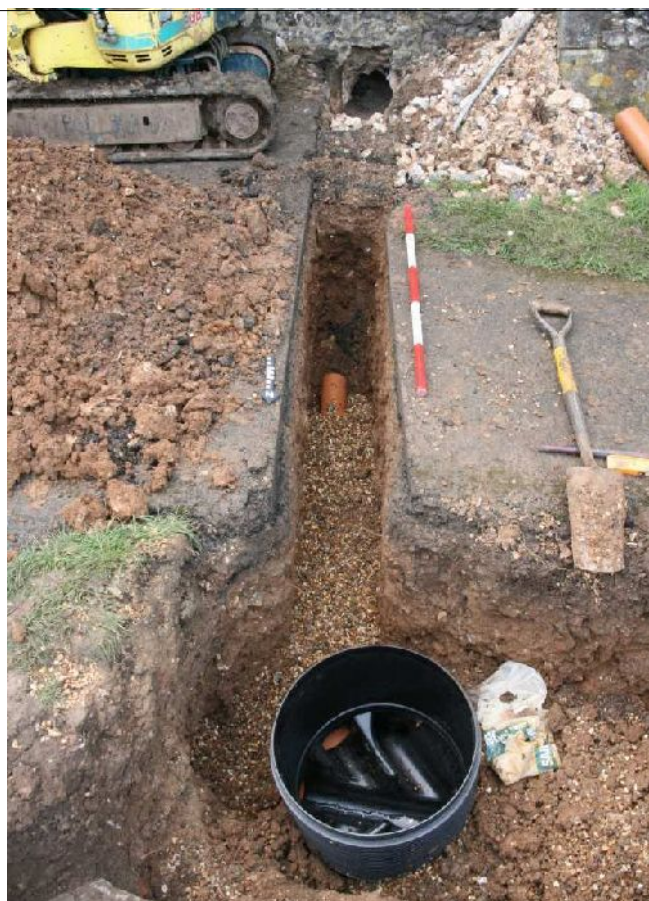
Plate 13: Trench 2, looking south
