**TOP FARM,
Beadlow, Bedfordshire**

HN1043

***ARCHAEOLOGICAL
EVALUATION REPORT***

Archaeological Evaluation

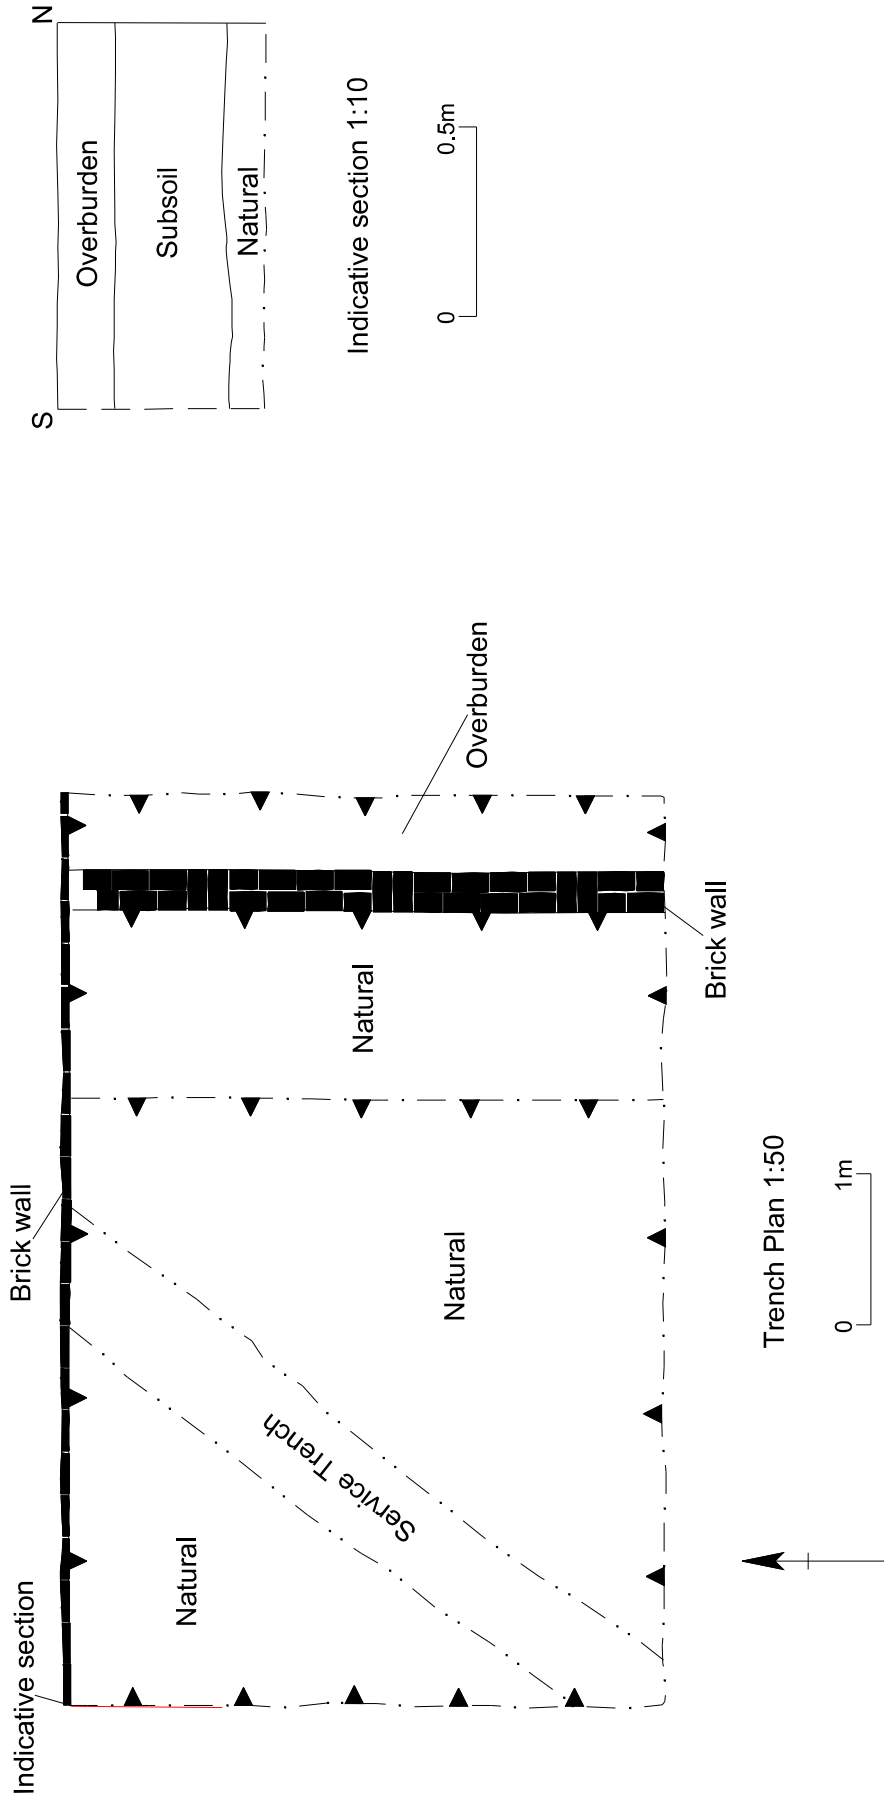
Figure 3

2.10 Trench 1 was located in the northwestern corner of the site and was oriented east-west. It measured 6m long by 4m wide (Figures 2 & 3).

2.11 The stratigraphy in this area of the site comprised modern black sand and gravel over a pale greyish brown sandy subsoil layer. Below the subsoil was a yellowish brown natural sand layer.

2.12 The trench revealed a number of modern features including two modern walls and a service trench.

Trench 1

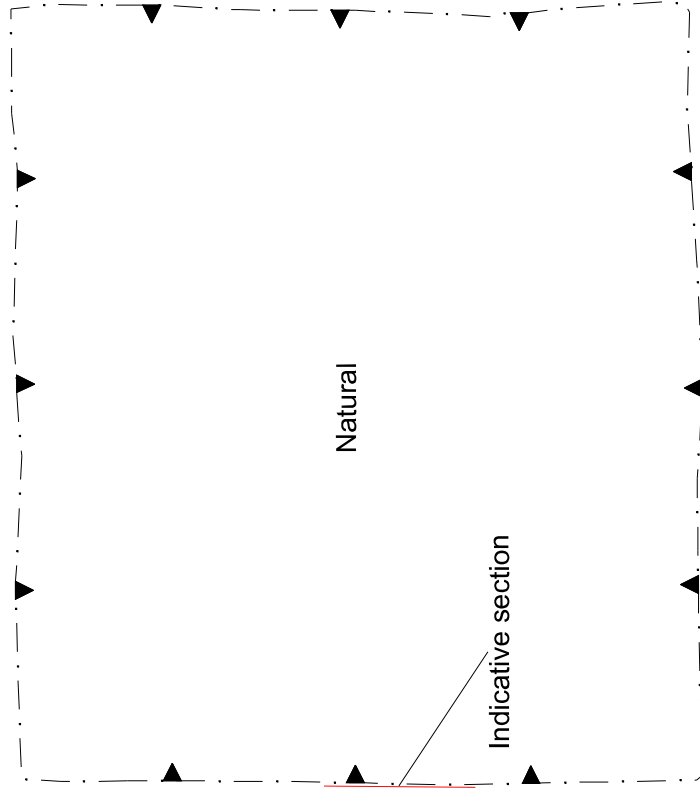
Figure 5

2.18 Trench 3 was located in the northeast corner of the proposed development and measured 5m long by 5m wide and was excavated to a depth of c.0.3m (Figure 2).

2.19 The stratigraphy in Trench 3 consisted of concrete and hardcore over natural sand and sandstone gravel.

Trench 3

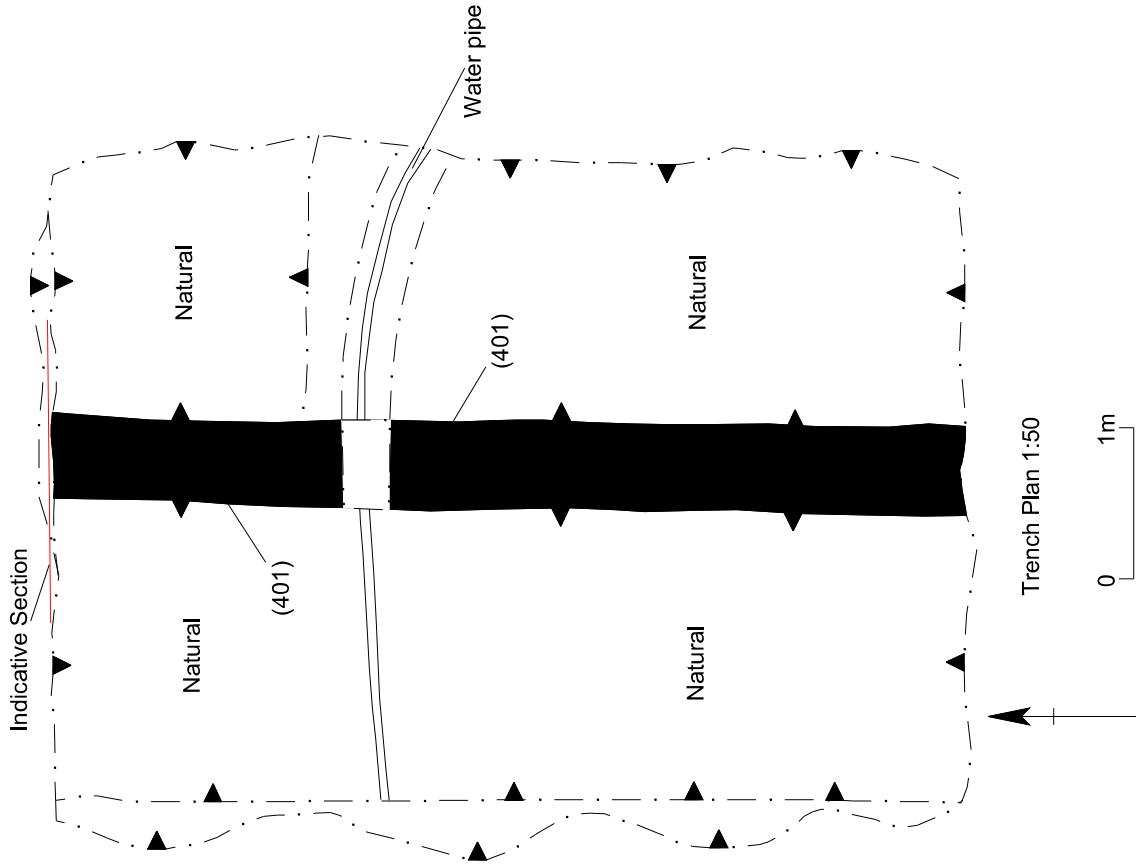
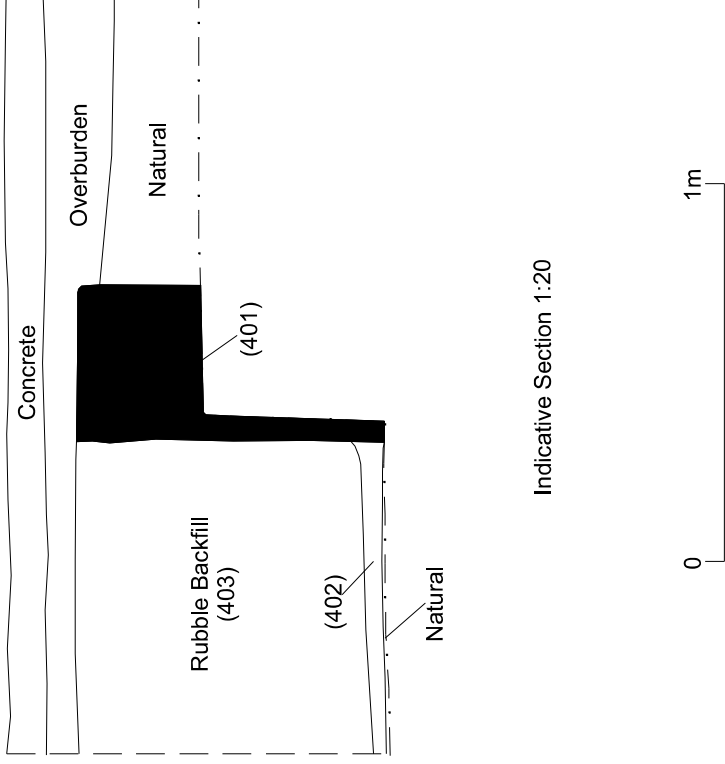
Figure 6

2.21 Trench 4 was located on the east side of the proposed development and measured 6m in length by 4m wide and was excavated to a depth of c. 1.0m (Figure 2).

2.22 The stratigraphy in Trench 4 consisted of a concrete slab, over a rubble levelling deposit. The removal of the levelling deposit revealed a substantial north-south oriented wall (401). On the west side the ground level was lower than on the east and had been backfilled to a depth of 0.75m with brick and tile rubble (403) over a 0.05m thick dark brown soil layer (402). Below layer (402) was natural sand. On the west side of the wall, the natural sand was immediately below the levelling deposit.

Trench 4

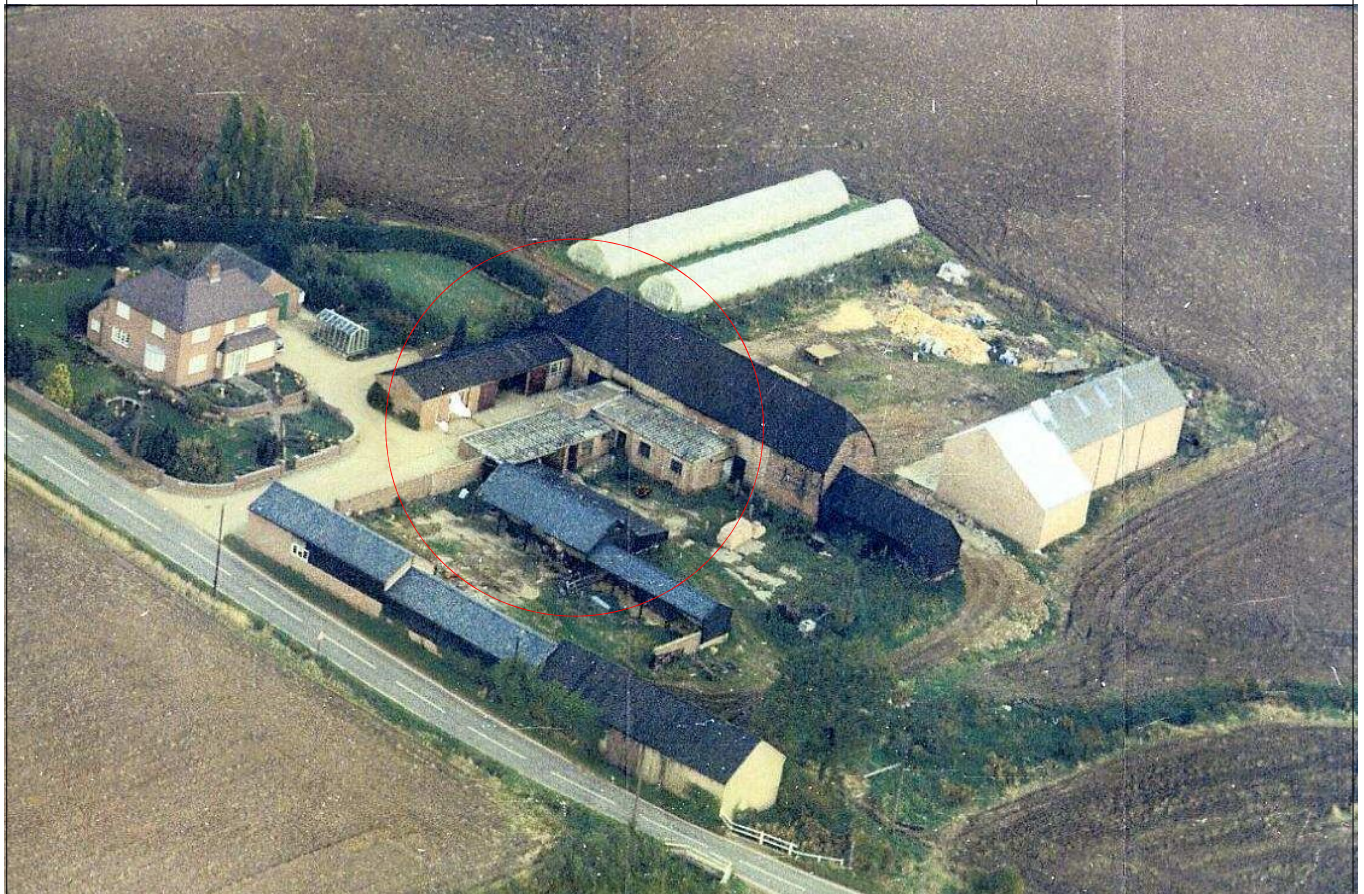
Figure 8

Aerial view of Top Farm in the 1970s

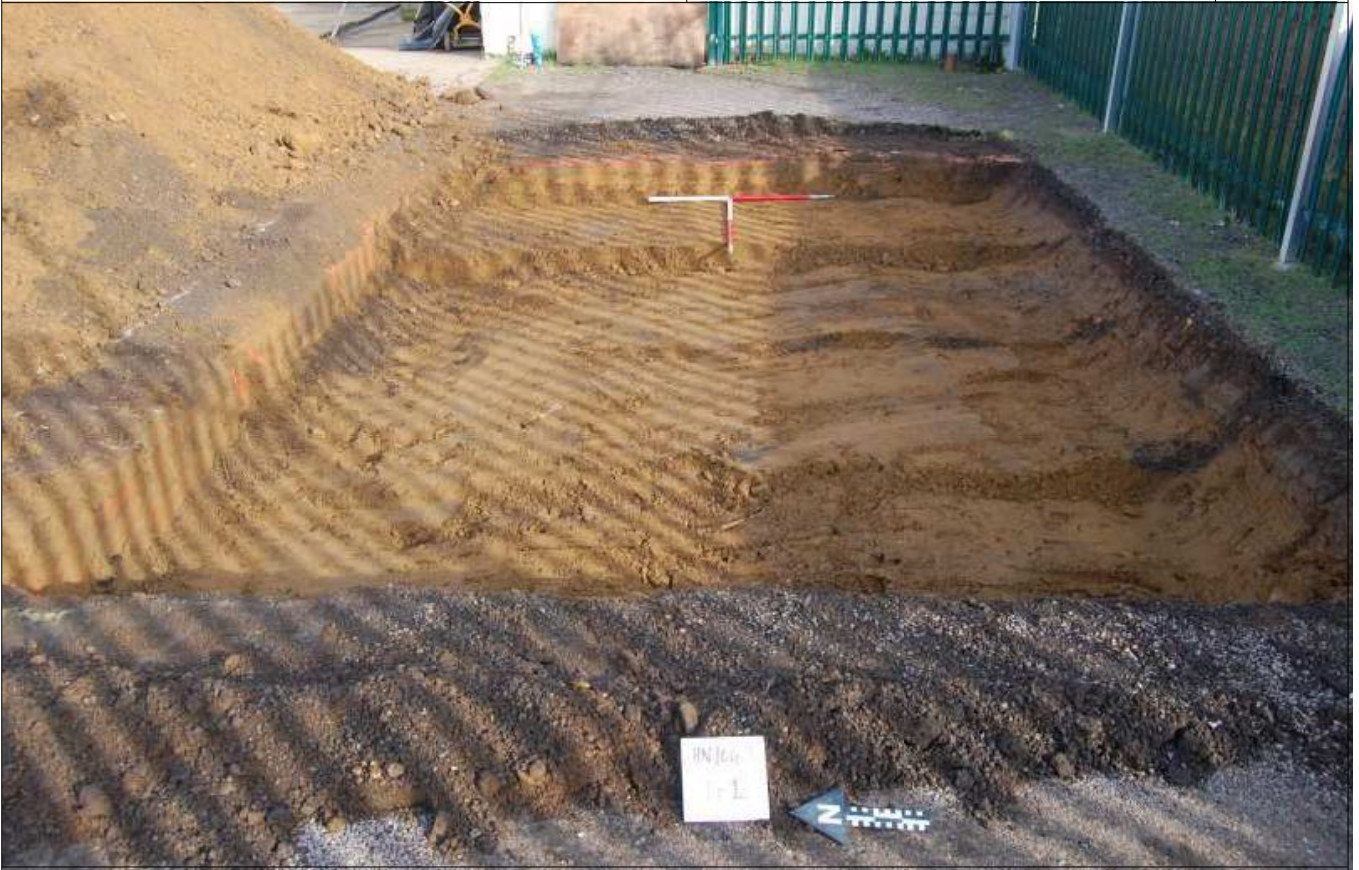
2.13 No archaeological features, deposits or finds were encountered in Trench 1 (Plate 1).

Plate 1: Trench 1, looking east

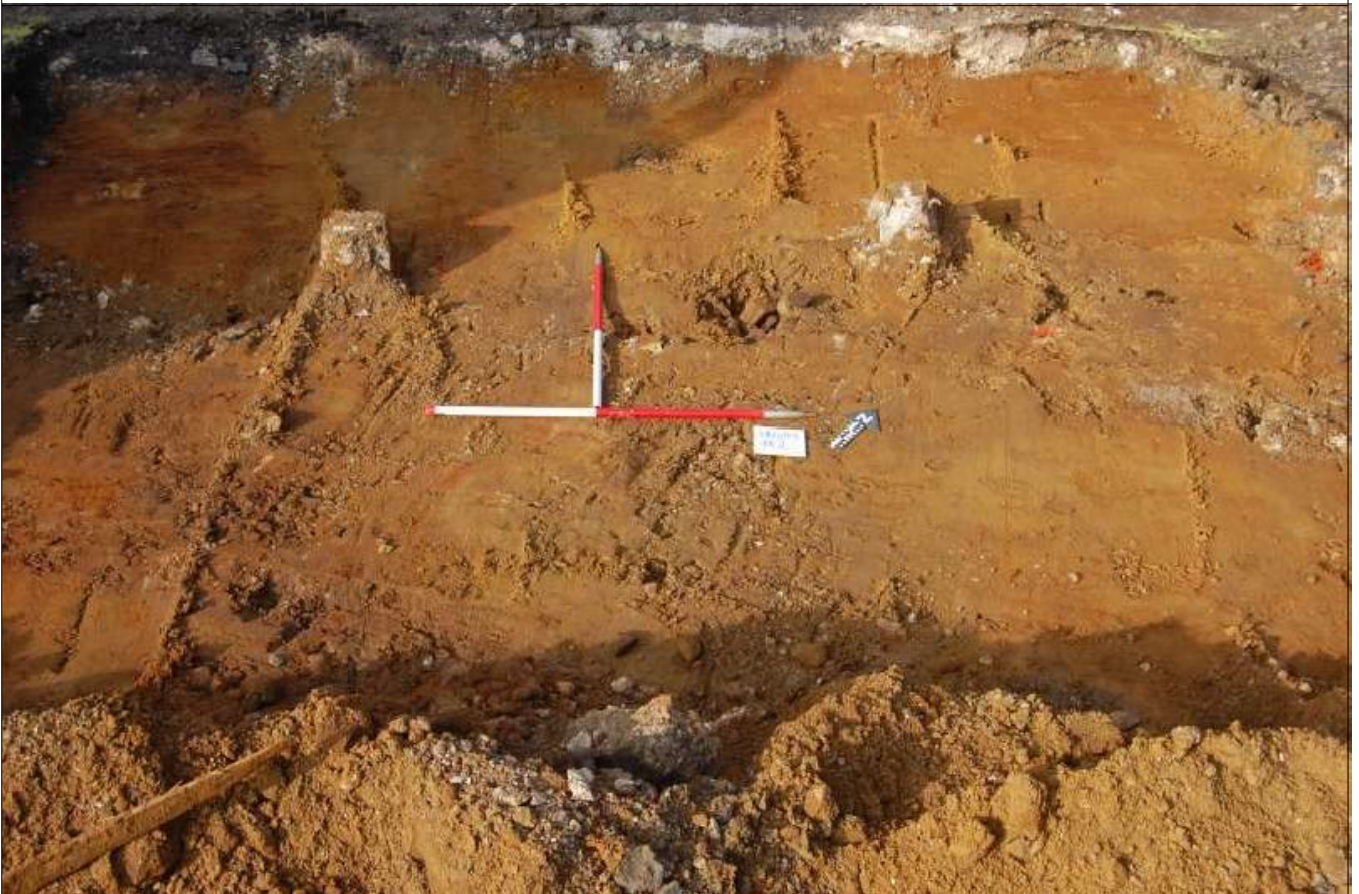
2.17 No archaeological features, deposits or finds were encountered in Trench 2 (Plate 2).

Plate 2: Trench 2, looking north-east

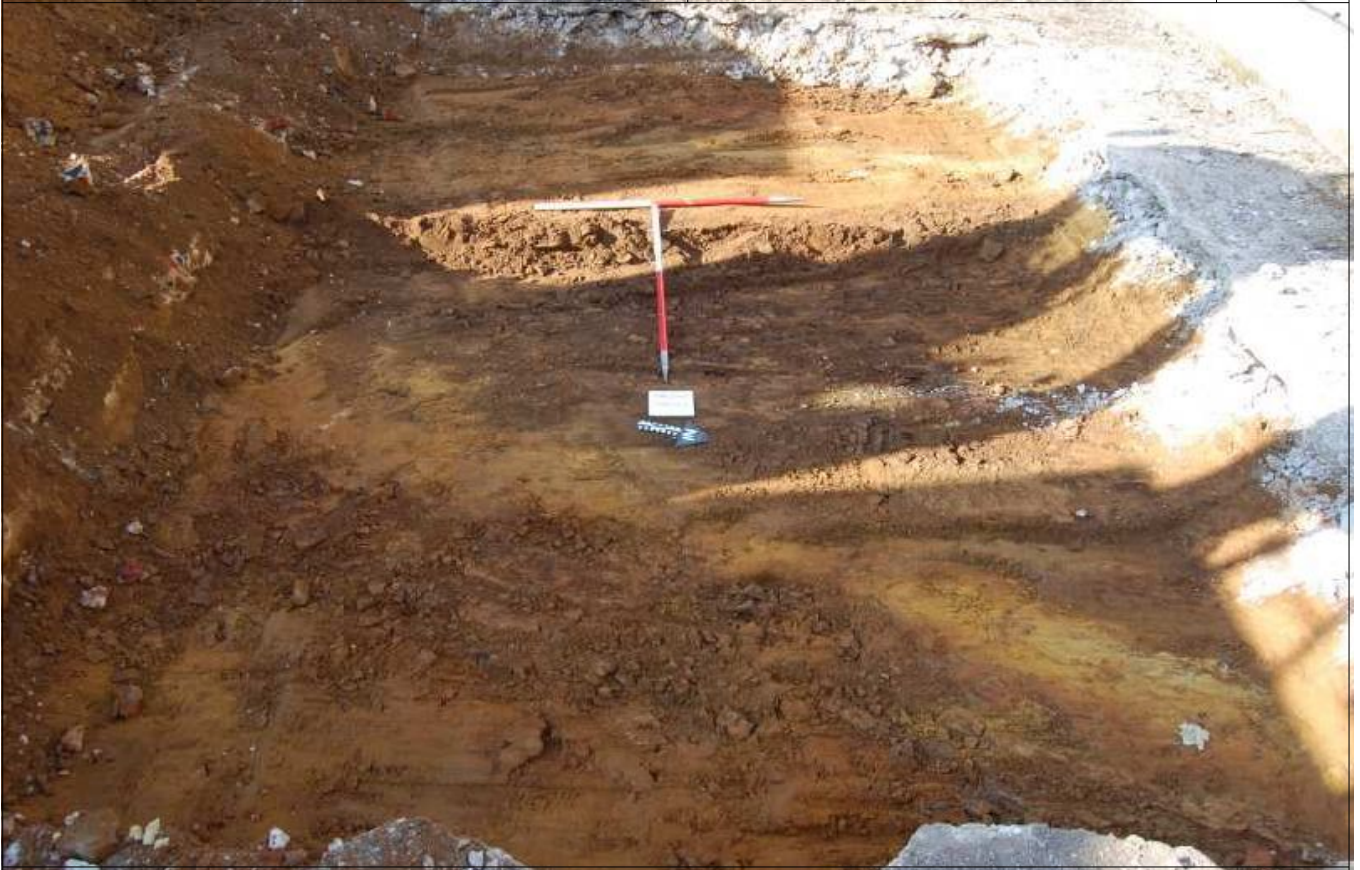
2.20 No archaeological features, deposits or finds were encountered in Trench 3 (Plate 3).

Plate 3: Trench 3, looking west

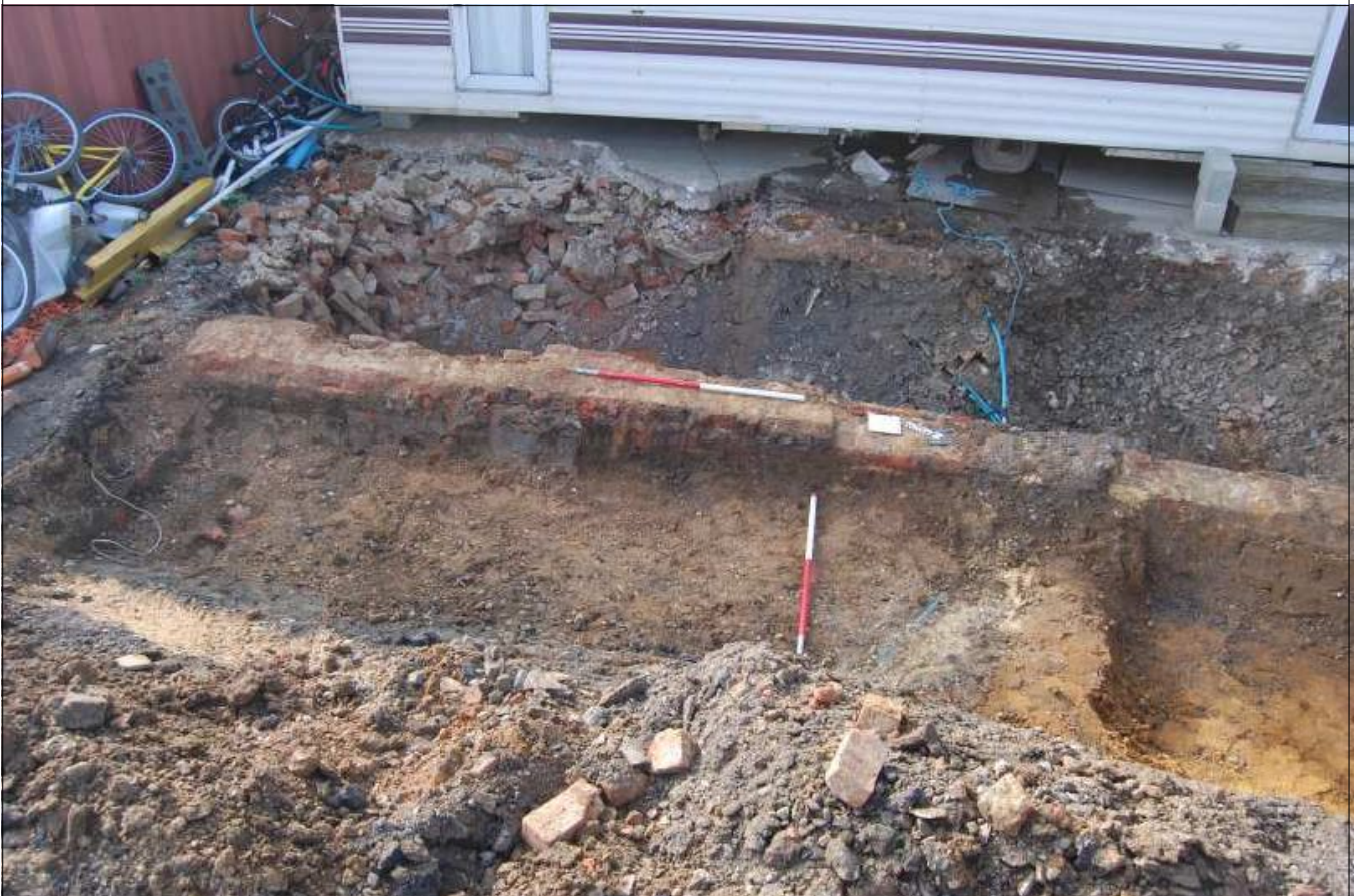
2.23 No other archaeological features, deposits or finds were encountered in Trench 4 (Plate 4).

Plate 4: Trench 4, looking west

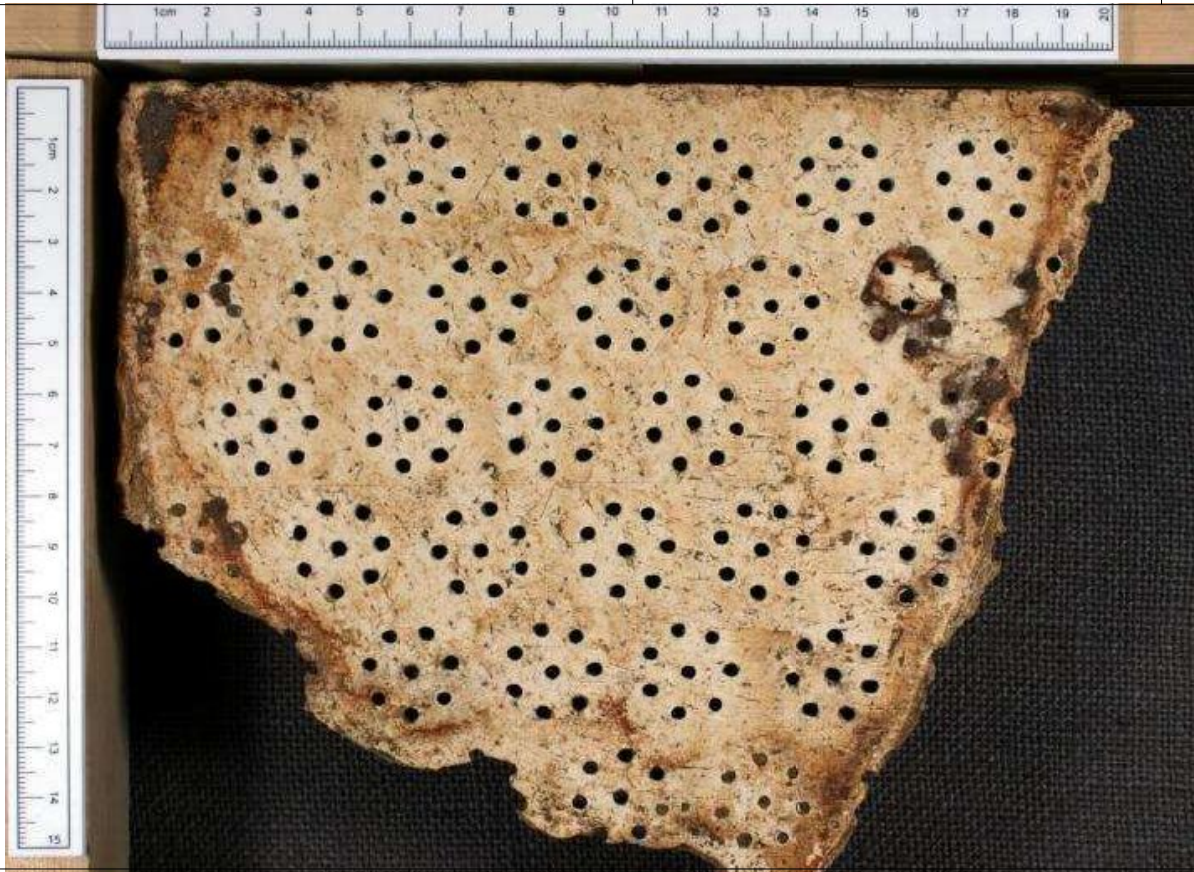
2.24 One broken fragment of a perforated malting tile, weighing 1705g, was recovered from the layer of backfill adjacent to wall [401]. The piece, which is made of white clay, measures 195mm in length, 145mm in width and 50mm in depth. The upper face is covered in a pattern of slightly raised perforations arranged in circles approximately 20mm in diameter, comprising seven small holes set around a central hole (Plate 5). The individual holes measure approximately 2mm in diameter. These are arranged in diagonal rows. The lower face consists of larger holes, approximately 21mm in diameter, made by the perforating tool (Plate 6).

2.25 Malting tiles were laid to form the floor of the drying kiln, with the green malt laid directly on the tiles.

Plate 5: Malting tile from (403), upper face

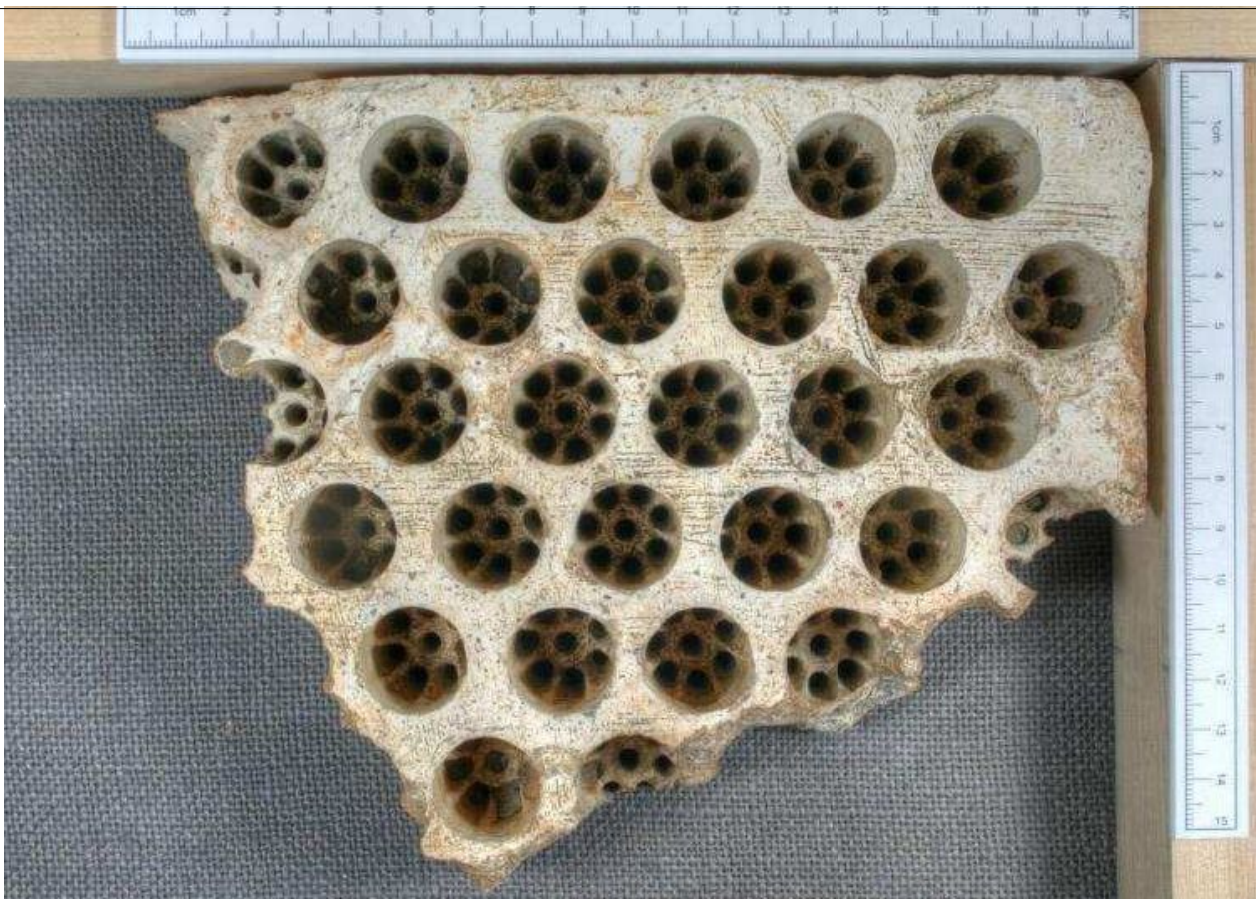
Plate 6: Malting tile from (403), lower face
