44 GREEN END
Braughing, Hertfordshire

(HN590)

Archaeological Monitoring Report

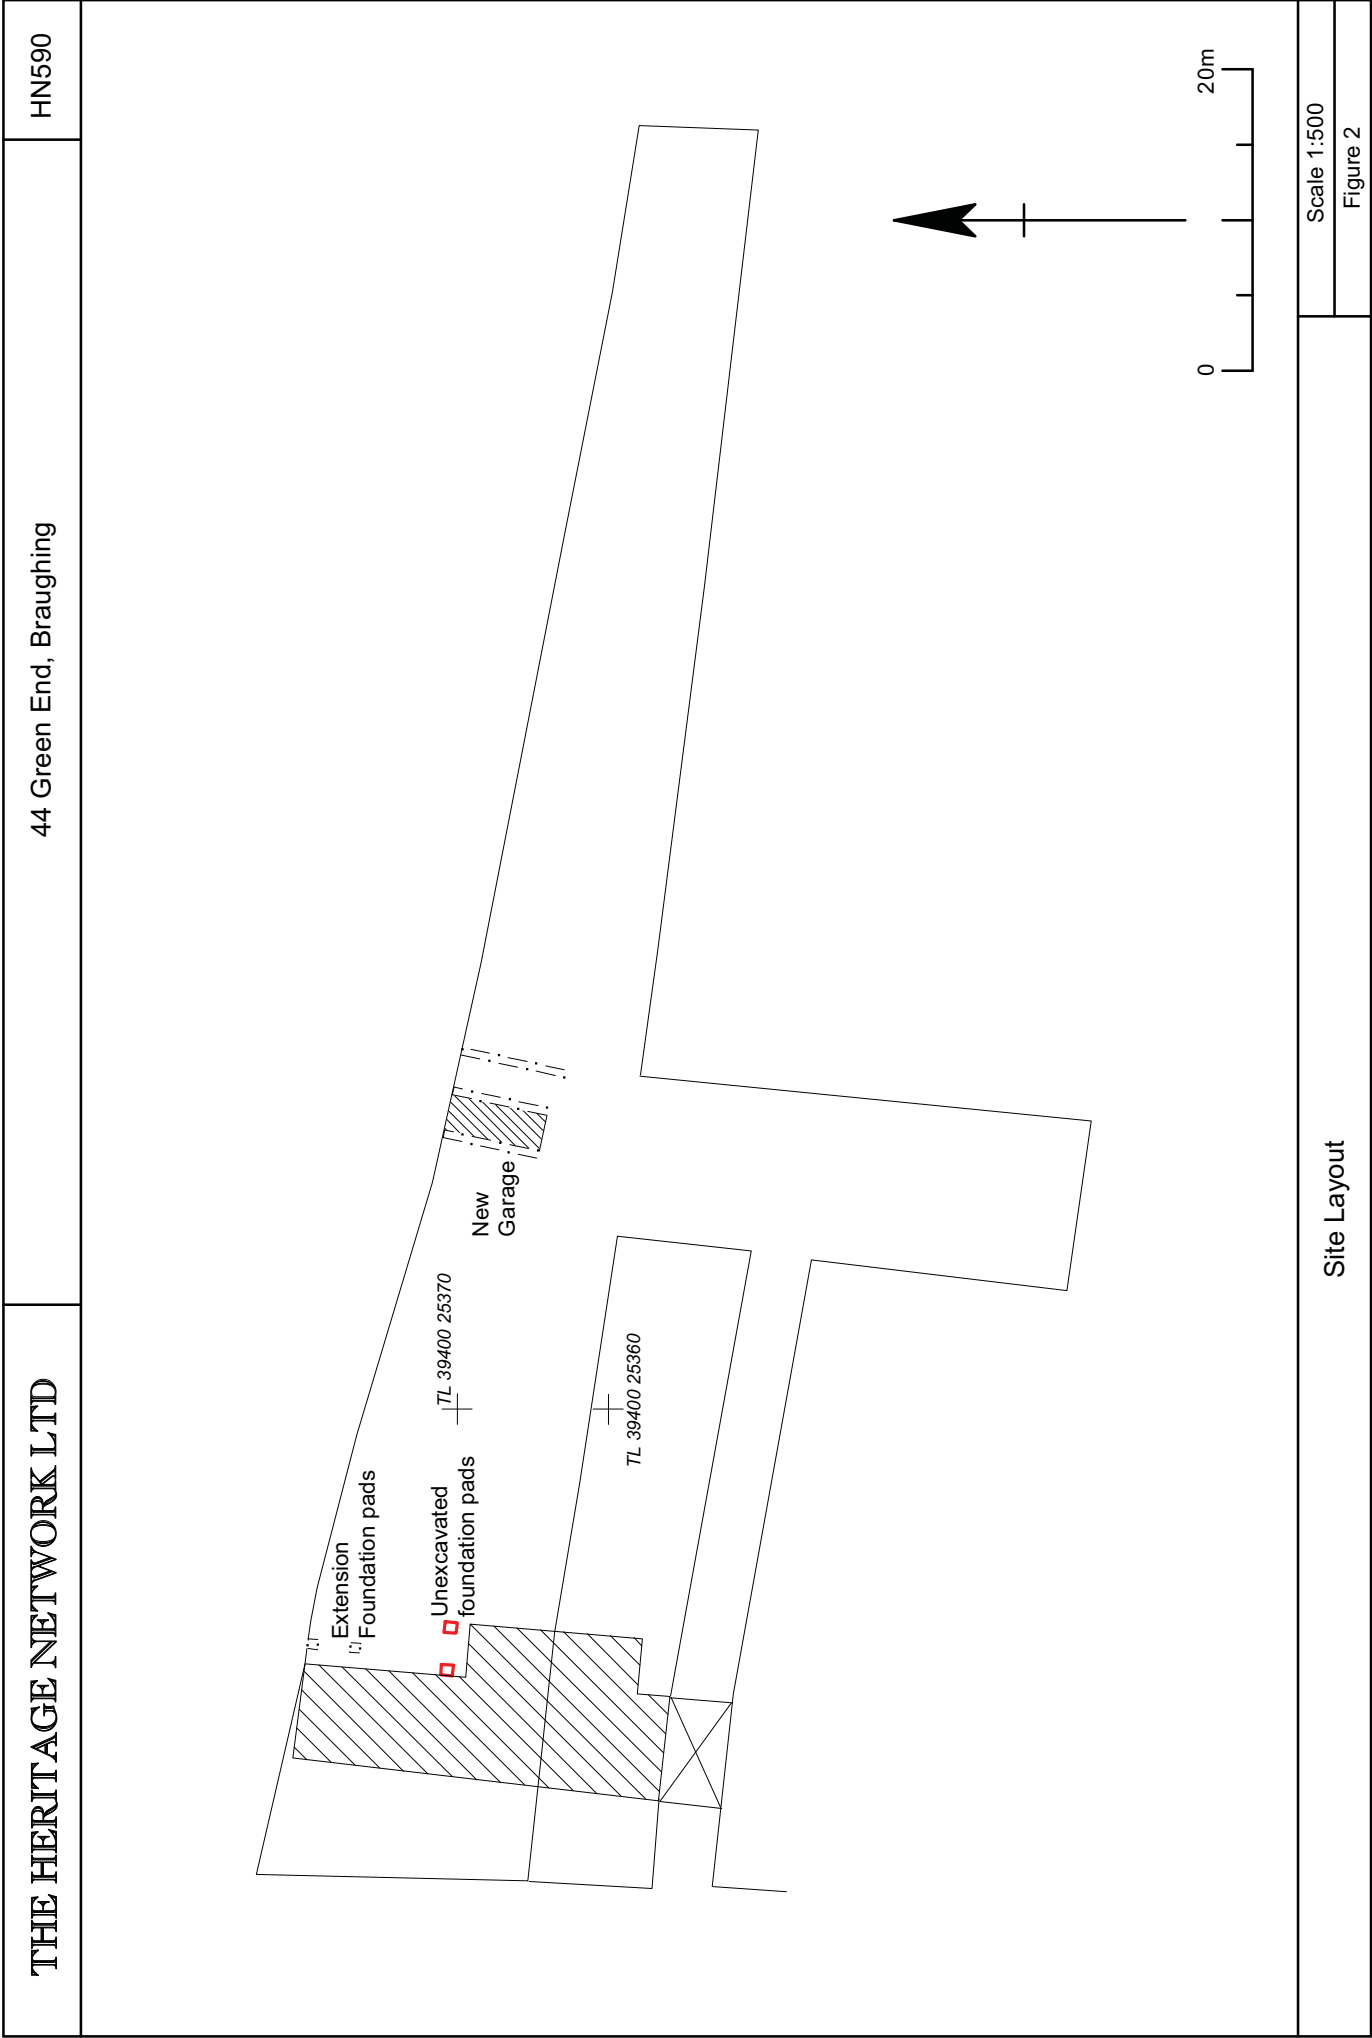
Figure 2 Site layout

2.6 The groundworks included the reduction of the ground level within the footprint of the new garage, the excavation of the footing trenches, and the excavation of the foundation pads for the new extension.

2.7 The new garage was located in the centre of the garden. At this point the ground had been terraced, with a step down to the eastern half of the garden. The new garage straddles this terrace. The ground level was reduced by approximately 0.70m in the raised part of the terrace.

2.10 Three strip footings were excavated for the new garage, the trenches measured 0.50m in width. The two westernmost trenches were excavated to a total depth of 1.20m, the eastern trench was excavated to a depth of 0.50m.

2.13 Two foundation pads were excavated for the proposed new extension on the northern half of the east face of the house. The pads measured 0.65m square and were excavated to a maximum depth of 1.05m.

2.16 A further two foundation pads were planned for a second extension on the southern half of the east face of the building. These have not yet been excavated as construction of the second extension may no longer occur. One of the proposed pads abuts the existing property which has been already underpinned. The second proposed pad would be located close to an existing service trench.
