STAGE 3: ARCHAEOLOGICAL MONITORING REPORT

THE FRYTHE, Welwyn, Hertfordshire

Stage 3: Archaeological Monitoring and Historic Building Recording

Report no.795

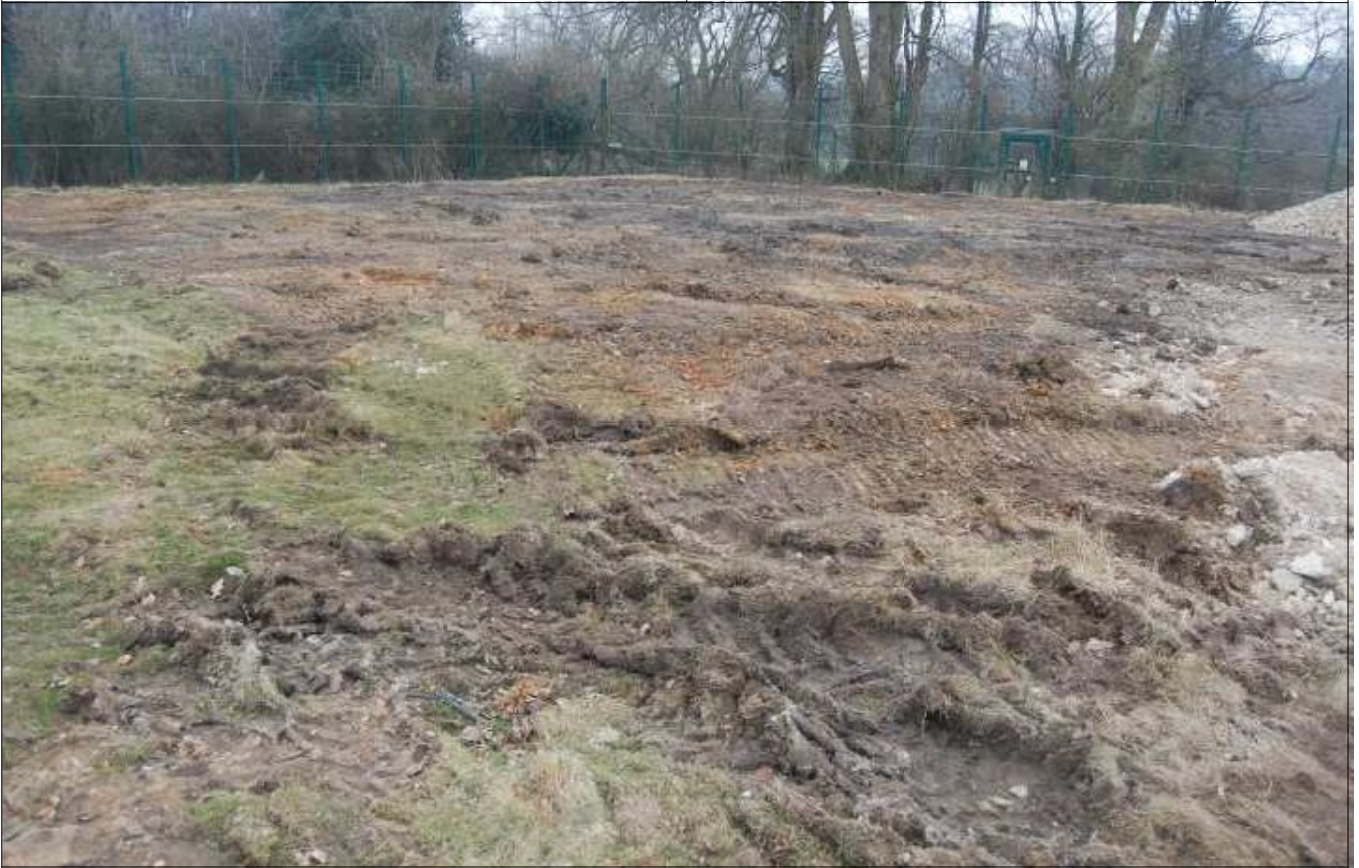
Plate 1: Area of ground reduction prior to start of work, looking NE

2.16 The mound was located in the north-eastern corner of the study area (Figure 2; Plate 1). It measured 25m long and 20m wide and over 1m in height. The mound was removed by machine and was found to be composed of mixed soil and building rubble.

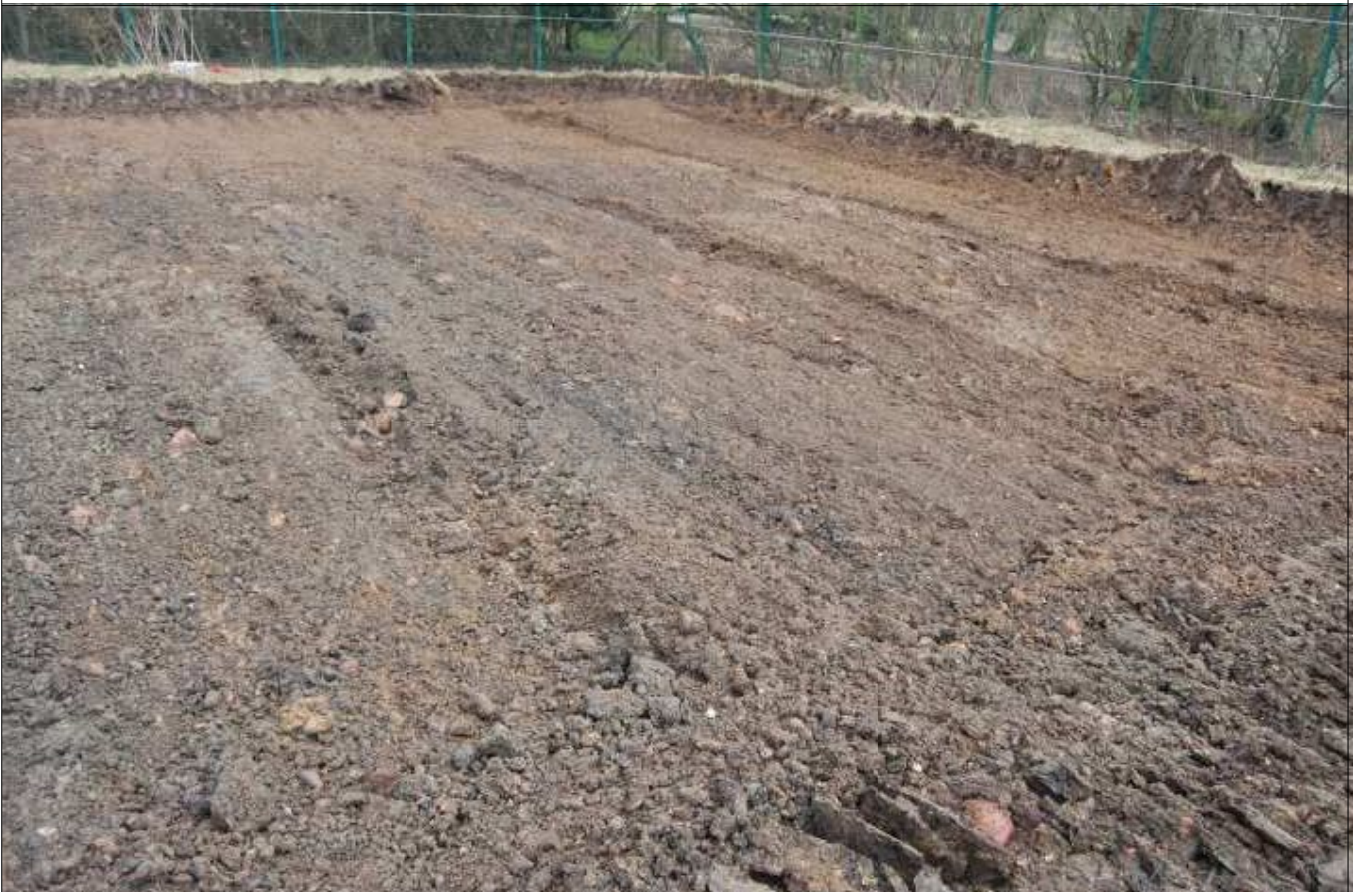
Plate 2: Area of ground reduction after the works, looking NE

2.17 After the mound had been removed the underlying ground level was reduced in depth by approximately 0.60m. The removed material comprised a dark greyish brown (10YR 4/2) clay/silt with sand, containing frequent gravel and modern concrete and brick fragments (Plate 2). Evidence for diesel contamination was also noted, particularly in the centre of the area covered by the mound.

2.18 No archaeological features, deposits or other artefacts were observed during the ground reduction. The underlying natural clay was not exposed during these works.

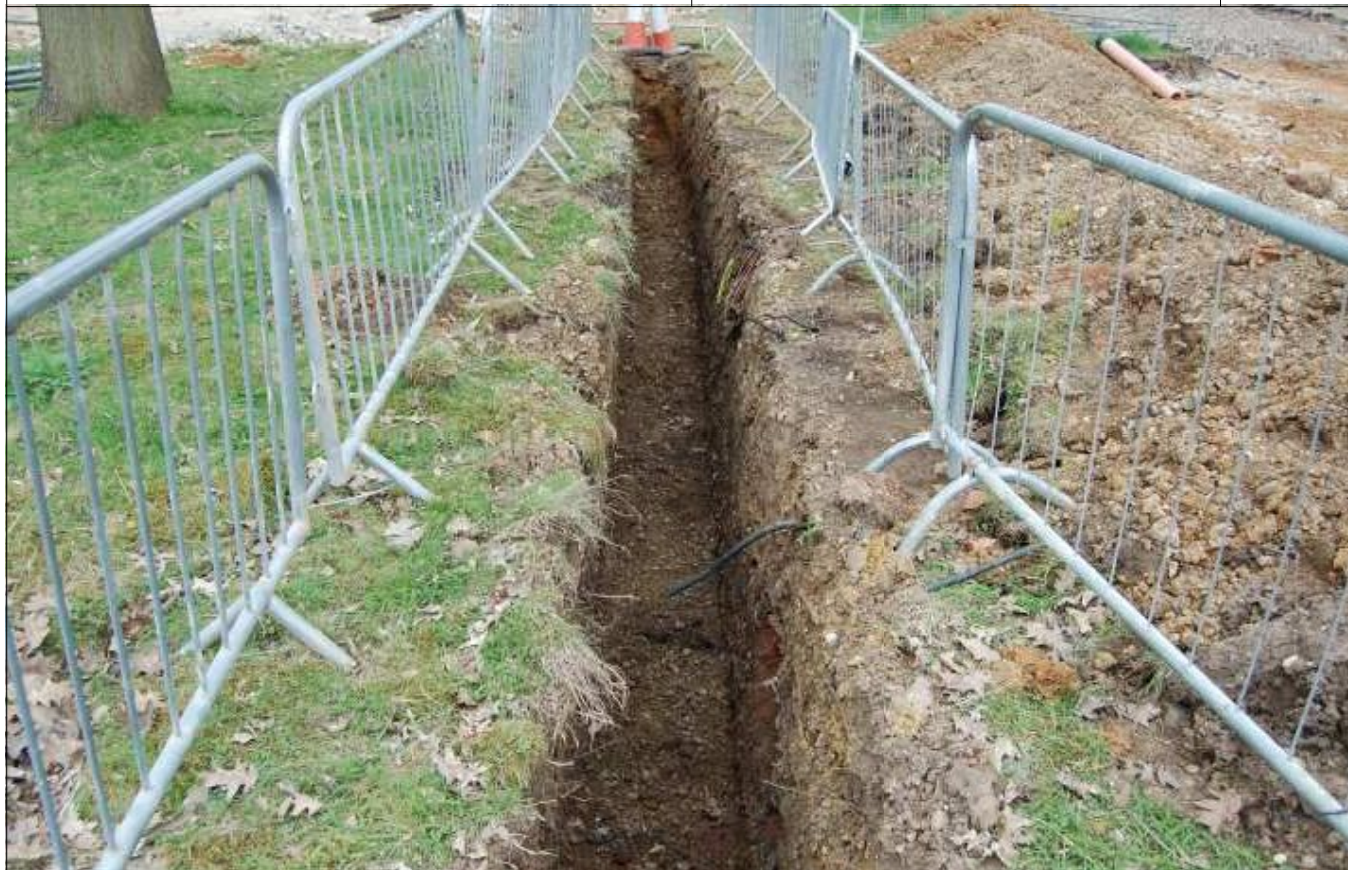
Plate 3: Trench 1, looking NE

2.21 Trench 1 ran north-east to south-west for approximately 36m from an existing road. It measured approximately 0.50m in width and approximately 1m in depth (Plate 3). The exposed sections revealed a layer of dark greyish brown (10YR 4/2) clay/silt with sand and frequent stones, approximately 0.30m in depth (Plate 4). Above this was a layer of tarmac, 0.10m thick, below a deposit of light reddish brown (2.5YR 7/4) sandy silt containing frequent stones, brick and concrete fragments, approximately 0.60m in depth. Lenses of modern brick rubble were also present. The underlying natural was not reached in the trench.

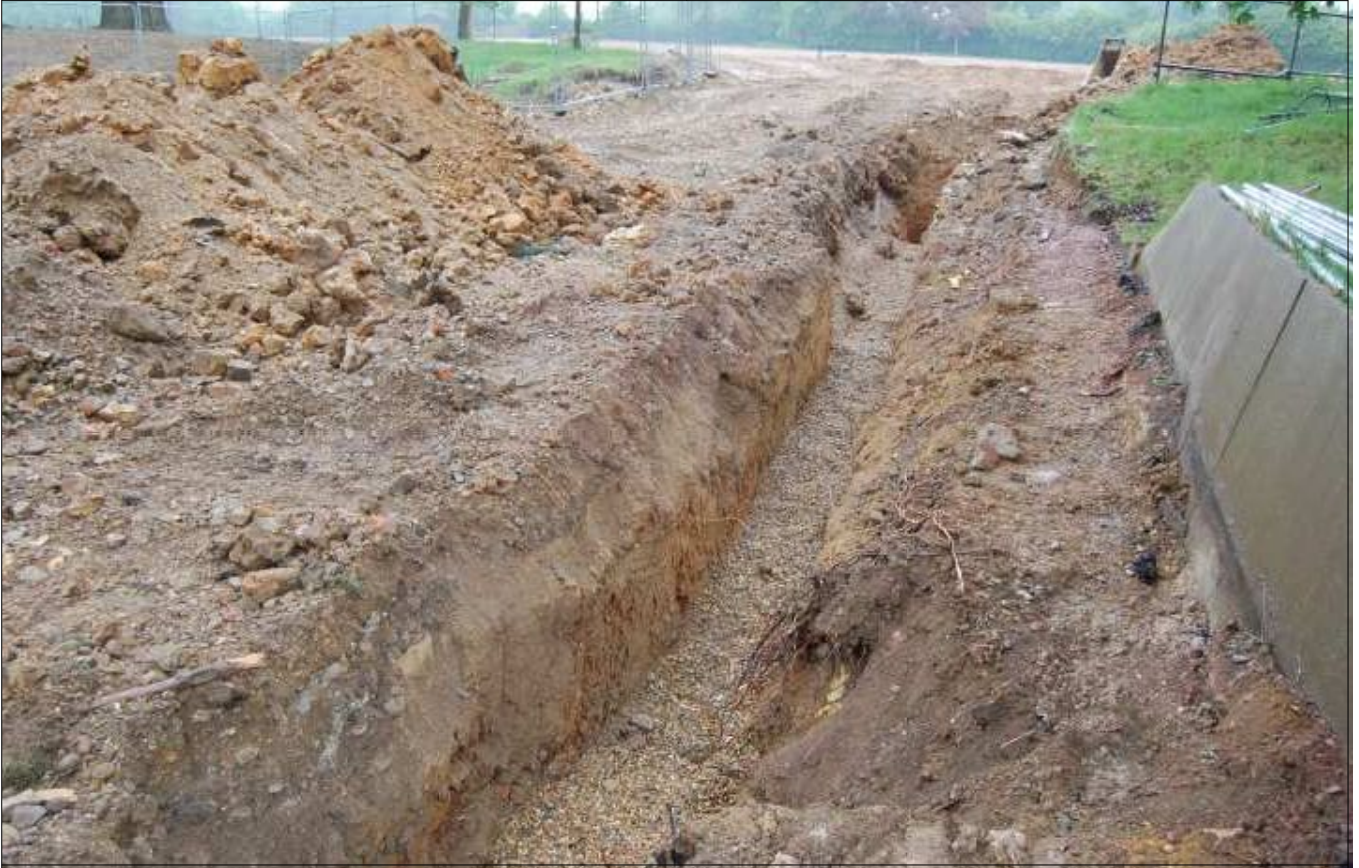
Plate 5: Trench 2, looking NW

2.23 Trench 2 was located to the west of Trench 1 and ran north-west to south-east, following the line of an existing road, the surface of which had been removed prior to the monitoring visit. The trench measured approximately 51m in length and over 1m in depth. It varied between 0.50m and 4.5m in width. The stratigraphy in the sections comprised a layer of dark greyish brown (10YR 4/2) clay/silt with sand containing frequent stones and brick and concrete fragments, 0.20m in depth, above the reddish brown natural clay (Plate 5).

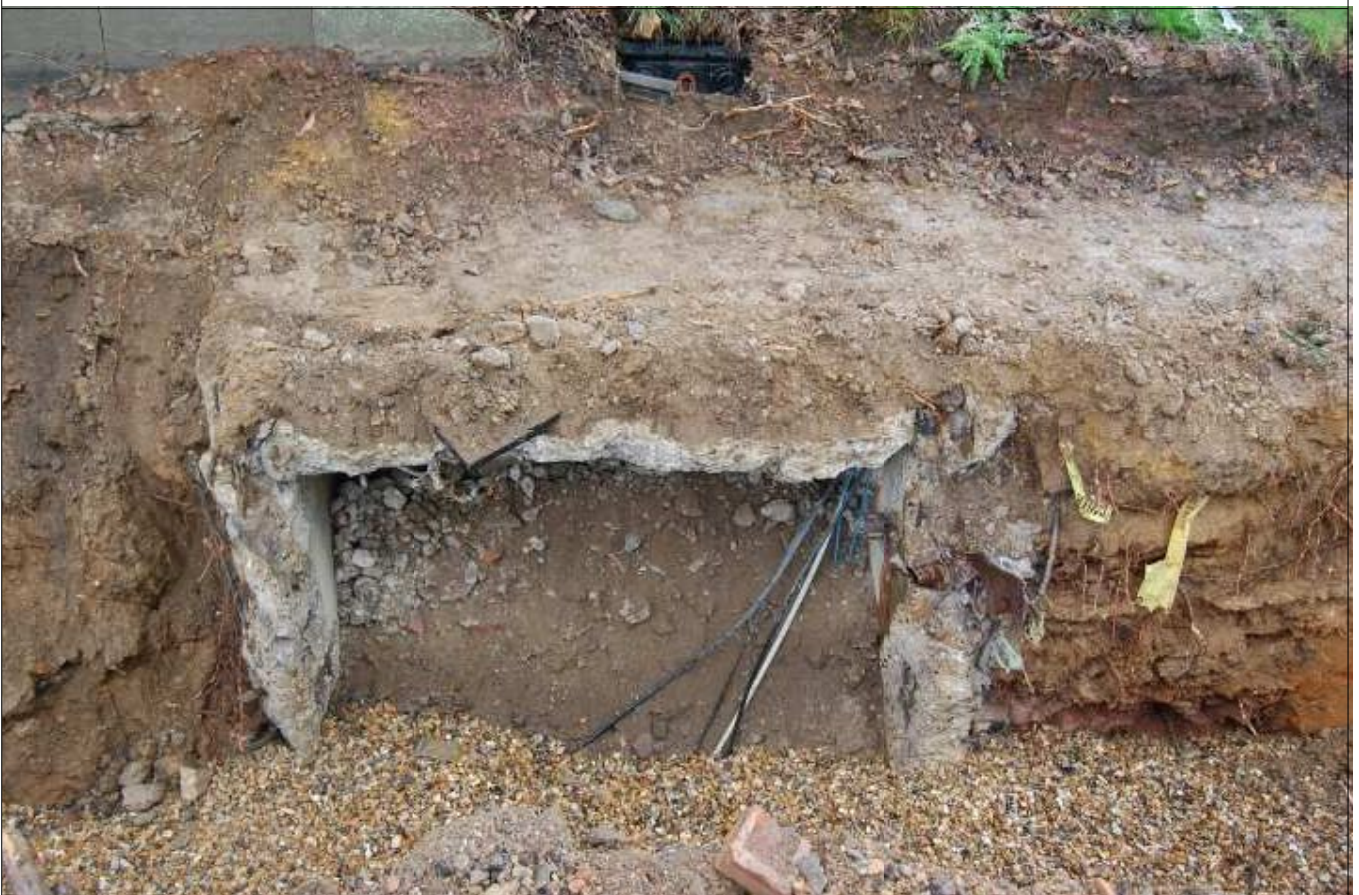
Plate 6: Trench 2, tunnel or duct exposed in the trench, looking SE

2.24 A buried tunnel or duct, of probable World War II date, was encountered in the trench at 18.06m from the south-western end of the trench, at a depth of approximately 0.20m below the present ground surface (Figure 3). It was constructed of reinforced concrete, approximately 0.20m thick, and measured approximately 1.20m in width (Plate 6). Cables and a possible air vent pipe were observed on the south-western side. The full height of the feature was not exposed in the trench.

2.25 The cut for the construction trench for the tunnel was visible at approximately 1m to either side. It sloped steeply inwards and had been backfilled with brick rubble at the lower level, with redeposited natural clay above (Plate 6). The tunnel had apparently been backfilled with stony dark greyish brown (10YR 4/2) clay/silt with sand. The course of the tunnel, which was previously known, continues to the north-west, before turning to run south-west.

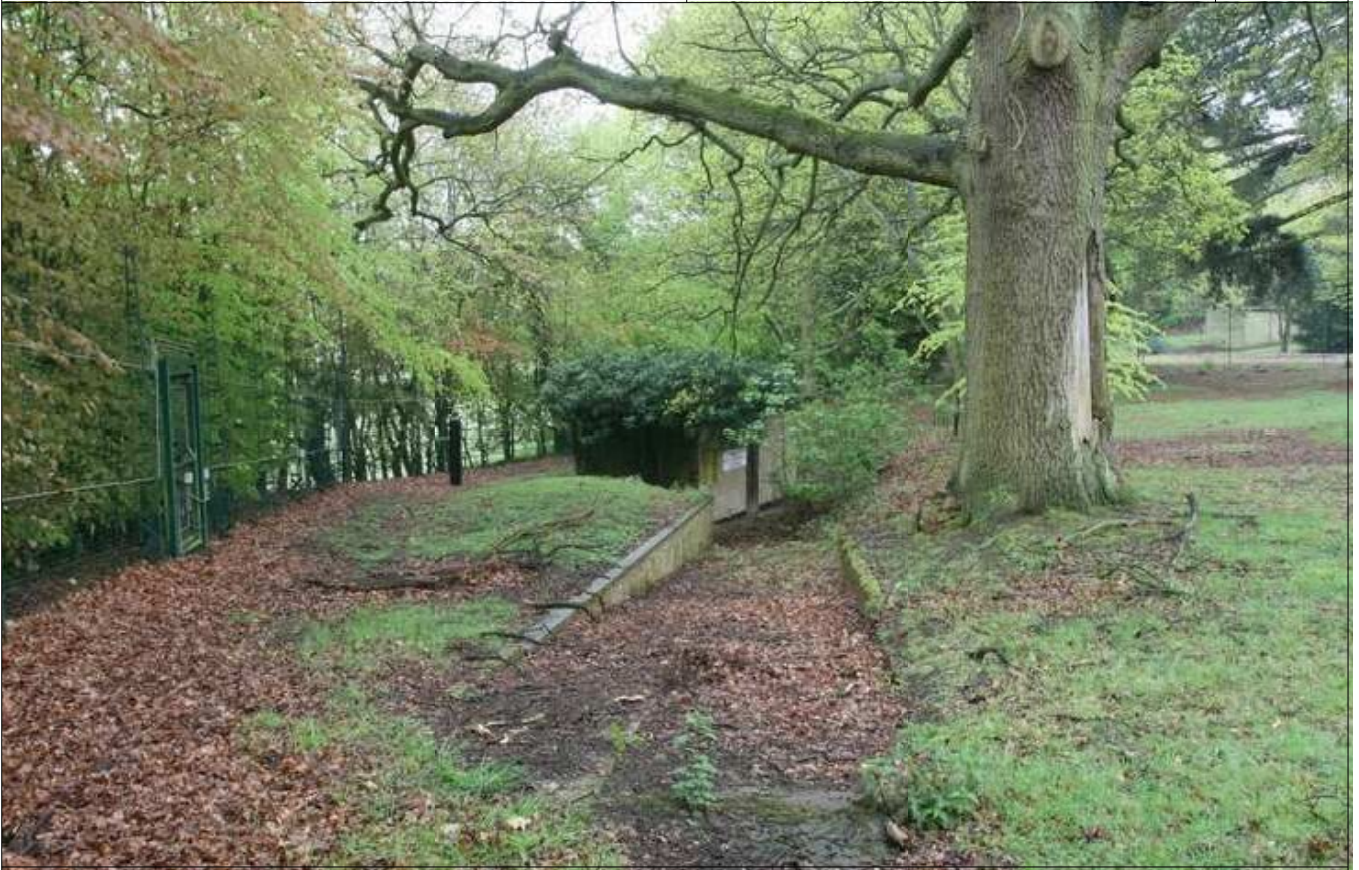
Plate 7: Concrete ramp to Building 101 / 7A, looking SE

2.29 The building is accessed via a sloping concrete ramp on its northern side, with retaining walls formed of Fletton bricks (Plate 7). The ramp bends to the east at the bottom, possibly as a precaution against blast.

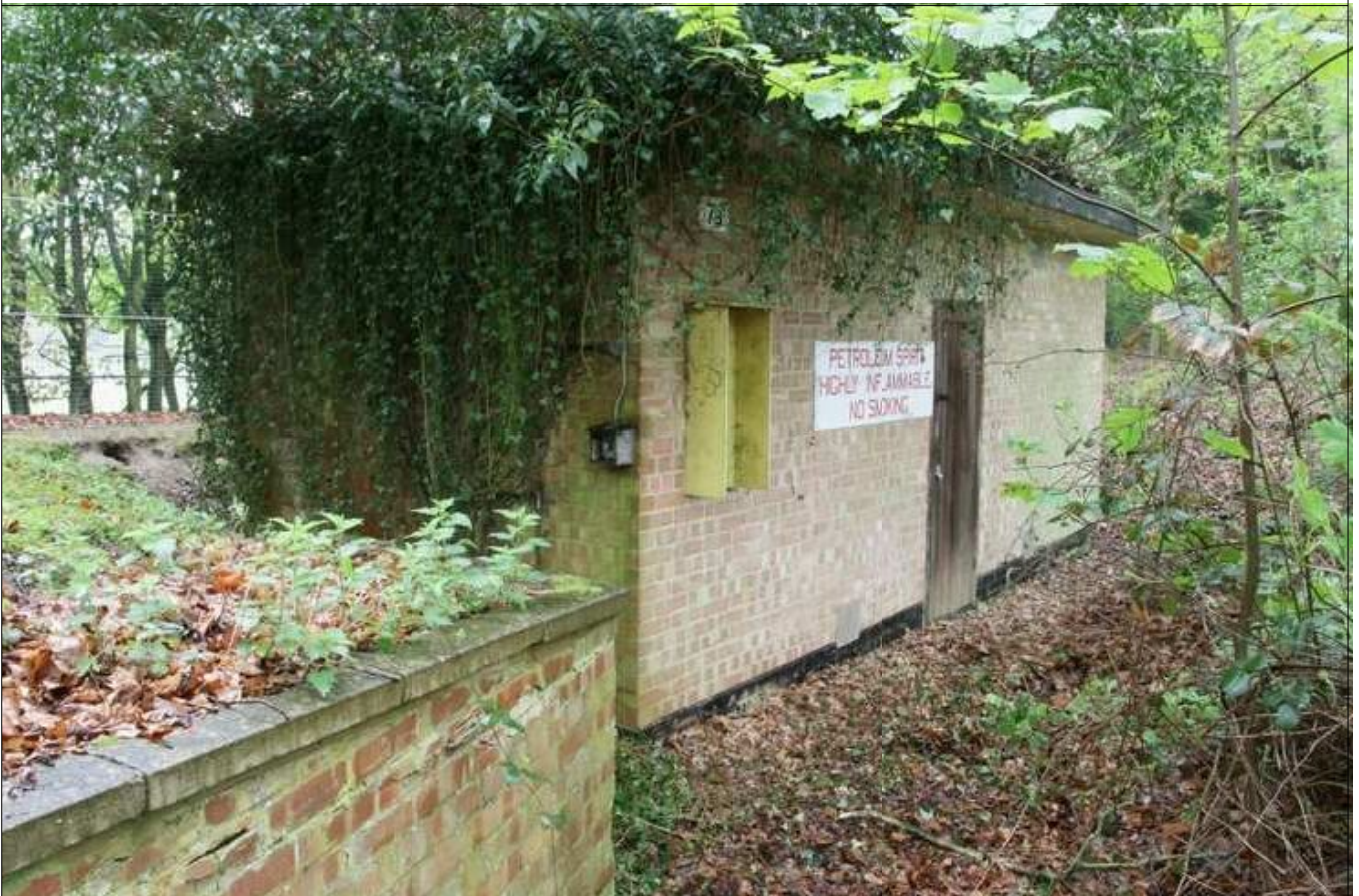
Plate 8: Building 101/7A, NW elevation

2.30 Building 101 is a rectangular single storey structure, built of Fletton bricks, with a braced and ledged wooden door in the centre of the north-west elevation and a flat reinforced concrete roof which extends beyond the walls of the building (Plate 8). The building is numbered '7A' on the north-west elevation. A sign on the same wall carries a warning about petroleum spirit.

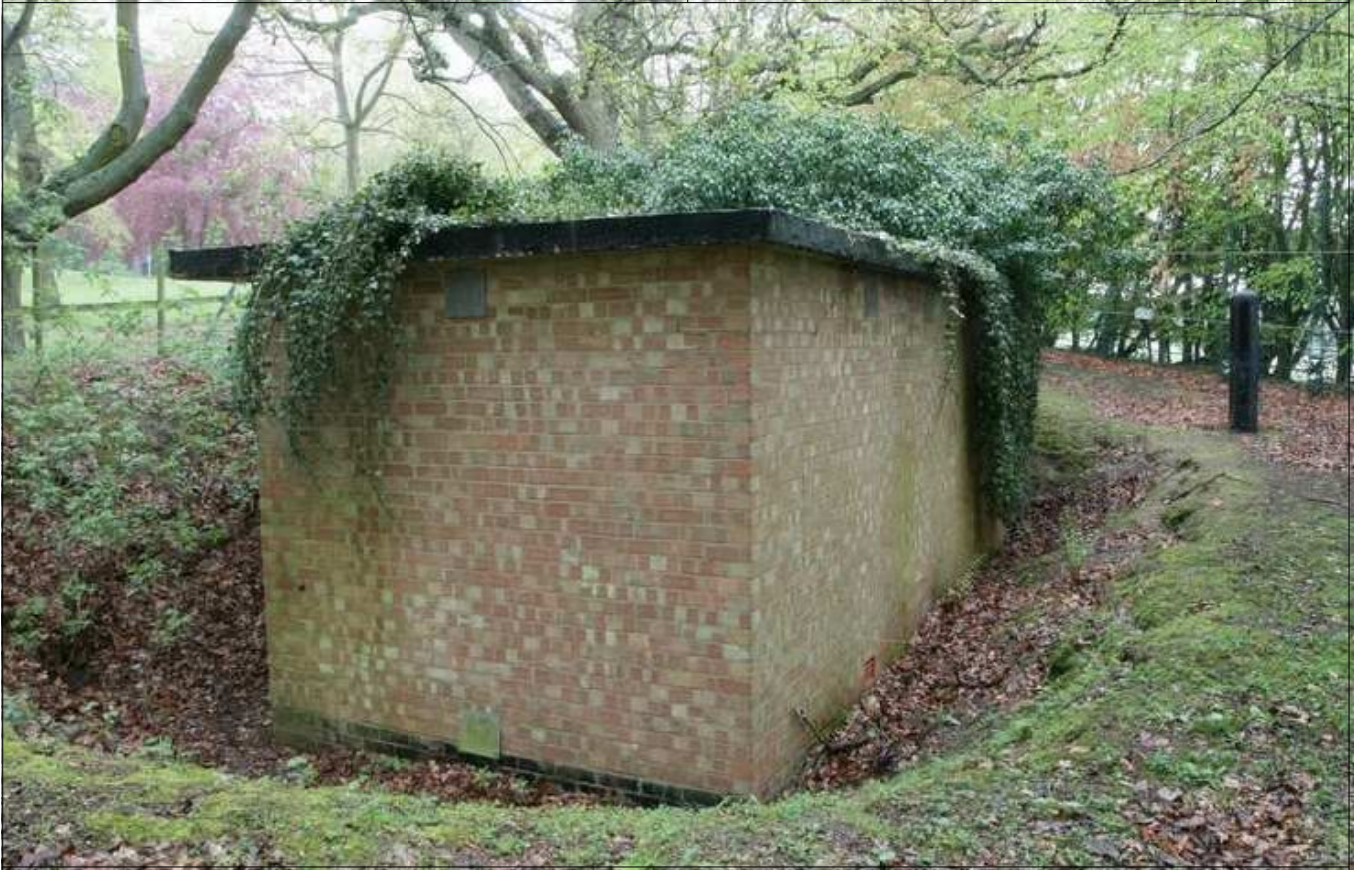
Plate 9: Building 101/7A, SW & SE elevations, looking N

2.31 The other elevations have no openings, apart from vents at eaves and ground level (Plate 9).

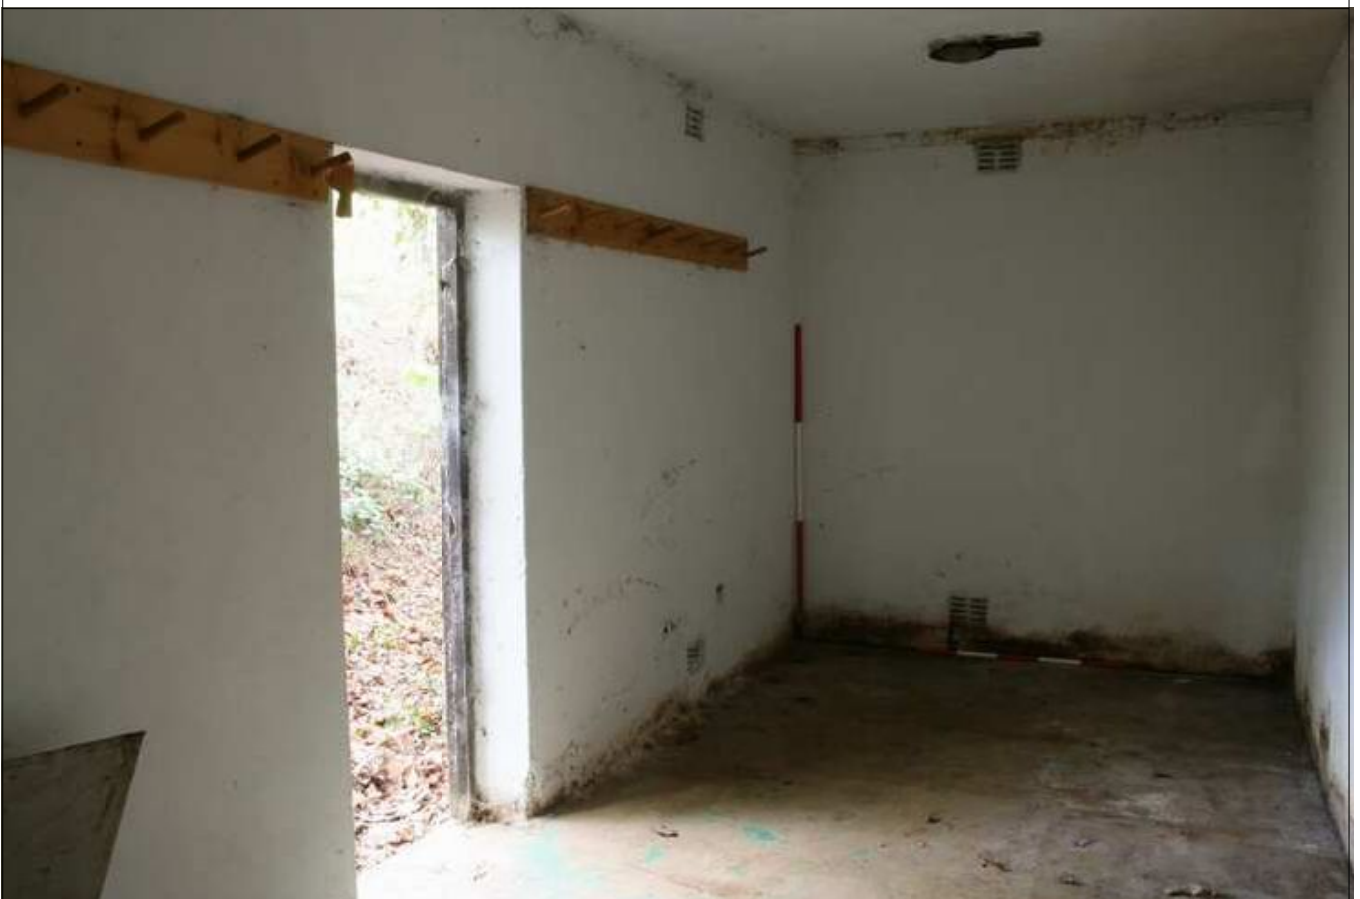
Plate 10: Building 101/7A interior, looking NE

2.32 The interior consists of one room, measuring 6.07m in length, 2.40m in width and 2.59m in height, with whitewashed walls (Figure 4). A timber batten, with wooden pegs, runs along the east elevation at door top height. Vents are set in the walls at ground and ceiling level. An original light fitting survives in the centre of the ceiling (Plate 11).

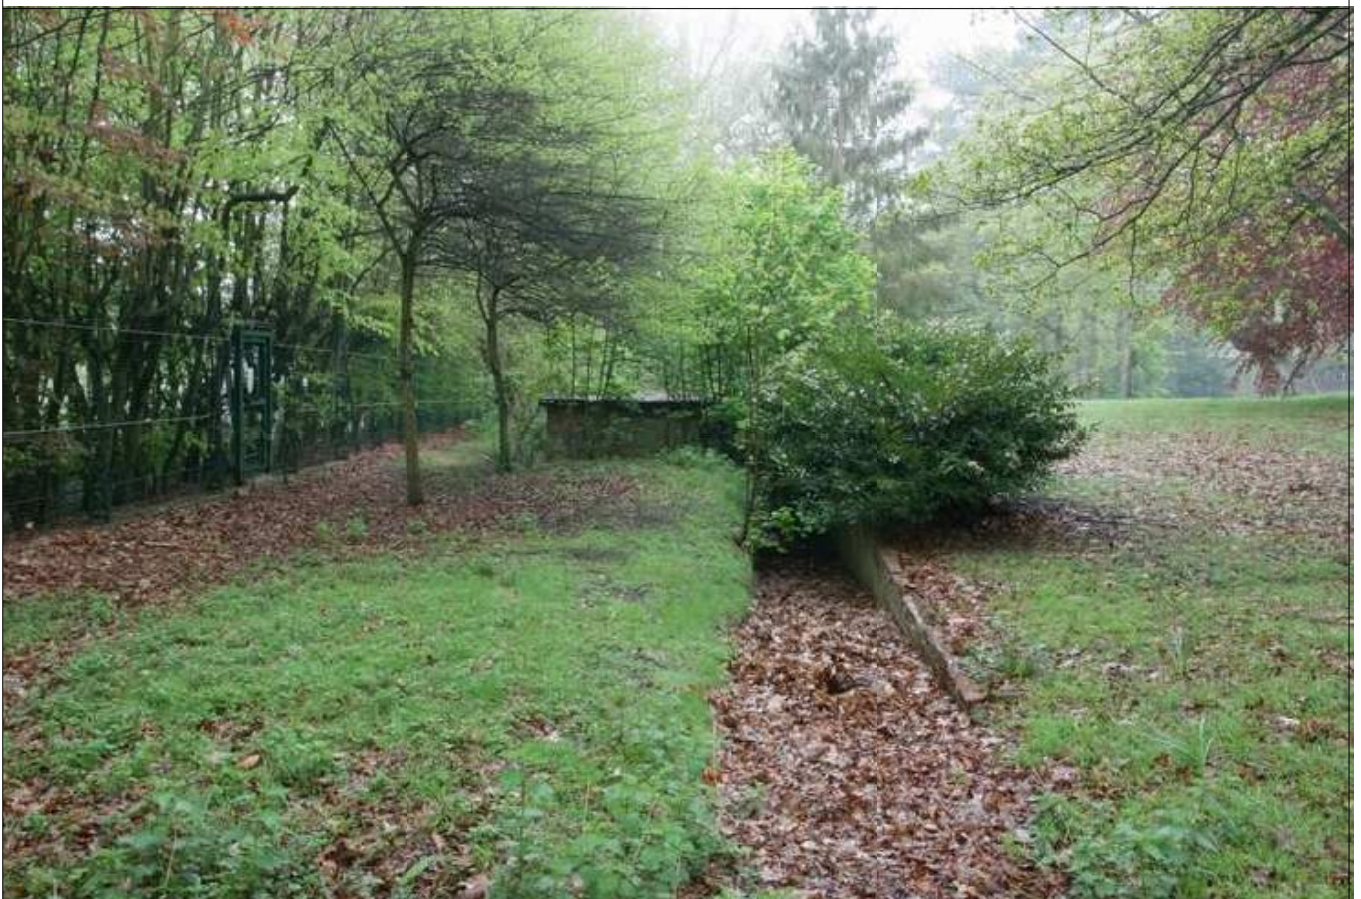
Plate 12: Access ramp to Building 102/8A, looking SE

2.34 Building 102, which is numbered 8A on the north-west elevation, is located along the eastern boundary of the site to the north of Building 101/7A, centred on TL 2272 1496. It is accessed via a sloping concrete ramp on the northern side, with retaining walls in Fletton brick (Plate 12). As with Building 101/7A the ramp bends eastwards at the bottom.

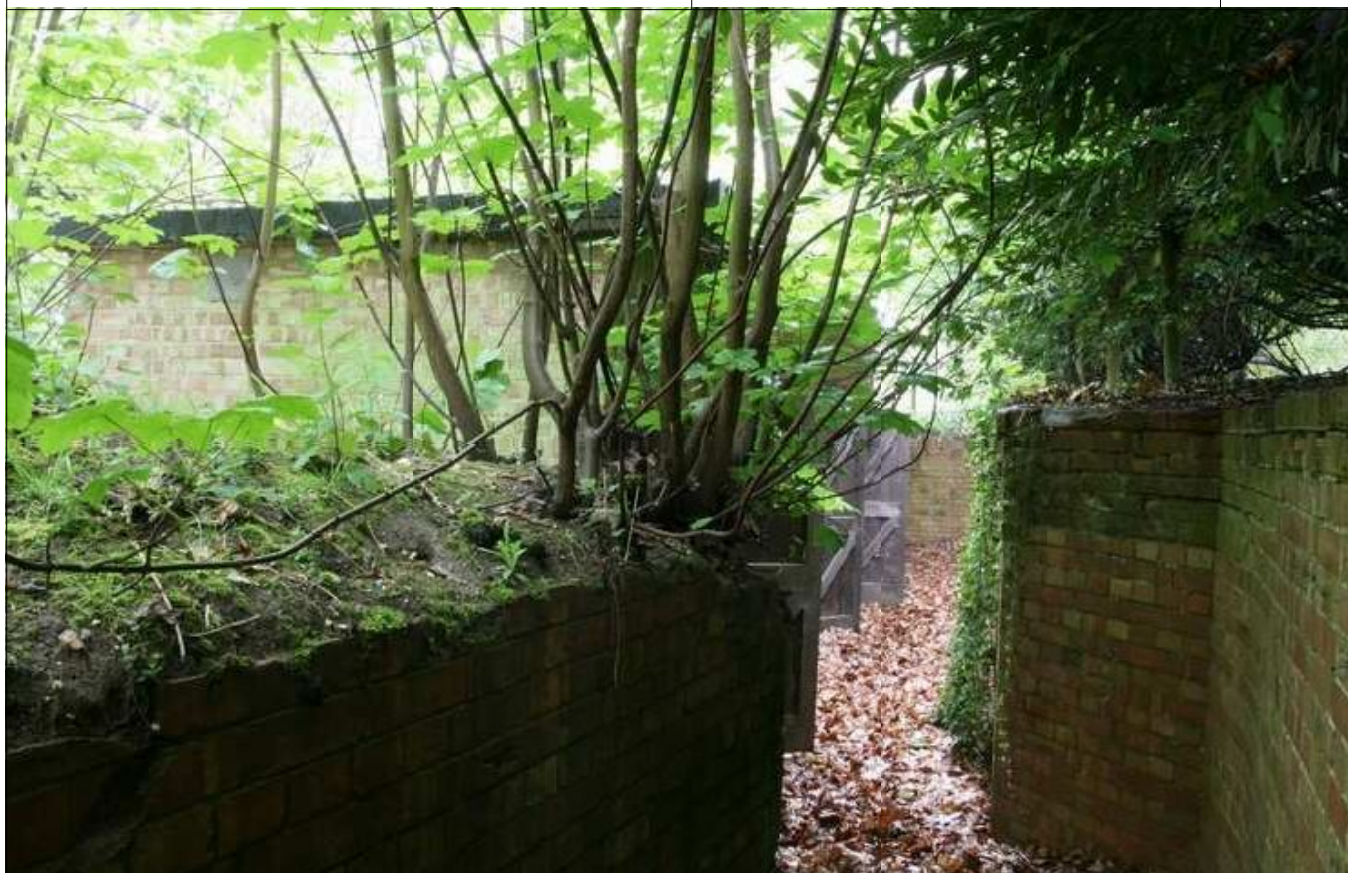
Plate 13: Building 102/8A, detail of retaining wall, looking S

2.35 The building is a rectangular single storey structure, built of Fletton bricks, set below ground level within an enclosure protected by retaining walls, 2m in height and 0.10m in width, formed of Fletton bricks (Plate 13). The roof is flat and of reinforced concrete.

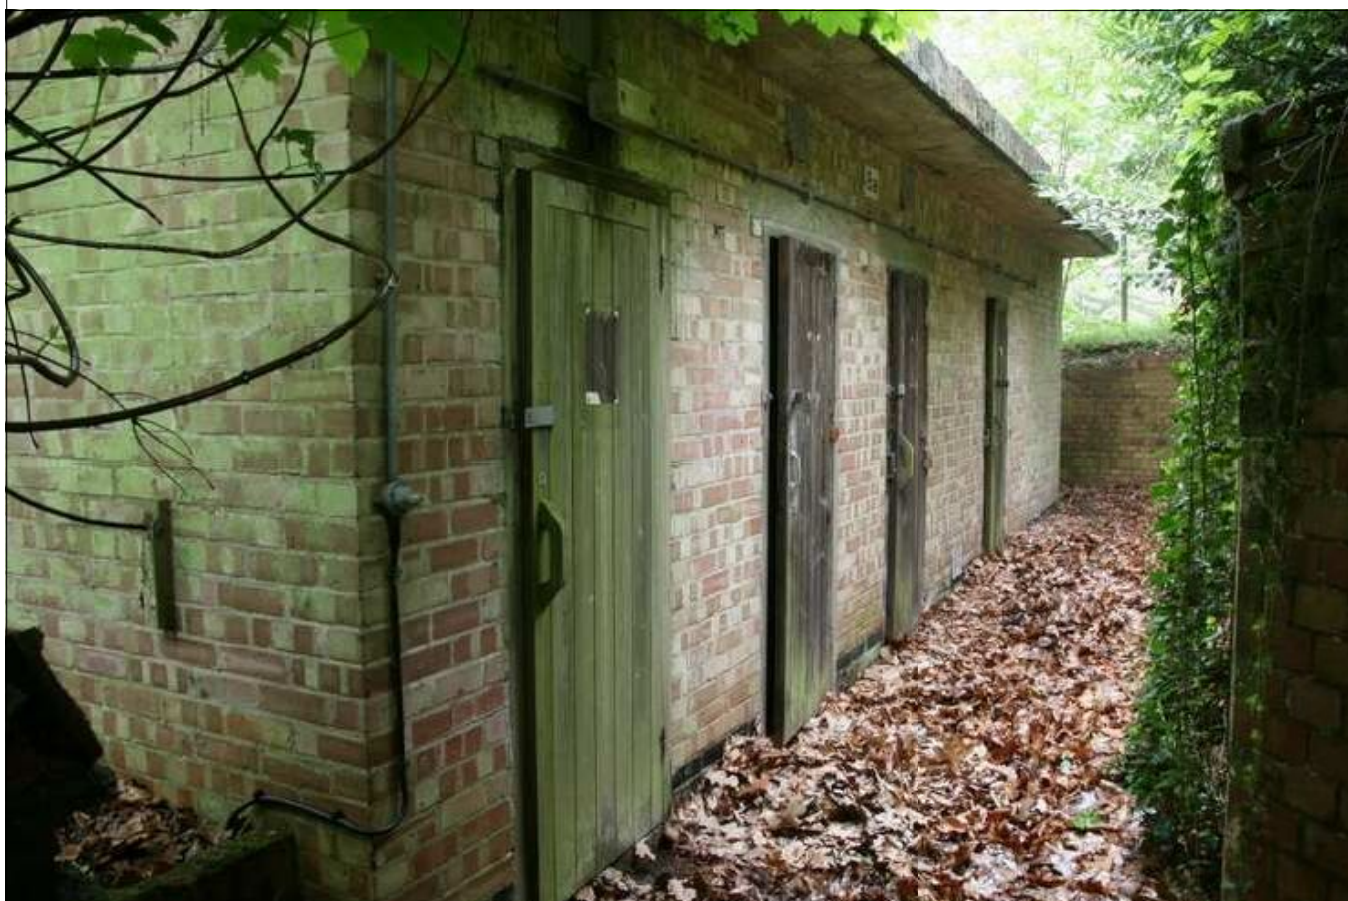
Plate 14: Building 102/8A, NW elevation, looking SSW

2.36 The north-west elevation has four doorways, the northern three are at regular intervals, with a larger gap to the southern doorway (Plate 14). The door jambs are of wood, with concrete lintels above. The doors are of wood and are ledged and braced on the interior (Plate 15). Small vents, measuring 0.22m by 0.26m are located above each doorway, just below the roof overhang. Similar vents have been inserted into the three other elevations, but there are no other openings in the building (Plate 16).

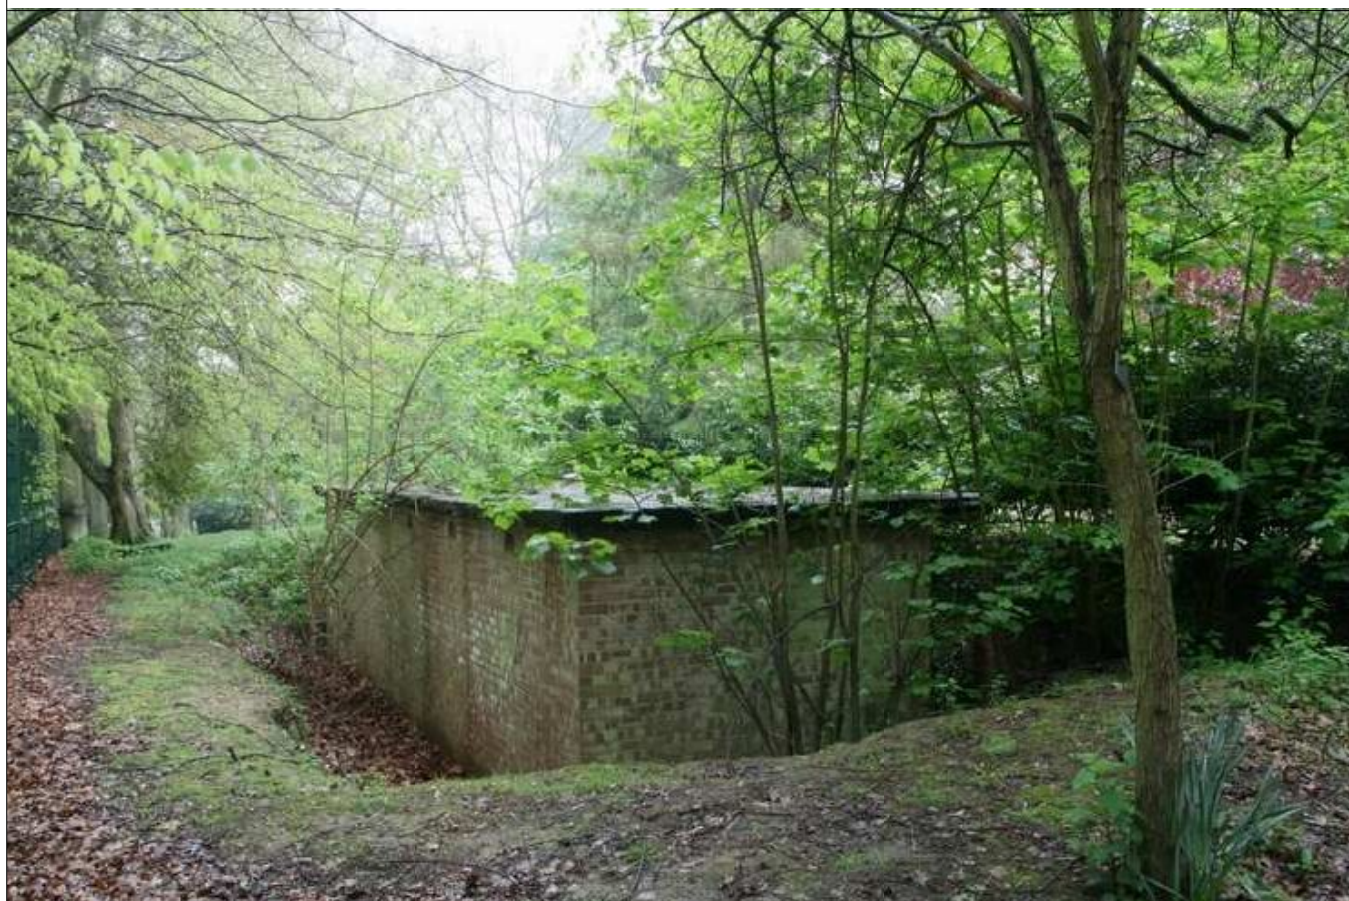
Plate 16: Building 102/8A NE & SE elevations, looking SSW

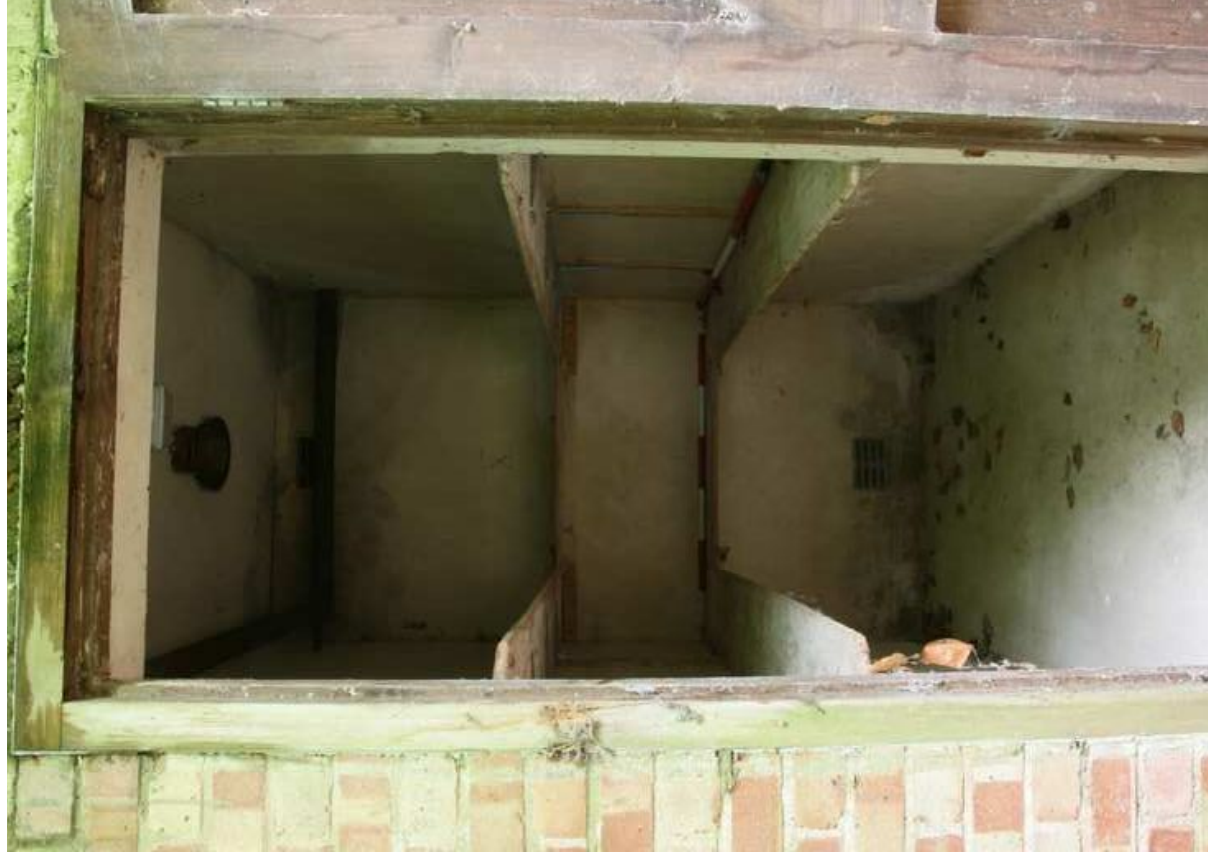
Plate 17: Building 102/8A, looking into Bay 1

2.37 Internally the building is divided into four bays, numbered 1-4 from the north-east, each with a door in the north-west elevation (Figure 5). The three northern bays measure 2.40m x 1.35m and 2.56m floor to ceiling. Two shelves run around each side of these bays (Plate 17).

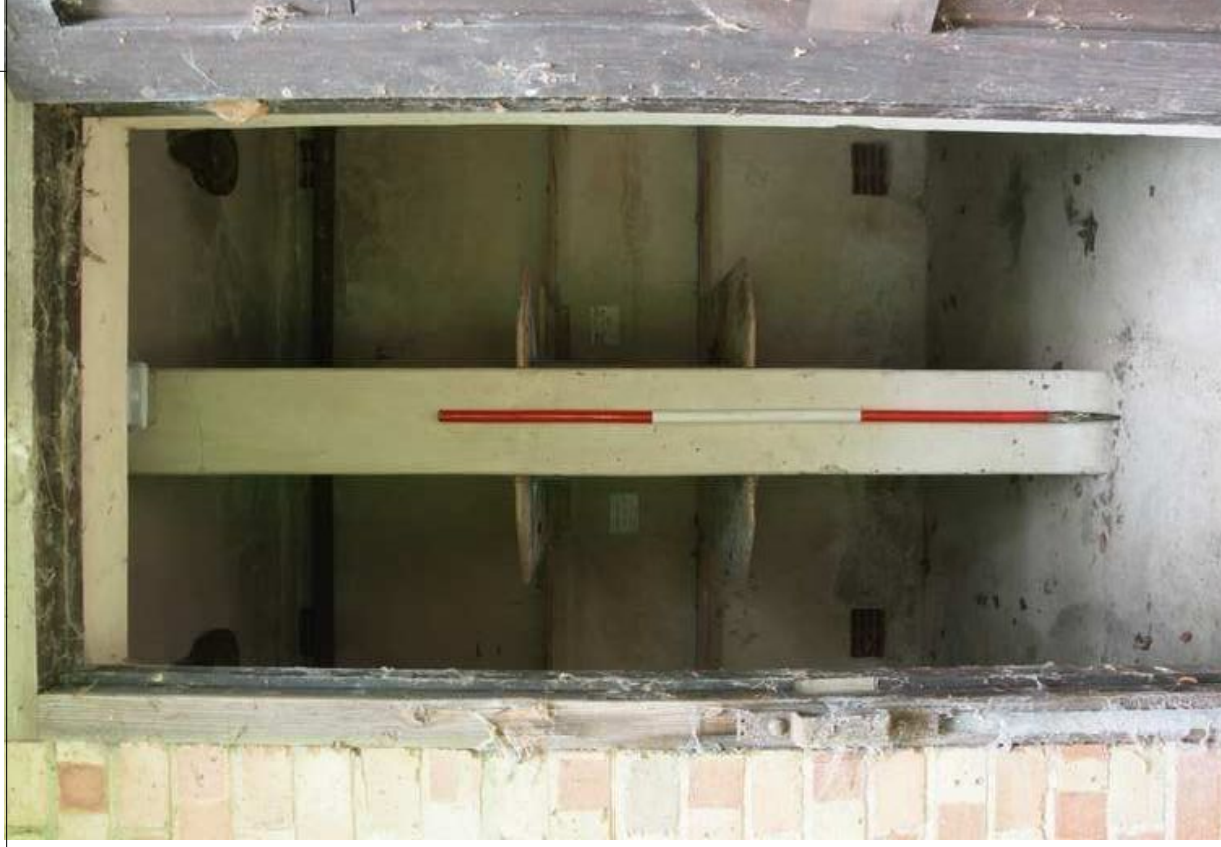
Plate 18: Building 102/8A, Bay 4 interior, looking E

2.38 The southern bay is sub-divided into three small compartments, 1.35m in width, with a narrow passage, 0.88m in width, on the north-western side. The dividing walls measure 1.53m in length and 0.25m in width and support shelves in each compartment (Plate 18).
