**NORTHWOOD PREPARATORY SCHOOL
Moor Park, Rickmansworth, Herts.**

HN639

Archaeological Monitoring Report

Report no.414

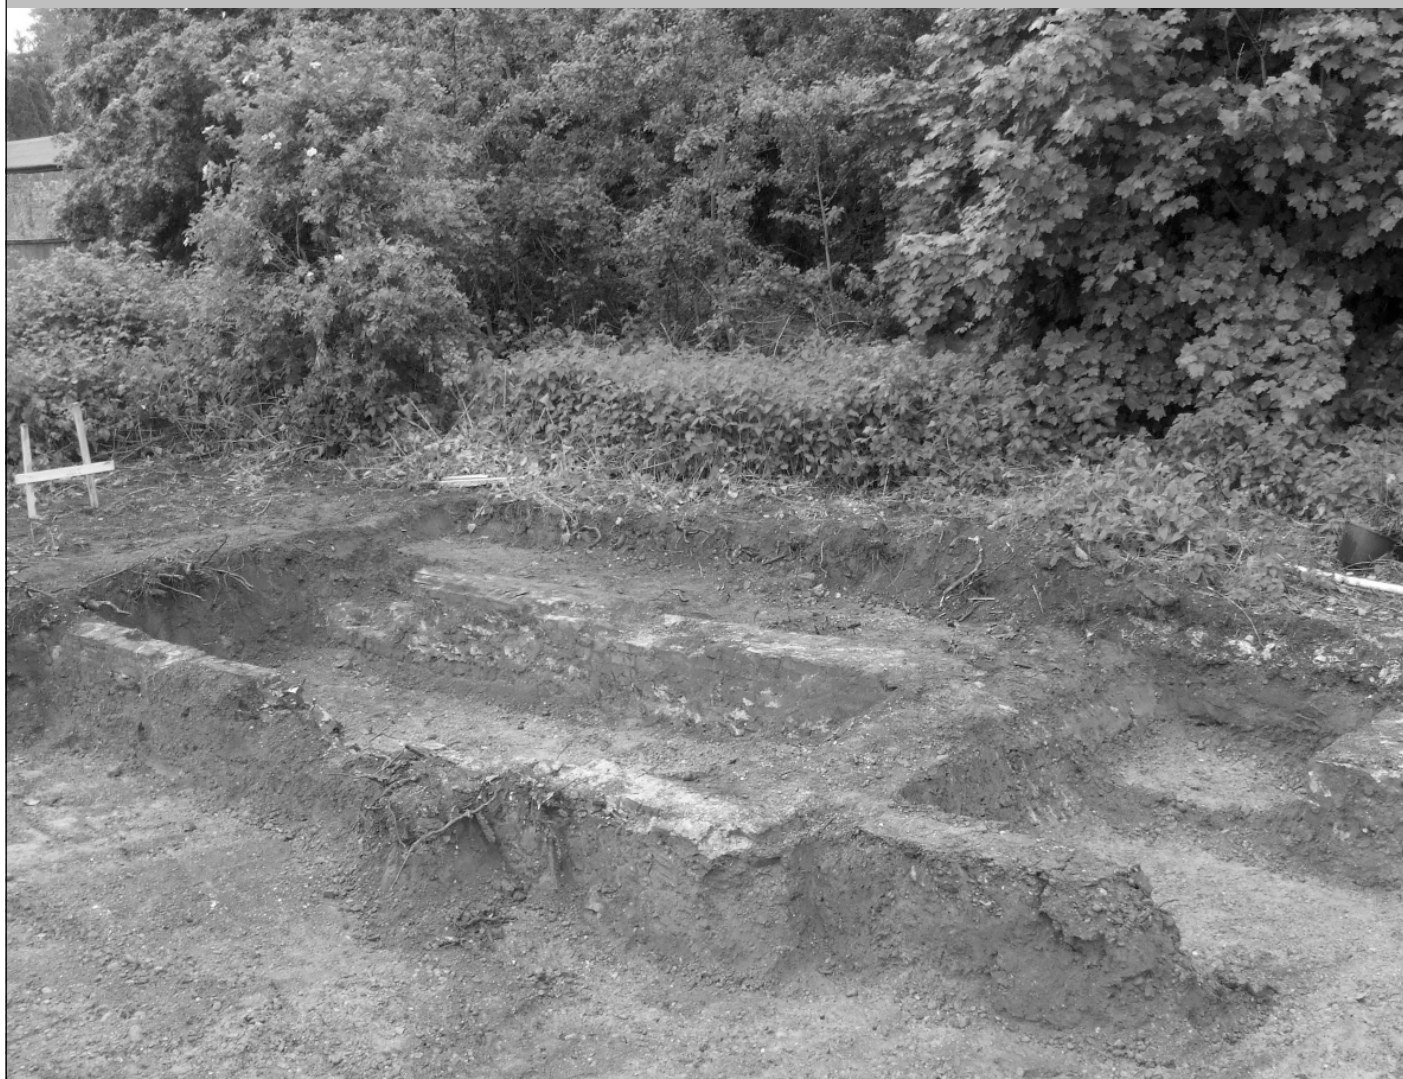
The cover photograph shows Walls 1,2 4 and 5, looking south-east

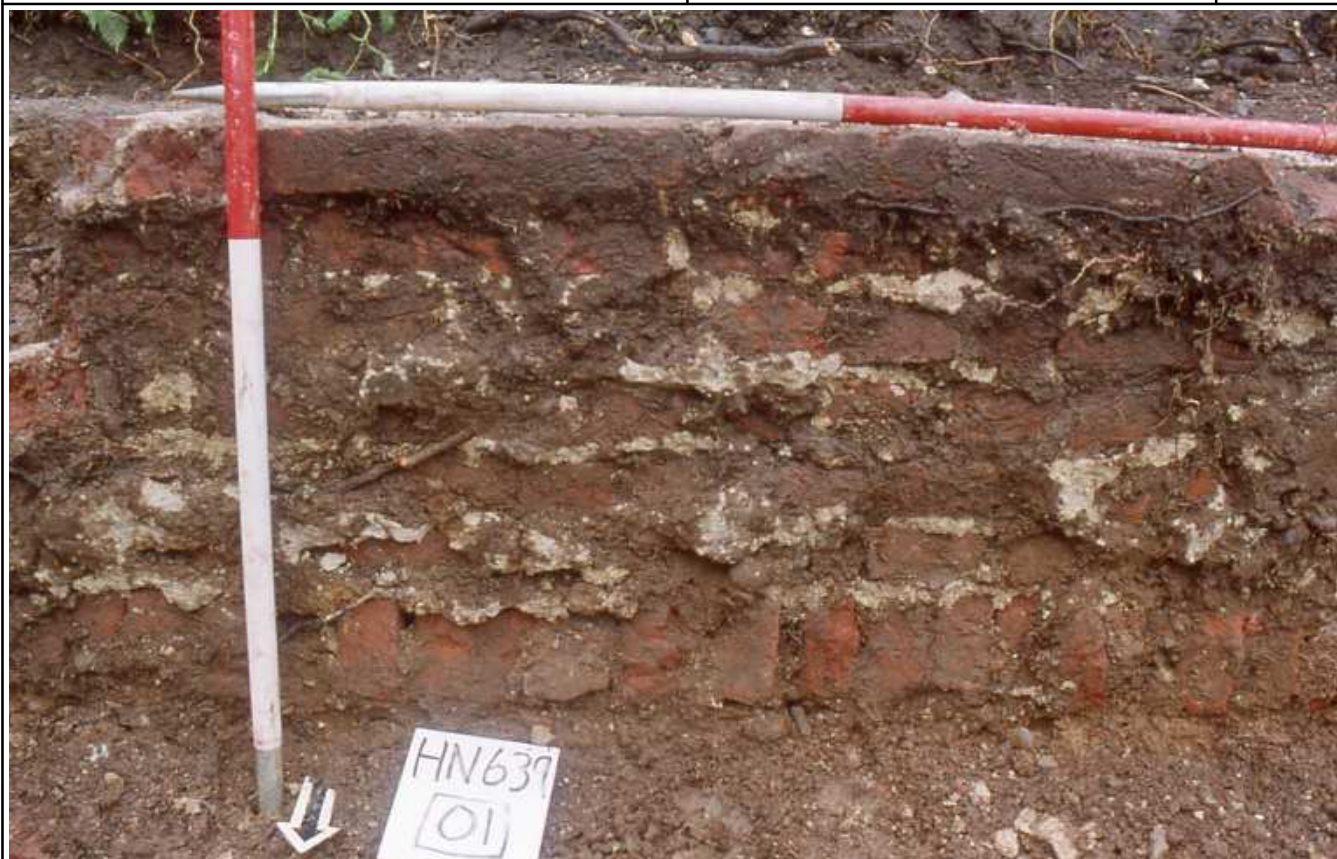
Plate 1: Wall [01] looking south

- Wall [01] was orientated east-west and measured 0.59m (5 brick-widths or 2') in width, and over 6.16m in length (Plates 1 & 5). This wall survived to seven courses high (0.57m) with a yellow brown lime mortar. The base course consisted of a foundation layer of headers laid on edge, above which the bricks were laid in stretcher bond. The wall

continued eastwards under the baulk and was clearly truncated and 'robbed' out at its western end. It was substantial and well constructed, similar in nature to wall [02]. The reddish brown bricks were poorly fired and measured 220mm (8¾") long, 105mm (4¼") wide and 60mm (2½") thick.

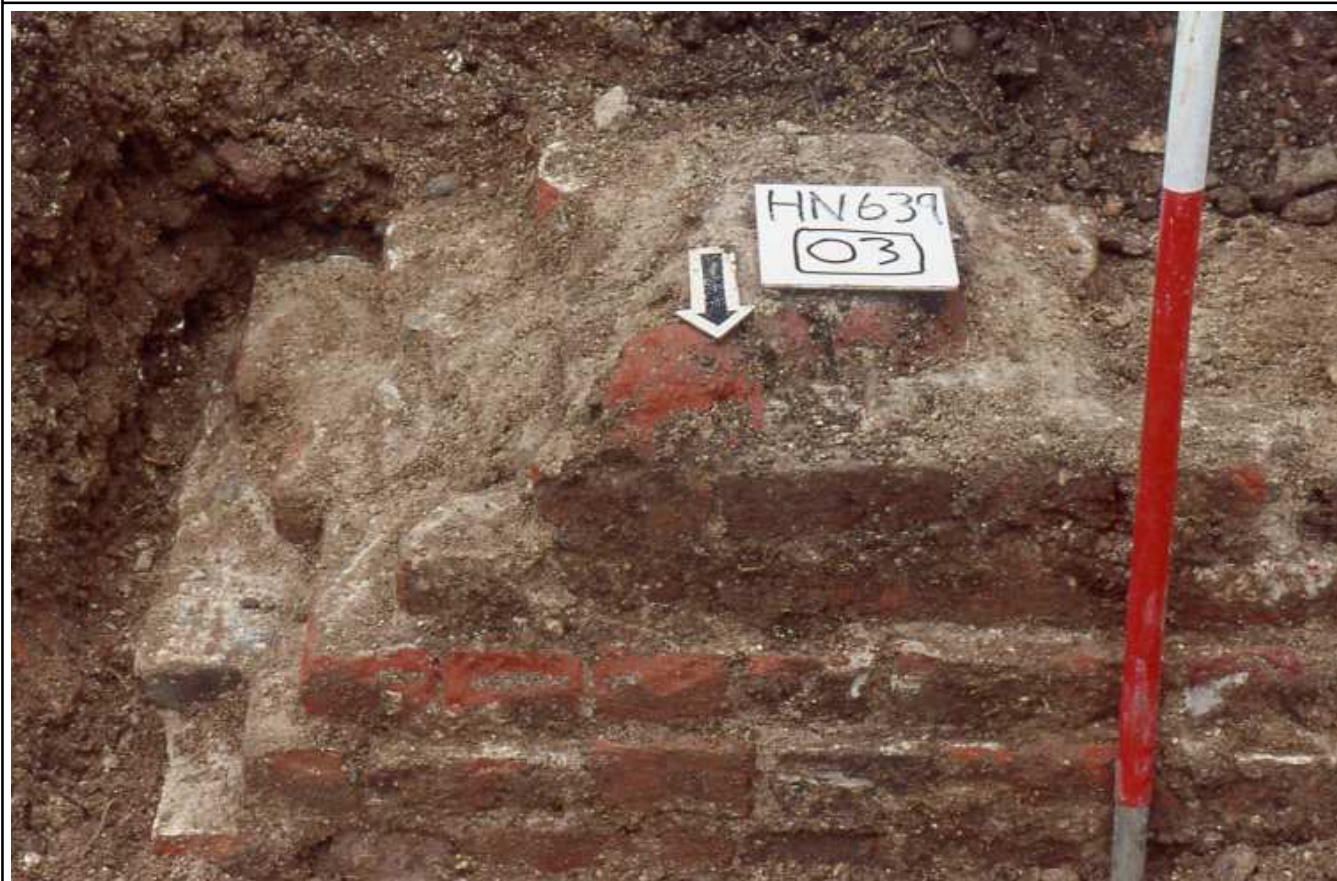
Plate 2: Wall [03] looking south

- Wall [03] was orientated east-west and measured 0.63m in width, 5.92m in length and survived to a height of five courses (0.36m), mainly in stretcher bond with a yellowish white lime mortar (Plates 2 & 7). It was truncated at either end. This wall was well constructed and appears to be later than the walls [02] and [03]. It may represent a rear boundary wall. The bricks measured 215mm (8½") long, 110mm (4½") wide and 65mm (2½") thick.

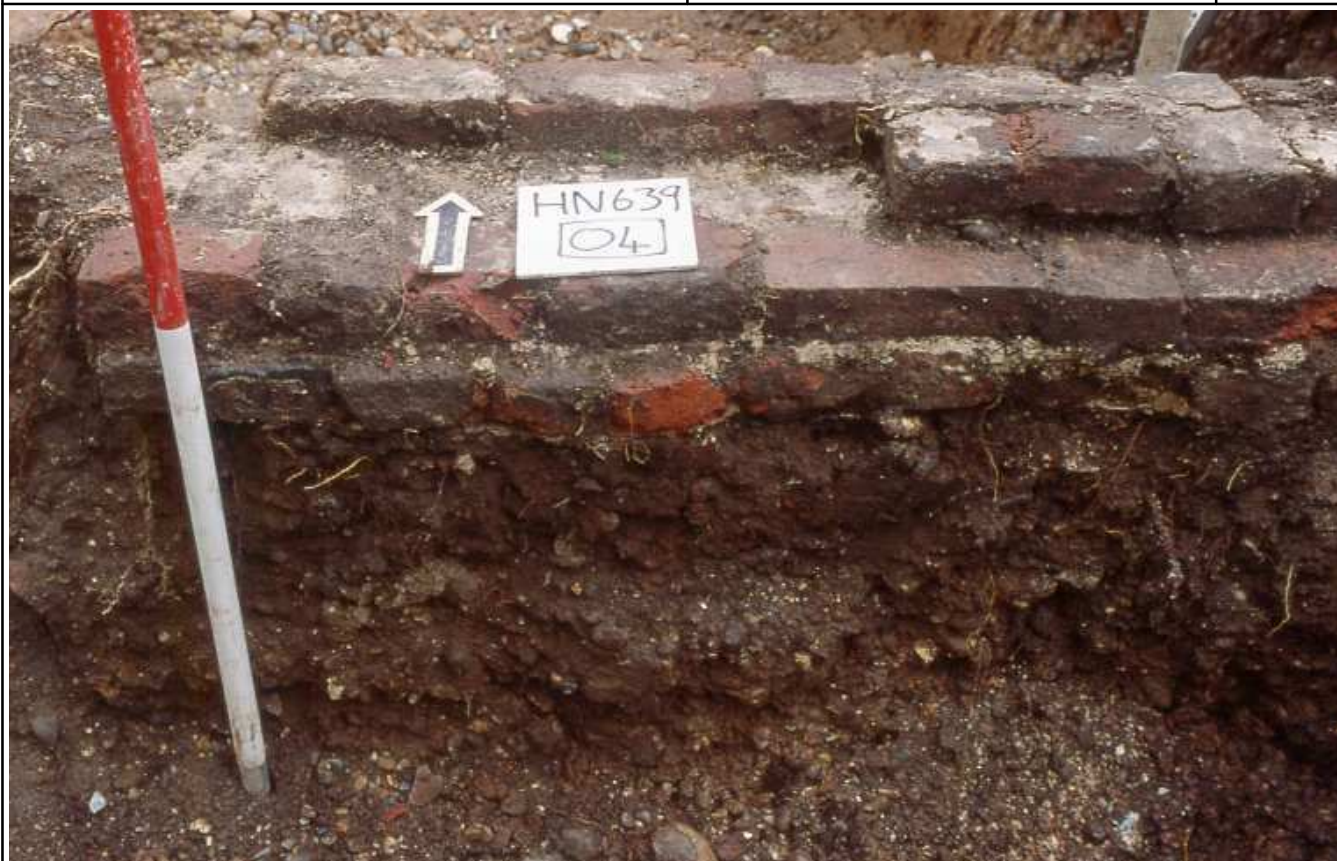
Plate 3: Wall [04] looking north

- Wall [04] was orientated east-west, broadly parallel to wall [01], and measured 0.33m in width, over 6.14m in length and survived to a height of three courses (0.17m), but only a single course remained at the western end (Plates 3 & 8). The wall continued eastwards under the baulk and appear to turn southwards at the western end to join onto wall [05], though it was clearly truncated and 'robbed' out in this location. It was poorly constructed, loosely bonded with yellow brown lime mortar, and was highly disturbed by tree roots. The reddish brown bricks were poorly fired and measured 215mm (8½") long, 105mm (4¼") wide and 60mm (2½") thick.

2.10 All the walls appeared to have been affected by tree root activity, particularly wall [04] which had been badly damaged and undermined.

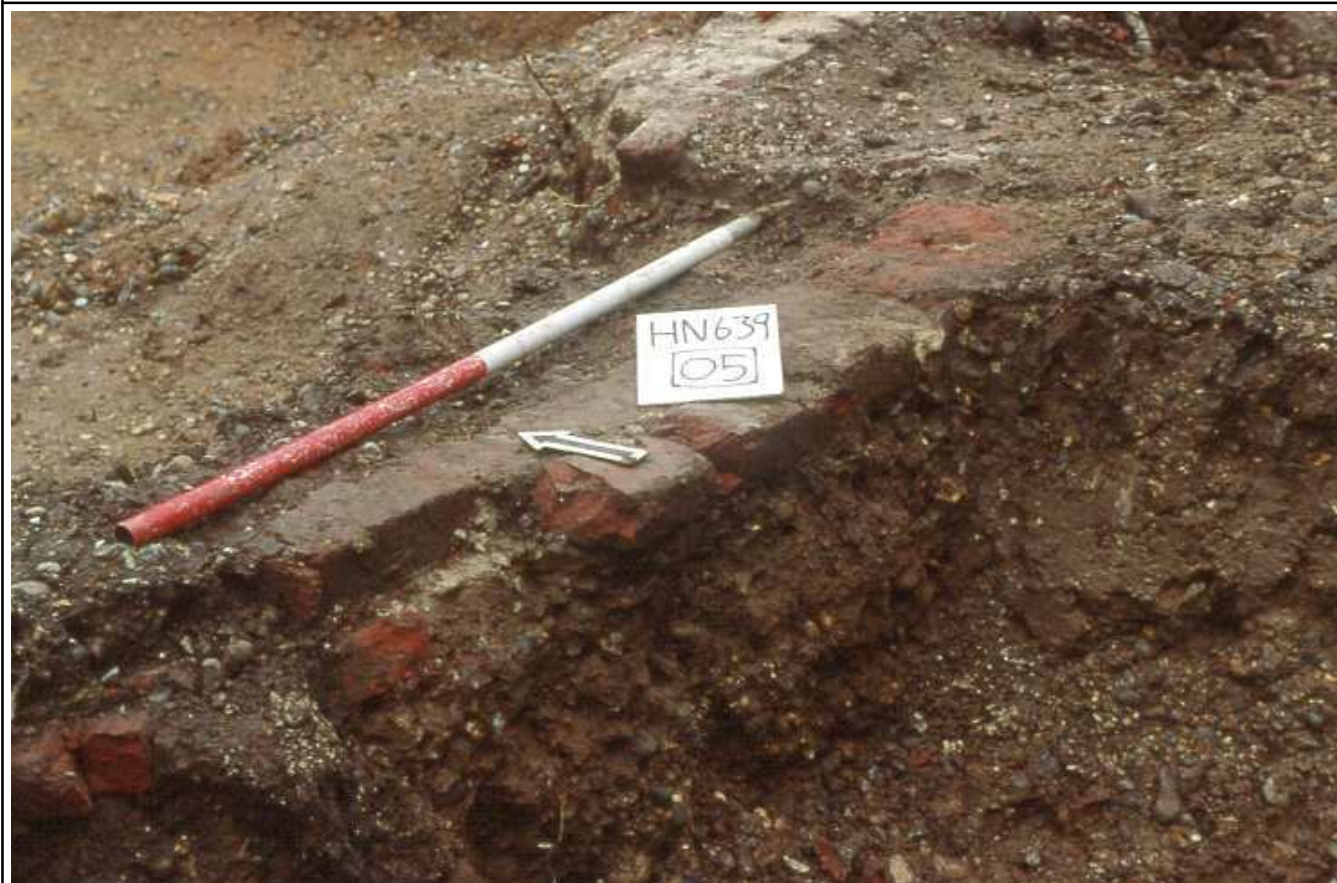
Plate 4: Wall [05] looking north-east

- Wall [05] was orientated east-west and measured 0.23m in width, and 1.26m in length and survived to a height of one course (0.06m) (Plate 4). The western end was apparently truncated and the ground later consolidated. It lies to the south-west of wall [04], with its eastern end starting in line with the western end of wall [04]. The reddish brown bricks were poorly fired and measured 220mm (8¾") long, 110mm (4½") wide and 60mm (2½") thick.

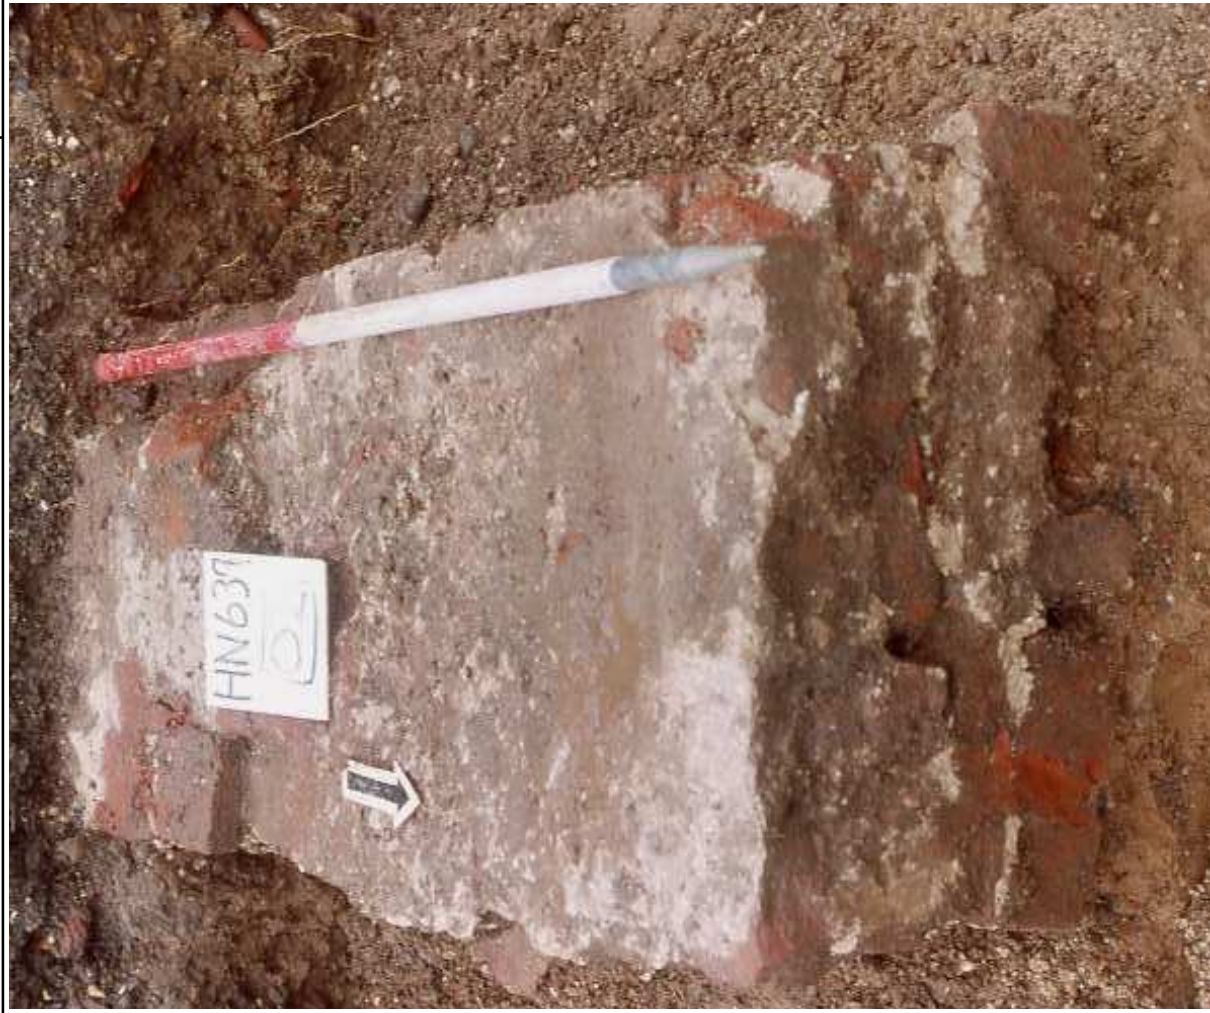
Plate 6: Wall [02] looking south

- Wall [02] was orientated north-south and measured 0.59m (5 brick-widths or 2') in width, over 1.23m in length and survived to a height of four courses (0.37m) in stretcher bond with a yellow brown mortar (Plate 6). It continued southwards under the baulk and would undoubtedly have butted onto wall [01] at right angles before that wall was 'robbed' out. The reddish brown bricks were poorly fired and measured 230mm (9") long, 110mm (4½") wide and 60mm (2½") thick.
