**61A MAIN ROAD
Gidea Park, Romford**

HN594

Historic Building Record

Report no.377

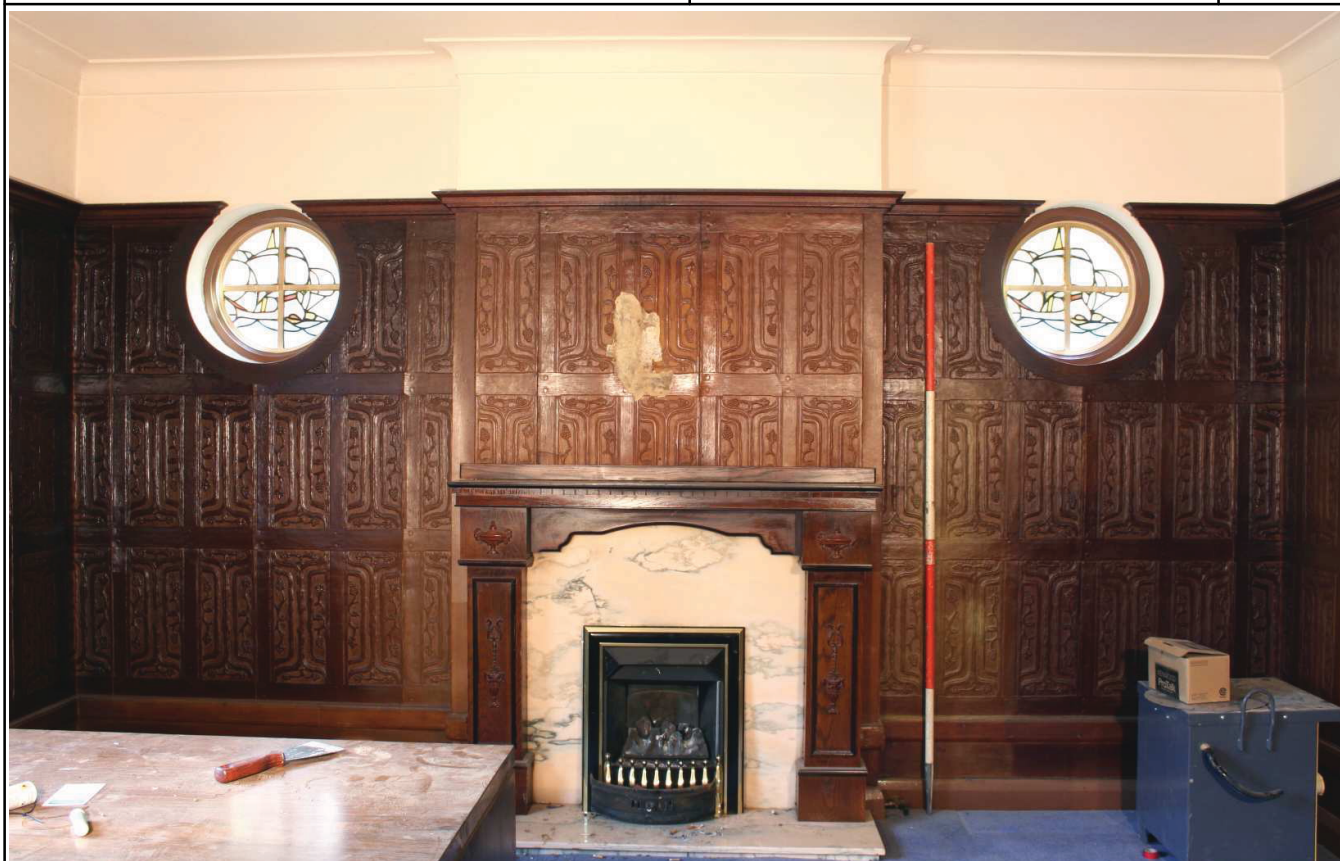
Plate 9: Dining room, showing wood panel wall paper & circular windows

2.30 The dining room is decorated in a mock Tudor style with dark wood-panel effect anaglypta wall paper. The original skirting board, picture rail, and cornice, survive throughout. Although the room is now carpeted it is likely to originally have had exposed floorboards also observed in the hall and anteroom. The room has wooden twin bulb side lights and a central wooden chandelier. The style of the light fittings are in keeping with the decoration of the room, though marks on the wall paper by the side lights suggest that they are in fact replacements. Further light is provided by incandescent strip lights located above the picture rail. An original

cast iron radiator is present on the southern wall. The wood and marble fireplace on the eastern wall is a replacement. The two round stained glass windows noted above are located on either side of the chimney breast. On the west wall a set of French windows lead to the back garden. The southern wall has a large opening fitted with a set of large wooden folding double doors. Each door consists of two panels, the central panels are fitted with a full length brass locking mechanism. The doors lead through to the anteroom. The door from the hall has the same art deco style handles noted elsewhere.

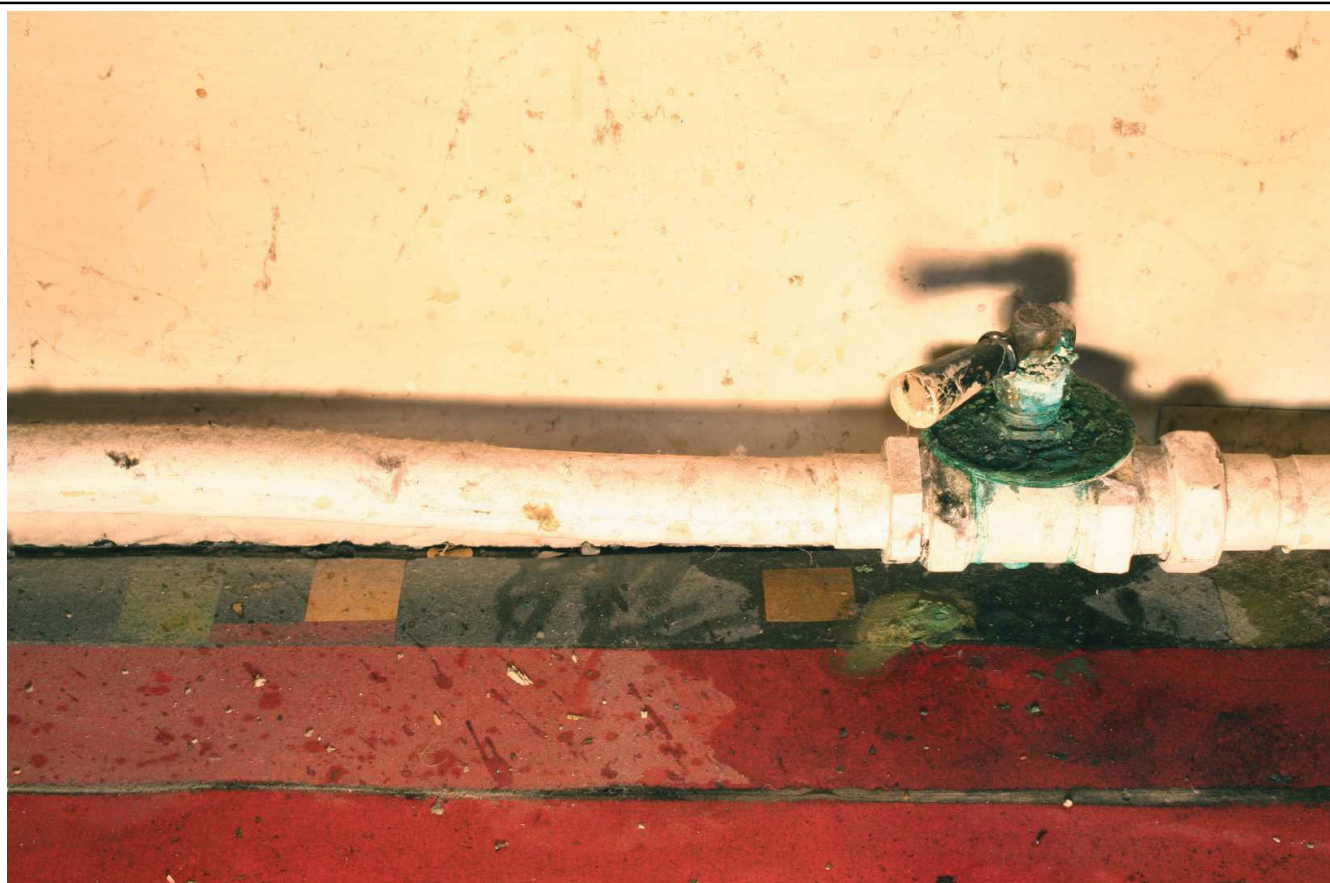
Plate 10: Original linoleum in kitchen
