PATHFINDER HOUSE **St Mary's Street, Huntingdon, Cambridgeshire**

***Desk-based Archaeological Assessment
& Archaeological Evaluation Report***

Prepared on behalf of Huntingdonshire District Council

Report No.383

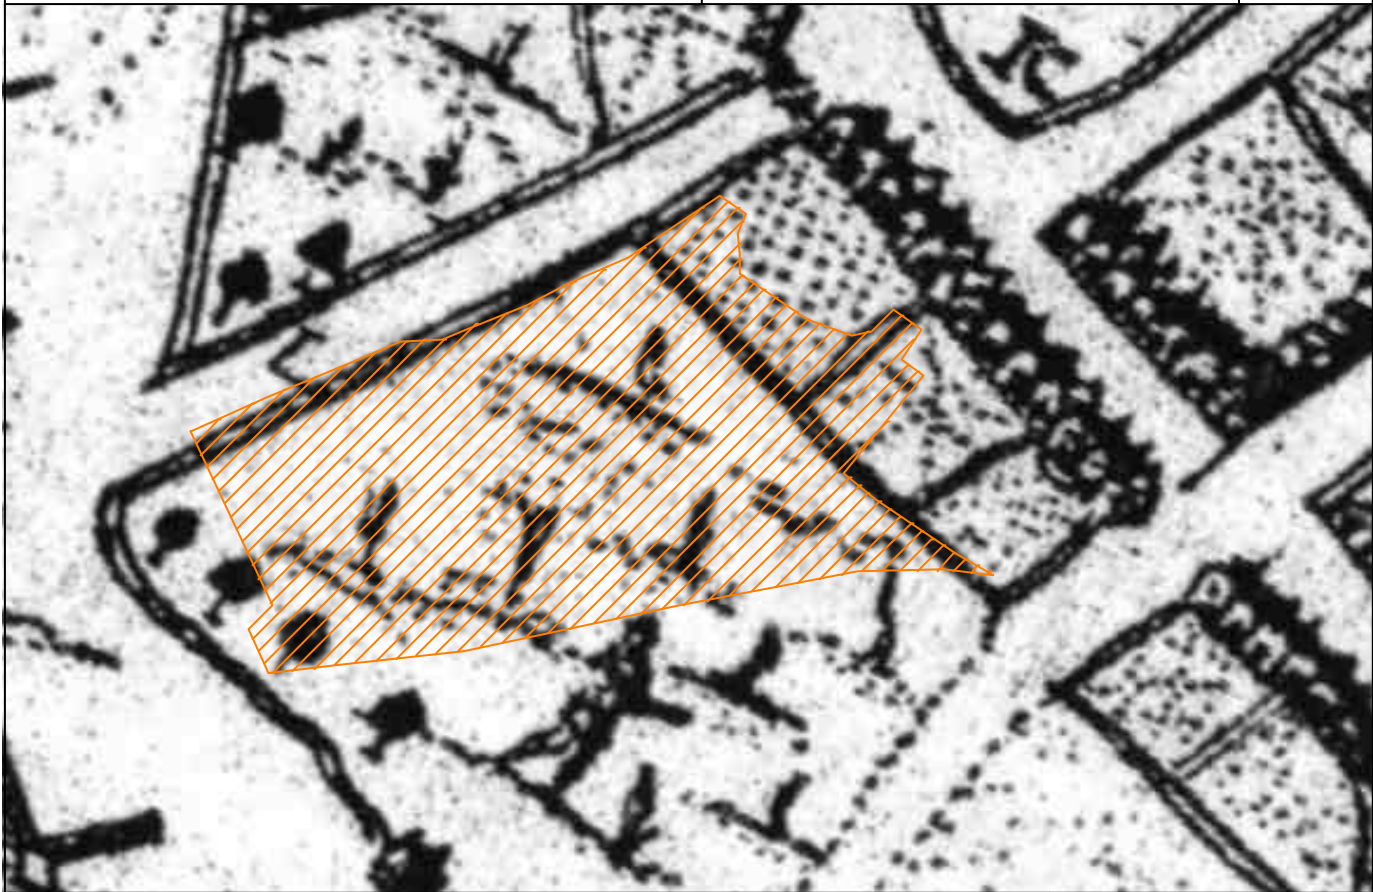
Figure 6

Speed's Map, 1610

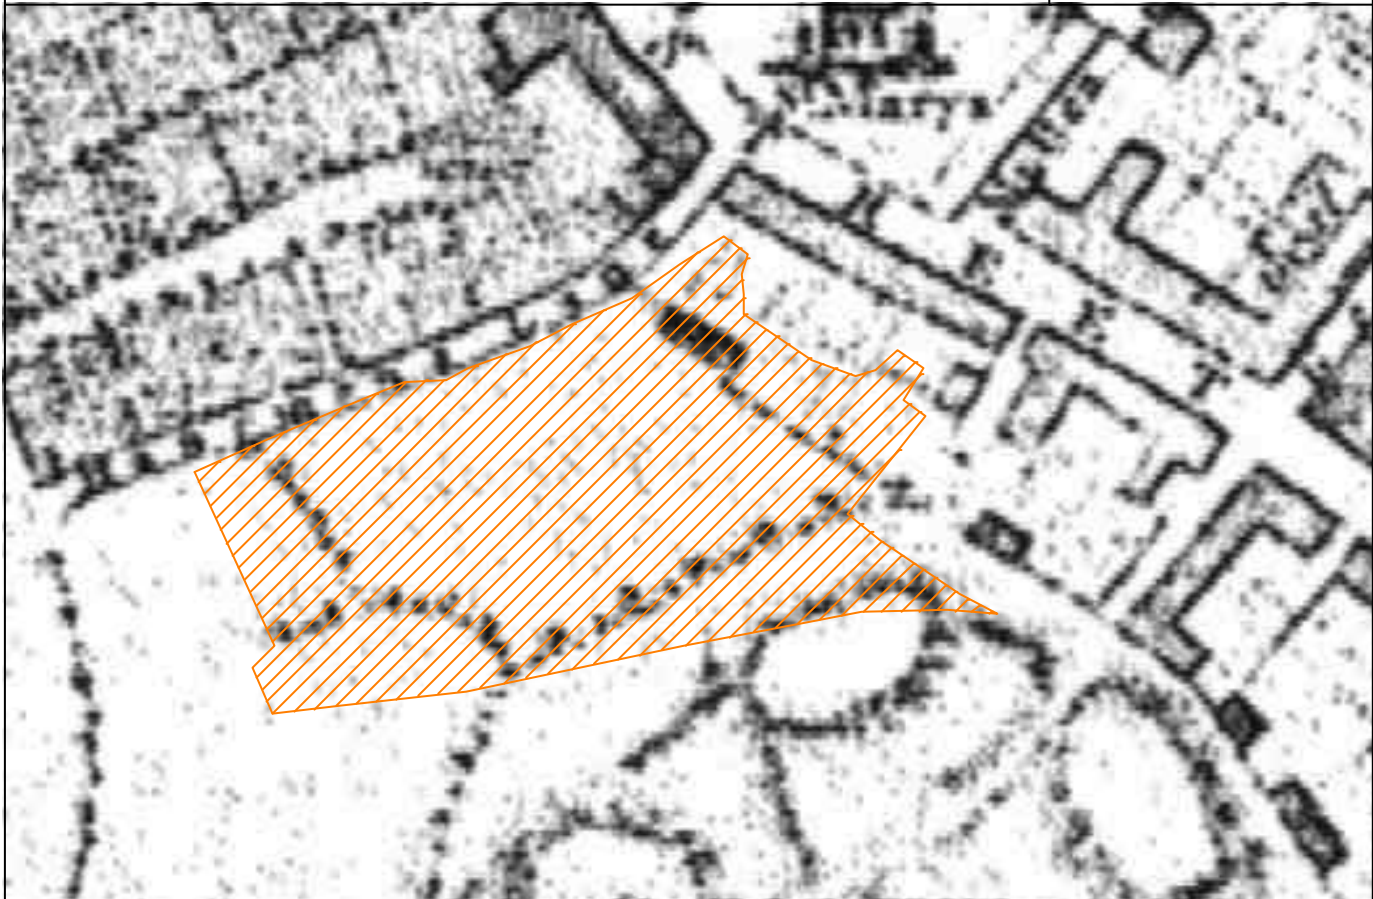
Figure 7

Jeffrey's Map, 1768

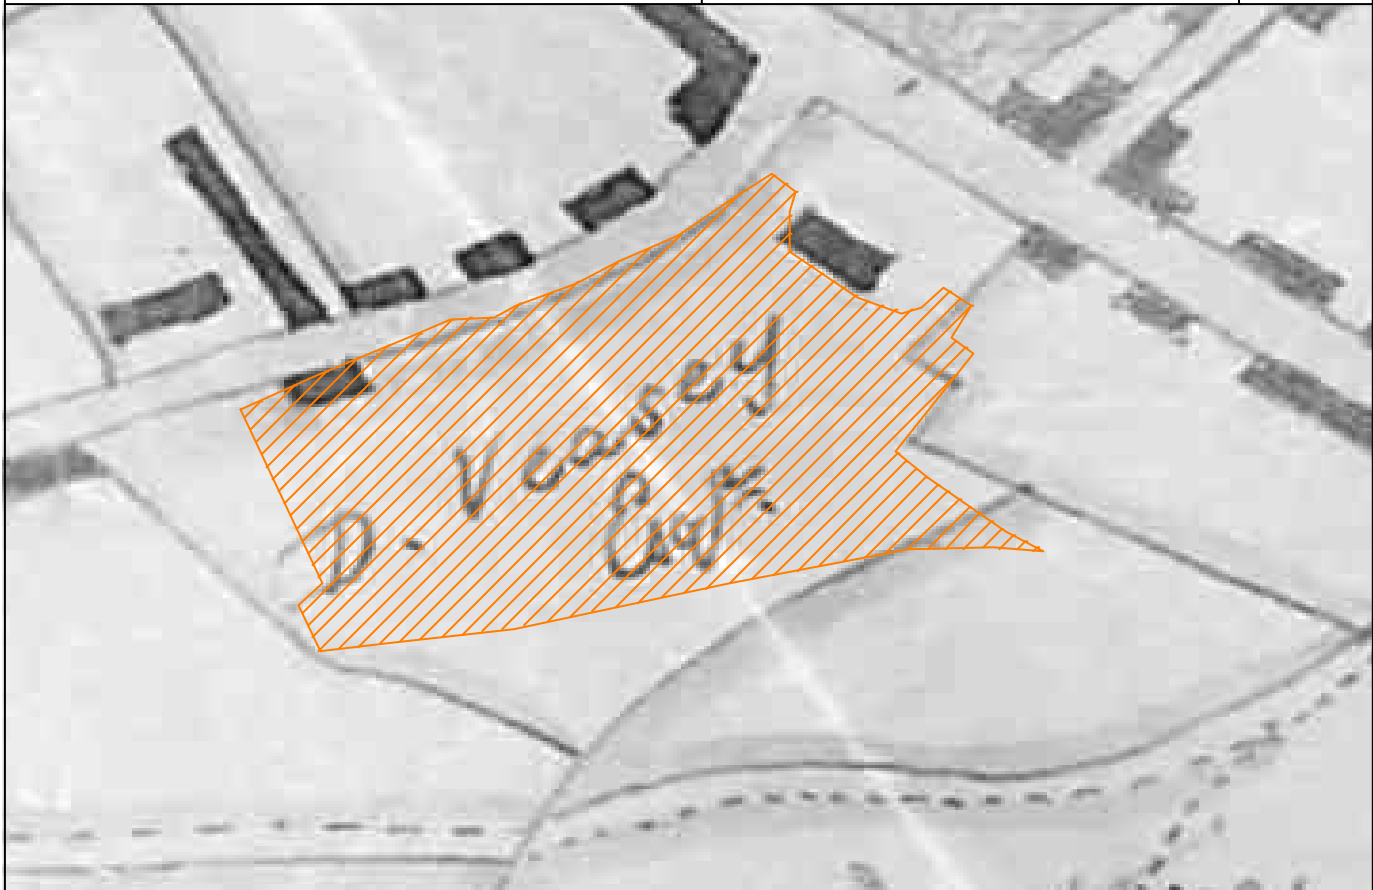
Figure 8

1845 Map
CRO DDM 76/5

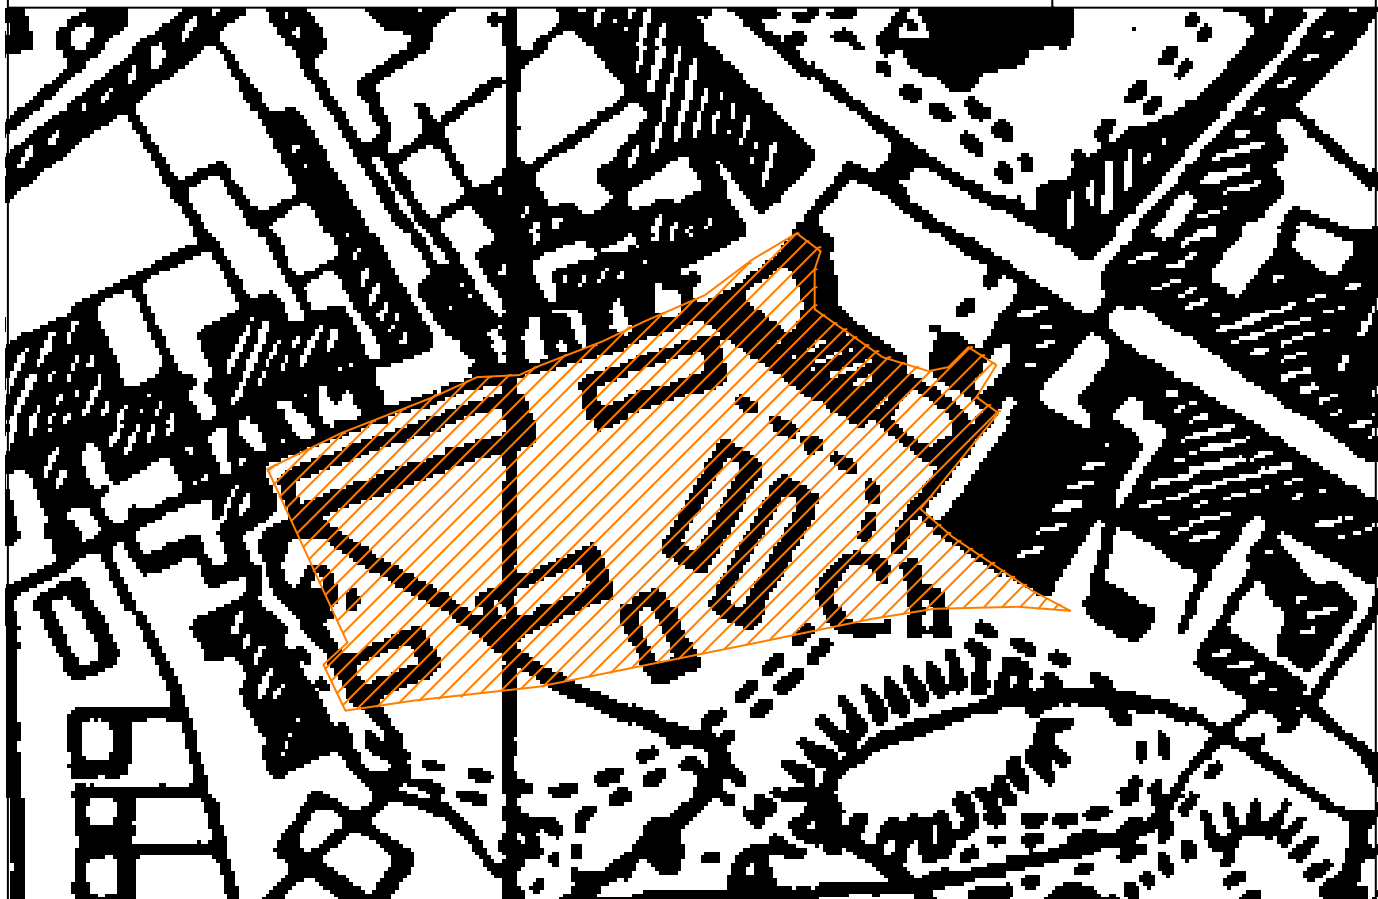
Figure 13

Ordnance Survey, 1958

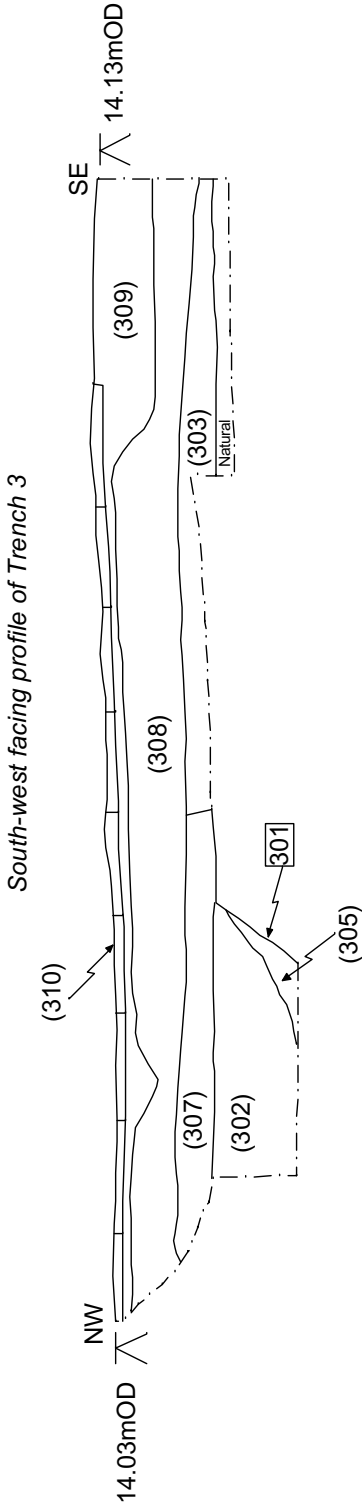
Plan of Trench 3

- A large linear feature [301] was observed cut through the natural geology in the northern half of the trench on a NE – SW alignment. The full dimensions of the feature were unclear as it ran beneath the north eastern baulk, but it had sloping concave sides. The primary fill (305), of firm greyish brown silty clay, contained three sherds of 3rd century AD Samian pottery. The secondary fill (302) was a firm reddish brown mottled silty clay. A few sherds of 2nd century AD shell tempered and grey ware pottery and a small amount of animal bone were collected from this fill. The animal bone had an unfused element suggesting juvenile animals, and showed evidence of gnawing. This ditch was not observed within the confines of Trench 2 to the west.

- A large linear feature [303] was observed cut through the natural geology in the southern half of the trench on a N – S alignment. The length of the feature was unclear as it ran beneath the baulk in the south western corner. The exposed area was 1m wide by 0.39m deep and had sloping concave sides and a rounded base. The primary fill (306) of loose reddish brown gravel yielded a single fragment of animal bone showing butchery evidence and a shell. The secondary fill (304) of firm greyish brown clayey gravel contained a few sherds of highly abraded late 2nd/ early 3rd century AD pottery, CBM, a single fragment of animal bone and a piece of worked flint in the shape of an arrow or spear tip.

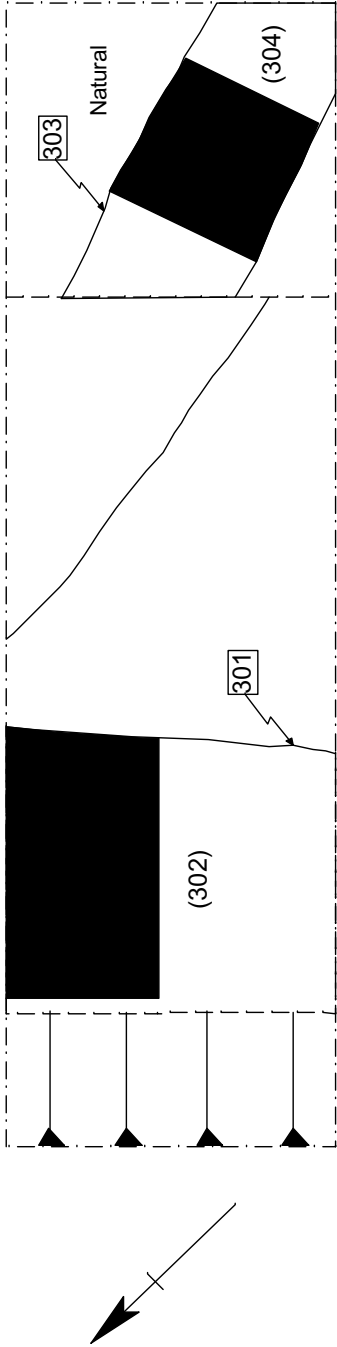
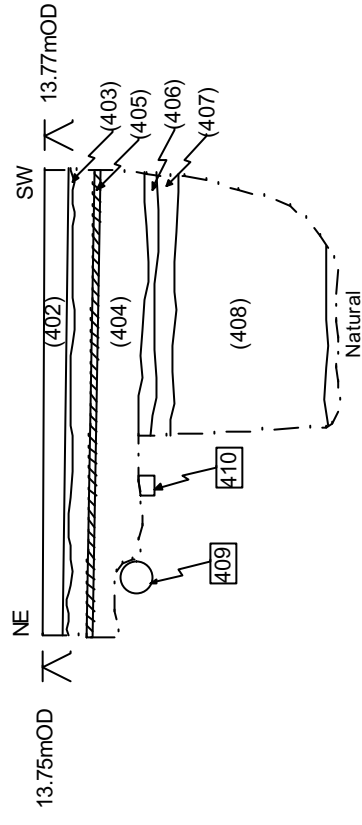
North-west facing profile of Trench 4

Plan of Trench 4

Trench 4 section and plan

- Structure [401] was observed cut through layer (404) in the north western half of the trench on a north east – south west alignment. The full dimensions of the feature were unclear as it ran beneath the north-western baulk. The exposed area was 0.2m in depth consisting of three courses above the brick base. The structure consisted of red, unfrogged, possibly hand made bricks measuring 0.23m x 0.11m x 0.07m bonded by a lime mortar. The north western line of the structure appeared to run parallel with the wall of Castle Hill House.

- Two lines of mortar [410] and [412] were observed cutting through layer (404) in the north eastern half of the trench. Context [410] was aligned north west – south east and measured 0.25m long by 0.15m wide. Context [412] was aligned north east – south west and measured 0.25m long by 0.15m wide. These features represent the vestiges of brick structures which suggest the presence of a network of Post-Medieval, brick built conduits that have since been destroyed.

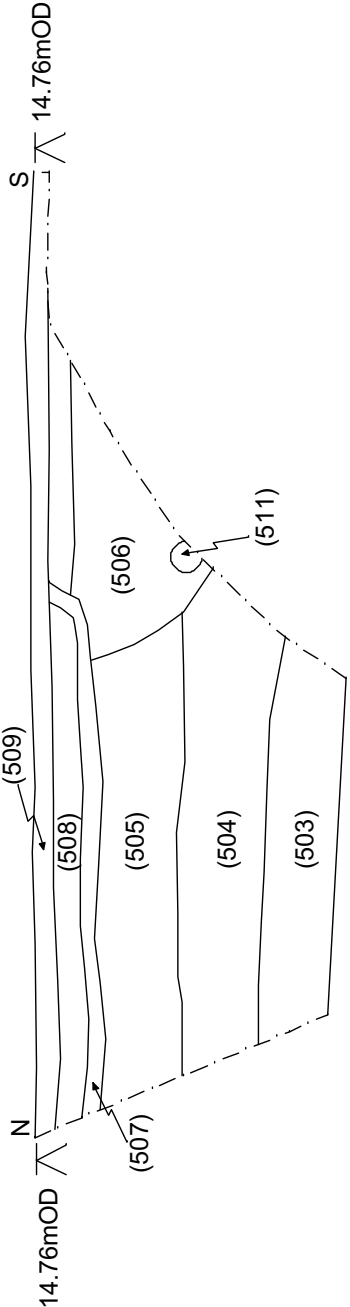
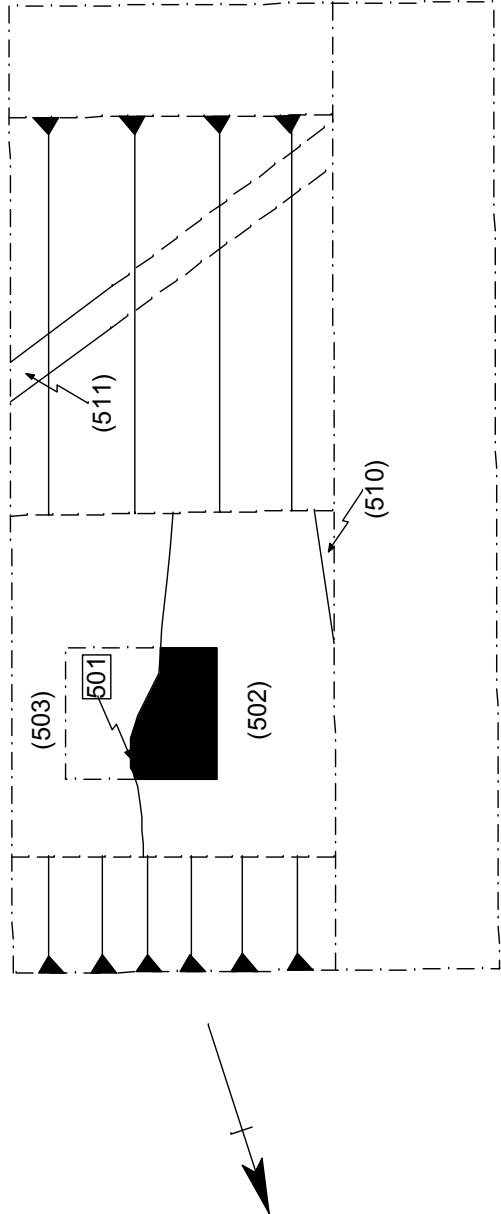
Figure 20

West facing profile of Trench 5

Plan of Trench 5

Trench 5 section and plan

- A large linear feature [501] was observed cut through the deposit/layer (503) in the northern half of the trench on a north – south alignment. The full dimensions of the feature were unclear as it ran beneath the baulk at the northern and western ends of the trench. It had a maximum depth of 0.40m, sloping, slightly rounded sides at approximately 45° and a rounded base. The primary fill (502) of loose dark brown silty sand yielded a small amount of abraded Roman, grey ware pottery sherds, and several types of animal bone. The animal bone had an unfused element suggestive of juvenile animals and showed evidence of butchery. The natural geology was observed in the base of the feature.

- A layer or deposit (503) was observed within the excavated area of the trench. The full dimensions of the layer or deposit were unclear as the limits could not be seen within the trench. Several sherds of 2nd to 3rd century AD grey ware, fragments of animal bone and shell were collected from the layer.

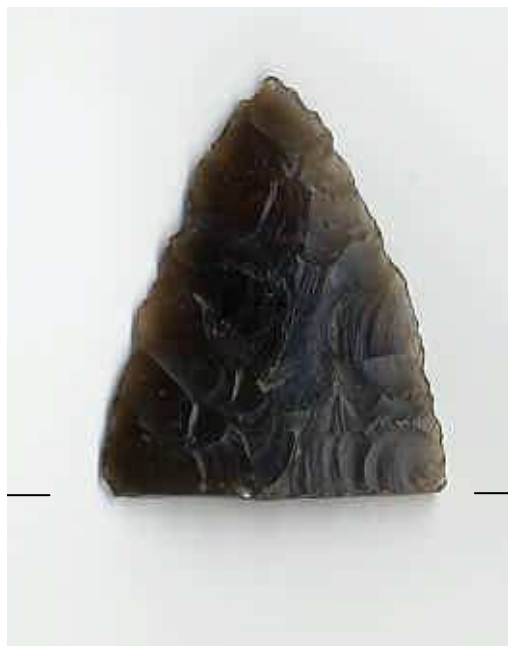
Flint Artefact - Face View

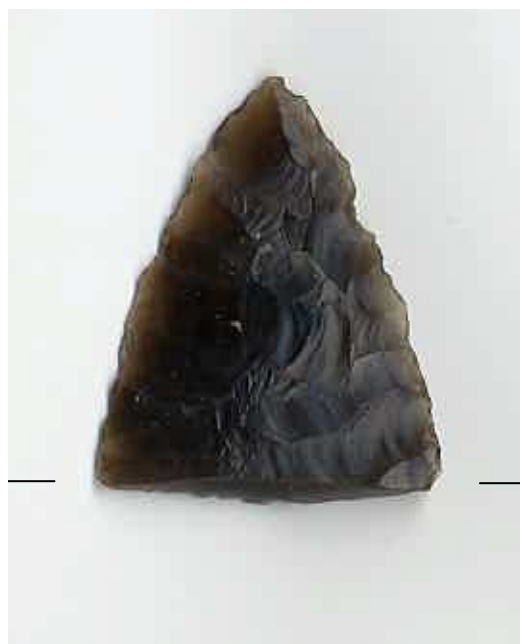
Flint Artefact - Reverse View
