**CLOPHILL HOUSE,
High Street, Clophill, Beds.**

HN1090

***ARCHAEOLOGICAL
MONITORING REPORT***

Project ref.: HN1090
Accession no.: BEDFM: 2013.50
LPA ref.: CB/13/00733/FULL

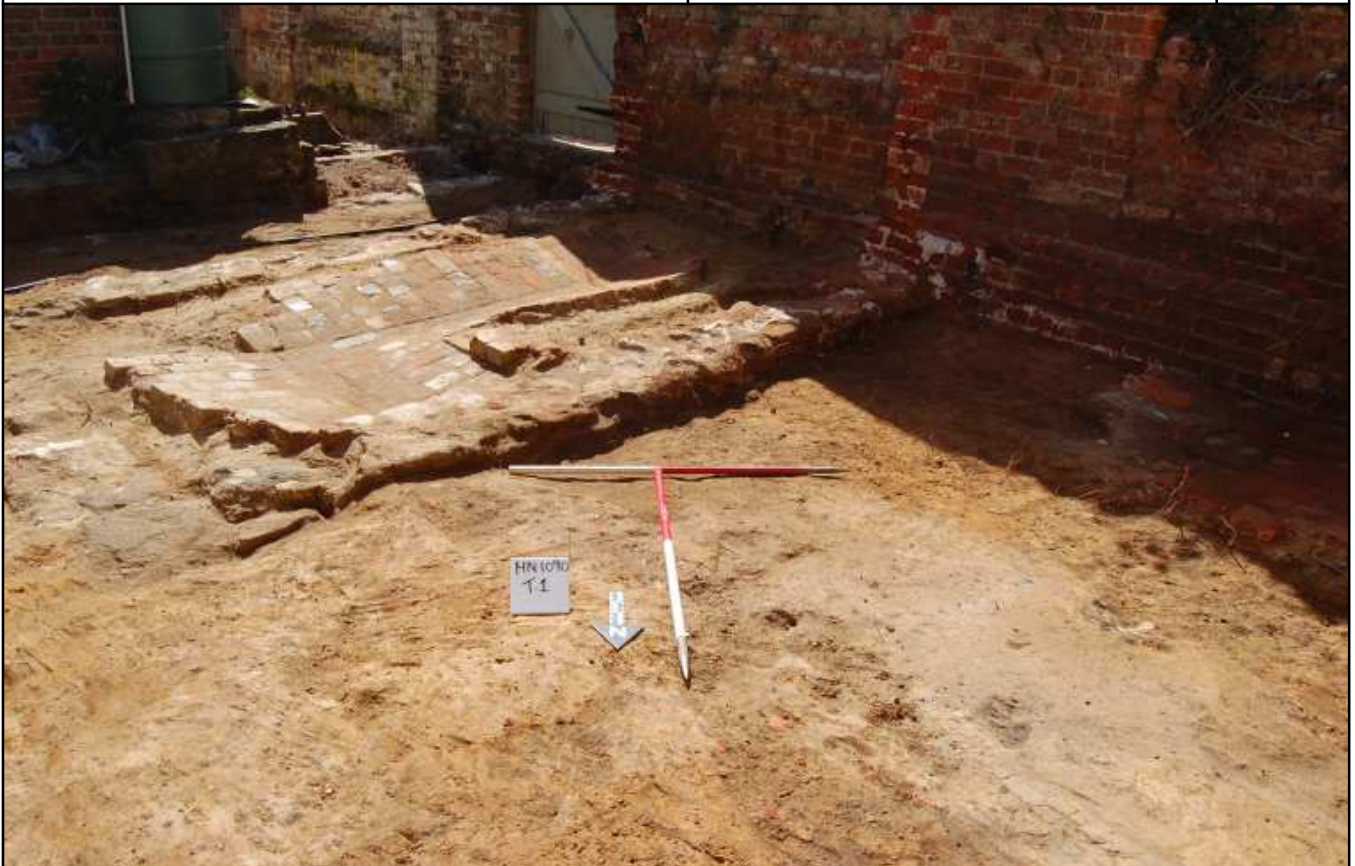
Plate 3: Linear [131], looking south

3.14 A distinct joint was observed in the western wall [177]. A substantial linear feature, [131], ran south-east from this point to meet structure [112] to the south of threshold [133] in its north-western wall. It is suggested that this marks the line of a robbed out foundation relating to the postulated earlier structure.

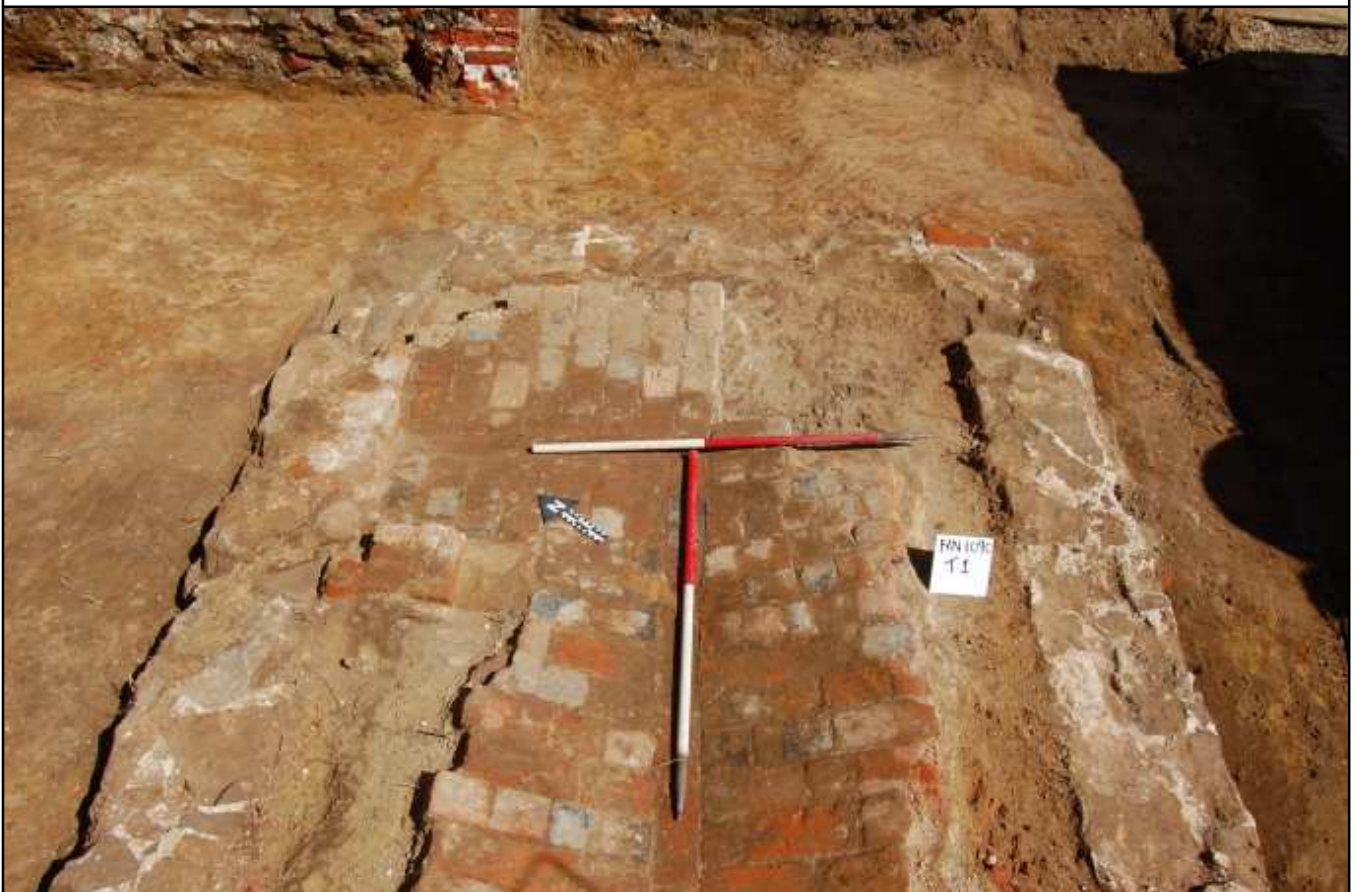
Plate 4: Structure [112], looking north-east

2.20 A single cell structure, [112], with substantial ironstone foundations, was exposed in the south-eastern corner of the trench. This was aligned north-east to south-west. Three lengths of wall foundation were revealed, enclosing a space which measured 3.6m by 1.8m internally (Plate 4). The south-west wall was not exposed as this either lay under the later wall [101] or beyond the excavation area.

2.21 The exposed wall foundations were constructed of roughly hewn ironstones, the largest of which measured 0.35m x 0.23m x 0.12m. These had been laid in lime mortar and were irregularly coursed. All three walls had a consistent width of 0.36m and stood two courses high, a depth of 0.12m. The base of the walls were not reached during this project.

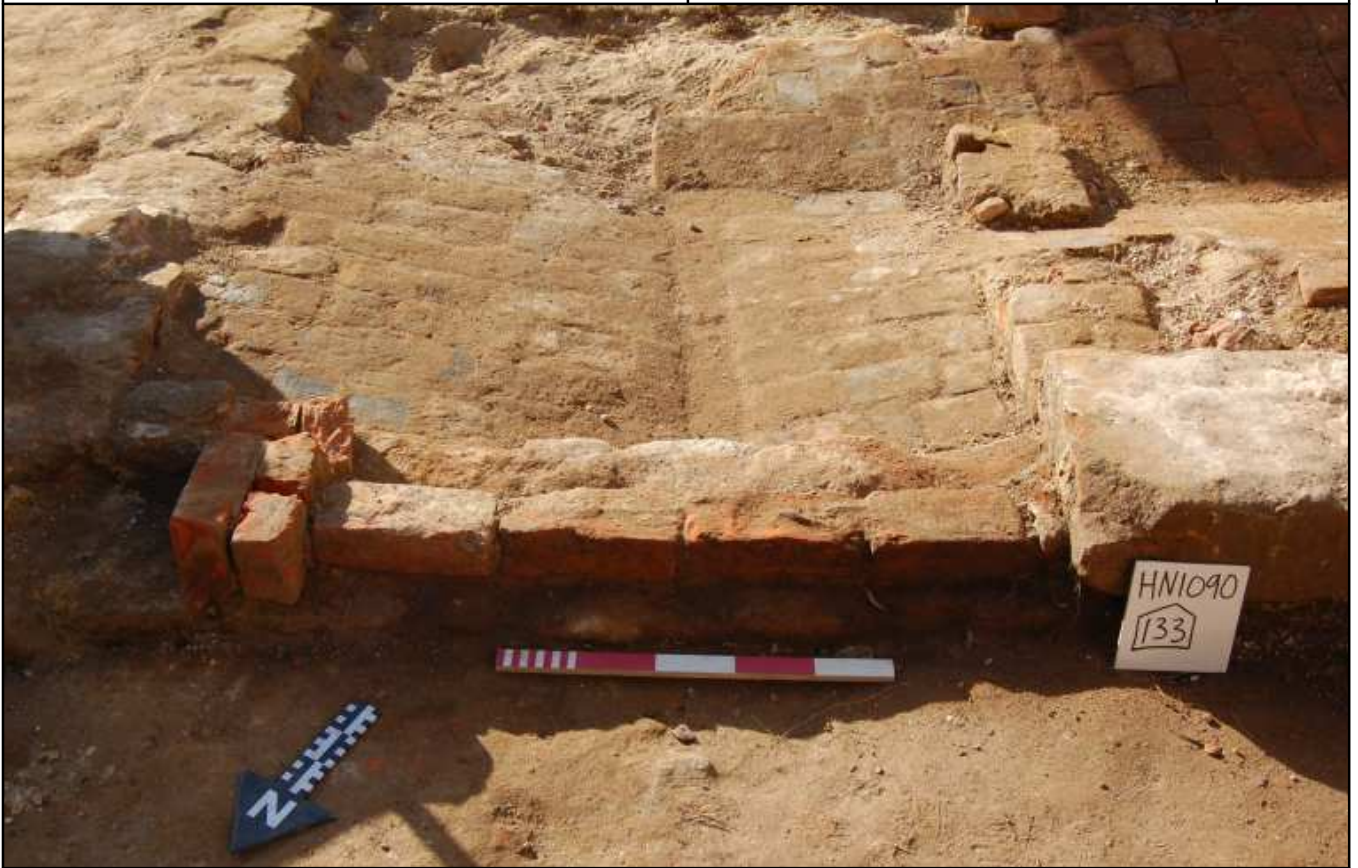
Plate 5: Threshold [133], looking south-east

2.22 A possible threshold, [133], marking a doorway into this structure, was recorded towards the north-eastern corner. This measured 1.2m in length by 0.12m in width and was constructed of unfrosted red bricks, laid end to end, and set in brownish yellow lime mortar (Plate 5). The bricks measured 9" x 4¼" x 2½" (230mm x 110mm x 50mm) and have been dated to between 1800 and 1830.

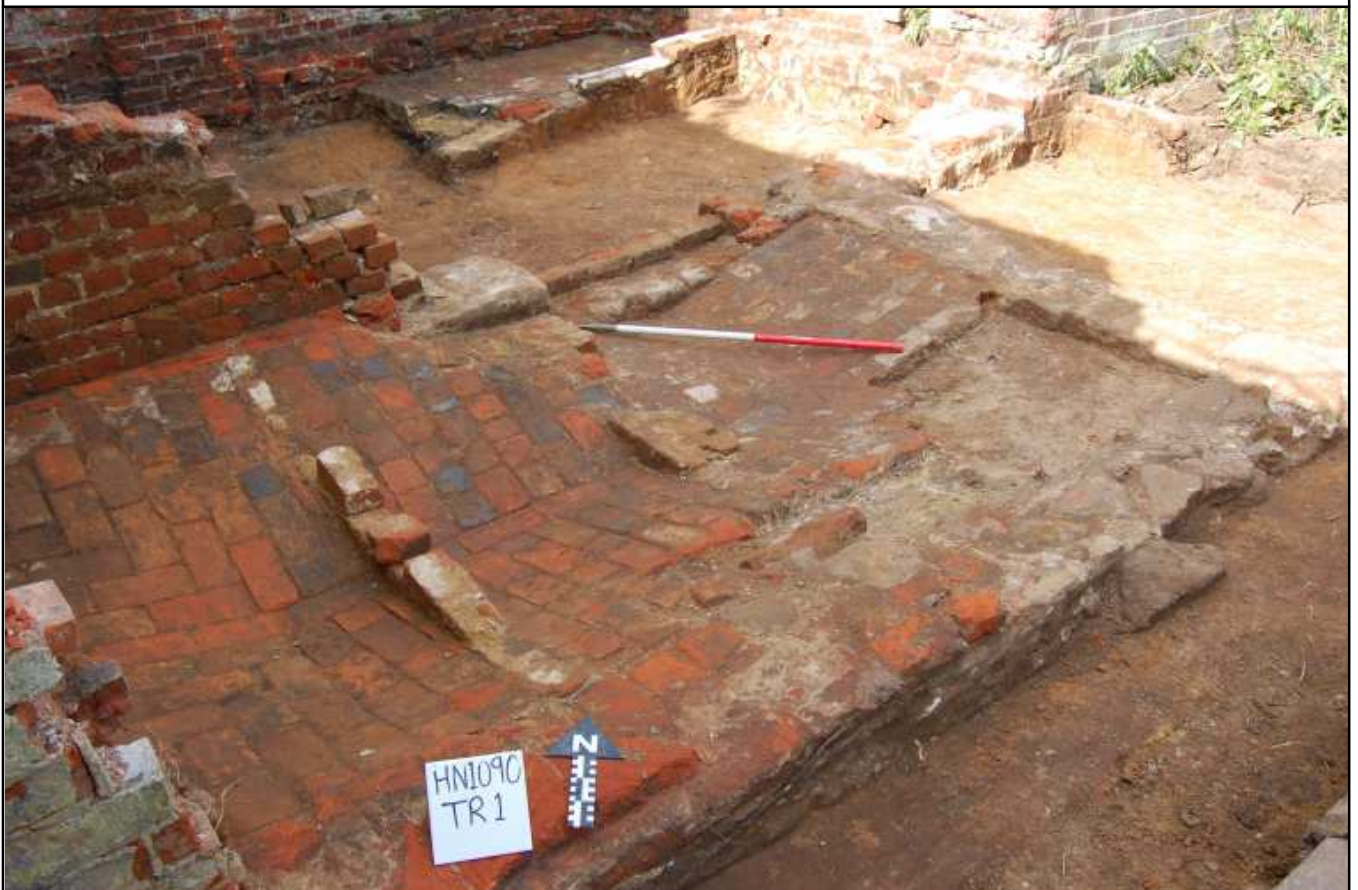
Plate 6: Floor [114], looking north

2.24 A brick floor surface, [114], measuring 3.48m in length, 1.92m in width and 0.06m in depth, occupied the space between the walls (Plate 6). This had been built so that it sloped downwards on all sides, to a maximum depth of 305mm. A single row of stretcher bricks ran down the centre. Although the floor had originally covered the entire internal space later damage resulted in only about two thirds of it surviving.

2.25 The floor was constructed of red unfrosted bricks, set in a bed of soft sandy mortar. The complete individual bricks measured 8½" x 4" x 2½" (215mm x 10mm x 50mm) and have been dated to the 1780s. A number of half bricks were also collected from the floor and these have been dated to the 1830s.

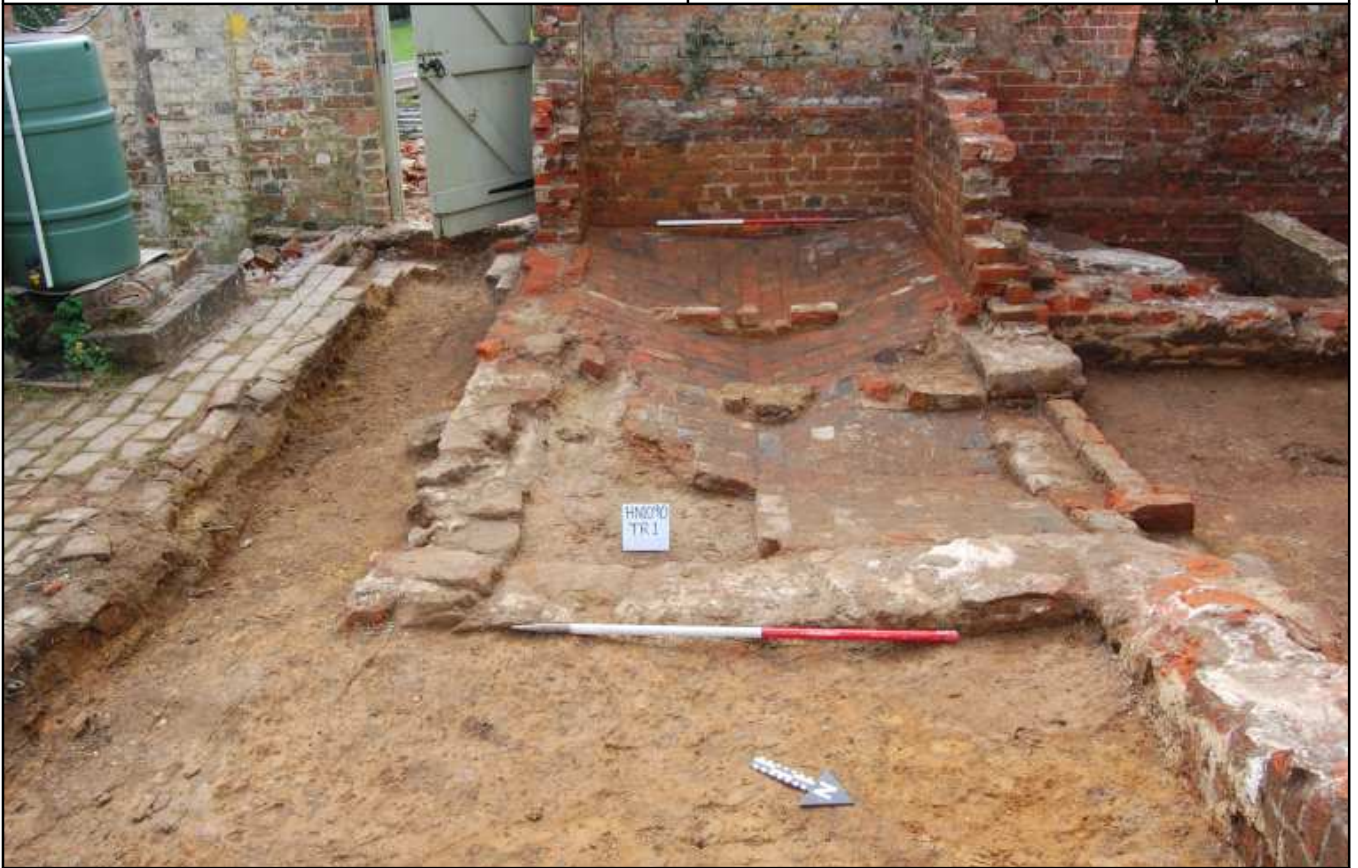
Plate 7: Bedding layer (117), looking south-west

2.26 The brick floor had been laid on a bedding layer, (117), which comprised pale yellow (10YR 7/3) loose, fine sand (Plate 7). This appeared to butt against wall [112].

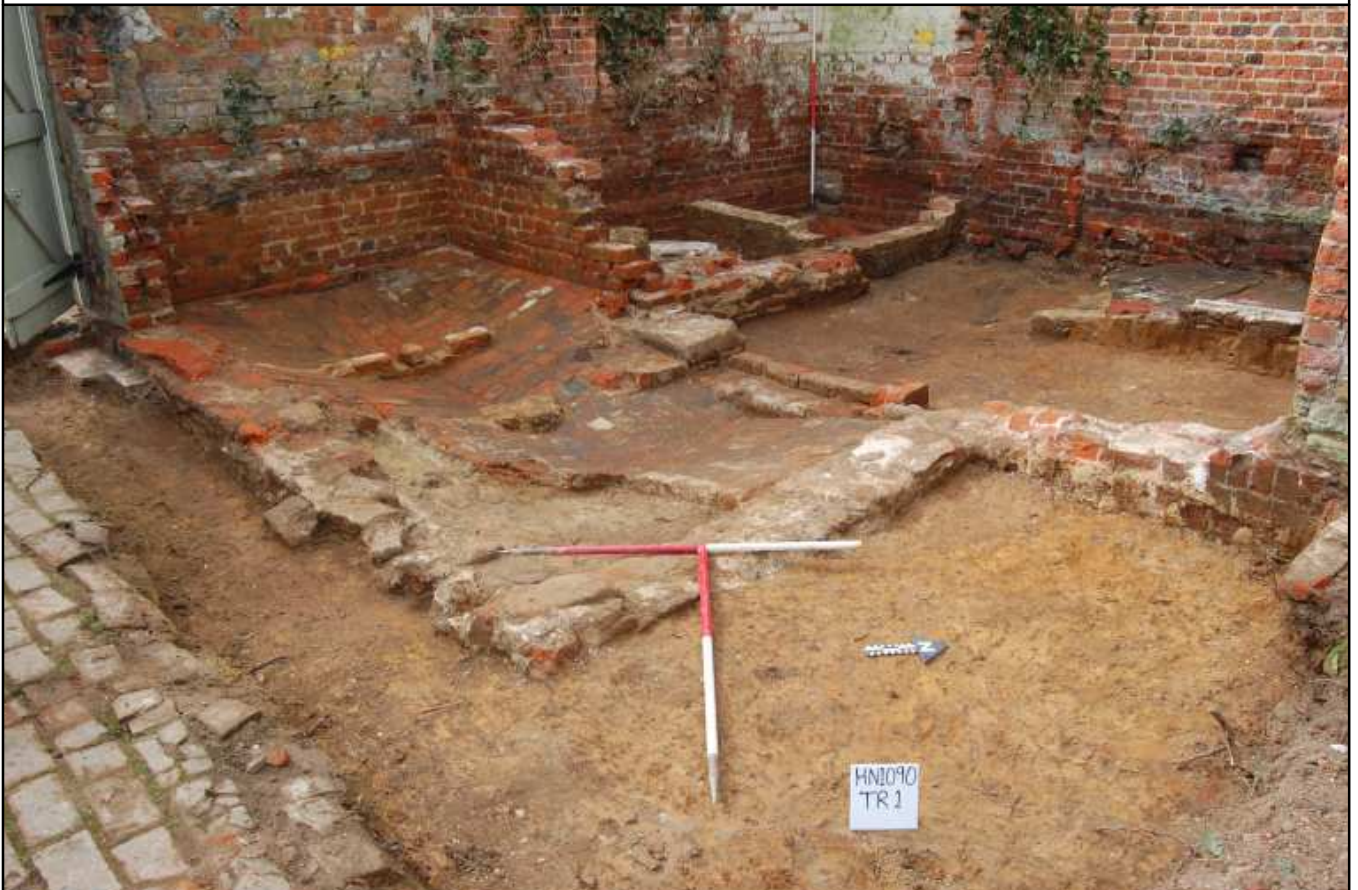
Plate 8: Structure [112], looking south-west

2.27 The remains of two brick walls crossed the space, apparently sub-dividing it into three unequal areas (Plate 8). Wall [115] to the south-east, measured c.0.8m long by c.0.12m wide, and was constructed of a single skin of red unfrosted bricks, two courses high. The bricks, which have been dated to the early 19th century, before 1830, measured 9" x 4" x 2³/₄" (230mm x 100mm x 60mm). White mortar marks on the floor showed that the wall extended across the entire space. Wall [116] was located approximately 0.60m to the northwest of [115]. It measured 0.4m in length by 0.24m in width and was constructed of a single course of red unfrosted bricks in a bed of soft sandy mortar. No sample brick could be recovered from this feature.

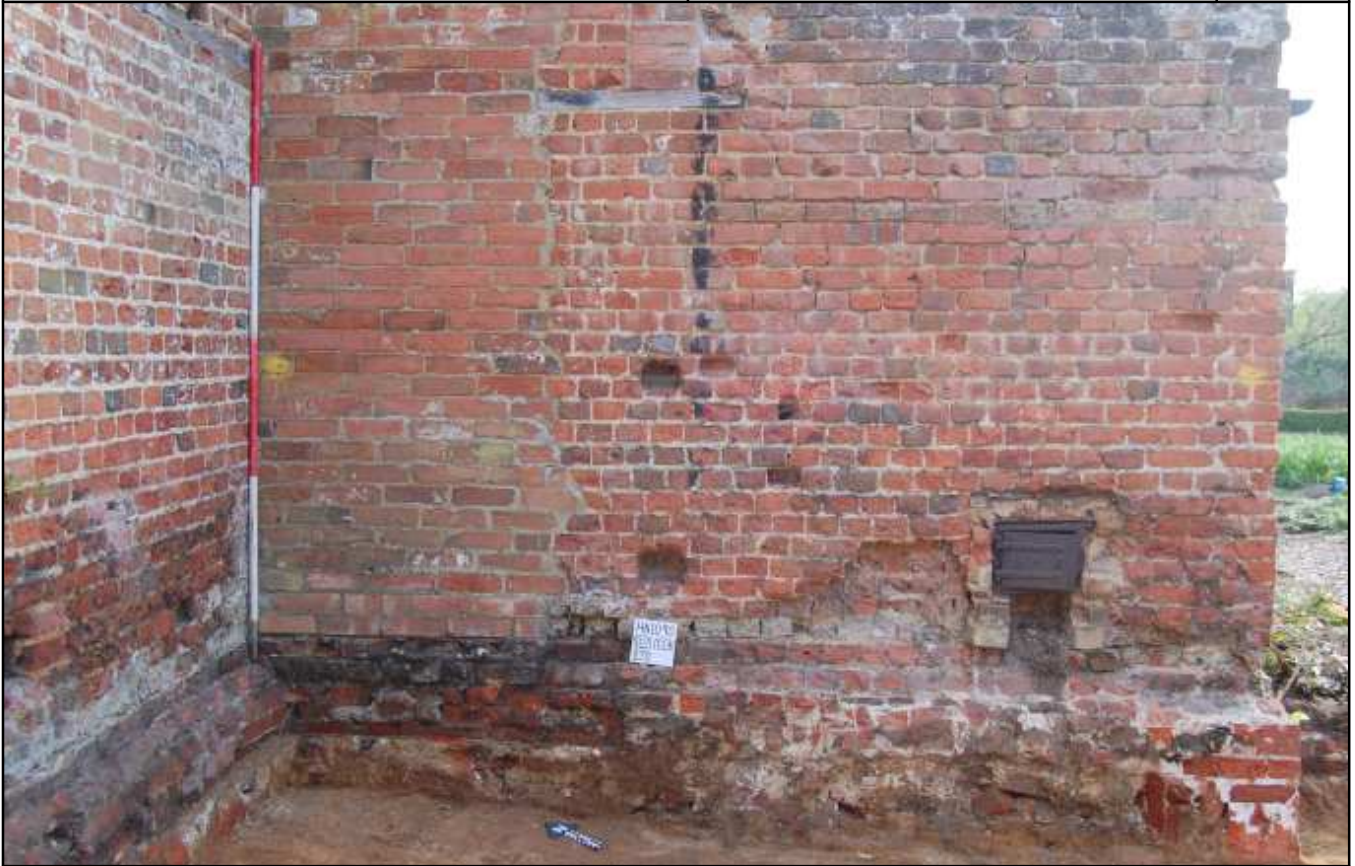
Plate 9: Wall [175], looking north-east

2.31 Wall [175], on the north-eastern side of the site, forms the south-western side to a greenhouse, which appears to have existed since at least the 1880s and was built against the southern elevation to the outbuilding range. It stands to a maximum height of 4.15m and was originally constructed of handmade unfrosted red bricks, bonded with lime mortar but not laid in any clearly discernible bond pattern (Plate 9). The earliest bricks measure 8¹/₂" x 4" x 2¹/₂" (215mm x 100mm x 60mm). It has a chamfered offset approximately 0.50m above the impact level, which appears to mark the top of the footings. The wall has clearly been rebuilt or repaired on a number of occasions.

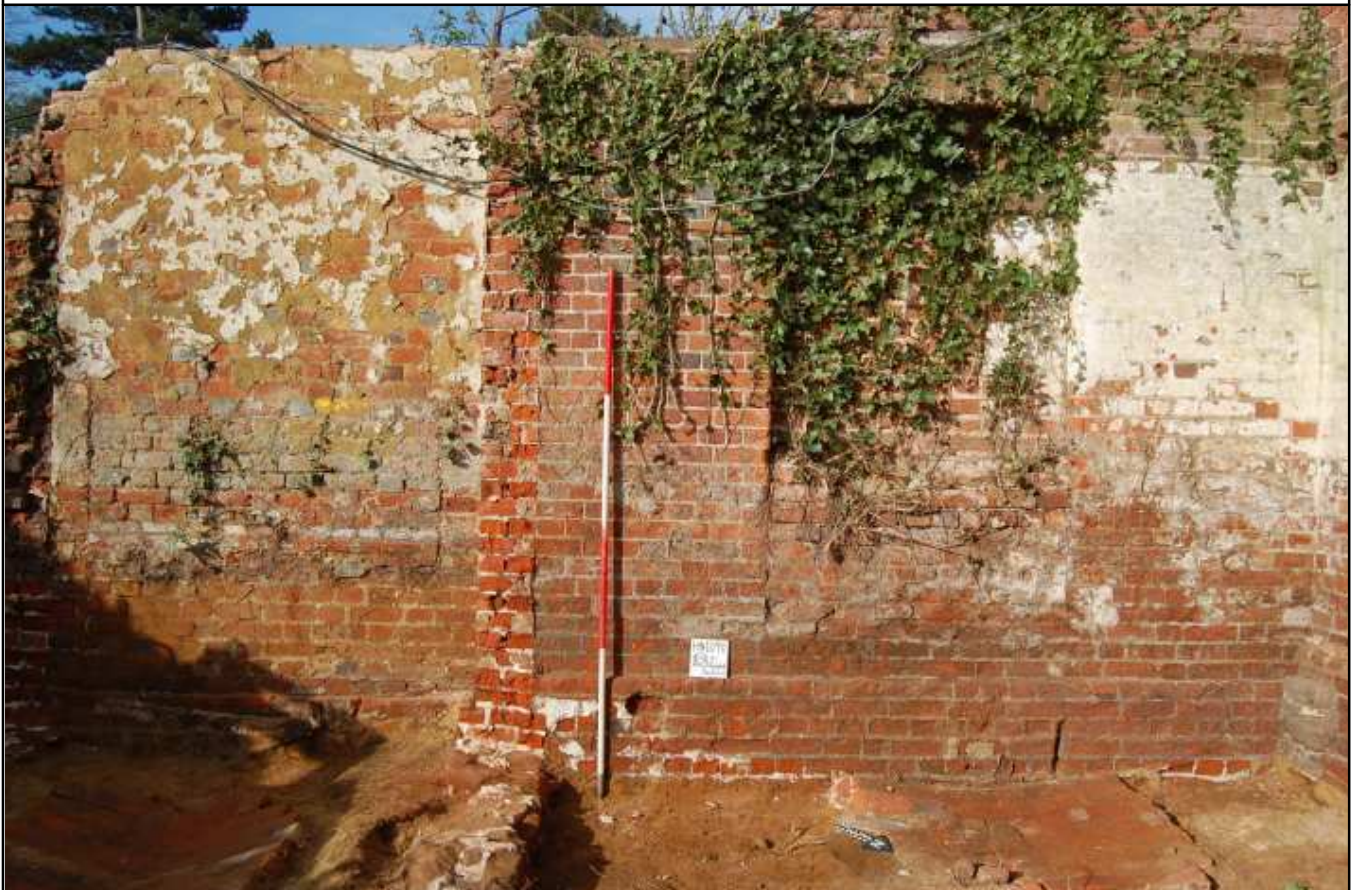
Plate 10: Wall [176], looking south-west

2.32 Wall [176] forms the south-western boundary to the site. It stands approximately 4.15m high and measures 5.60m in length and 0.34m in width (Plate 10). The wall is constructed of handmade unfrosted red bricks, laid in no clearly discernible pattern and bonded with lime mortar (Plate 9). Bricks recovered during the groundworks measure 8³/₄" x 4" x 2¹/₂" (225mm

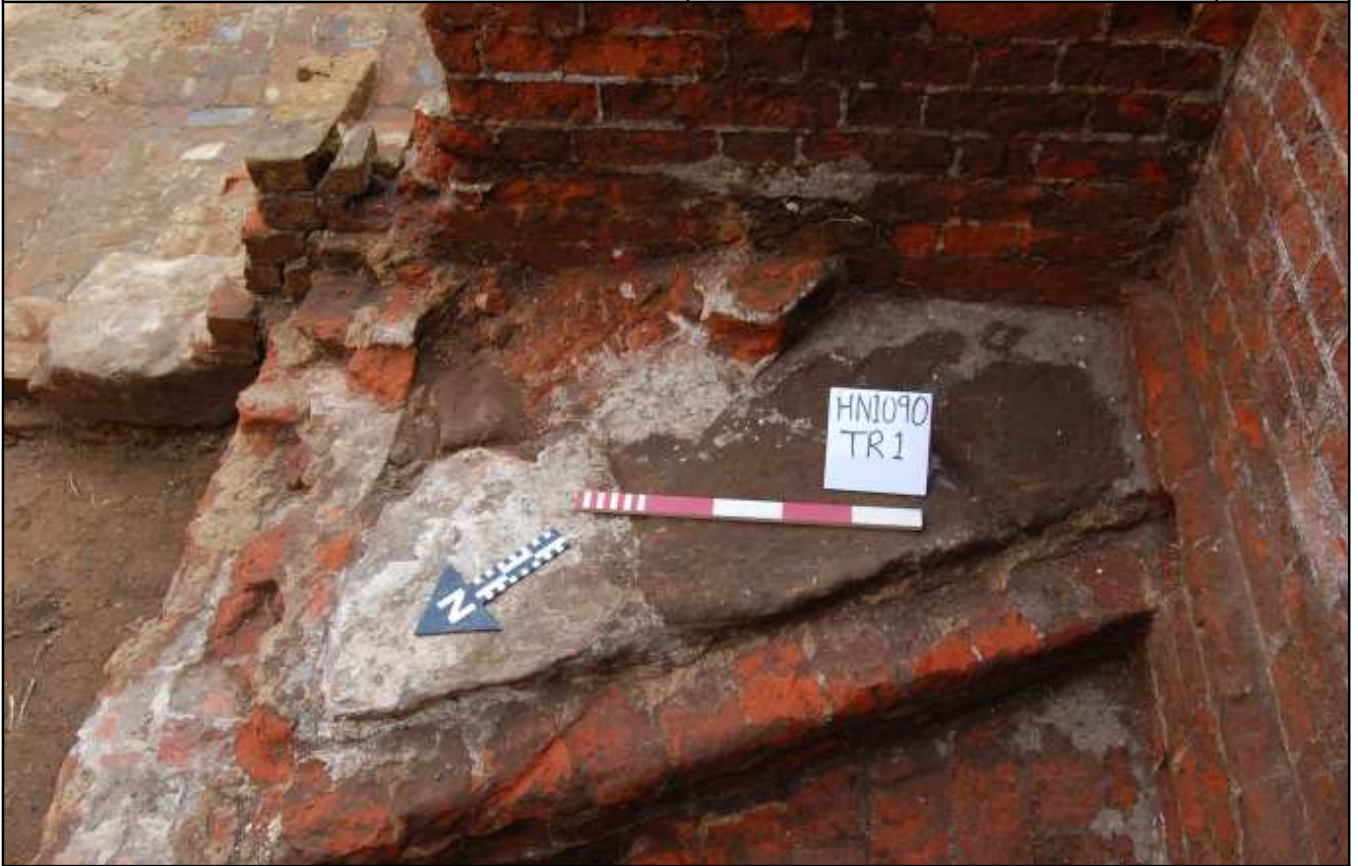
Plate 13: Wall [140] and surface [139], looking south-east

2.34.2 A diagonal wall, [140], which ran approximately north – south, was located in the south-eastern corner (Plate 13). Its exposed area measured c.1.2m in length, 0.18m in width and c.0.24m in height, and was constructed of broken red unfrosted bricks, dated to the 1830s, set in a very pale mortar with gritty inclusions. A line of bricks, cut into [176], may have marked the western edge of surface [139]. This was formed of irregular stone slabs, 0.09m thick, set in a very hard mortar.

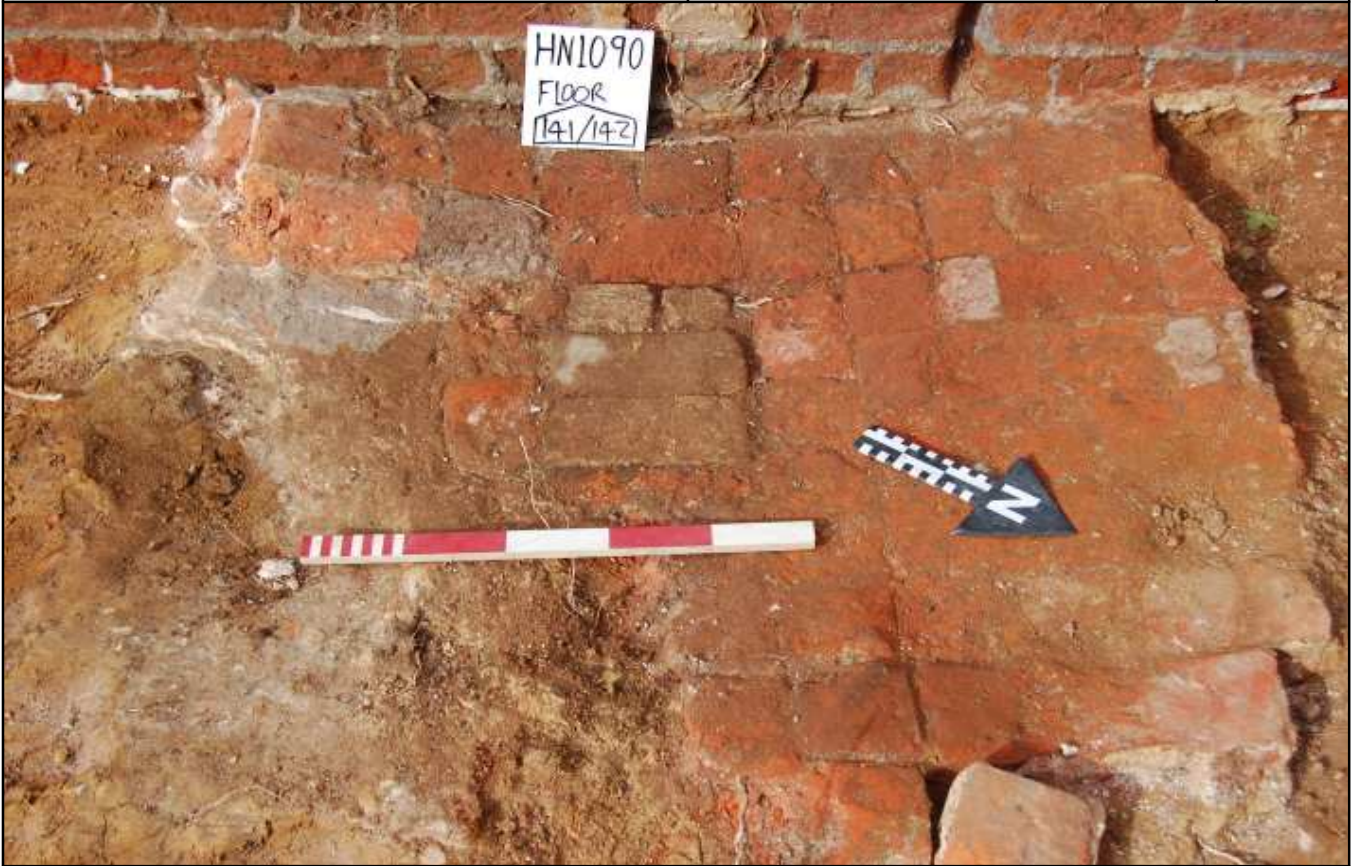
Plate 15: Detail of brick floor [141] / [142], looking south-west

2.34.5 To the north-west of [140] was a brick floor surface, [141], which was exposed at approximately 0.25m lower than surface [139]. It consisted of half bricks laid in parallel lines on a bed of yellow (10YR 8/6) soft sandy mortar (Plate 15). The floor was worn and sloped downwards to the east.

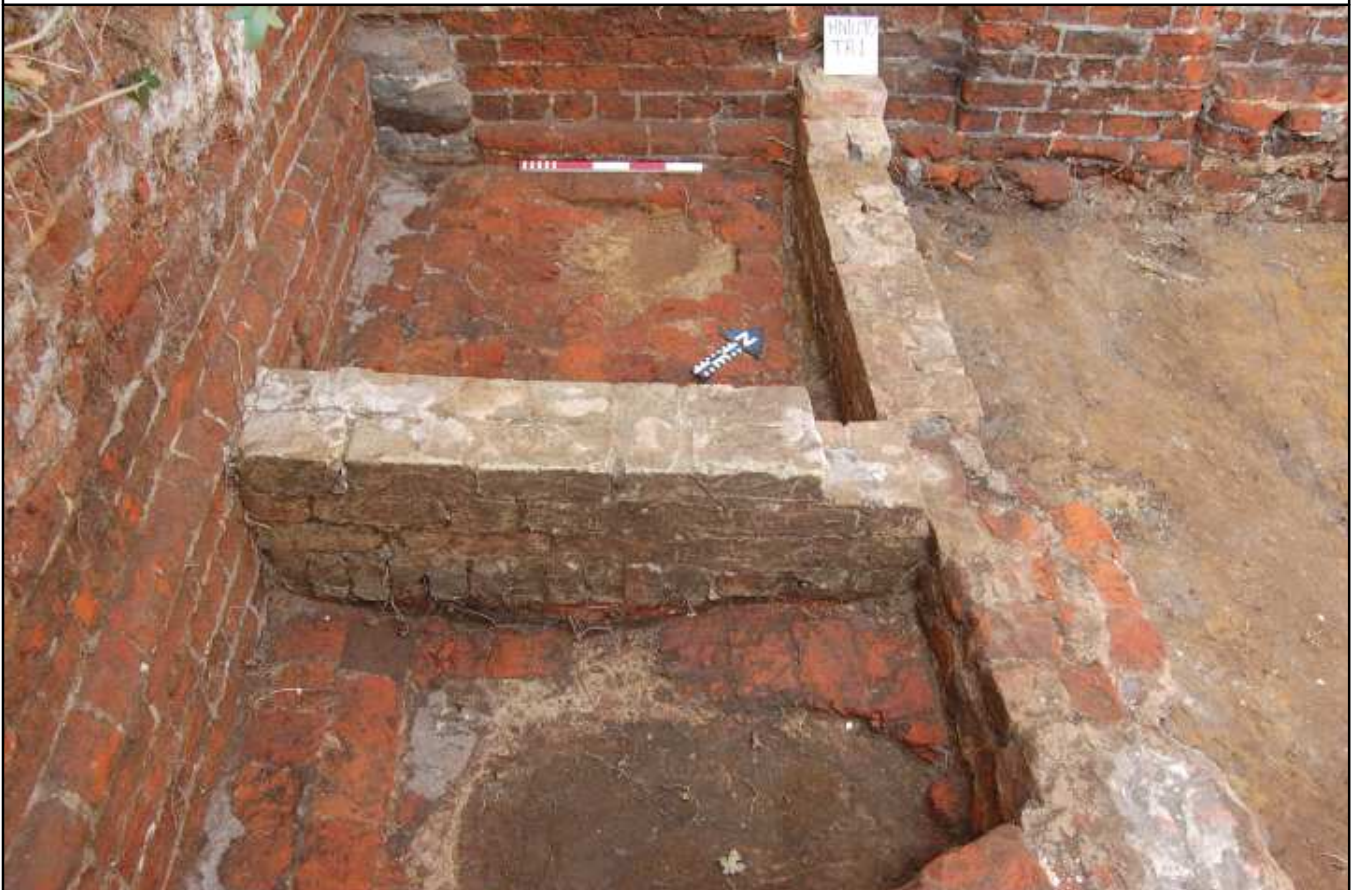
Plate 16: Room [179], showing floor [142] and plinth [143], looking north-west

2.36 Wall [134] continued the line of walls [136] and [137]. It was constructed of mainly unfrosted yellow bricks, bonded with lime mortar and laid in Flemish bond pattern. The exposed area measured 1.18m in length, 0.28m in width and 0.25m in height. The individual bricks measured 9" x 4" x 2½" in depth (230mm x 100mm x 50mm) and have been dated to the 1830s – 40s, indicating that this is one of the latest structures on the site. This wall and [135] appear to represent later subdivisions of this area in the mid 19th century (Plate 16).

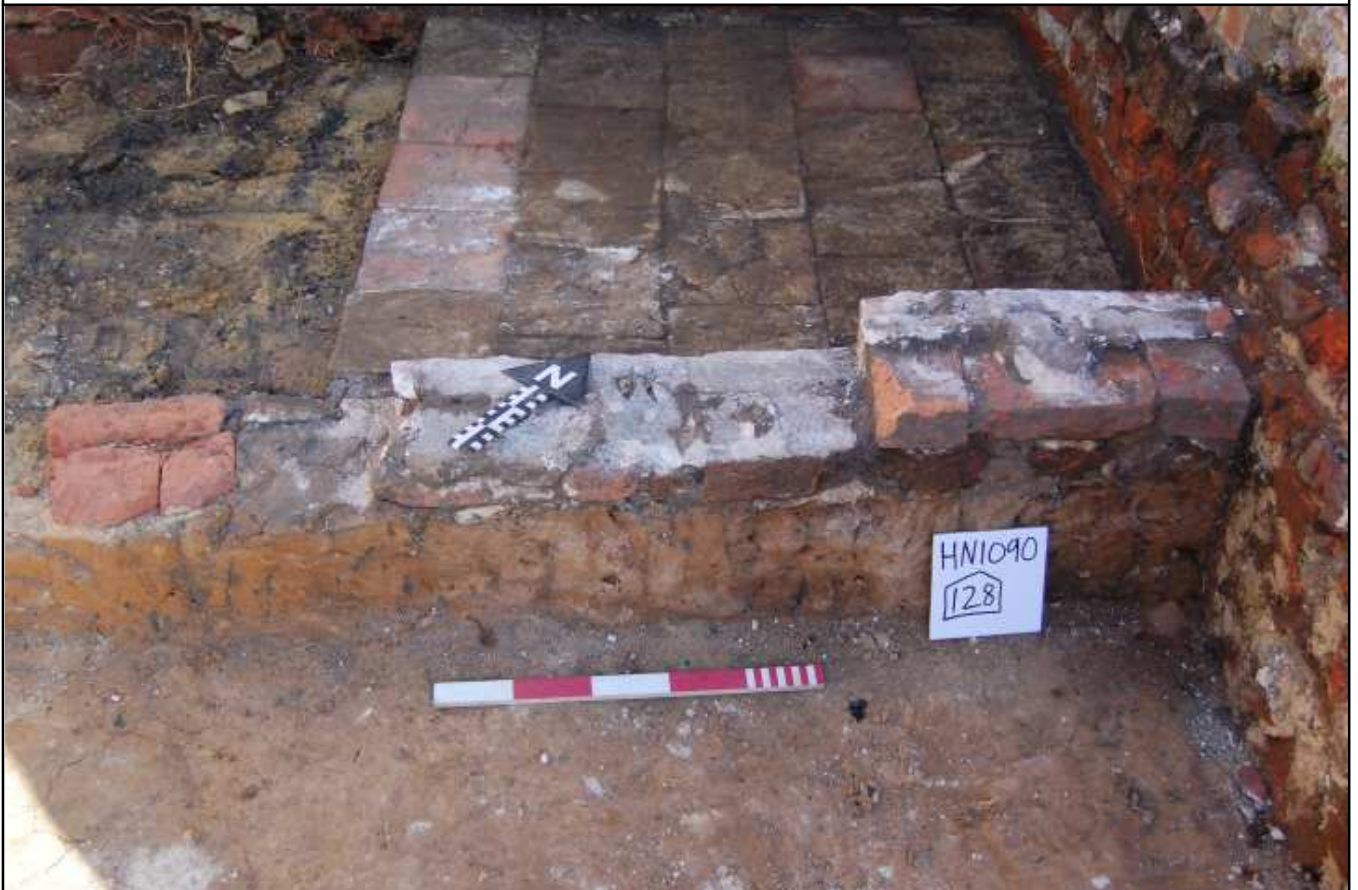
Plate 18: Room [180] showing wall [128] and burnt layer (151), looking north-west

its south-western end, but possibly formed part of the north-eastern continuation of [135]. No foundation trench was observed and it seems that the wall sat directly on the ground (Plate 18).

- 2.37.4** Removal of the floors, and the underlying bedding layers, revealed a layer of dark brown (10YR 3/3) friable burnt clayey sand, (151), which contained frequent coal and brick fragments (see Plate 18). This measured 0.90m in length, 0.80m in width and 0.01m in depth.

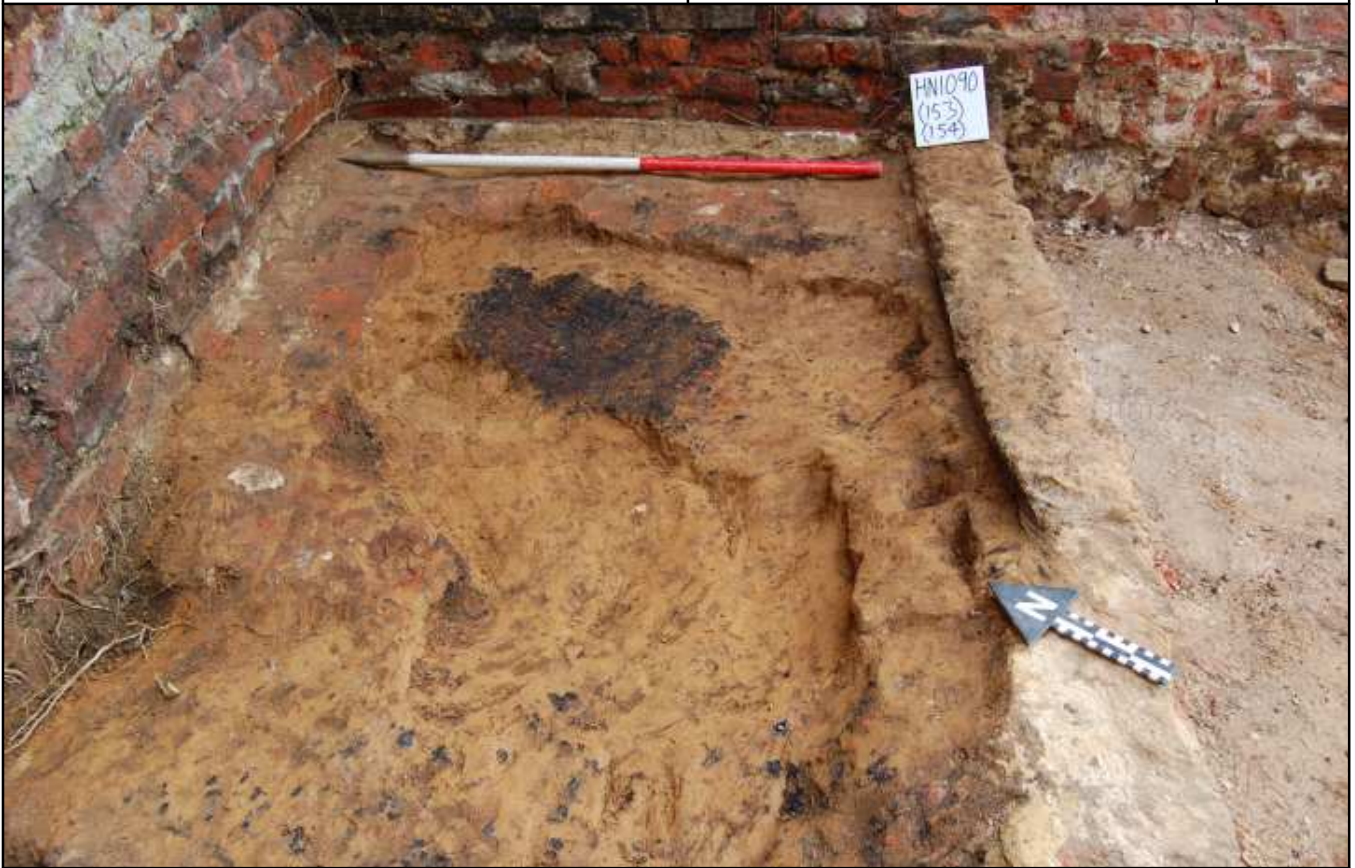
Plate 21: Oven [155] after removal of [150] & burnt layer (154), looking NE

- 2.37.8** An inverted L-shaped area of heat-marked clay, (154), was noted around the north-eastern and north-western edges of [155] (Plate 21). The markings appeared to indicate a brick structure surrounding the postulated oven. This was subsequently removed, possibly in the late 18th century, to lay floor [126]/[127].

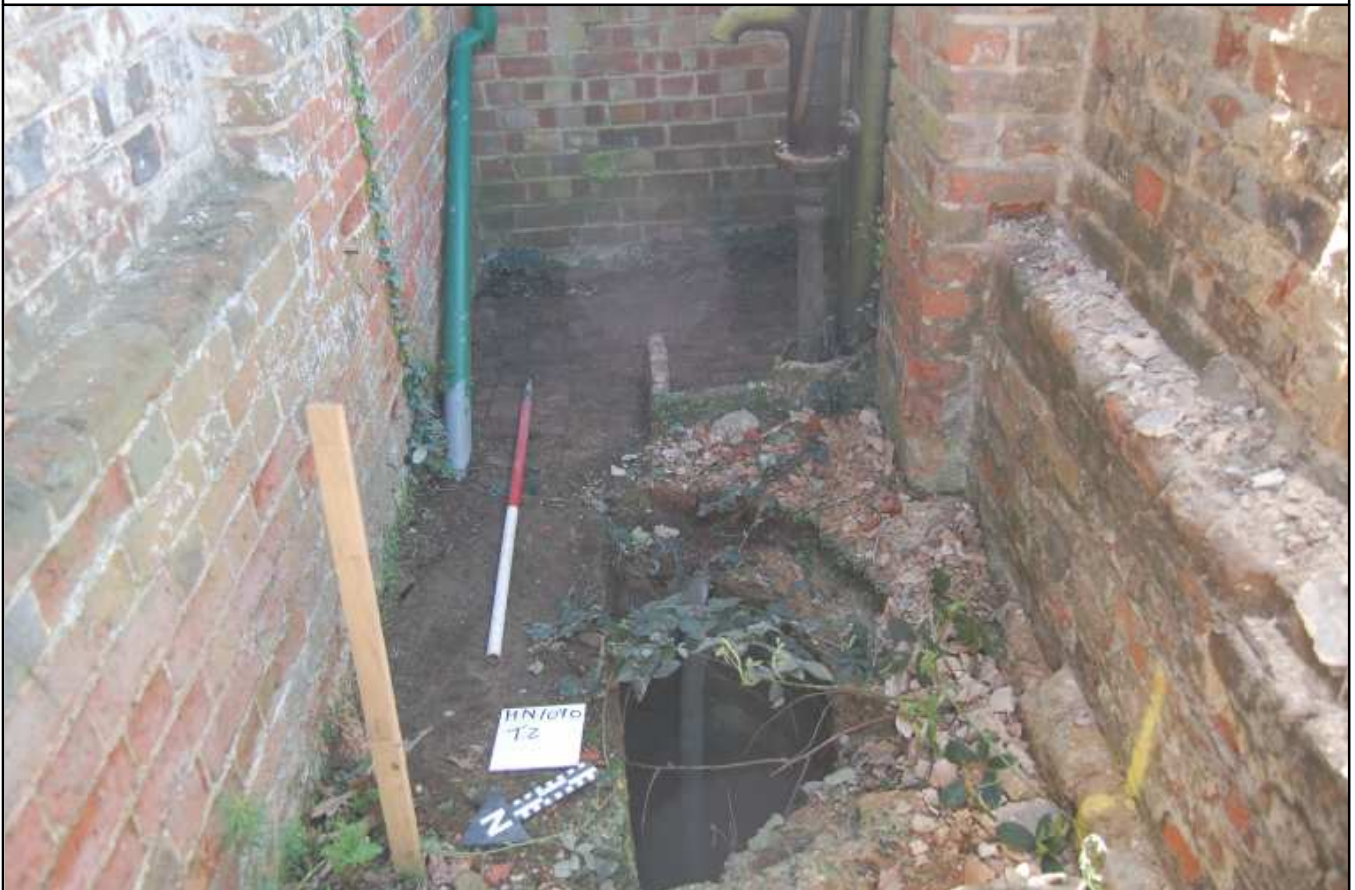
Plate 26: Well [204] before the start of groundworks, looking north-east

2.44 A circular brick well, [204] was exposed at the south-eastern end of Trench 2. It was capped by a millstone which was broken in half and visible prior to excavation, being flush with the existing brick surface (Plate 26). The well had an internal diameter of 0.92m and an external diameter of 1.12m and a depth of 4.35m below the present ground level. It was constructed of unfrosted red bricks, the top 15 courses of which had been set in mortar, while the lower courses were laid dry (Plate 27). No complete bricks were recovered, but the broken pieces have been dated to between 1800 and 1820.

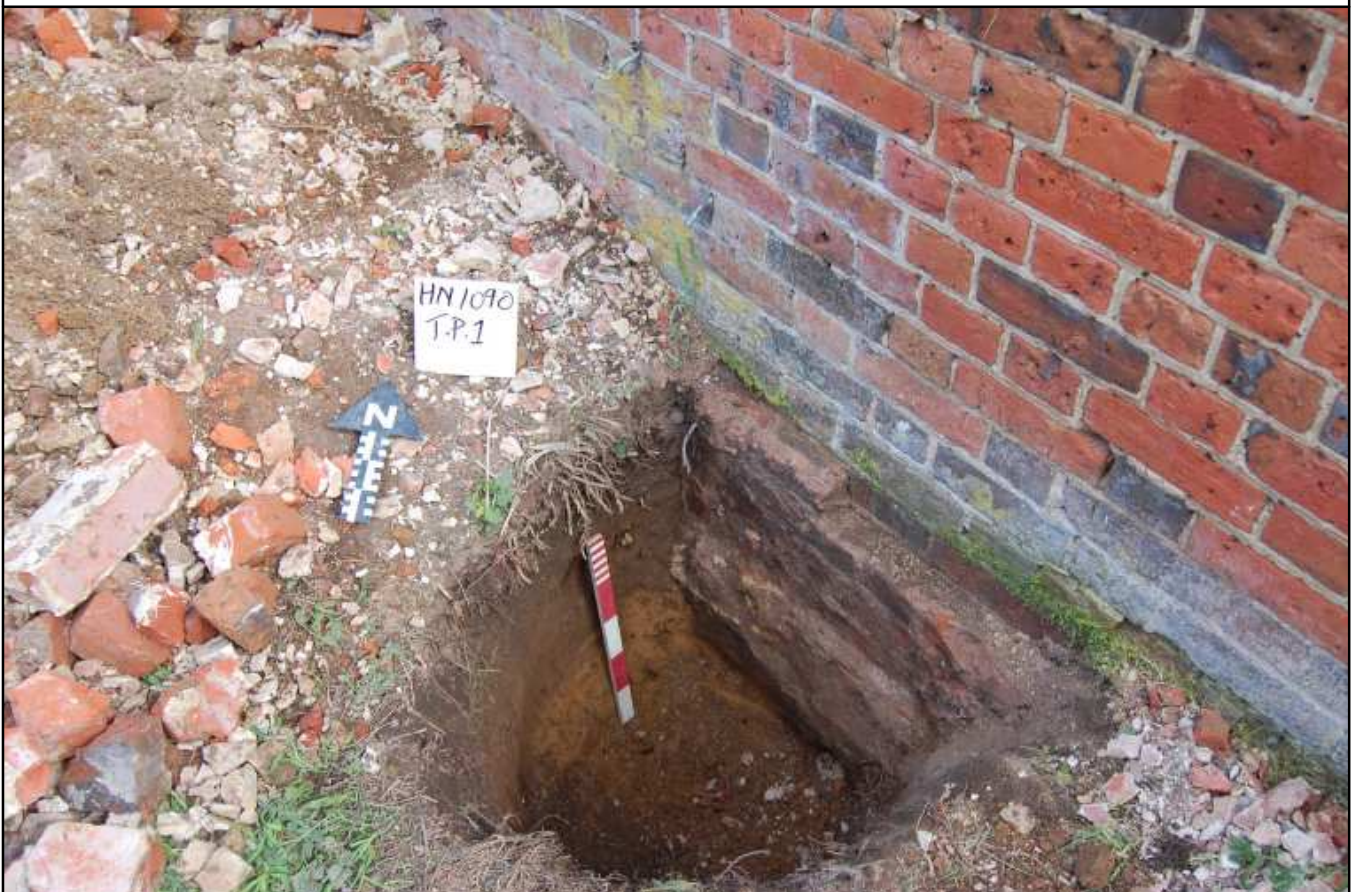
Plate 28: Test pit 1, looking north

2.47 The western section revealed that wall [201] had been built on a foundation of roughly coursed mortared sandstone, approximately 0.30m in depth (Plate 28). No clear evidence for a foundation trench was visible in the other sections.

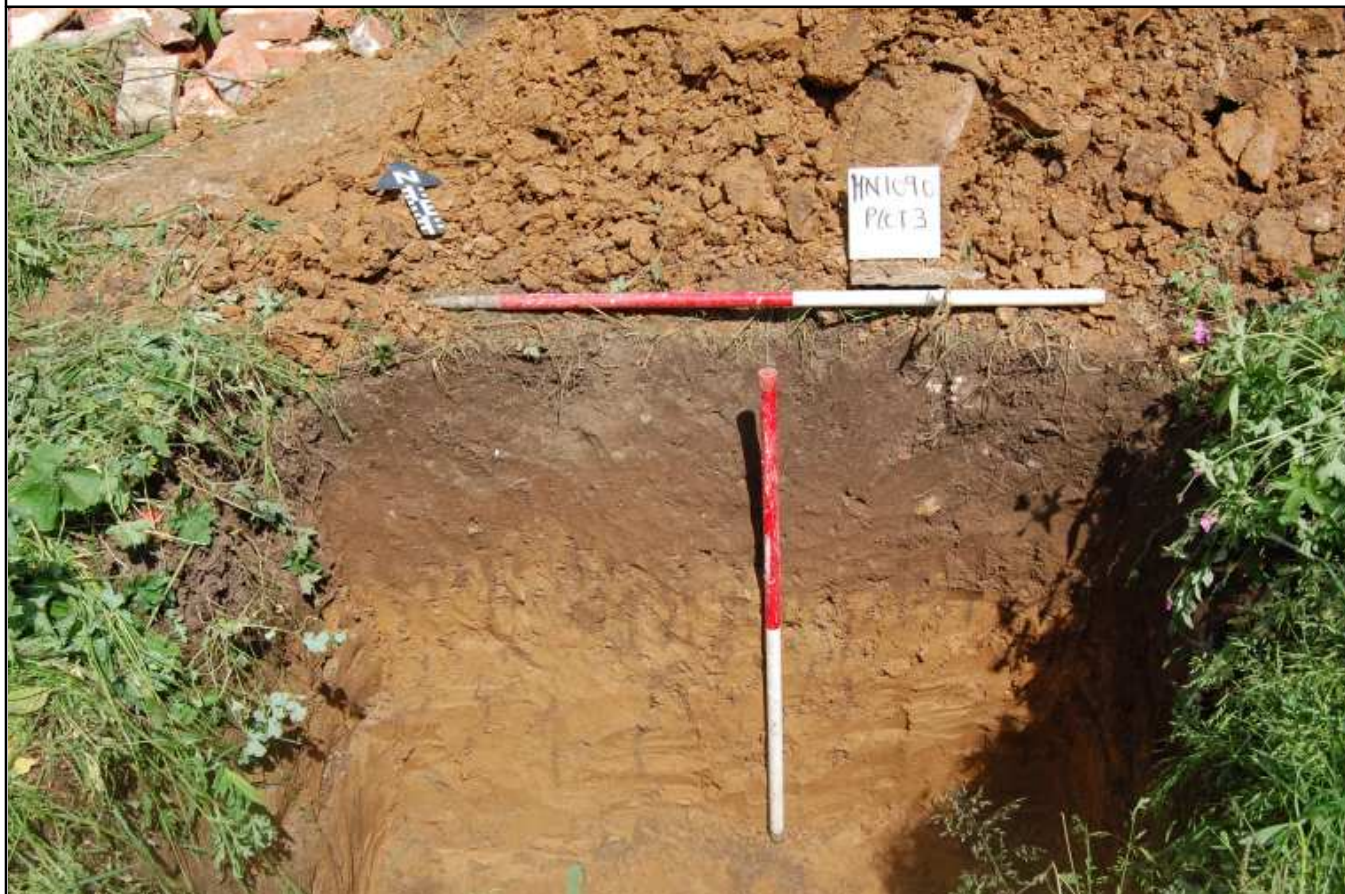
Plate 30: Soakaway, Trench 3, looking north-east
