CHURCH OF ST MARY THE VIRGIN, Stotfold, Beds.

HN1109

ARCHAEOLOGICAL MONITORING REPORT

CHURCH OF ST MARY THE VIRGIN Stotfold, Bedfordshire

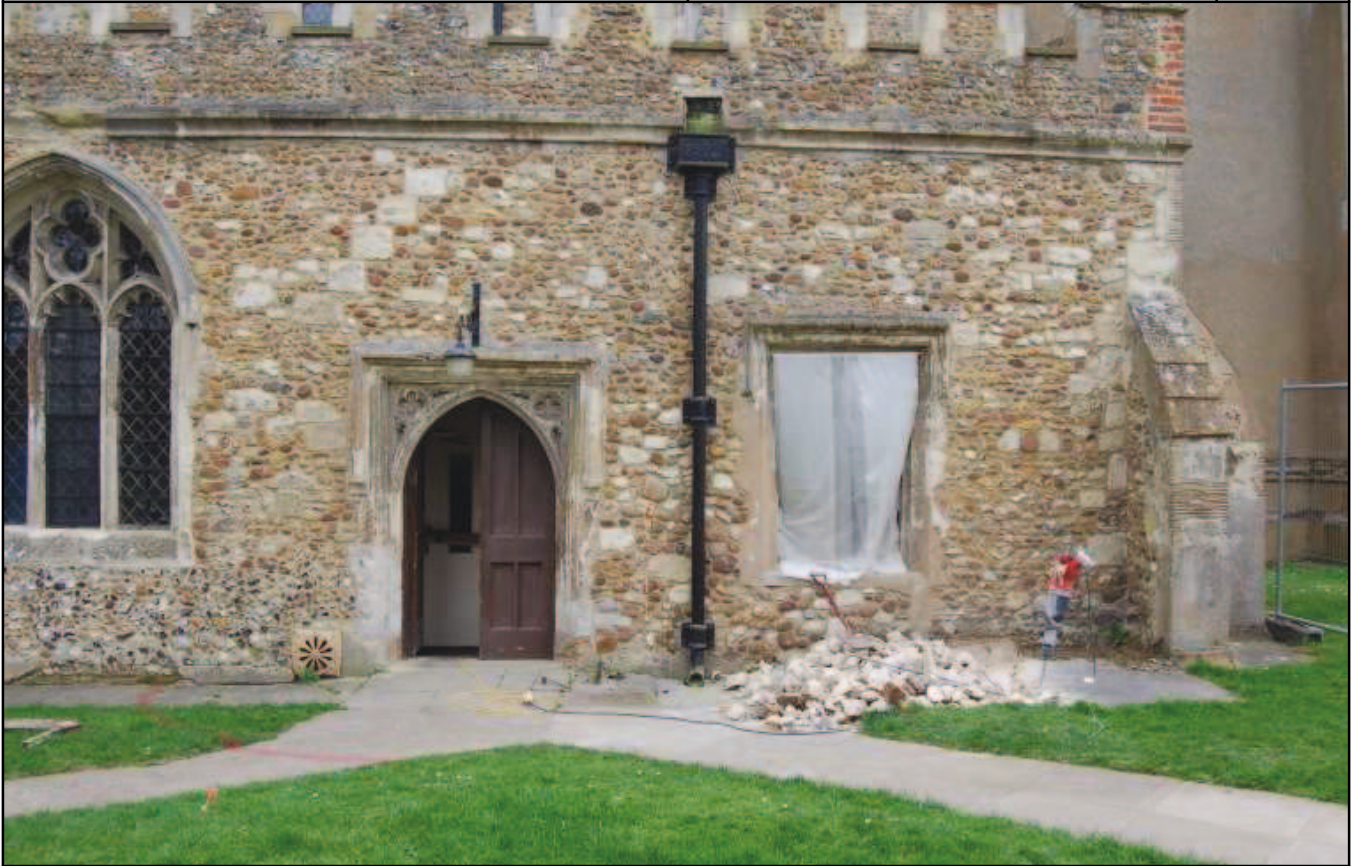
Plate 1: Pre-Excavation. North door, looking south

2.7 The present monitoring programme at St Mary's Church, covered the creation of a new disabled access to the north aisle entrance (Plate 1 & 14). This entailed a general ground reduction both internal and external to a new threshold. Part of the internal lobby was removed, the doorway lowered, the approaching two footpaths lowered and an overall external ground reduction to the new level. Excavation for a new drain was also undertaken.

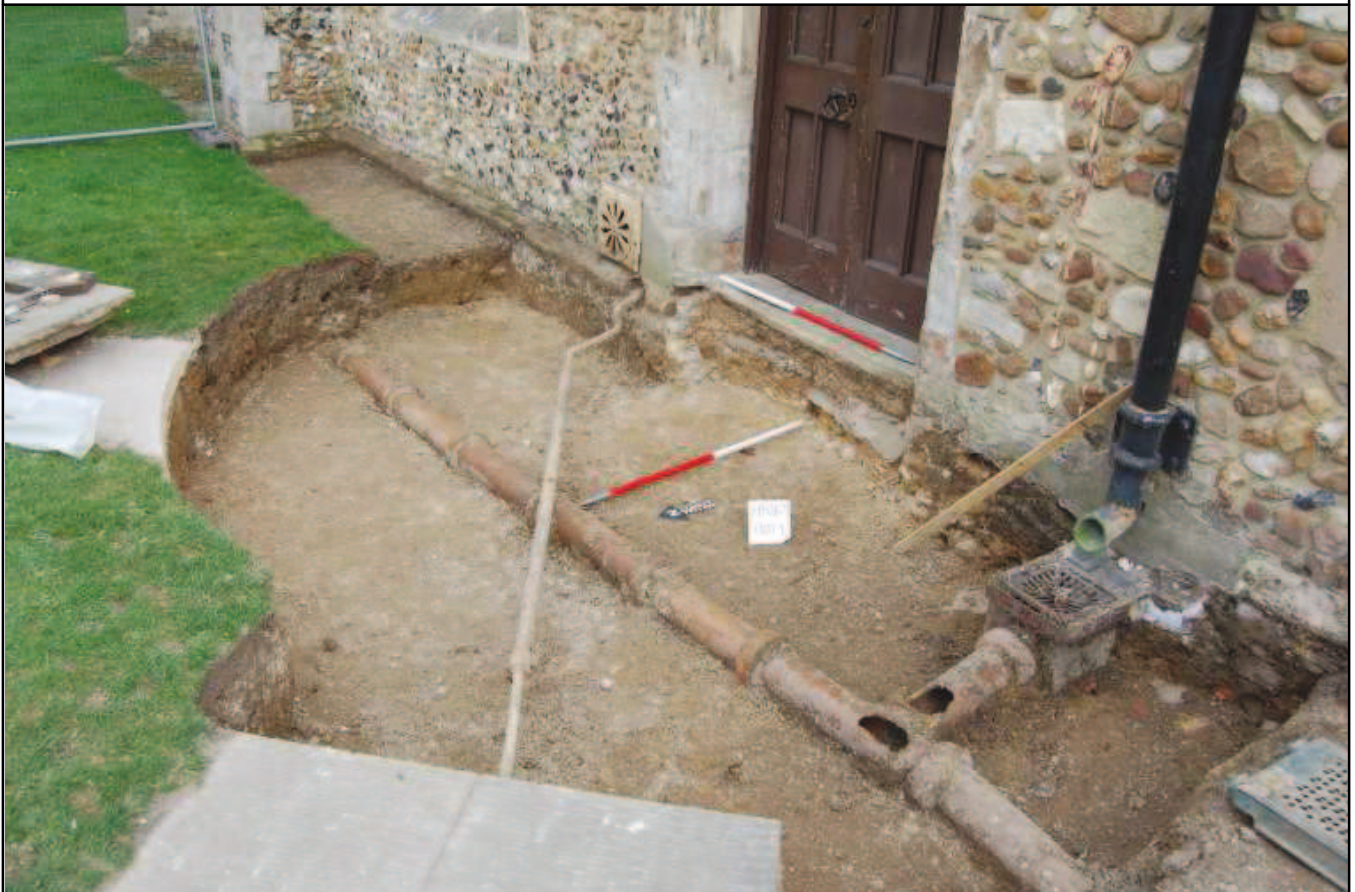
2.8 The ground immediately in front of the existing doorway was reduced by 0.5m below the existing surface. The excavated area had a semi-circular plan to accommodate a new, York stone paved entrance (Plate 2). It measured 2.5m in width and 5m in length. Either side of this, along the outside wall of the north aisle, the ground was also reduced by 0.5m. These two areas were both 0.9m wide and the combined excavated length was 10m.

2.9 The stratigraphy consisted of a 0.15m thick layer of loose dark brown (10YR 3/3) silty clay with moderate small sub rounded pebble inclusions, interpreted as a graveyard soil. This overlay a 0.35m thick layer of friable yellowish brown (10YR 5/4) silty clay with frequent small sub rounded flint, mortar, brick and tile inclusions.

Plate 2: External ground reduction, looking south-east

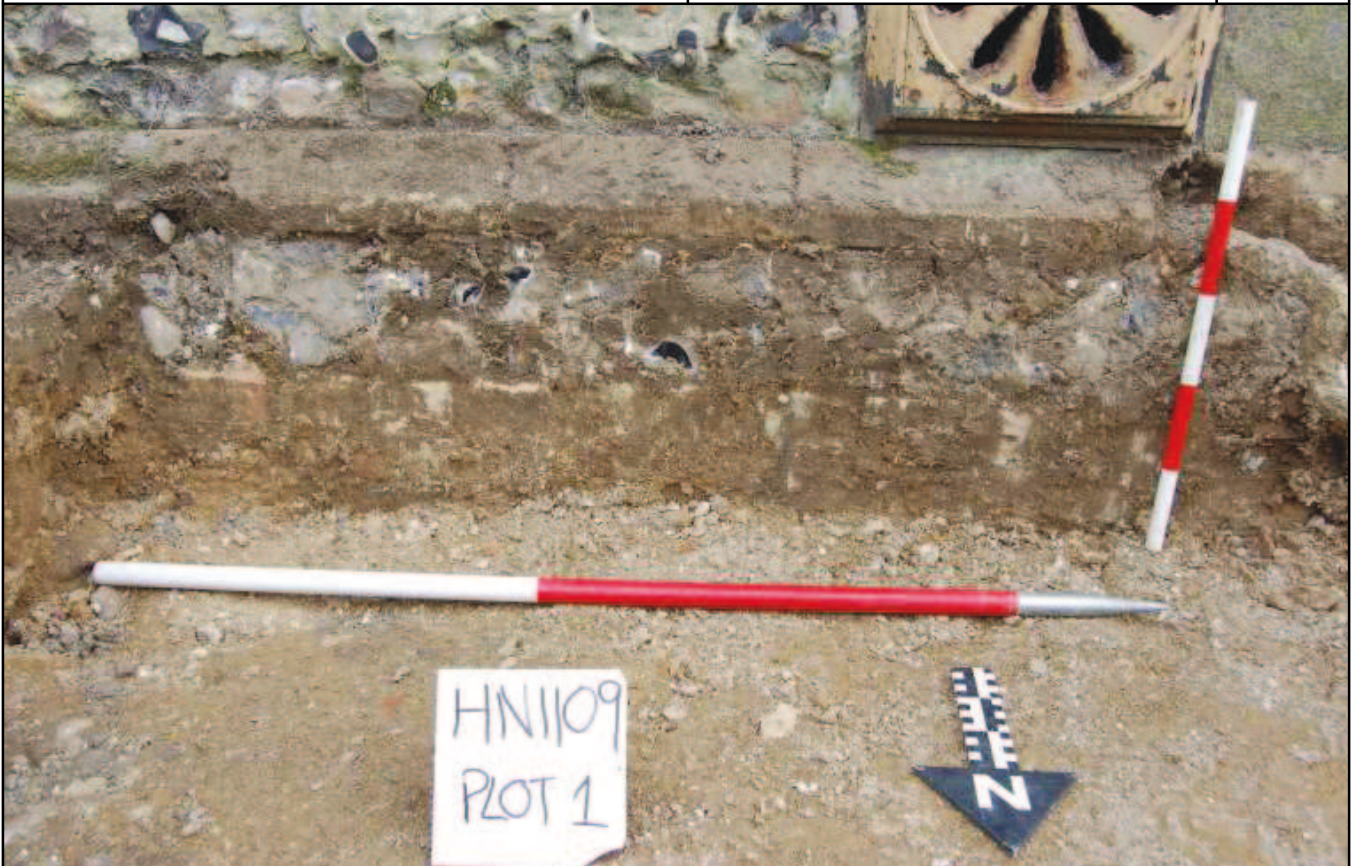
2.10 The foundation of the north aisle wall was revealed below the existing surface, consisting of a chamfered stringcourse formed in modern concrete above flint rubble, 0.18m deep. Below this were two courses of Arlesey white brick underpinning (Plate 3). The upper

Plate 3: Exposed underpinning to north aisle wall, looking south

3.8 The works also revealed the foundation of the north aisle below the existing ground surface, consisting of a chamfered stringcourse formed in modern concrete above a course of flint rubble which overlay two courses of Arlesey white bricks.

3.12 The ground reduction to the existing paths and grassed area on the exterior of the north aisle revealed graveyard soil with no significant archaeological features, deposits or finds. The foundations of the north aisle wall were exposed, however, and were shown to have been underpinned with Arleseey white brick and repaired with a chamfered string course in concrete. This modern underpinning extended the length of the exposed section.

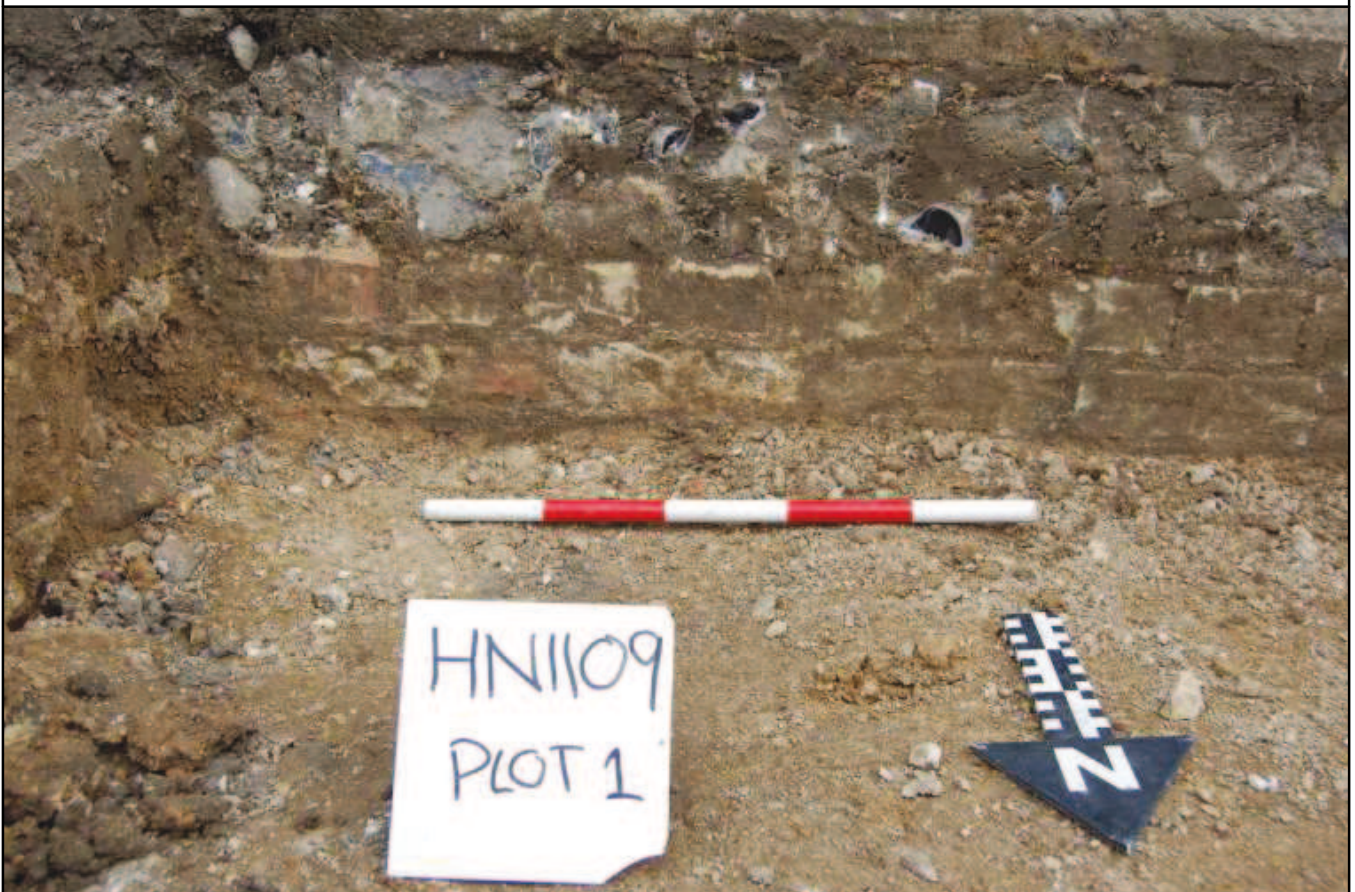
was a row of headers (0.11m x 0.07m). The lower course was a row of headers (0.11m x 0.07m) and stretchers (0.22m x 0.07m) (Plate 4).

Plate 4: North aisle underpinning, showing Arleseey white bricks

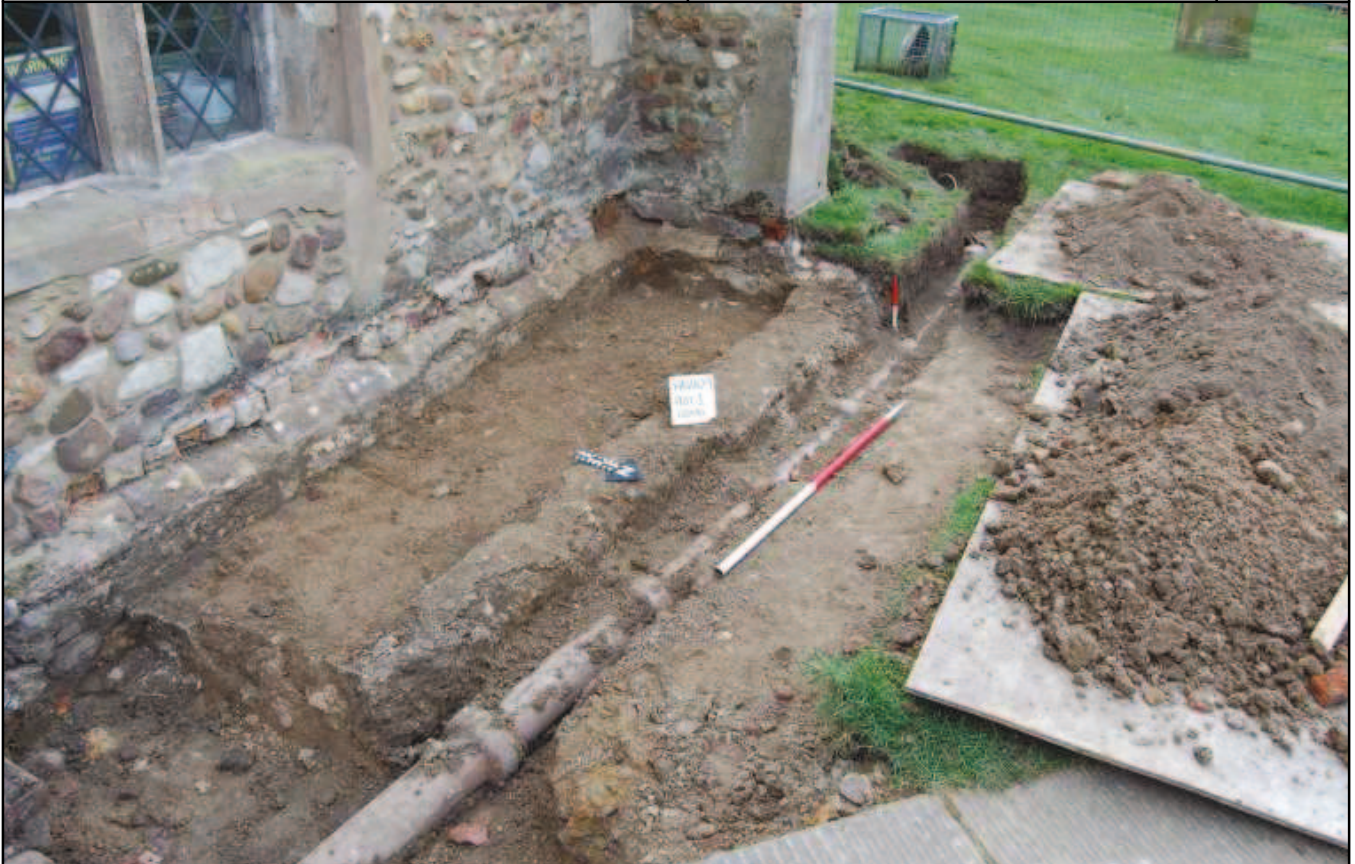
2.11 Within the excavated area a modern gas main was exposed as well as an existing ceramic rainwater drain. To allow this to be reused (rather than a new drain and soakaway being created, as originally proposed) the ground level required lowering by a further 0.25m. To achieve this a 0.3m wide trench was dug on the same line, running parallel with the north aisle wall (Plate 5). The stratigraphy revealed a continuation of the previously observed friable yellowish brown (10YR 5/4) silty clay.

Plate 5: Lowering of existing drain, looking south-west

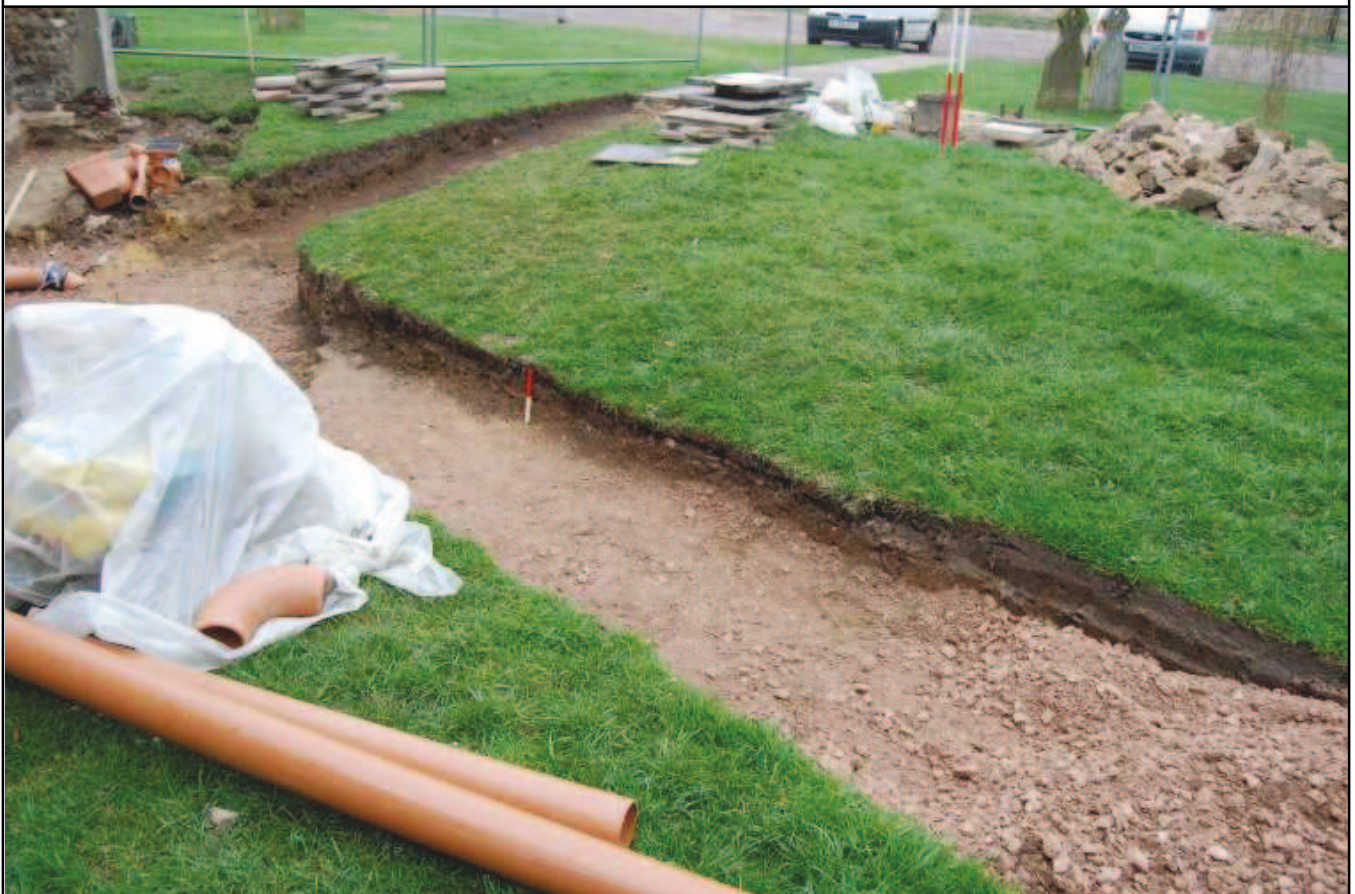
2.12 The two existing footpaths leading to the north aisle entrance were also reduced to the level of the new threshold (Plate 6). The excavated area for the eastern path (Plate 7) measured 3.3m in length and 1.1m wide. The excavated area for the western path (Plate 8) measured 5.6m in length and 1.4m wide.

2.13 Following the removal of the existing concrete slab, each footpath was graded from 0.15m at their northern ends, to 0.3m where they connected with apron in front of the door. The stratigraphy below the concrete slabs consisted of a mixed levelling layer of hardcore and sand. This overlay the loose dark brown (10YR 3/3) silty clay graveyard soil.

Plate 6: Footpath reduction, looking north-west

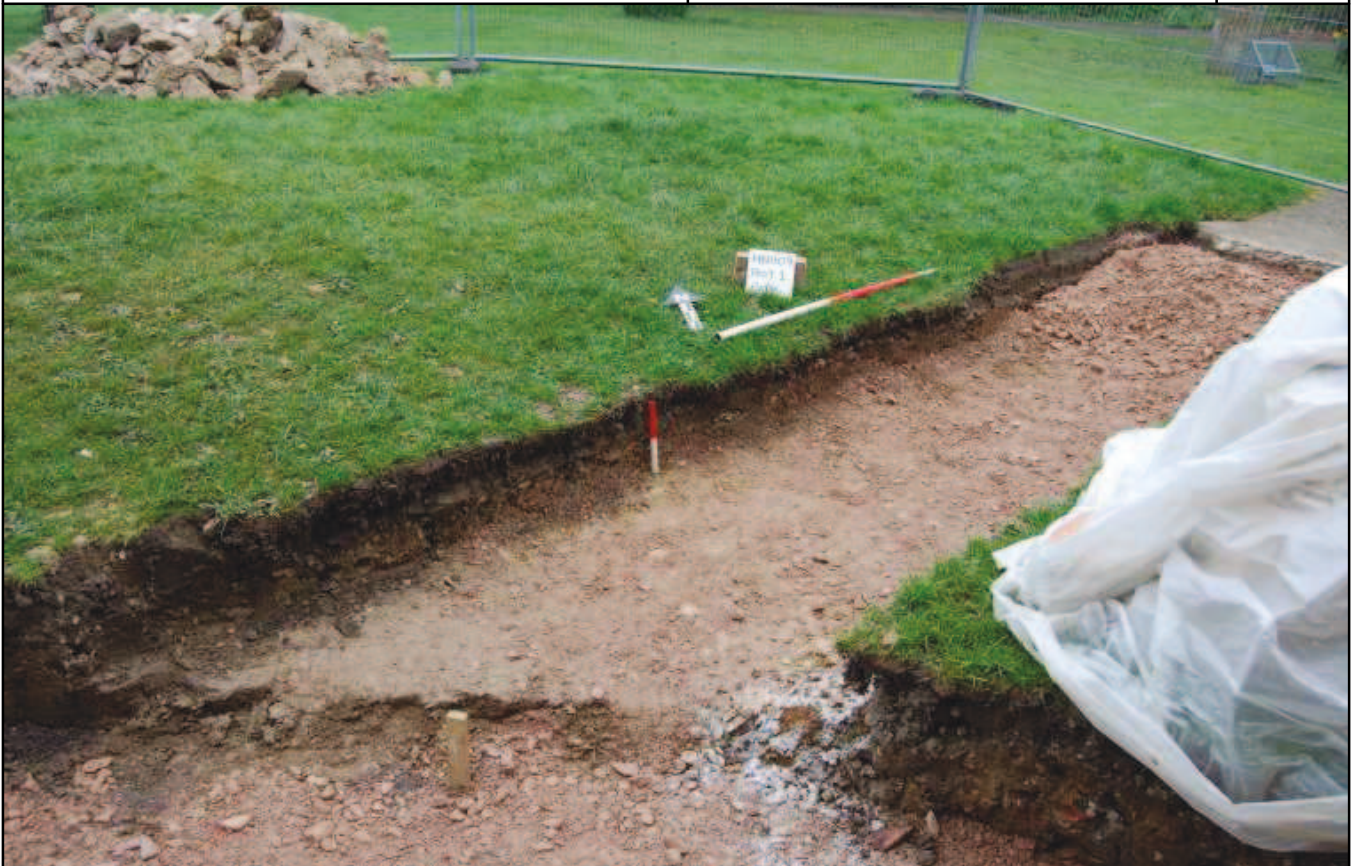
Plate 7: Eastern path, as reduced, looking north

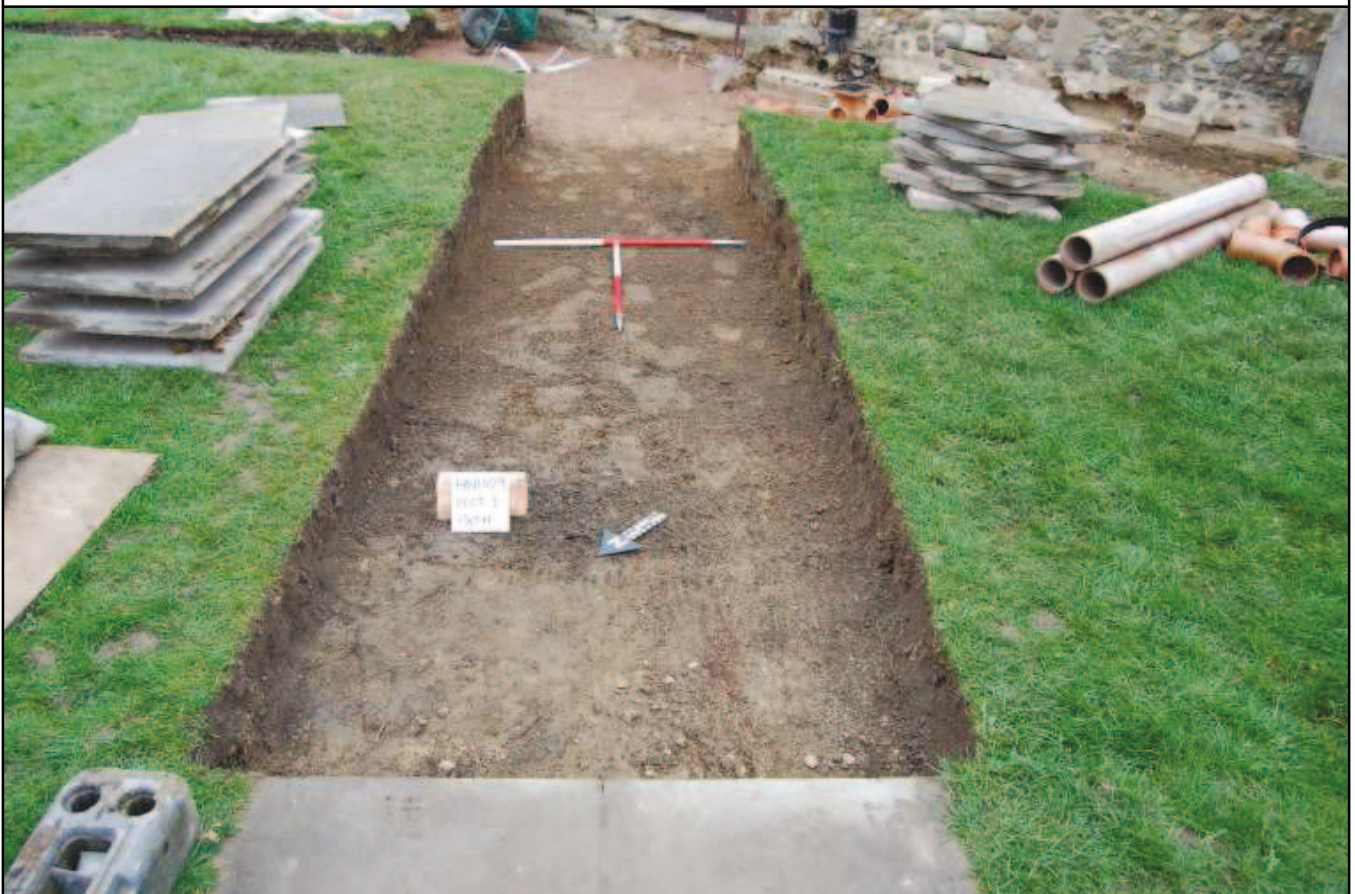
Plate 8: Western path, as reduced, looking south-east

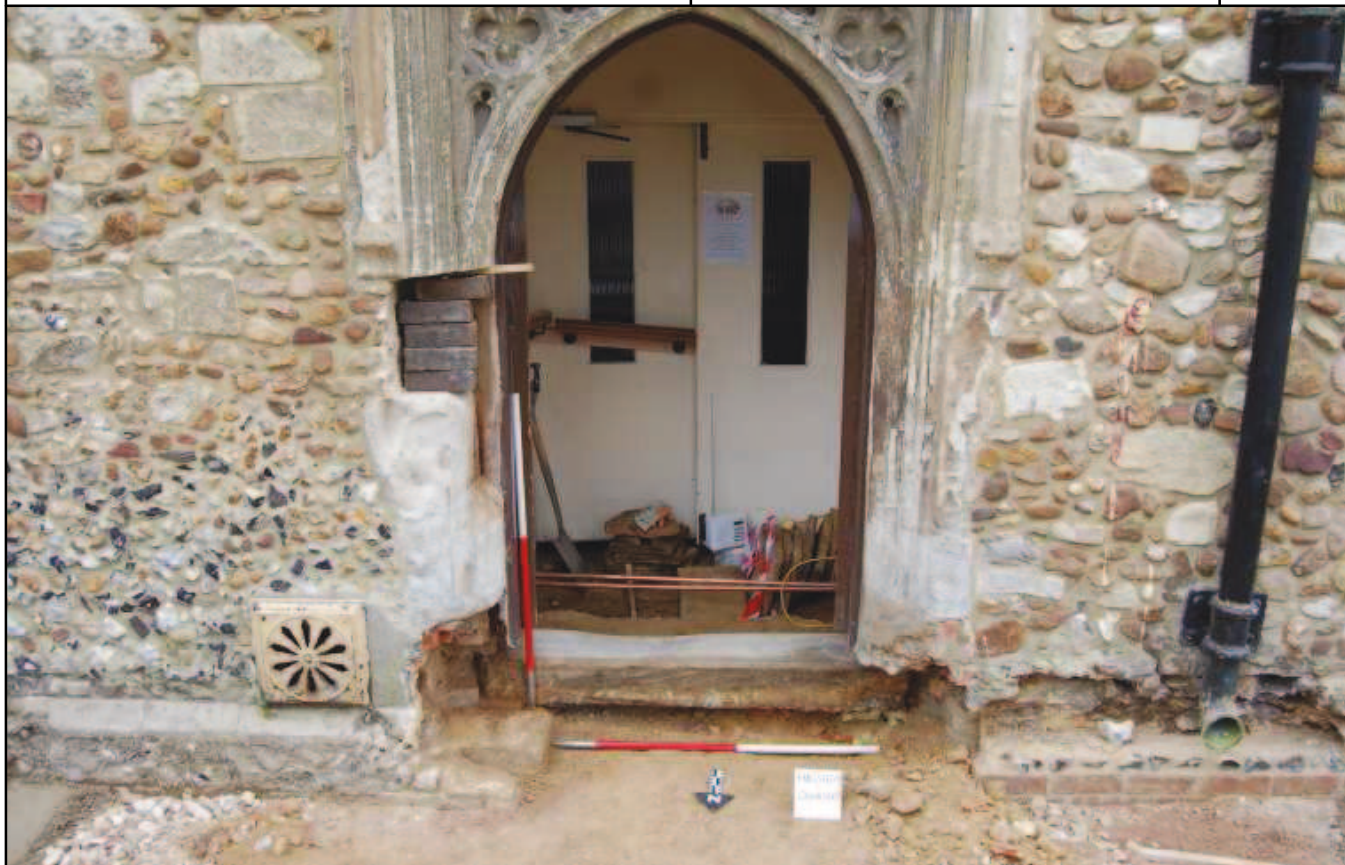
2.17 The work on the doorway involved the removal of the lower portions of the existing stone door frame and their replacement with new stonework (Plate 9). The existing York stone steps in the entrance were also removed.

Plate 9: North doorway, looking south

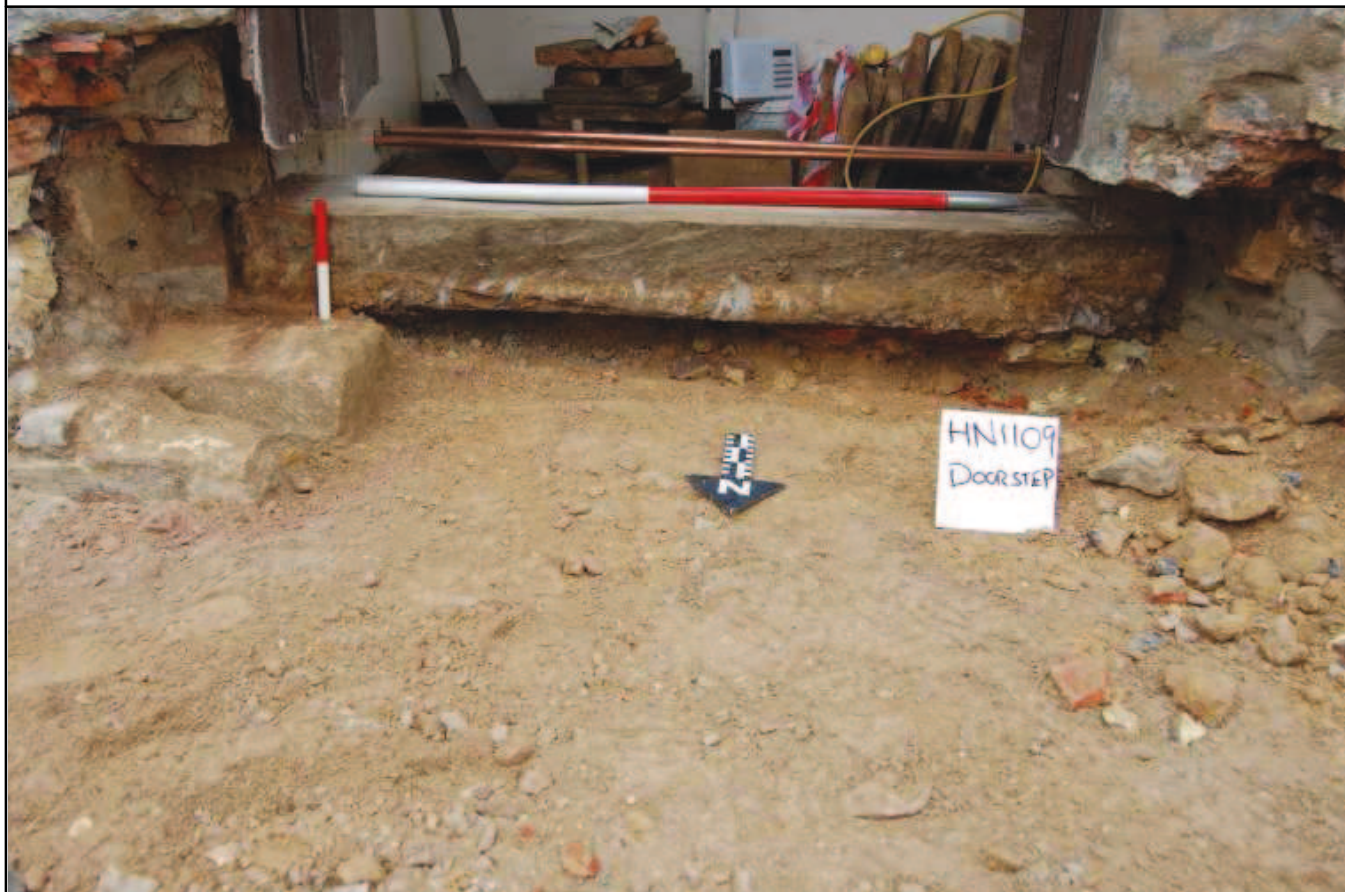
2.18 Once the first and upper step had been removed a second lower step was discovered, also in York stone (Figure 3 & 4). It measured 1.5m in length, 0.3m in width and 0.15m in thickness and was worn in the middle. It was lying on top of post-medieval red brick and tile fragments (Plate 10), which also included Arlesey white brick similar to that observed in the underpinning of the north aisle wall.

Plate 10: York stone step, showing underpinning material, looking south

3.9 The lowering of the north aisle doorway and the removal of parts of the stone door frame revealed a heavily worn York stone step bedded on a levelling layer of compacted red brick, tiles and Arleseey white brick.

3.13 Similar underpinning was noted below a hidden York stone slab within the entrance.

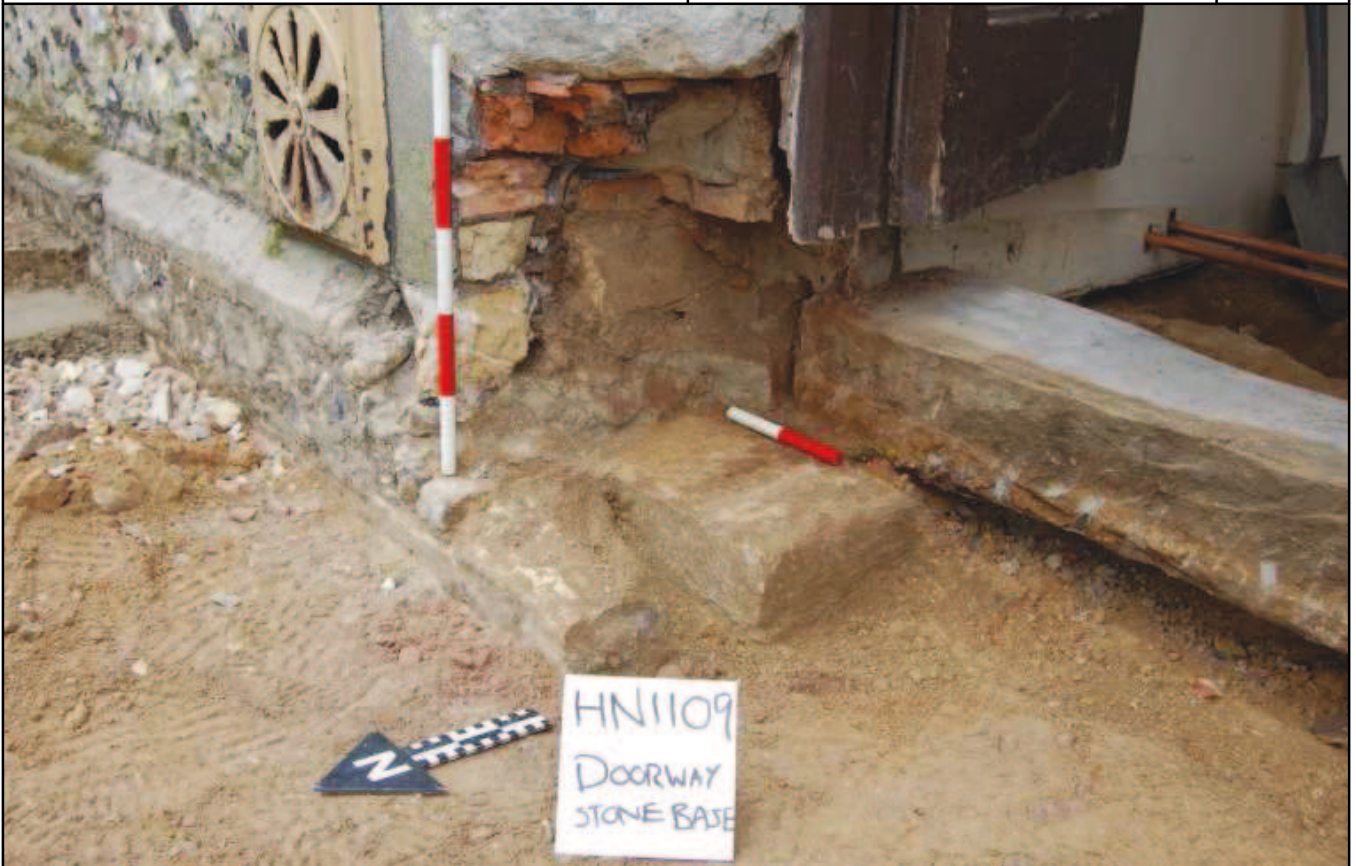
2.19 During this stage of work, a stone block was revealed at the east end of the exposed doorway, below the current ground level and within the wall fabric (Figure 3 & 4, Plate 11). It appeared to be square in shape with straight, smooth edges, and was overlain by the east end of the previously recorded lower step (Plate 12). It may mark the end of an earlier threshold to the doorway.

Plate 11: Exposed York stone block, looking south-east

3.10 Within the wall fabric at the east end of the doorway a square stone block, possibly part of an earlier threshold with straight, smooth sides was revealed.

3.14 A York stone block at the base of the east end of the doorway may represent part of an earlier threshold.

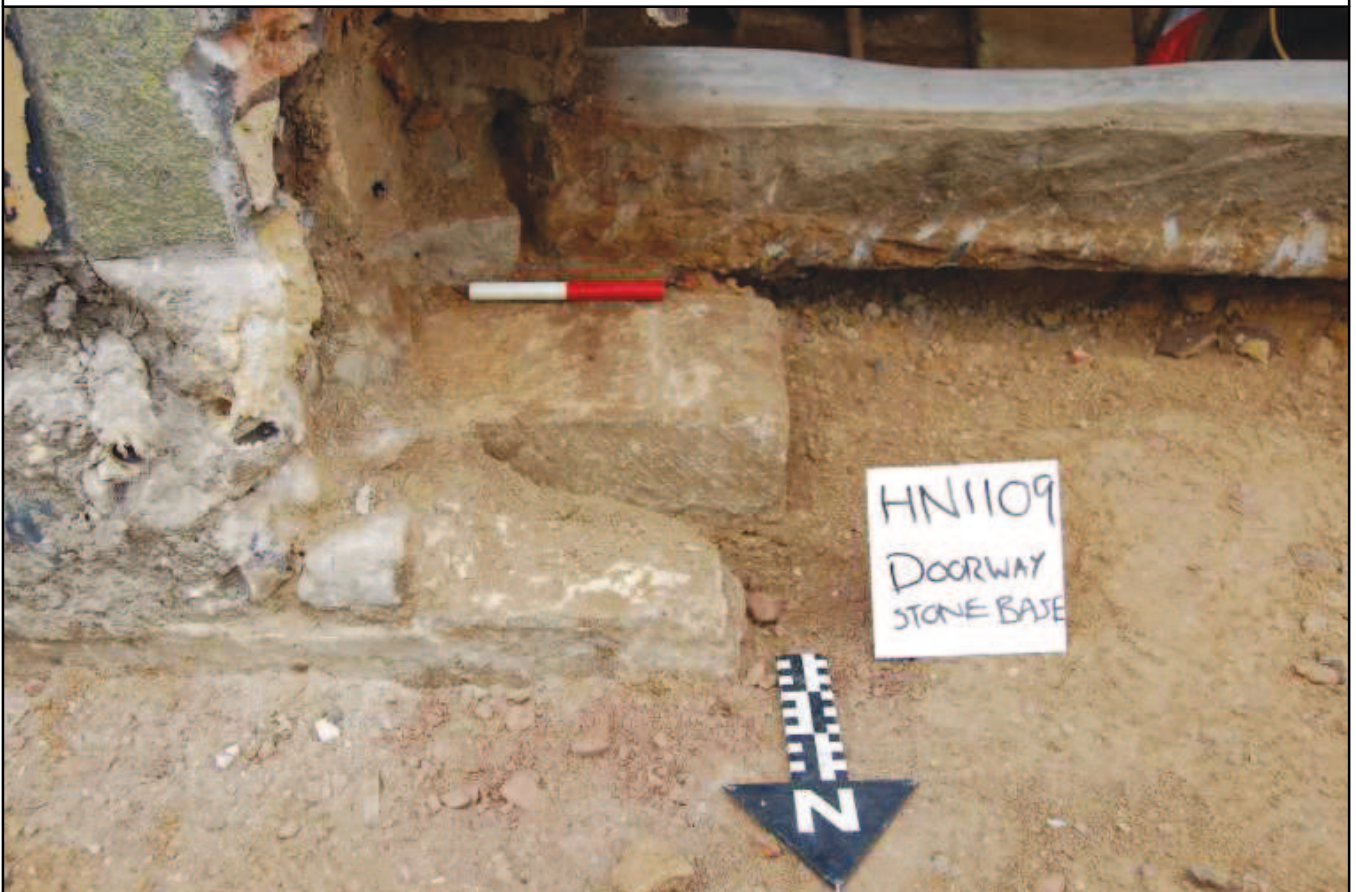
Plate 12: Exposed York stone block, looking south

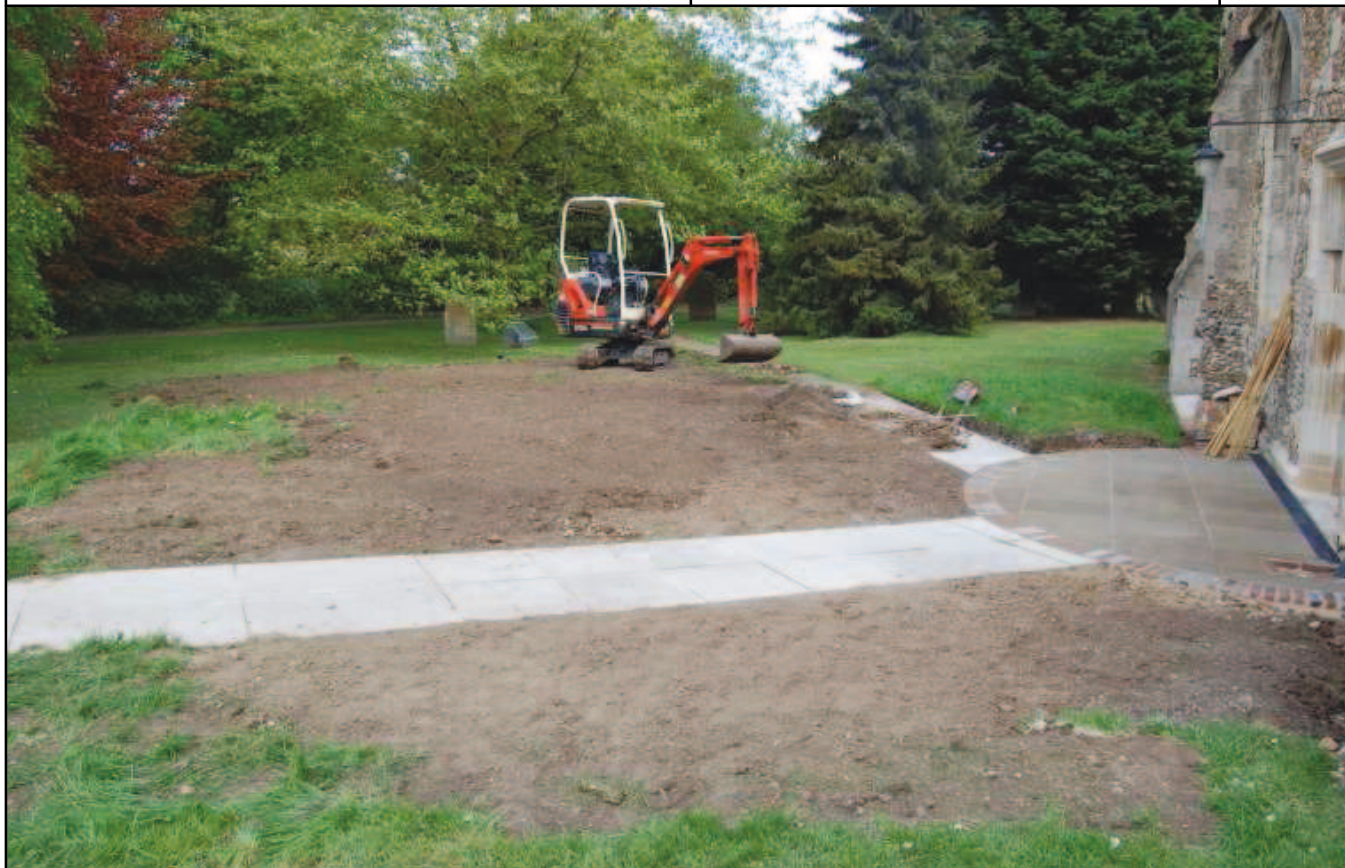
2.14 In addition, the entire grassed area around the north aisle entrance was reduced and graded to match the new footpaths and doorway (Plate 13). The excavation revealed the loose dark brown (10YR 3/3) silty clay graveyard soil observed across site.

Plate 13: Grading of grassed area around entrance, looking east

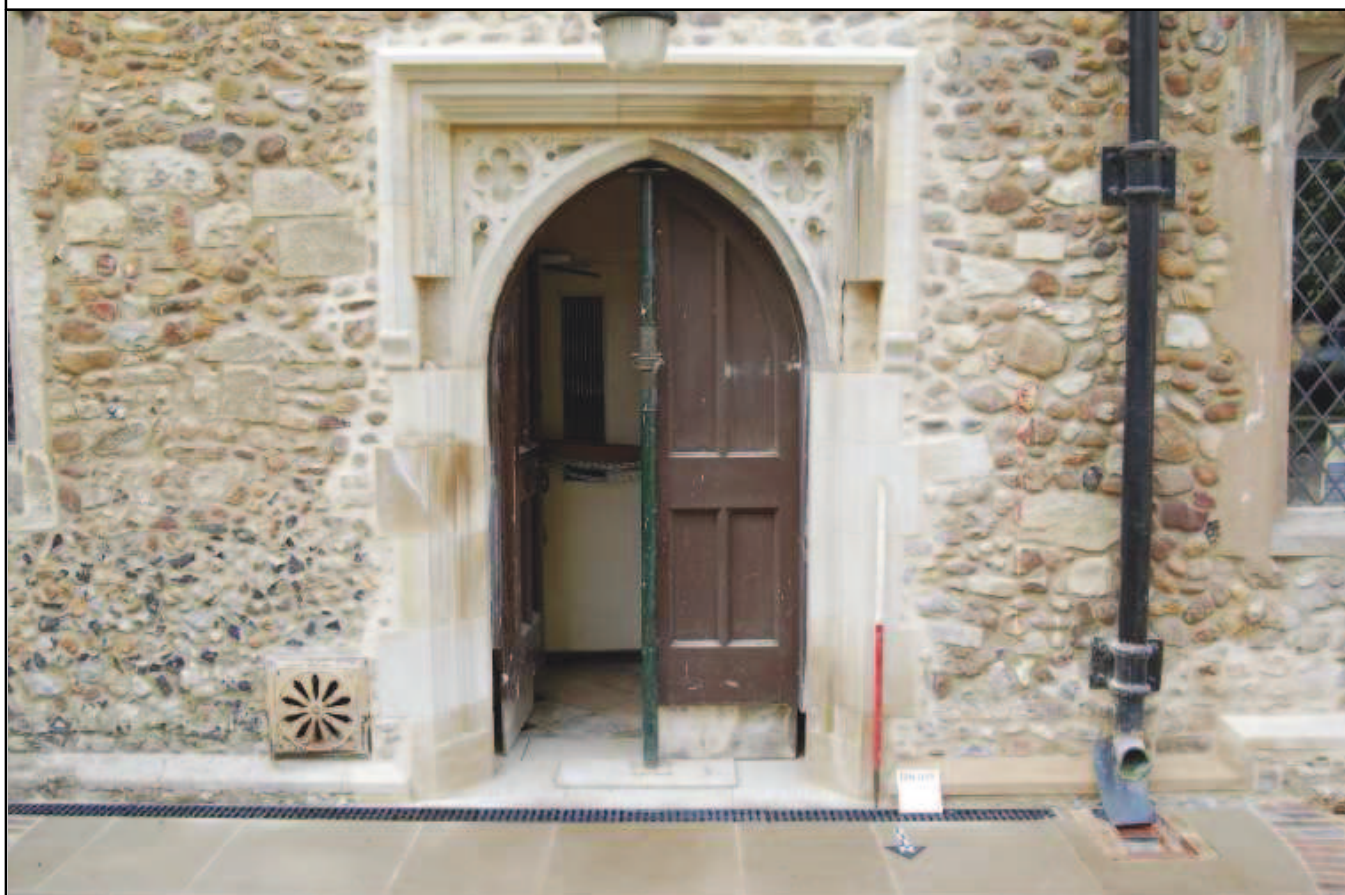
Plate 14: New north doorway, looking south
