**Land South-West of  
REED HALL  
Church Lane, Reed, Herts.**

*(HN617)*

*Archaeological Monitoring Report*

Report no. 361

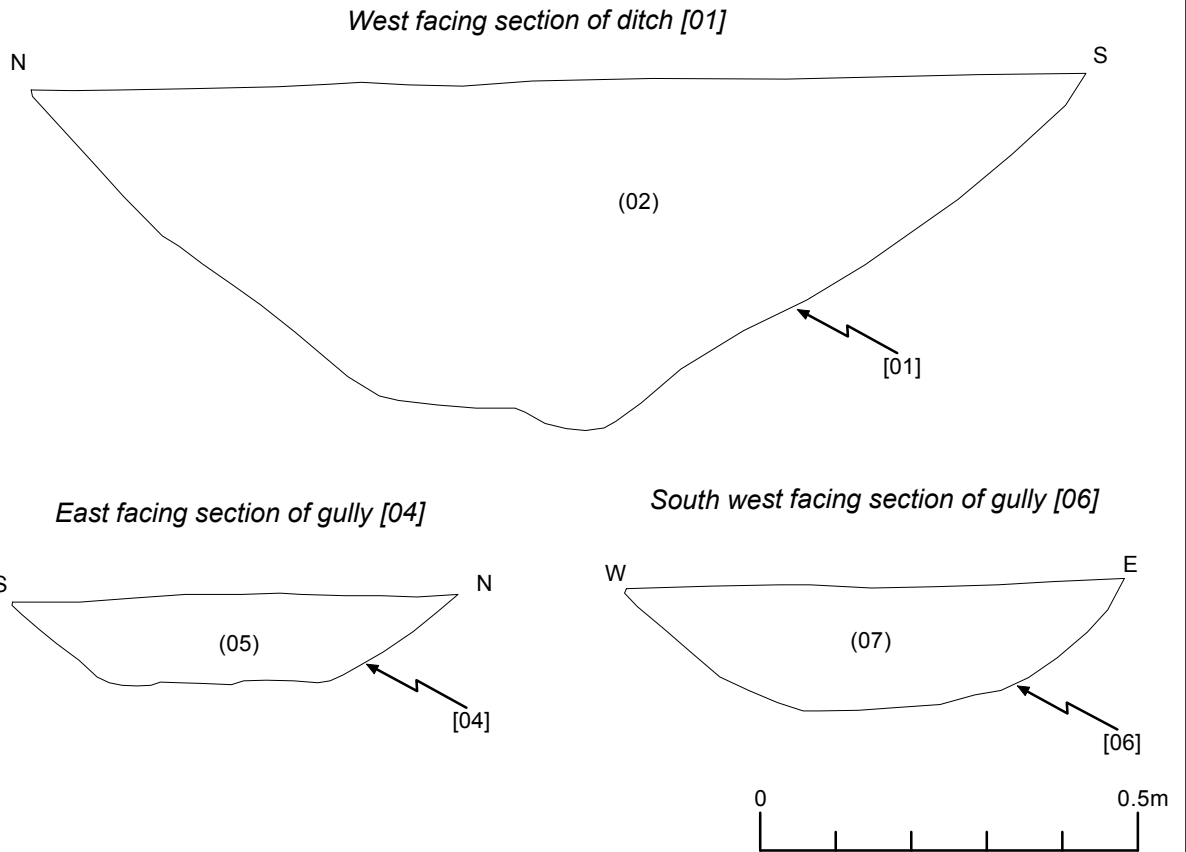
Figure 4

**2.8** The ditch [01] measured 1.4m wide, 0.46m deep and was greater than 10.6m in length. It was clearly visible in the subsoil up to 3m beyond the reduced area on the eastern side, where the edge of the excavation had been battered. It was orientated NW-SE and may have been a boundary ditch.

**2.9** The fill [02] consisted of a firm, light olive brown (2.5Y 5/6), slightly silty clay with frequent sub-ovoid flints less than 50mm in length.

Sections

**2.11** Gully [04] was 0.6m wide, 0.14m deep and greater than 4.3m in length. Its fill consisted of a firm, light olive brown (2.5Y 5/4), slightly silty clay with occasional sub-ovoid flints less than 30mm in length.

**2.12** Gully [06] was a curvilinear feature 0.7m wide, 0.17m deep and greater than 3.5m in length. Its fill consisted of a firm, dark yellowish brown (10YR 4/6), slightly silty clay with flecks of ironstone and occasional sub-ovoid flints less than 30mm in length.
