HUNSDON AIRFIELD **Hunsdon, Herts.**

Archaeological Monitoring Report

HN598

Report no. 384

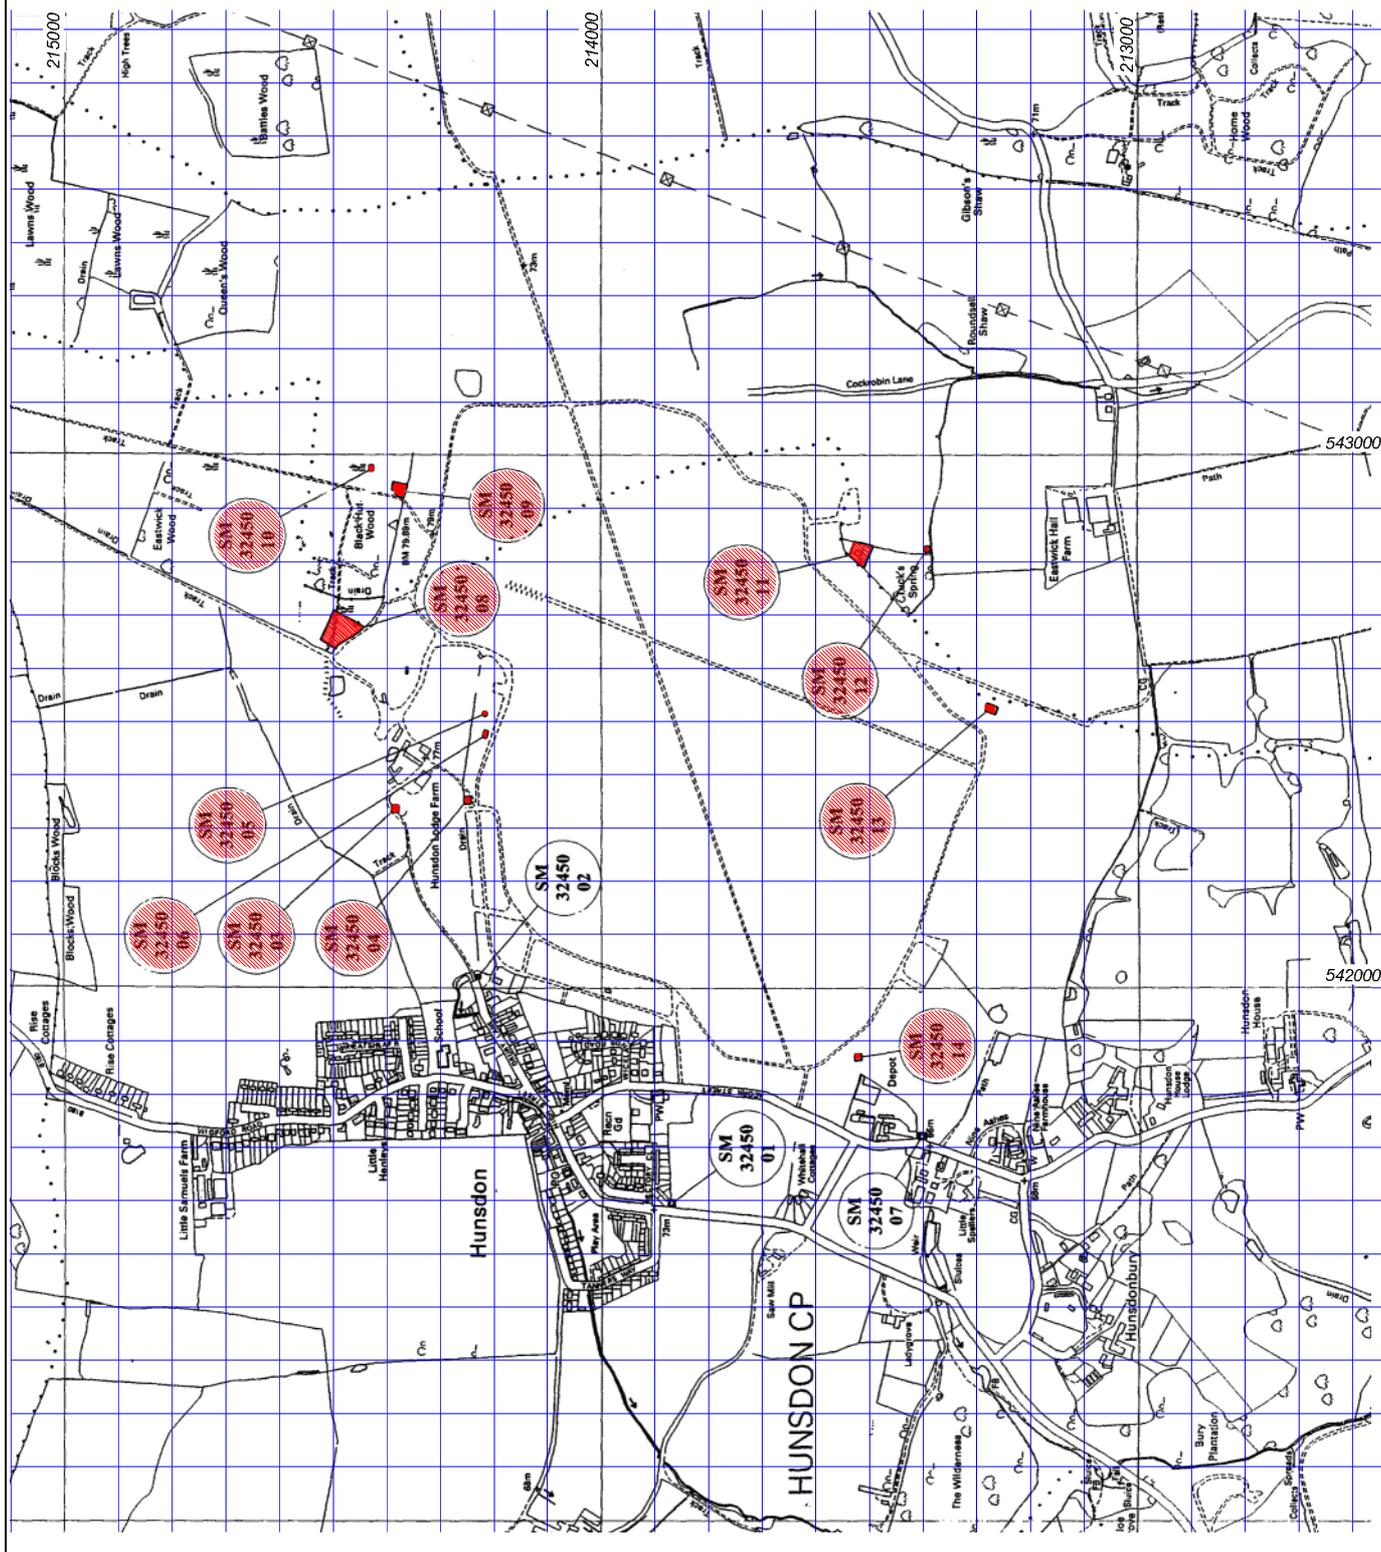
Figure 2

- Area 3: Hunsdon-type hexagonal pillbox
- Area 4: Hunsdon-type hexagonal pillbox
- Area 5: Cantilever pillbox
- Area 6: Stanton-type air-raid shelter
- Area 8: Hunsdon-type hexagonal pillbox + ammunition store
- Area 9: Hunsdon-type hexagonal pillbox + ammunition store
- Area 10: Hunsdon-type hexagonal pillbox + ammunition store
- Area 11: Sleeping shelter
- Area 12: Type 22 hexagonal pillbox
- Area 13: Battle headquarters
- Area 14: Hunsdon-type hexagonal pillbox

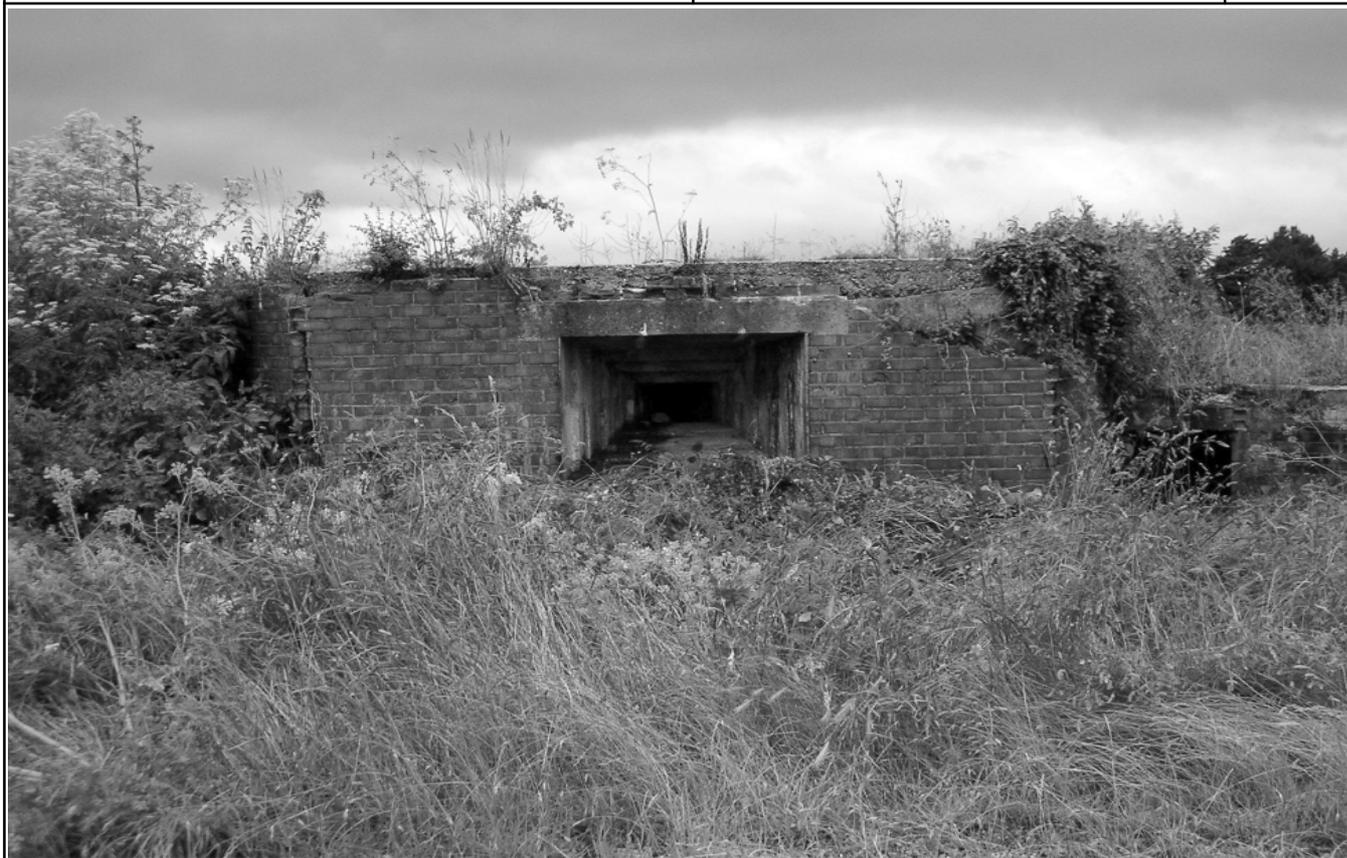
Plate 1: Area 4, Hunsdon-type hexagonal pill-box, looking north

2.7 Areas 3 and 4 are located in the north eastern part of the site. Both contain a single hexagonal concrete and brick Hunsdon-type pill-box (Plate 1). The structures are entered via a low L-shaped tunnel with anti-ricochet brickwork (Plate 2). The single internal chamber has a maximum width of 4m, a central Y-shaped anti-ricochet partition, and a corrugated ceiling (Plate 3). The pillboxes contained dumped soil and modern building debris. No artefacts contemporary with the structures' wartime role were observed or recorded.

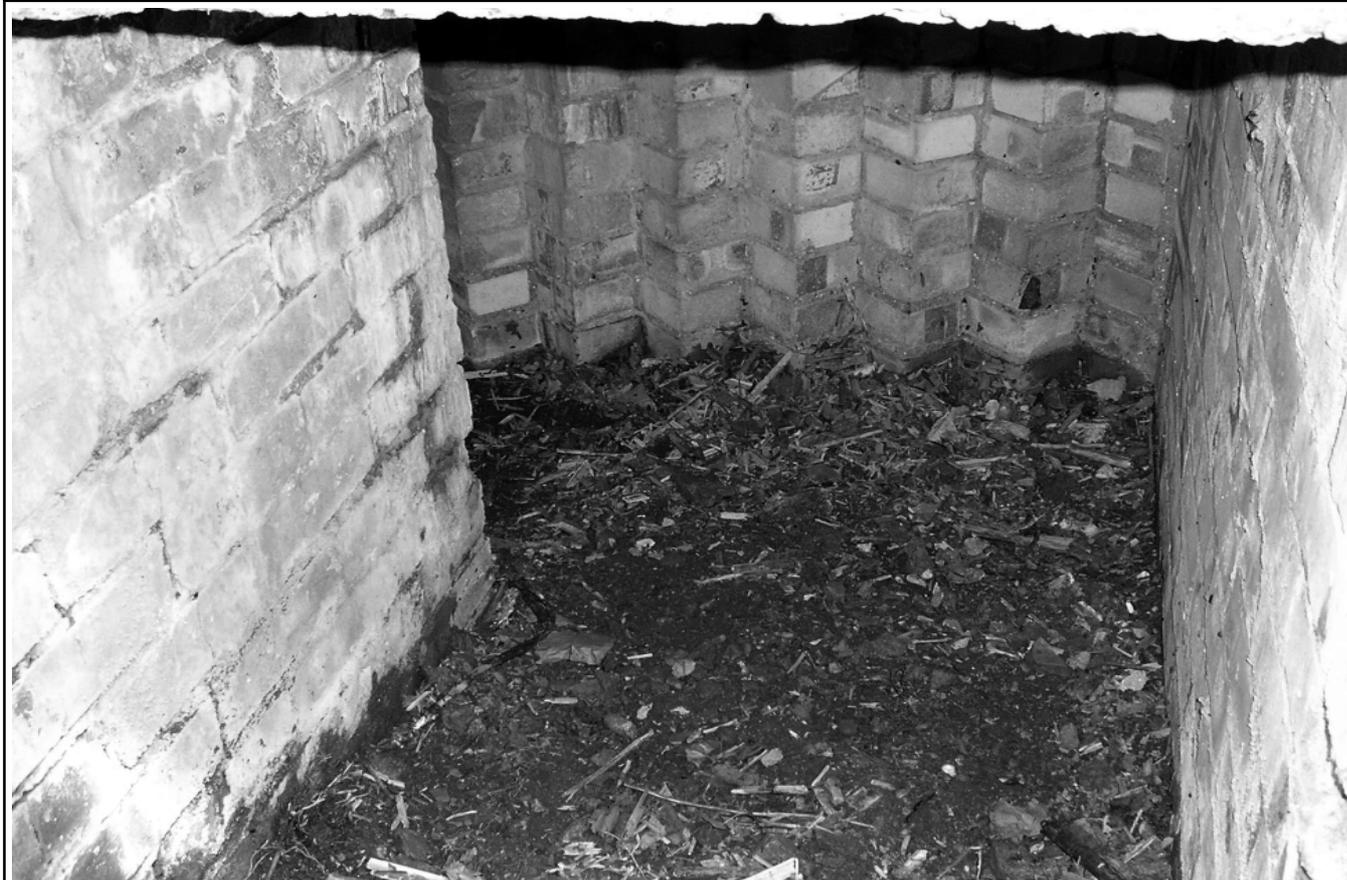
Plate 2: Area 3, Hunsdon-type hexagonal pill-box,
entrance way and anti-ricochet wall

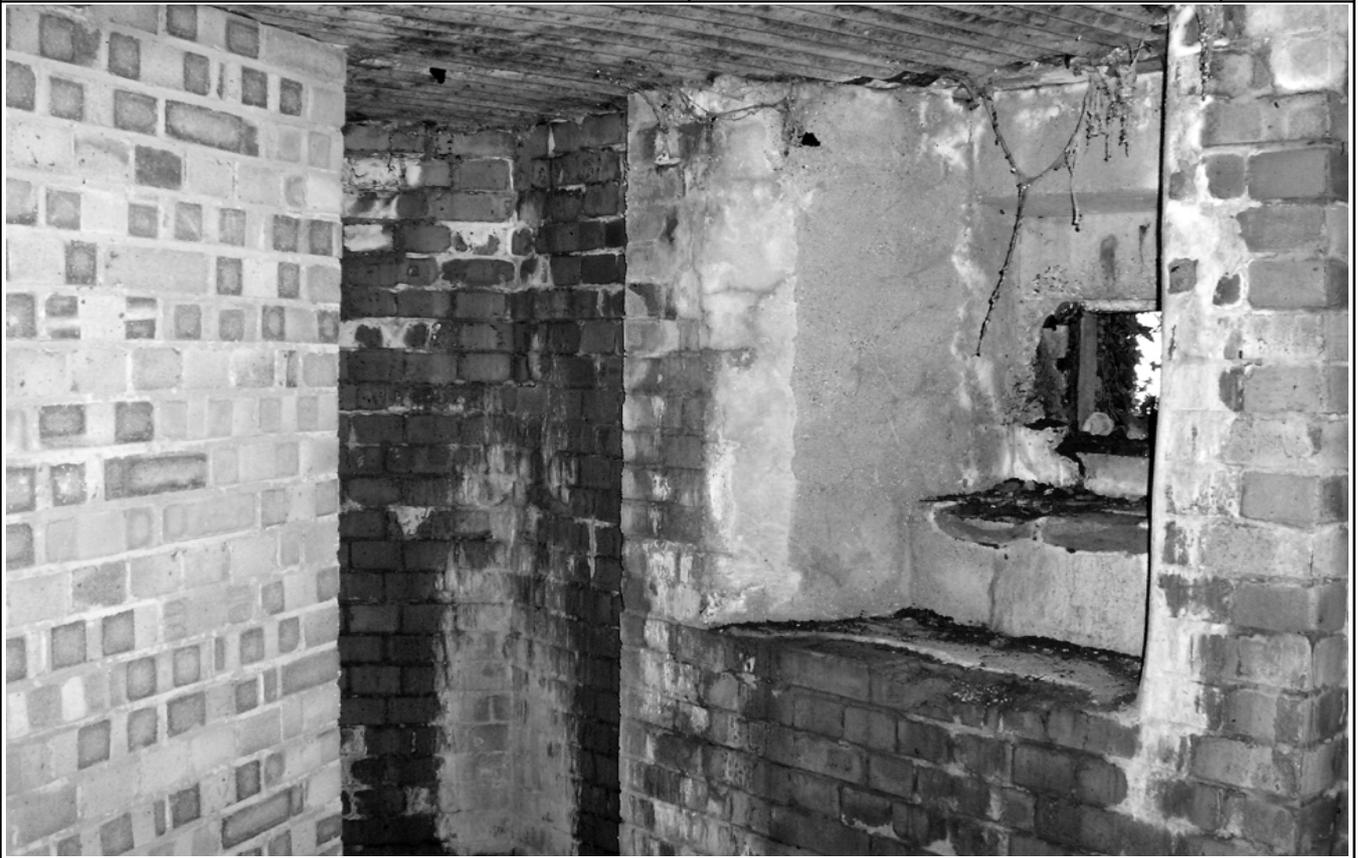
Plate 3: Area 3, Hunsdon-type hexagonal pill-box,
Y shaped anti-ricochet partition and corrugated ceiling

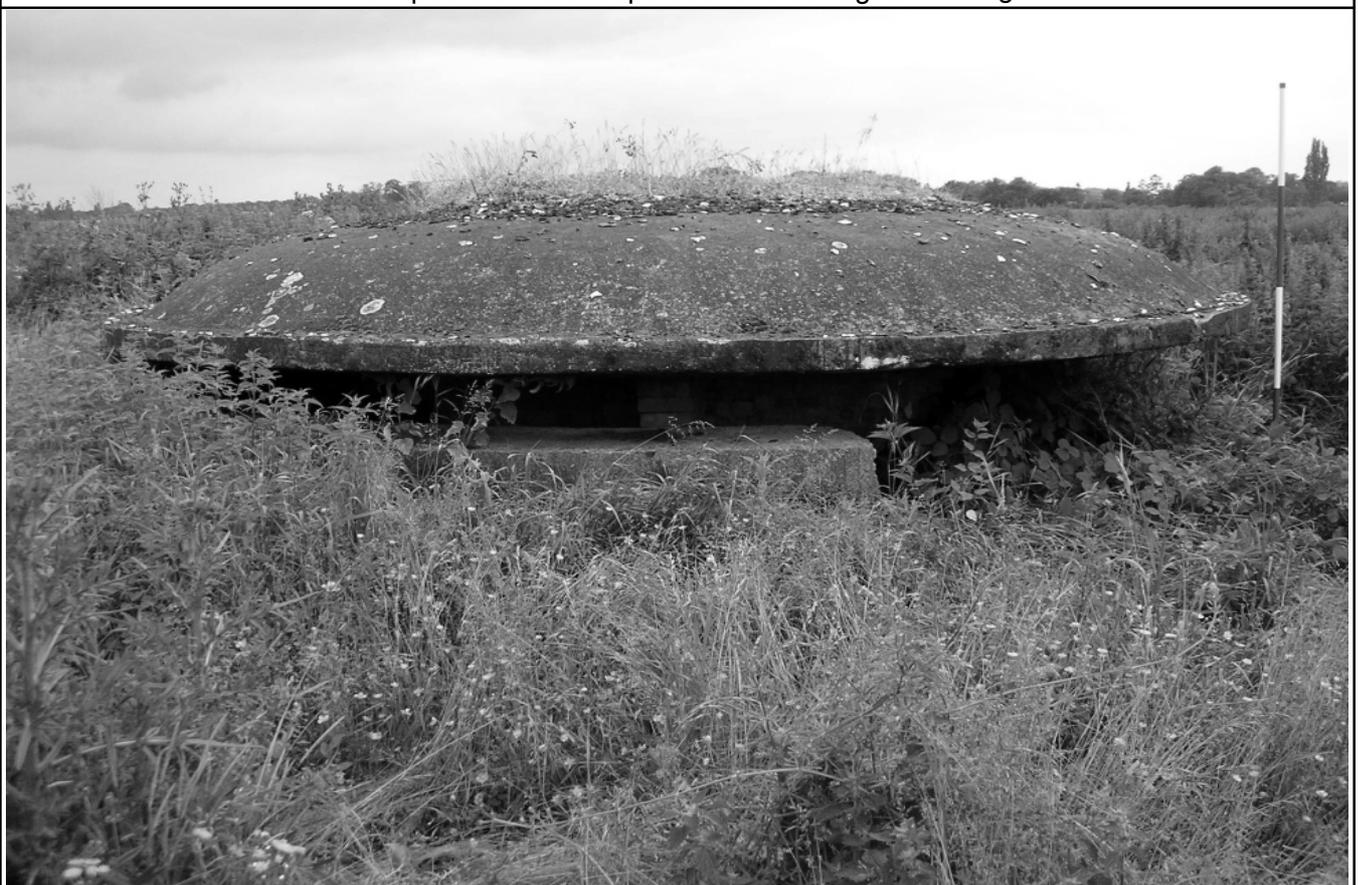
Plate 4: Area 5, cantilever pill-box, looking north-west

2.8 Area 5 is located in the northern part of the site, and contains a cantilever pill-box. The circular structure consists of a sunken brick-lined chamber with a diameter of 5.5m, approximately 1.5m below ground level, roofed with a concrete dish supported by a central pillar. There is a gap between the dish and the chamber wall that affords a 360° firing capability (Plate 4). The northern half of the concrete dish had collapsed into the chamber making access to the structure difficult. The metal gun mounting rail, running around top of

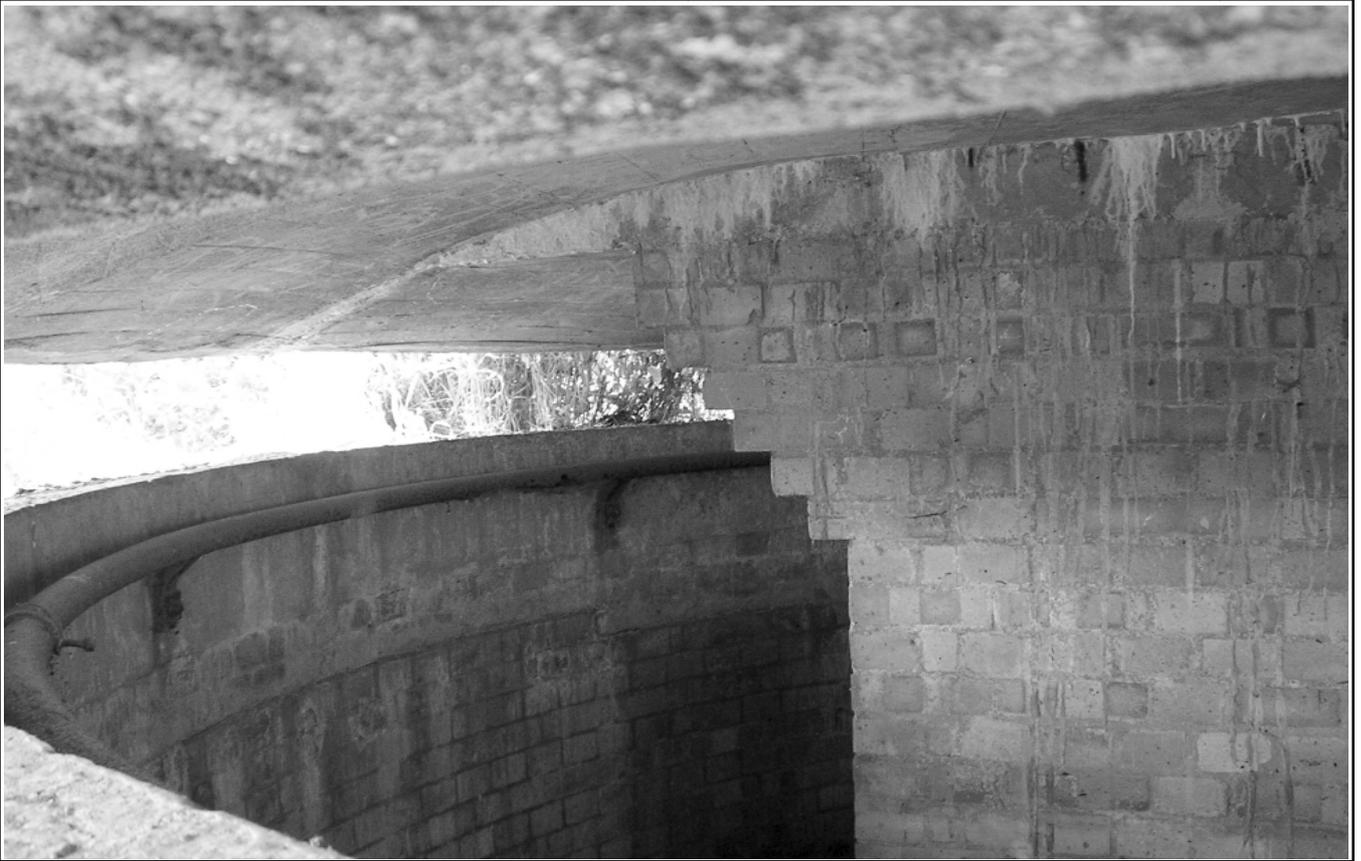
Plate 5: Area 5, cantilever pill-box interior showing metal rail

the chamber was still evident (Plate 5). The pill-box contained dumped soil and modern rubbish. Some miscellaneous iron objects, that appear to be agricultural in origin, were collected but not retained.

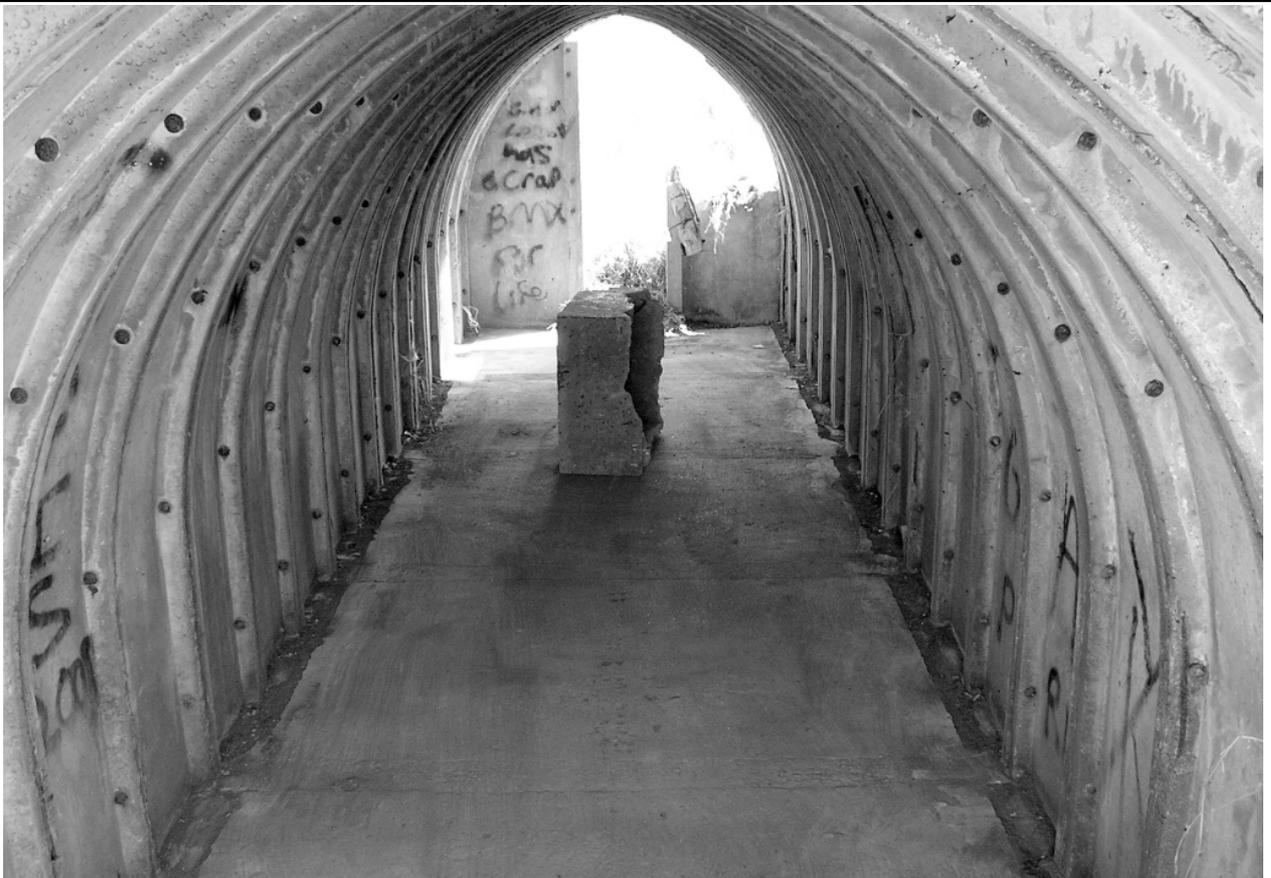
Plate 6: Area 6, Stanton air-raid shelter showing bolted panels and remains of removed escape hatch

2.9 Area 6 is located to the west of Area 5, and contains a Stanton-type air-raid shelter. The shelter was constructed of prefabricated concrete panels bolted together with an escape hatch (now removed) in the eastern end (Plate 6). The shelter was approximately 9m in length and contained modern building debris and items of modern rubbish. Two metal objects, an iron bracket and a coach bolt, were retrieved from the structure but were not retained.

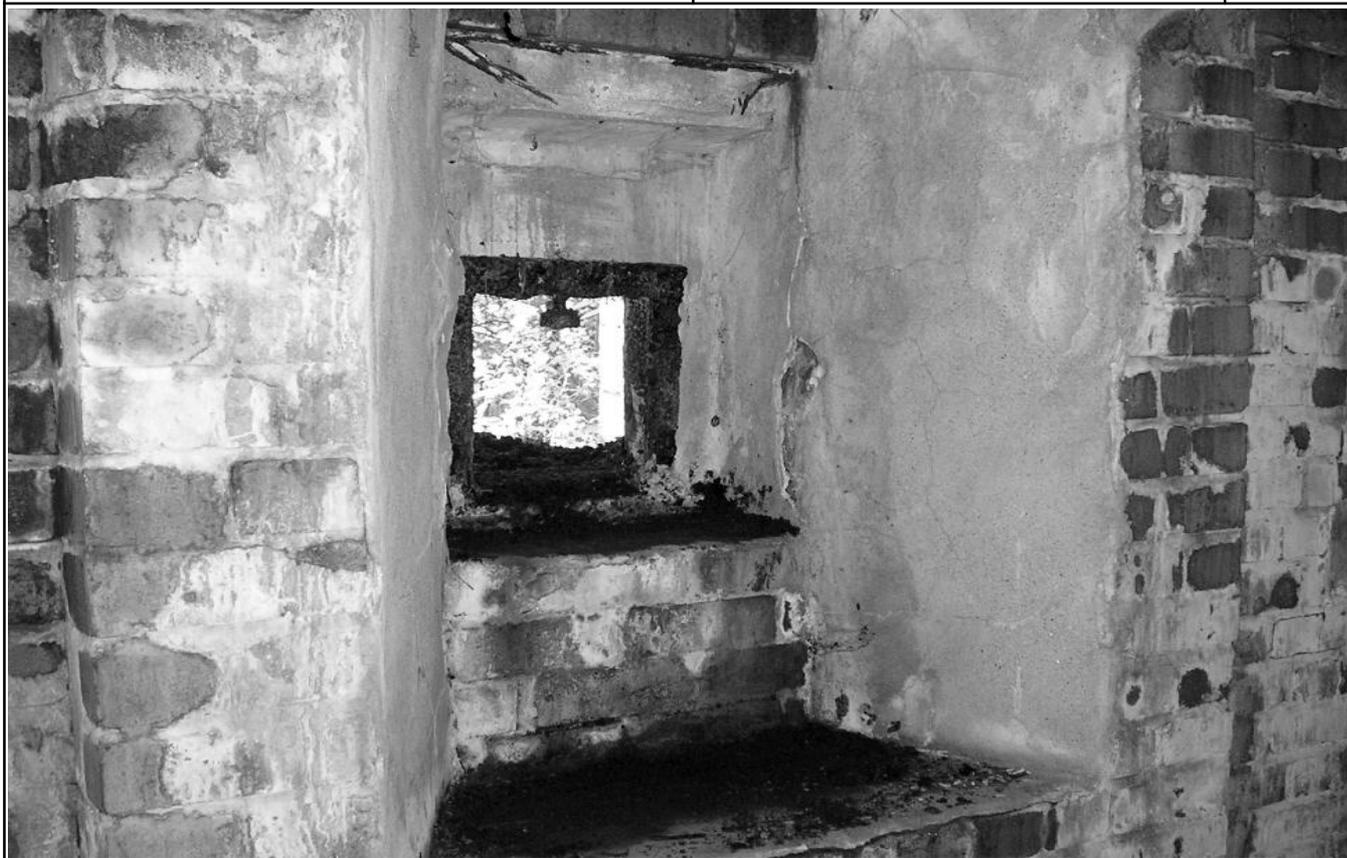
Plate 7: Area 8, Hunsdon-type pill-box interior showing remains of machine gun mounting pivot at top of aperture.

2.10 Area 8 is located in Black Hut Wood, at the north western end of the site. The area contains a Hunsdon-type pill-box of the type previously described, a semi-sunken brick and concrete ammunition store and two brick-lined slit trenches. The interior of the pill-box exhibited the remains of machine gun mounting pivots in some of the apertures (Plate 7), and 13 small corroded metal canisters (identified as CO₂ gas cylinders) and a length of iron pipe were observed but not collected. The two trenches were both approximately 21m long, one zigzag and the other straight. A two-metre section of the zigzag trench was cleaned, and found to consist of a concrete base sealed by a build up of soil approximately 0.15m in depth (Plate 8). No artefacts contemporary with the structure's wartime role were observed or recorded.

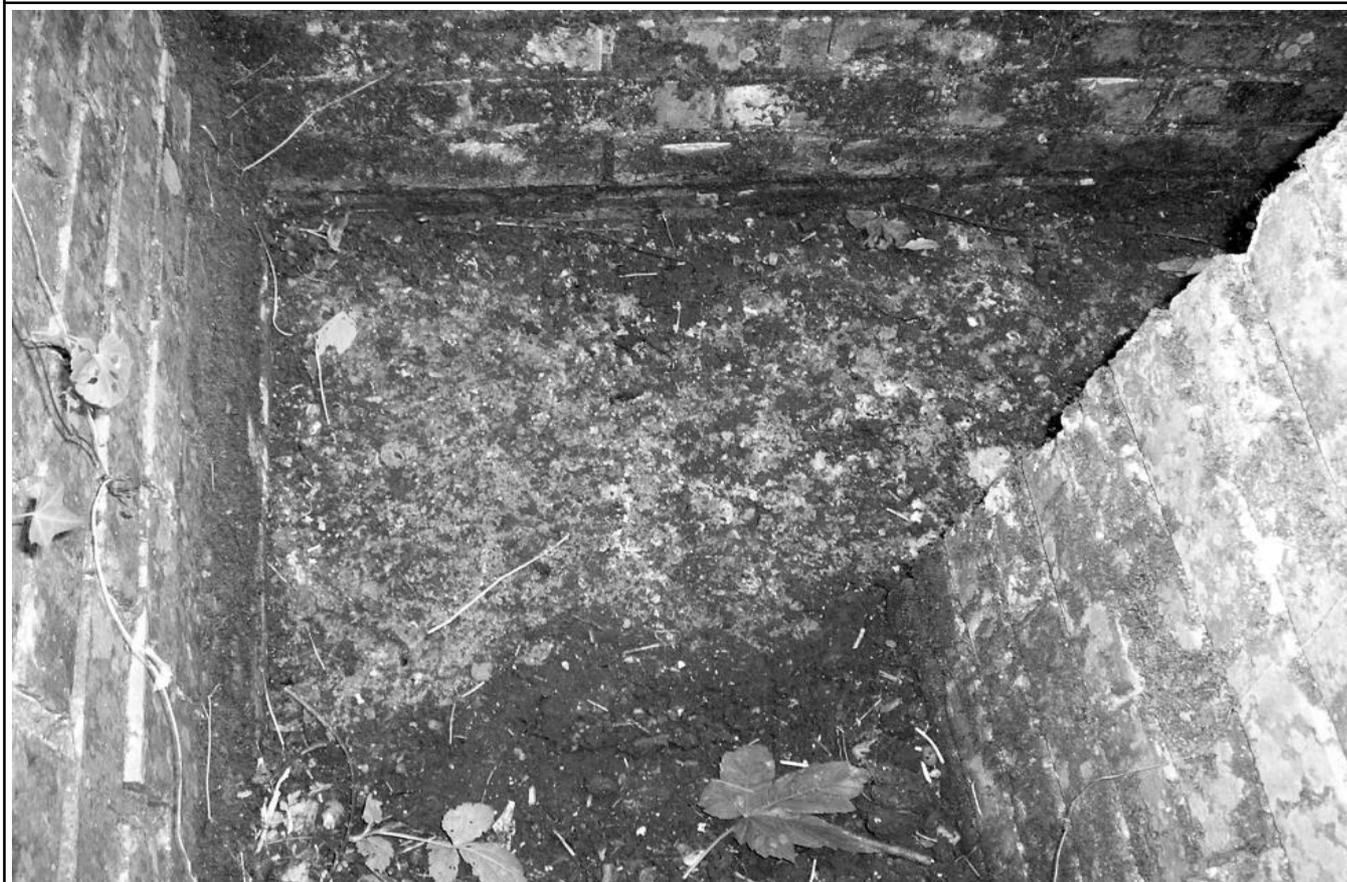
Plate 8: Area 8, cleaned section of slit-trench looking south

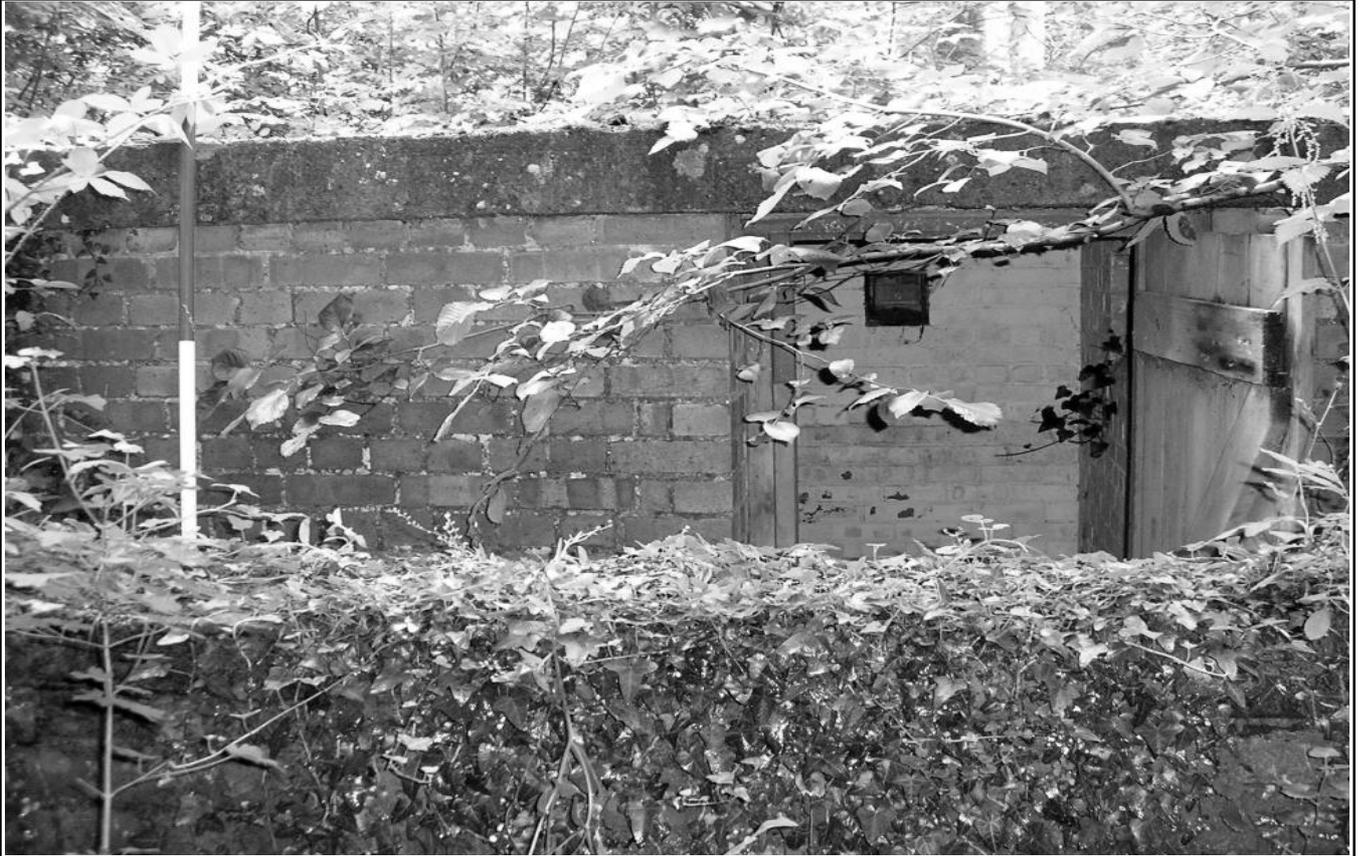
Plate 9: Area 8, ammunition store looking north

The ammunition store lies some 50m to the south east of the pillbox and trenches (Plate 9). It measures approximately 4 x 3m and has three small window openings in the northern elevation. An iron ladder leads to an escape hatch in the north western corner of the ceiling. The floor was under approximately 5cm of water (Plate 10). The store contained modern scaffolding and a considerable number of corroded metal canisters. No artefacts contemporary with the structure's wartime role were observed or recovered.

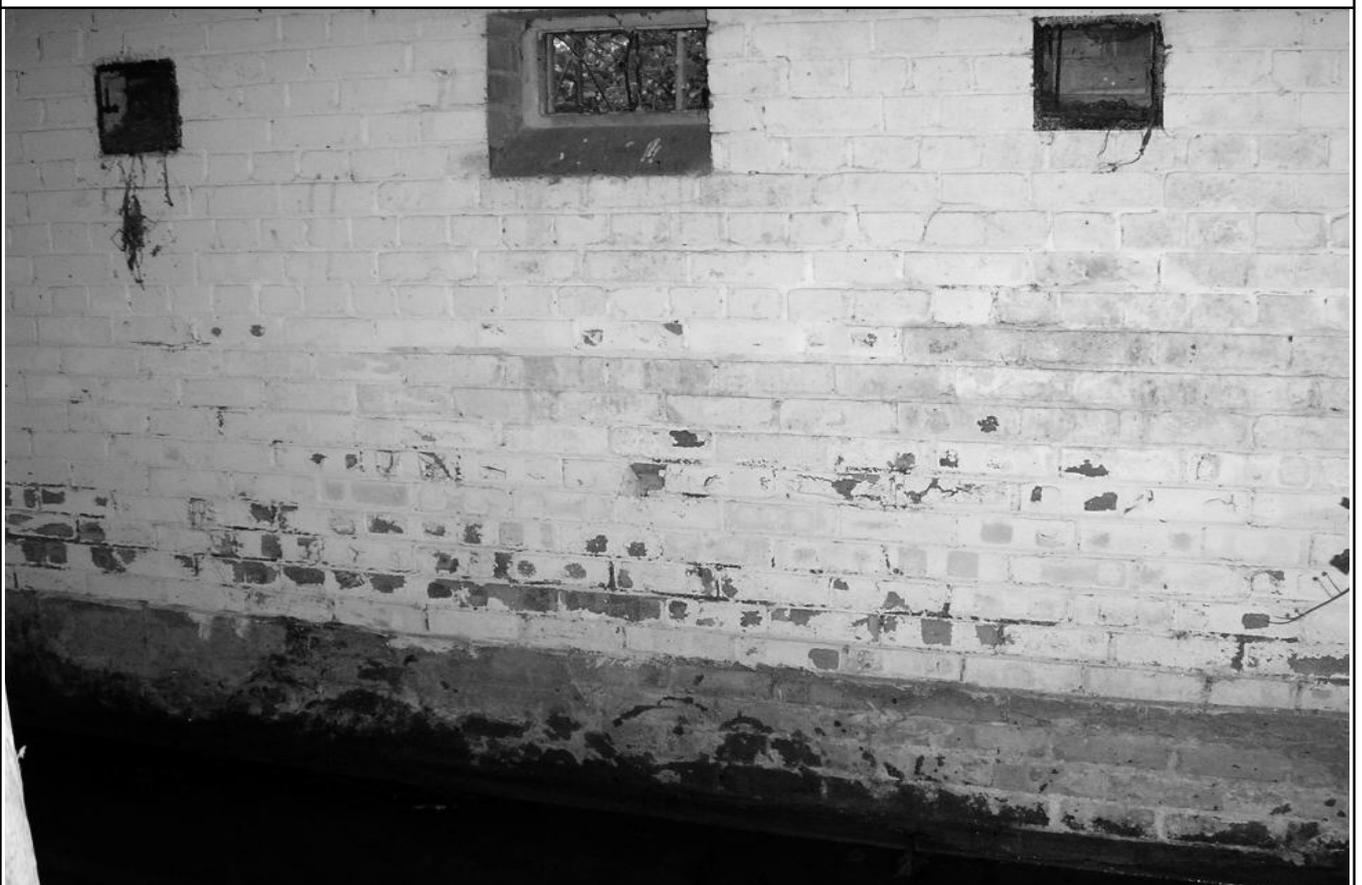
Plate 10: Area 8, ammunition store, northern interior elevation showing window openings

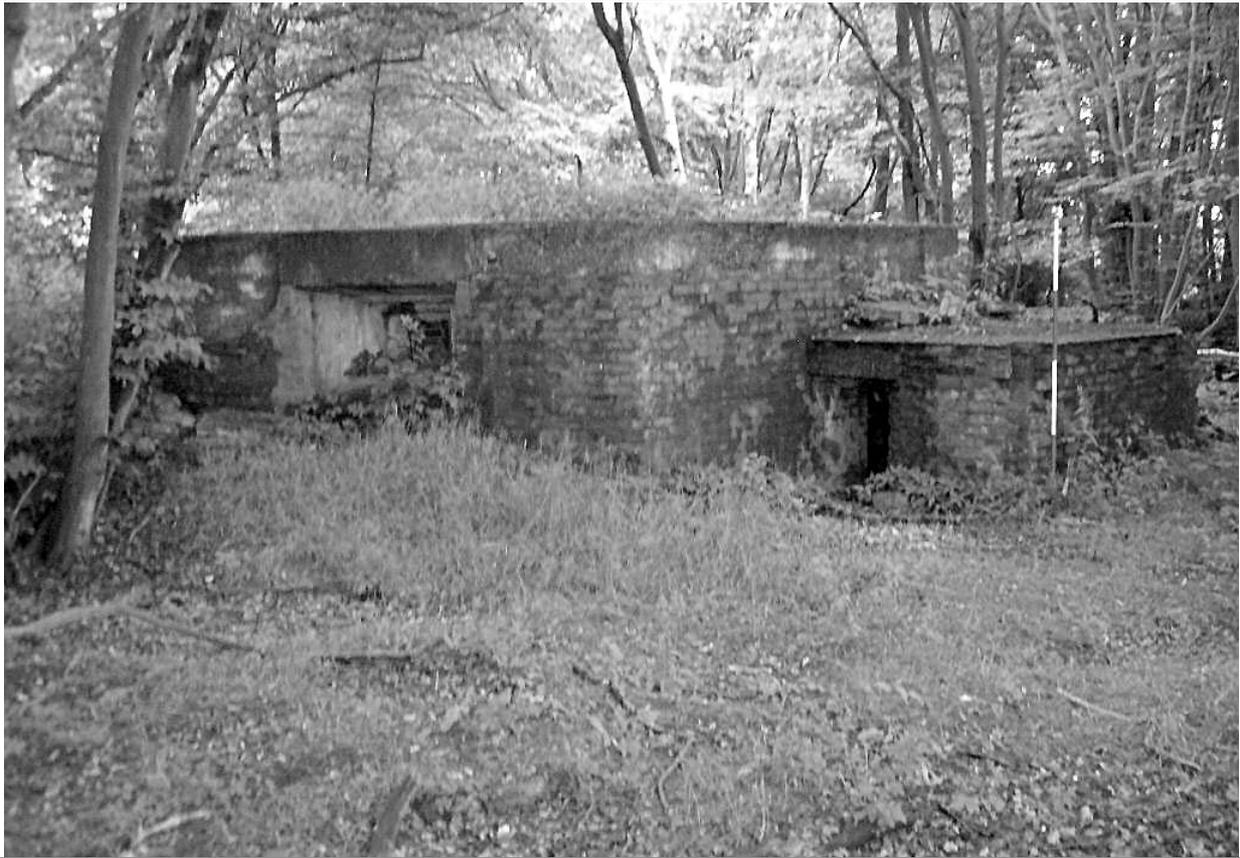
Plate 11: Area 9, Hunsdon-type pill-box, looking north

2.11 Area 9 is located at the eastern end of Black Hut Wood, and contained a Hunsdon-type pill-box of the type previously described and associated slit trenches (Plate 11). The pill-box contained six corroded metal canisters and a section of flanged lead pipe (not retained). A large iron bracket was observed but not collected. The trenches were completely infilled with dumped soil and were not cleared.

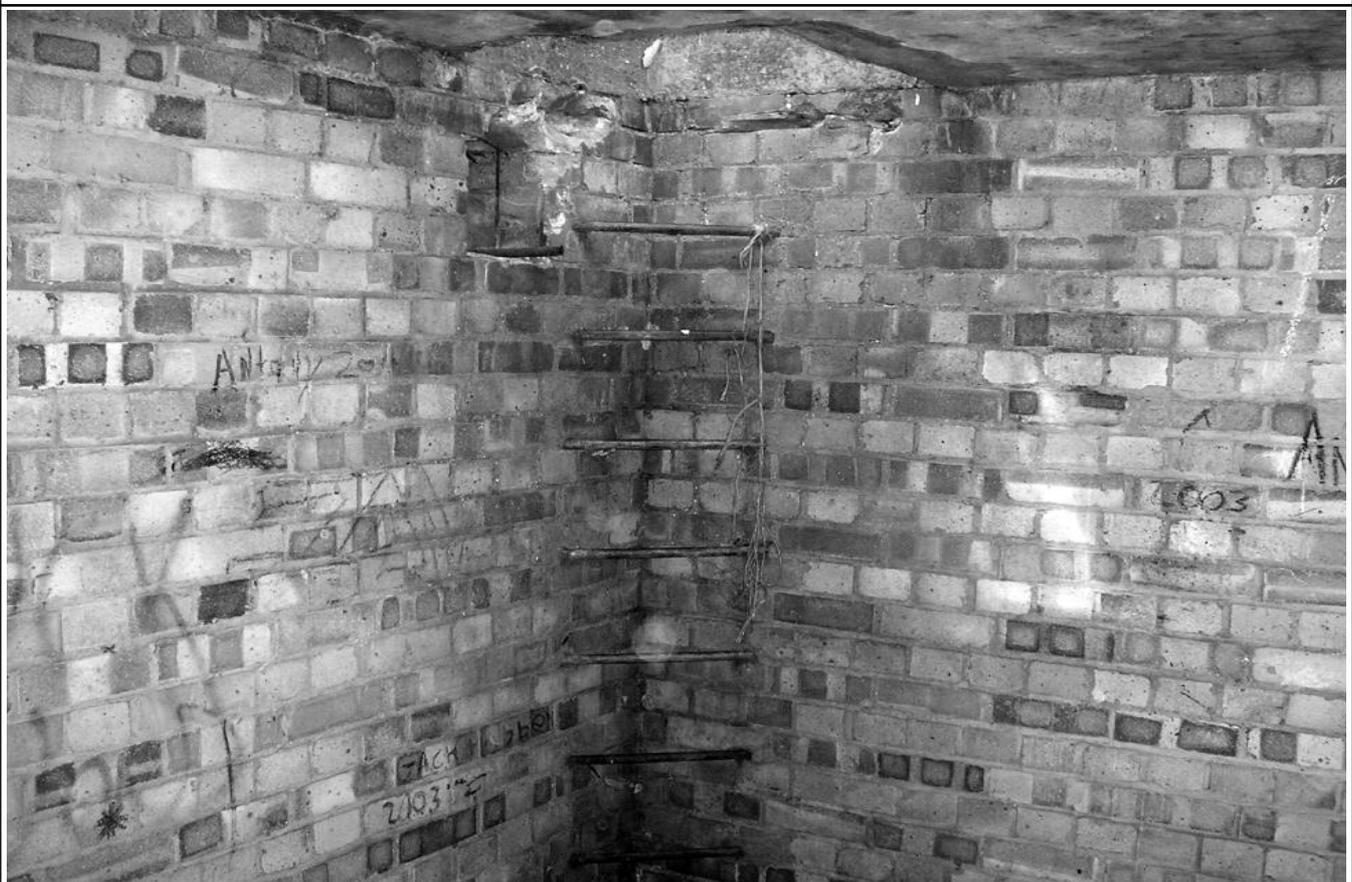
Plate 12: Area 10, ammunition store, escape ladder and hatch

2.12 Area 10 is also located at the eastern end of Black Hut Wood, approximately 50m to the north east of Area 9. It contained an ammunition store. The brick and concrete structure is similar to the one in Area 8, with three small window openings and an escape hatch in the south western corner (Plate 12). It contained dumped soil, modern building debris and items of modern rubbish, and there was modern graffiti on the western wall. No artefacts contemporary with the structure's wartime role were observed or recovered.

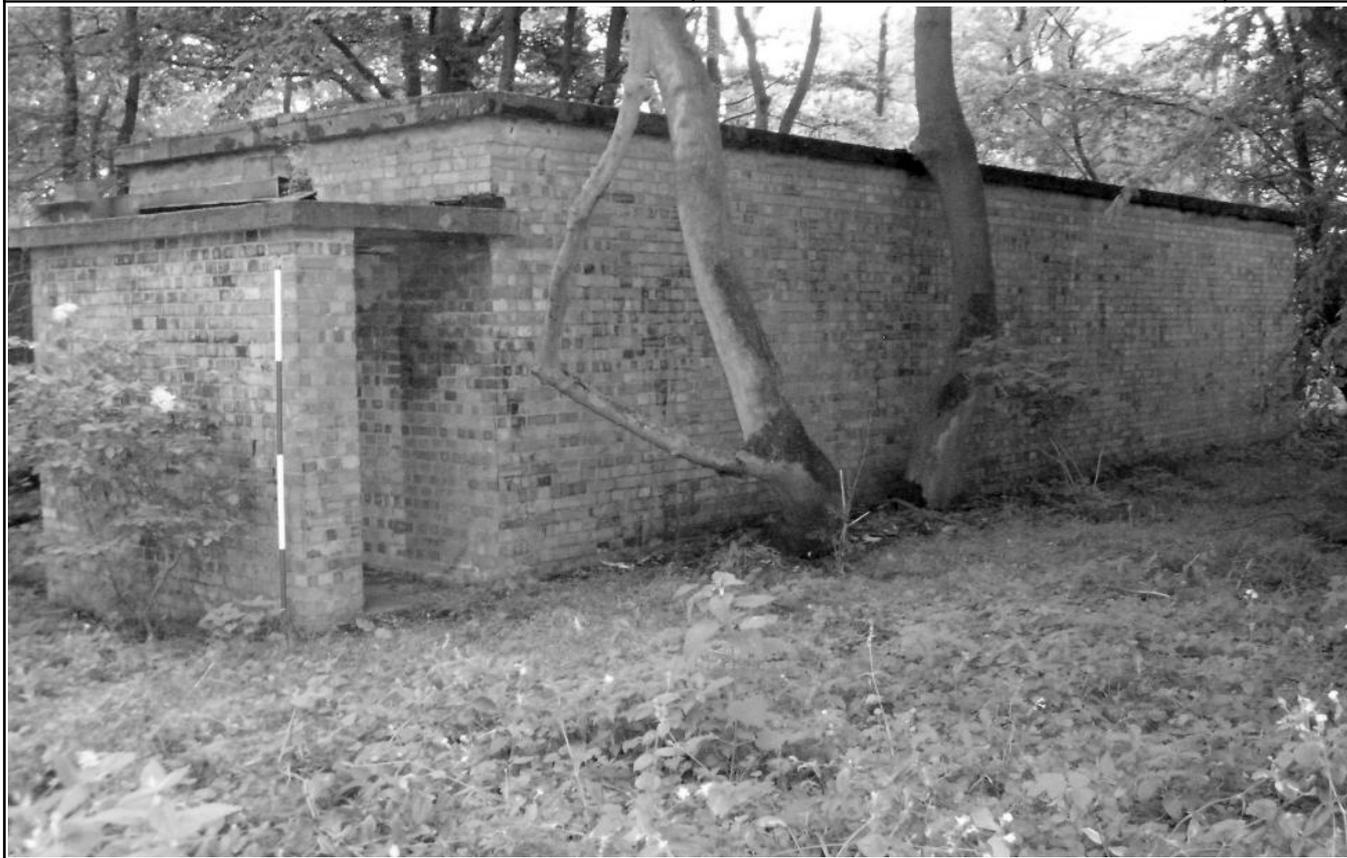
Plate 13: Area 11, eastern sleeping shelter, looking north

2.13 Area 11 is located in the south eastern part of the site, within a small wood, and contains two brick-built, flat-roofed sleeping shelters (Plates 13 & 14). The interior of the shelters are divided into bays that could accommodate up to six bunks, and the steel brackets that supported the bunks were still apparent (Plate 15). The shelters had no windows and ventilation was provided by air bricks spaced at intervals along the walls and an air extraction system, the ducting for which was still visible running along the ceiling (Plate 16). Both buildings contained original cable ducting, some light fittings and the remains of an electrical junction box. The eastern building had a porch at each end, whilst the larger western building had a porch at the northern end only. A large amount of debris and modern rubbish was

discovered within the structures, including large metal sheets and containers, which were observed and recorded but not retained. A small glass screw-cap bottle, and some metal objects including an aluminium spray head, an oil can and a door handle were retrieved from the shelters but not retained. A newspaper fragment dated 16th November 1947 was collected from the eastern shelter.

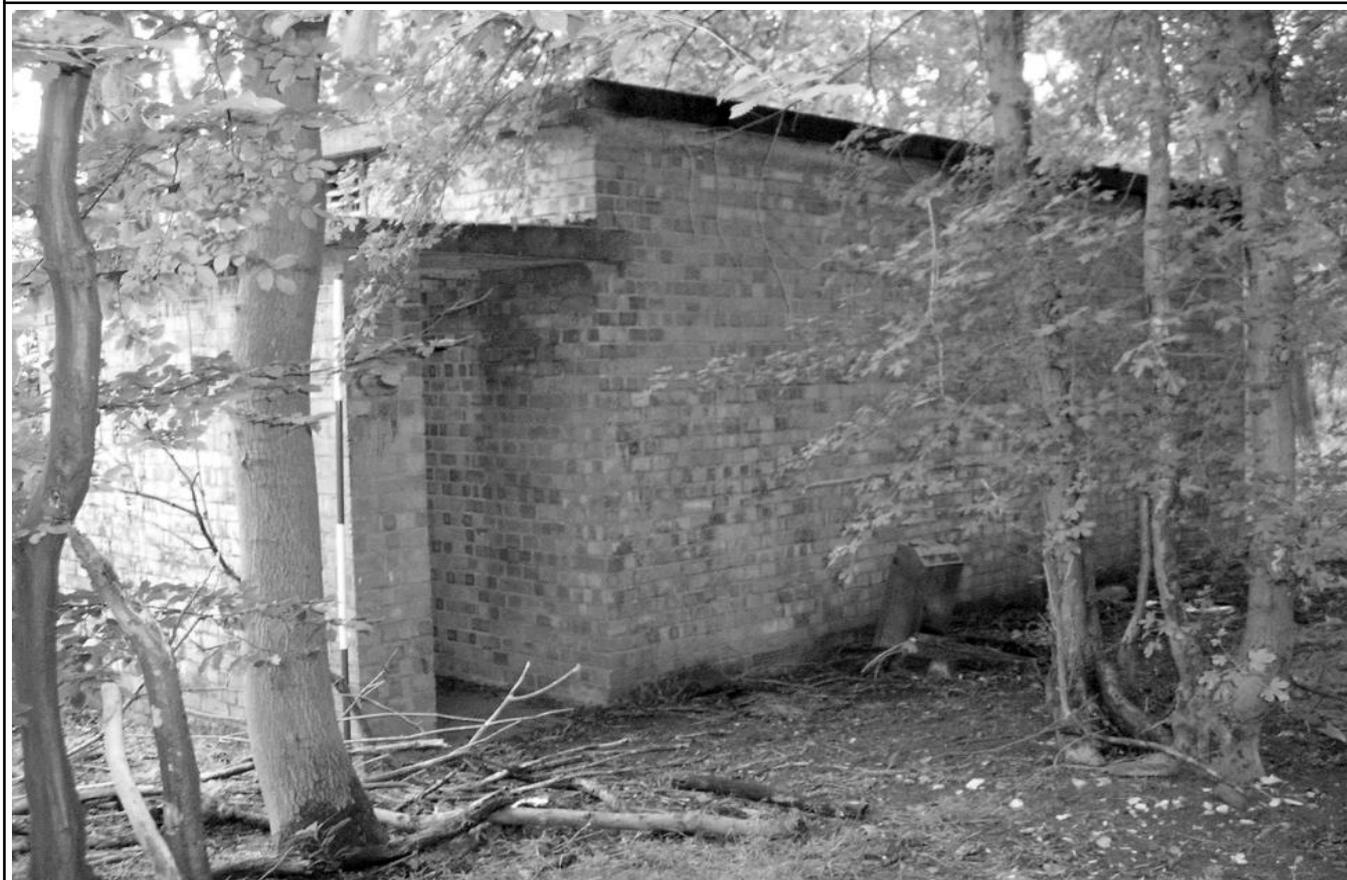
Plate 14: Area 11, western sleeping shelter, looking north

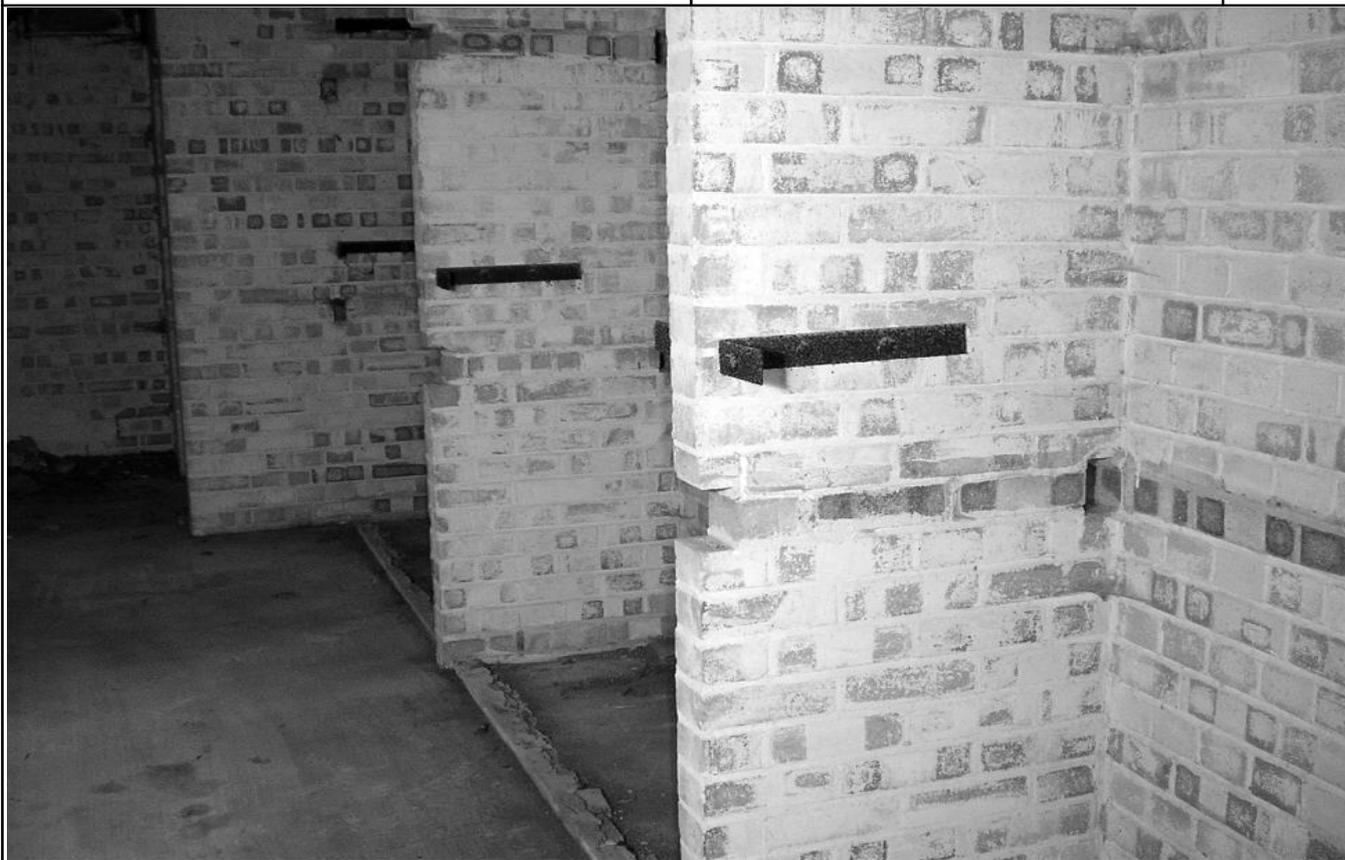
Plate 15: Area 11, eastern sleeping shelter, sleeping bays

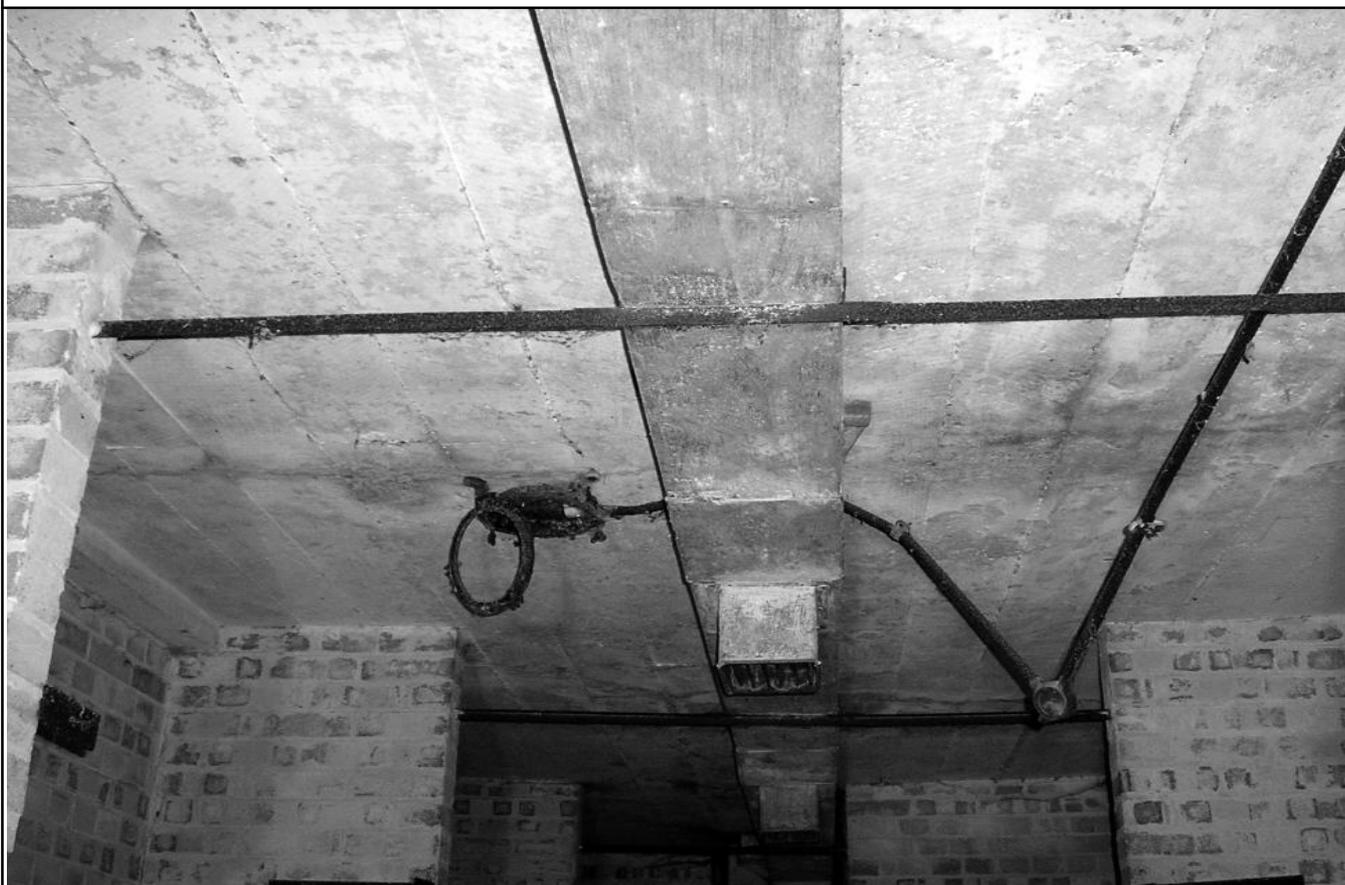
Plate 16: Area 11, eastern sleeping shelter, detail of air duct and electrical trunking
