HUNSDON AIRFIELD **Hunsdon, Herts.**

Archaeological Monitoring Report

HN598

Report no. 384

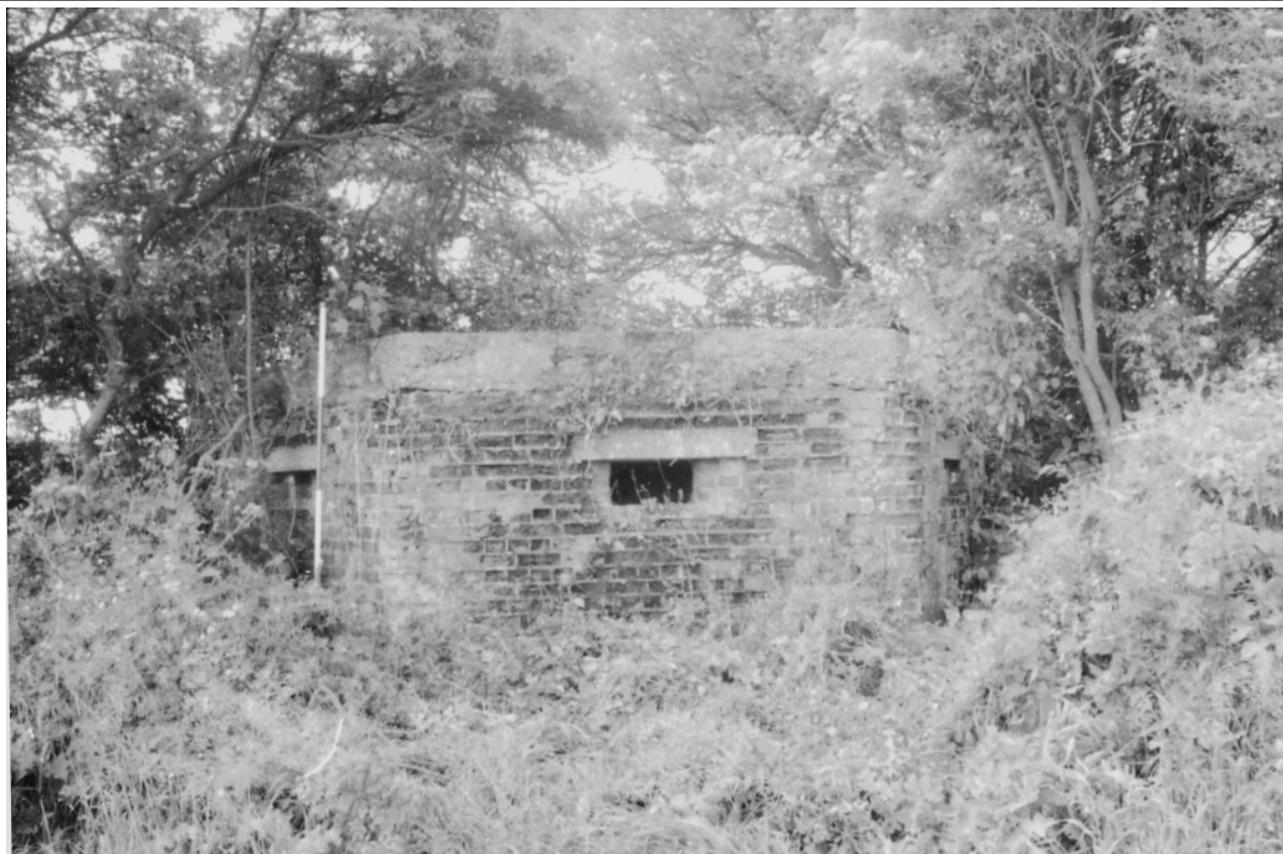
Plate 17: Area 12, Type-22 pill-box, looking west

2.14 Area 12 is located to the south of Area 11, and contains a brick and concrete Type 22 hexagonal pill-box (Plate 17). The pill-box is entered via a brick built tunnel (Plate 18). The single chamber has six gun apertures and a central Y-shaped anti-ricochet partition. It contained dumped soil, modern building debris and items of modern rubbish. No artefacts contemporary with the structure's wartime role were observed or recovered.

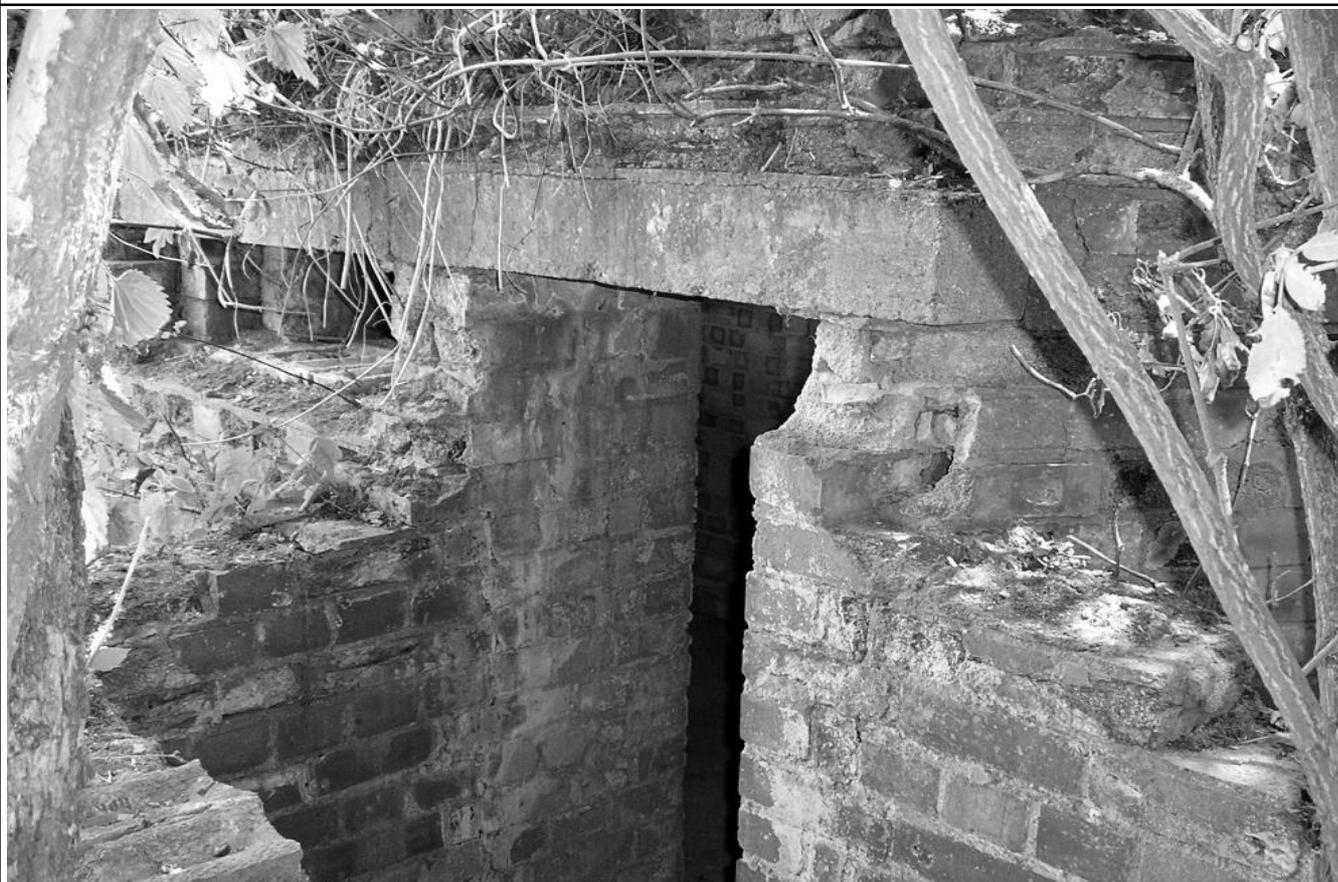
Plate 18: Area 12, Type-22 pill-box entrance

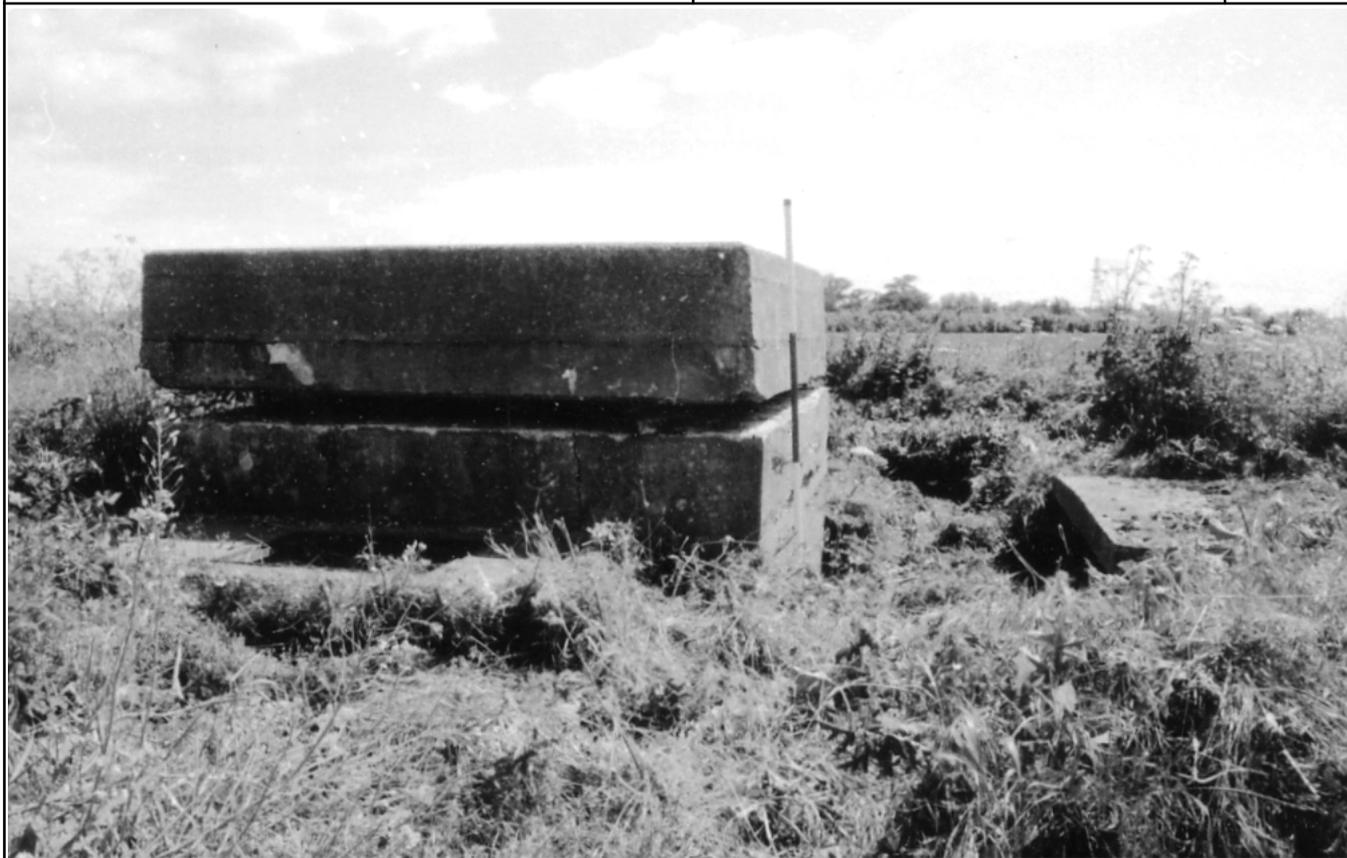
Plate 19: Area 13, battle headquarters, looking south-east

2.15 Area 13 is located in the southern part of the site, and contains the battle headquarters building and surrounding slit trenches. The concrete building was mostly underground, with an observation tower extending above ground, and was entered either by steep stairs at the eastern end or through a narrow rectangular opening adjacent to the observation tower (Plate 19). The subterranean areas of the building were flooded with water and were not examined or cleared due to health and safety considerations.

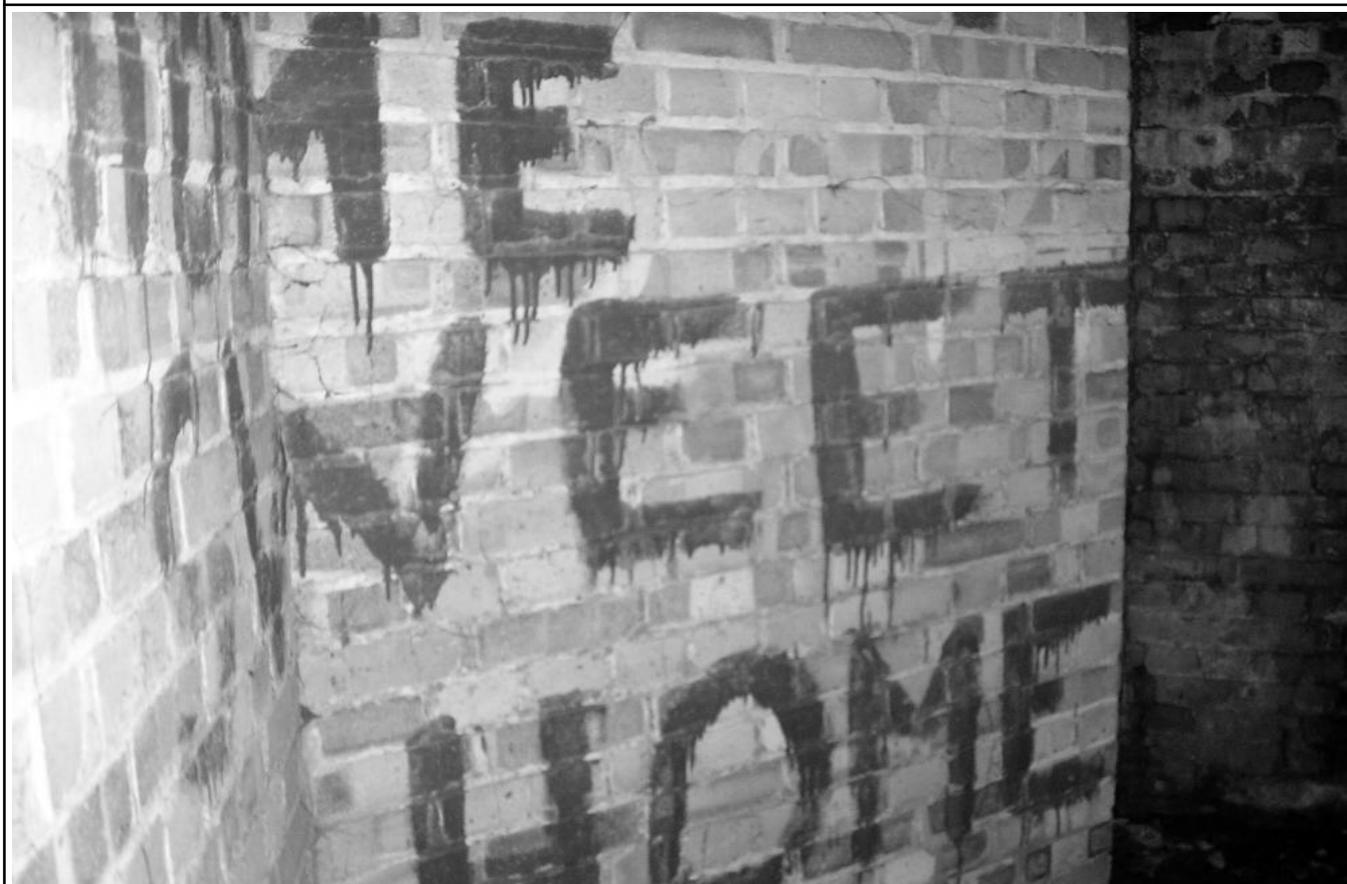
Plate 20: Area 14, Hunsdon-type pill-box, graffiti on anti-ricochet wall

2.16 Area 14 is located in the western part of the site, and contains a further Hunsdon-type brick and concrete hexagonal pill-box. The remnants of machine gun mounting pivots were observed in two of the gun apertures. The interior Y-shaped anti-ricochet partition revealed the graffiti: 'NO SMOKING', 'RAF HUNSDON', and 'HOME SWEET HOME'. These are likely to be contemporary with the war time use of the building (Plates 20 - 22).

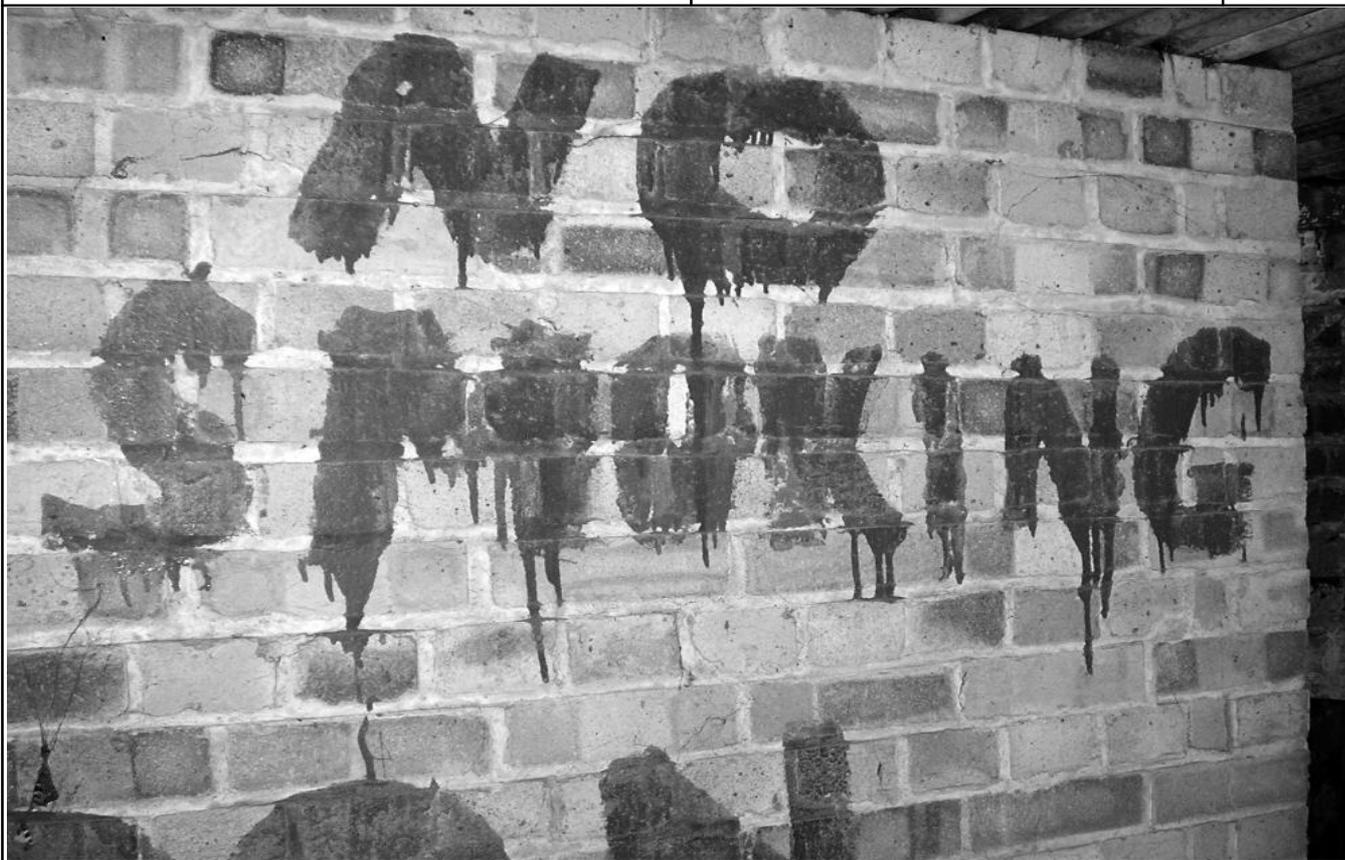
Plate 21: Area 14, Hunsdon-type pill-box, graffiti on anti-ricochet wall

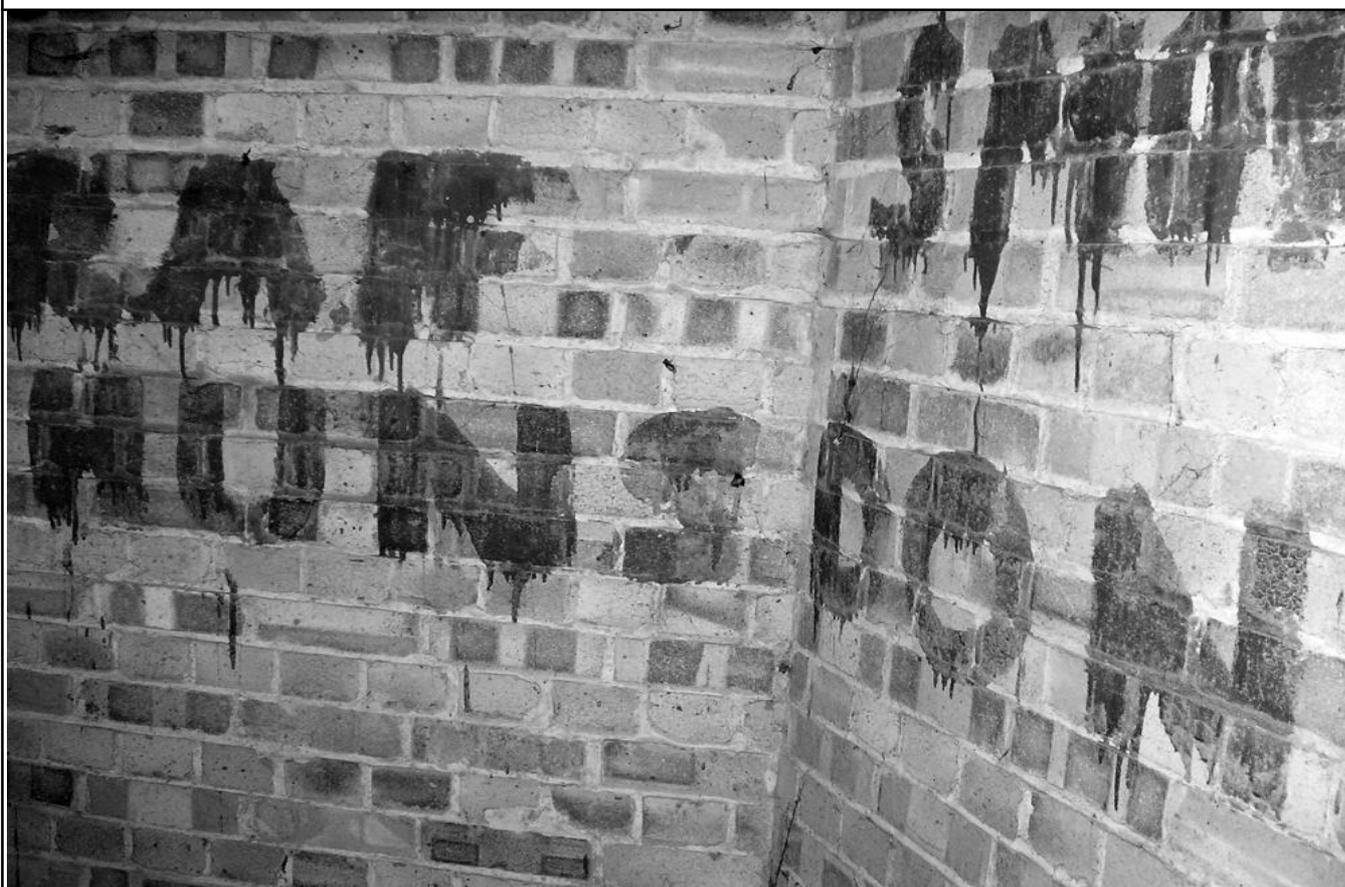
Plate 22: Area 14, Hunsdon-type pill-box, graffiti on anti-ricochet wall
