LAND AT CHIVERS WAY Histon, Cambridgeshire

HN609

Archaeological Evaluation Report

Prepared on behalf of Carebase Ltd

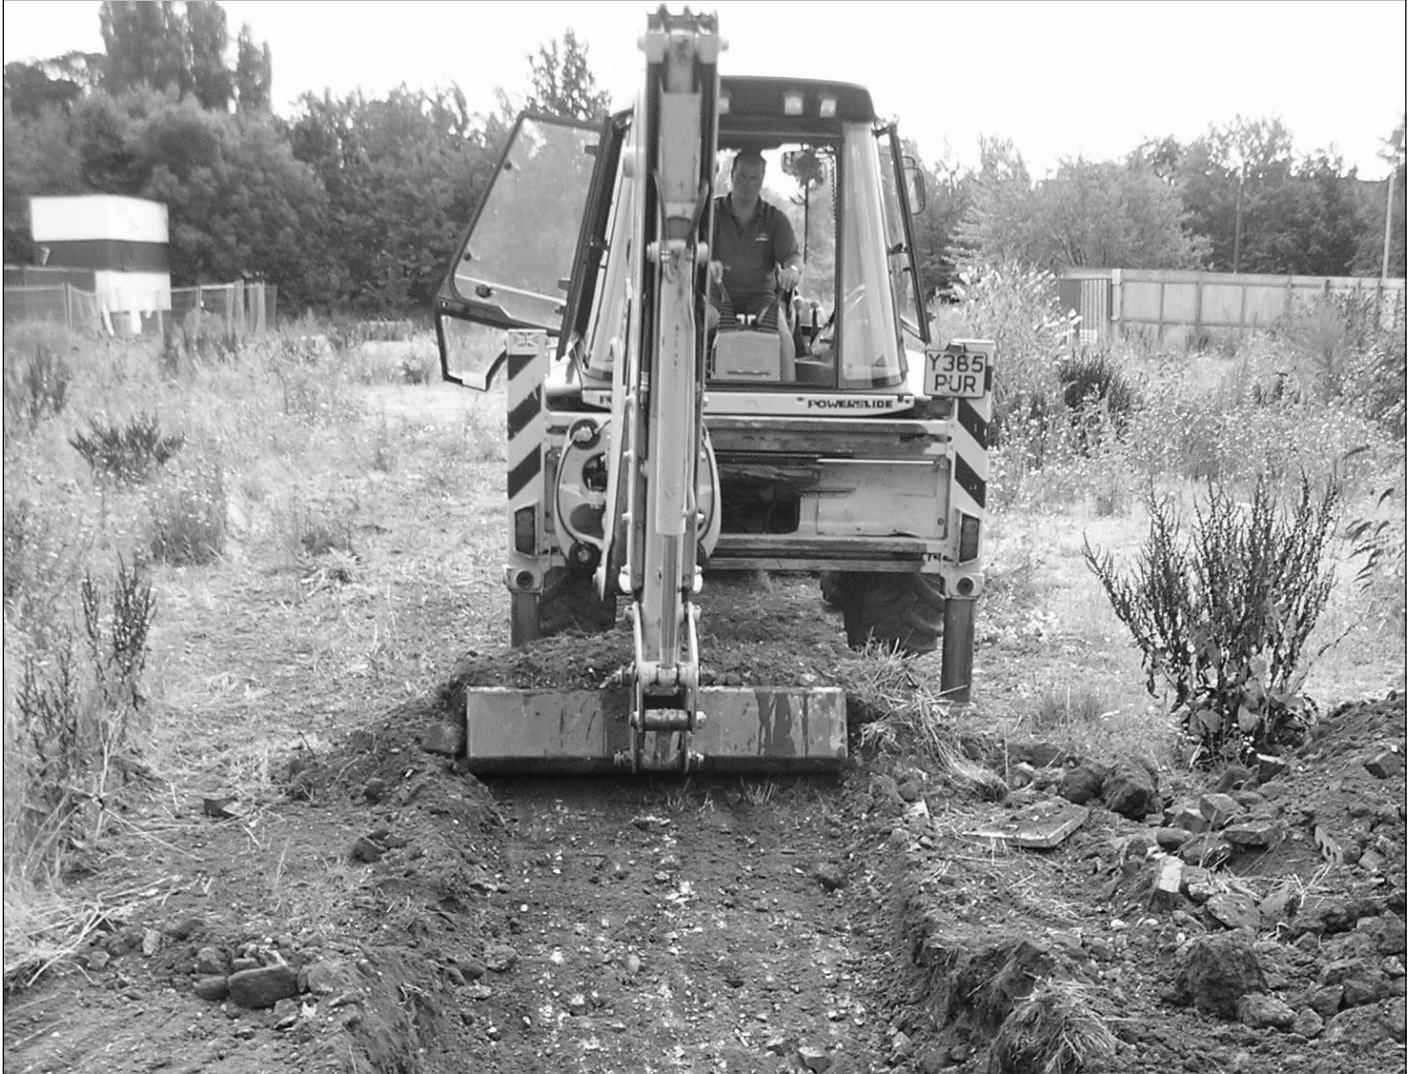
The cover photograph shows the machining of Trench 2, looking south east

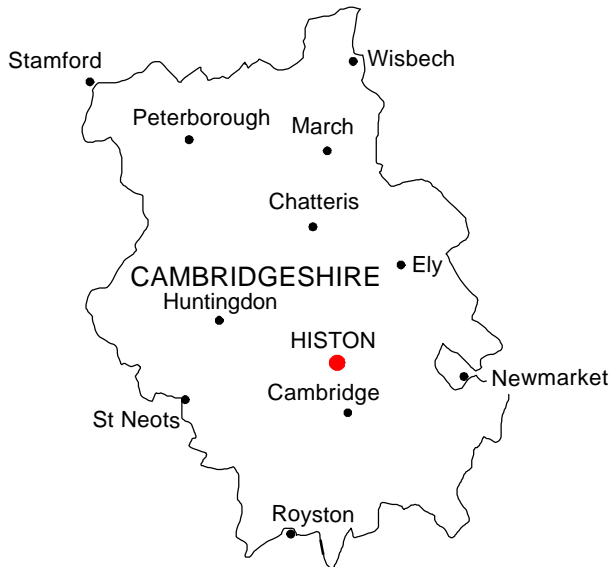
Site location plan

Scale 1:1000

1.3 The study area is in the south west of the village of Histon, centred at NGR TL 4387 6294. The site is located within the former grounds of the Chivers Factory. It lies on the northern side of Chivers Way which was formerly occupied by factory buildings. Demolition of these buildings has already taken place. The development proposes the construction of a new care home with associated car parking and landscaping on the footprint of the previous factory building (Figure 2).

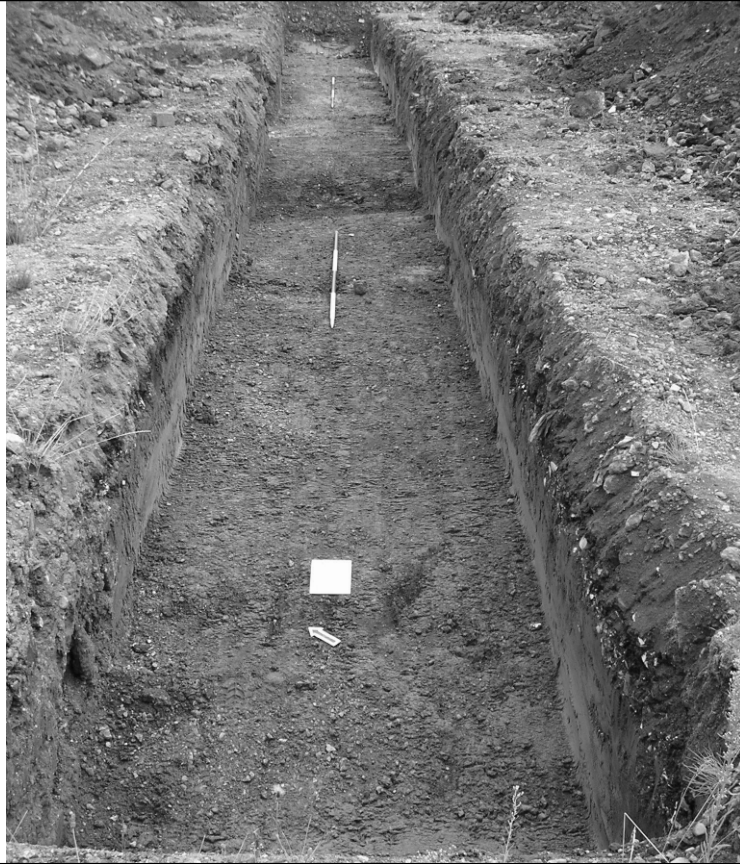
Trench 1 was aligned northeast-southwest. The trench measured 20 x 1.5m, and was excavated to a maximum depth of 1m. The trench contained no archaeological features. A modern drain laid in a pea shingle fill, which continued into Trench 2, and a large concrete post setting were identified (Figure 4).

Plate 1: Trench 1, looking north-east

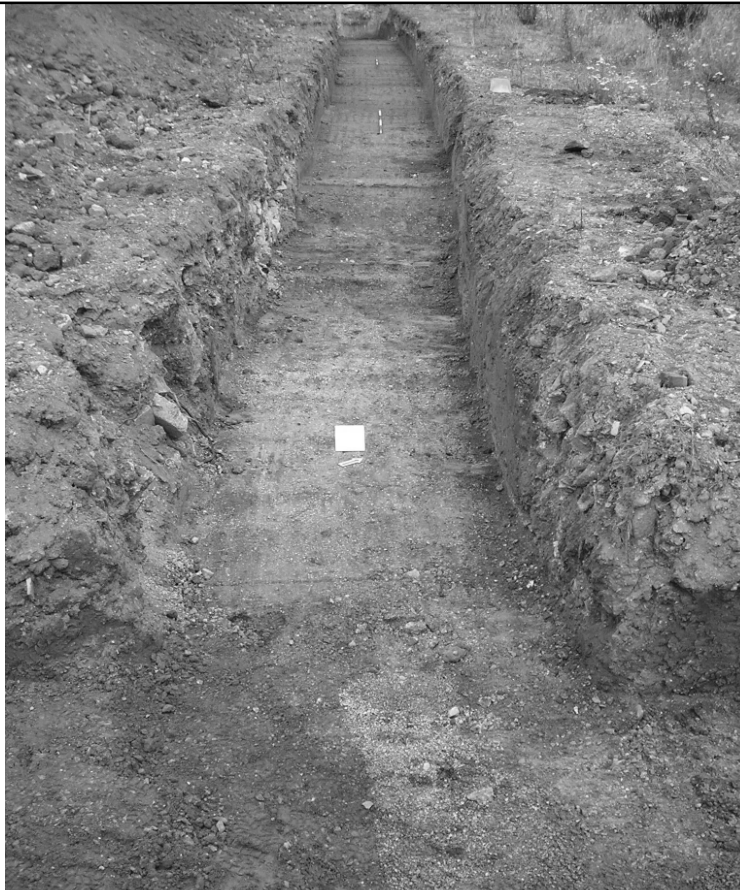
Trench 2 was aligned northwest-southeast. The trench measured 35 x 1.5m, and was excavated to a maximum depth of 1.6m. The trench contained no archaeological features. A

modern drain laid in a pea shingle fill, also seen in Trench 1, a service pipe, and an area of decaying tree root were identified (Figure 4).

A sondage was excavated at the northwest end of Trench 2 to confirm that a gravel outcrop noted in this area was of natural origin.

Plate 2: Trench 2, looking north-west
