THREE GABLES **2 Bury End, Pirton, Hertfordshire**

***ARCHAEOLOGICAL
MONITORING REPORT***

Project ref.: HN1137
NHDC Planning Refs.: 13/02669/1HH
HER Consultation: 325/14

Report no.969

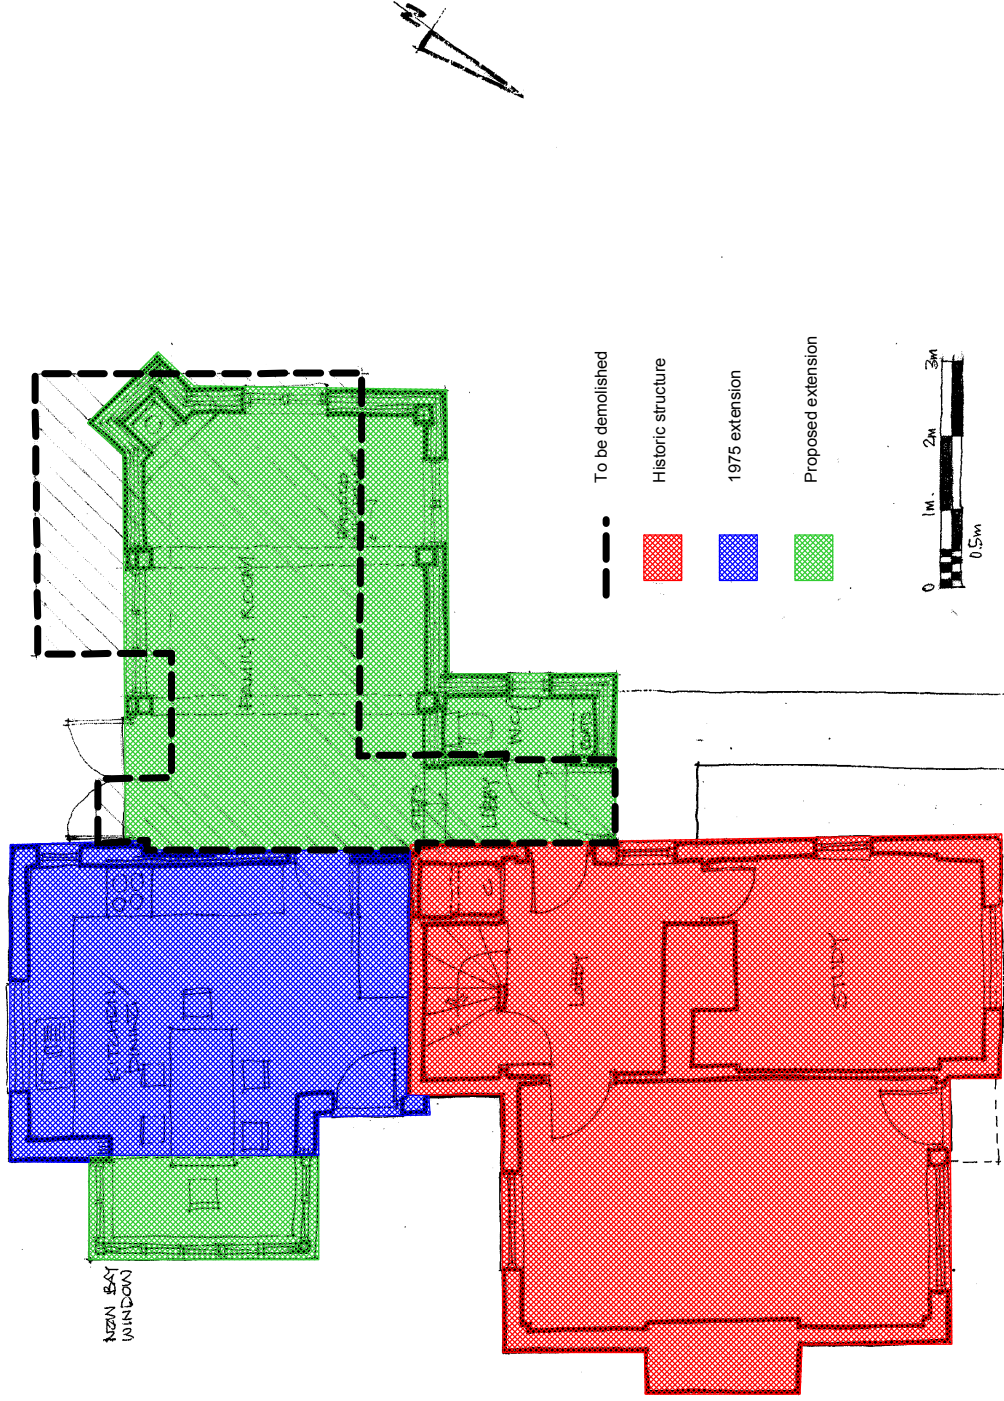
Site layout
Base plan courtesy of Pentangle Design

1.5 The development proposes the demolition of an existing single-storey workshop and sun room, and its replacement with a new two storey side extension with entrance lobby and WC, and the addition of a new bay window to the NE elevation (Figure 2).

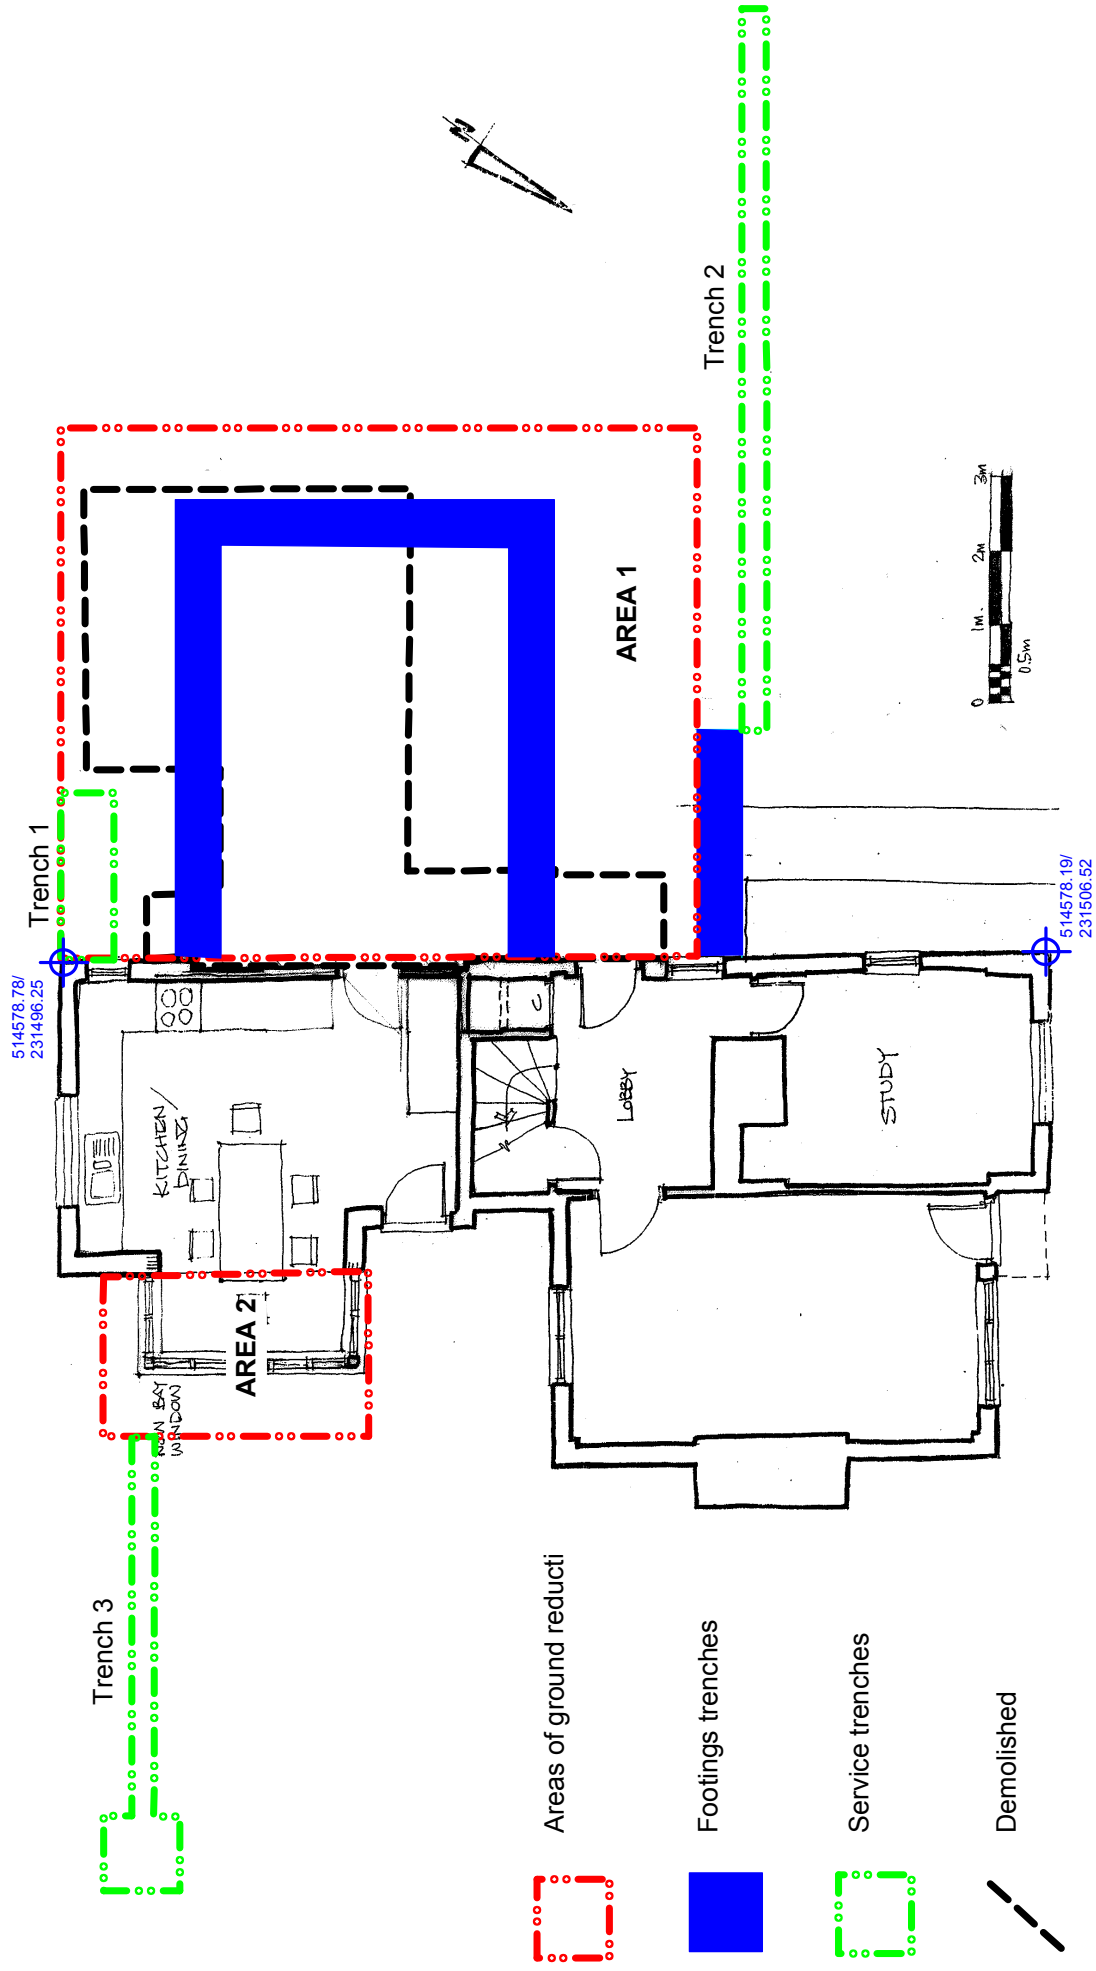
Plan showing location of development groundworks
Base plan courtesy of Pentangle Design

3.14 The groundworks for the present project involved ground reduction and footings trenches for a new extension to the western elevation of the existing building (Area 1), following the demolition of an existing extension, and the addition of a new bay window on the eastern elevation (Area 2). New services included a soakaway in the garden to the east of the new bay and service trenches to the west of the new extension.

3.15 This was located towards the south end of the west elevation and located across the site of the former single storey extension (Figure 3).

3.21 A number of service trenches were excavated on the western side of the house (Figure 3).

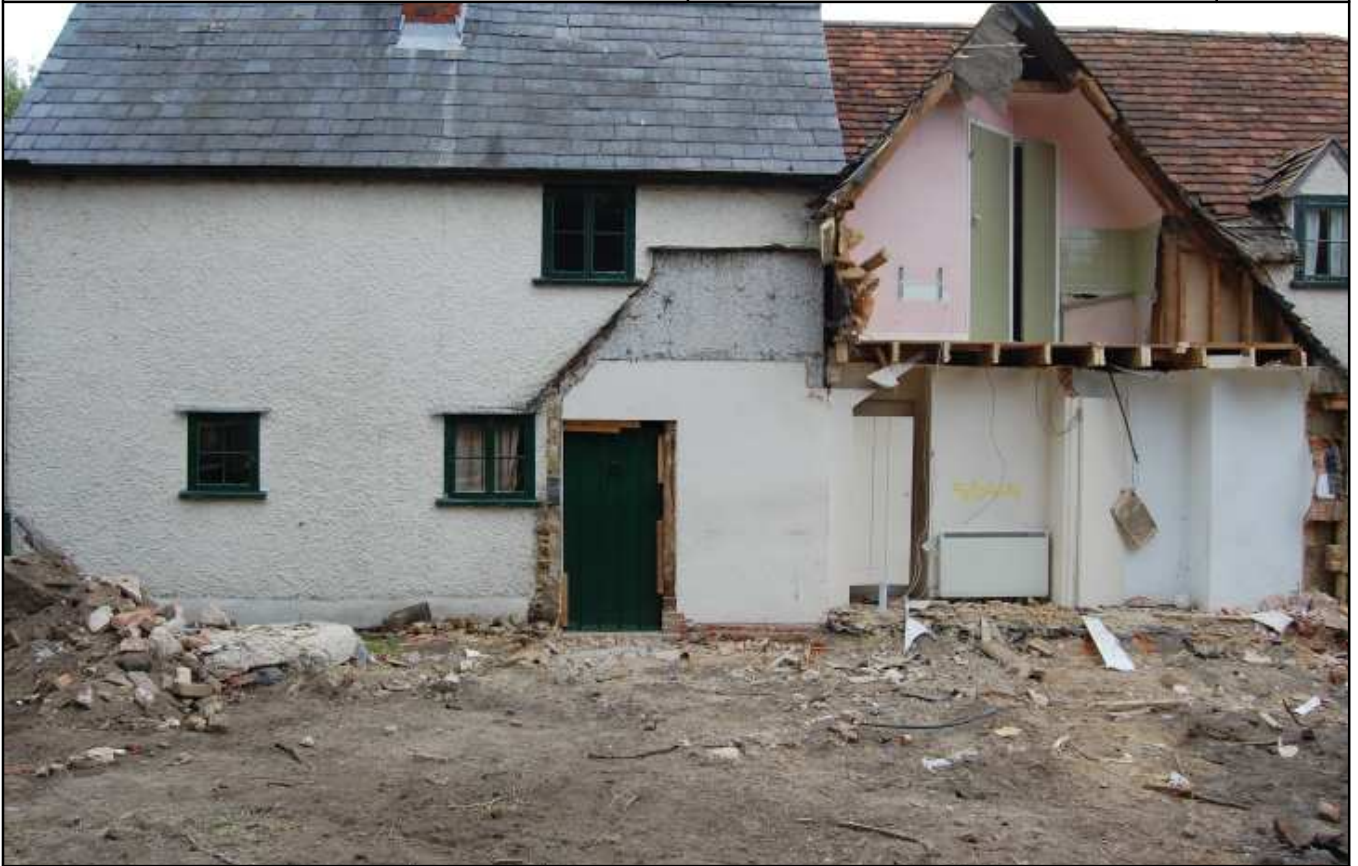
Plate 1: North end of W elevation, looking E

3.9 The western elevation to the northern block has two small windows, each with a plain sill and projecting lintel, at ground floor level (Plate 1). The northern window is a single light side hung casement with four panes separated by glazing bars; the southern window is a two-light casement, with each light divided into two panes by glazing bars. A 2-light casement is located at first floor level, offset to the south. An internal doorway, located at the southern end of the north block, has been exposed immediately to the south of the double casement window to the ground floor. The elevation is covered in white roughcast.

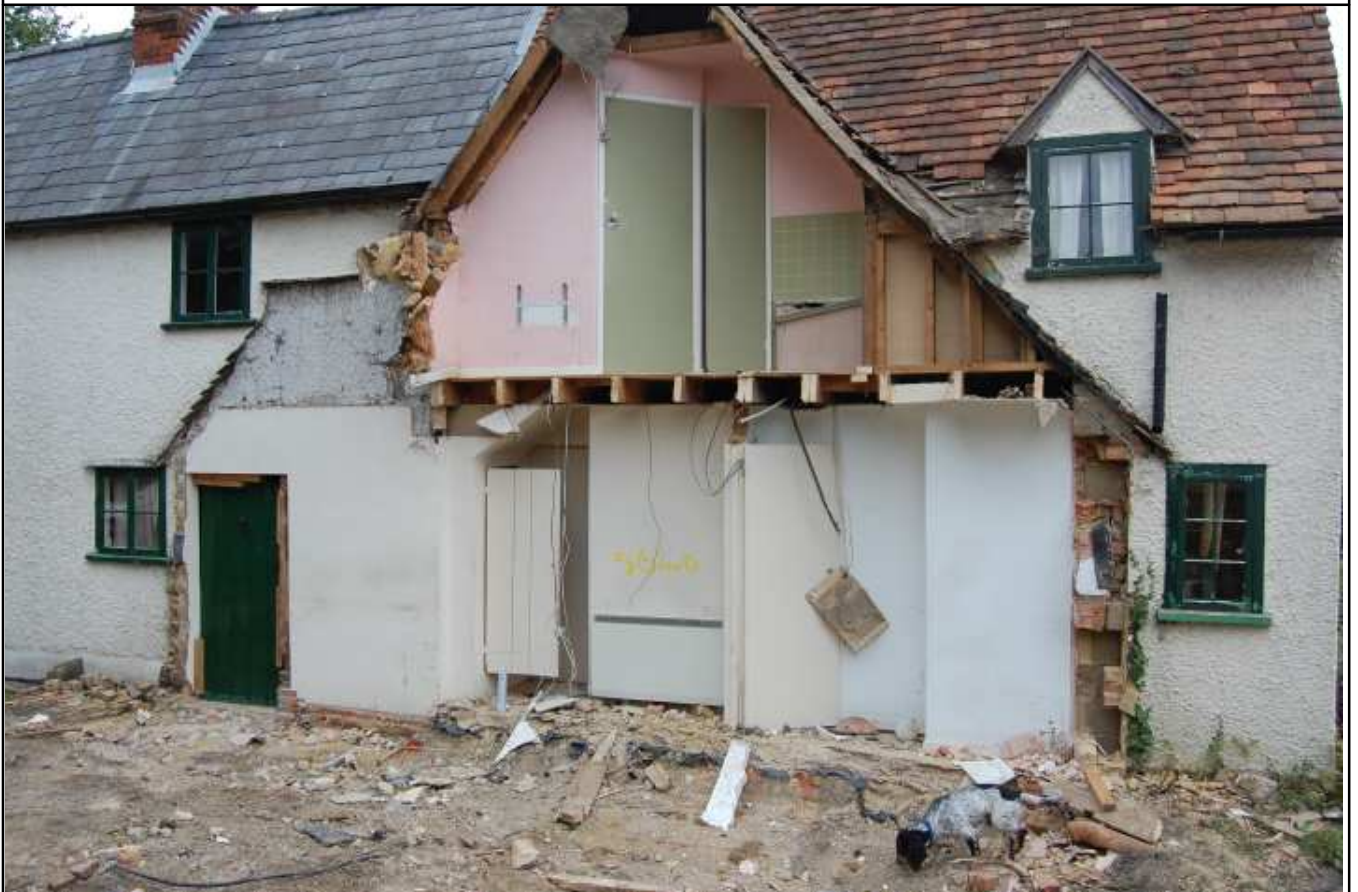
Plate 2: South end of W elevation, looking SE

3.10 To the south, the modern extension is also covered in white roughcast. It has a clay tiled roof and a dormer window, with a single-light side hung casement of four panes to the upper floor, and a single light side hung casement of six panes to the ground floor (Plate 2).

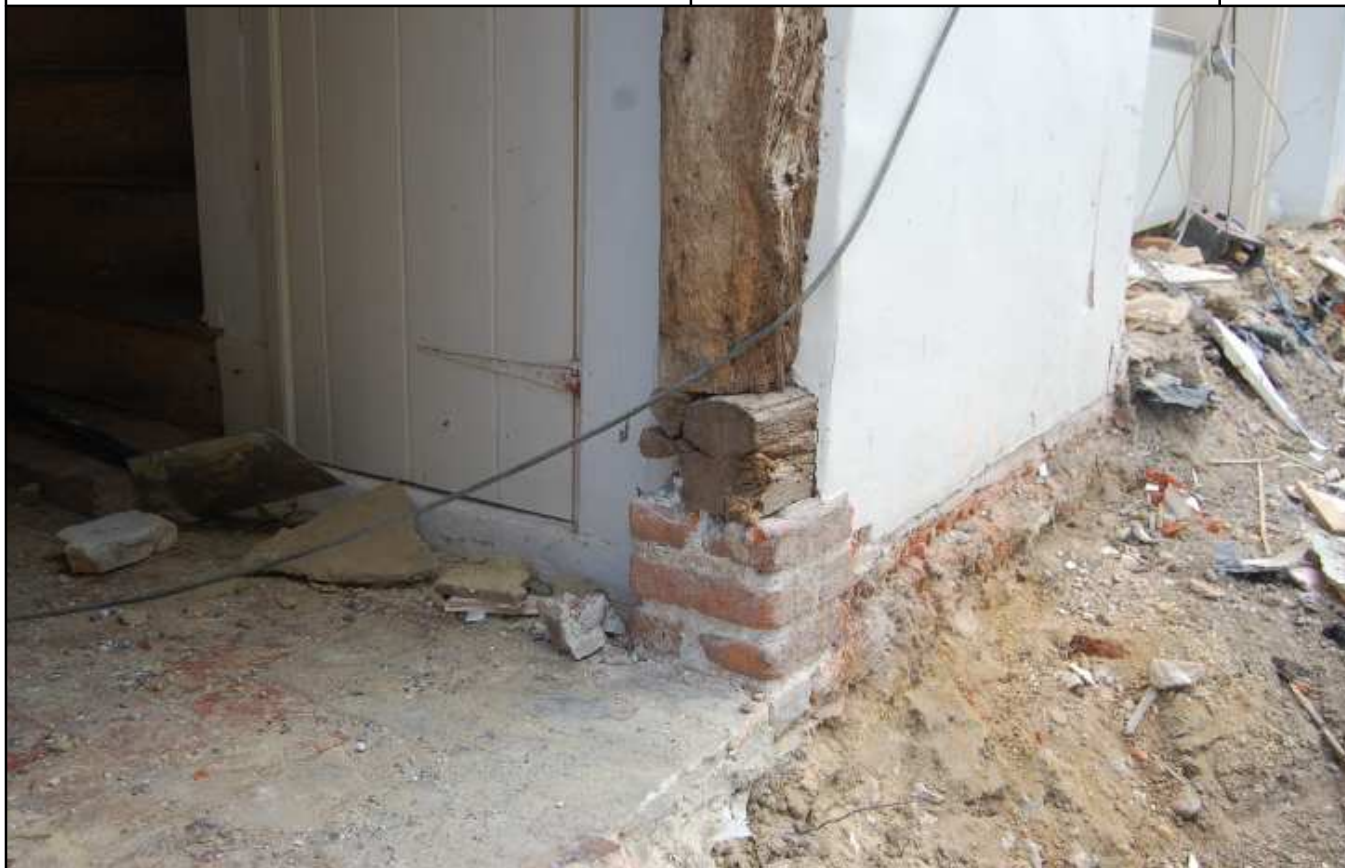
Plate 3: Post and cut wall plate, doorway at S end of northern block

3.11 The demolition of the modern western extension revealed that the doorway at the southern end of the historic block is a later insertion. The post on the southern side of the

doorway sits directly on the oak wall plate, which has apparently been cut to allow the insertion of the doorway (Plate 3). At this point the wall plate is supported on a plinth, at least six courses high, constructed in a mixture of red brick and large limestone cobbles bonded with a lime mortar (Plate 4).

3.12 The post may also be a later addition, possibly added when the doorway was inserted, as it is rather wider than the wall plate and is supported by two wooden wedges, with the lower wedge driven into the wall plate. The upper three courses to the brick plinth below the post appear to be a later addition.

4.3 The wall plate to the historic north block was exposed following the demolition of the former extension. It appeared to have been cut for the insertion of a doorway in the west elevation, possibly when the extension was added in the late 20th century.

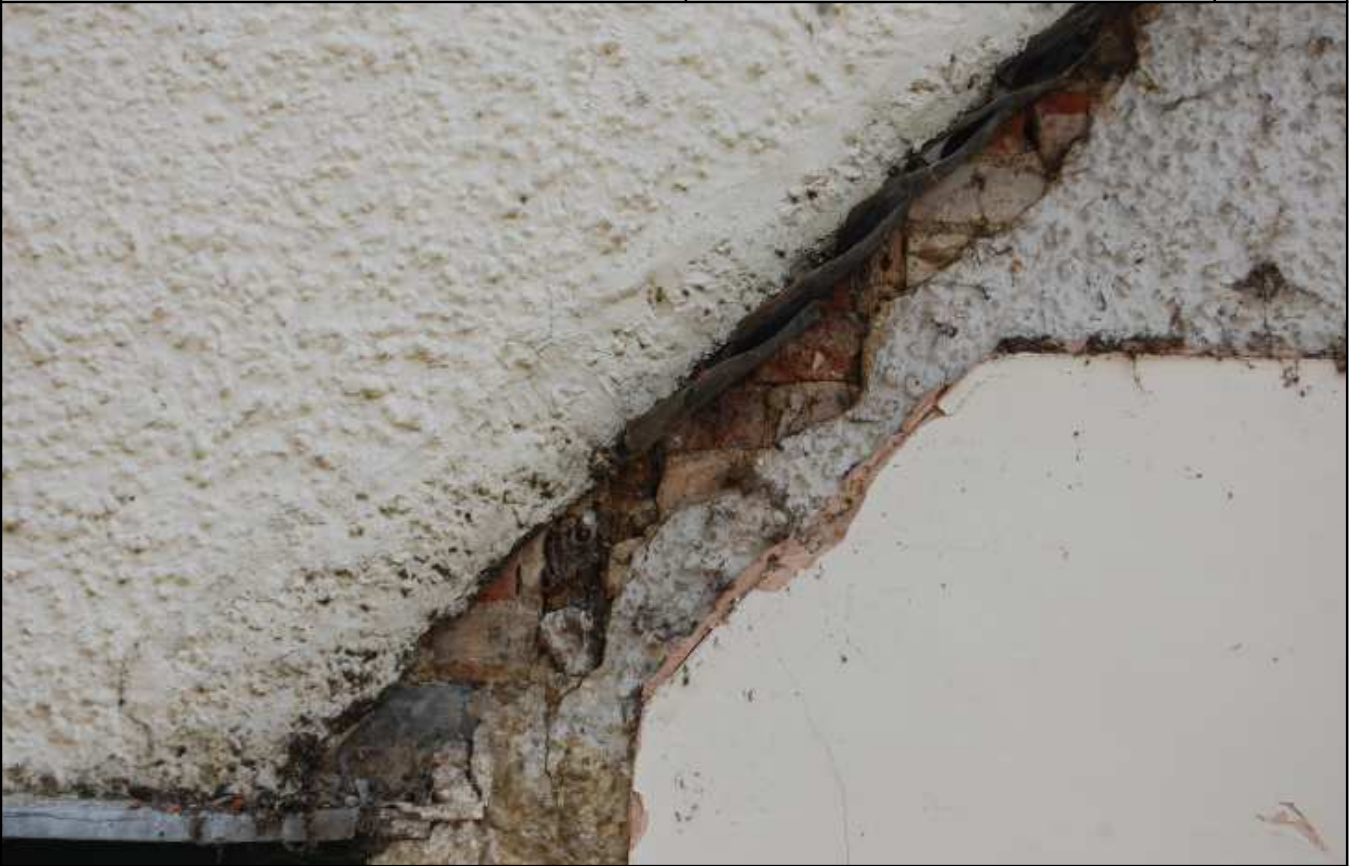
Plate 5: Narrow strip of brickwork exposed below the render, S end of north block

3.13 A narrow strip of brickwork was exposed below the roughcast following removal of the roof to the northern side of the demolished extension (Plate 5).

4.2 A narrow strip of brickwork, exposed below the roughcast, suggests that the timber framing to the north block is infilled by brick nogging.

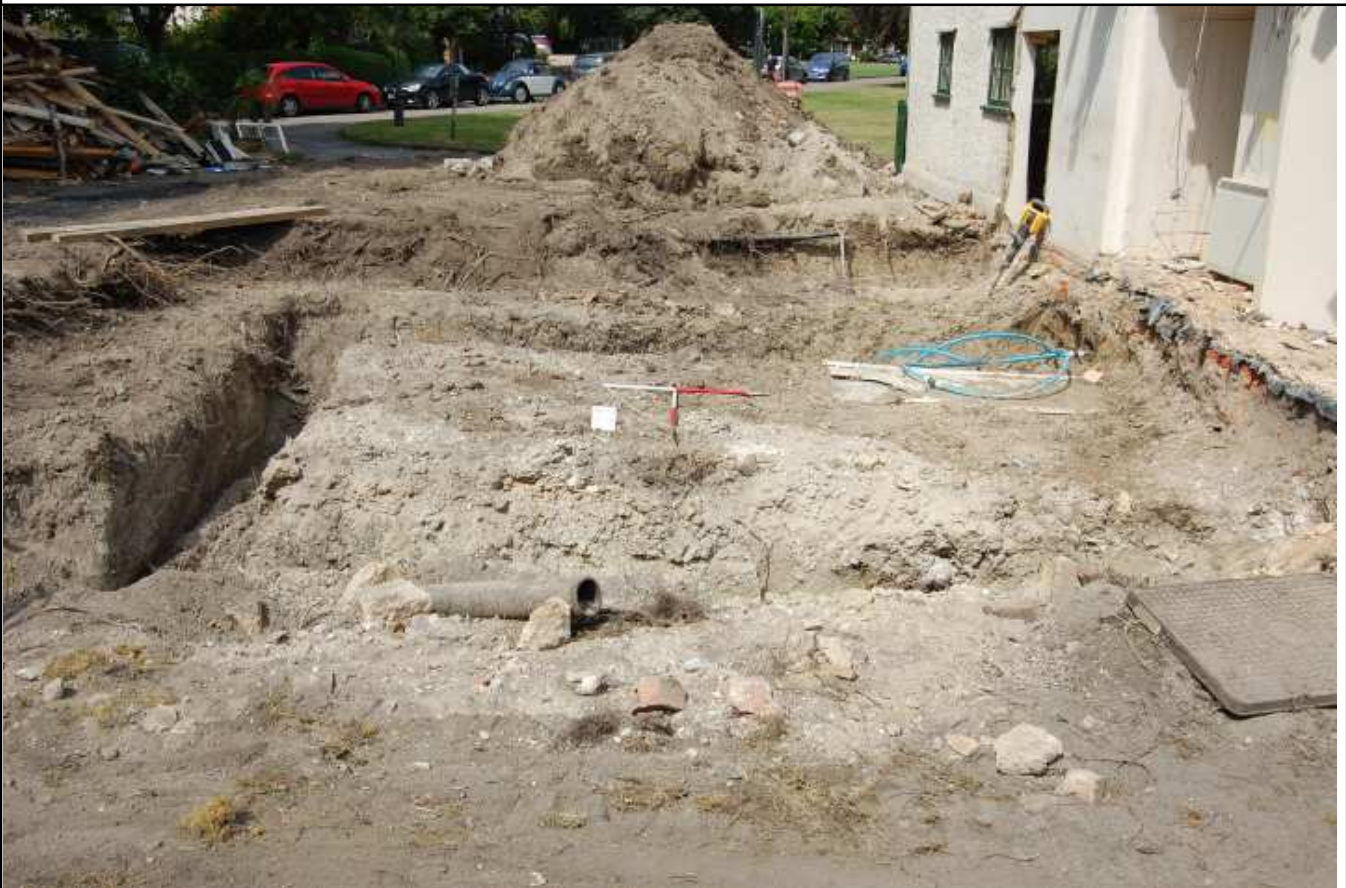
Plate 6: Area 1, looking NW

3.16 Following the removal of an existing concrete floor, 0.20m in depth, the ground level across an area of approximately 59m² was reduced by approximately 0.30m. Footings trenches for the extension were then excavated within this area. These measured between 5m and 6m in length, 0.60m in width and 1.30m in depth (Plate 6). A further short length of trench, for a porch to the new extension, was dug on the northern edge of the reduced area.

3.18 No archaeological features, deposits or finds were observed in this area.

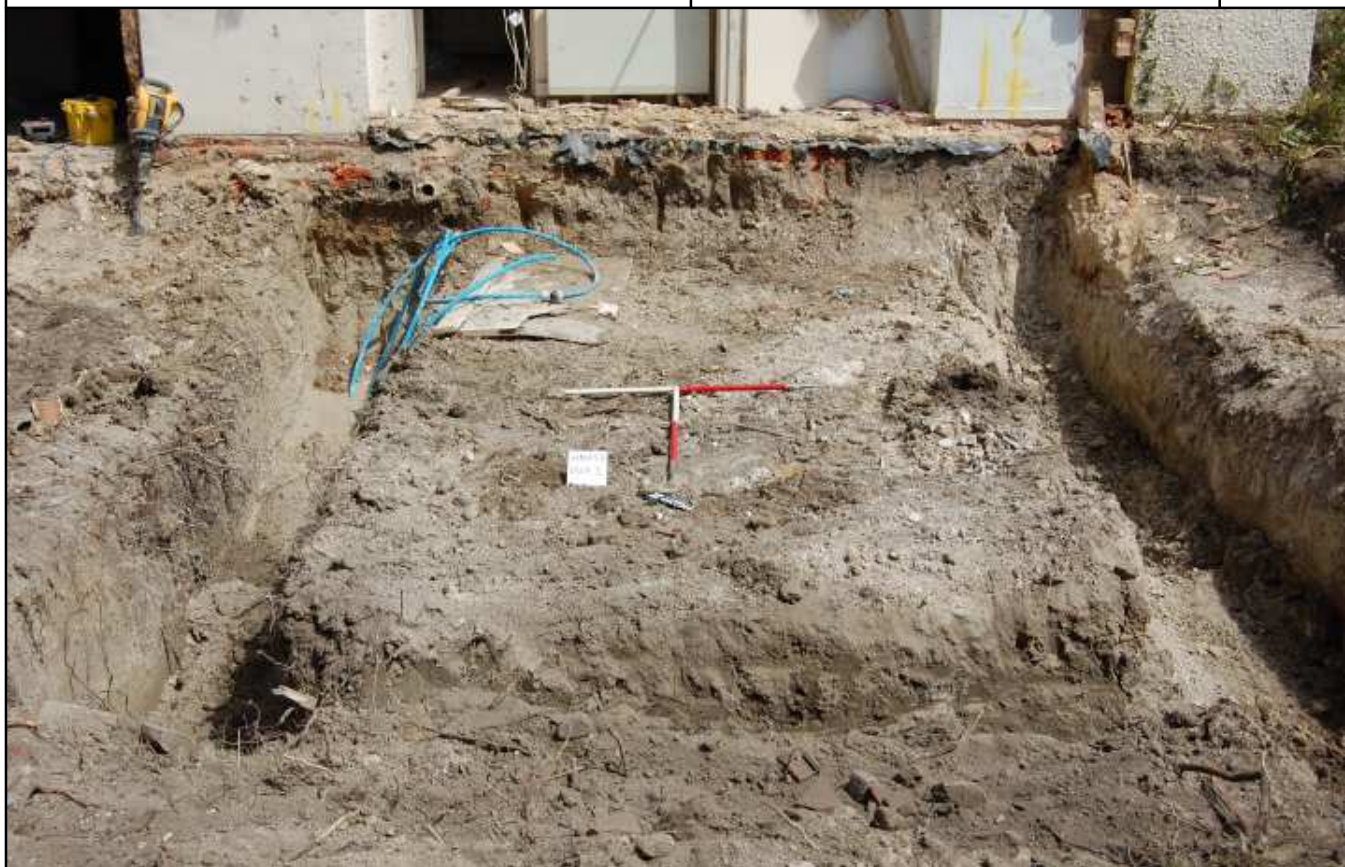
Plate 7: Area 1, looking W showing stratigraphy

3.17 The stratigraphy revealed in the trench sections consisted of a layer of redeposited dark yellowish brown (10YR 4/4) friable silty sandy clay subsoil, 0.50m in depth, which contained modern brick fragments. Below this was a layer of redeposited chalk, 0.25m in depth, which overlay the natural pale yellow (2.5Y 8/3) clay.

4.4 Monitoring of the development groundworks revealed that the ground level in Area 1 had been reduced for the former extension. No evidence for a topsoil layer was encountered. A layer of redeposited chalk was present beneath a redeposited subsoil, which may represent a bedding layer for an earlier structure.

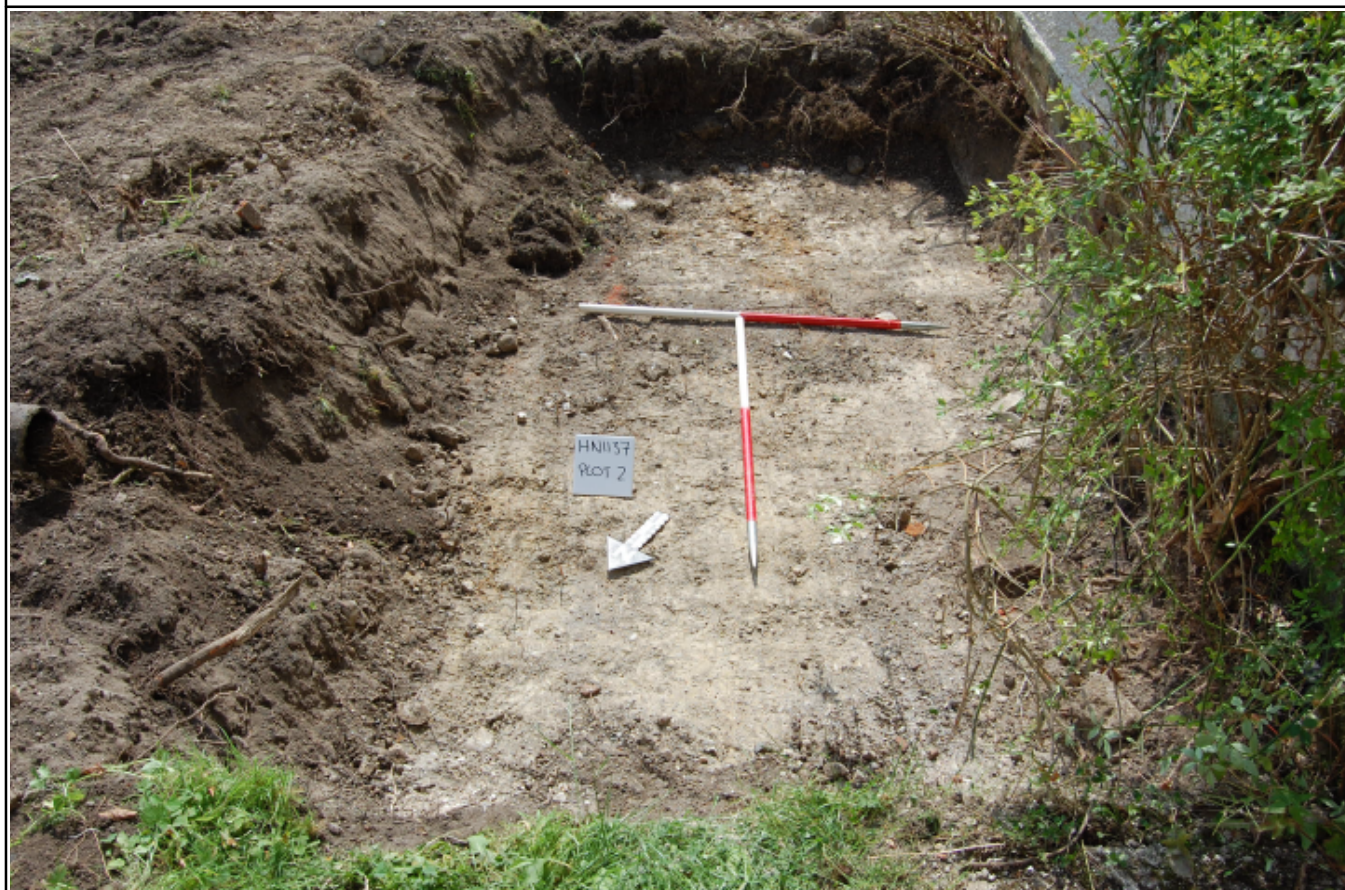
Plate 8: Area 2, looking SW

3.19 This was located against the east elevation to the south block and measured 3.50m in length, 2.20m in width and 0.50m in depth (Figure 3). The stratigraphy exposed in the sections consisted of a layer of dark brown (10YR 3/3) loose silty sandy clay topsoil, 0.10m in depth, above a friable dark yellowish brown (10 YR 4/4) silty sandy clay subsoil, 0.30m in depth. The natural pale yellow clay was encountered below the subsoil.

3.20 No archaeological features, deposits or finds were observed in this area.

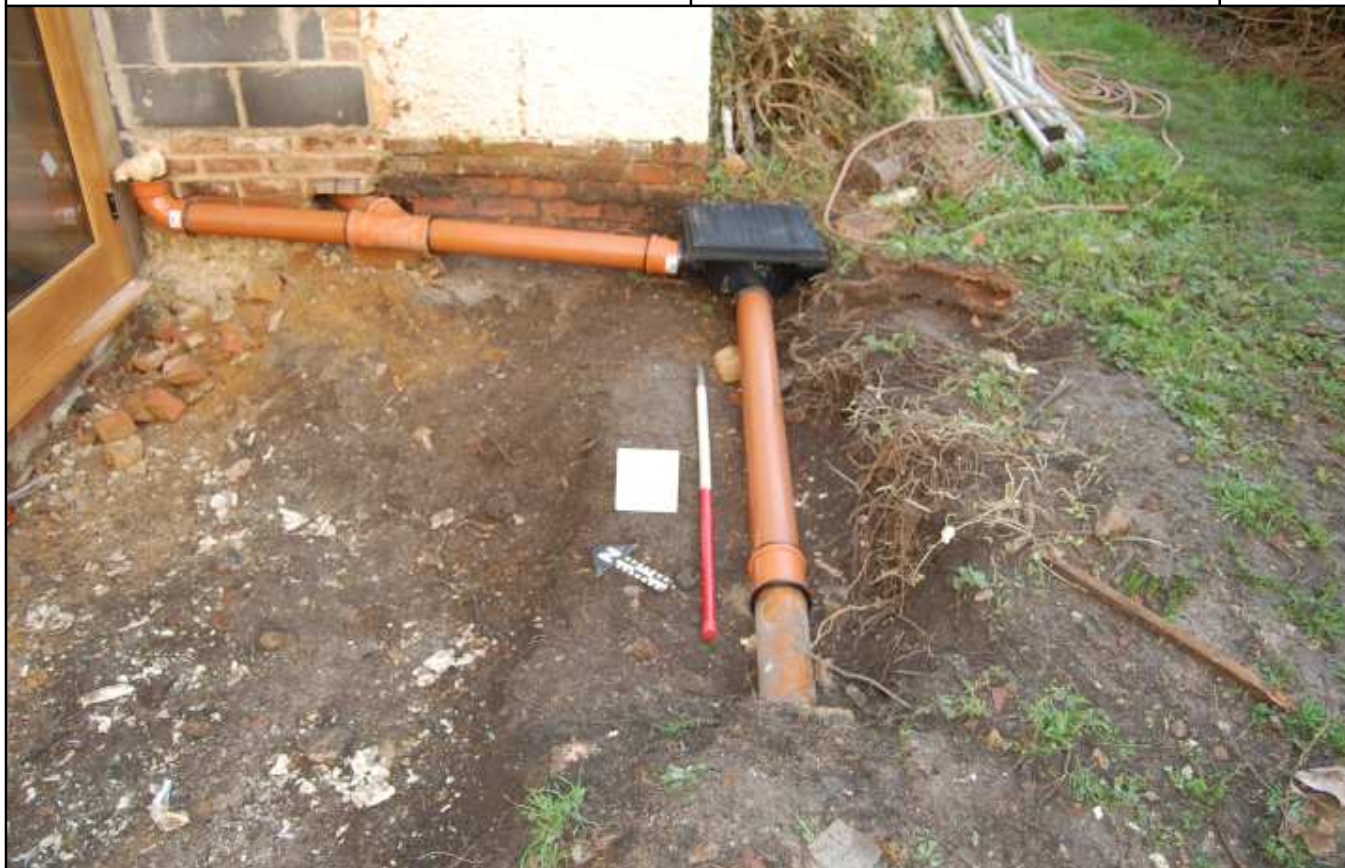
Plate 9: Trench 1, looking W

3.22 Trench 1 was located on the southern end of the south block to allow a new drain to link to an existing service. It measured 2.20m in length, 0.70m in width and approximately 0.20m in depth. It was cut into, but did not breach, the very dark greyish brown (10YR 3/2) silty clay topsoil (Plate 9).

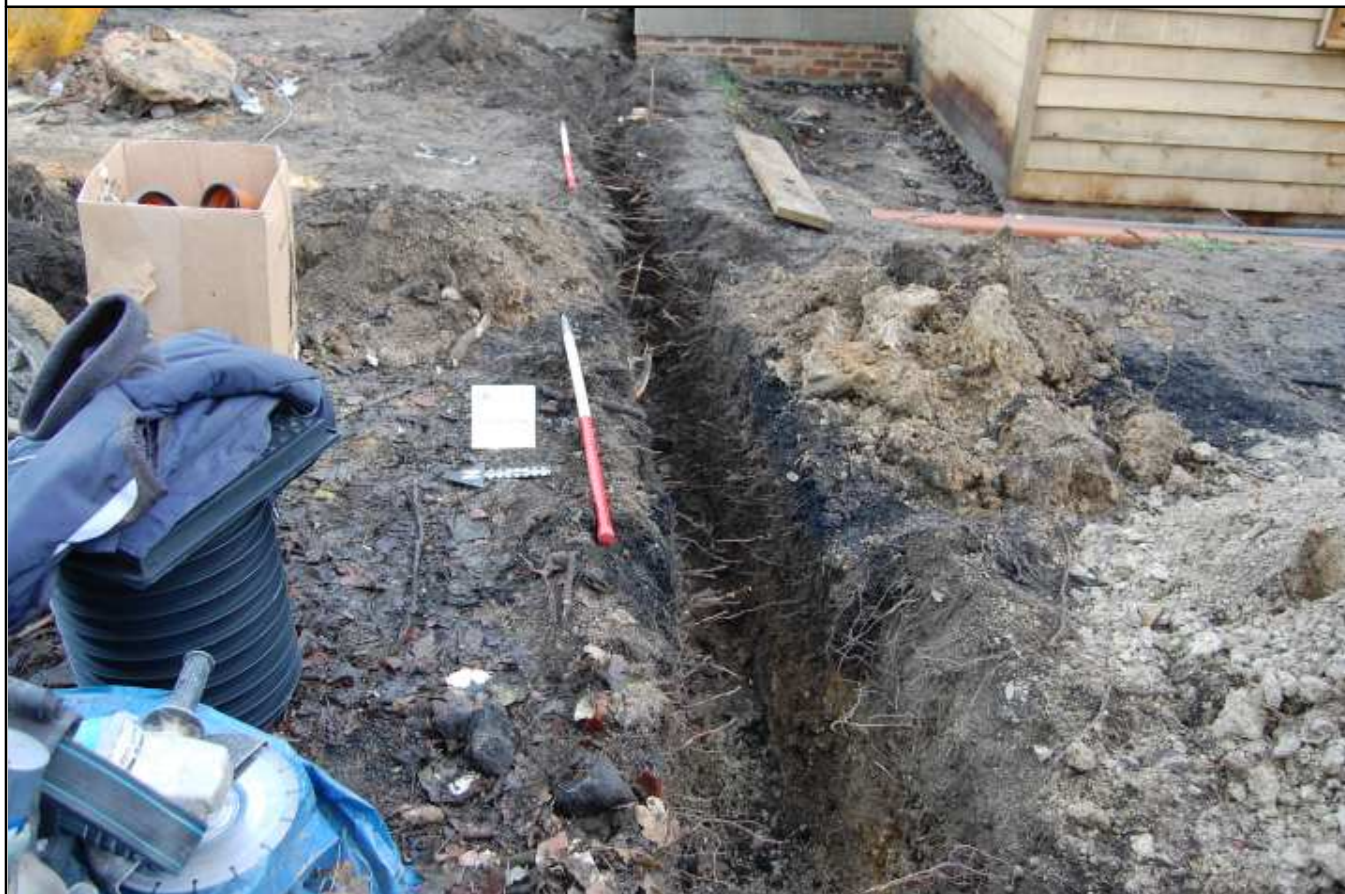
Plate 10: Trench 2, looking E

3.23 Trench 2 was located at the northern end of the porch to the new extension and measured 9.50m in length, 0.30m in width and was excavated to a depth of approximately 0.50m (Plate 10). The stratigraphy recorded in the section comprised a layer of very dark greyish brown (10YR 3/2) silty clay topsoil, 0.25m in depth, above a friable dark yellowish brown (10YR 4/4) silty sandy clay subsoil, 0.20m in depth (Plate 11). The natural pale yellow clay was observed below the subsoil.

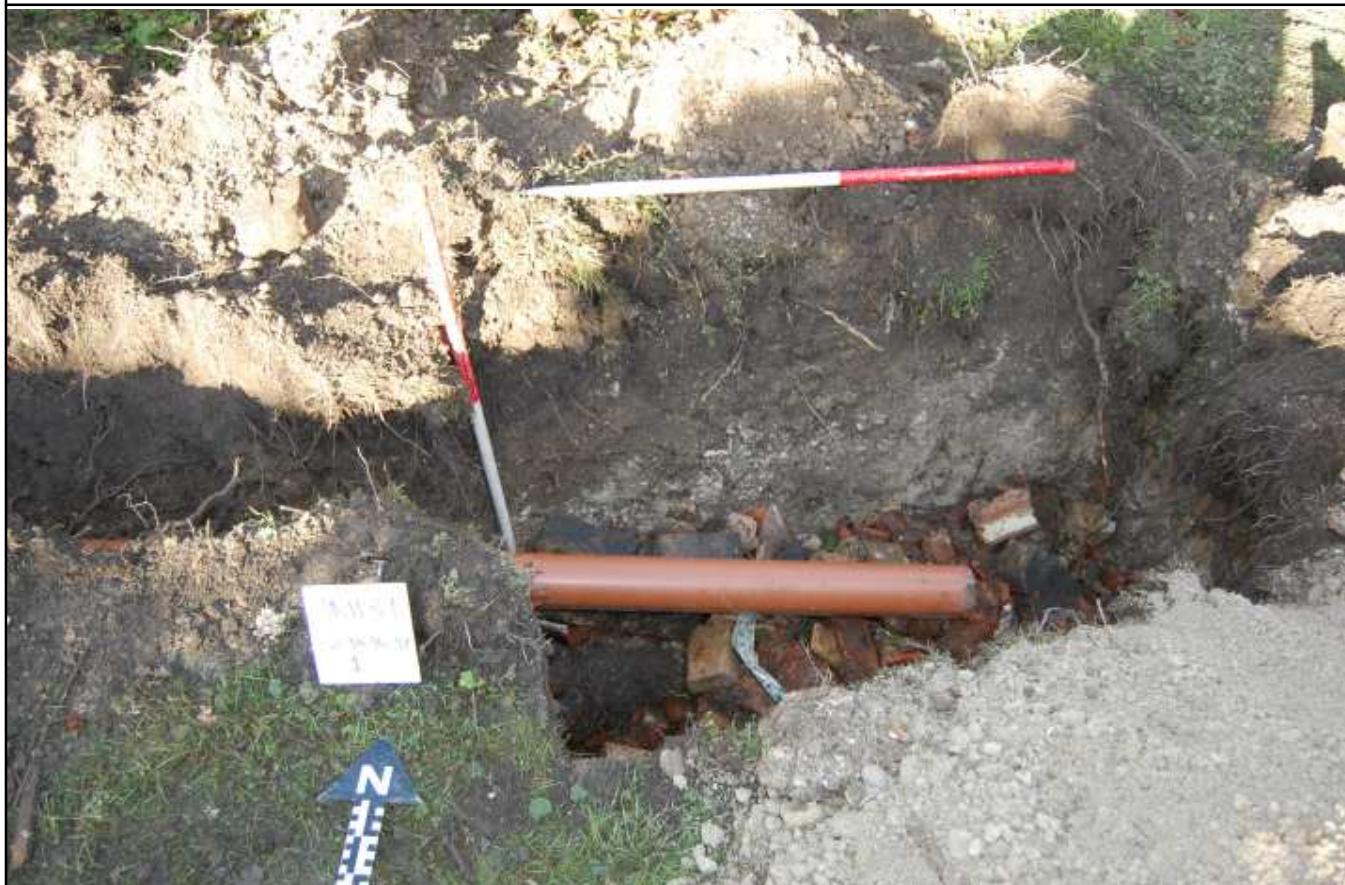
Plate 12: Soakaway, looking N

3.24 A soakaway was excavated in the garden to the east of the house (Figure 3). It measured 1m square and 1.20m in depth. It was fed by a trench measuring 5m in length, 0.50m in width and 0.50m in depth. The stratigraphy exposed in the sections was similar to that recorded in Area 2, consisting of a layer of loose dark brown (10YR 3/3) silty sandy clay topsoil, 0.10m in depth, above a friable dark yellowish brown (10 YR 4/4) silty sandy clay subsoil, 0.30m in depth (Plate 12). The natural pale yellow clay was encountered below the subsoil.

3.25 No archaeological features, deposits or finds were observed in any of the service trenches or the soakaway.

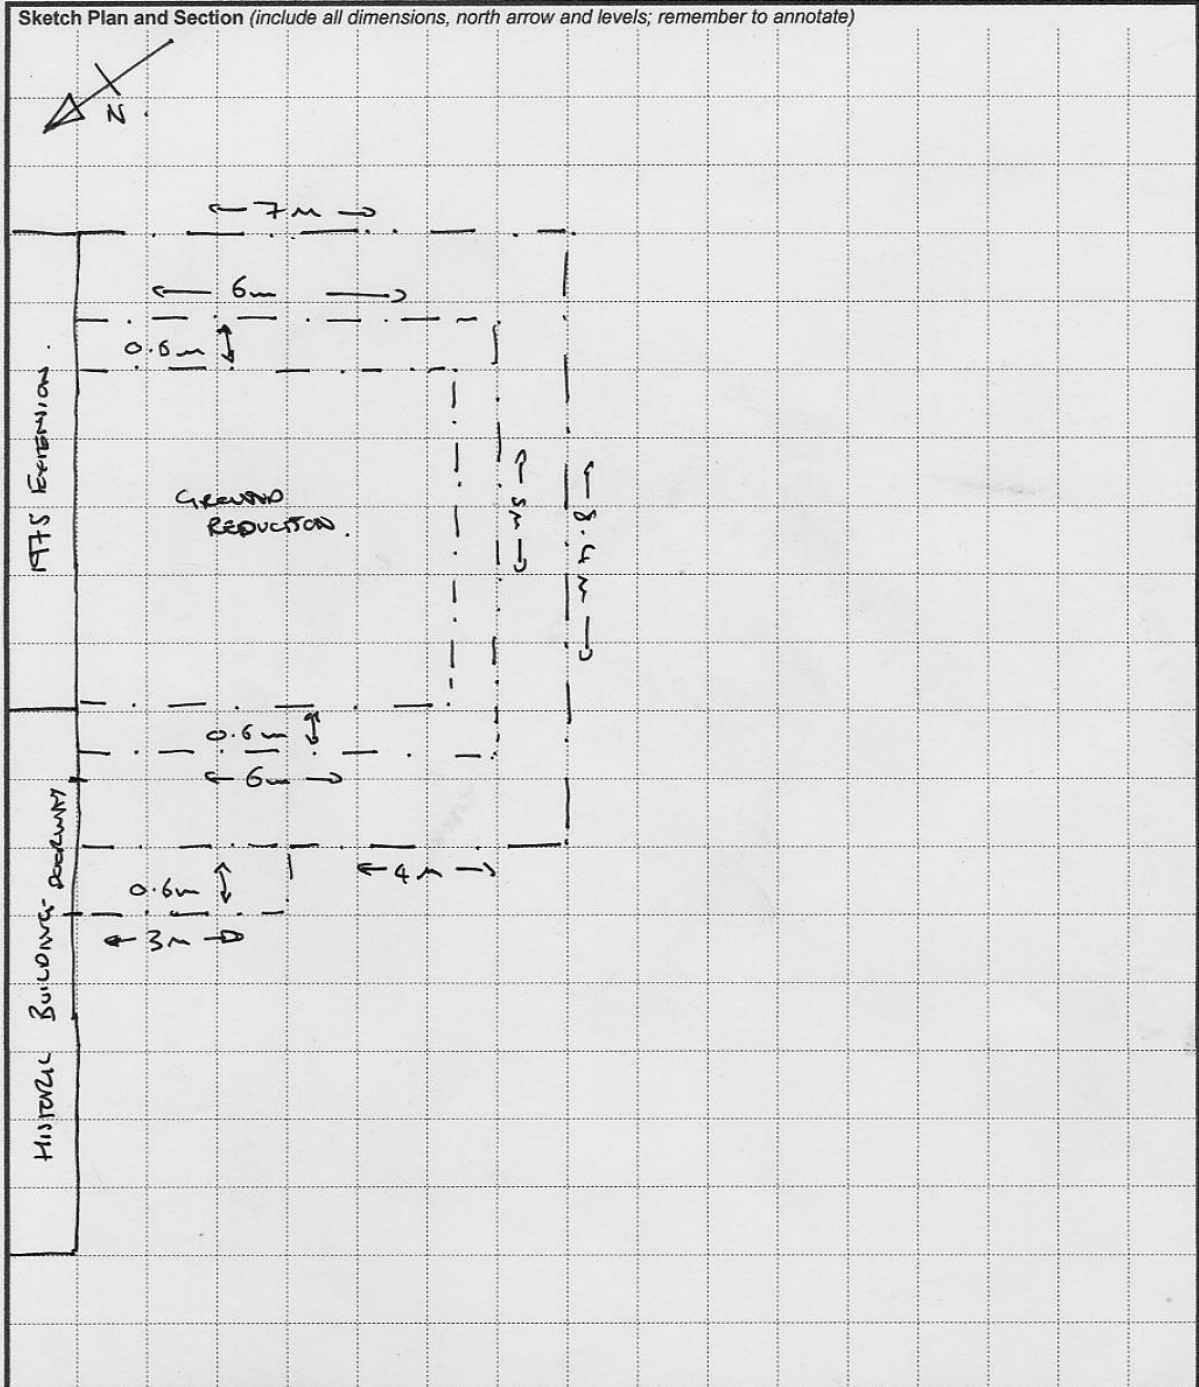
SKETCH PLAN OF PLOT 1 - GROUND REDUCTION + FOOTING TRENCHES
