Joseph Rochford Gardens, Old Coach Road, Birch Green, Herts.

Report No. 897

Joseph Rochford Gardens,
The Old Coach Road, Birch Green, Herts.

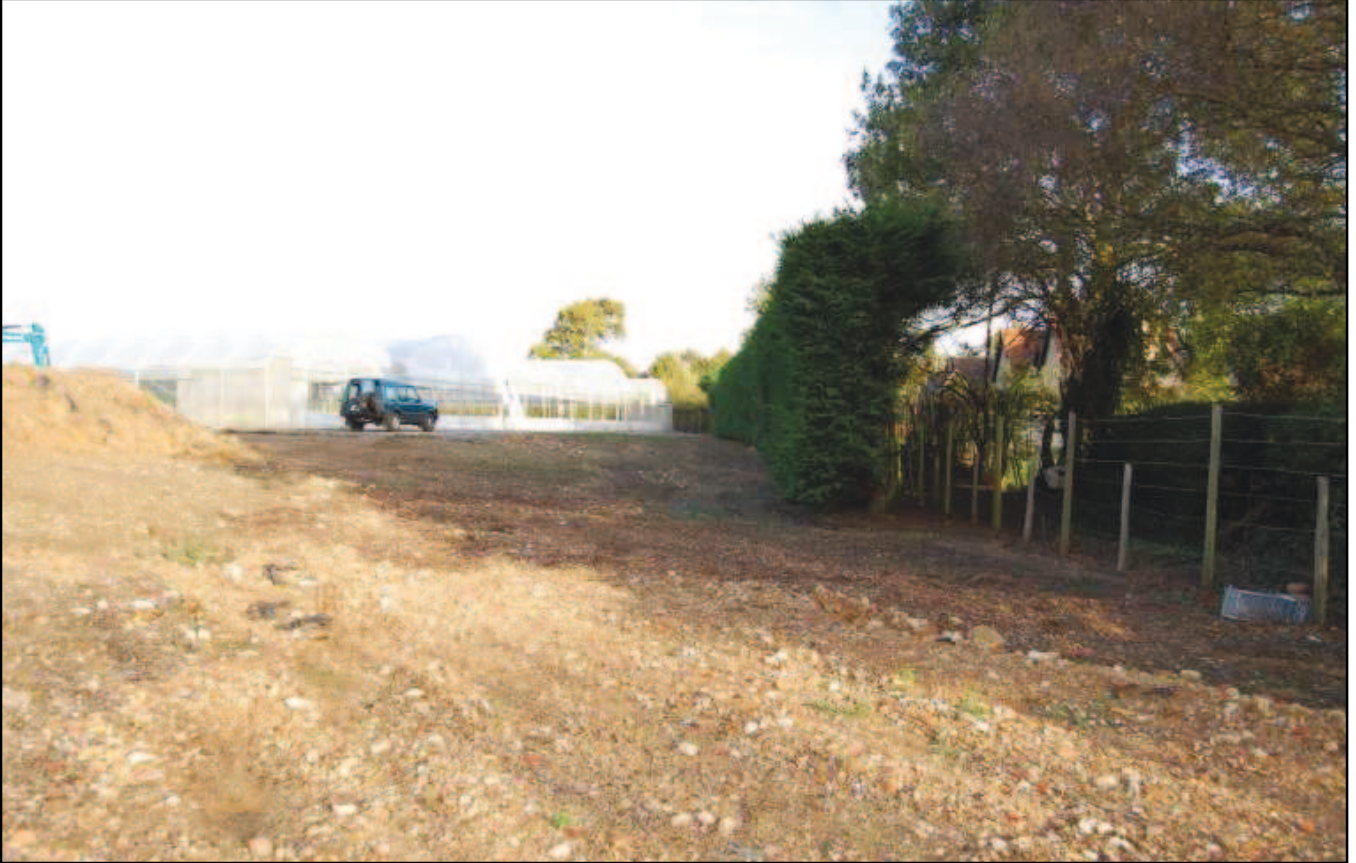
The study area comprises a former ploughed field, which had subsequently been used to deposit subsoil extracted during the development of other areas of the site as a nursery. This redeposited subsoil, a brownish yellow (10YR 6/6) sticky clay, contained occasional brick, tile, glass and metal debris. It was observed across the entire site to a depth of approximately 0.4m (Plates 1 & 2).

Plate 1: Overburden height from original ground level; East end of site, looking north.

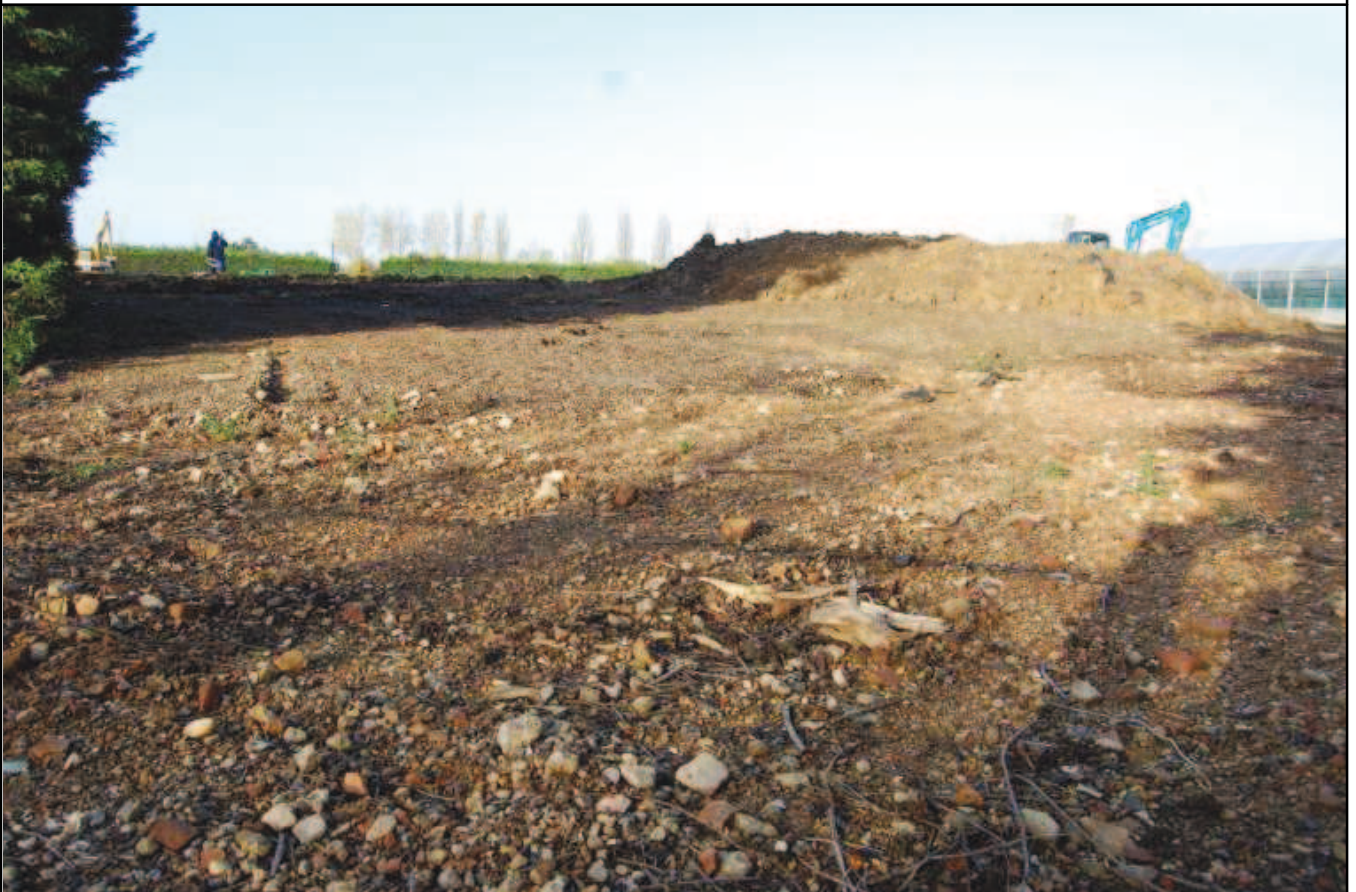
Plate 2: Overburden height from original ground level; East end of site, looking south.

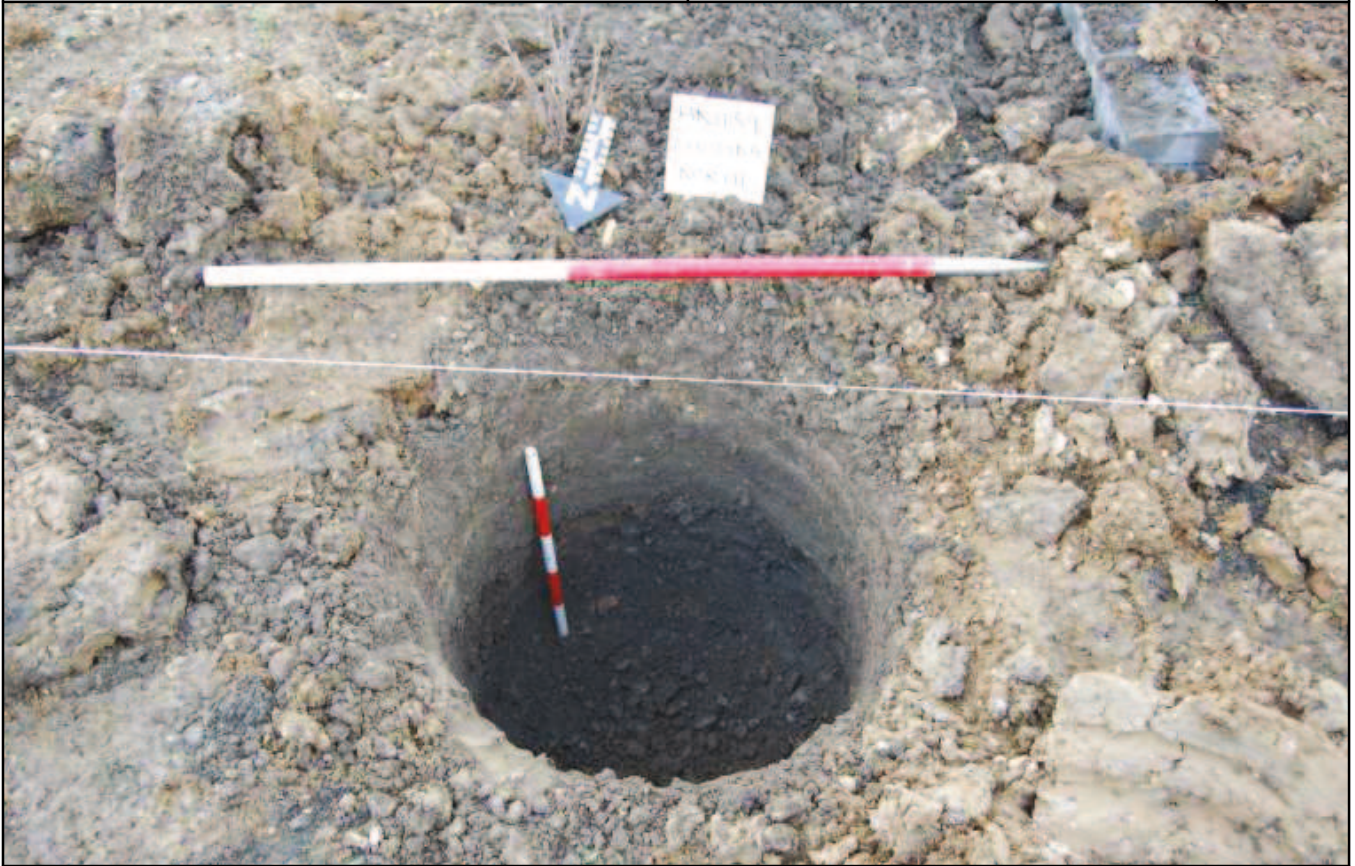
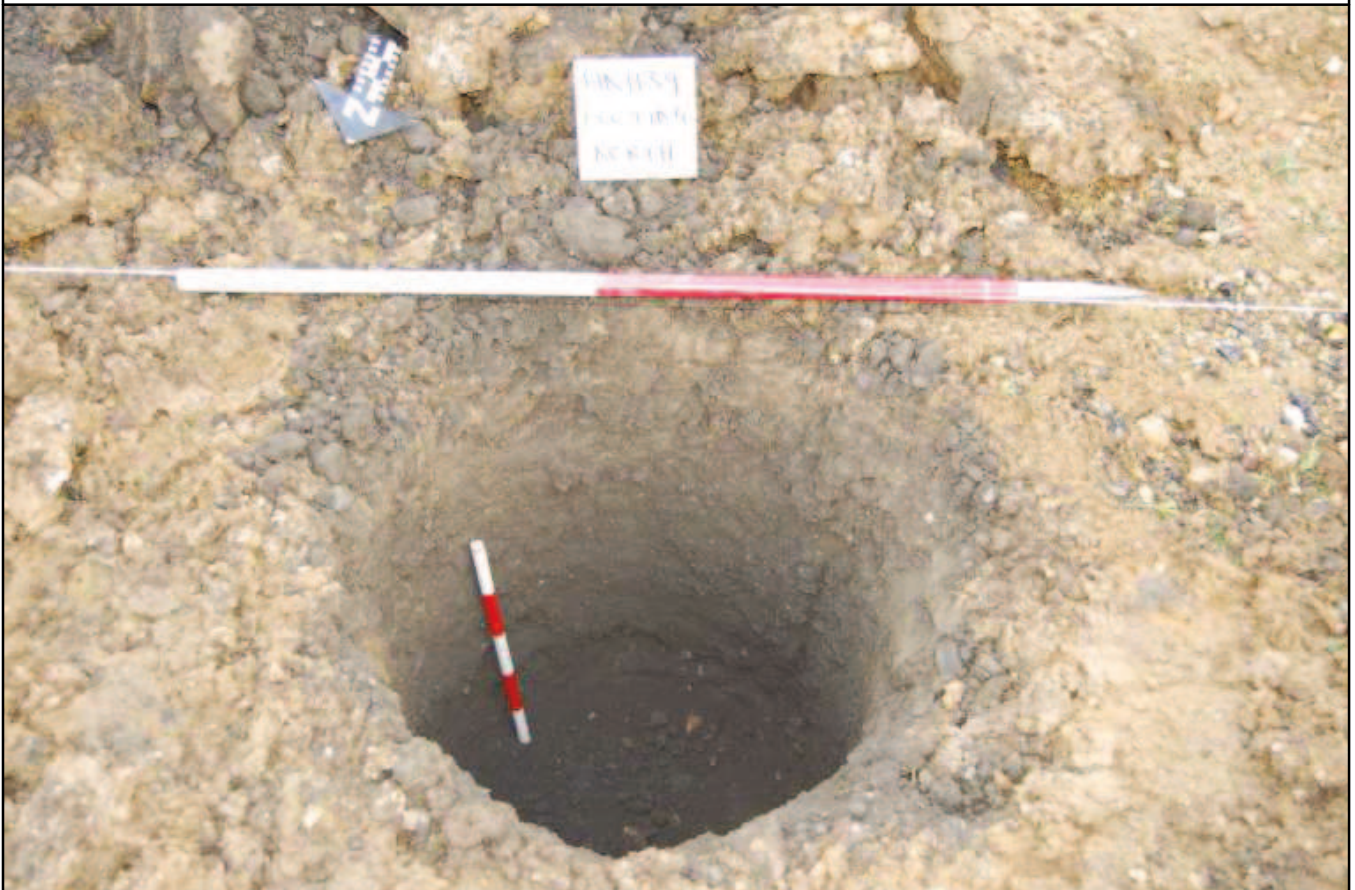
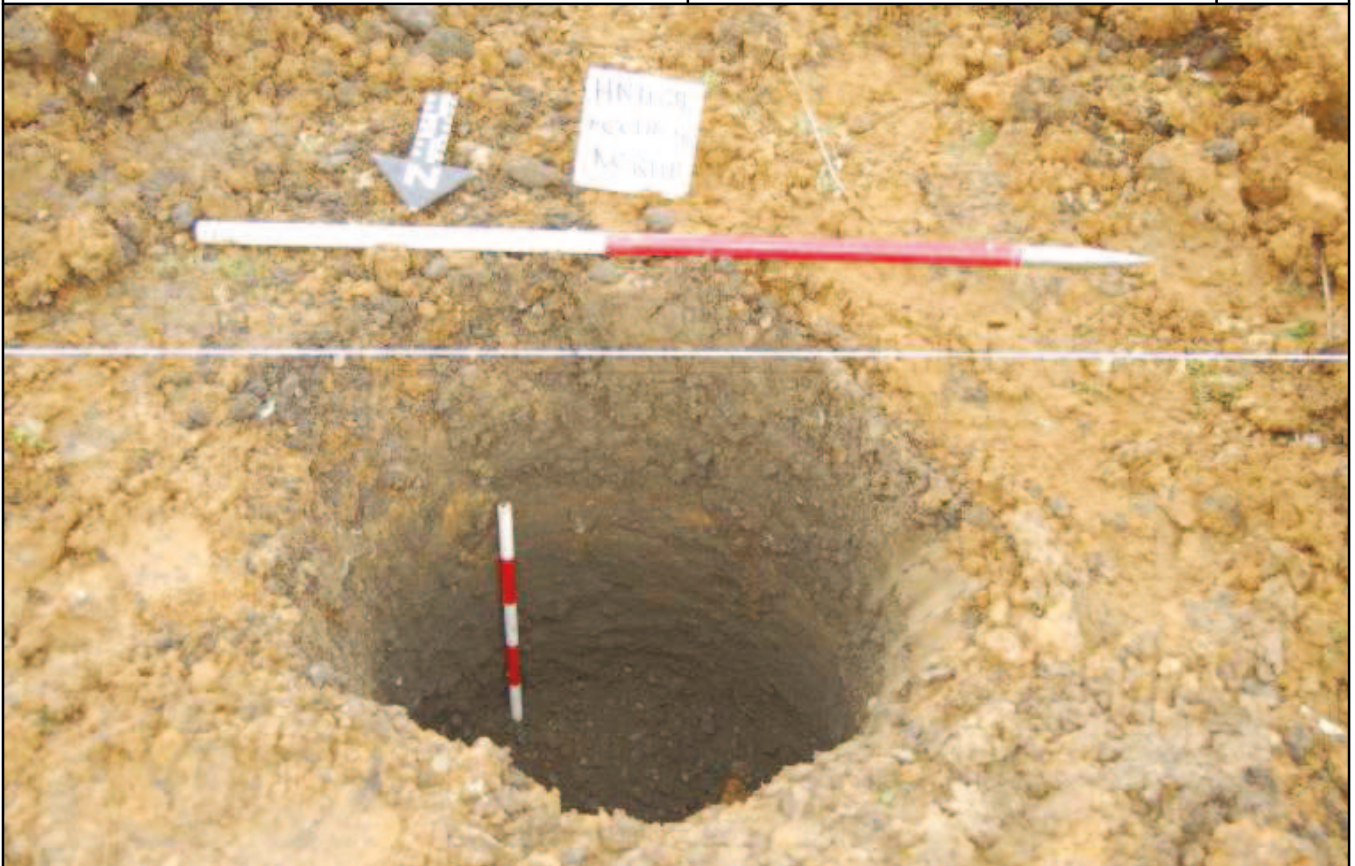
A total of 32 augured holes were recorded across the site (Figure 2), including 9 along the north side (Plates 3-5), 7 along the south side (Plates 6-8), 7 along the east side, 5 along the west side and 4 across the centre (Plates 9-11). Each pit revealed a similar stratigraphy, comprising c.0.4m of redeposited brownish yellow (10YR 6/6) sticky clay, with occasional brick, tile, glass and metal debris, above c.0.2m of dark grey (10YR 4/1) loose silty sandy clay ploughsoil with occasional small rounded pebbles (Figure 3). This overlay a brownish yellow (10YR 6/6) sticky clay subsoil, >0.1m thick, with occasional gravel. The underlying natural sand and gravel was not reached in any of the pits.

Plate 3: Augured hole, north side, looking south.

Plate 4: Augured hole, north side, looking south.

Plate 5: Augured hole, north side, looking south.

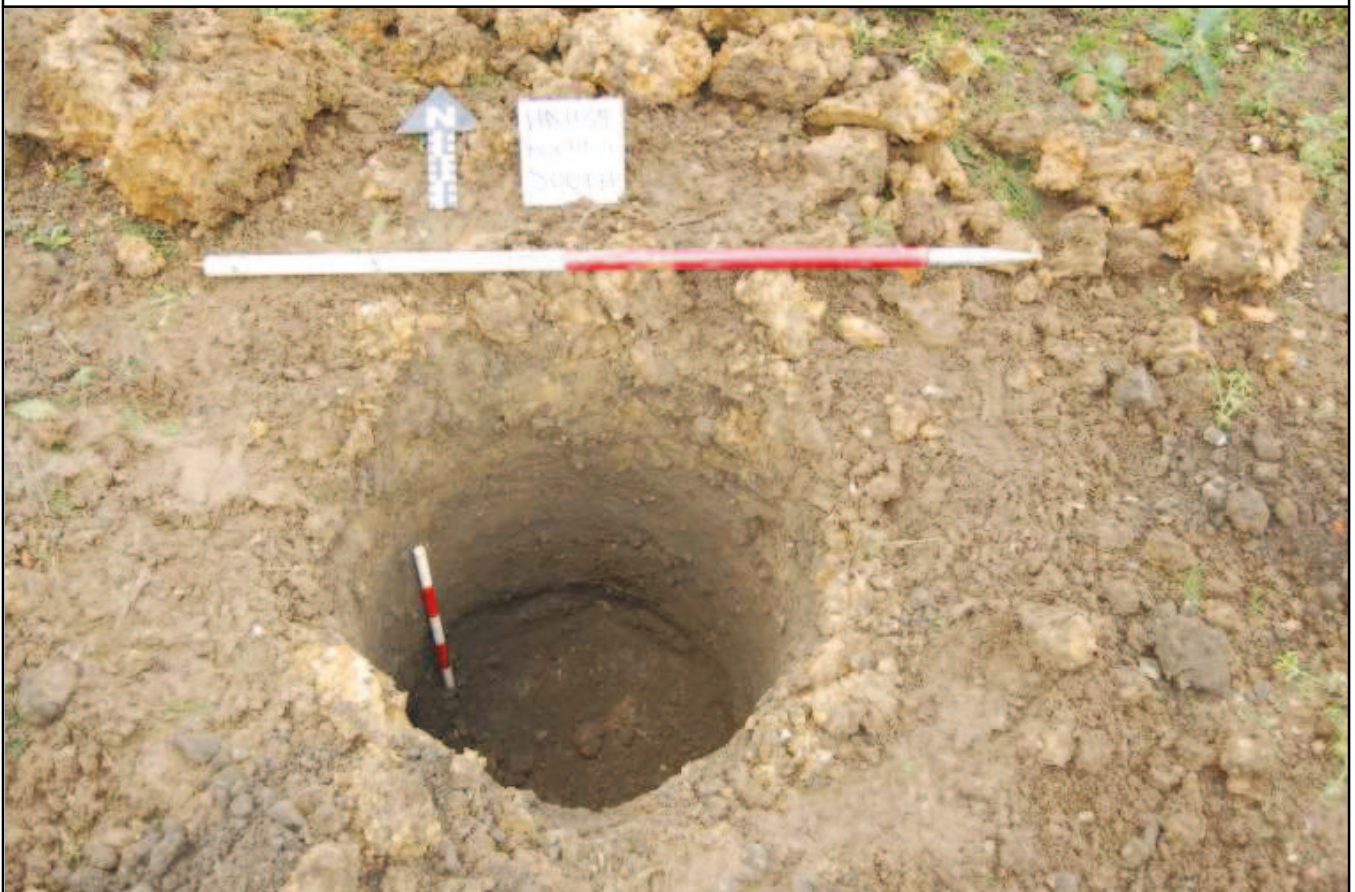
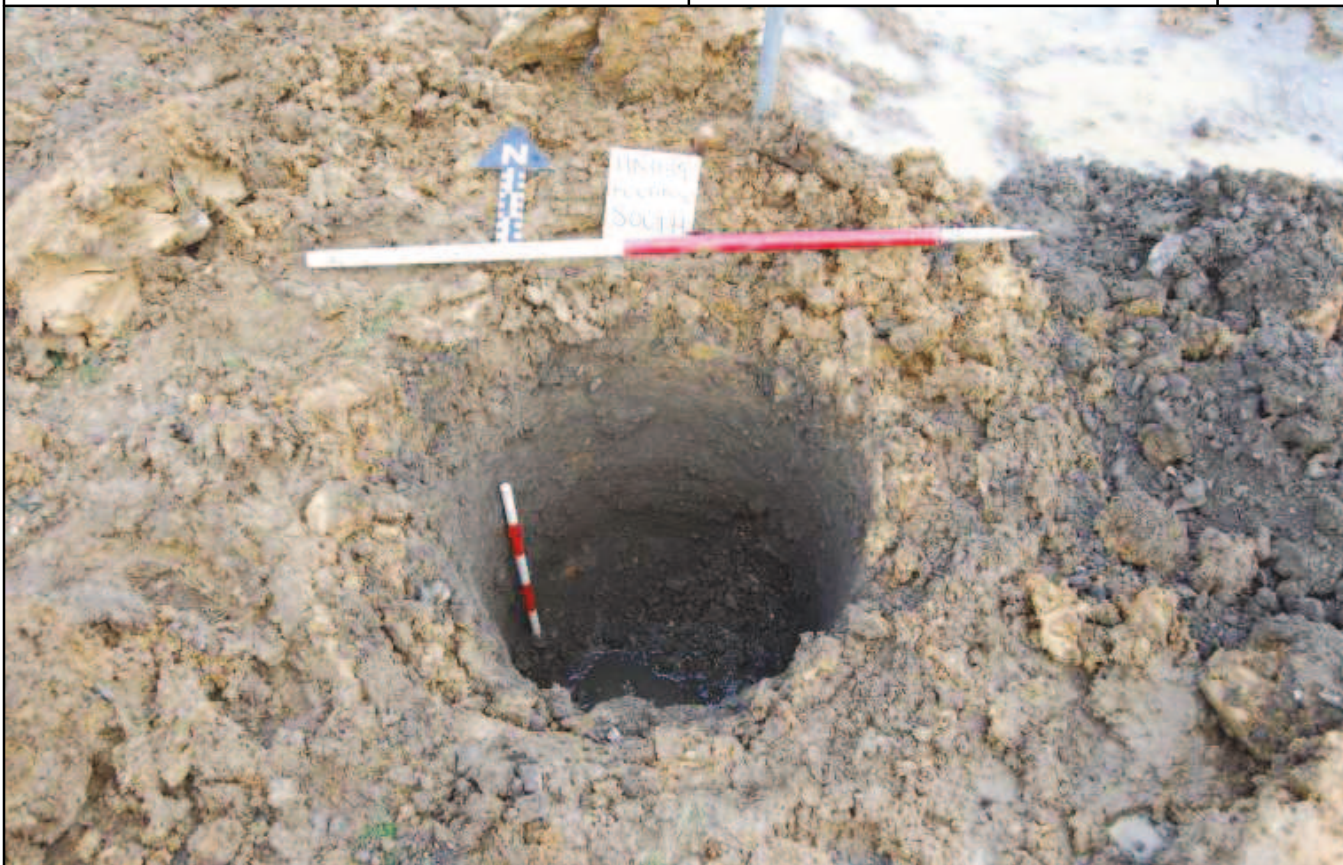
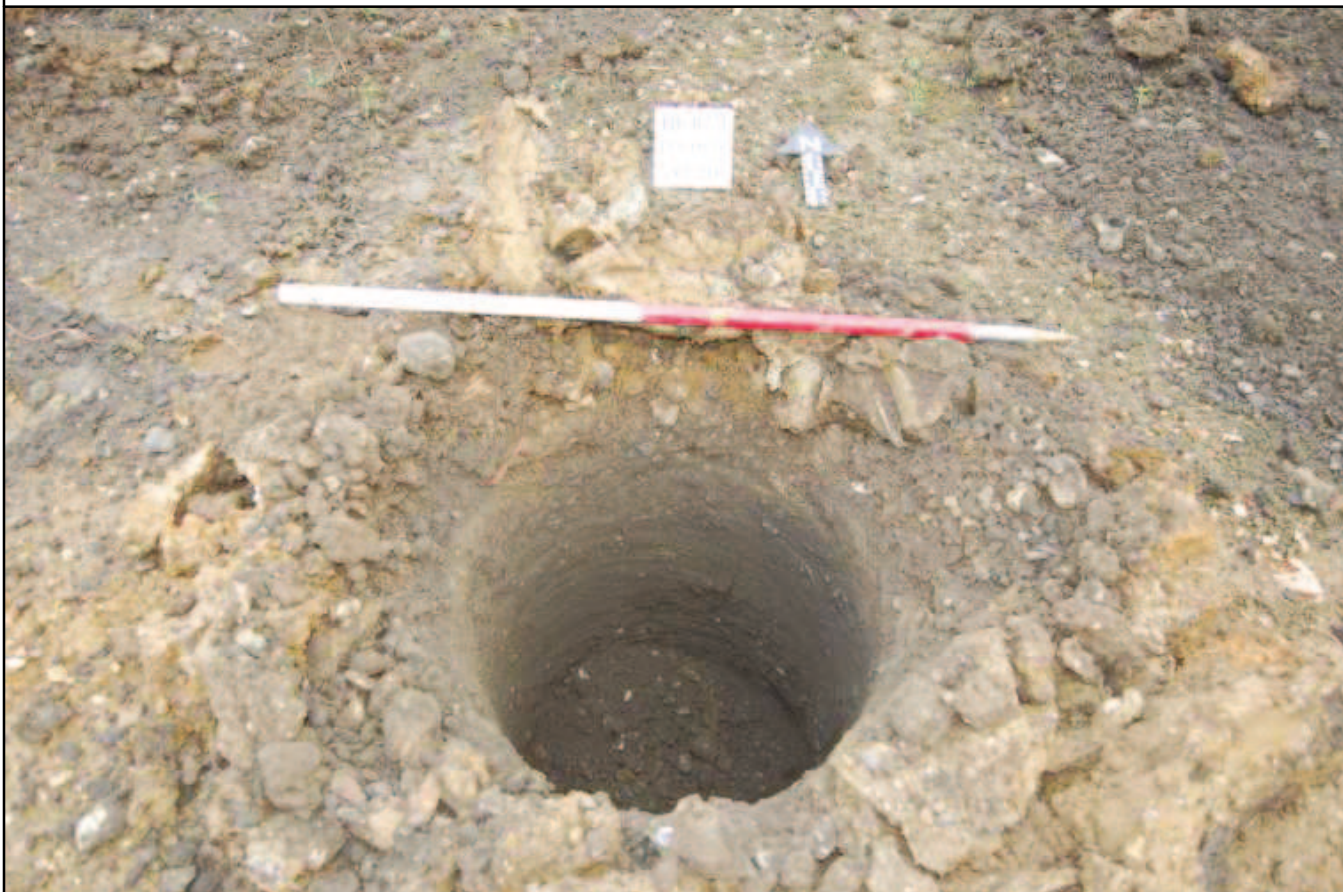
Plate 6: Augured hole, south side, looking north.

Plate 7: Augured hole, south side, looking north.

Plate 8: Augured hole, south side, looking north.

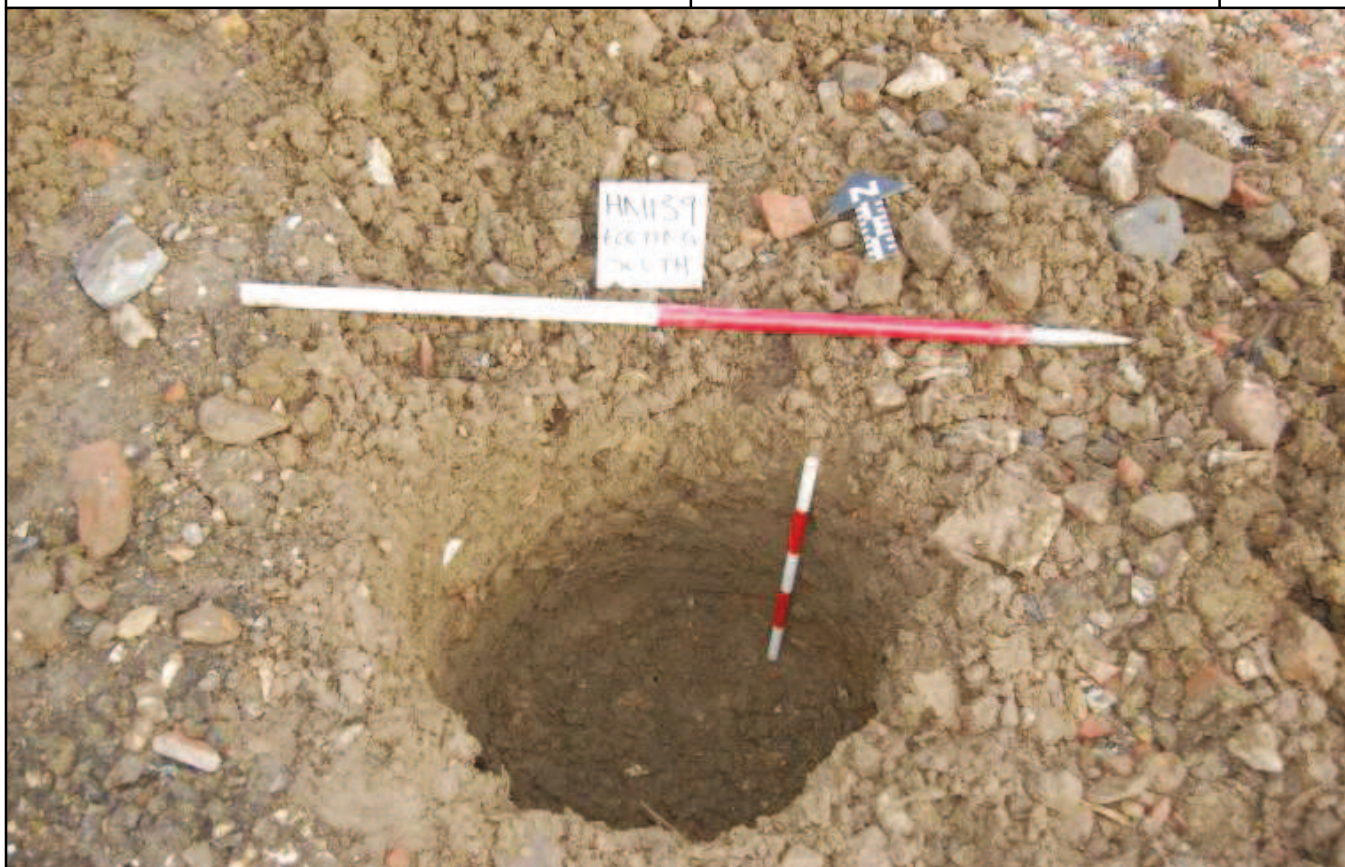
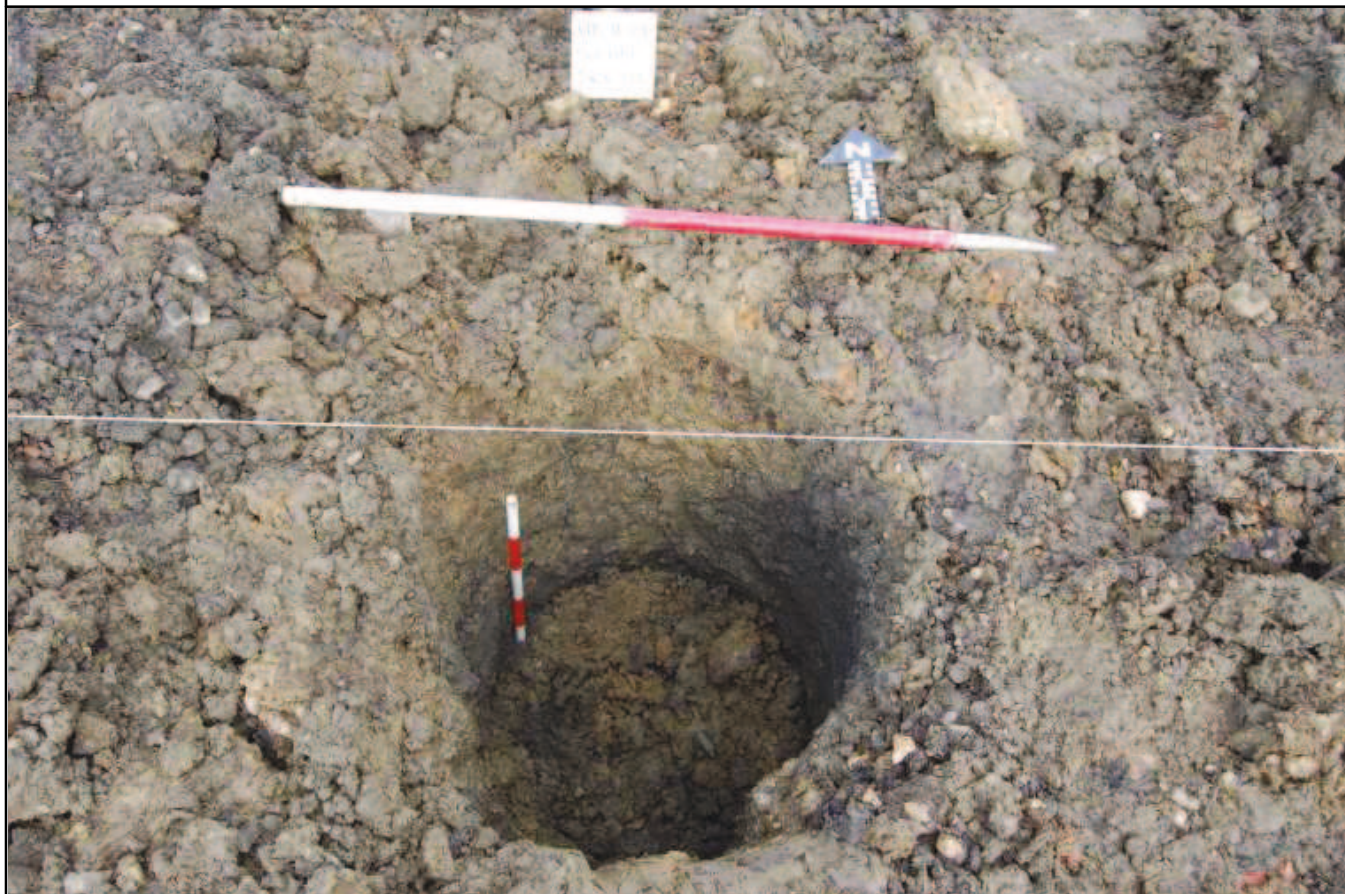
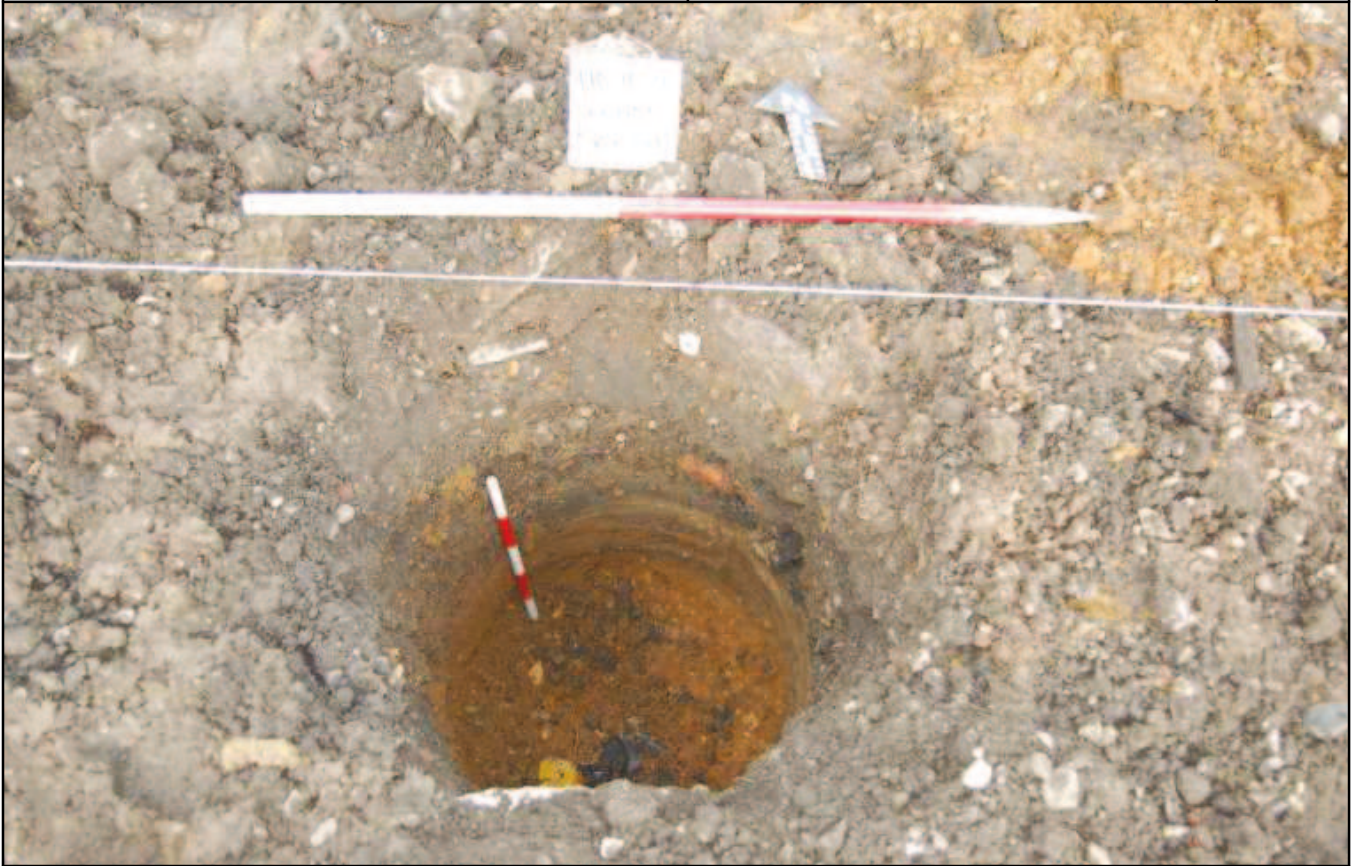
Plate 9: Augured hole, middle, looking N

Plate 10: Augured hole, middle, looking N

Plate 11: Augured hole, middle, looking N
