**21 MOOR END
Eaton Bray
Beds**

***ARCHAEOLOGICAL
MONITORING REPORT***

21 MOOR END
Eaton Bray, Bedfordshire

Project ref.: HN1157
Planning ref: CB/14/01758/FULL
Museum ref.: LTNMG 1112

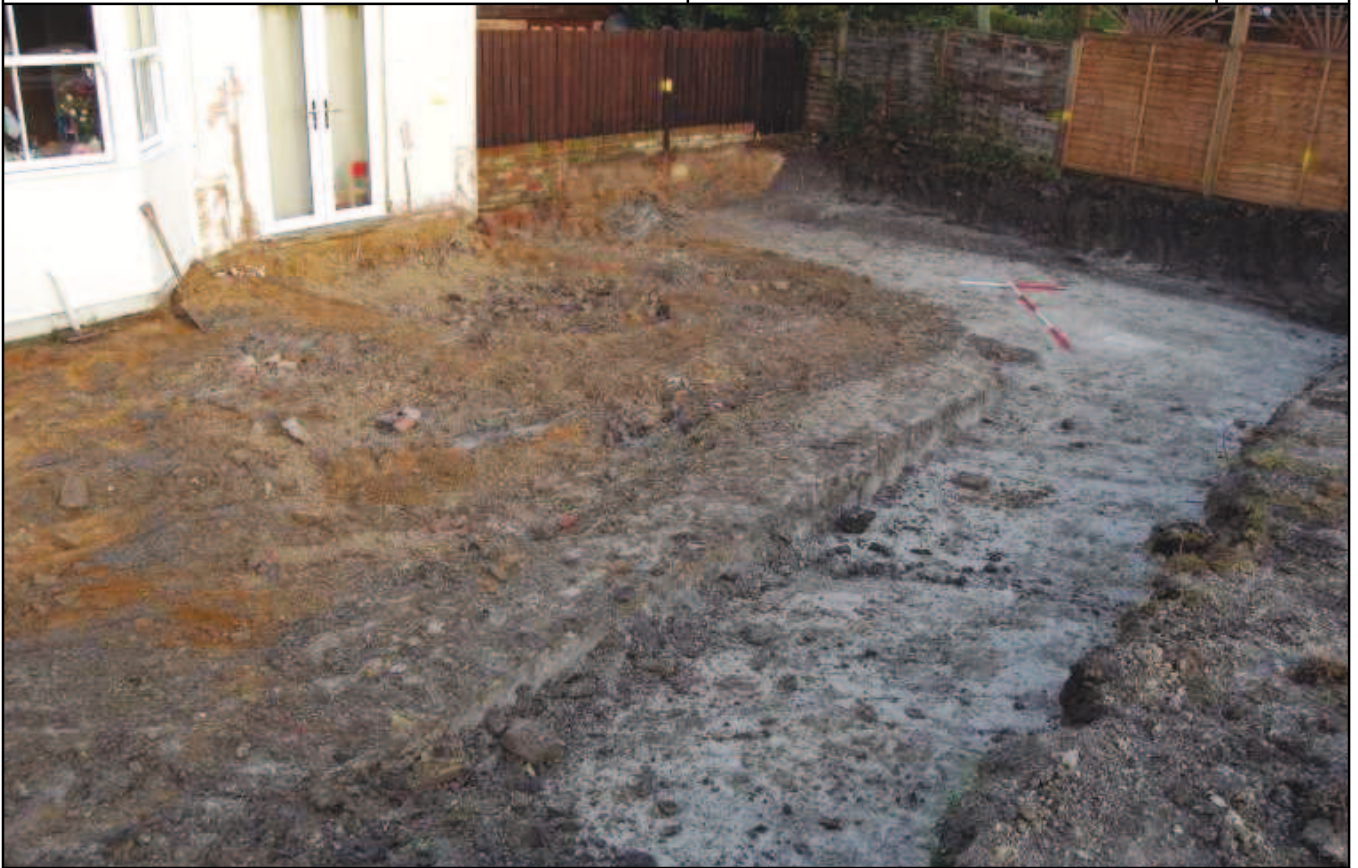
Plate 1: Area of ground reduction, looking NW

2.12 At the northern end of the site an area of approximately 12.5m by 8.5m was reduced by up to 1.1m (Figure 3, Plate 1). The stratigraphy revealed in the sections comprised a layer of dark greyish brown (10YR 4/2) clayey sand topsoil, c.0.55m thick, overlying a dark grey (10YR 4/1) clayey silt subsoil, c.0.2m thick, overlying a white (2.5 Y 8/1) clayey silt natural.

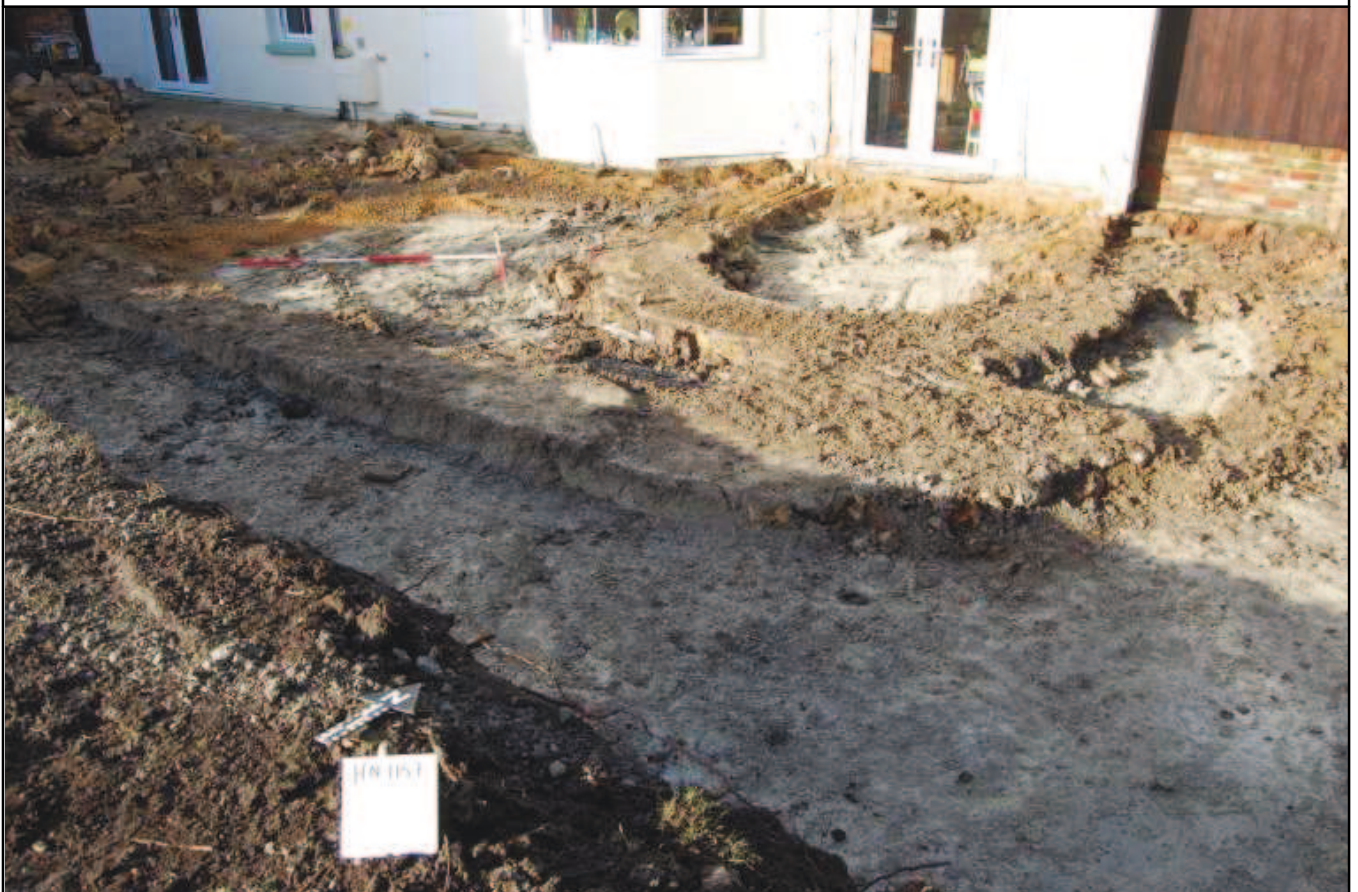
Plate 2: Area of ground reduction, looking SW

2.13 The western side of this area, which lay directly below the former patio and conservatory, was made up of modern overburden related to their construction. This chiefly consisted of a sand bedding layer directly overlying the natural clayey silt (Plate 2).

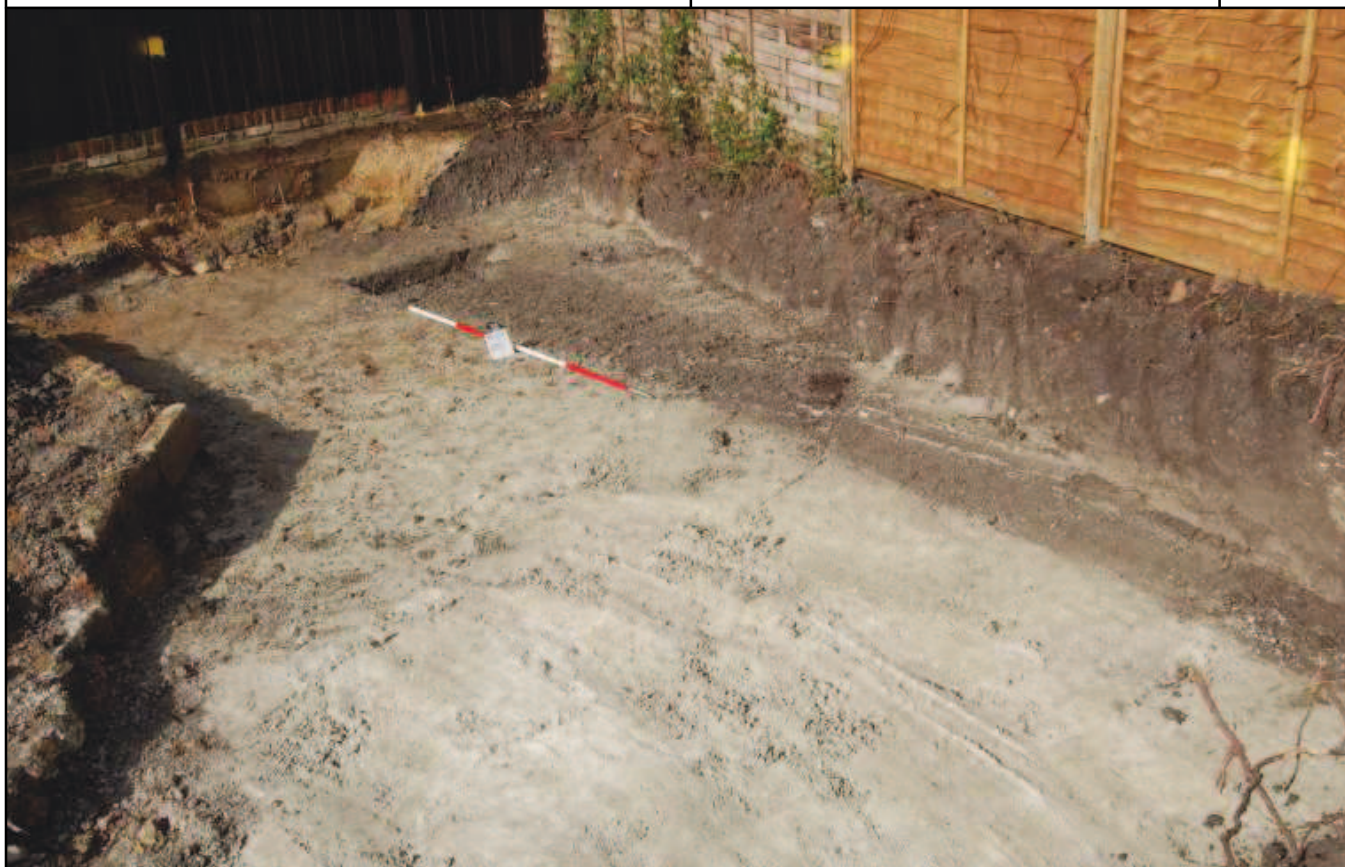
Plate 3: Ditch [101] looking NW

2.14 Two features, a linear ditch and a pit, were revealed on the northern edge of this area. Ditch [101]/[103] ran on an east - west alignment, close to and almost parallel with, the northern boundary to the property (Figure 3, Plate 3). Two sections were excavated across the ditch, revealing that it contained a single fill, context (102)/(104), which comprised dark grey (10YR 4/1) clayey silt with rare small sub-angular flint and occasional sub-rounded chalk (Figure 4). Finds recovered from this feature include sherds of medieval and post-medieval pottery and fragments of post-medieval peg tile.

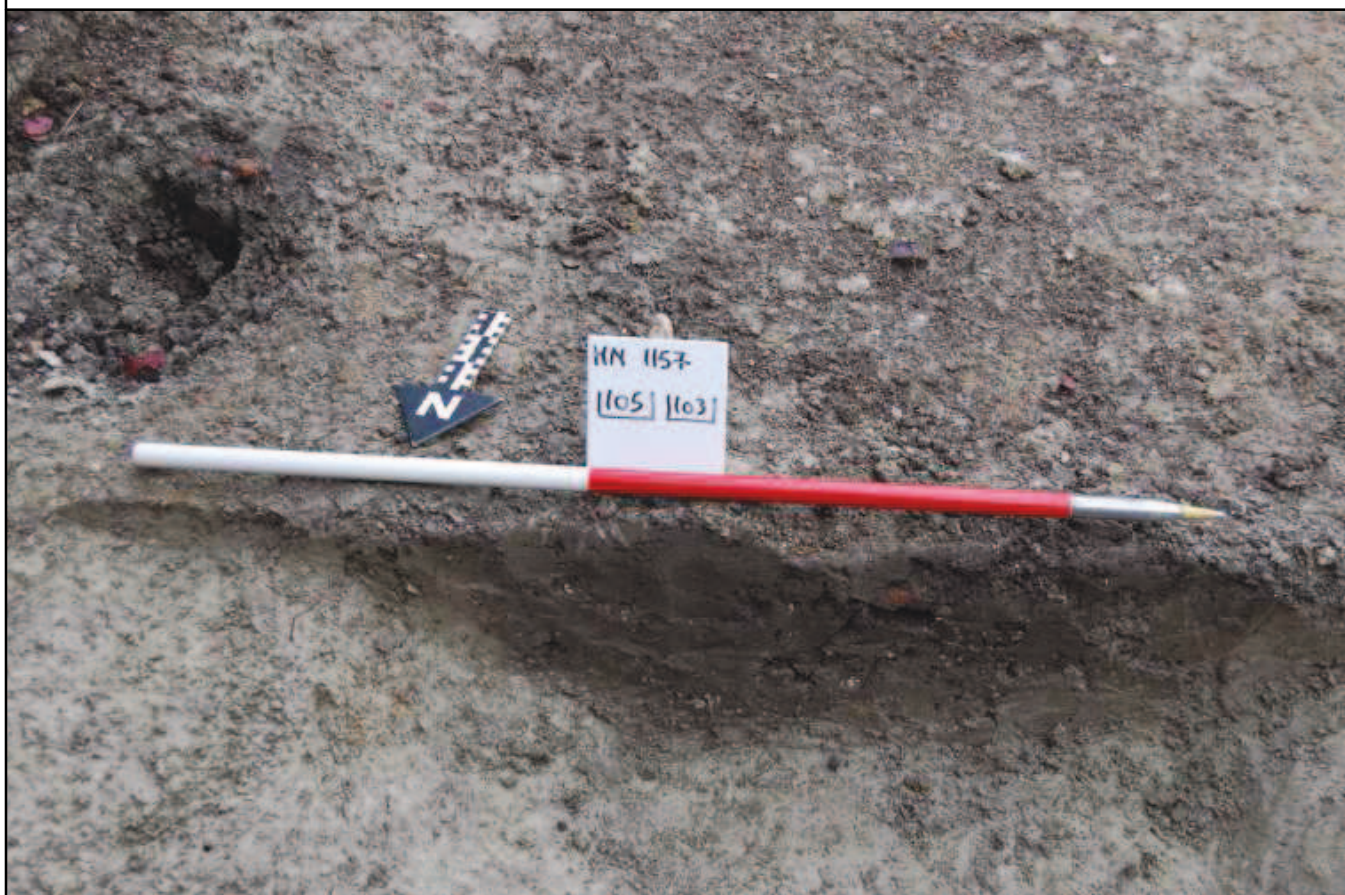
Plate 4: Features [103] and [105] looking west

2.15 At its western end the ditch cut a shallow sub-circular feature [105], interpreted as a possible pit. This contained fill (106), a grey (10YR 6/1) clayey silt, with no inclusions (Plate 4). Sherds of medieval, post-medieval and modern pottery were recovered from this feature

3.12 Two features were identified during the monitoring of the works. Linear ditch [103] was identified on the northern side of the site, running to the south of, and almost parallel with, the present boundary. This suggests that the feature is likely to represent an earlier alignment of a boundary to the property and this is supported by the 1860 Enclosure Map (Collins 2014, figure 5). The finds recovered from its fill suggest that it is at least of later post-medieval date, but possibly earlier, and appears to have gone out of use by 1880.

3.13 At its western end the ditch cut pit [105]. Pottery sherds of medieval and early post-medieval date were recovered from the fill of this feature, but not in such quantities as to suggest that it represents a refuse pit.
