## PATHFINDER HOUSE, HUNTINGDON, CAMBRIDGESHIRE.

## HN615 Report No.372

**Archaeological Summary**

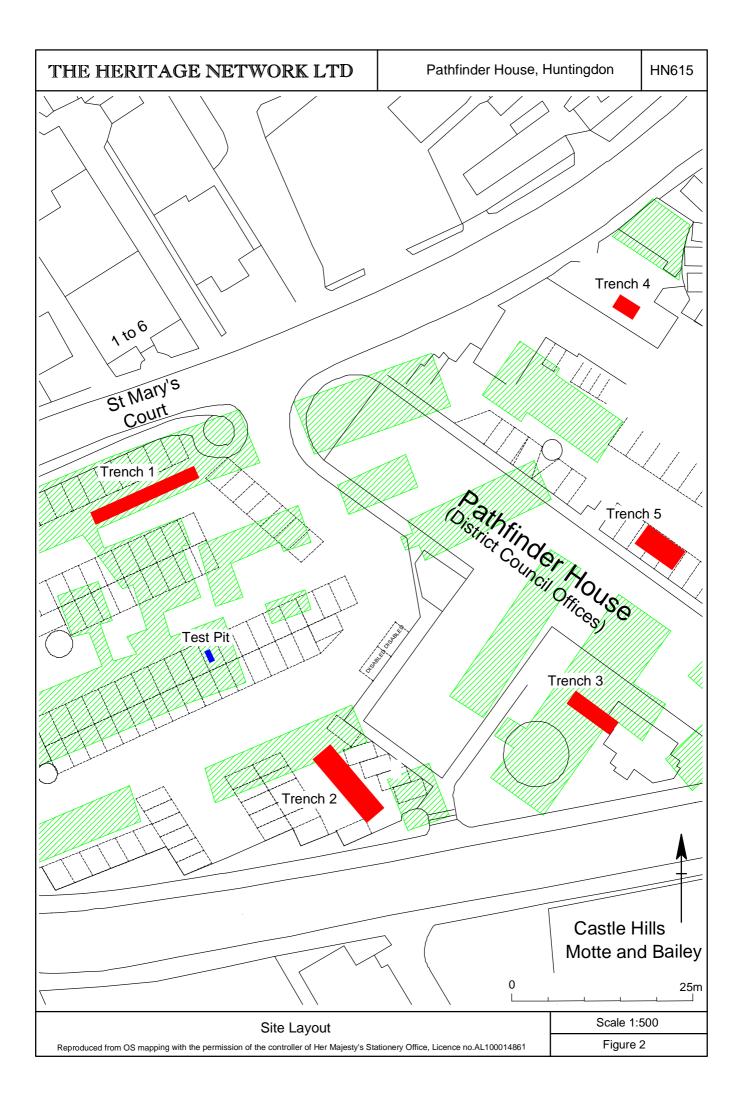
One site visit was made to monitor the excavation of a soakage test pit measuring 1.6m x 0.7m x 1.2m deep. It was located close to the centre of the existing car park, midway between two of the previous evaluation trenches (Figure 2).
