**Barn at  
WATERLOO FARM  
White Roding, Essex**

***HISTORIC BUILDING  
RECORD***

Barn at  
WATERLOO FARM  
Matching Lane, White Roding, Essex

*Historic Building Record*

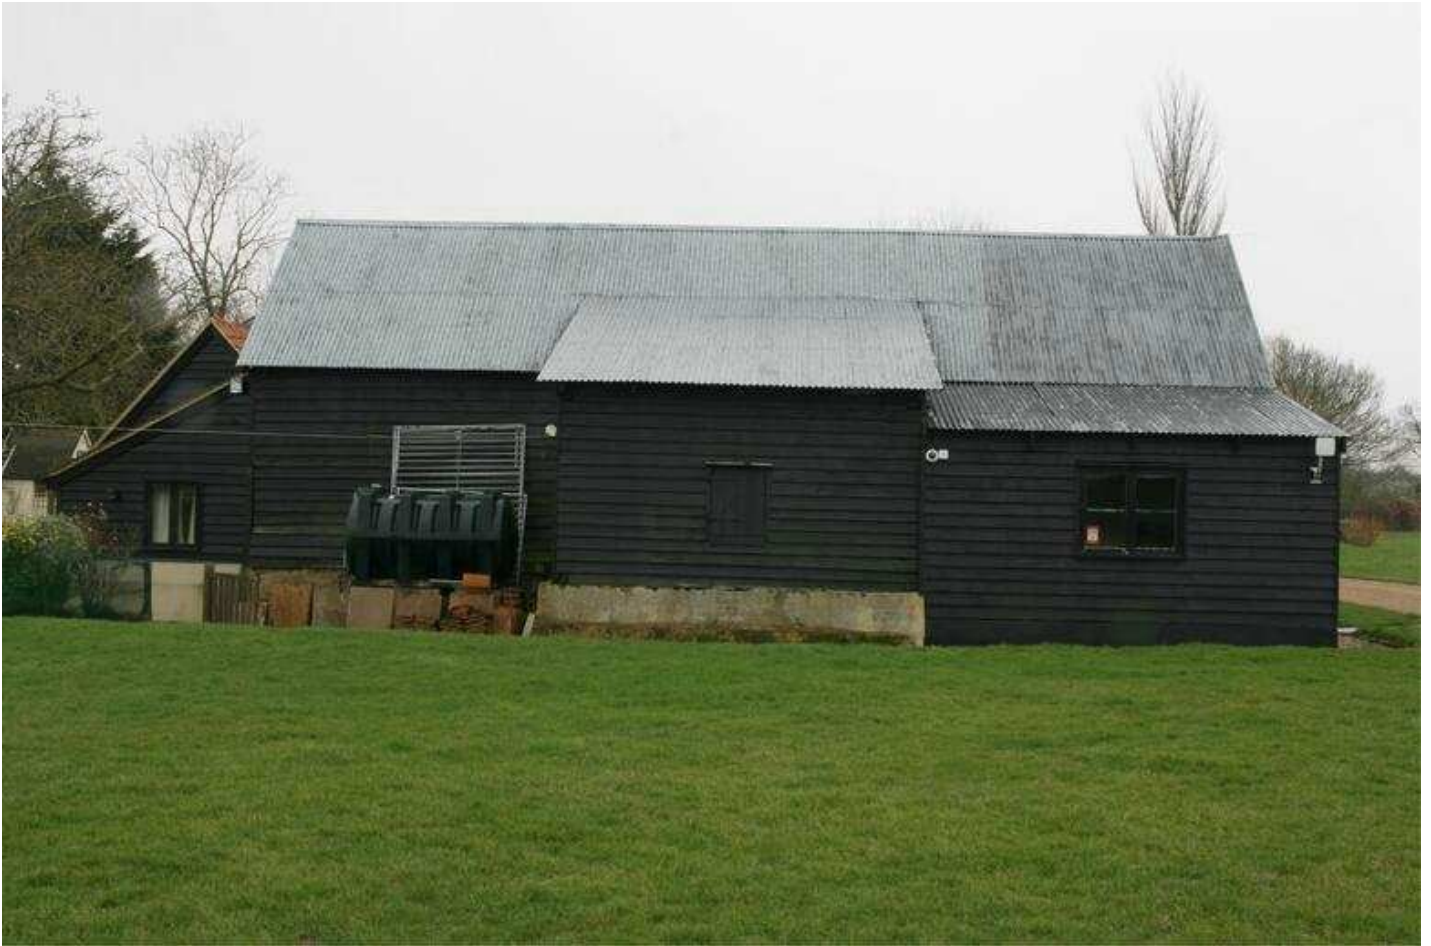
Plate 01 - NW exterior elevation

**3.5.1** The north-west elevation has a small shuttered opening in the centre of the midstrey (Plate 1). The lean-to extension to the south-west of the midstrey has a centrally placed modern two-light casement.

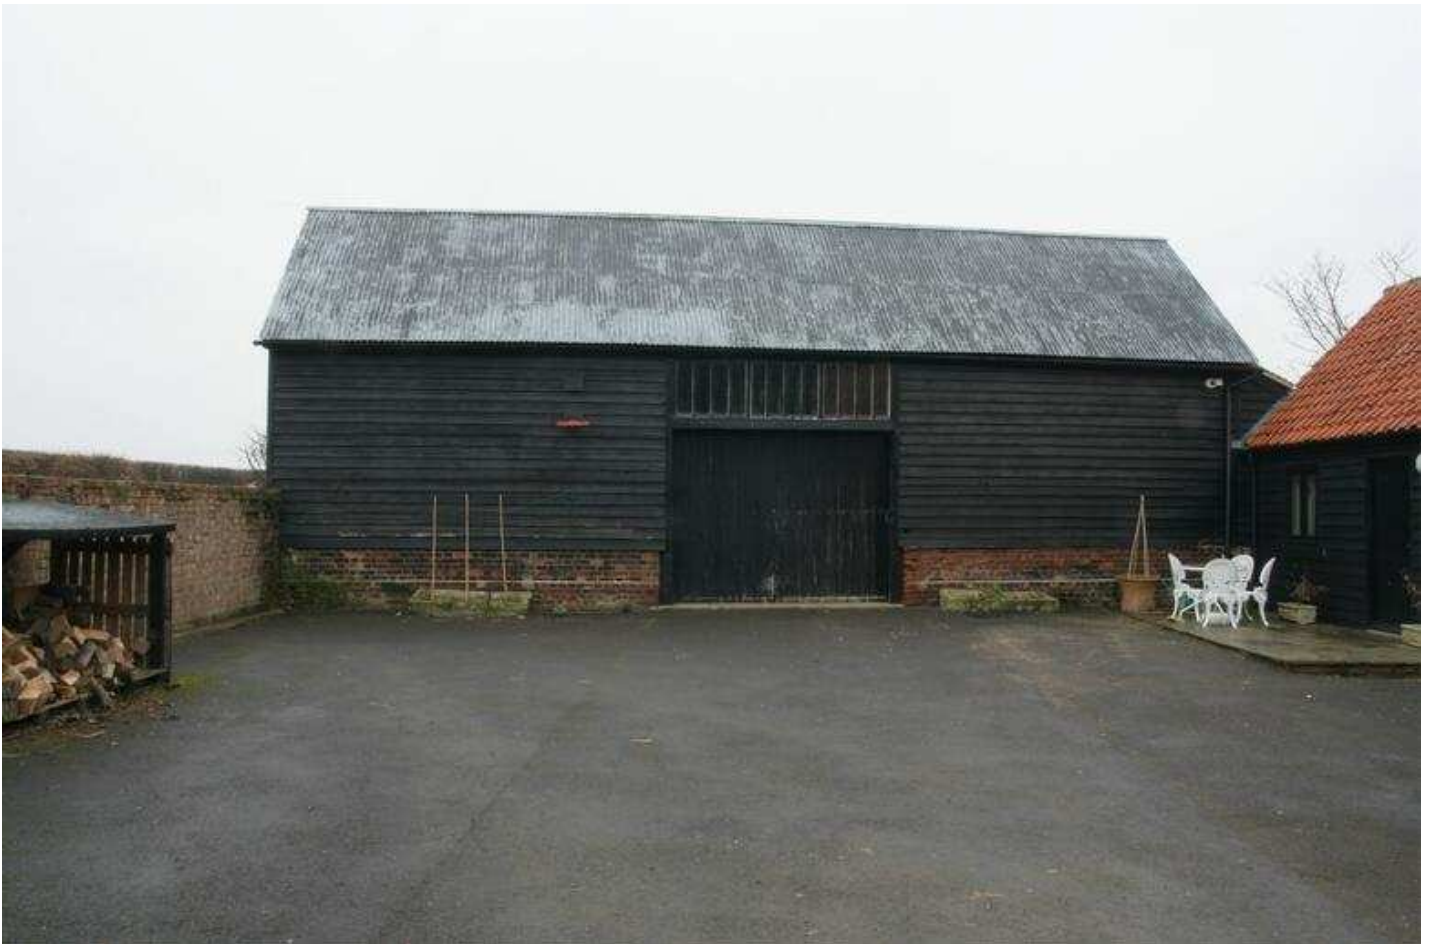
Plate 02 - SE exterior elevation

**3.5.2** The south-east elevation has large sliding boarded double doors occupying the middle bay, with a bay-width three-light glazed panel above, each light being of four tall and narrow panes (Plate 2).

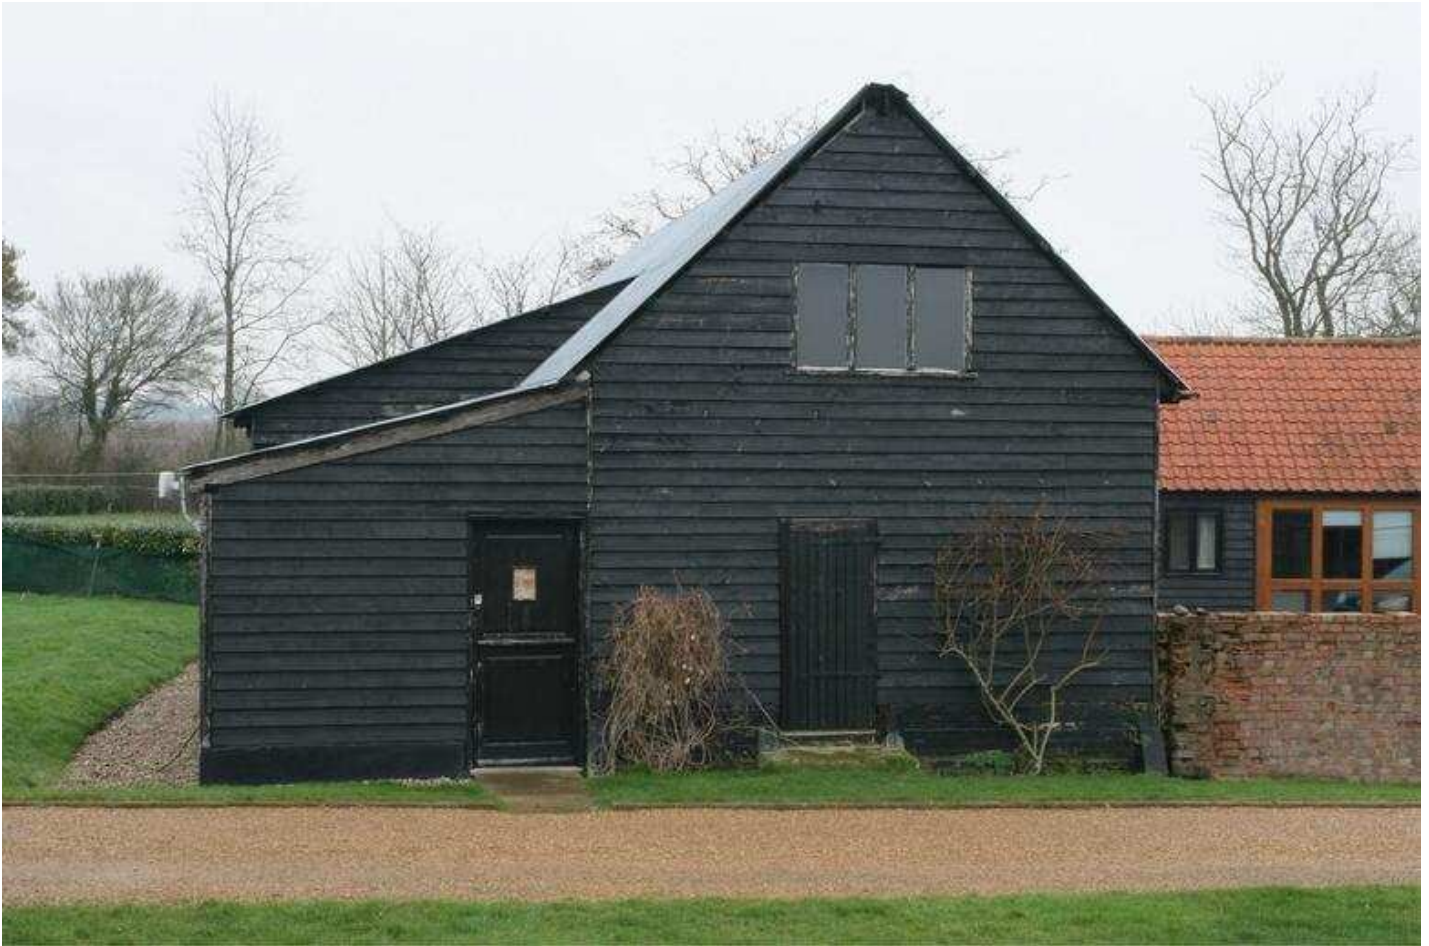
Plate 03 - SW exterior elevation

**3.5.3** The south-west elevation has an inserted boarded door, offset to the north-west of the centre line, and a central three-light window inserted above eaves level (Plate 3). To the north-west of this, the lean-to extension has a modern stable-door adjacent to its junction with the main barn.

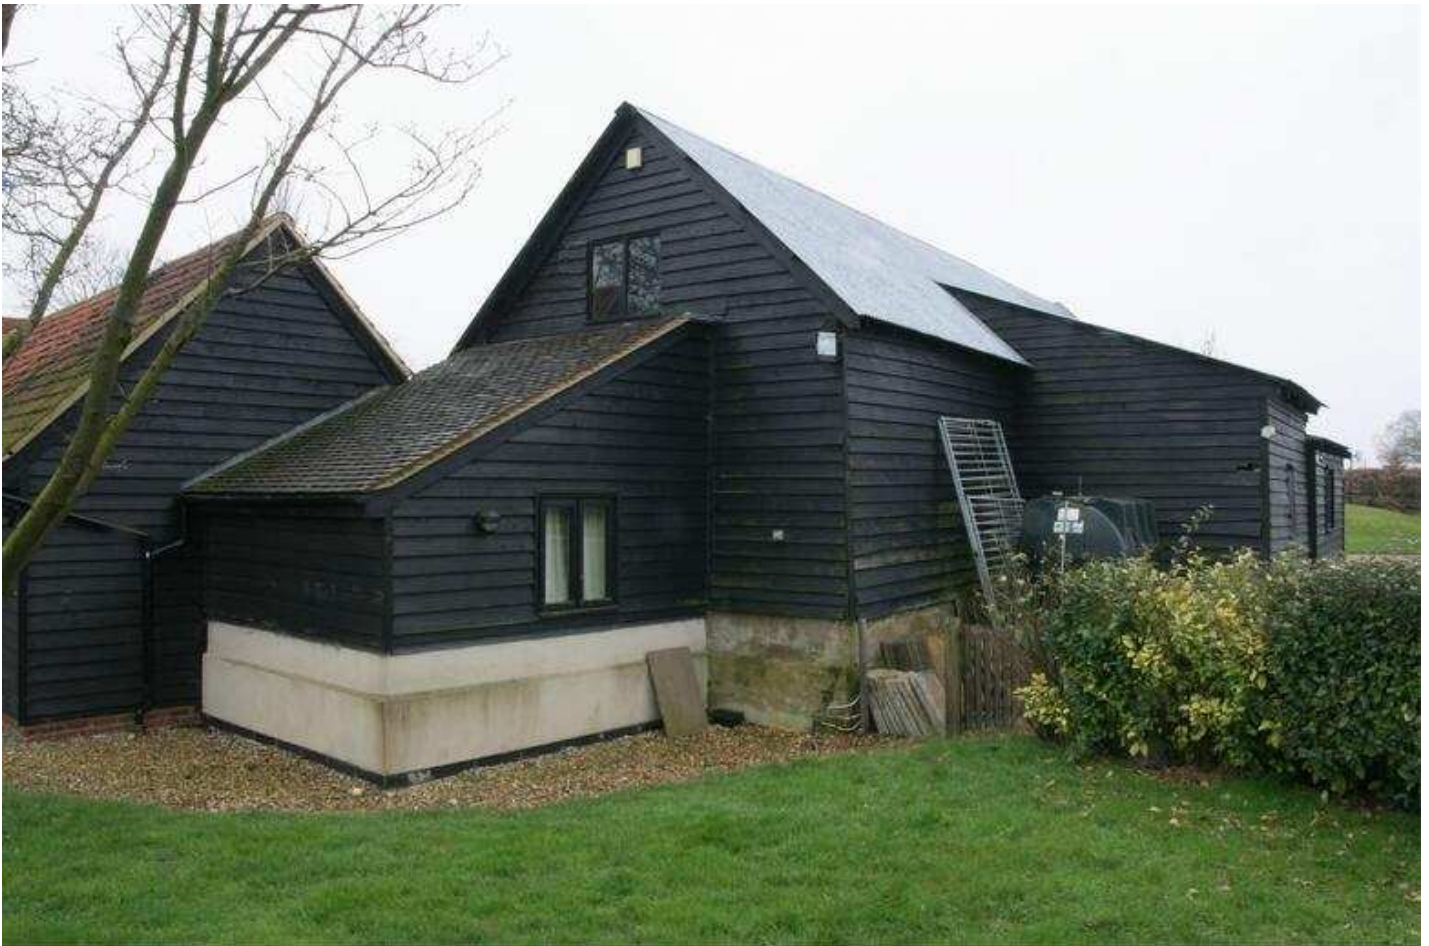
Plate 04 - NE exterior elevation

**3.5.4** A modern lean-to has been added to the north-east elevation, in the angle between the barn and the north-eastern range (Plate 4). Above this, and above the level of the eaves, a modern two-light window has been inserted.

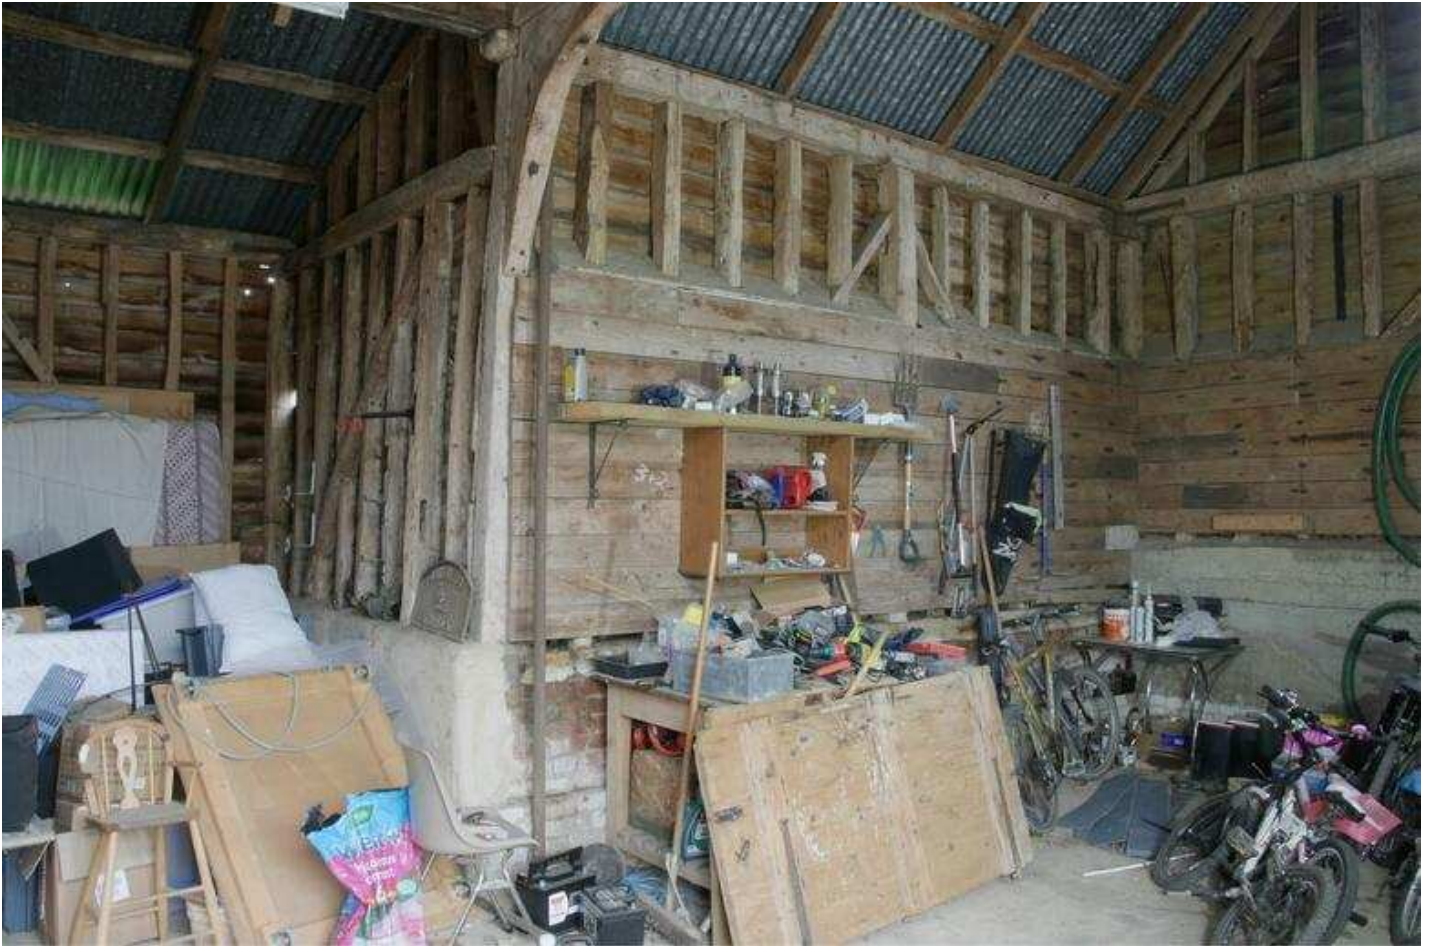
Plate 05 - NW & NE elevations, Bay 3

**3.6** The framing to the principal bay elevations consists of a soleplate, now encased in cement in Bay 1 and the midstrey (Plate 5) and a wall plate. There are principal posts at either end and a centre post with diagonal primary bracing flanked by five studs on either side (Plate 6).

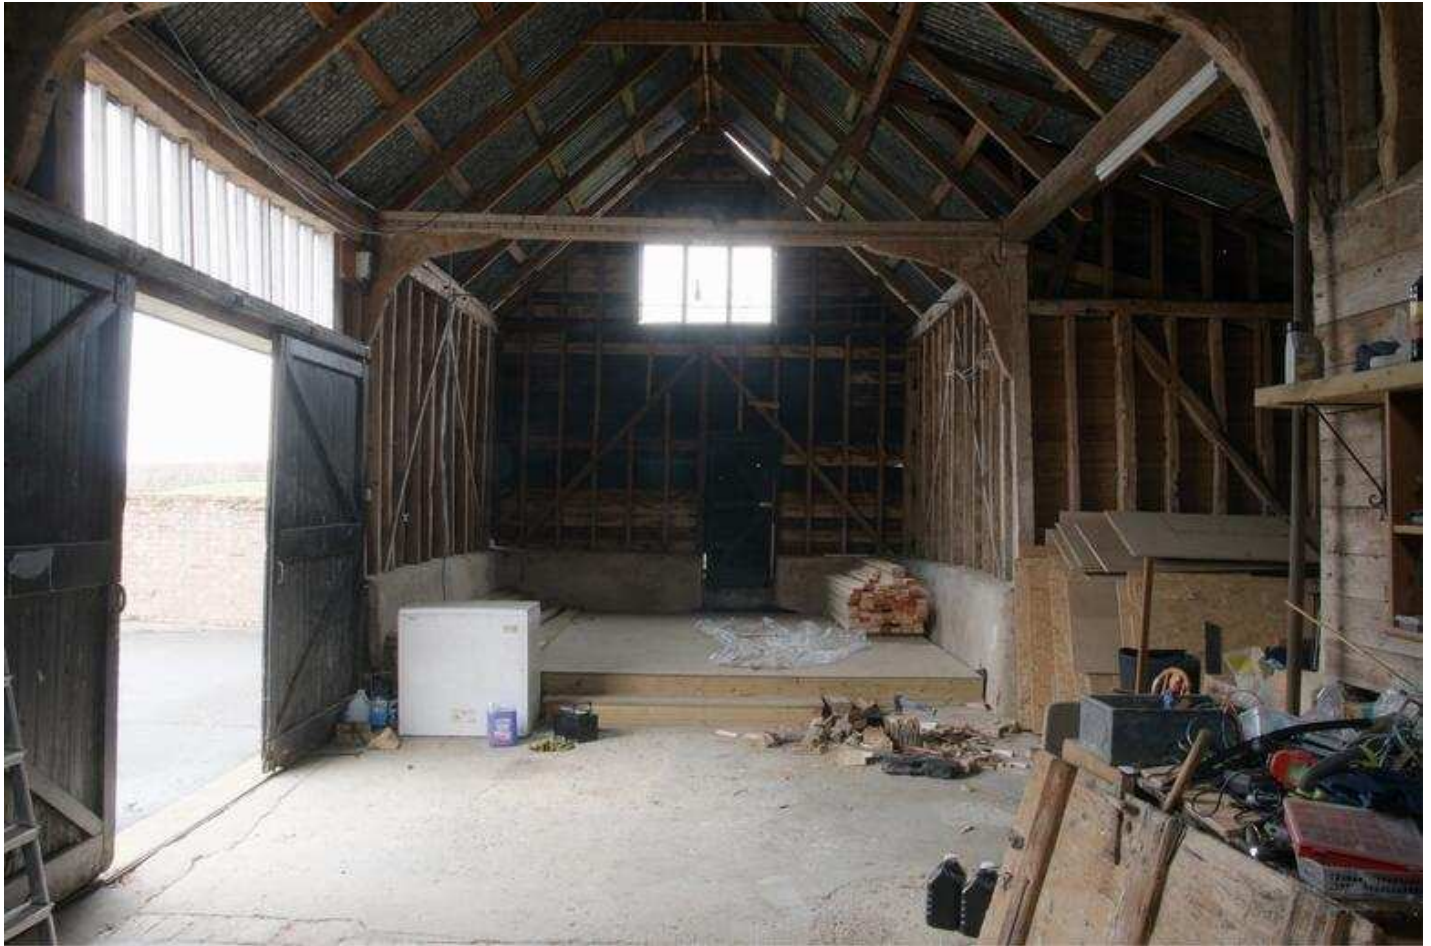
Plate 07 - SW gable end

**3.7** The gable ends differ, the south-western gable having been entirely re-built in new softwood (Plate 7) while the north-eastern gable is original (Plate 8). In both gables the soleplate has been encased, but in modern concrete rather than cement. The framing is similar to that noted in the bays, consisting of a central post with diagonal primary bracing, flanked by five studs on either side. Above the tie beam a modern window has been inserted in both gables, slightly offset to the south. Iron ties link the tie beam with the wall plates on either side (Plate 9).

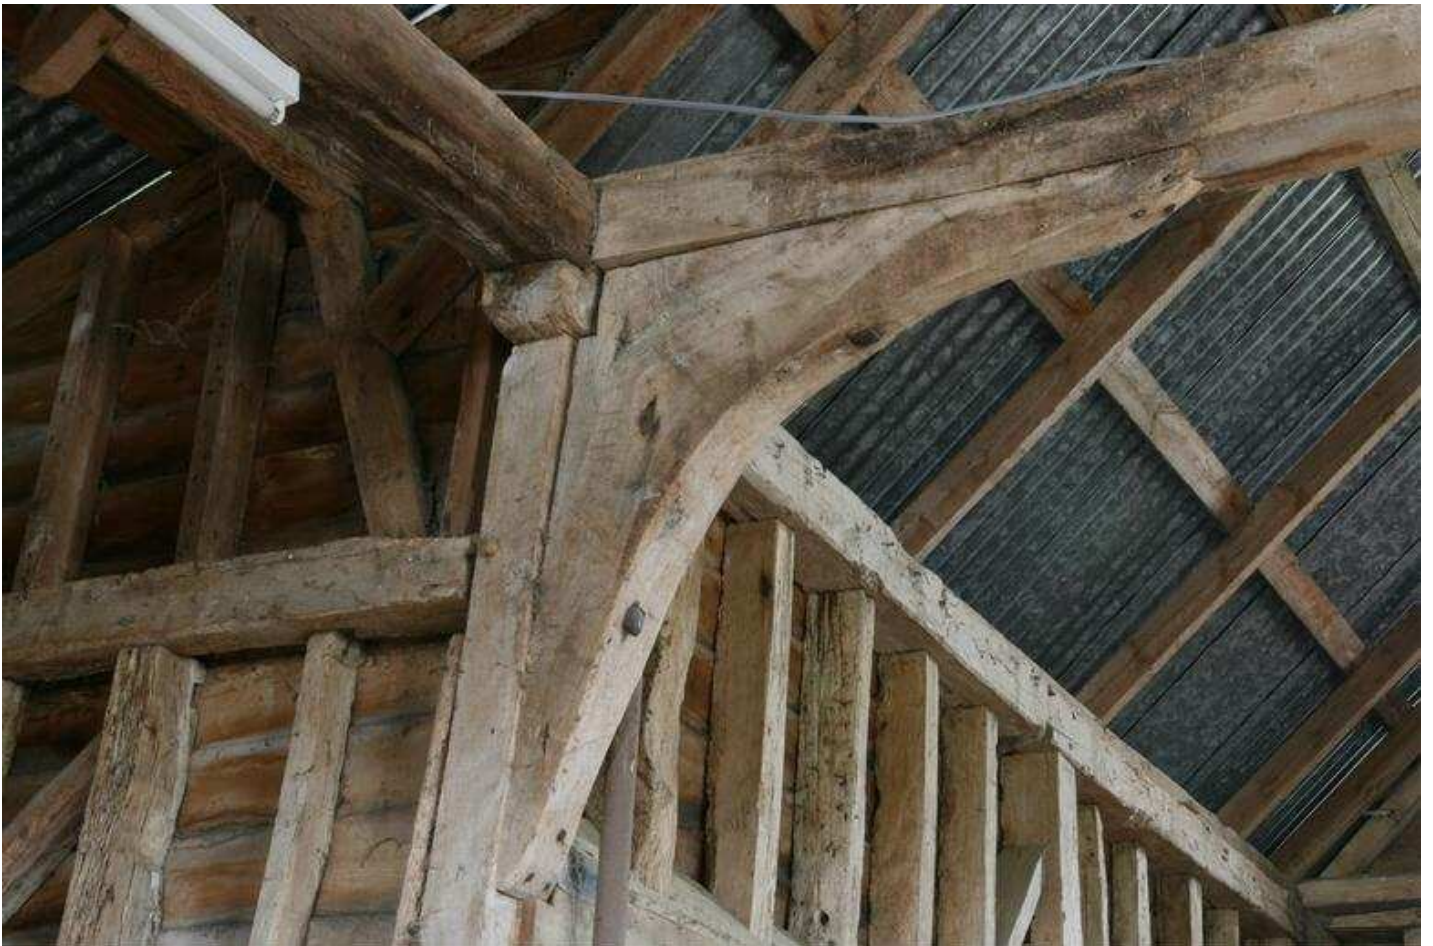
Plate 10 - Bay 2 & 3, detail of brace, NE side

**3.8** The tie beams between Bays 1 & 2 and Bays 2 & 3 appear to be of elm. They have substantial braces connecting them to the adjacent principal posts, secured by nails and square-headed bolts (Plate 10). The braces all have simple carpenter's marks: Bay 1/2 north is '1', Bay 1/2 south is 'll', Bay 2/3 south is 'lll' and Bay 2/3 north is 'llll'. Modern horizontal planking has been attached to each of the elevations in Bay 3 (Plate 11).

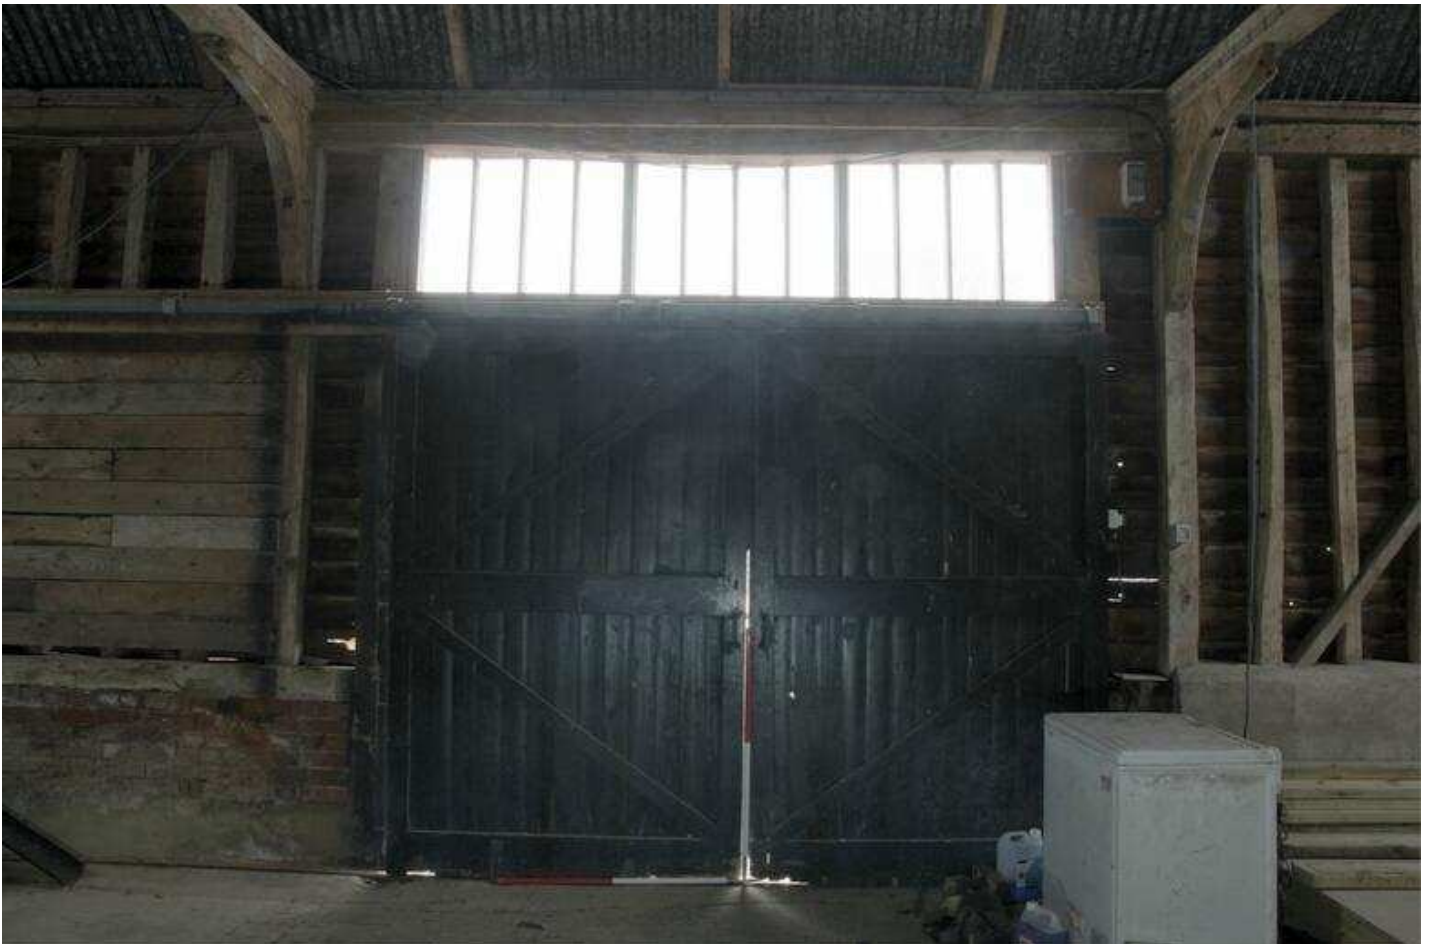
Plate 12 - double doors in SE elevation of Bay 2

**3.9** The south elevation of Bay 2 is occupied by a pair of modern boarded, ledged and braced sliding doors, with a full-width glazed panel above with wooden mullions (Plate 120). This opening would formerly have been closed by hinged double doors opening outwards. Two hooks survive on the outside elevation to demonstrate this (Plate 13) but the original hinges are concealed by later planking.

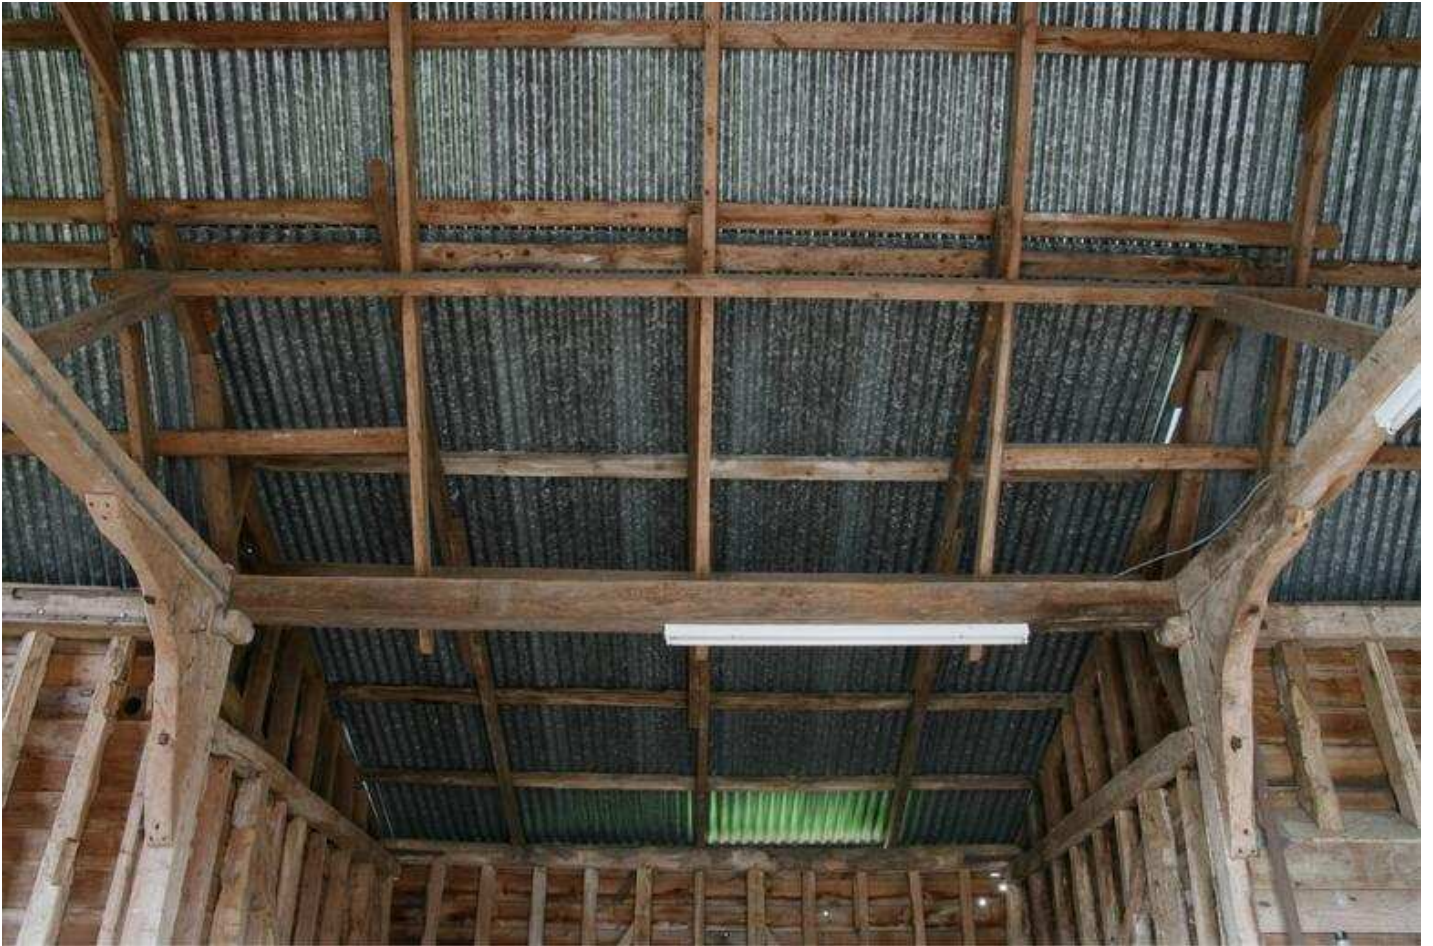
Plate 17 - replaced wall plate across opening to midstrey

**3.11** A new plate links the wall plates in the north elevation of Bays 1 and 3 across the opening of the midstrey. The wall plates to either side terminate just beyond their respective tie beams and their edges have been rounded (Plate 17).

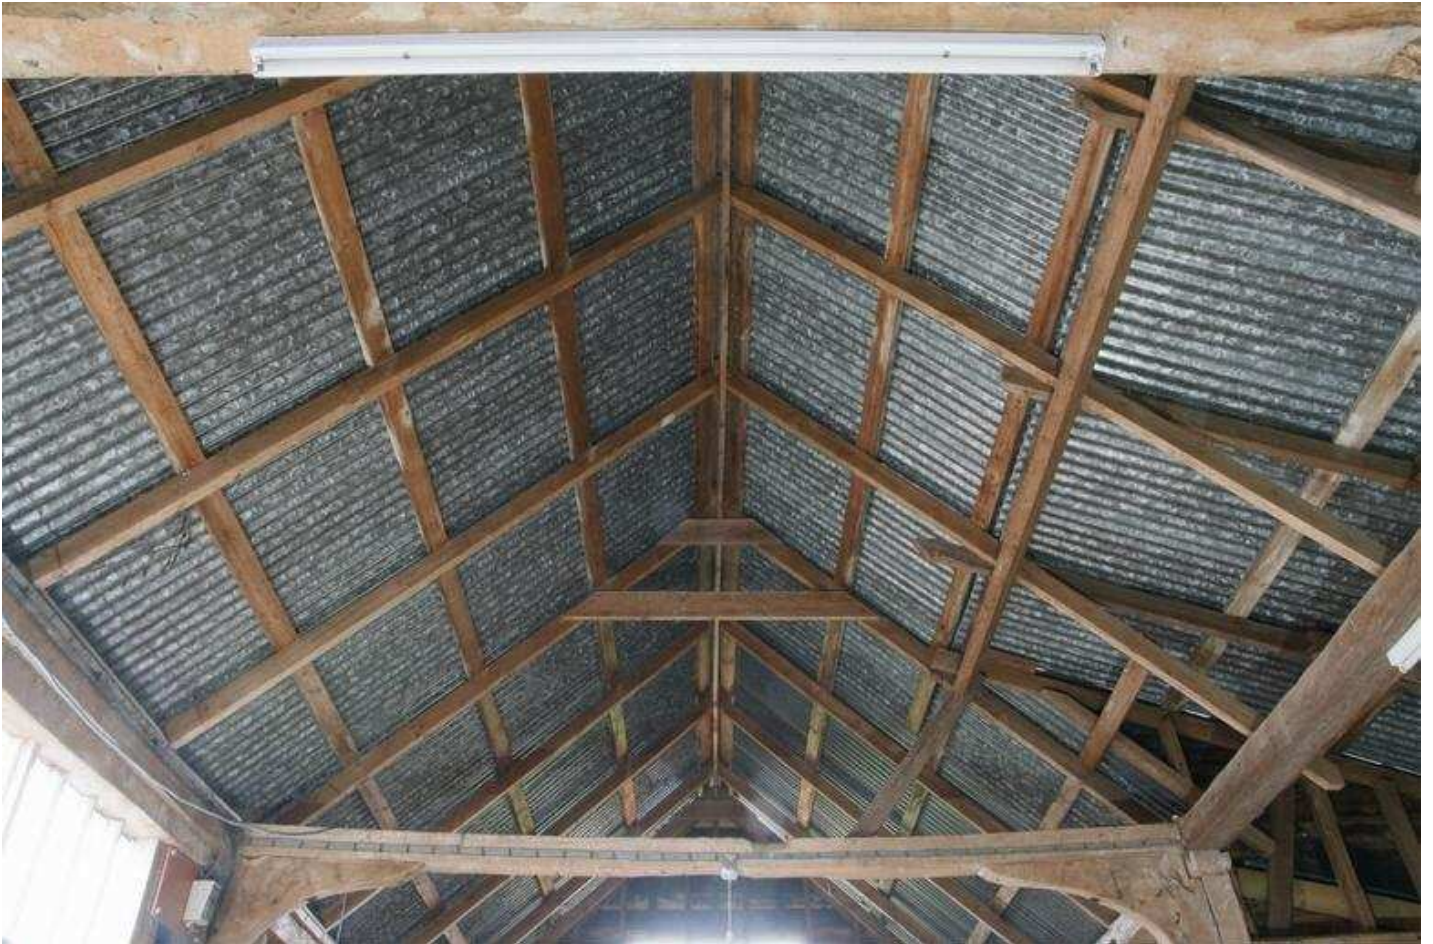
Plate 20 - roof structure, looking NW

**3.13** The roof structure to the entire barn is modern, formed of treated softwood rafters on a wide separation (approximately 1.2m) meeting at a ridge plate, with two purlins in each slope (Plate 20).

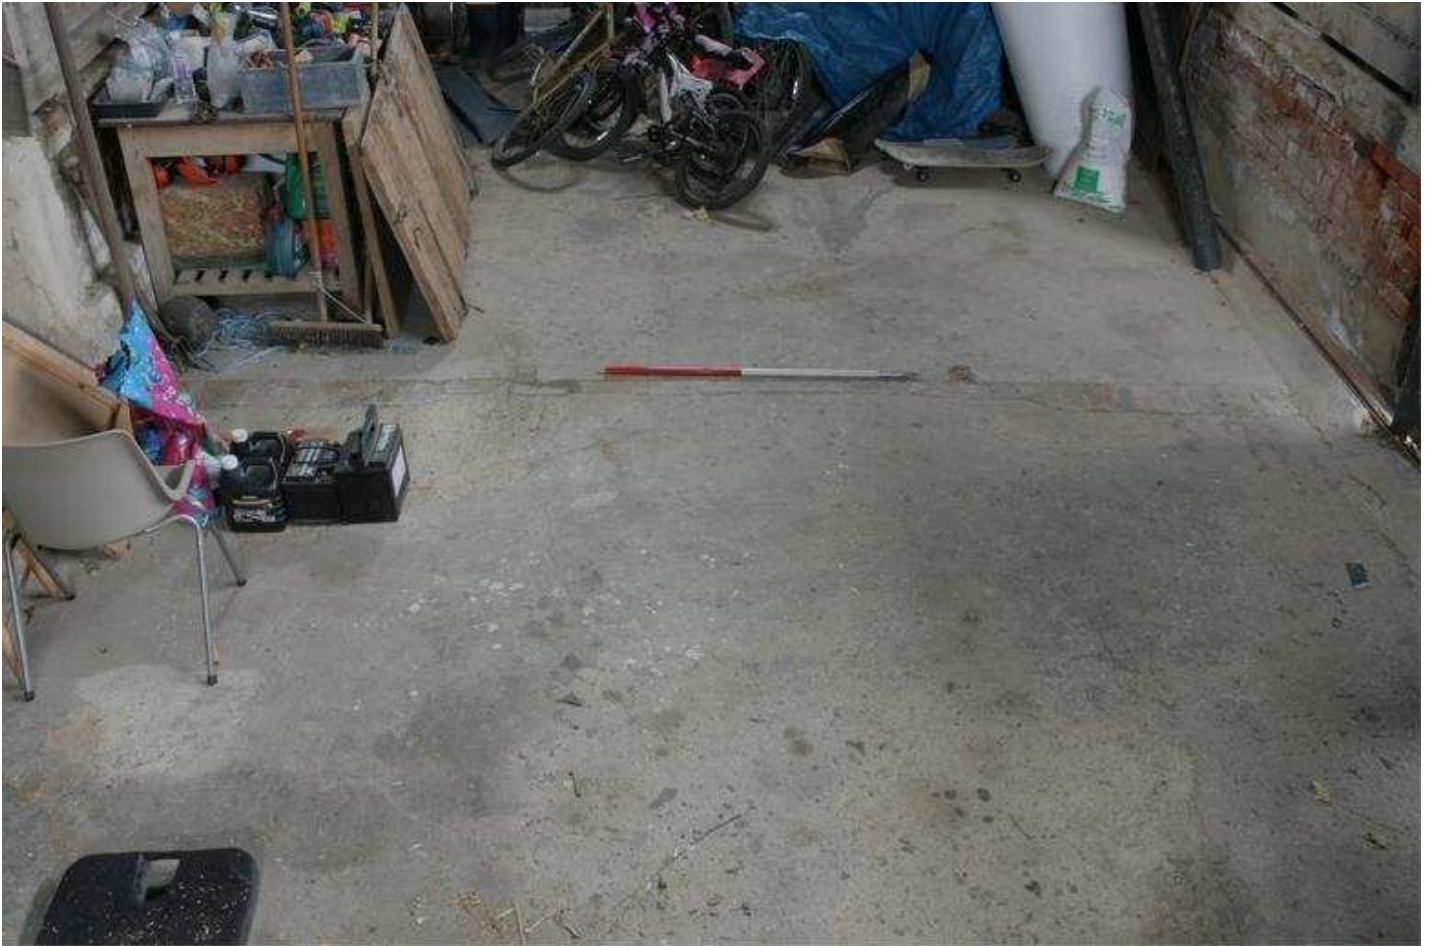
Plate 21 - remains of brickwall to NE of double doors

**3.14** The present floor is of concrete, which probably seals brick flooring. The base of a now removed brick partition or plinth crosses the barn from north to south just to the east of the doors, suggesting that Bay 3 had a different purpose (Plate 21).
