ALL SAINTS CHURCH, Shillington, Bedfordshire

HN592

Archaeological Monitoring Report

Prepared on behalf of Shillington Parochial Church Council

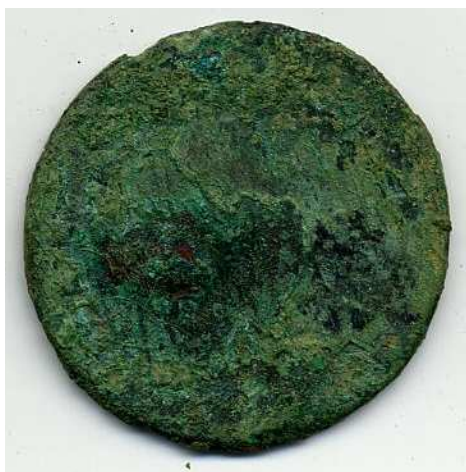
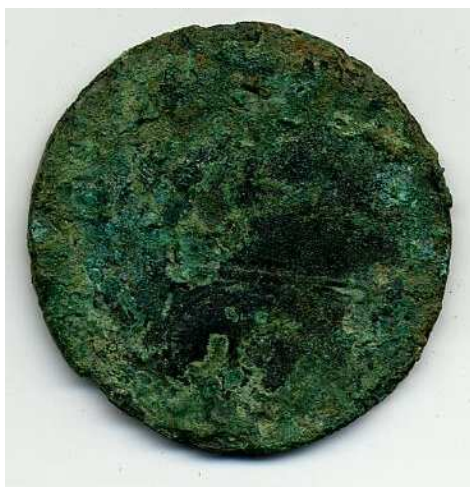
Figure 6

A concordance between the identified graves and the presence of artefacts is listed in Appendix 3. Only two of the burials, [101] and [165], included identifiable remains of wooden coffins. A fragment of wood within grave [165] was in contact with a corroded copper alloy coin (Figure 6), located beneath the right hand of the skeleton. It appears that the wood has been preserved by the corrosion products of the coin, which was too corroded to identify or date.

Copper alloy coin from Grave [165]

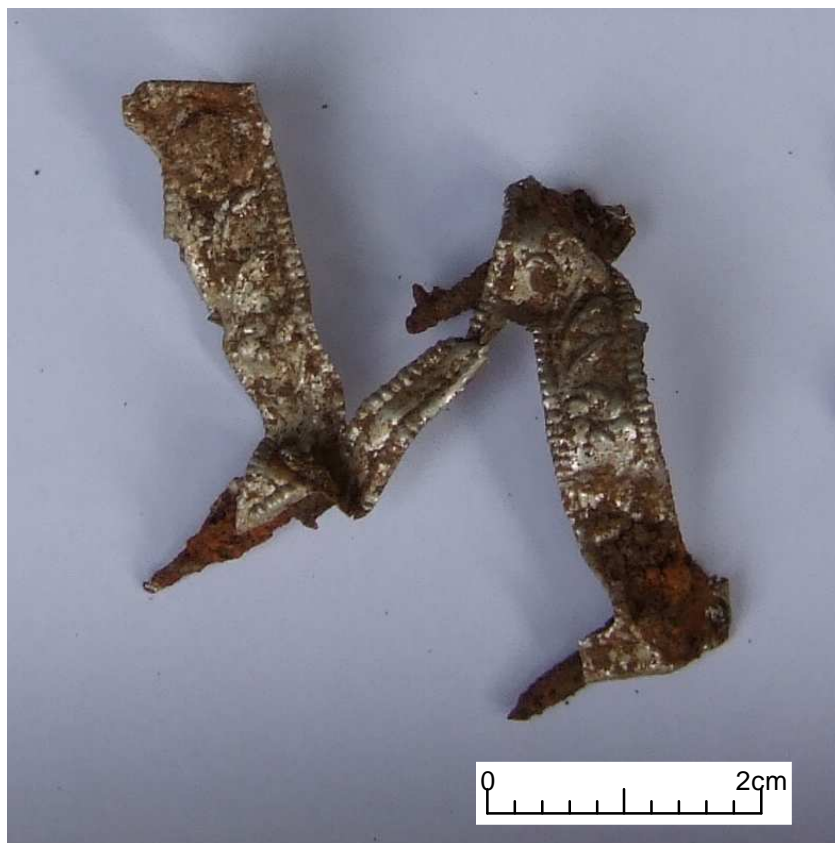
Four graves [101], [147], [165] and [177] included pressed or stamped tin lettering. Most of the lettering had a fine embossed beading delineating each letter (Plate 2a). The most complete inscription was from an infant burial [147] (Plate 2b). The individual letters “J A AGED 1 ONTHS” were recovered. Mechanically embossed lettering made from sheet metal, particularly tin, was popular between the late 18th and the mid 19th century, when the majority of coffin furniture had become mass-produced (Budd, 1993).

Plate 2a: Embossed lettering from Grave [101]

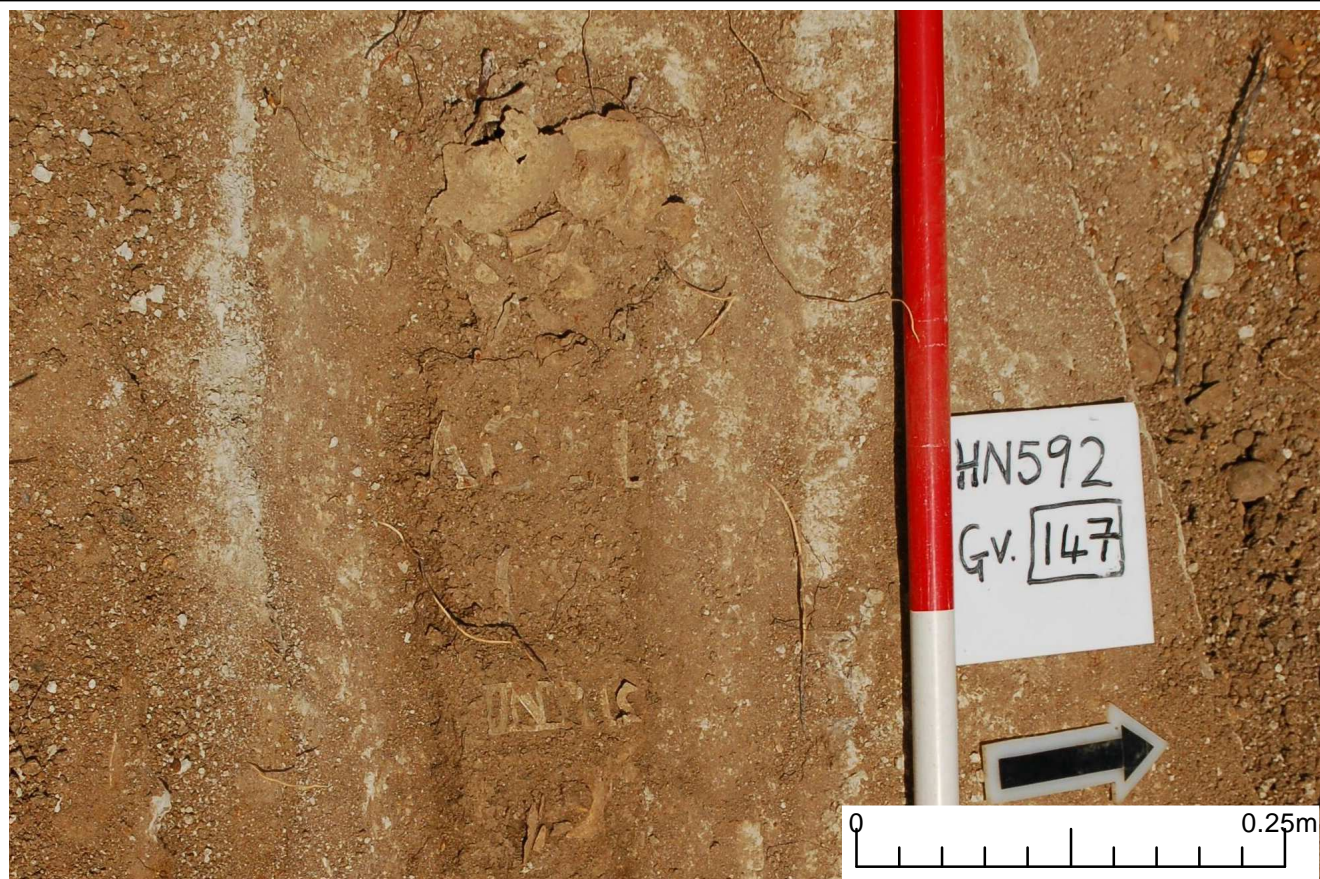
Plate 2b: Lettering from Grave [147], in situ

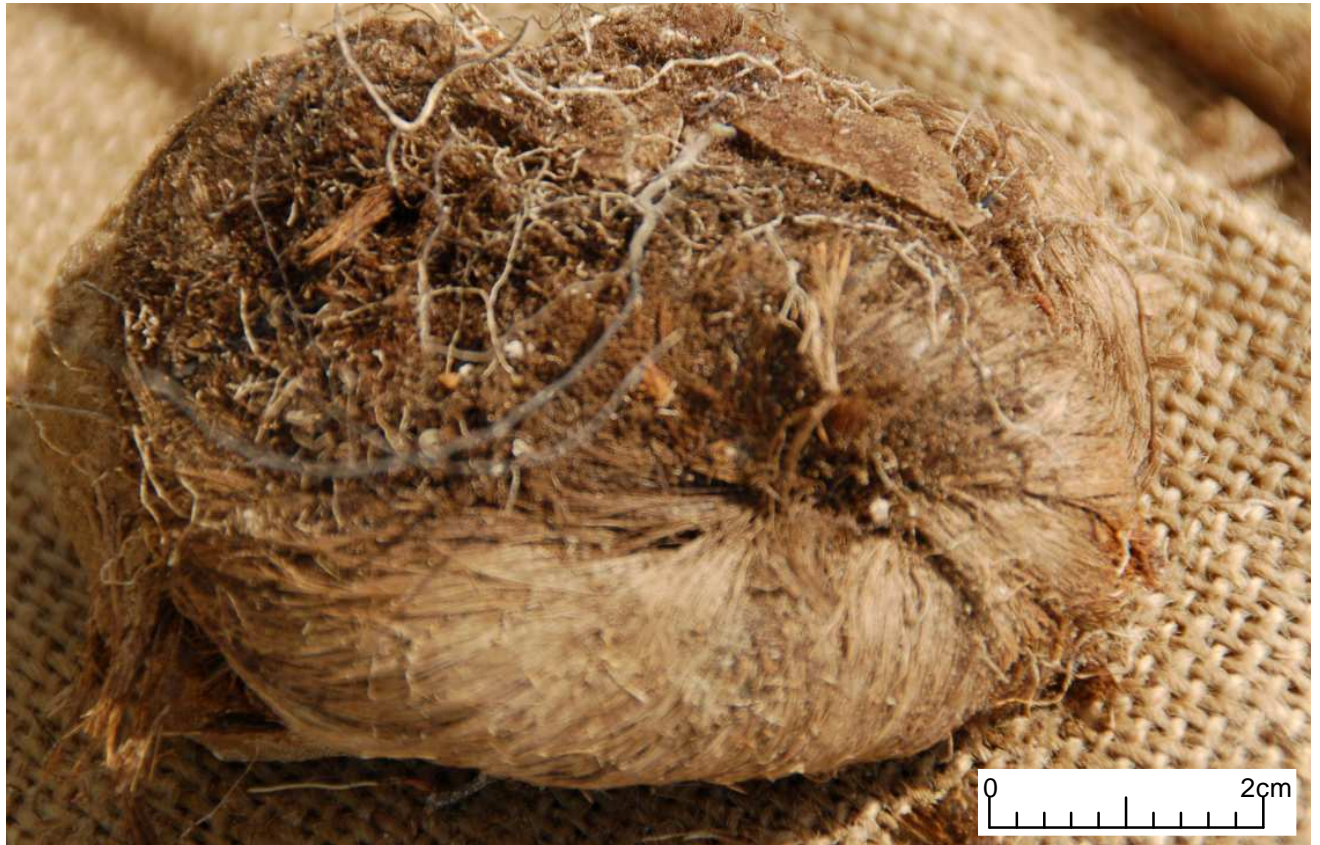
Few personal effects were recovered from the burials; however, a hairpiece in a ‘bun’ style was present in Grave [141] (Plate 3a). Shroud pins were recovered from two graves and shroud buttons from three.

Plate 3a: Hair piece from Grave [186]

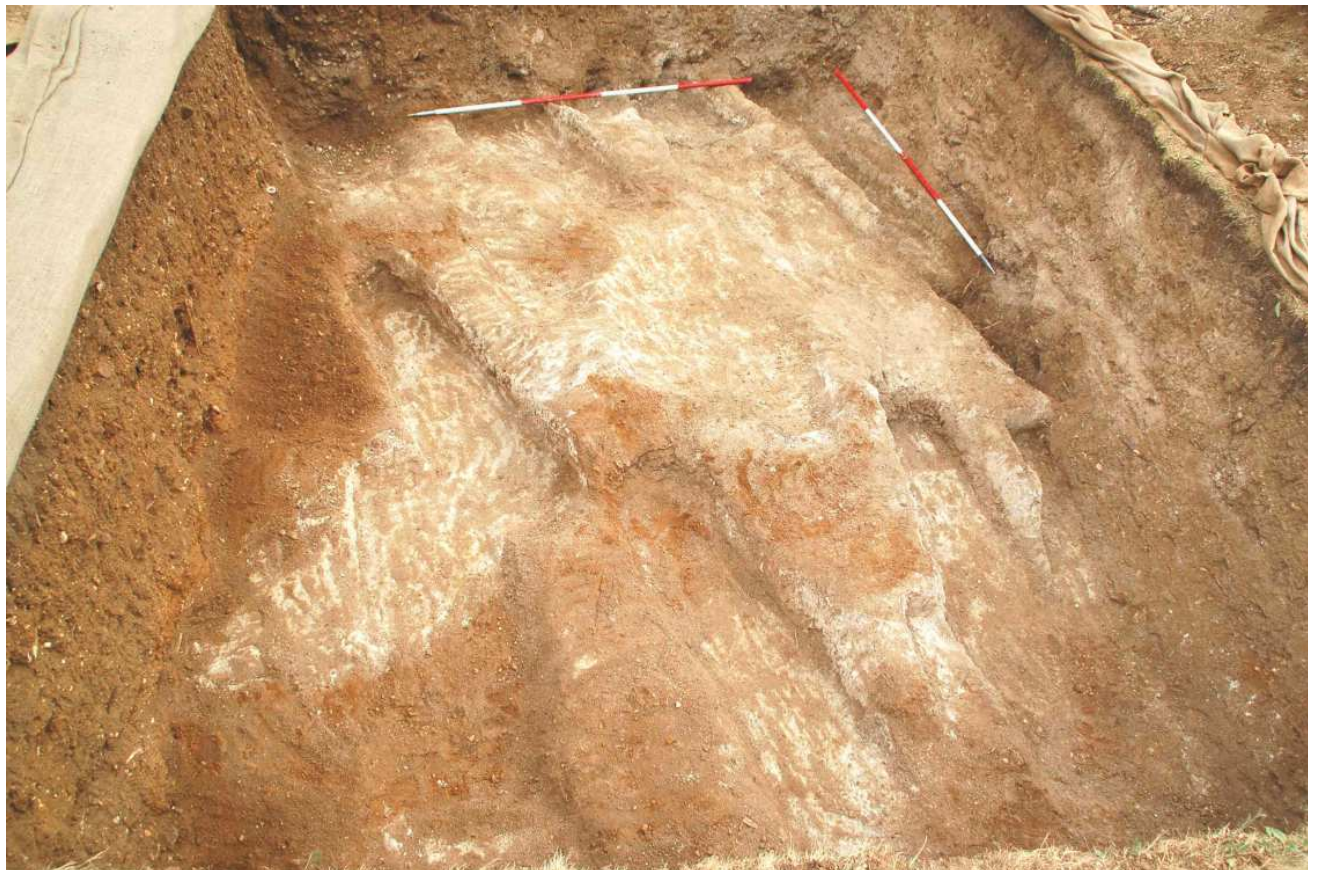
The lack of chalk in the matrix of the cemetery soil suggests that the graves were not routinely cut into the natural geology to a significant depth. Sixteen graves were cut into the chalk (Plate 3b), and virtually all of these contained skeletons in a good state of completeness, suggesting they were of a later date, uncut by subsequent graves. The greater depth may suggest that they date to 1847 or later, when the Burial Act enforced a minimum depth of 30 inches (0.76m) between the coffin lid and the ground surface.

Plate 3b: Septic tank pit, as excavated
