Church of St John the Baptist, Aldenham, Hertfordshire

HN1165

Report No. 895

As part of the faculty requirements, the Heritage Network was commissioned to undertake a programme of archaeological monitoring during the groundworks for the construction of an exterior access ramp at the Church of St John the Baptist, Church Lane, Aldenham, Herts. The present project is part of an ongoing scheme of works to improve the facilities at the church.

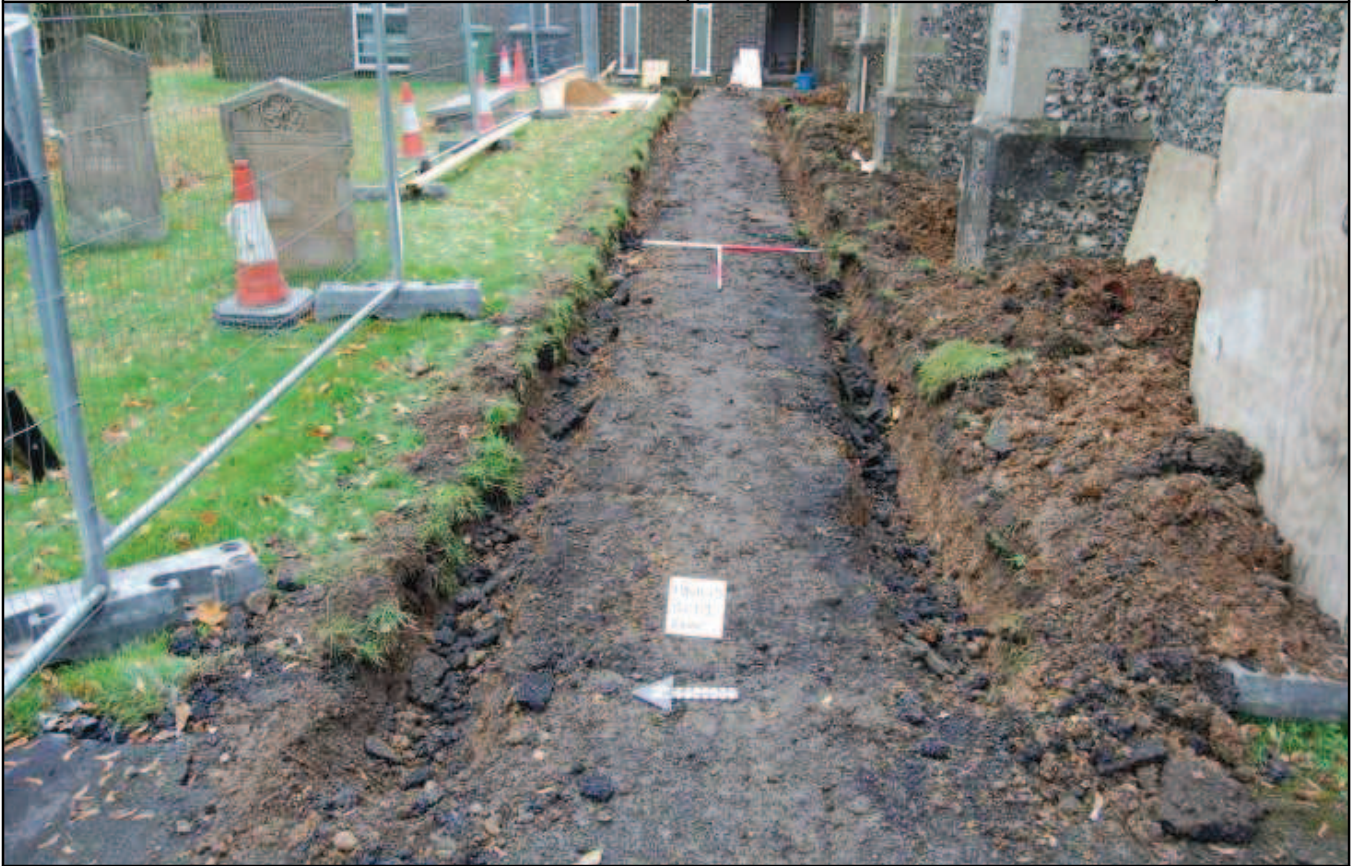
Plate 1: Area of main ground reduction, looking east

The groundworks consisted of an area of ground reduction, which measured 19m in length and 1.80m in width, on the north side of the church. The ground was reduced by 0.12m across the whole area, removing an existing tarmac surface. Two narrow channels, 0.35m in width and between 0.30m in depth at the western end and 0.45m in depth at the eastern end, were created on the northern and southern sides, leaving a central island (Figure 2, Plate 1).

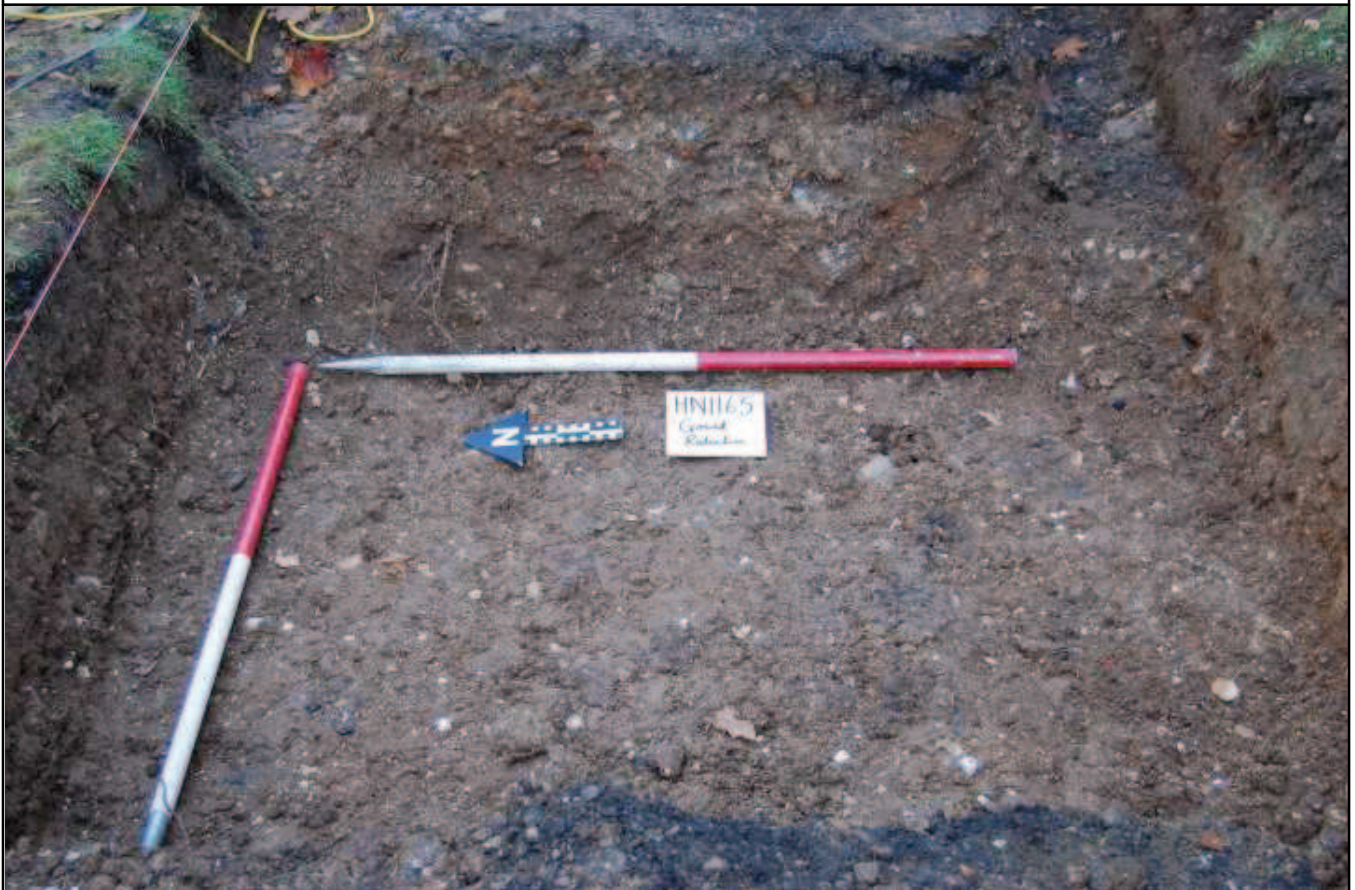
Plate 2: Area of secondary ground reduction, looking east

The central island was reduced by c.0.33m, to the same depth as the channels on either side, at 6.50m from the eastern end of the trench (Figure 2, Plate 2). This area, which was designed to allow a York stone insert, measured 1.40m in length and 1.80m in width.

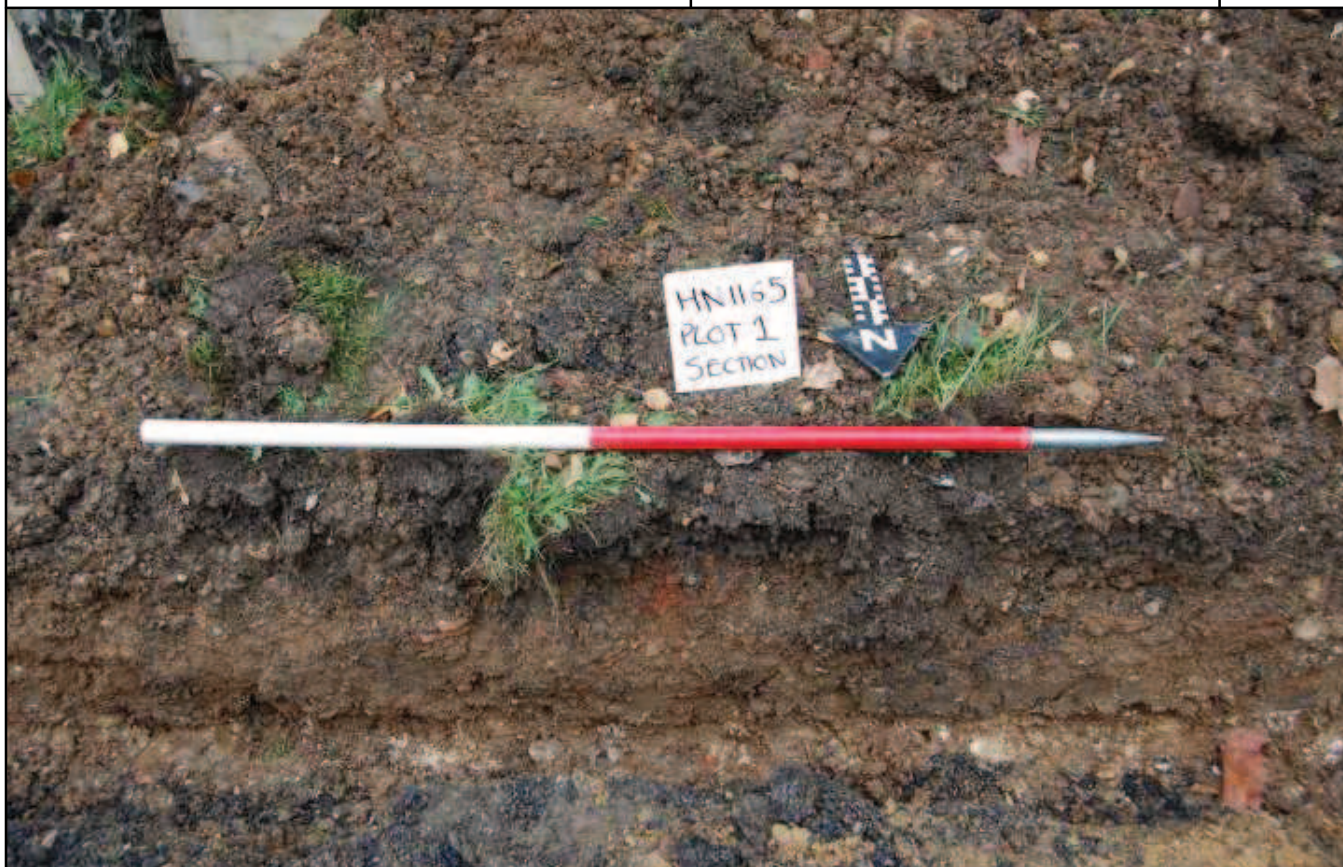
Plate 3: Indicative section, looking south

The stratigraphy exposed in the sections below the tarmac comprised a layer of very dark greyish brown (10YR 3/2) friable silty clay topsoil, 0.10m in depth, above a dark yellowish brown (10YR 3/4) sandy silty clay subsoil, over 0.30m in depth (Plate 3). This has been interpreted as a cemetery soil. The natural substratum was not reached during the present works.

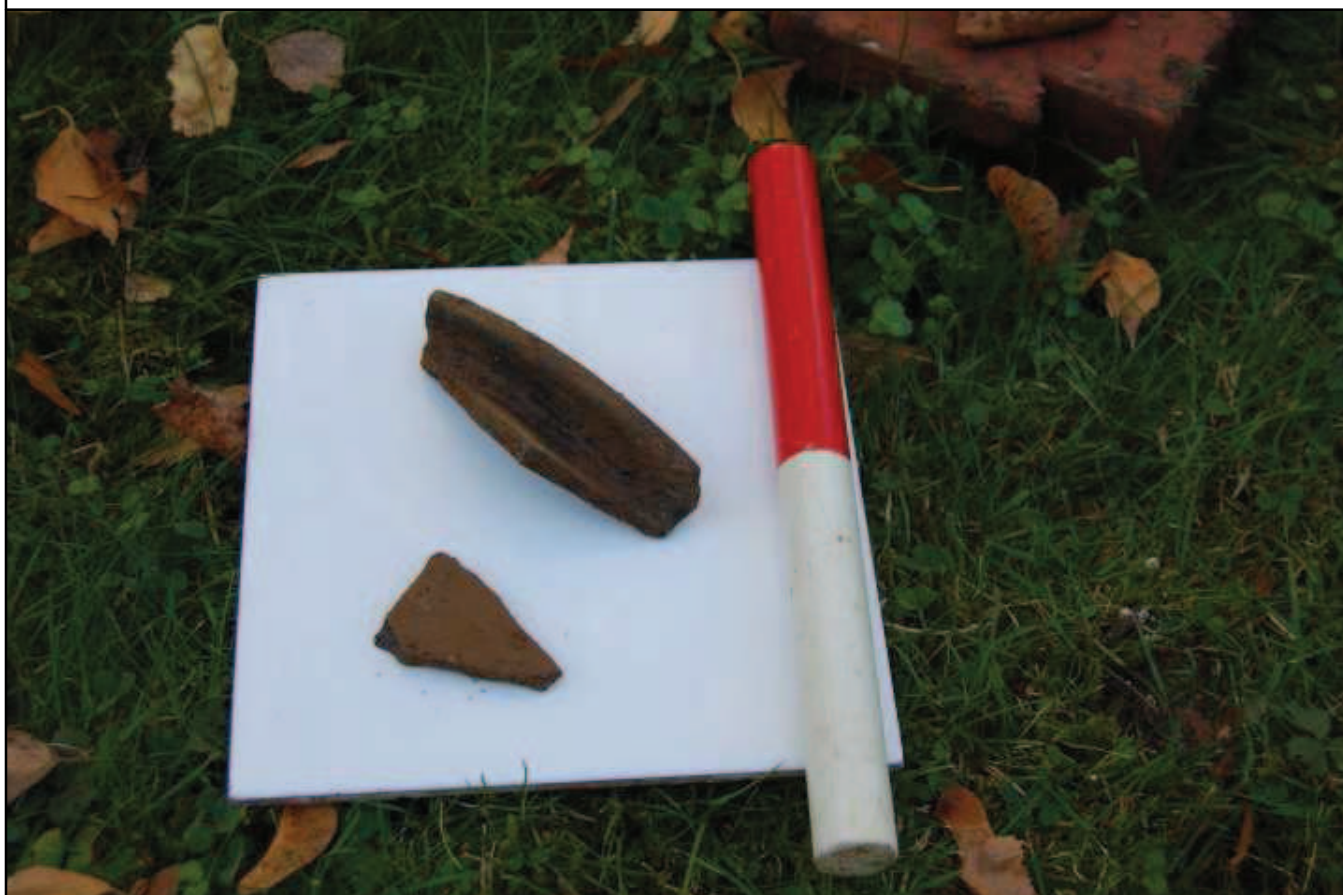
Plate 4: Pottery sherds recovered from the cemetery soil

A number of unstratified finds were present in the spoil. These included fragments of disarticulated human bone, post-medieval brick and tile fragments, and two sherds of Hertfordshire Greyware, of 12th – 14th century date (Plate 4). The disarticulated human bone fragments were reburied on site.
