St. Catherine's Church, Sacombe, Hertfordshire.

Report No.959

The Heritage Network was commissioned by Mike Dales Partnership Ltd, acting on behalf of the Sacombe PCC, to undertake a programme of archaeological monitoring as part of an ongoing series of improvements at St Catherine's Church, Sacombe, Hertfordshire.

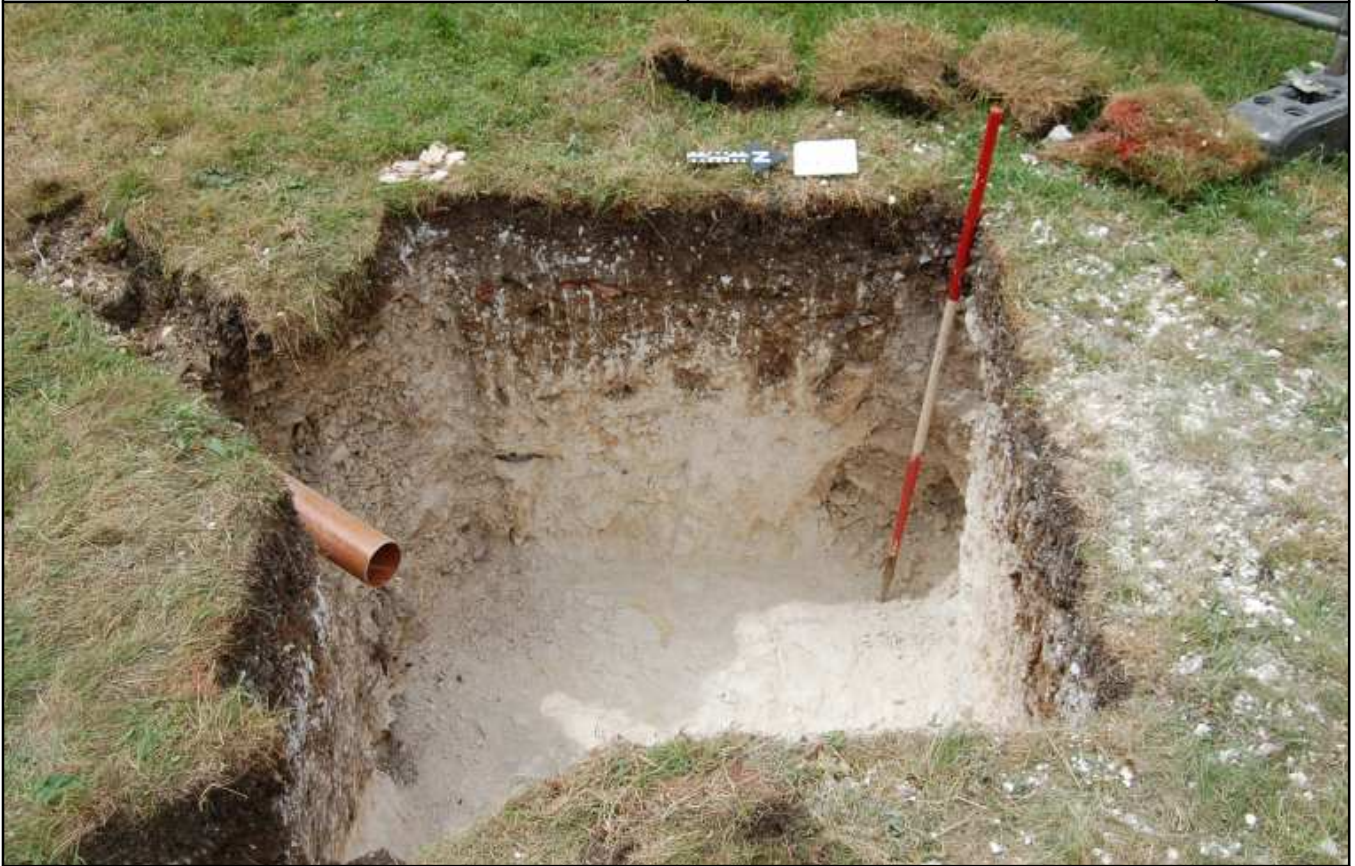
Plate 3: Soakaway looking W, showing cut [101]

The soakaway pit, which measured 1.40m by 1.40m and 1.40m in depth, was located approximately 5m to the north of the church. Two possible grave cuts, [101] and [103], were revealed in its southern and western sections immediately below the topsoil. Cut [101] was observed in the western section, cutting through a thin layer of the graveyard soil and into the natural chalk (Figure 3, Plate 3). It measured 1.20m in width and 0.35m in depth, with irregular sides and a flat base. The feature, which has been interpreted as a possible grave, contained fill (102), a brown (10YR 4/3) friable sandy clay containing frequent chalk fragments and occasional

peg tile fragments. No skeletal material was encountered, suggesting that the soakaway had only clipped its edge.

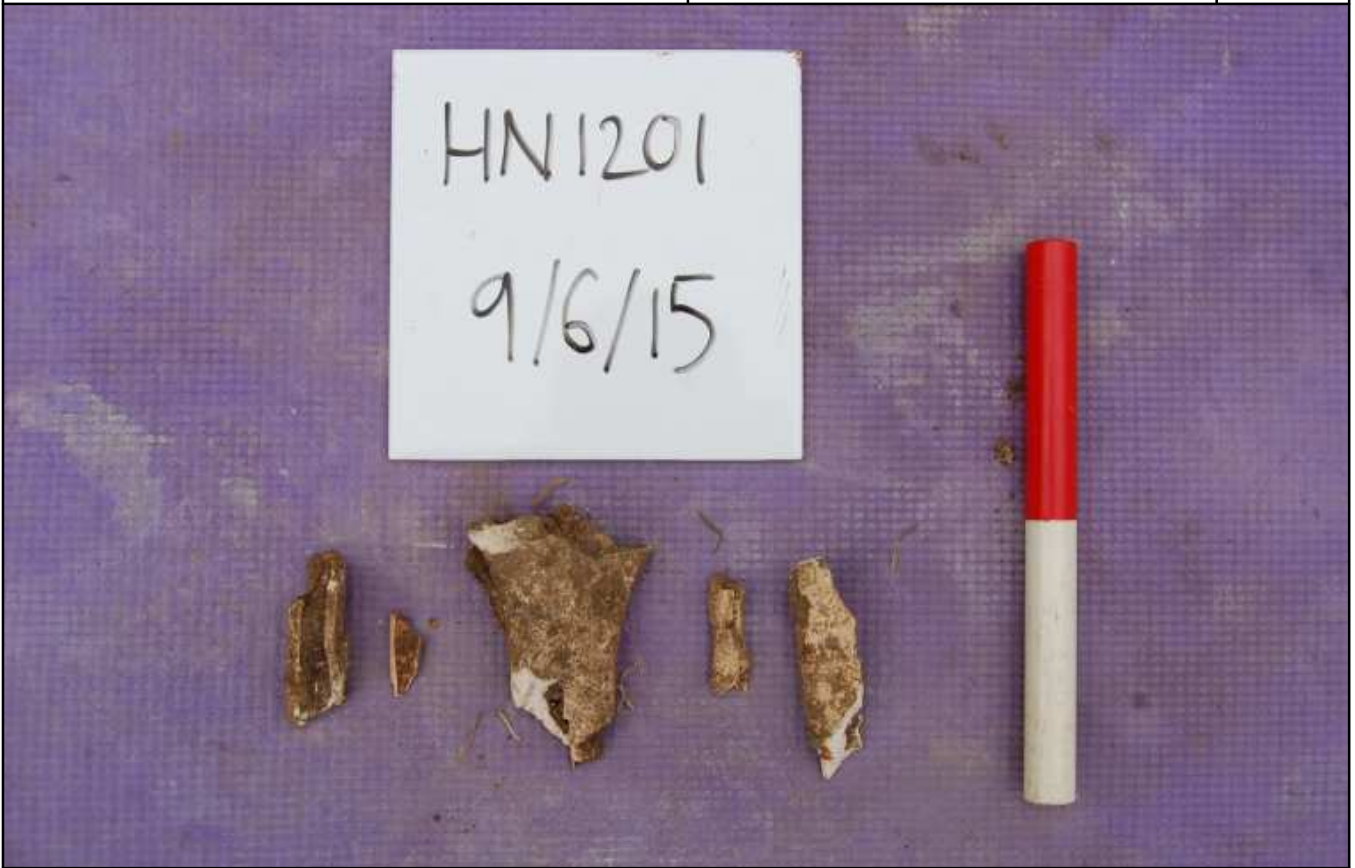
Plate 5: Disarticulated bone from trenches

No archaeological features or deposits were encountered in the drainage trenches. The only finds consisted of a number of disarticulated human bones, recovered from both the topsoil and the graveyard soil.

A small quantity of human bone was recovered from the graveyard soil, including fragments of long bone, as well as numerous small fragments that could not be identified. The gender and age of any individual could not be clearly ascertained from the recovered material, though the majority appeared to be from adults. A brief assessment showed that the assemblage represented disarticulated remains from several individuals. Photographs were taken of the best preserved and most identifiable bones. The bone was retained on site for re-burial.

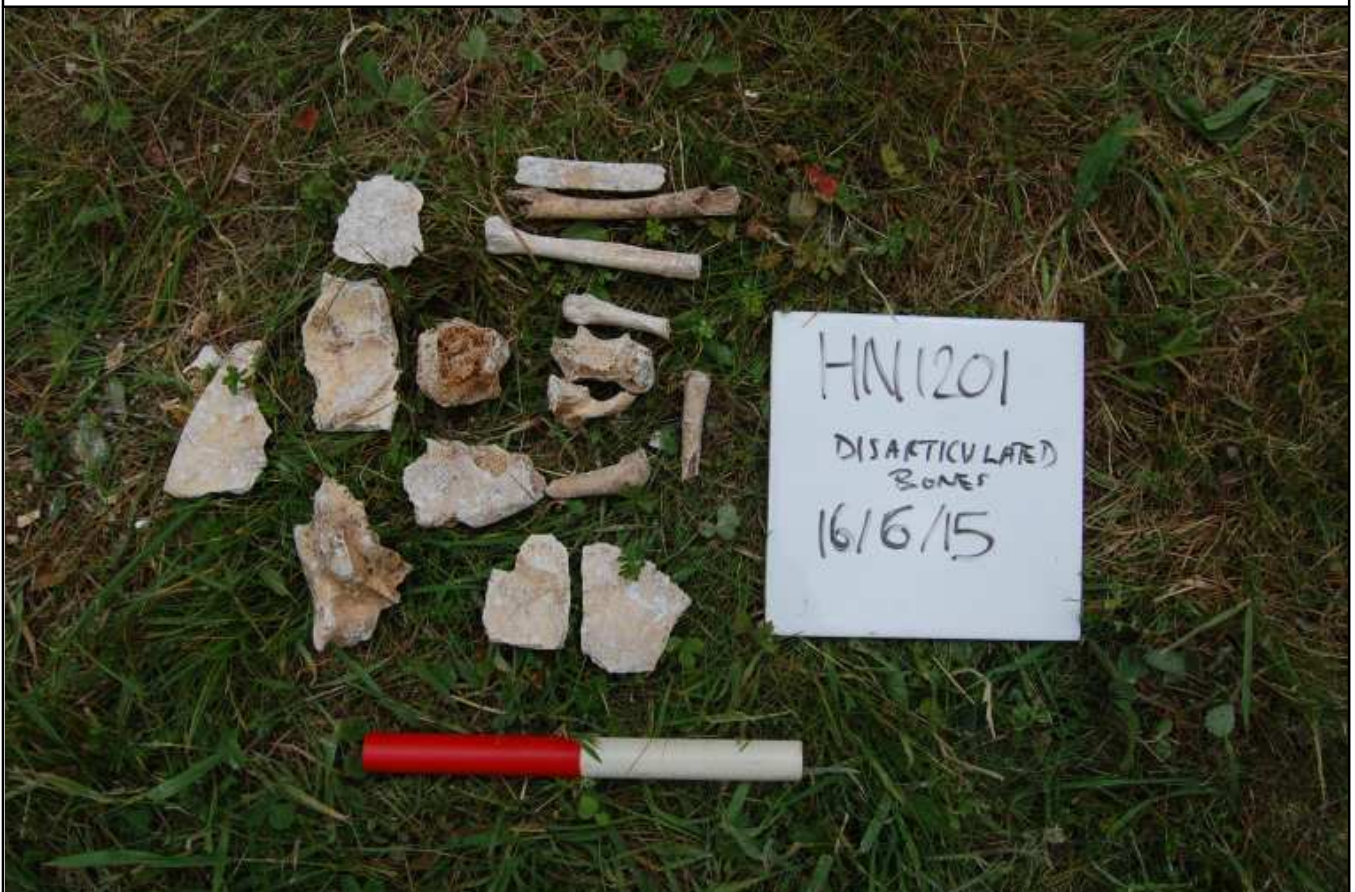
Plate 6: Disarticulated bone from soakaway

Bone from a number of probably adult humans was recovered, including rib, vertebrae and long bone fragments. The bone is likely to represent burials that have been disturbed and disarticulated by the continuous use of the churchyard. The lack of any marked graves in the area could indicate that the original burials were of considerable antiquity, although the lack of finds and discrete graves prevents any secure dating.
