## **ST. JOHN'S HOSPITAL** **St. John's Close, Peterborough**

HN1152

***HISTORIC BUILDING  
RECORD***

Project ref.: HN1152  
Planning ref.: 14/00536/OUT

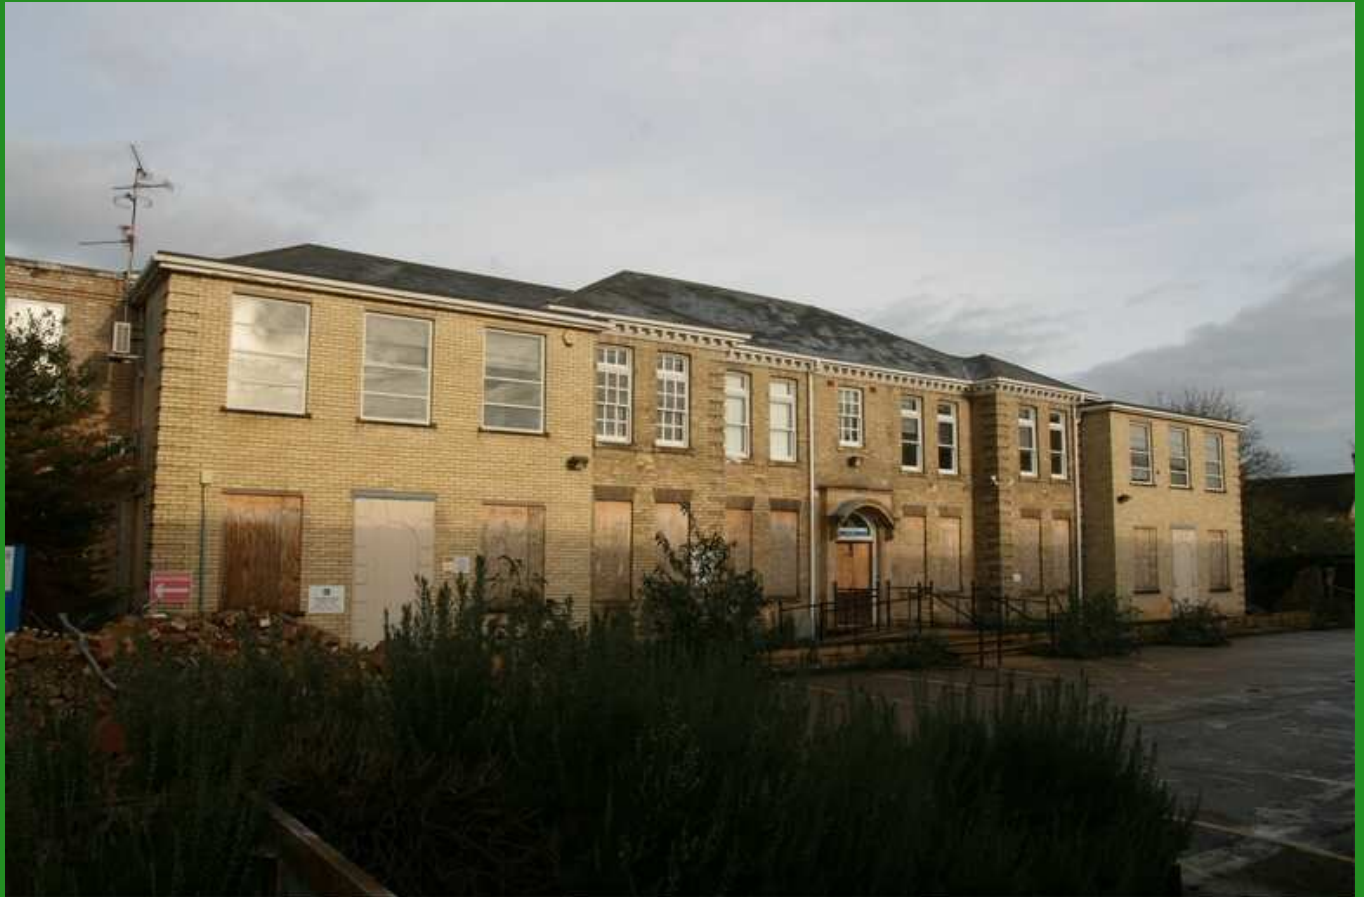
*The cover photograph shows the south elevation, looking NE*

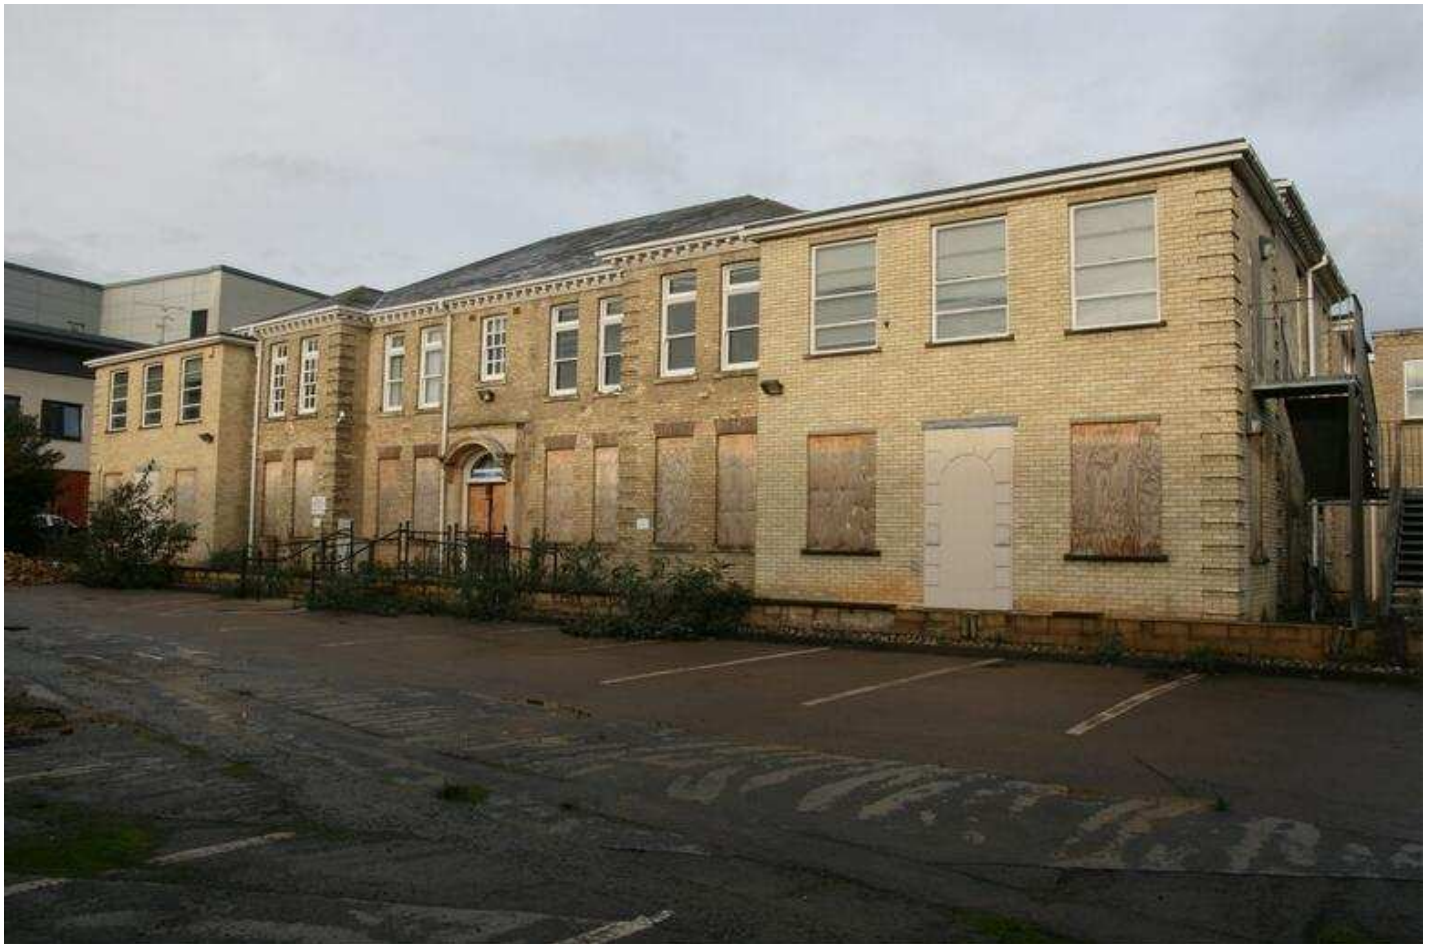
**3.3** The original structure is of five bays (Plate 2). The centre bay is occupied by the main entrance, which incorporates sandstone jambs and a curved hood, and glazed double doors with a semi-circular fanlight above (Plate 3). Above the doorway, on first floor, is a small two-light sash (six over six) with gauged brick header and sandstone sill. The doorway is accessed via three steps which appear to form part of a late access ramp, but are likely to replace an earlier arrangement.

**3.7** The front elevation has been extended to east and west with a projecting flat-roofed bay on each side. These are also constructed of white brick, with three openings to each storey (see Plate 2). A stone panel, with rusticated decoration, occupies the central opening in the ground floor, suggesting a blocked doorway.

Plate 02 - South elevation

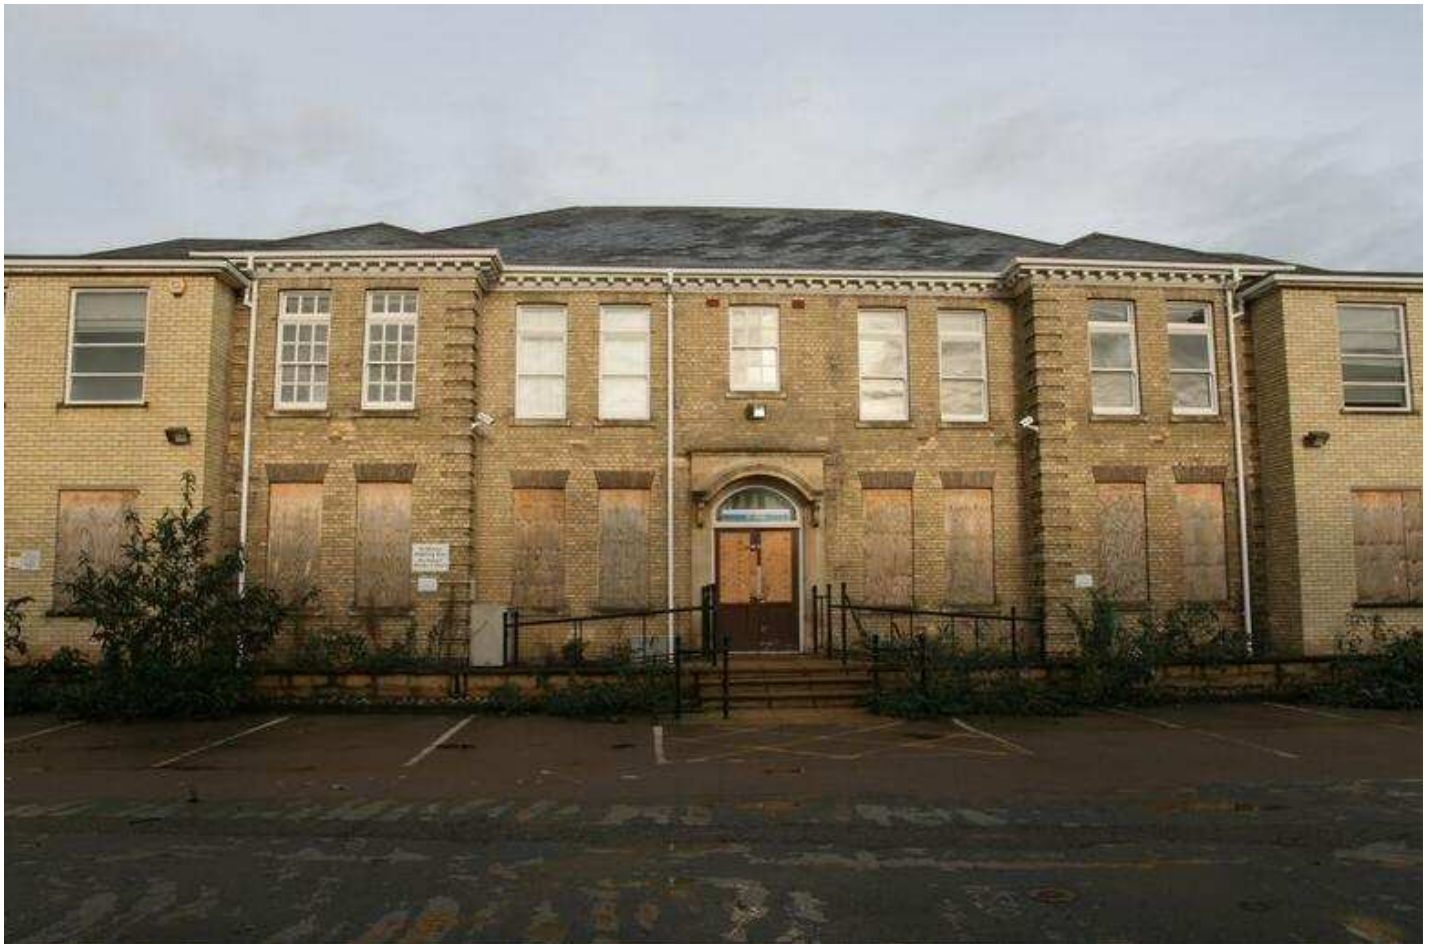
**3.4** The bays flanking the doorway have two tall and narrow window openings in each storey (Plate 4). The windows in the lower storey are boarded, while those in the upper storey are three-light sash windows with a fixed quarter-light above. These have been re-glazed following the removal of the glazing bars. Each window has a gauged brick header and a sandstone sill.

Plate 04 - S elevation, Central bays

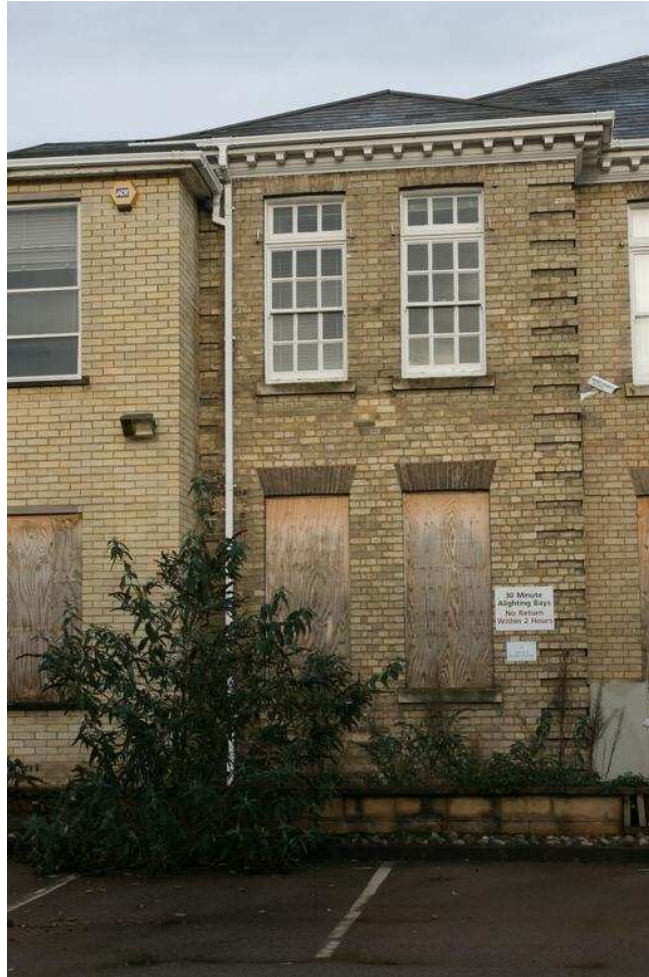
**3.5** The outer bays project forward from the line of the building, with two windows to each storey, in the same pattern. The upper windows in the western bay retain their original glazing bars (Plate 5). These windows are flanked by metal brackets (Plate 6), which may have accommodated an awning or security grilles.

Plate 05 - S elevation, detail of W bay

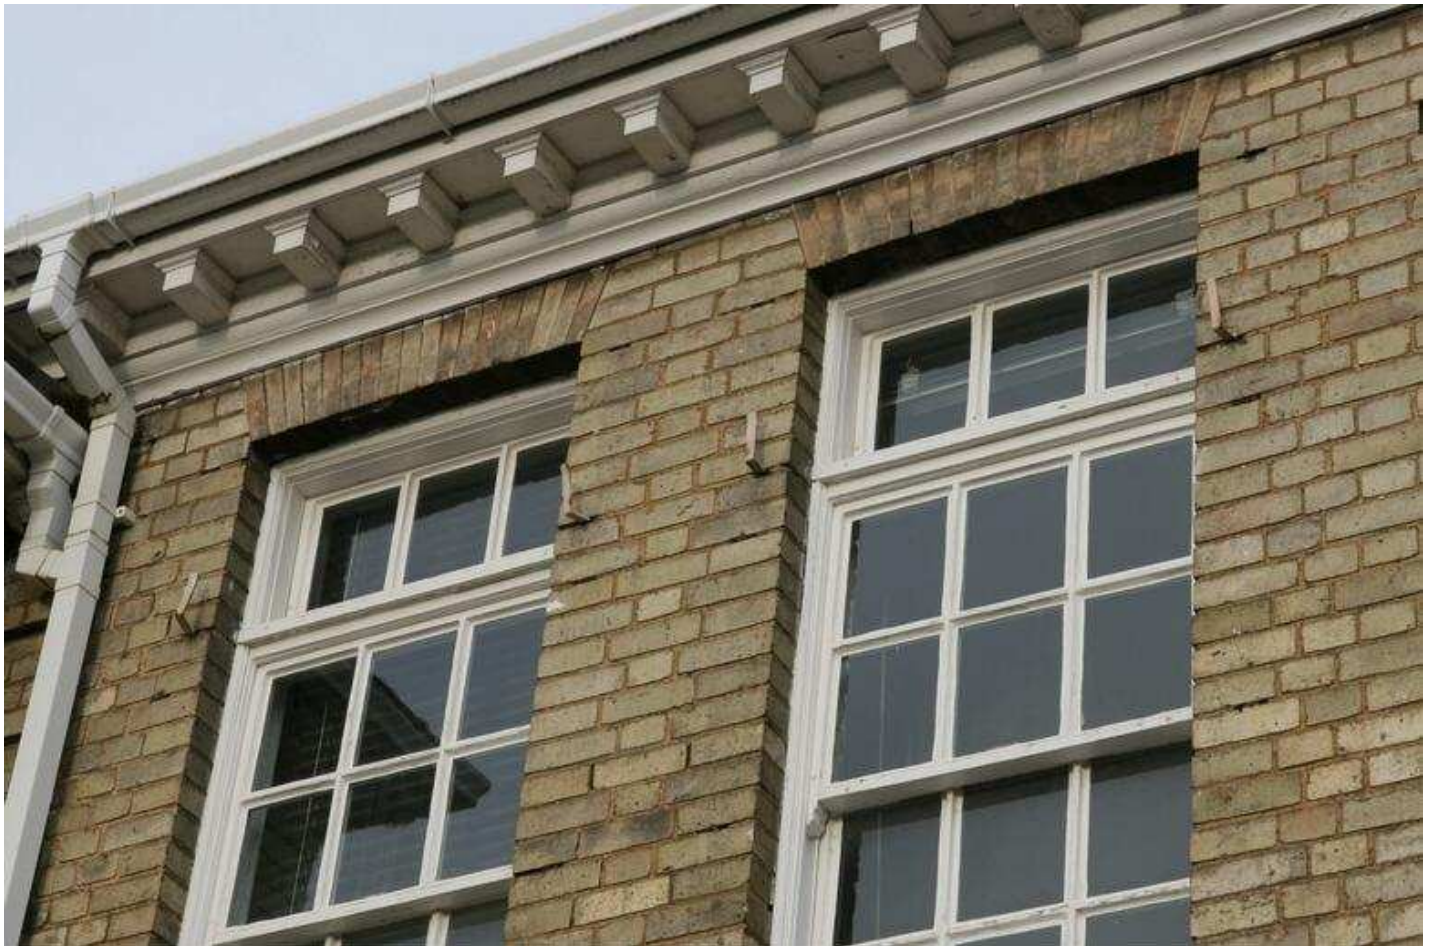
Plate 06 - S elevation, detail of metal brackets flanking the windows

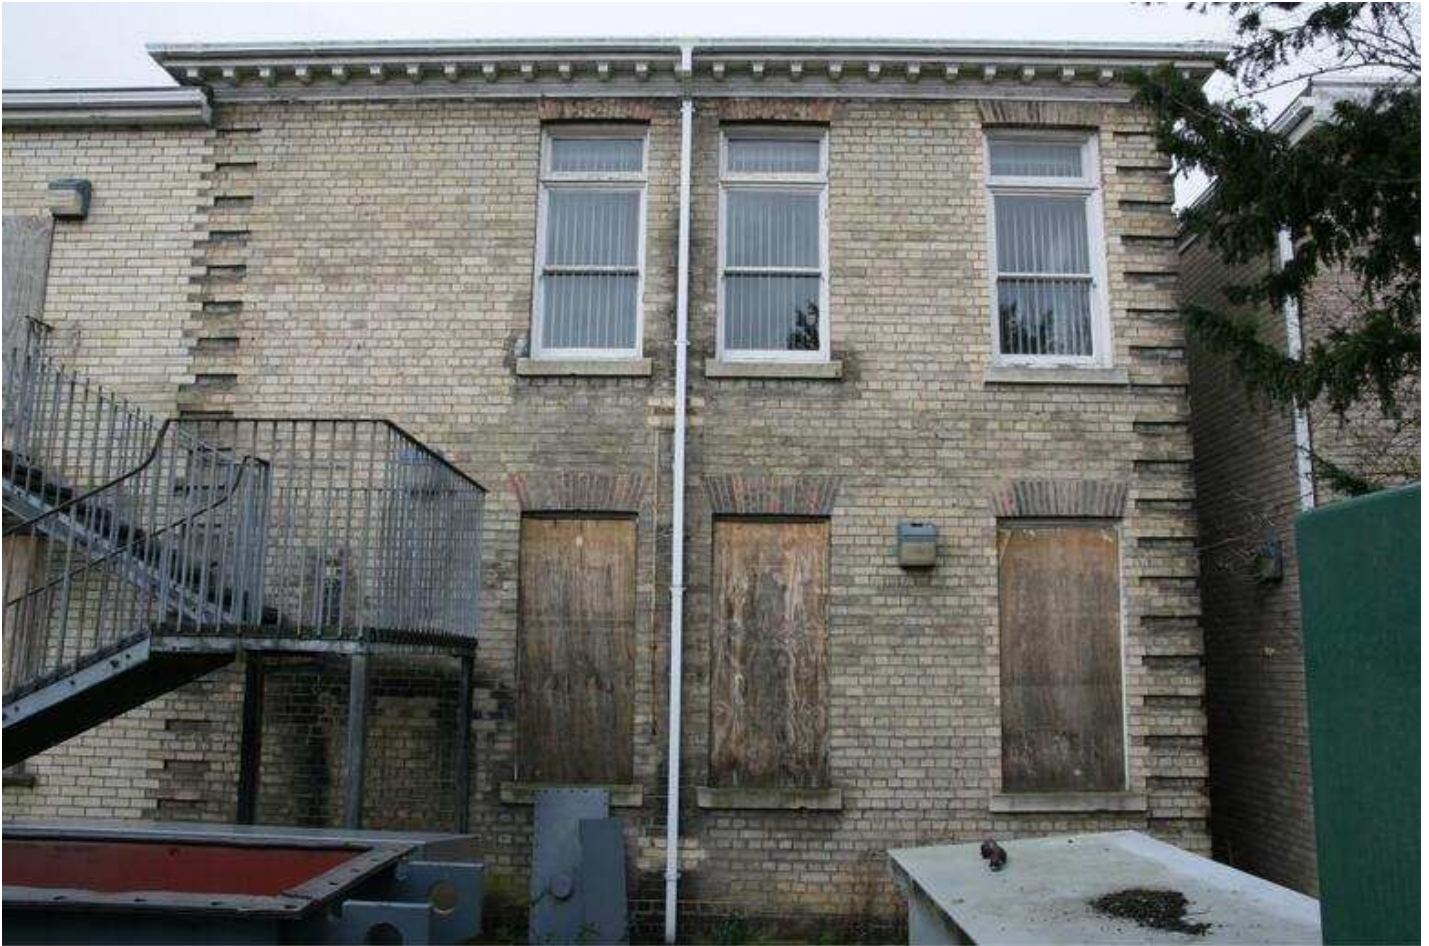
**3.8** The original east elevation to the 1920s infirmary is still visible (Plate 7). This also has rusticated quoins and a dentilled cornice. Three window openings, offset to the north, are located in each storey. These are in a similar style to those observed in the south elevation. A modern metal fire escape occupies the southern end of the elevation.

Plate 07 - Original east elevation

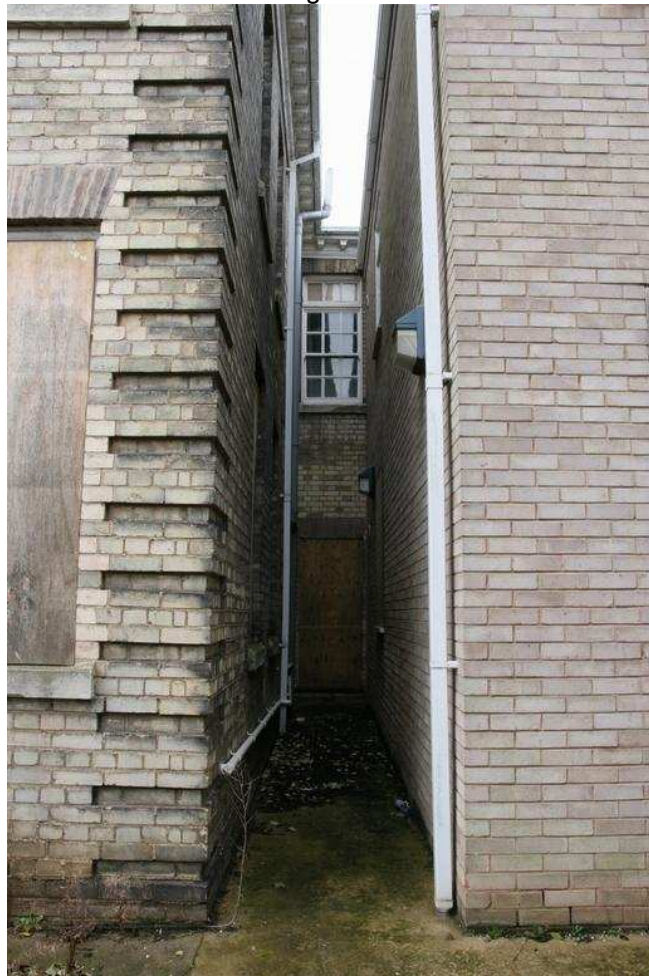
**3.9** Part of the east elevation of one of the original rear extensions to the north elevation is visible between the original block and the modern extension to the rear (Plate 8). This has an opening to each storey. The lower opening appears to be a blocked doorway, with a gauged header, while the upper opening is a sash window, in a similar style to those noted in the south elevation, which retains its original glazing bars.

Plate 08 - Remains of original northern extension, E elevation

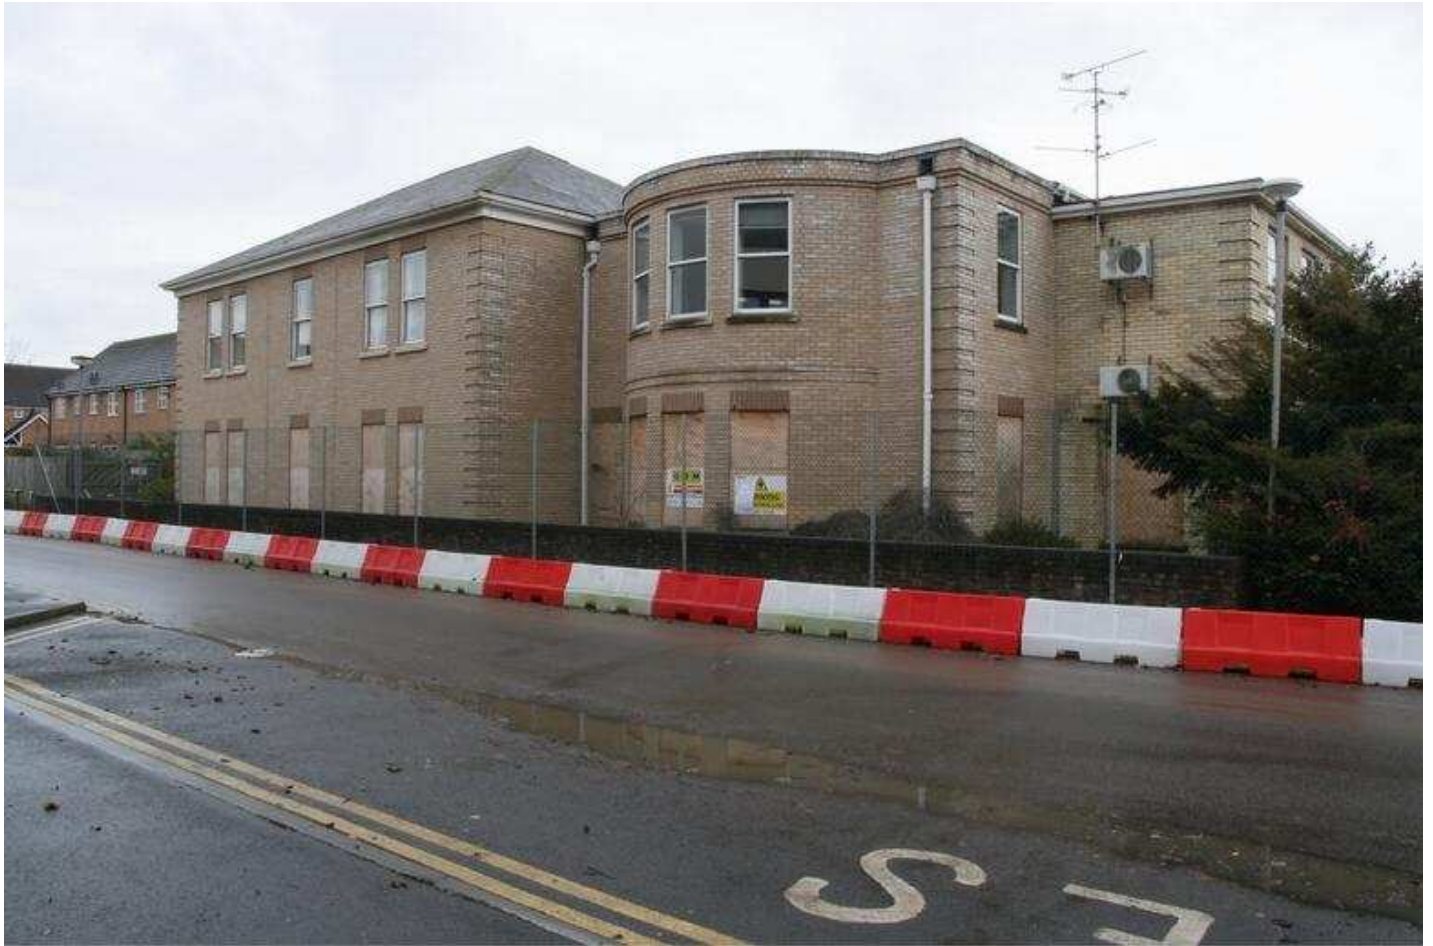
**3.10** The west elevation, which is of late 1980s/1990s date, is of at least four bays in length (Plate 9). It is constructed in white brick, with a curved bay at the southern end. This has three window openings to each storey. To the north the elevation is flat, with five window openings to each storey. The style of this elevation has echoed that of the south elevation, with sash windows, brick headers to the ground floor windows and rusticated quoins.

Plate 09 - West elevation

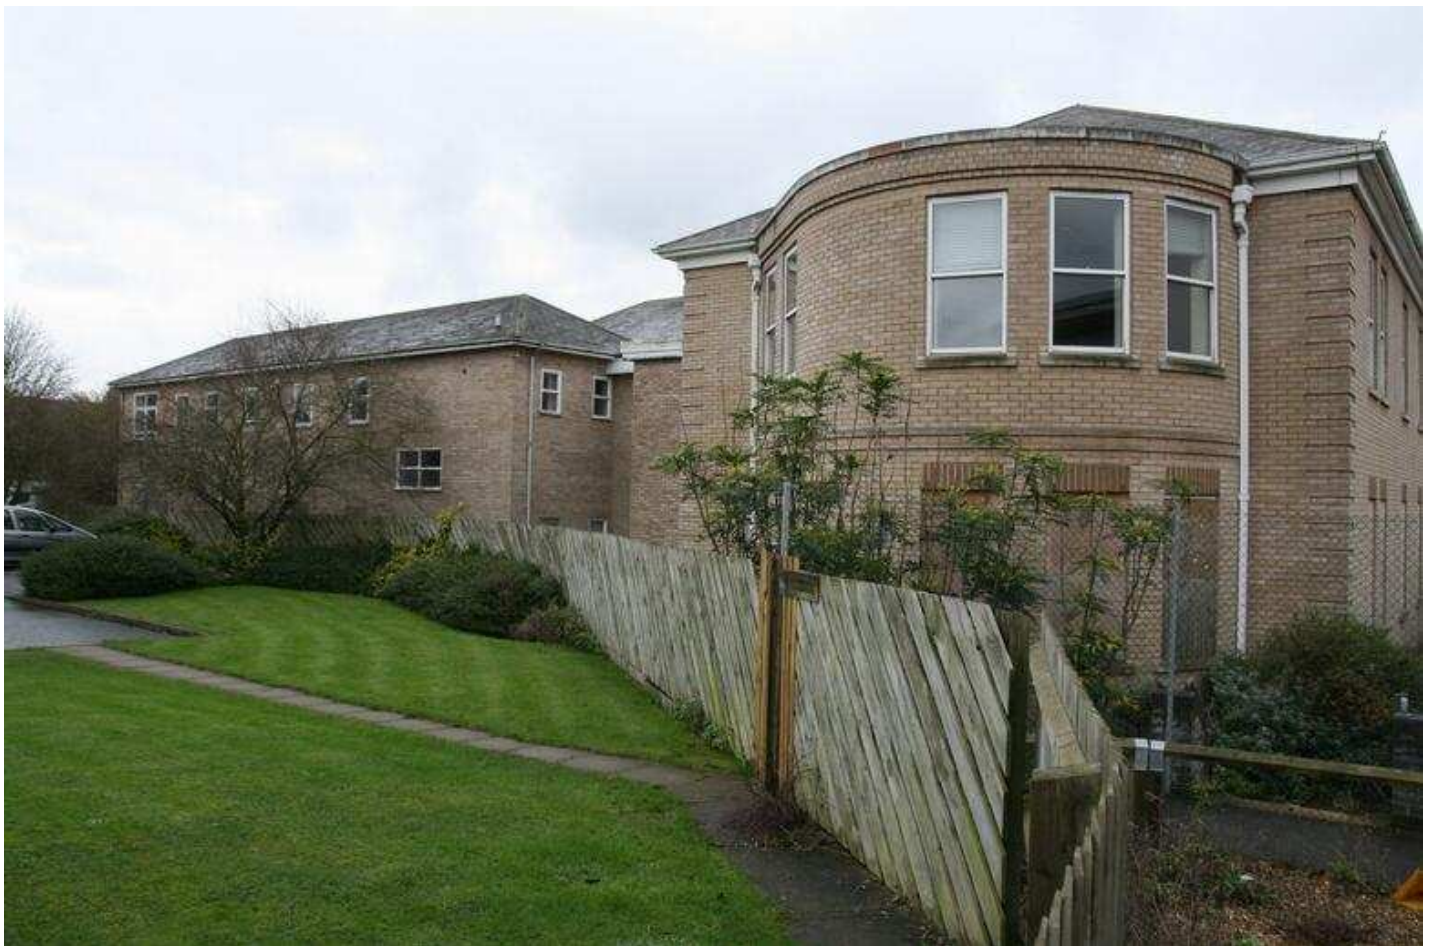
**3.11** The curved western end of the north elevation is of late 1980s/1990s date and is similar to the curved bay at the southern end of the west elevation (Plate 10). The eastern end was built between 1976 and 1984. Apart from the use of white bricks, the architectural style does not match that of the original building.

Plate 10 - North elevation

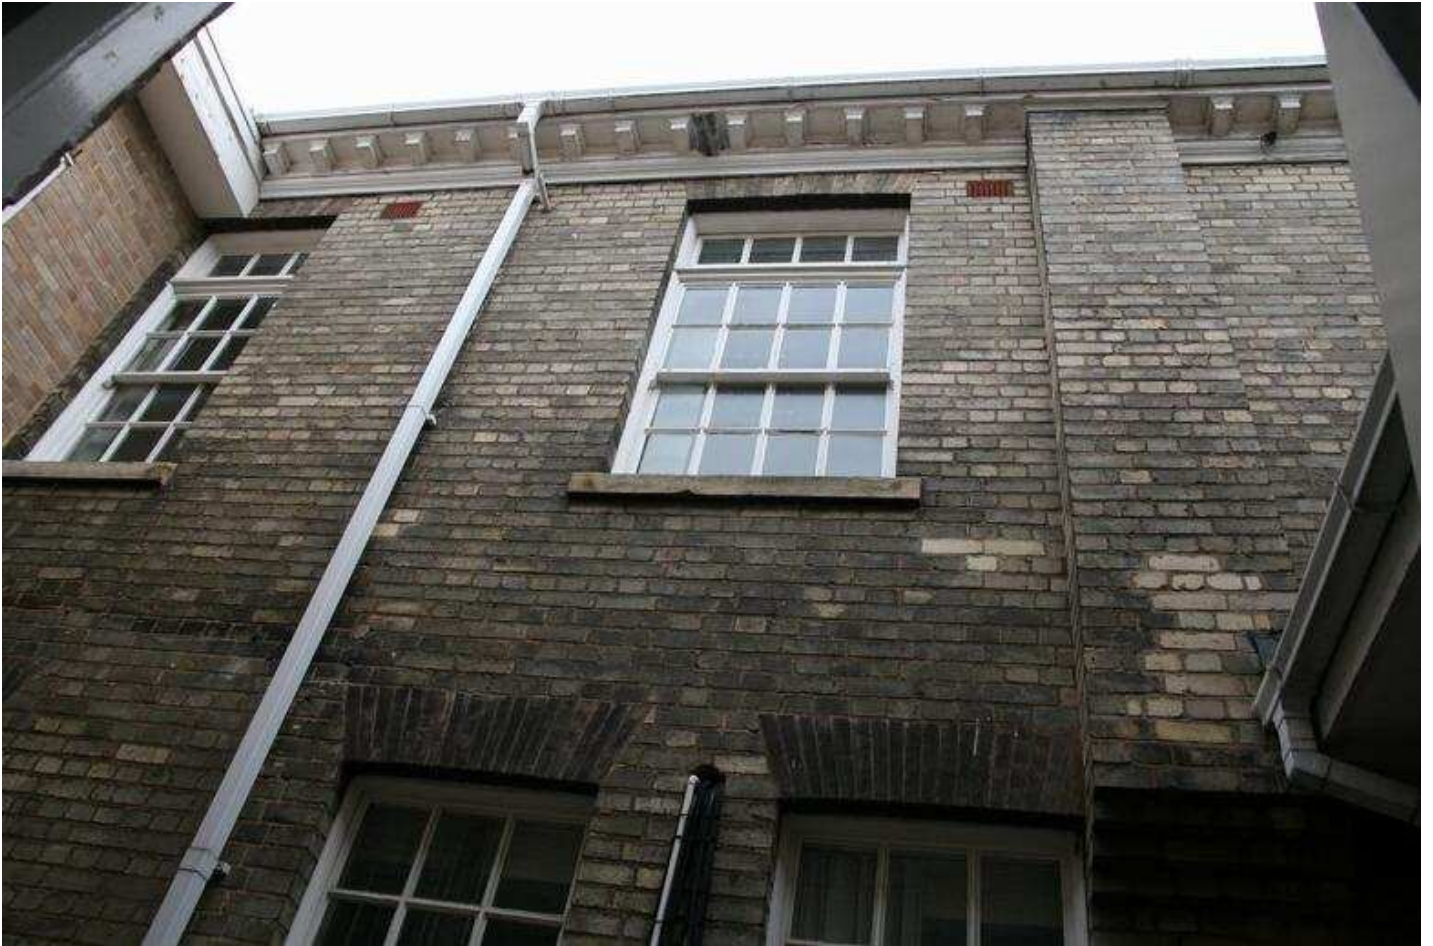
**3.12** Part of the original north elevation is visible in the courtyard at the rear of the hospital, created when the eastern block was added to the north elevation between 1976 and 1984. The features are similar to those observed in the south elevation, comprising a dentilled cornice and tall narrow sash windows, with gauged brick headers and sandstone sills (Plate 11).

Plate 11 - Surviving part of original north elevation

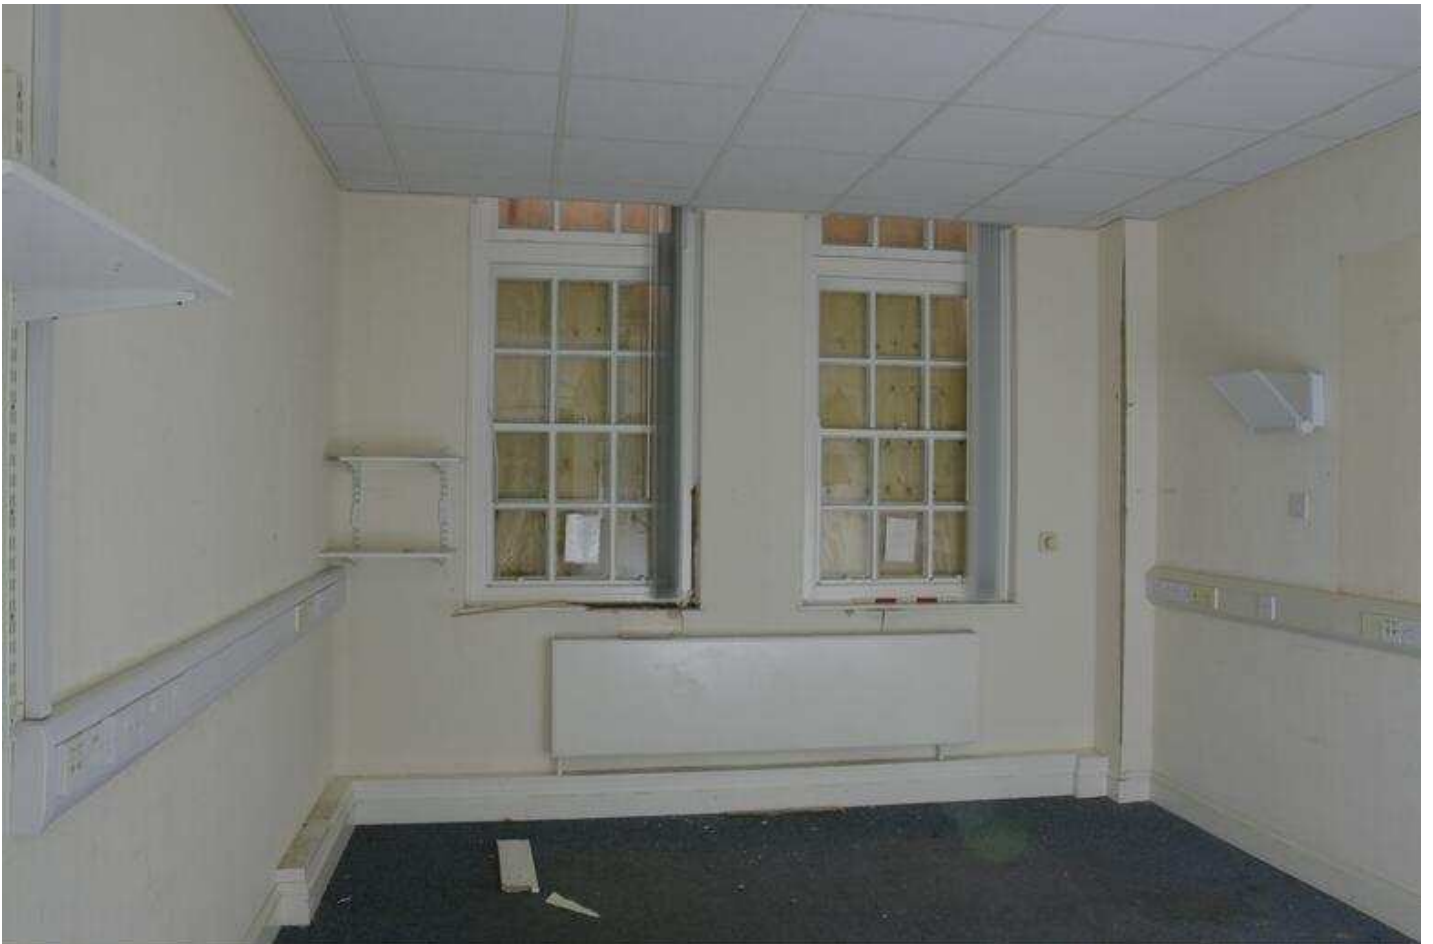
**3.14** The surviving features include the original sash windows, with their glazing bars, in Rooms G2 and G3, although they are partly obscured by suspended ceilings in both rooms (Plate 12), and two surviving doorways, now blocked, in the east elevation of the ground floor plant room. These originally gave access to the eastern rear extension (Plate 13).

Plate 12 - Room G2, looking S

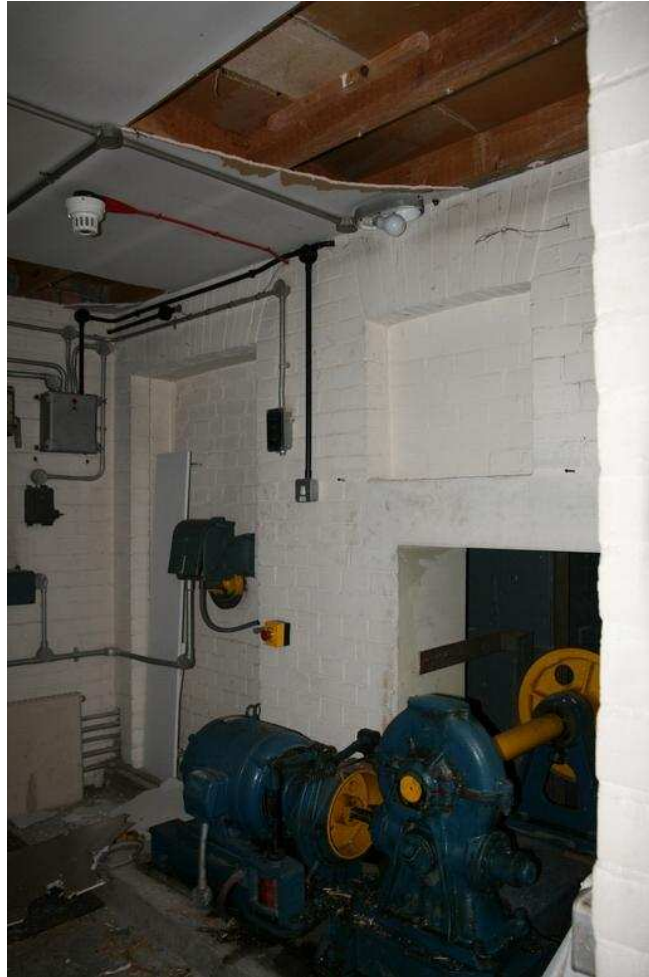
Plate 13 - Original doorways in east elevation of Plant Room

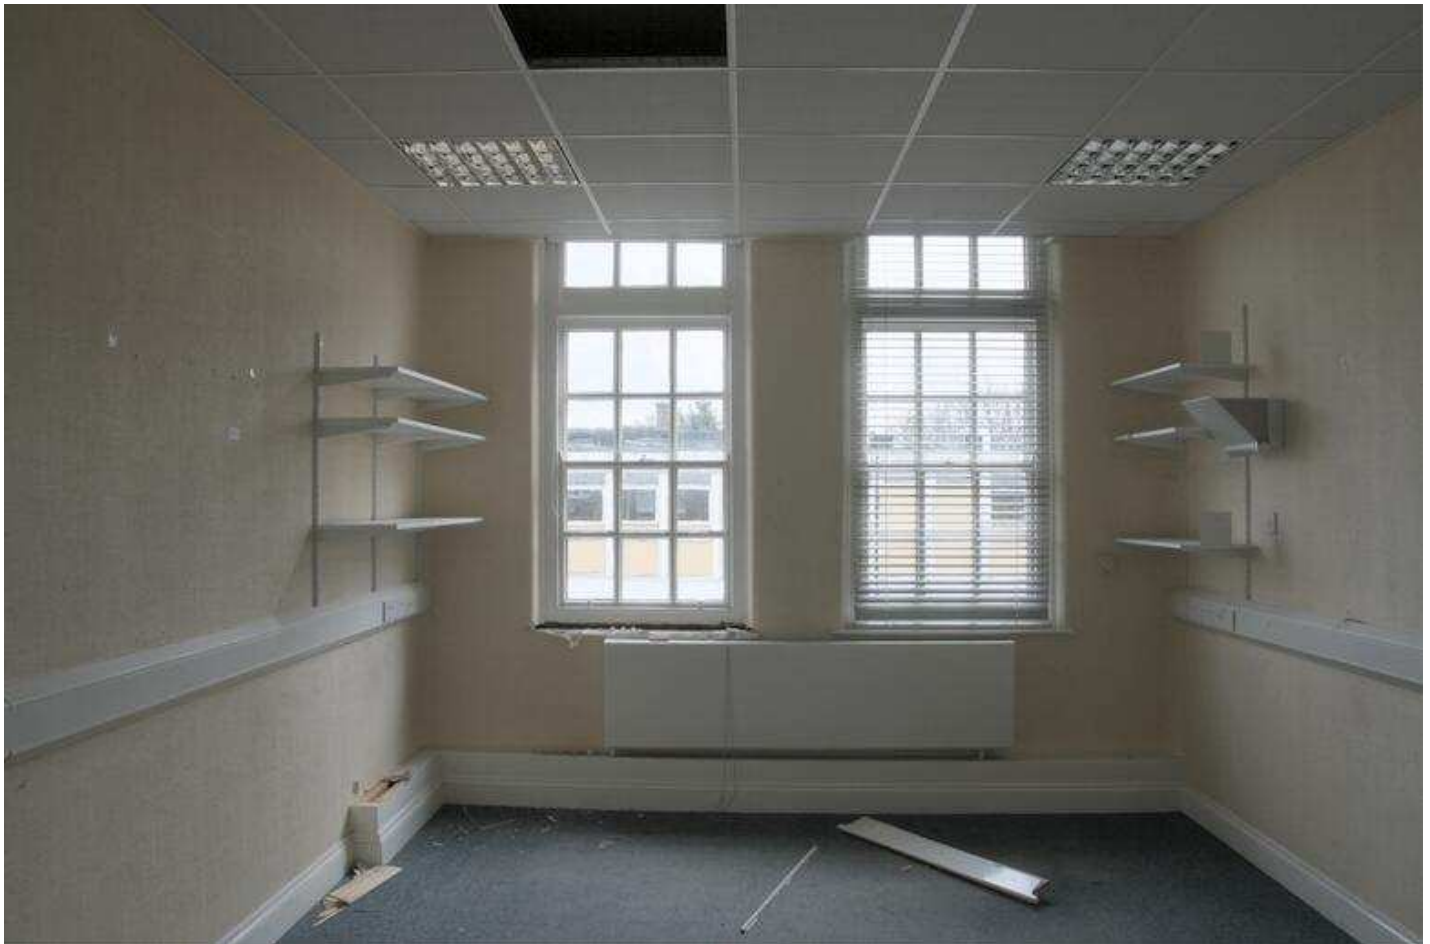
**3.16** Few original features survive at first floor level. The windows to the south elevation and part of the north elevation remain (Plates 14 and 15). As with the ground floor rooms, suspended ceilings have been installed. The partition wall between F2 and F3 is original, as shown by the surviving moulded wooden skirting (Plate 16). Room F3 has been enlarged by the removal of the former partition wall, while Room F8 has been sub-divided by the insertion of a partition wall (Figure 6).

Plate 14 - Room F1, looking S

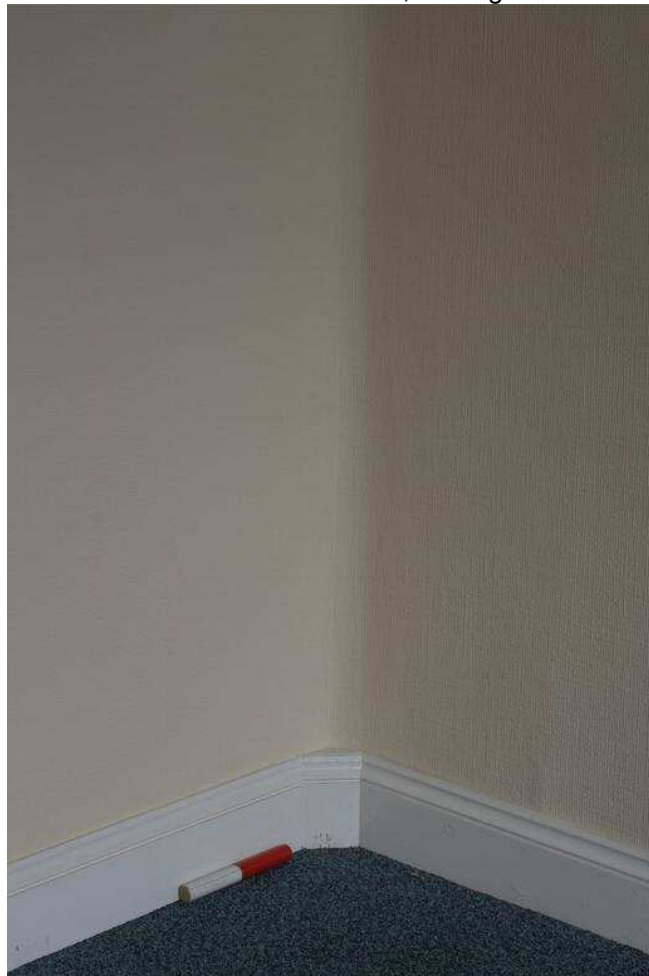
Plate 16 - Room F2, original skirting in NE corner

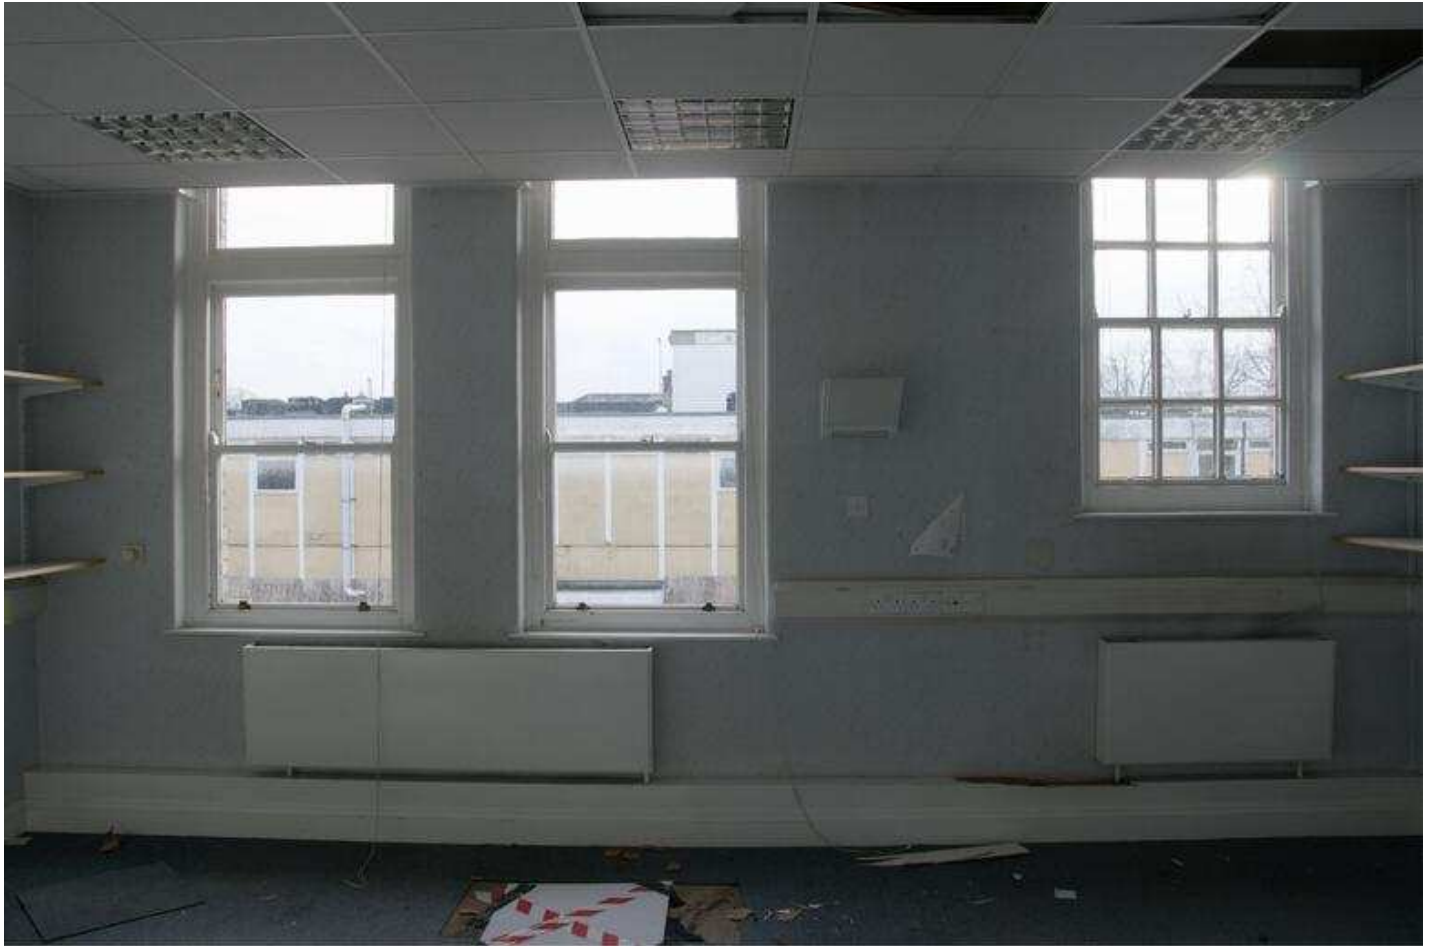
Plate 17 - Room F3, looking S
