The Priory Church of St. Peter, Dunstable, Bedfordshire

HN1220

Report No.964

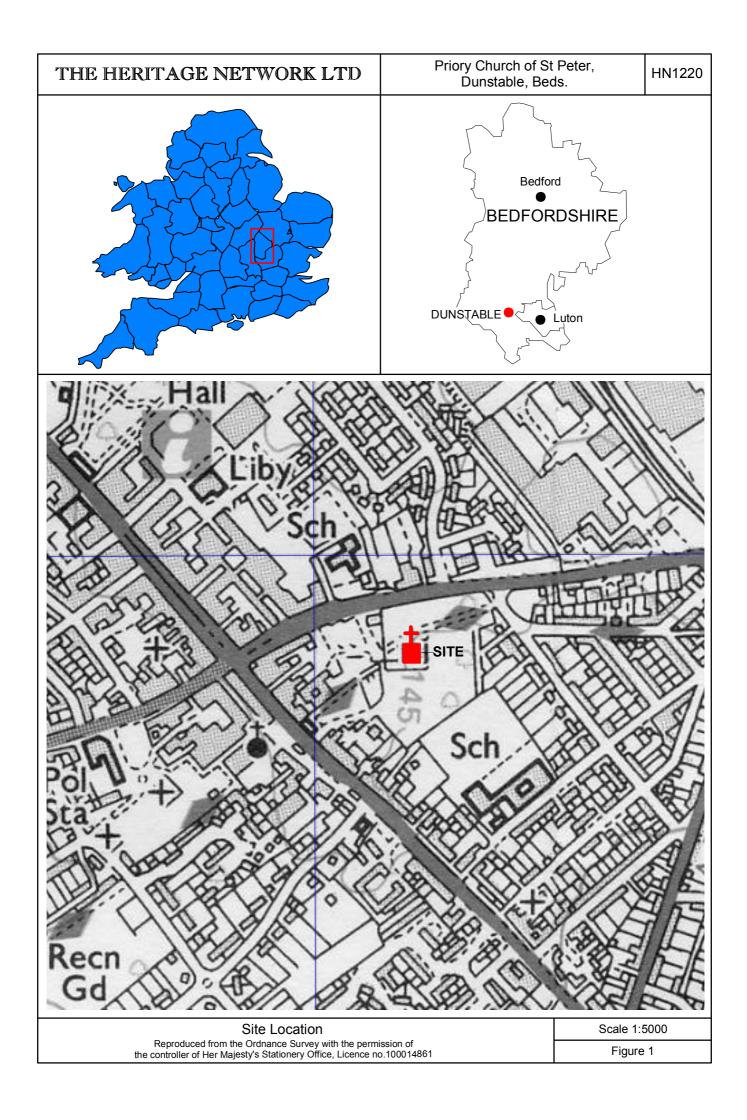
TH A was located at the eastern end of the north aisle, adjacent to the eastern pillar of the arcade. It measured 0.60m by 0.50m and between 0.15m and 0.25m in depth (Plates 1&2). The stratigraphy consisted of a layer of concrete, 0.08m thick, over dark yellowish brown (10YR 4/4) loose sandy silty make up with brick, tile and chalk inclusions, 0.17m in depth. A red brick structure with a sloping roof, [101], which has been interpreted as a burial vault was encountered below the made ground. This was aligned north-south, perpendicular to the aisle. The bricks were bonded with a dry lime mortar, which also covered the surface of the vault, and were laid in stretcher bond. The apex of the vault, on the eastern edge of the trial hole, was approximately 0.15m below the surface of the concrete floor. On the western edge the level of the vault dropped to 0.25m below the concrete surface.

An existing gas pipe, of probable late 19th or early 20th century date, was observed extending into the trial hole from the western baulk, above the probable vault.

No other features, deposits, or artefacts were observed in this trial hole.

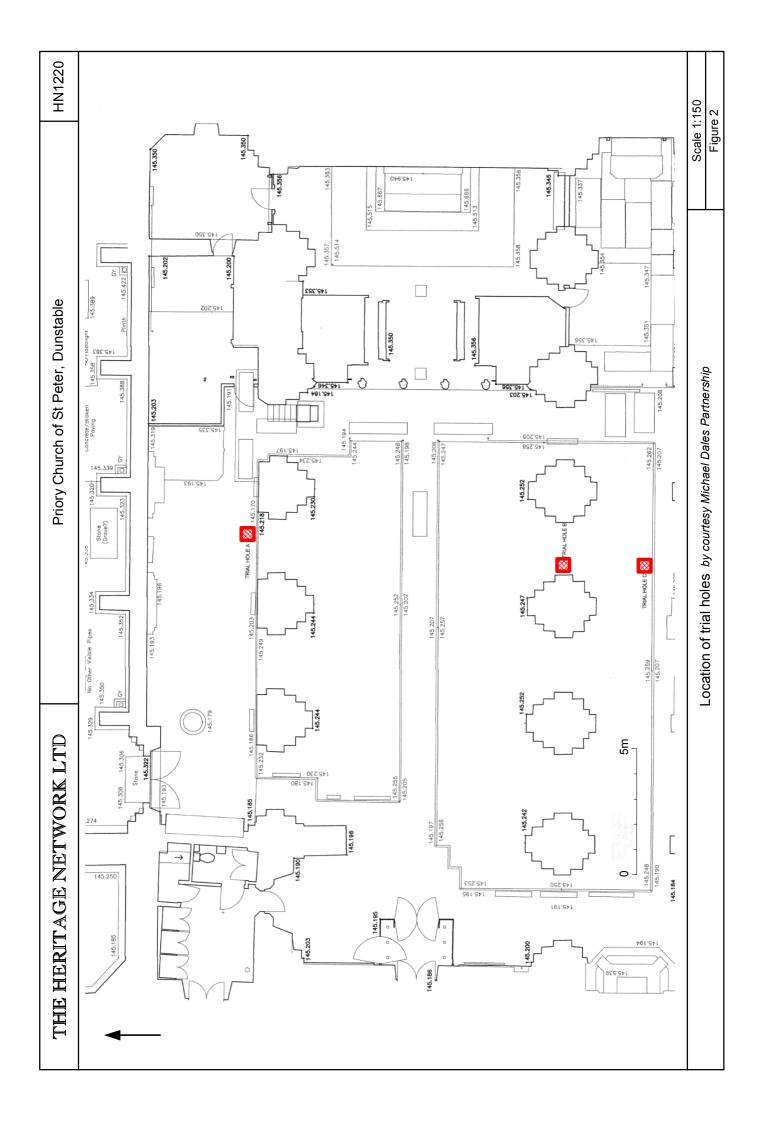
TH B was located adjacent to a pillar at the eastern end of the southern arcade and measured 0.70m in length, 0.50m in width and 0.35m in depth (Plate 3). The stratigraphy consisted of a layer of concrete, 0.08m thick, over dark yellowish brown (10YR 4/4) loose sandy silty make up with brick, tile and chalk inclusions, 0.15m in depth. This overlay the white chalk natural substratum, >0.18m in depth.

No evidence for a foundation cut for the adjacent pillar was observed in the trial hole. It appears that the column base sits directly on the natural chalk.

No archaeological cut features, deposits, or artefacts were observed in this trial hole.

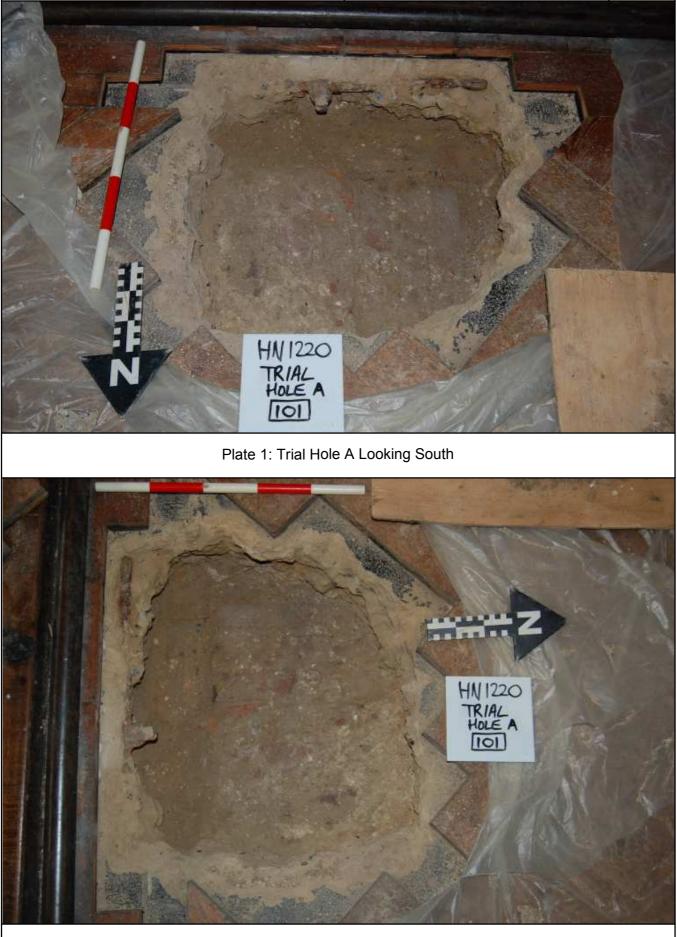
Plate 2: Trial Hole A Looking West

The roof of a late post-medieval brick structure, presumably part of a burial vault, was encountered at a minimum depth of 0.15m below the present surface in TH A, at the eastern end of the north aisle. This structure was oriented north - south, perpendicular to the aisle.

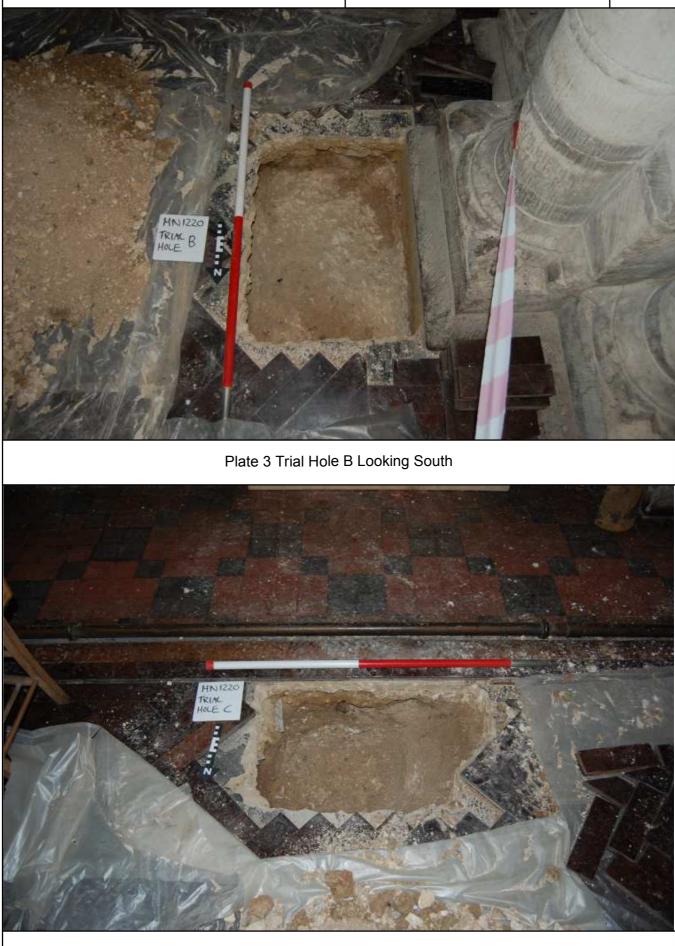
Plate 4 Trial Hole C Looking South

TH C was located to the south of Trial Hole B, close to the south wall of the church. It measured 0.50m in length, 0.40m in width and 0.40m in depth (Plate 4). The stratigraphy consisted of a layer of concrete 0.08m thick, over dark yellowish brown (10YR 4/4) loose sandy silty make up with brick, tile and chalk inclusions, 0.15m in depth. This overlay the white chalk natural substratum, >0.18m in depth.

No evidence associated with the construction of the south wall was encountered and no archaeological features, deposits, or artefacts were observed in this trial hole.
