**Former Coach House
CORNEYBURY FARM
Royston Road, Wyddial, Herts.**

(HN581)

*Historic Building Impact Assessment
& Archaeological Assessment*

Report no.386

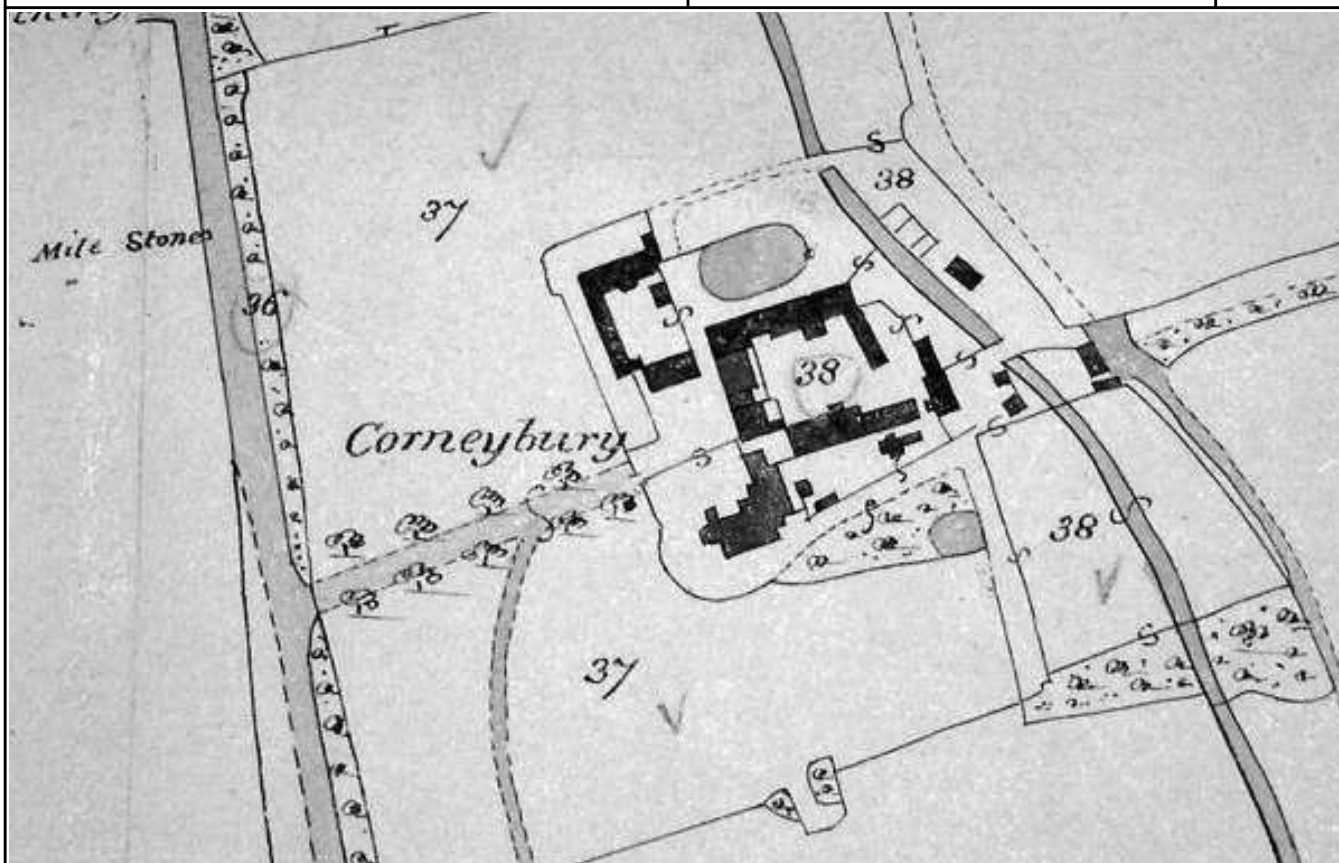
Figure 3

2.16 The Tithe Map of 1838 (Figure 3) provides a detailed and apparently accurate depiction of the site, and the first definitive representation of the coach house. The farm is shown divided into three distinct areas: a primary courtyard enclosed by the farmhouse, the stable block, and the coach house; a further yard to the north of the coach house, running up to the barn noted on the 1744 map, and enclosed on the southeast side by a long narrow barn, overlooks a pond on the northeast; and the main farmyard, on the east side of the stable block. The farmhouse is coloured red, indicating a dwelling, and the northern half of the stable block (beyond the archway) is similarly coloured.

Tithe Map, 1838

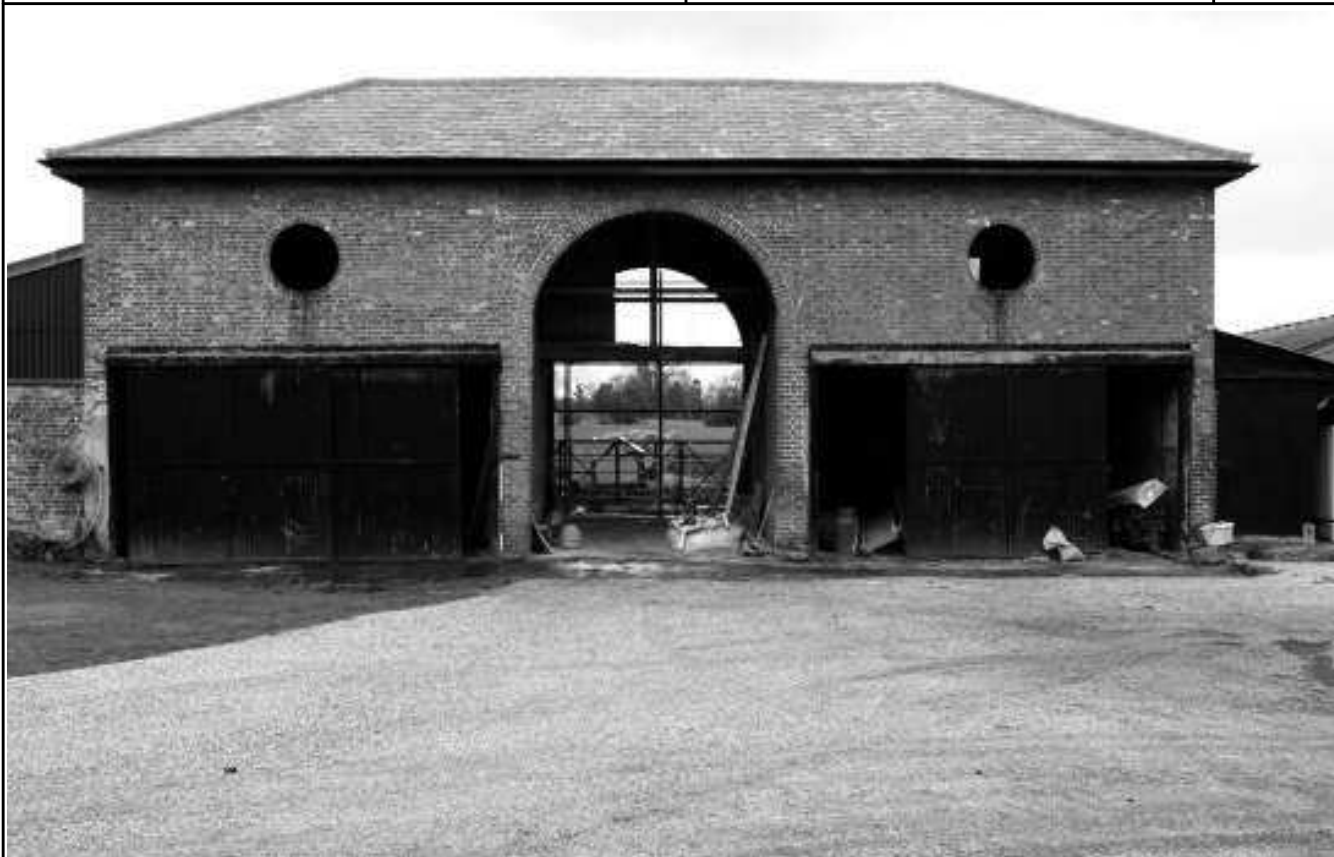
3.4 The building is a mid-18th century two-storey symmetrical rectangular block of red brick in Flemish bond with a hipped slate roof, and a full height, round arched central opening for a carriageway running through from the south to the north. The southern elevation has two wide rectangular openings flanking the central archway in the lower storey, covered with modern sliding doors, and two circular openings in the upper storey (Figure 11; Plate 1). The northern, eastern and western elevations have further circular openings in the upper storey (Figure 11; Plates 2 – 4). These openings formerly housed circular louvred vents set on square frames. These were in situ at the time of the preliminary site visit, but had been removed by the time that the full record was carried out. A surviving example was photographed at ground level (Plate 5).

Plate 1: Southern exterior elevation

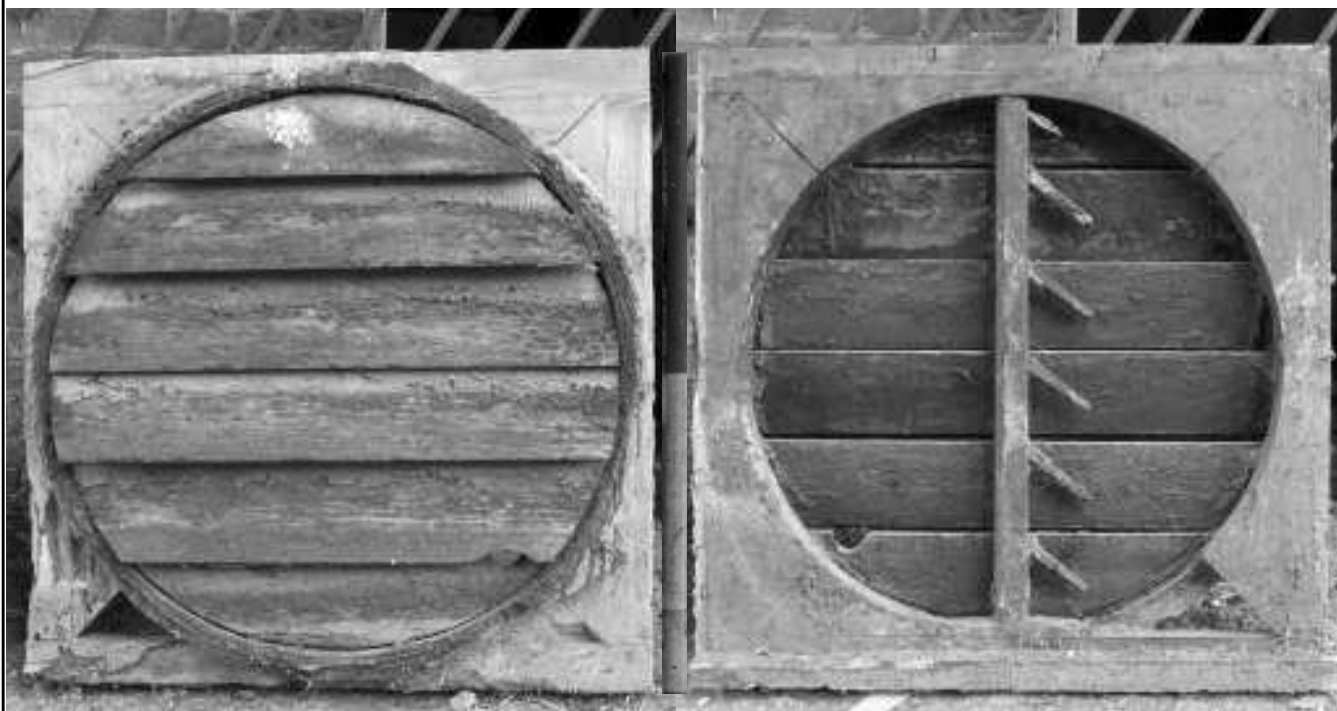
4.23 The circular openings for the louvered vents in each of the elevations may be later insertions, although, if so, they have been very cleanly achieved. The relieving arches, located above both of the openings in the southern elevation, suggest that they may have replaced earlier windows. However, the arches do not extend from the rear face to the front and may, rather, be associated in some way with the corbelling.

Plate 5: Louvered vent (front/rear)

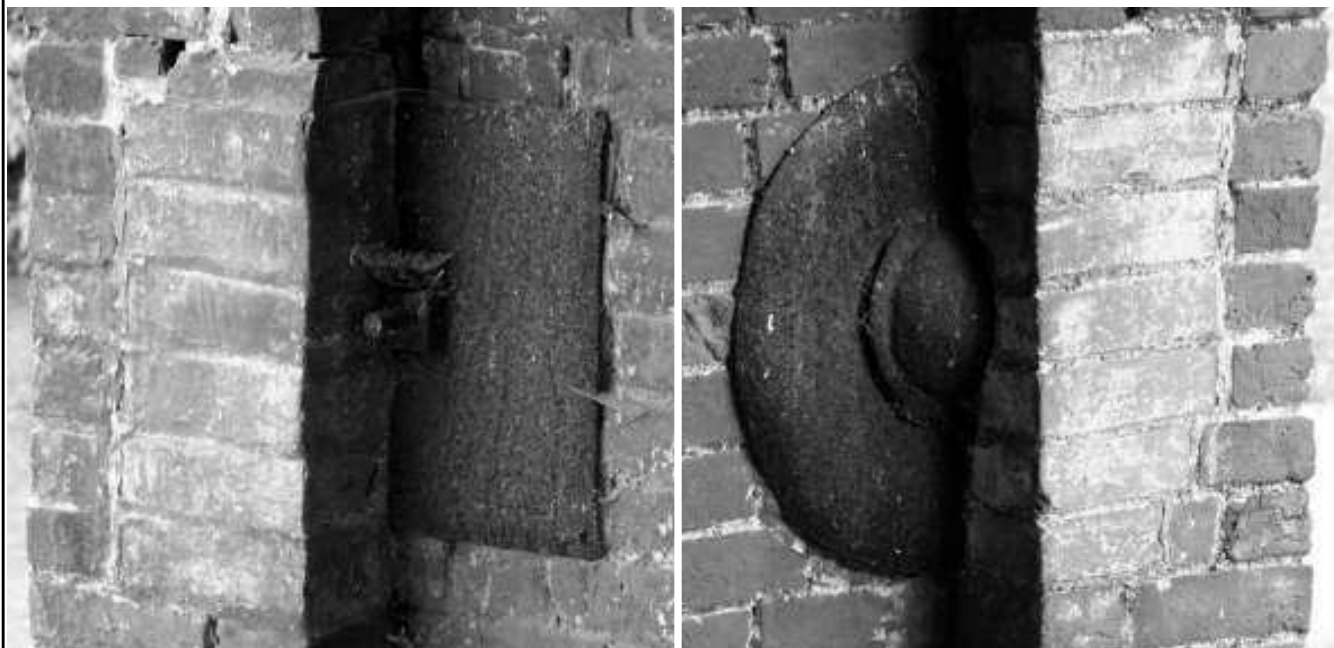
3.6 There is evidence that the southern archway has been rebuilt. The presence of iron tie rods and plates on either side of the archway (Plate 6) and at the northwestern corner further suggest that the building has suffered movement and possible subsidence.

4.24 That the building has been subject to structural weaknesses is demonstrated by the presence of tie-rods and plates supporting the front elevation, and evidence that the central archway has been rebuilt. Whether such weaknesses are inherent to the site, the result of the construction methods used, or the result of later alteration is unclear.

Plate 6: Tie-rod plates (west/east)

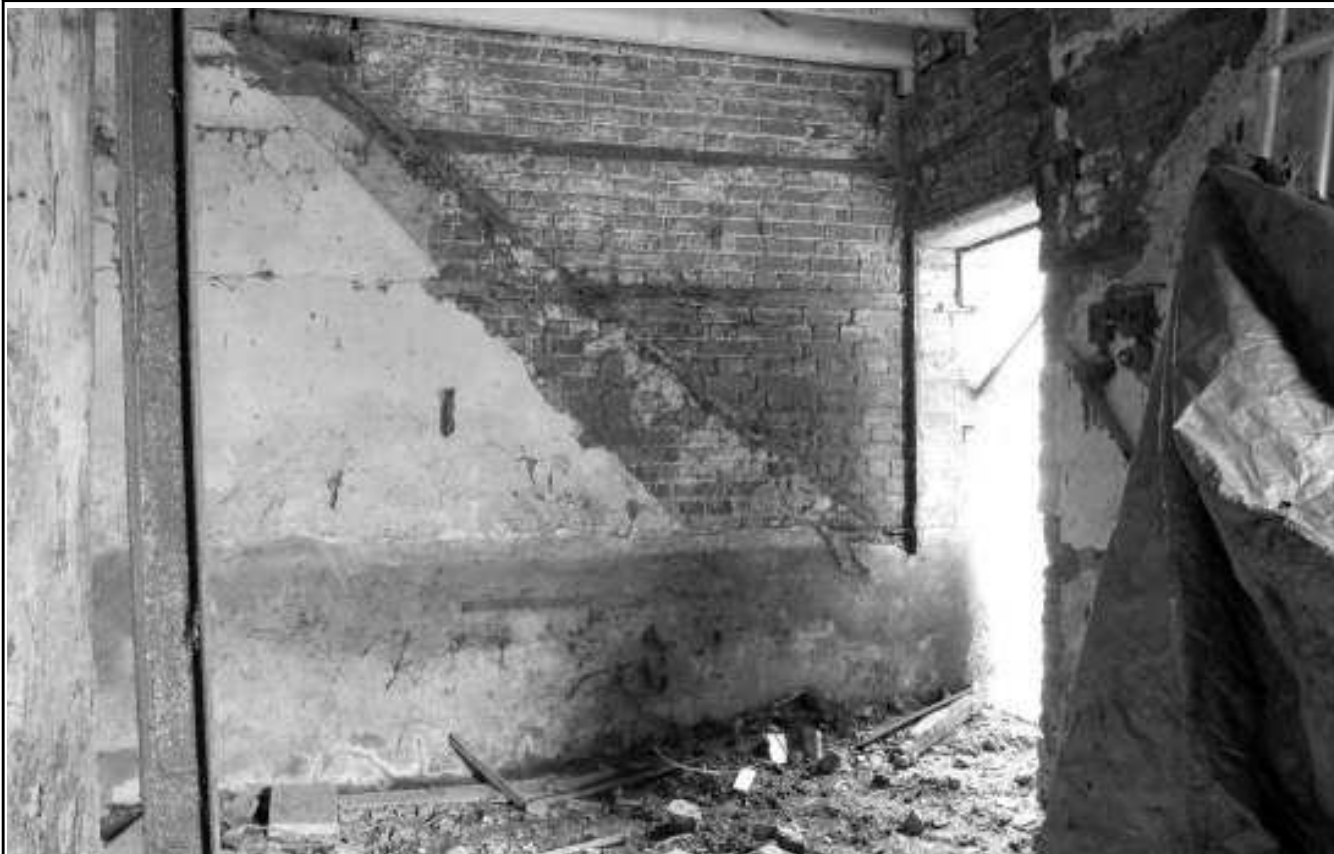
3.8 The western space is open, with a principal joist, aligned north-south and resting on inserted round posts, supporting the upper storey. A doorway at the northern end of the eastern elevation gives on to the central carriageway (Plate 7). In the north elevation, adjacent to the doorway, an area of surviving plaster and exposed brickwork indicates the location of a staircase giving access to the upper storey, which has been removed. The architect's plan appears to indicate the earlier presence of a hopper in the northern half of the western bay, since removed, which was probably linked to grain bins marked on the plan for the upper storey.

Plate 7: Western ground-floor space, NE doorway and location of former staircase

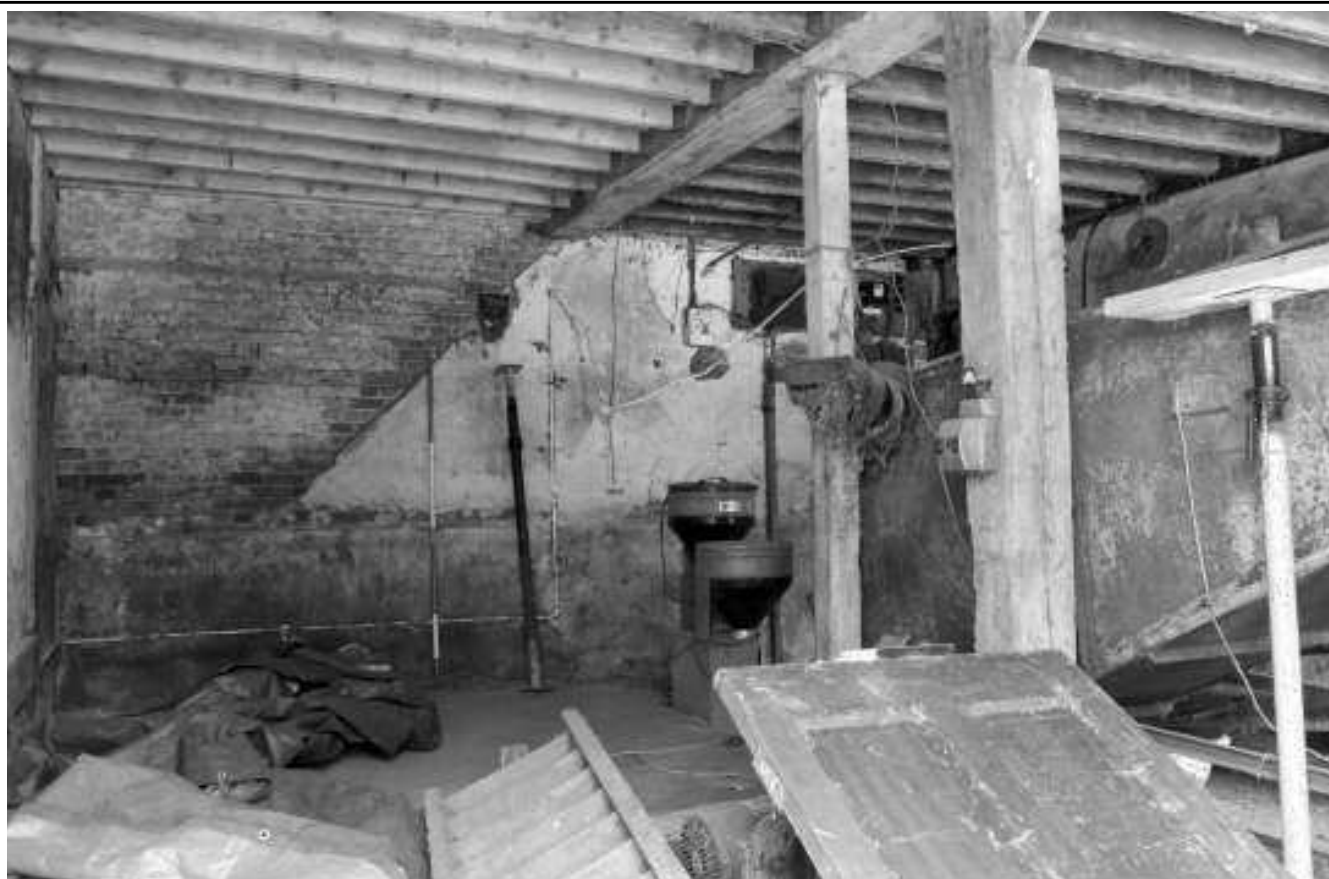
3.9 The eastern space is open, with a principal joist, aligned north-south and resting on inserted square posts, supporting the upper storey. A blocked doorway is located at the northern end of the western elevation, opposite the similar doorway in the western space. In the north elevation, adjacent to the blocked doorway, an area of surviving plaster and exposed brickwork indicates the location of a staircase giving access to the upper storey, which has been removed (Plate 8). The architect's plan appears to indicate the earlier presence of two hoppers, one in the northern half of the western bay, one in the southern half of the eastern bay, since removed, which were probably linked to a grain bin marked on the plan for the upper storey. A partially dismantled hopper is shown lying on its side in the photographs of this area (Plate 8) A staircase is also marked on the architect's plan, running along the western elevation from half way along the wall, but has since been removed.

Plate 8: Eastern ground-floor space, and location of former staircase

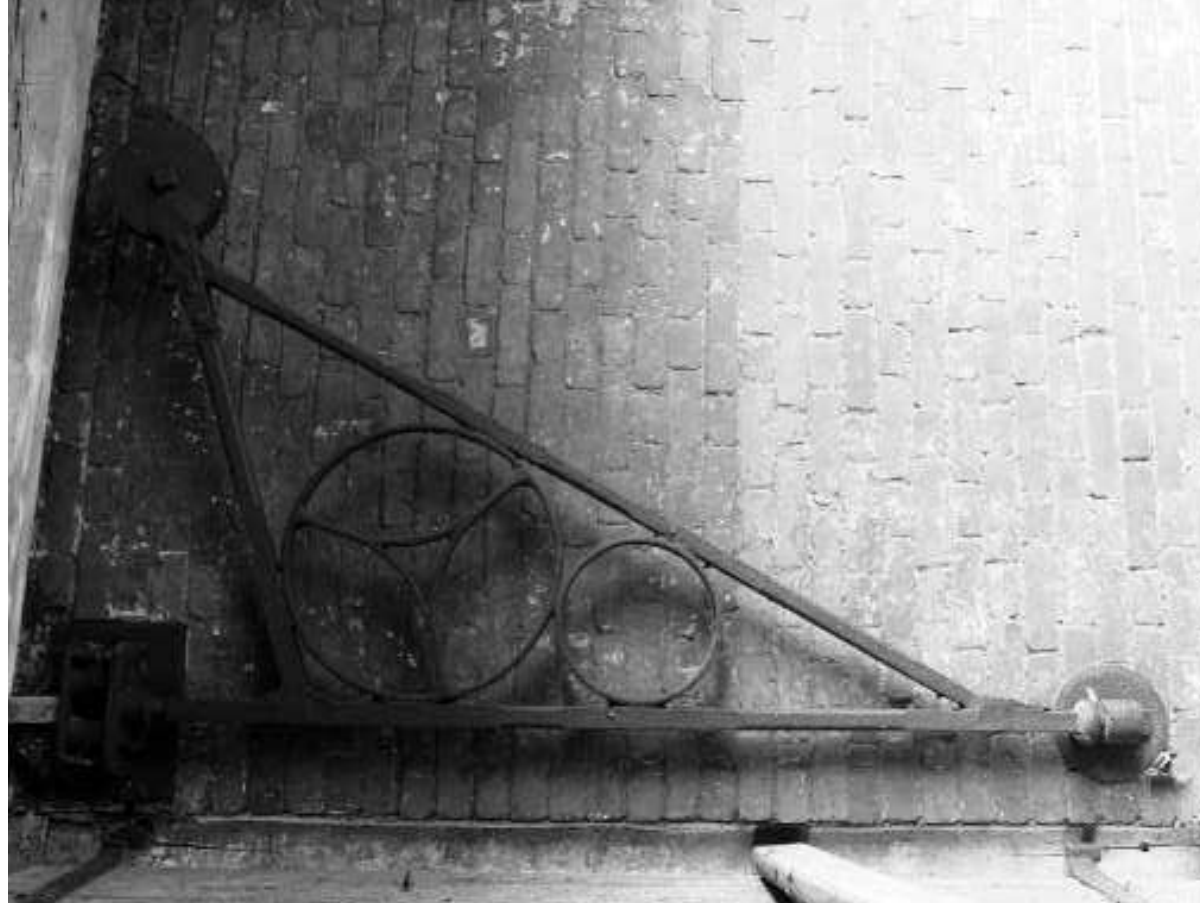
Plate 9: Western hoist

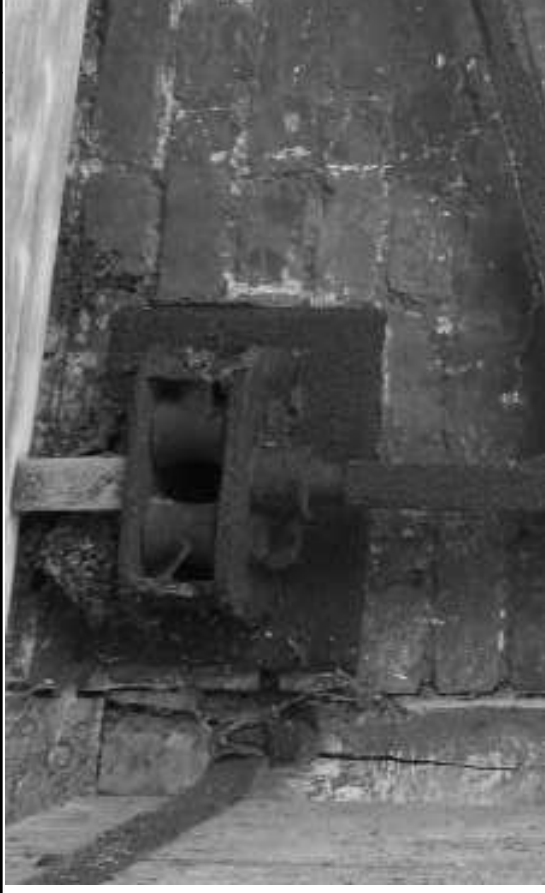
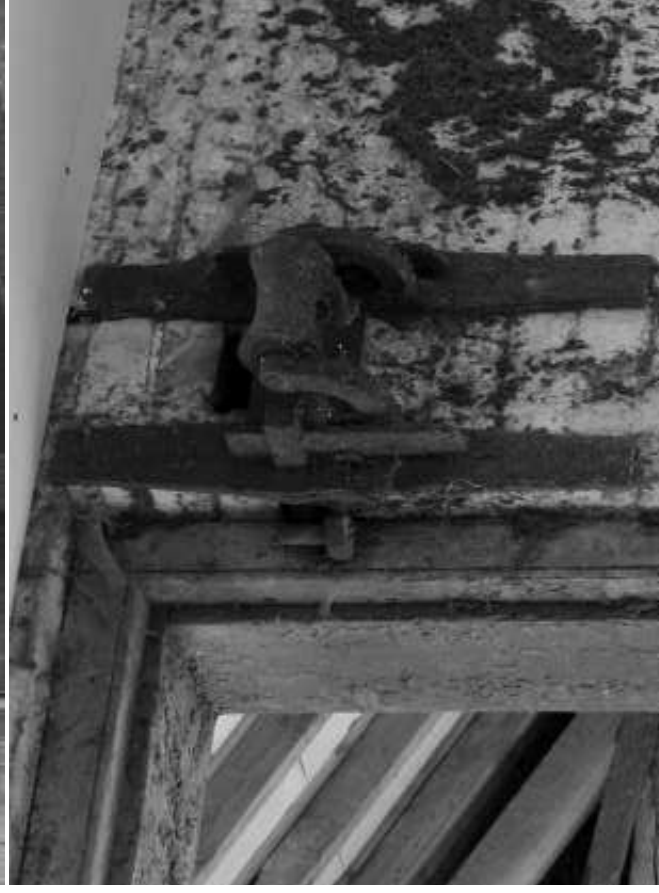
Plate 10: Hoist pulley details (exterior west/interior east)

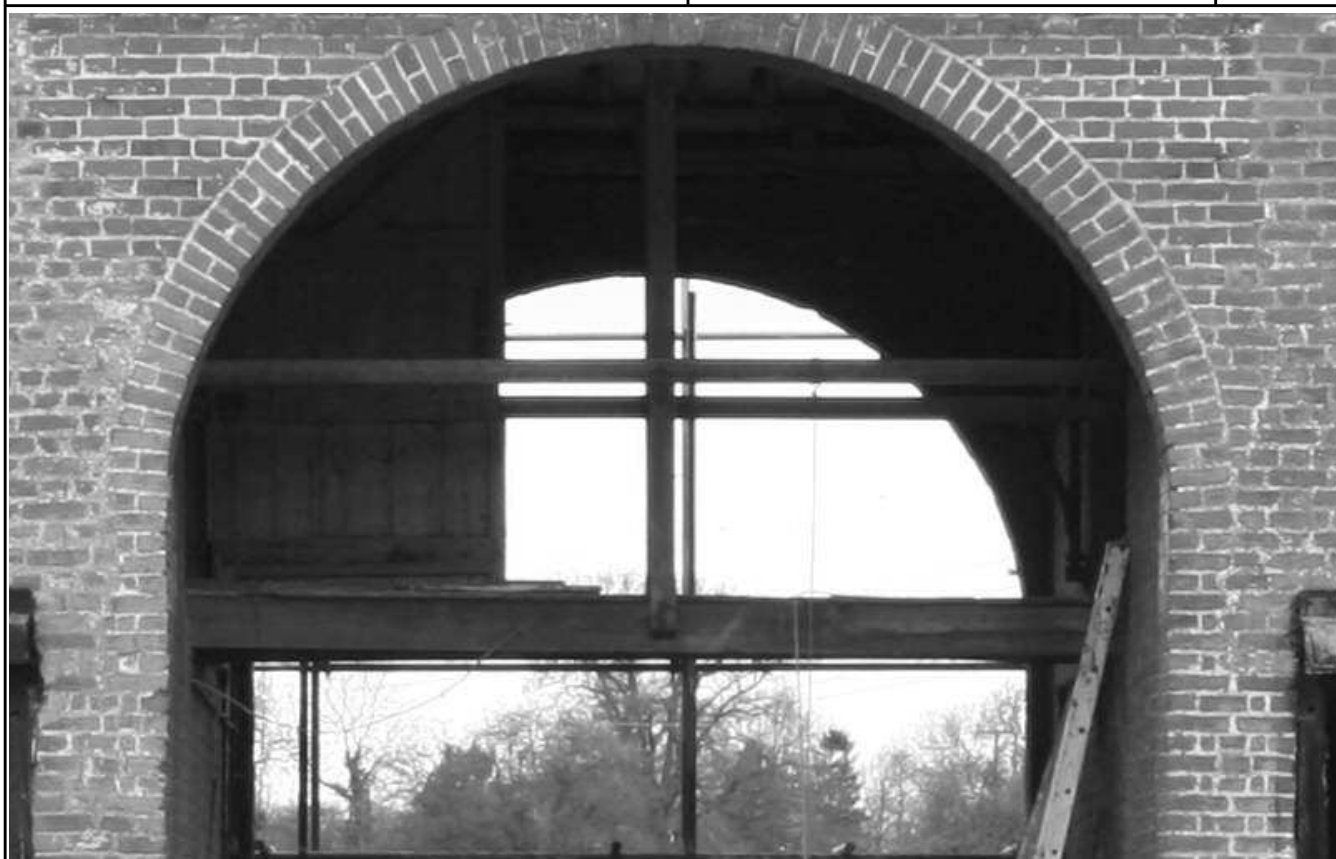
3.10 The arched carriageway extends to the full height of the building. Two doorways in the middle of the eastern and western elevations, at the level of the upper storey, are each flanked by a cast iron hoist on the northern side (Plate 9), the pulley rope passing through a hole in the wall, fitted with waisted rollers, adjacent to the top corner of the door (Plate 10). A bridge links the two doors across the opening (Plate 11). It is a modern construction and rests on wooden beams set below the doorways. It is additionally supported by vertical members attached to further beams laid across opposite trusses. The exposed king-post roof trusses are of a standardised design, probably dating to the first half of the 19th century (Plate 12). Simple carpenter's assembly marks are visible adjacent to the junction between the king-post and its struts.

Plate 11: Bridge across carriageway

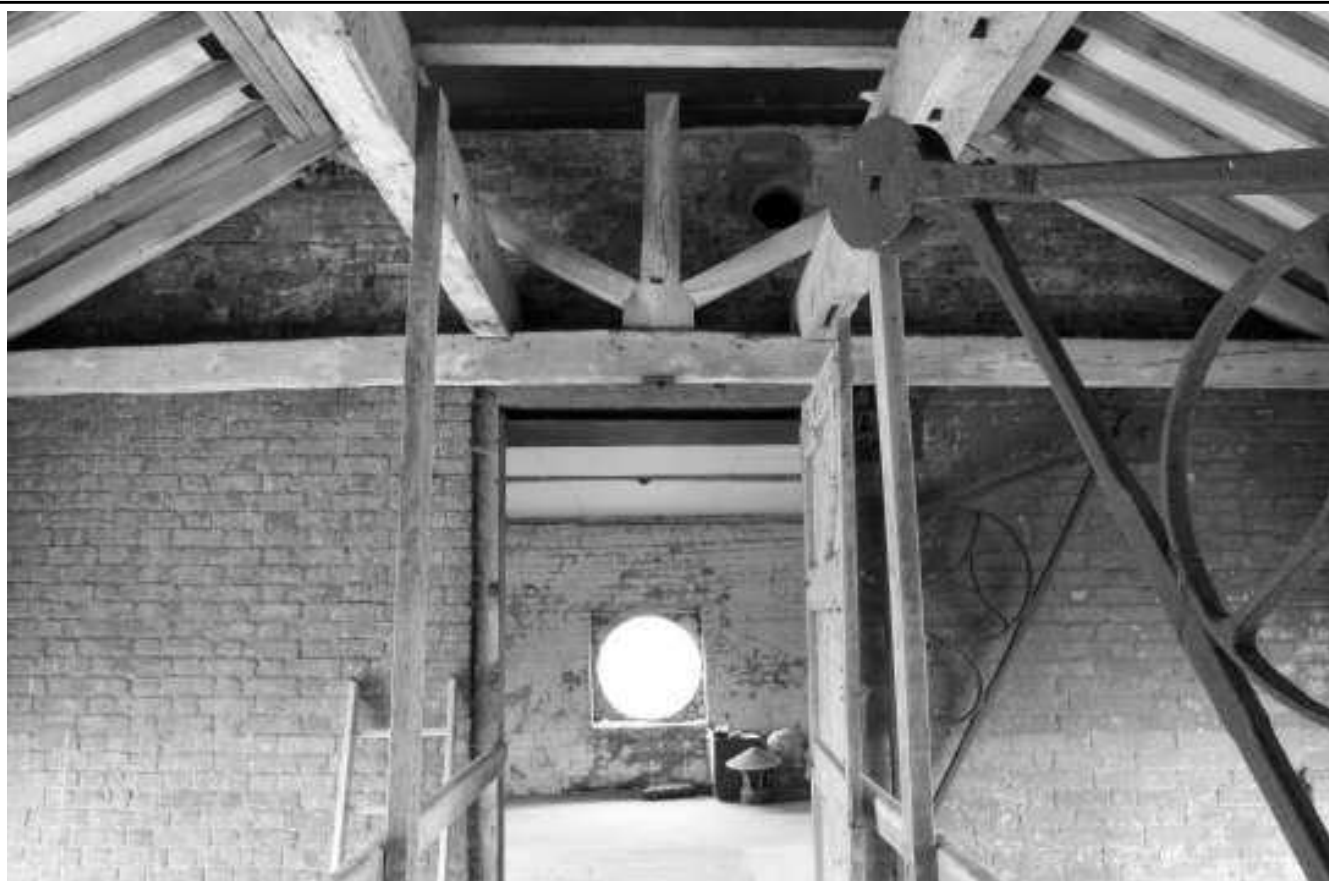
Plate 12: Roof truss

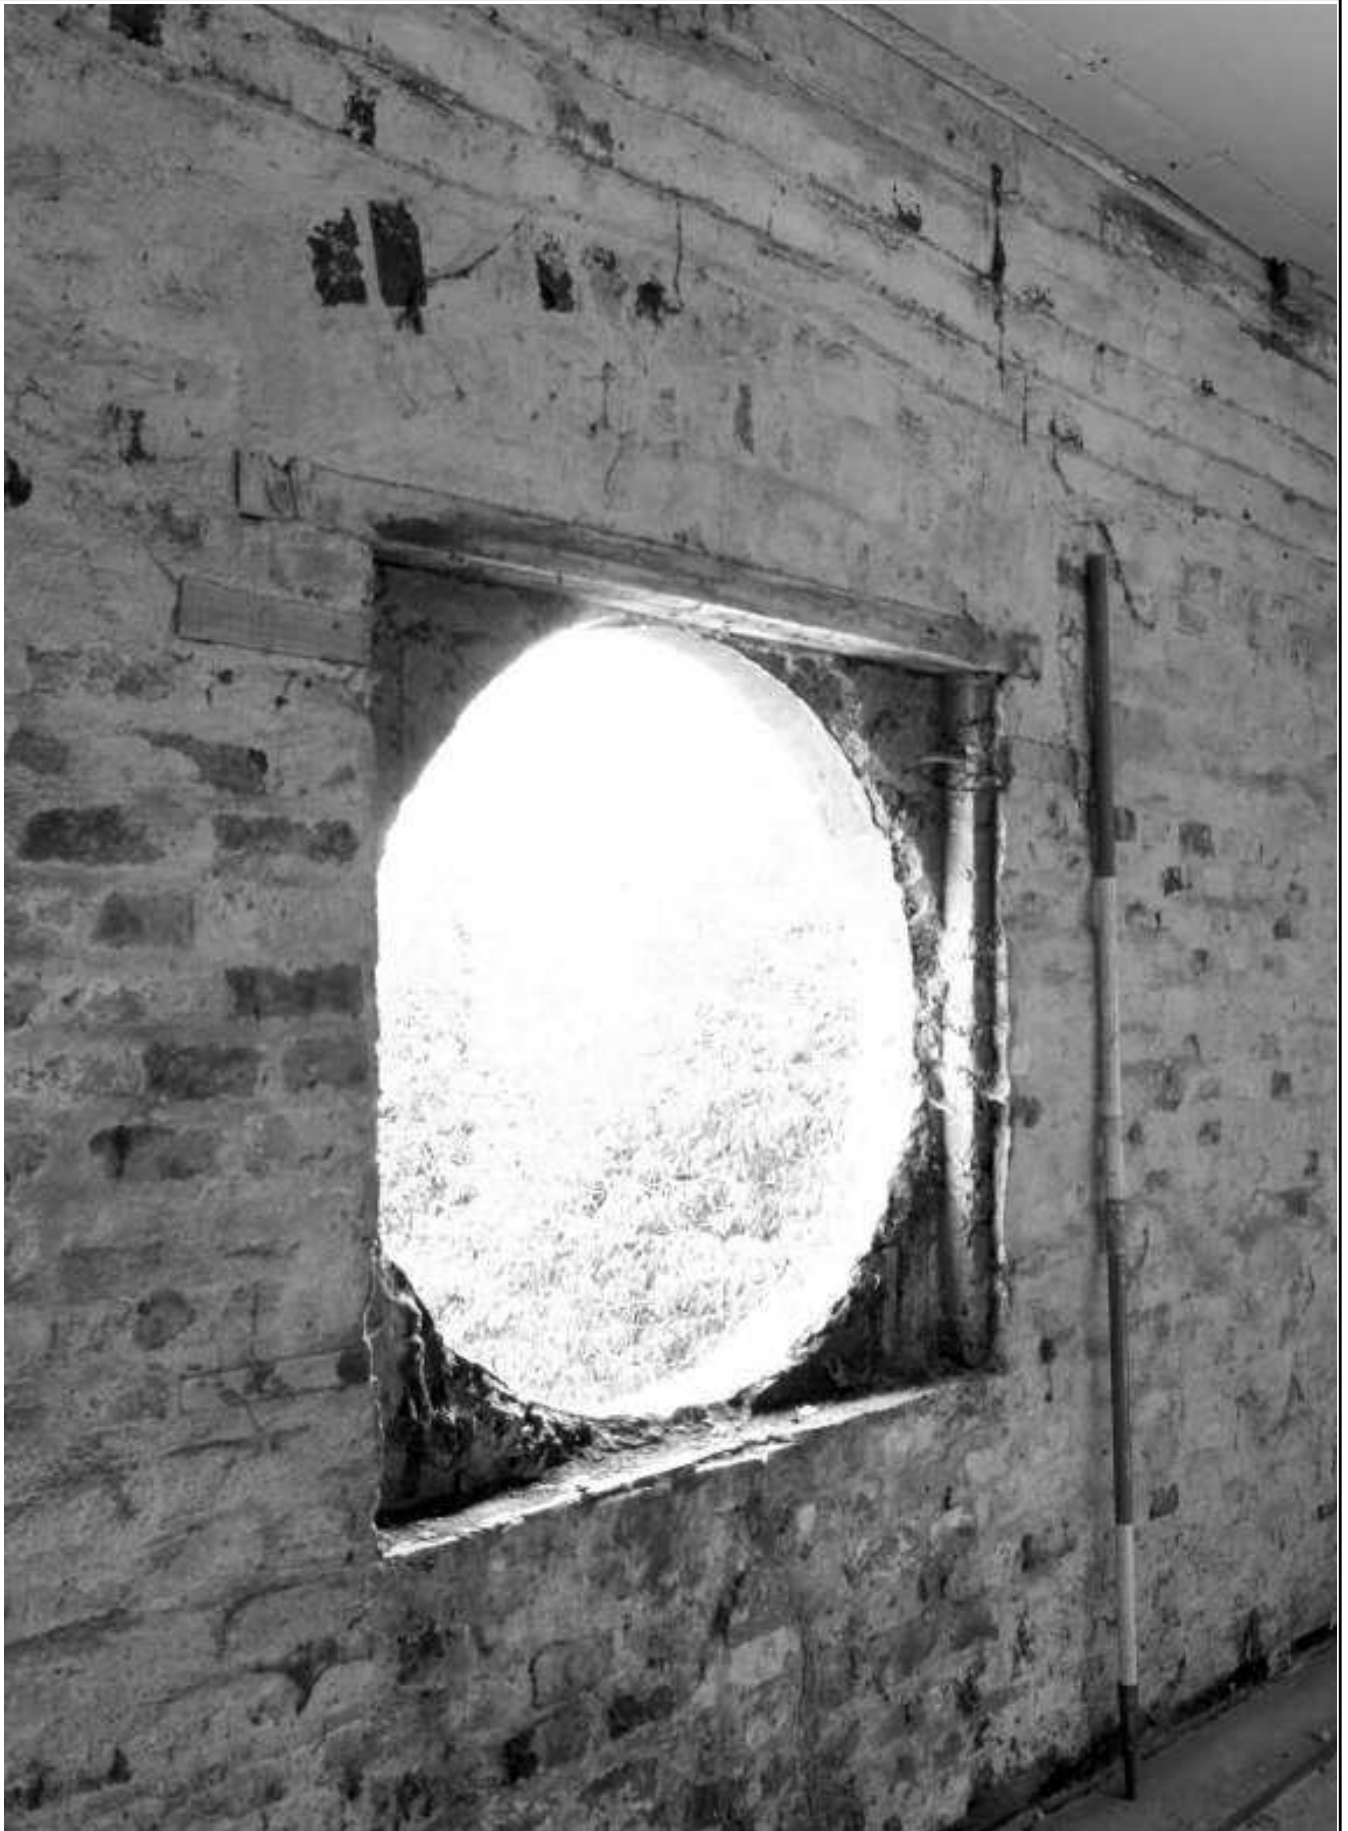
3.11 Both rooms in the upper storey had been re-floored and the ceiling plaster-boarded shortly before the present record was made. The inner skin of the walls had been cut back to a square shape behind each of the circular openings to accommodate the louvered vents (Plate 13). The two openings in the southern elevation each had a relieving arch above them, but no such arches were present above the other openings (Plate 13). Above this, also on the southern elevation alone, the inner face of the wall was corbelled out in three steps to support a substantial wall plate (Plate 13).

Plate 13: Circular window opening in S elevation, showing relieving arch and corbelling
