**20 LEYS ROAD  
Loughton  
Milton Keynes, Buckinghamshire**

***ARCHAEOLOGICAL  
MONITORING***

Project ref.: HN1237

### *Archaeological Monitoring Report*

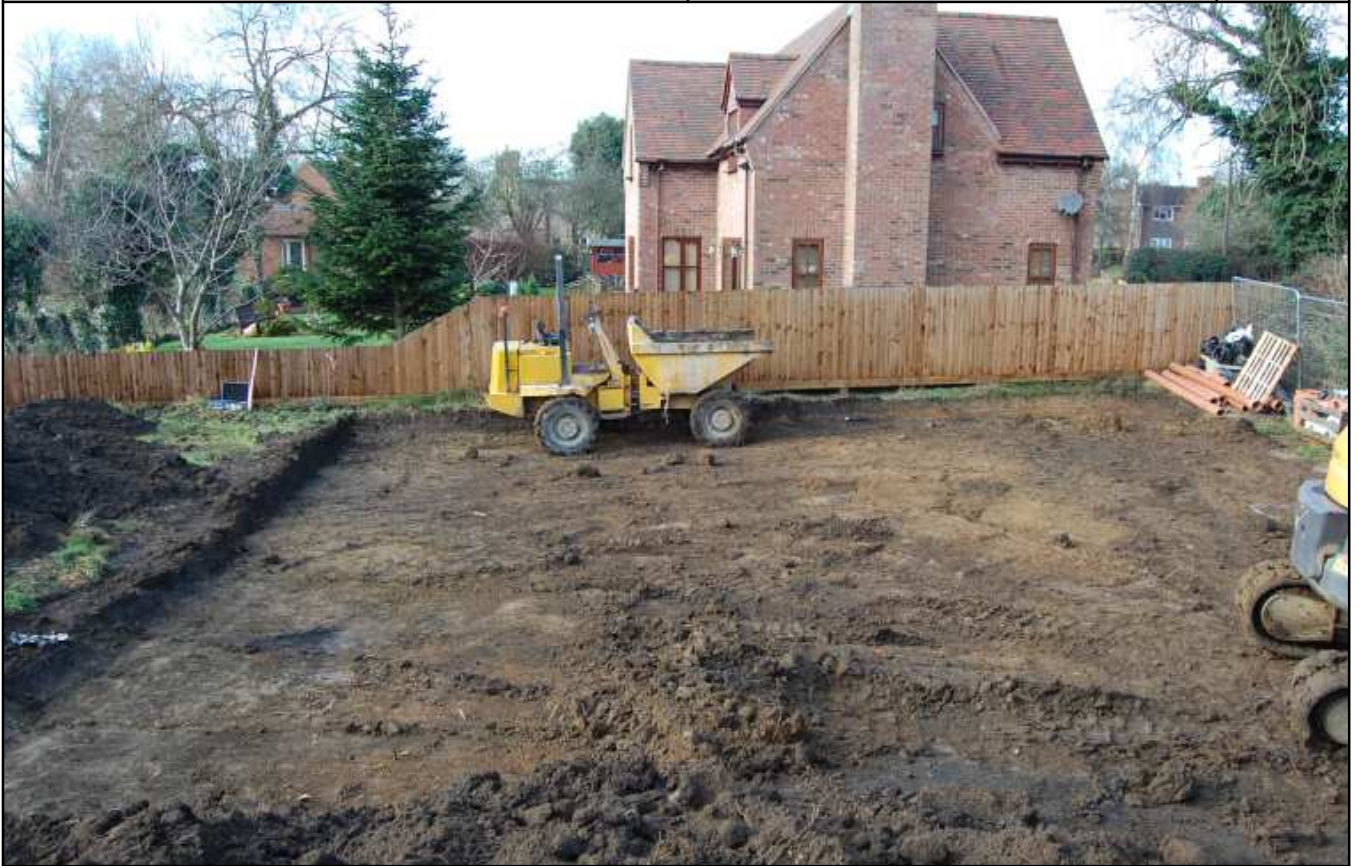
**2.11** The area across the footprint of the house plot and the adjoining access road was reduced to a depth of between 0.2m and 0.45m below the present ground level. This work involved the removal of the topsoil and most of the subsoil across the plot (Figure 2, Plates 1-4).

**2.12** The stratigraphy revealed during the ground reduction comprised dark yellowish brown friable silty clay topsoil, c.0.2m in depth, overlying mid-greyish brown friable silty clay subsoil, c.0.2m in depth. Large patches of the natural substrate were observed in the northern, southern

and eastern ends of the plot, as well as within the access road area. The natural consisted of compact clean light yellow natural clay, possibly formed as colluvium from the nearby brook. (Plates 1-4).

Plate 1: Reduced house plot looking west

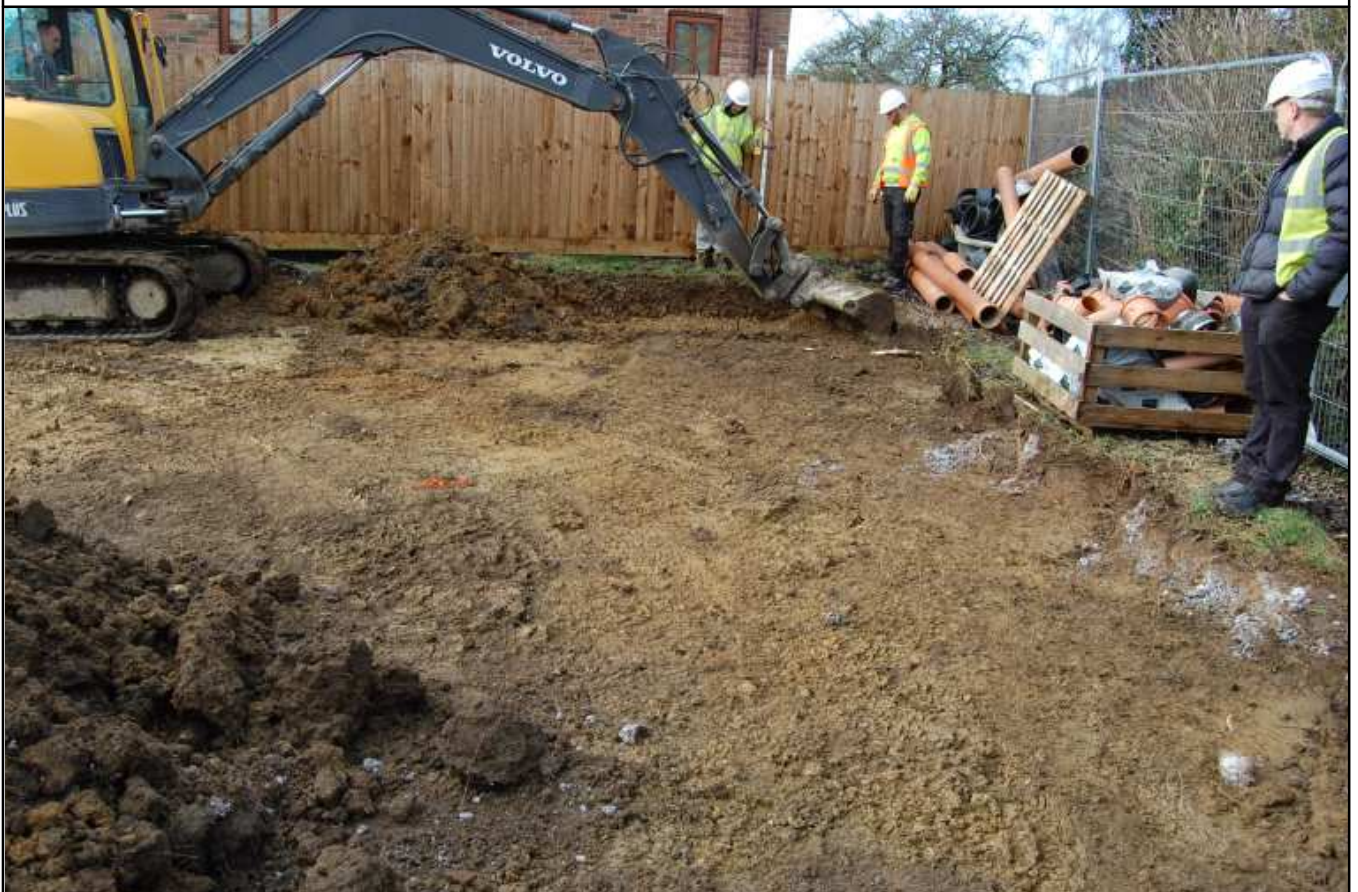
**2.13** A soakaway, measuring approximately 2 square metres in area, was encountered in the western half of the site, in the centre of the house plot (Figure 2, Plate 2). This was excavated approximately 12 years ago, during the construction of the adjacent property.

Plate 2: Working shot showing clay natural and modern soakaway in centre of shot, looking west

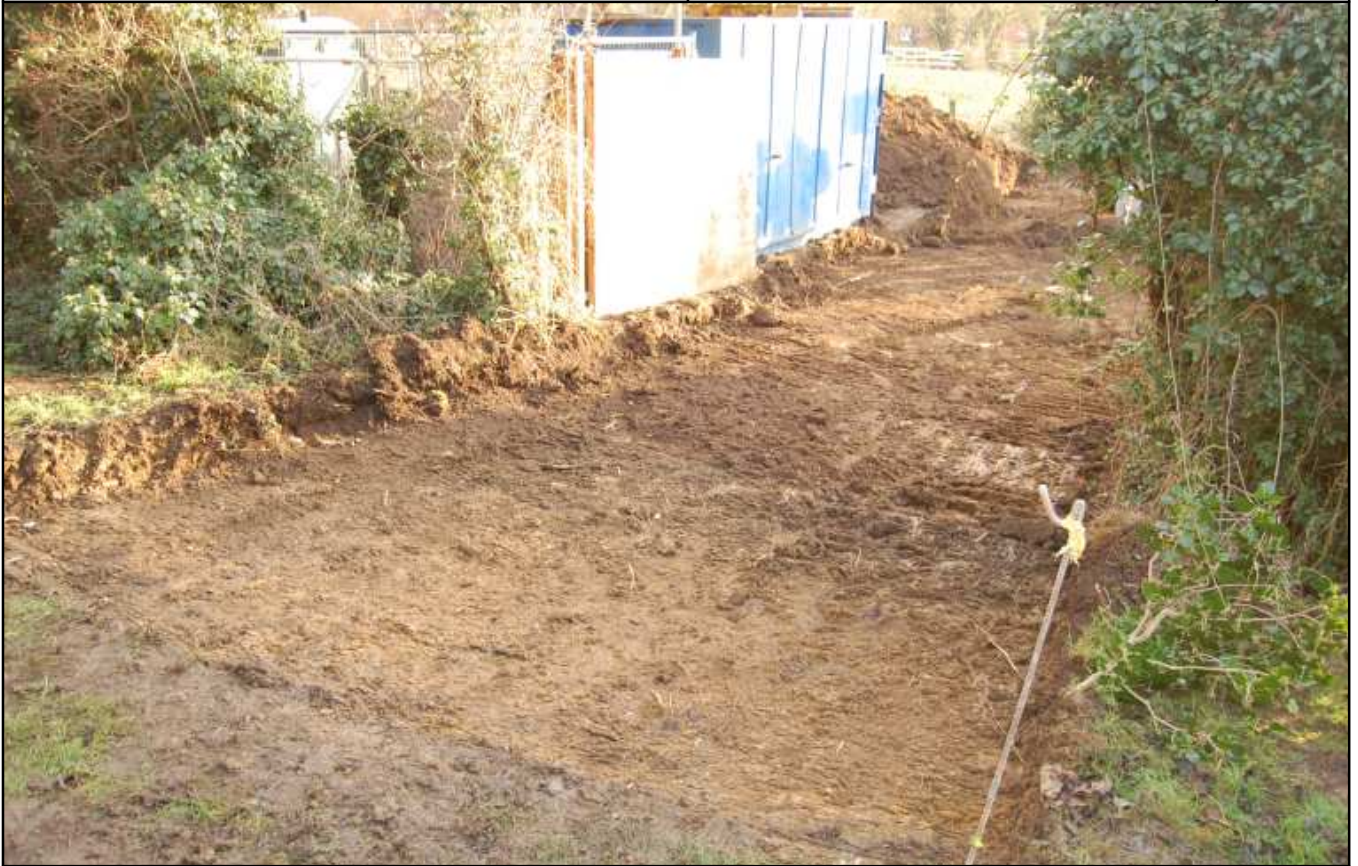
Plate 3: Reduced area of access road looking south

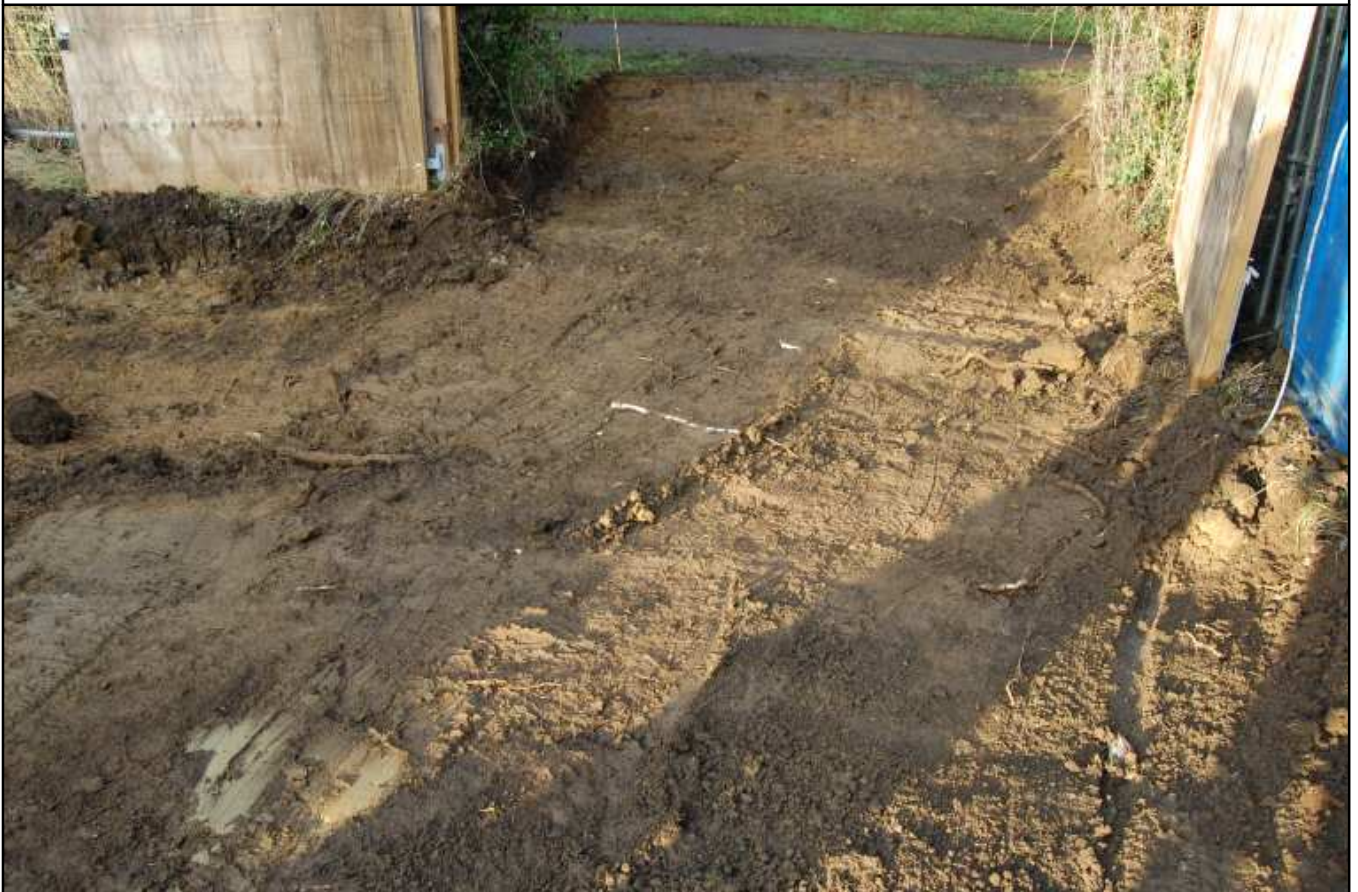
Plate 4: Reduced access road looking north

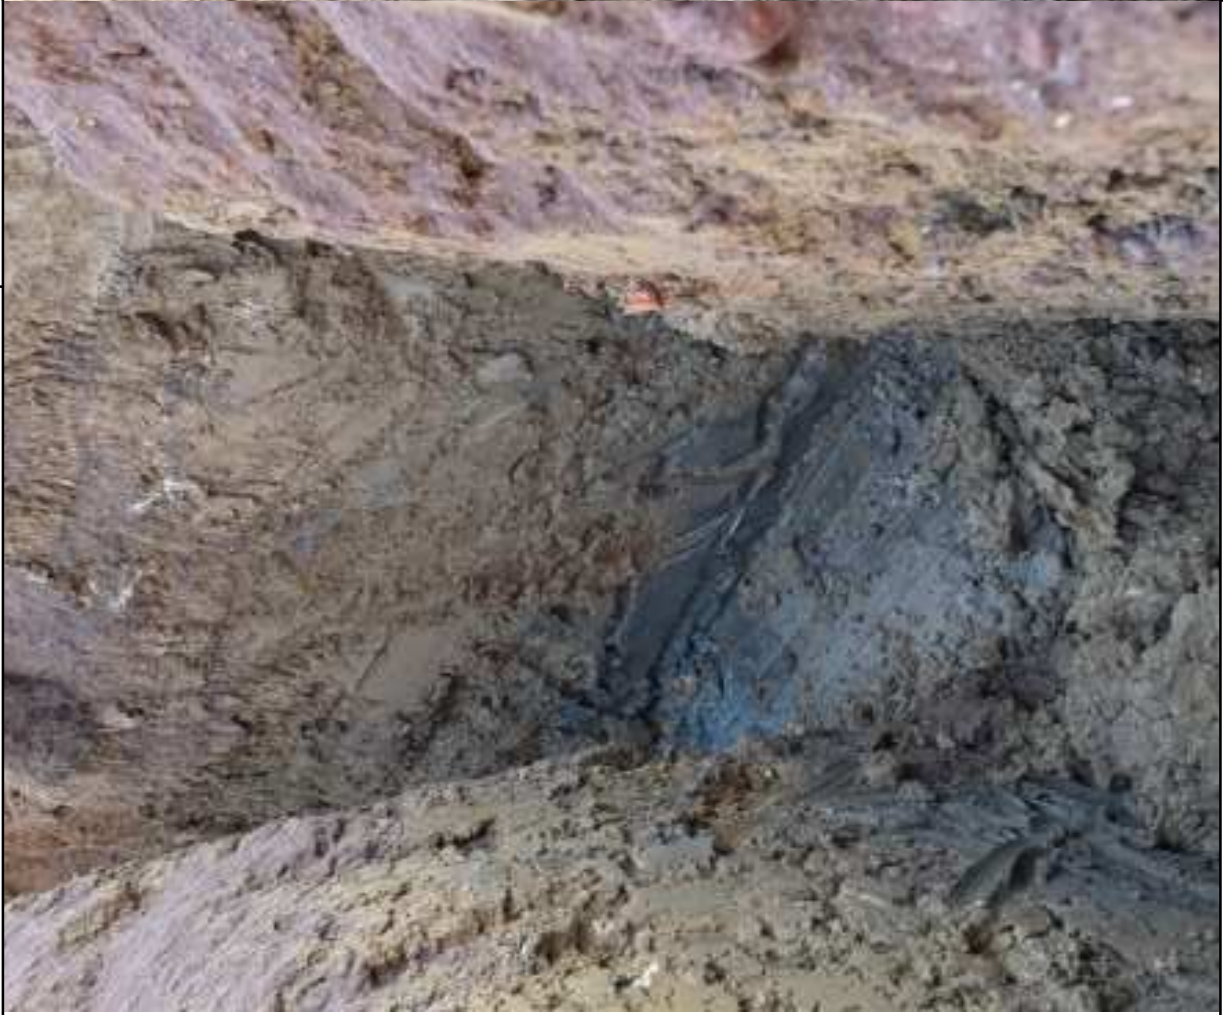
**2.16** The stratigraphy revealed in the trench sections was similar to that observed during the ground reduction phase and consisted of dark yellowish brown friable silty clay topsoil, c.0.2m in depth above mid-greyish brown friable silty clay subsoil, c.0.2m in depth (Plates 5-6). The underlying natural clay was encountered at approximately 0.40m below the present ground level.

Plate 5: Foundation trench sections looking N

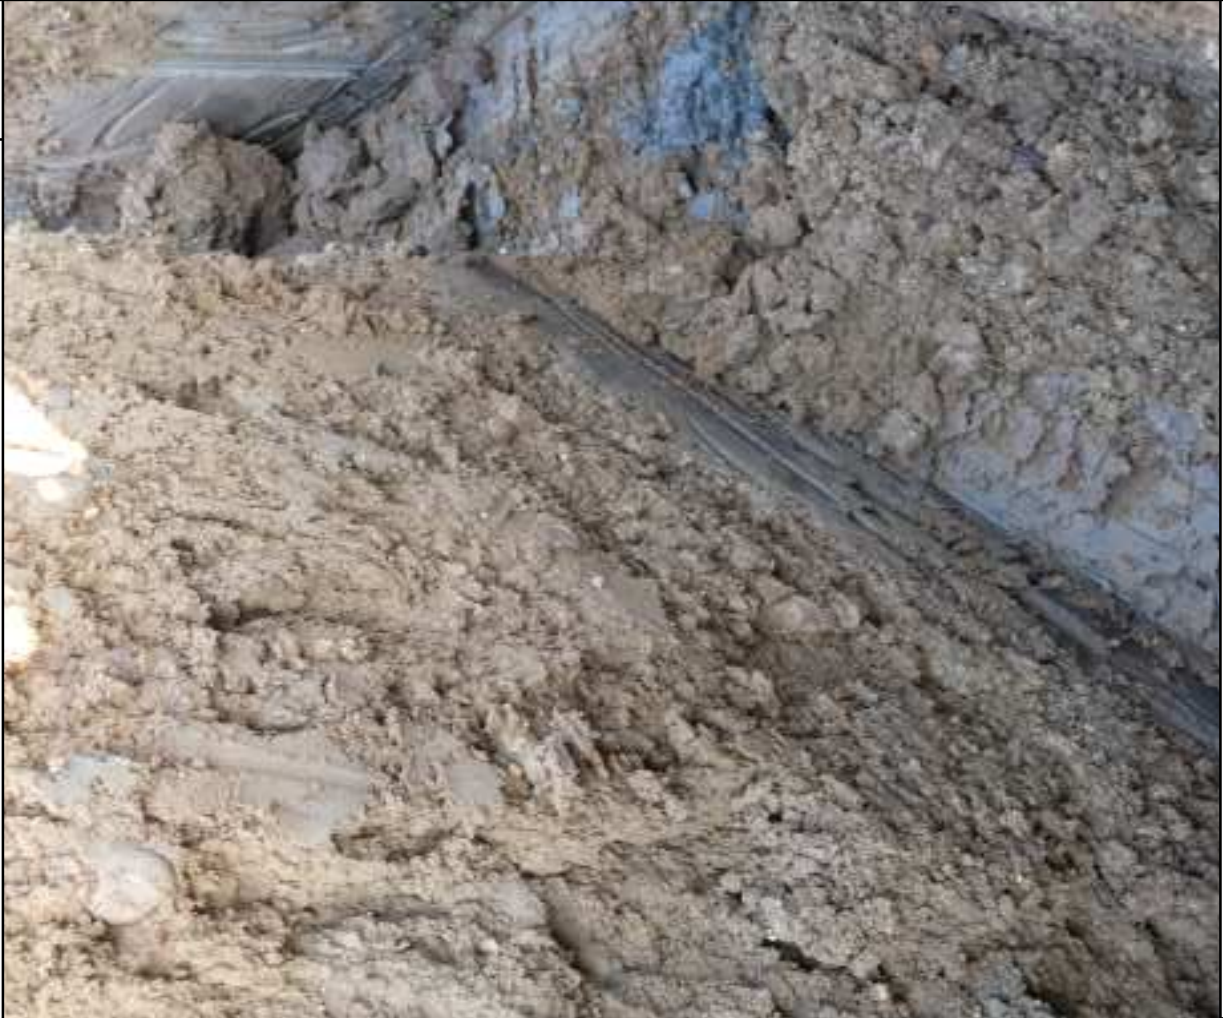
Plate 6: Foundation Trench sections looking south
