PLOT 1500

Comet Way, Hatfield, Herts.

Historic Buildings Record

Report no.387

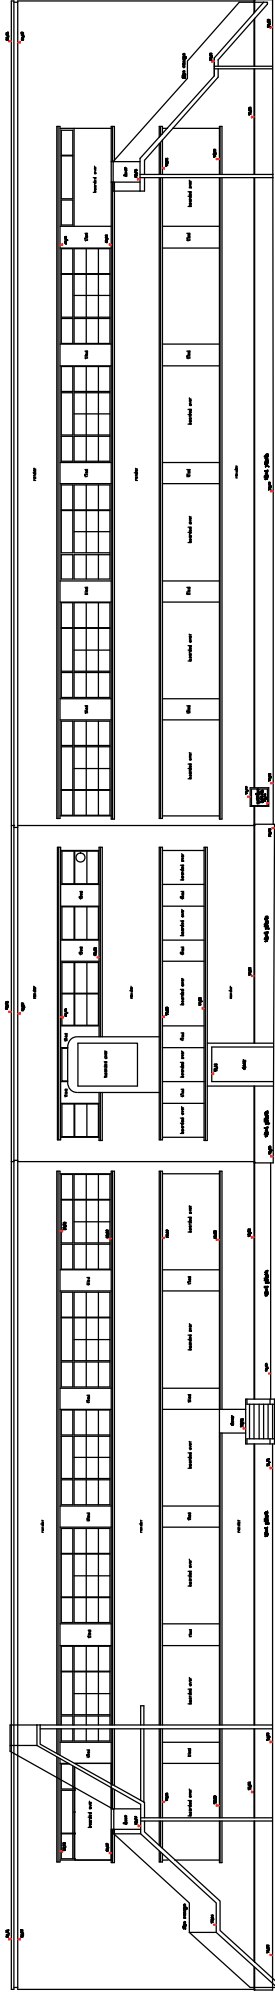
HN624 Scale 1:200 Figure 10

3.3 A white painted two storey building in International Modern style built of reinforced concrete in three blocks facing east (Figures 9-10; Plates 19-20). The building is symmetrical with a raised two storey central block flanked by two two-storey wings.

3.4 The central block is recessed to the front and projects to the rear. The front elevation has superimposed pilasters clasping the corners, with reeded panels at the top. The parapet is decorated with alternate fluted and plain panels with a pentagonal panel in the centre. At ground level, a wide doorway with a stepped green-glazed architrave is reached up a wide flight of four steps flanked by a series of curved and stepped planters. It is protected by a cantilevered concrete canopy, faced in yellow-brown glazed tiles, with a full-length planter set back from the front edge. Above this is a six-light metal framed window with a fluted frieze over. The rear elevation has two bands of windows separated by green-glaze tiled piers over-painted in beige (possibly a remnant of wartime camouflage). The first floor band is interrupted by a doorway and the remains of a concrete bridge, offset to the north, formerly linking the administration block with the factory building to the rear. Aligned with this, below the ground floor band, is a further doorway with a tiled architrave also over-painted in beige. A plinth in grey-green glazed brick shaped tiles, laid in stretcher bond, runs along the base.

3.7 The north and south wings are essentially identical but handed, each built in two jointed sections. In the east facing front elevation, the wings curve back to the recessed central block. Two horizontal bands of seven metal-framed windows, with green-glaze tiled piers and surrounds, as seen throughout, also terminate in a curve. In the west facing, rear elevation, are similar horizontal bands of six metal-framed windows, the end windows on the first floor in each wing accommodating a fire exit giving access to metal staircases attached to the exterior (now removed). The glazed window piers have been over painted throughout, as noted in the central block. A plinth in grey-green glazed brick shaped tiles, laid in stretcher bond, runs around both wings.

Admin Block: Elevations
(Courtesy Mike Worby Survey Consultancy)

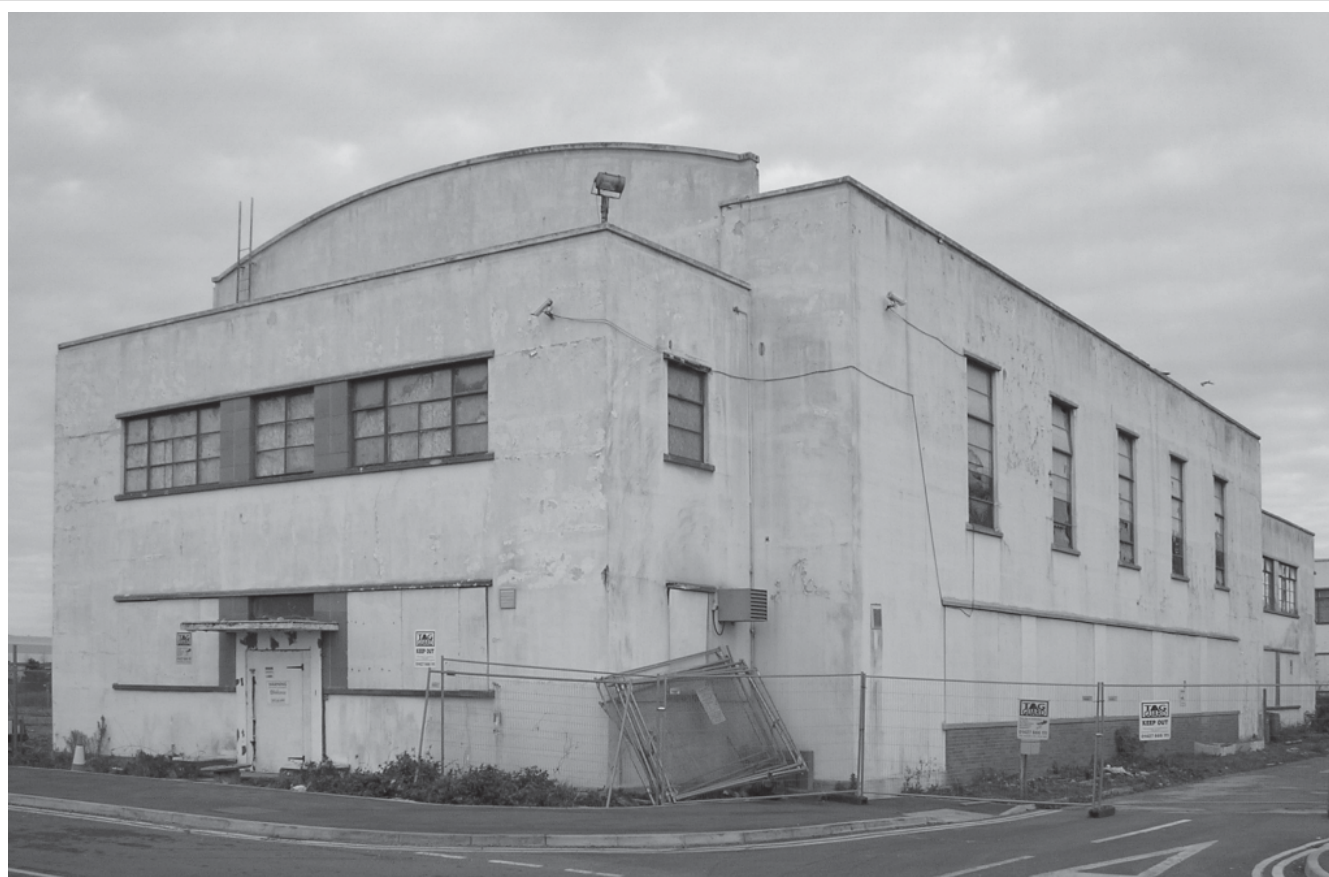
Plate 2: Canteen block, southern and eastern elevations

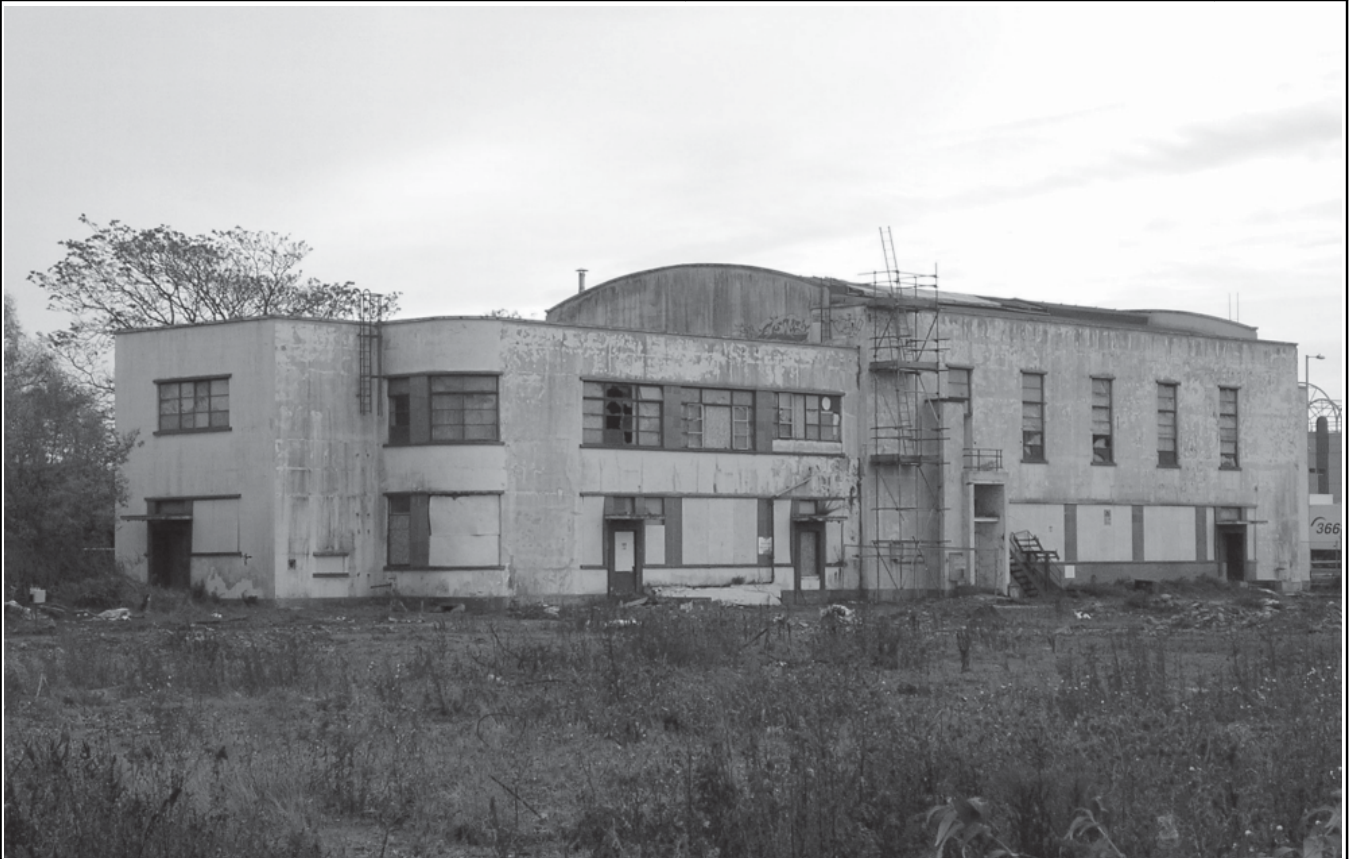
Plate 3: Canteen Block, northern and western elevations

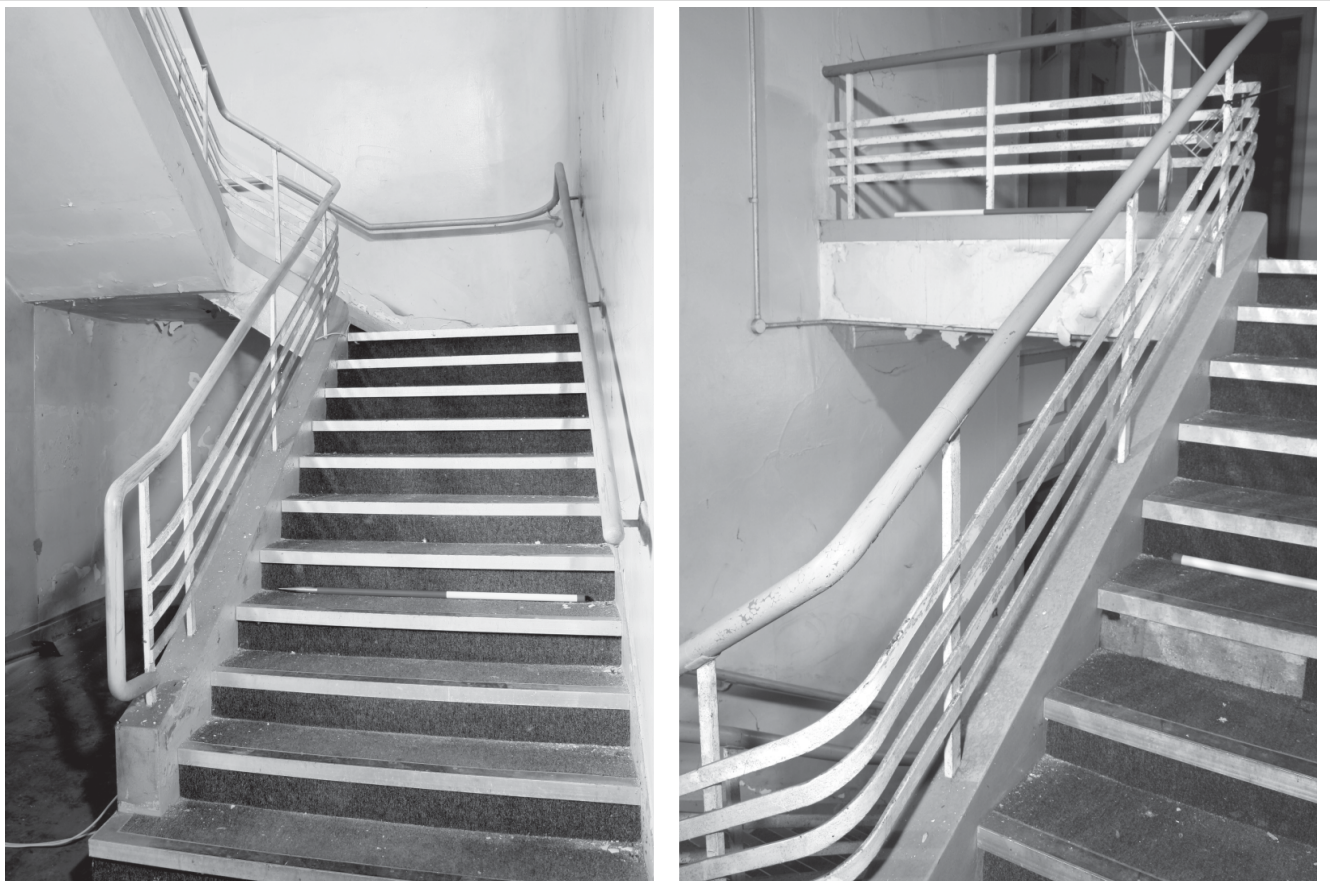
Plate 4: Canteen block, southern staircase

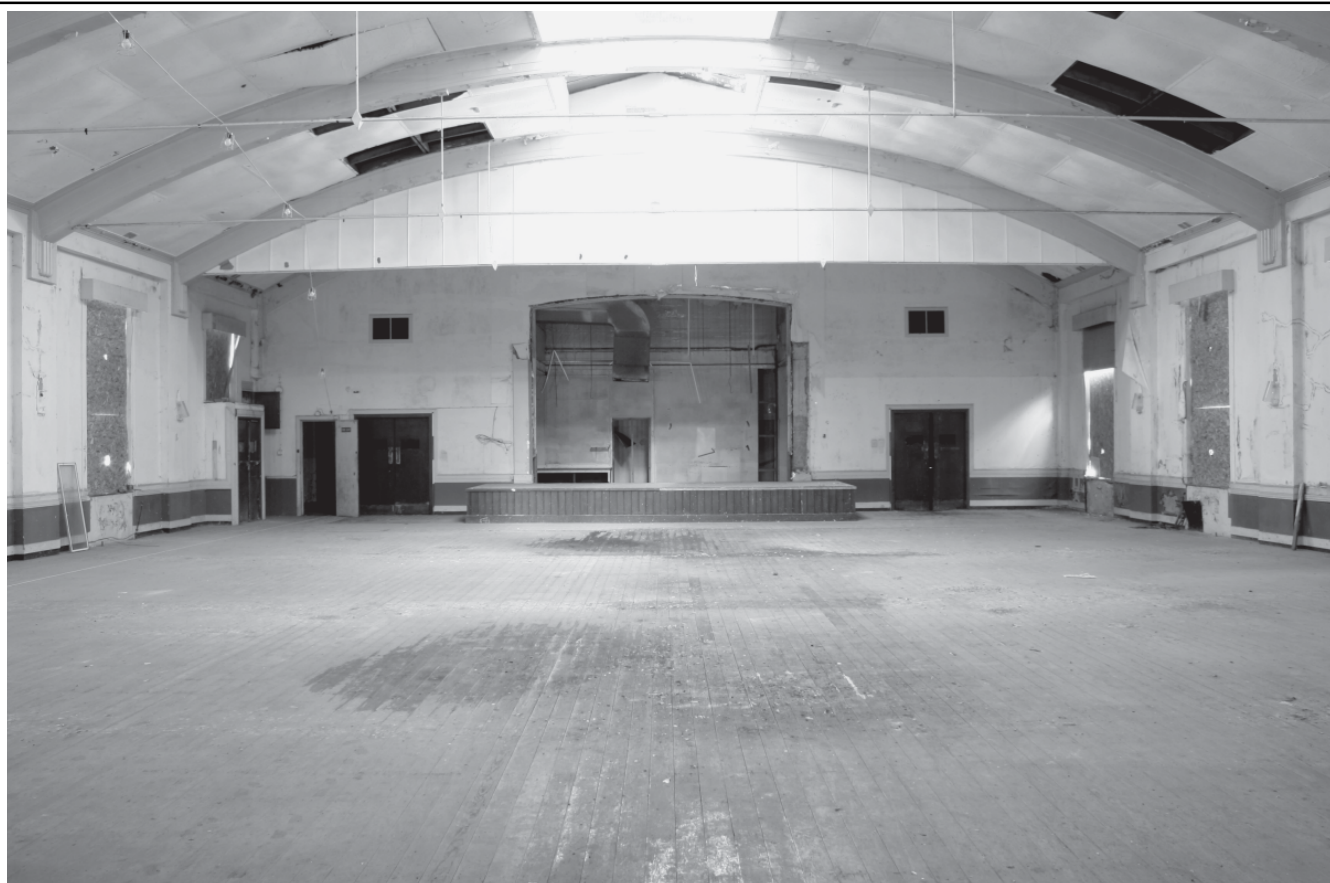
Plate 8: Canteen block, first floor hall, looking N

3.6 From the landing at the top of the principal stairs, a door to the east leads to cloakrooms and lavatories. Double doors to the north lead to a pine floored hall or ballroom of 5½ bays, with tall metal-framed windows to east and west set in the middle of each of the full five bays (the southernmost half bay being blank) (Plates 8-9). The window at the northern end of the west side includes an emergency exit and integral porch. Each window formerly had a radiator mounted beneath (already removed at the time of the present survey). The ceiling is vaulted with a central lantern supported on boxed steel joists braced by horizontal tie rods. The boxing sits on decorative reeded corbels (Plate 10). Marking out for a badminton court (or similar) is still visible on the floor. A stage and proscenium occupy the north end, with a servery to the rear. A single door immediately to the left of the stage gives access to the servery. Double doors to either side of the stage give access to the service area behind. To the right of the emergency exit at the northwest end of the room is a dumb waiter, with its motor housing above, which appears to have been attached to the exterior of the building (Plate 11). It is accessed on the ground floor from the exterior and was probably intended for deliveries.

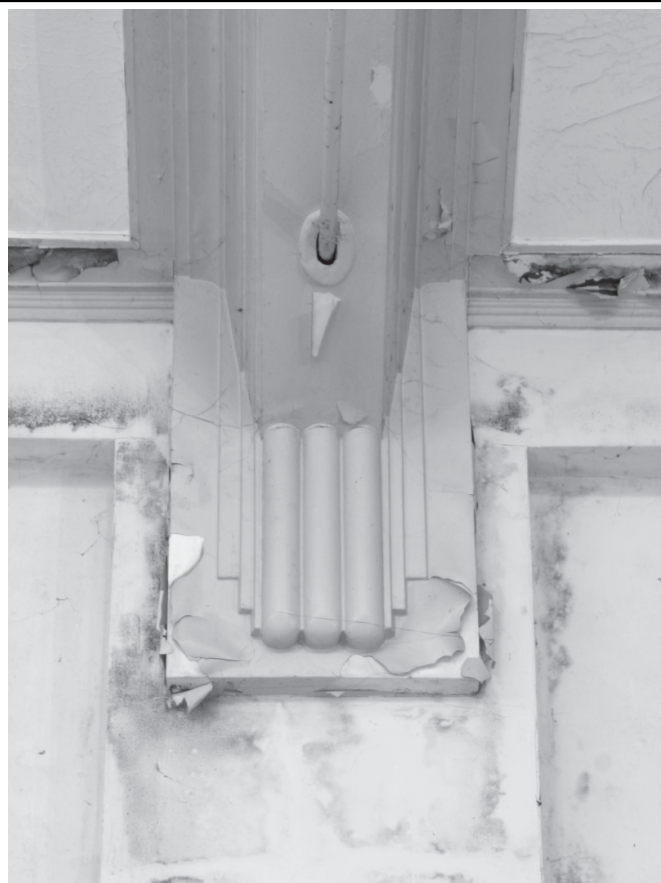
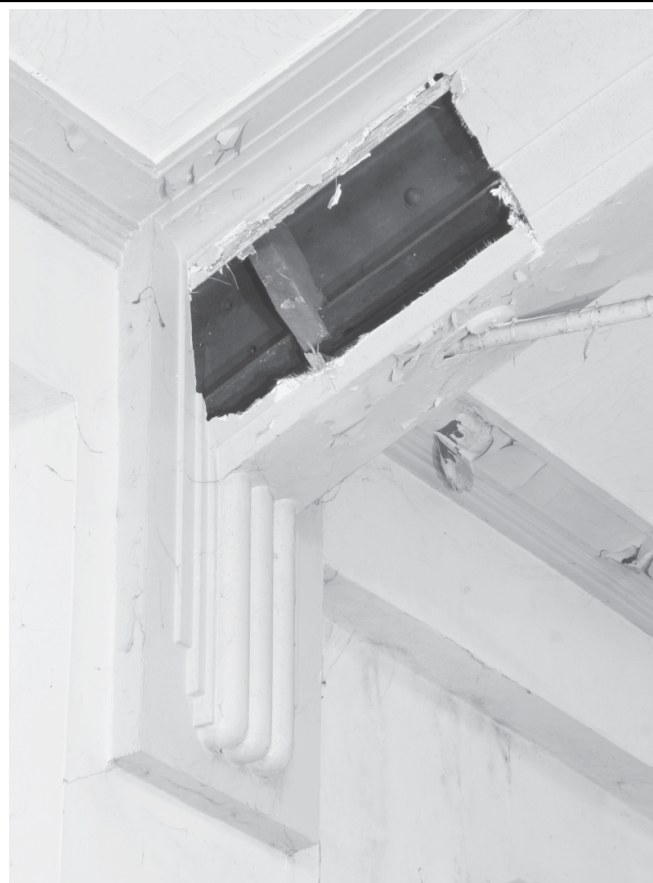
Plate 10: Canteen block, first floor hall, decorative corbel and boxed joist

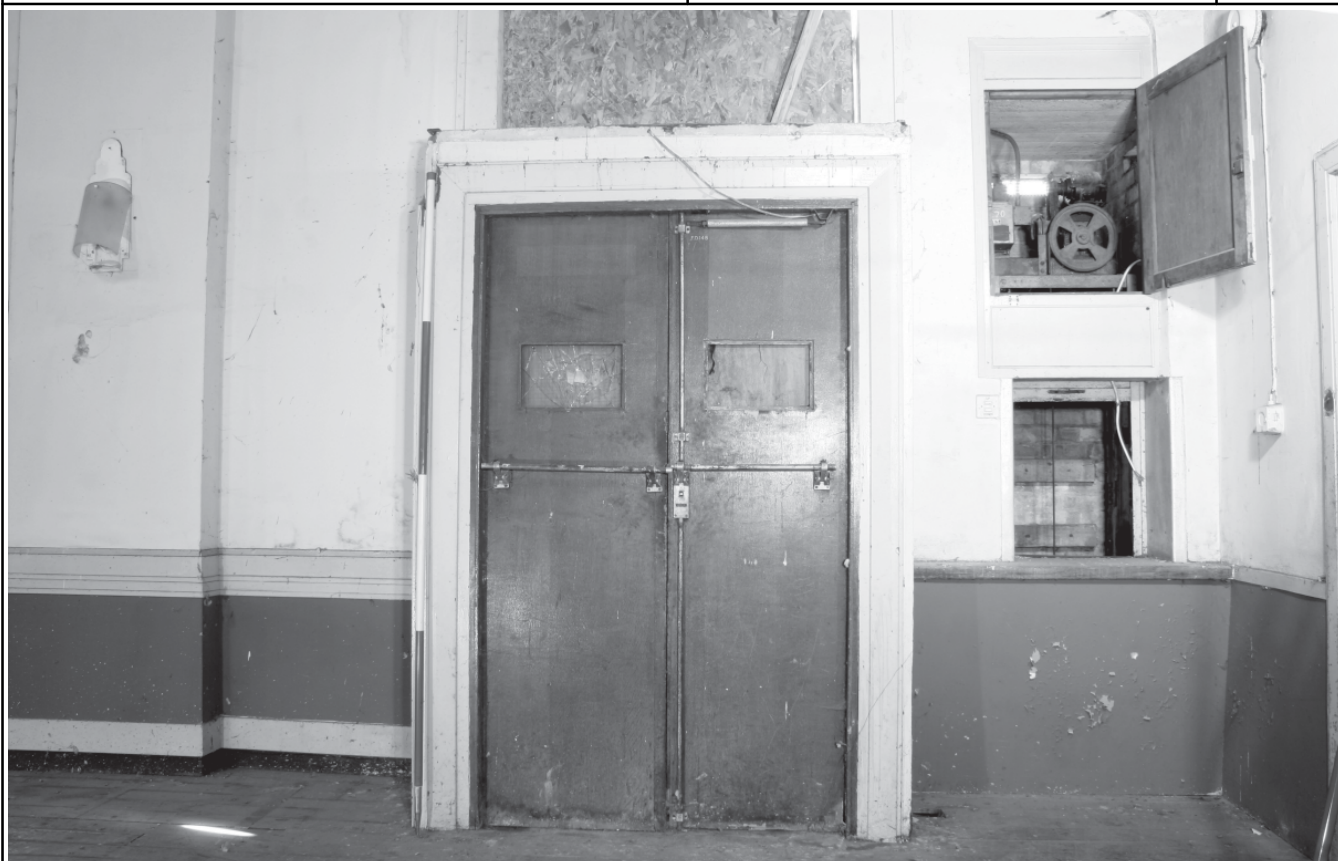
Plate 11: Canteen block, first floor hall, emergency exit and dumb waiter

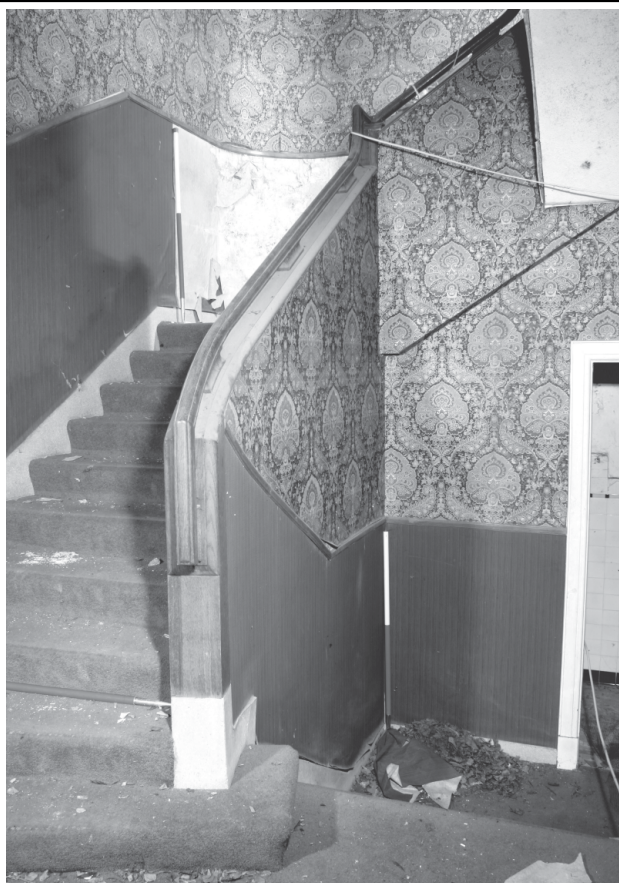
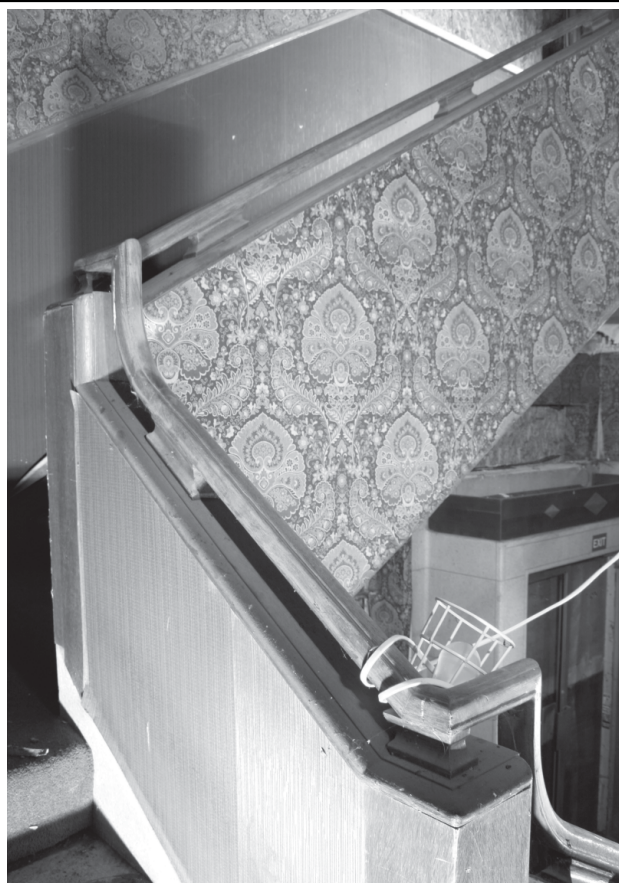
Plate 12: Canteen block, northern (managers') staircase

3.7 The service area divides the ballroom from separate function rooms, understood to have been the managers' dining rooms, accessed from a separate entrance in the north elevation of the building. Here a double doorway within a terrazzo framed porch (Plate 12) leads to an entrance hall with an open-well staircase of three flights, having an unpierced balustrade and moulded wooden handrail, which is raised and ramped up at the corners (Plate 13). A door to the west leads to a gents' lavatory with corner set urinals (Plate 14), while a door to the east, down three steps, leads to a single stall lavatory beneath the stairs. From the first floor landing a parquet floored corridor leads north. To the east is a long room with parquet flooring and a folding partition (Plates 15 and 16) running across the middle, shown in photographs dating to the 1930s or 40s as a common room with easy chairs at one end and a dining table at the other. To the west, a larger room with faux panelling and a parquet floor, has a low platform (Plate 17) in the middle of the east elevation and a bar.

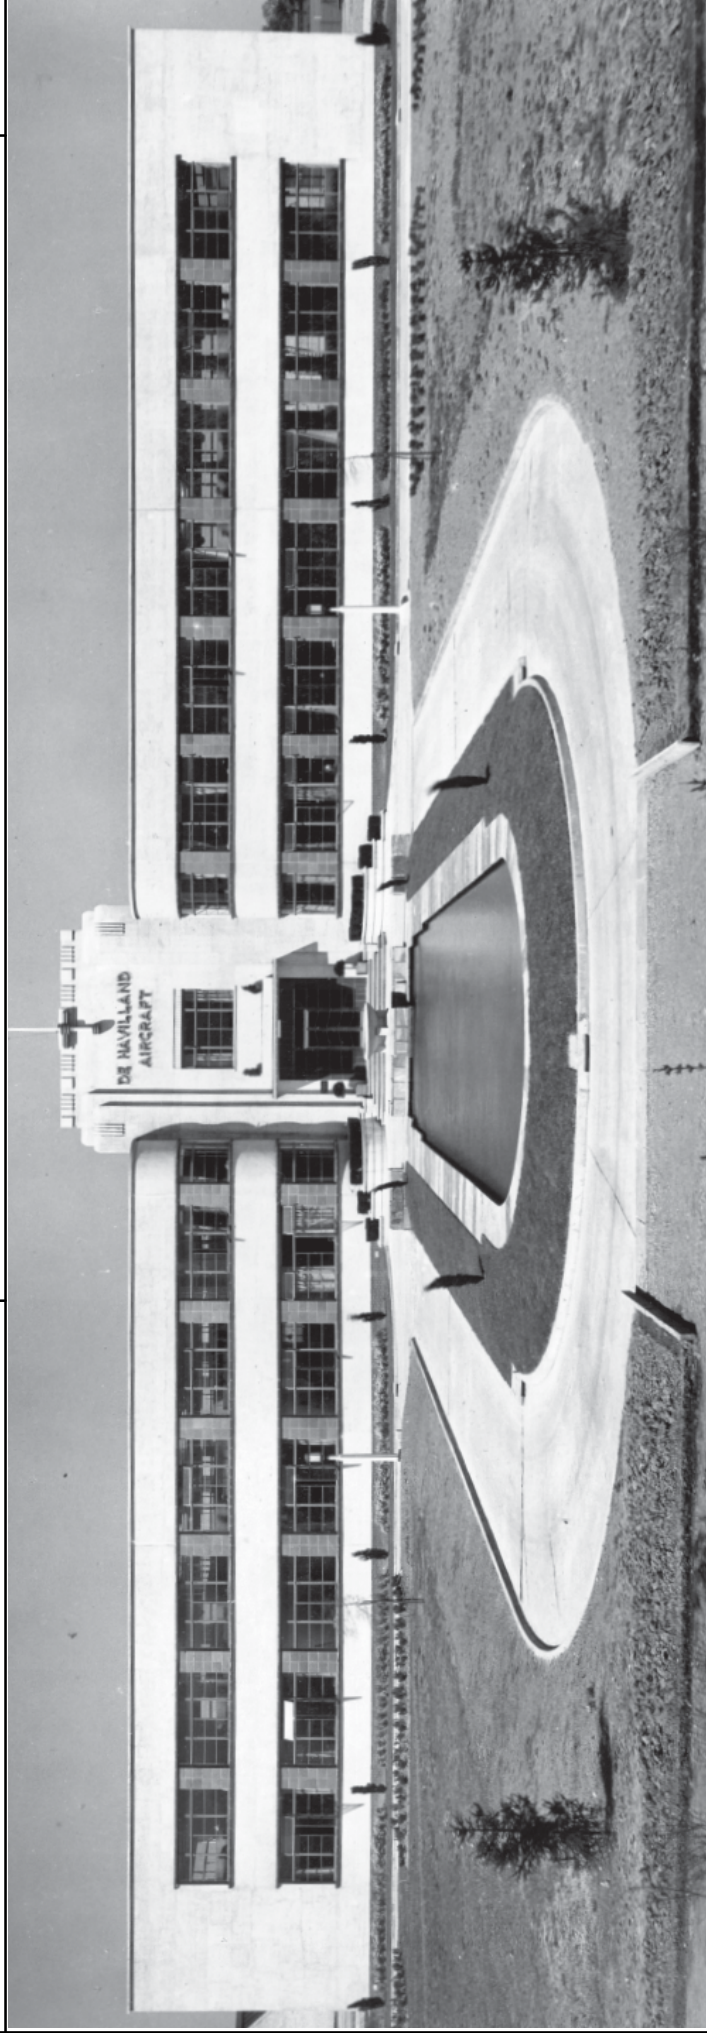
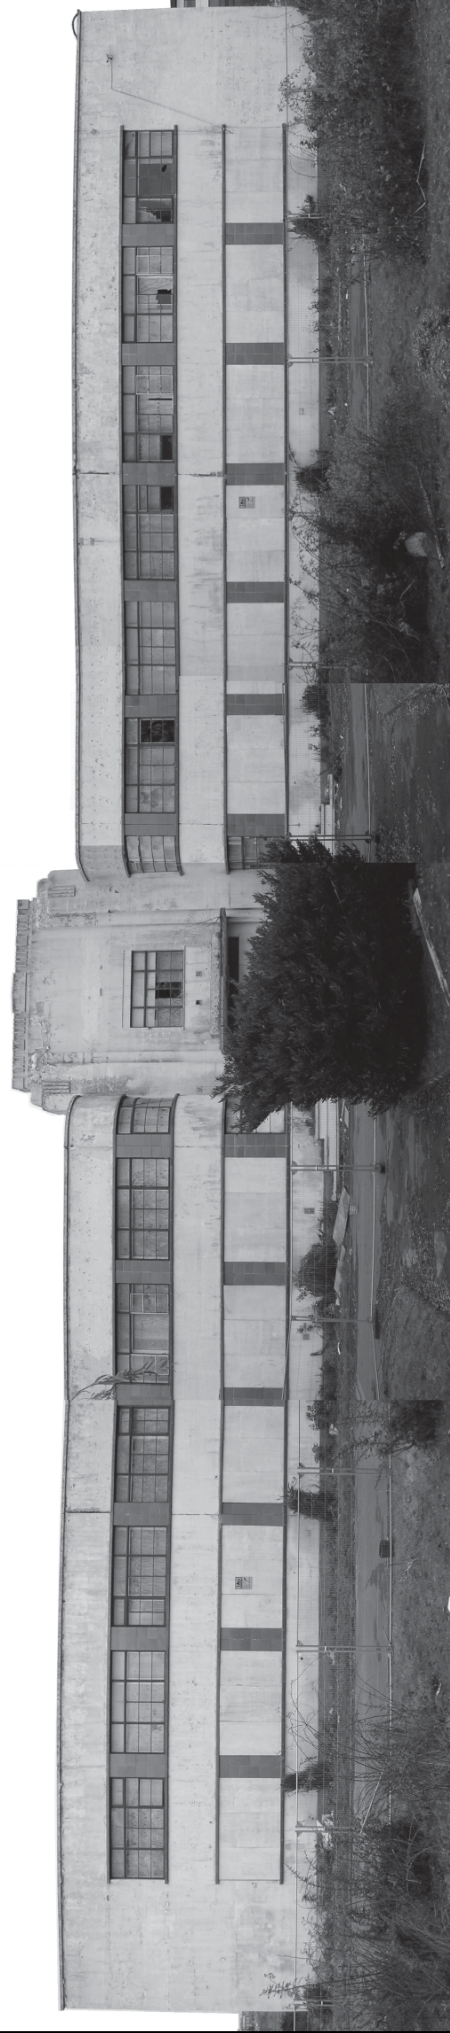
Plate 13a: Western elevation of Administration Block shortly after completion (Photo Sydney Newberry from BAE SYSTEMS archives)

Plate 13b: Composite photograph of western elevation of Administration Block as at 22 November 2006

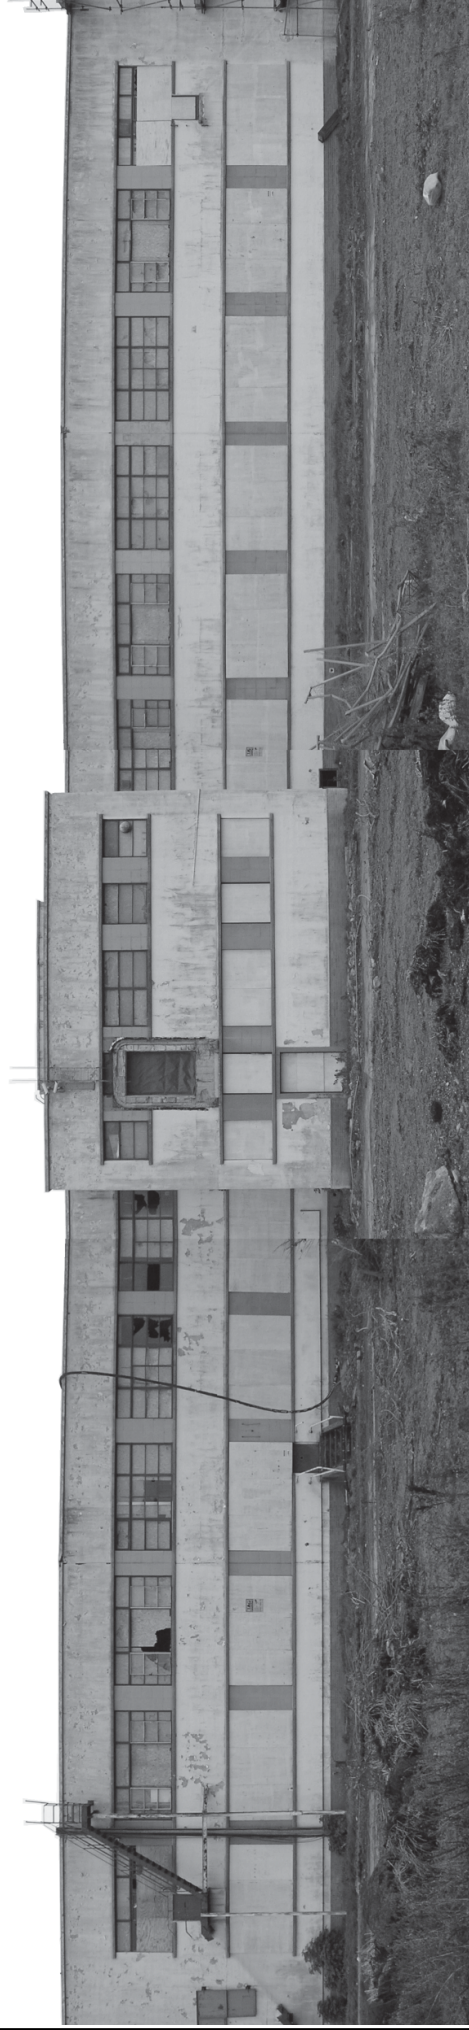
Plate 14 (top): Composite photograph of eastern elevation of Administration Block
Plate 14 (bottom left): Northern elevation of Administration Block
Plate 14 (bottom right): Southern elevation of Administration Block
