**Land Opposite
96-102 LEMS福德 LANE,
Welwyn, Herts.**

HN597

Archaeological Monitoring Report

Prepared on behalf of McCann Homes Ltd

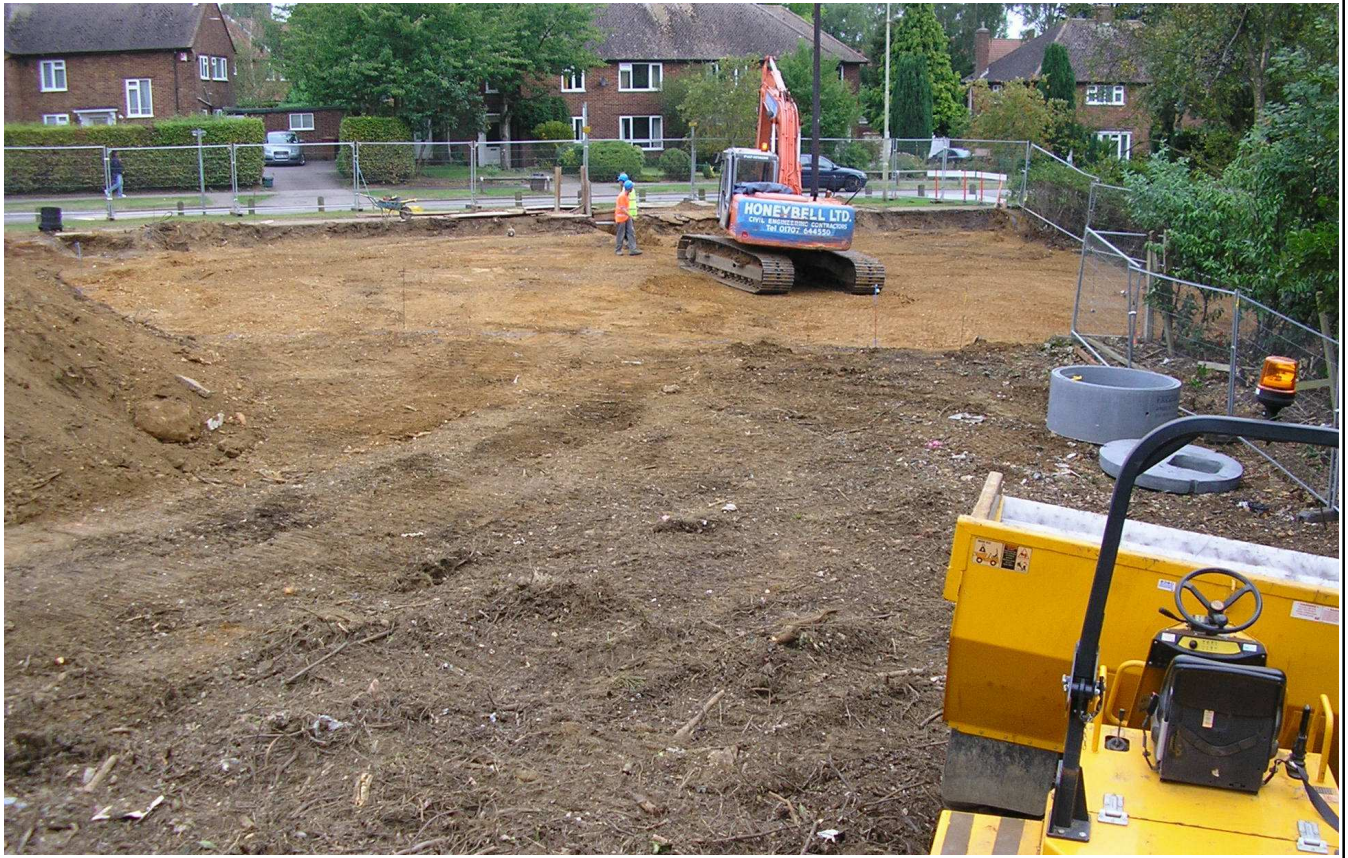
2.6 Ground reduction was carried out on two areas of the site, the access road and the car park (Figure 3) (Plate 1). The access road was reduced by up to 0.7m through made ground, exposing patches of the natural geology. This consisted of a yellowish red (5YR 5/6) hoggin.

2.7 The stratigraphy of the car park area appears to be undisturbed, consisting of 0.2m very dark greyish brown (10YR 3/2) silty clay top soil, overlying 0.25m dark yellowish brown silty clay subsoil, which has frequent flint inclusions. This overlies the natural hoggin.

2.9 The whole of this area was reduced to the level of the hoggin and some landscaping was subsequently required to level the surface. No archaeological cut features or deposits were encountered in this area.

Plate 1: Car park area after ground reduction, looking north

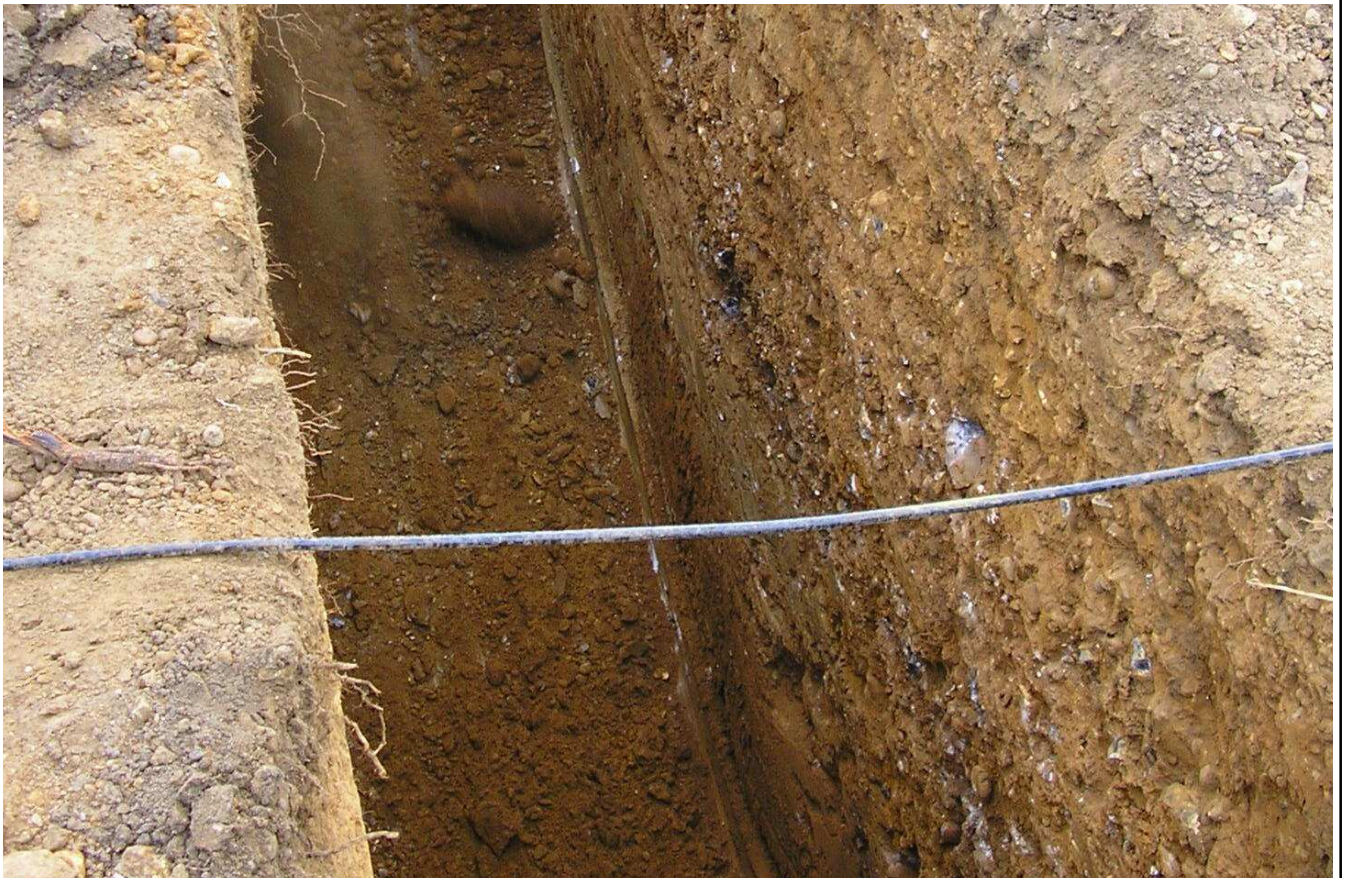
2.11 All the observed footings trenches were cut through the same stratigraphy, the only variation being the depth of the overburden (Plate 2).

Plate 2: Indicative stratigraphy from car park
