38 HIGH STREET Stanstead Abbots, Herts.

Archaeological Monitoring Report

Report no. 394

March 2007

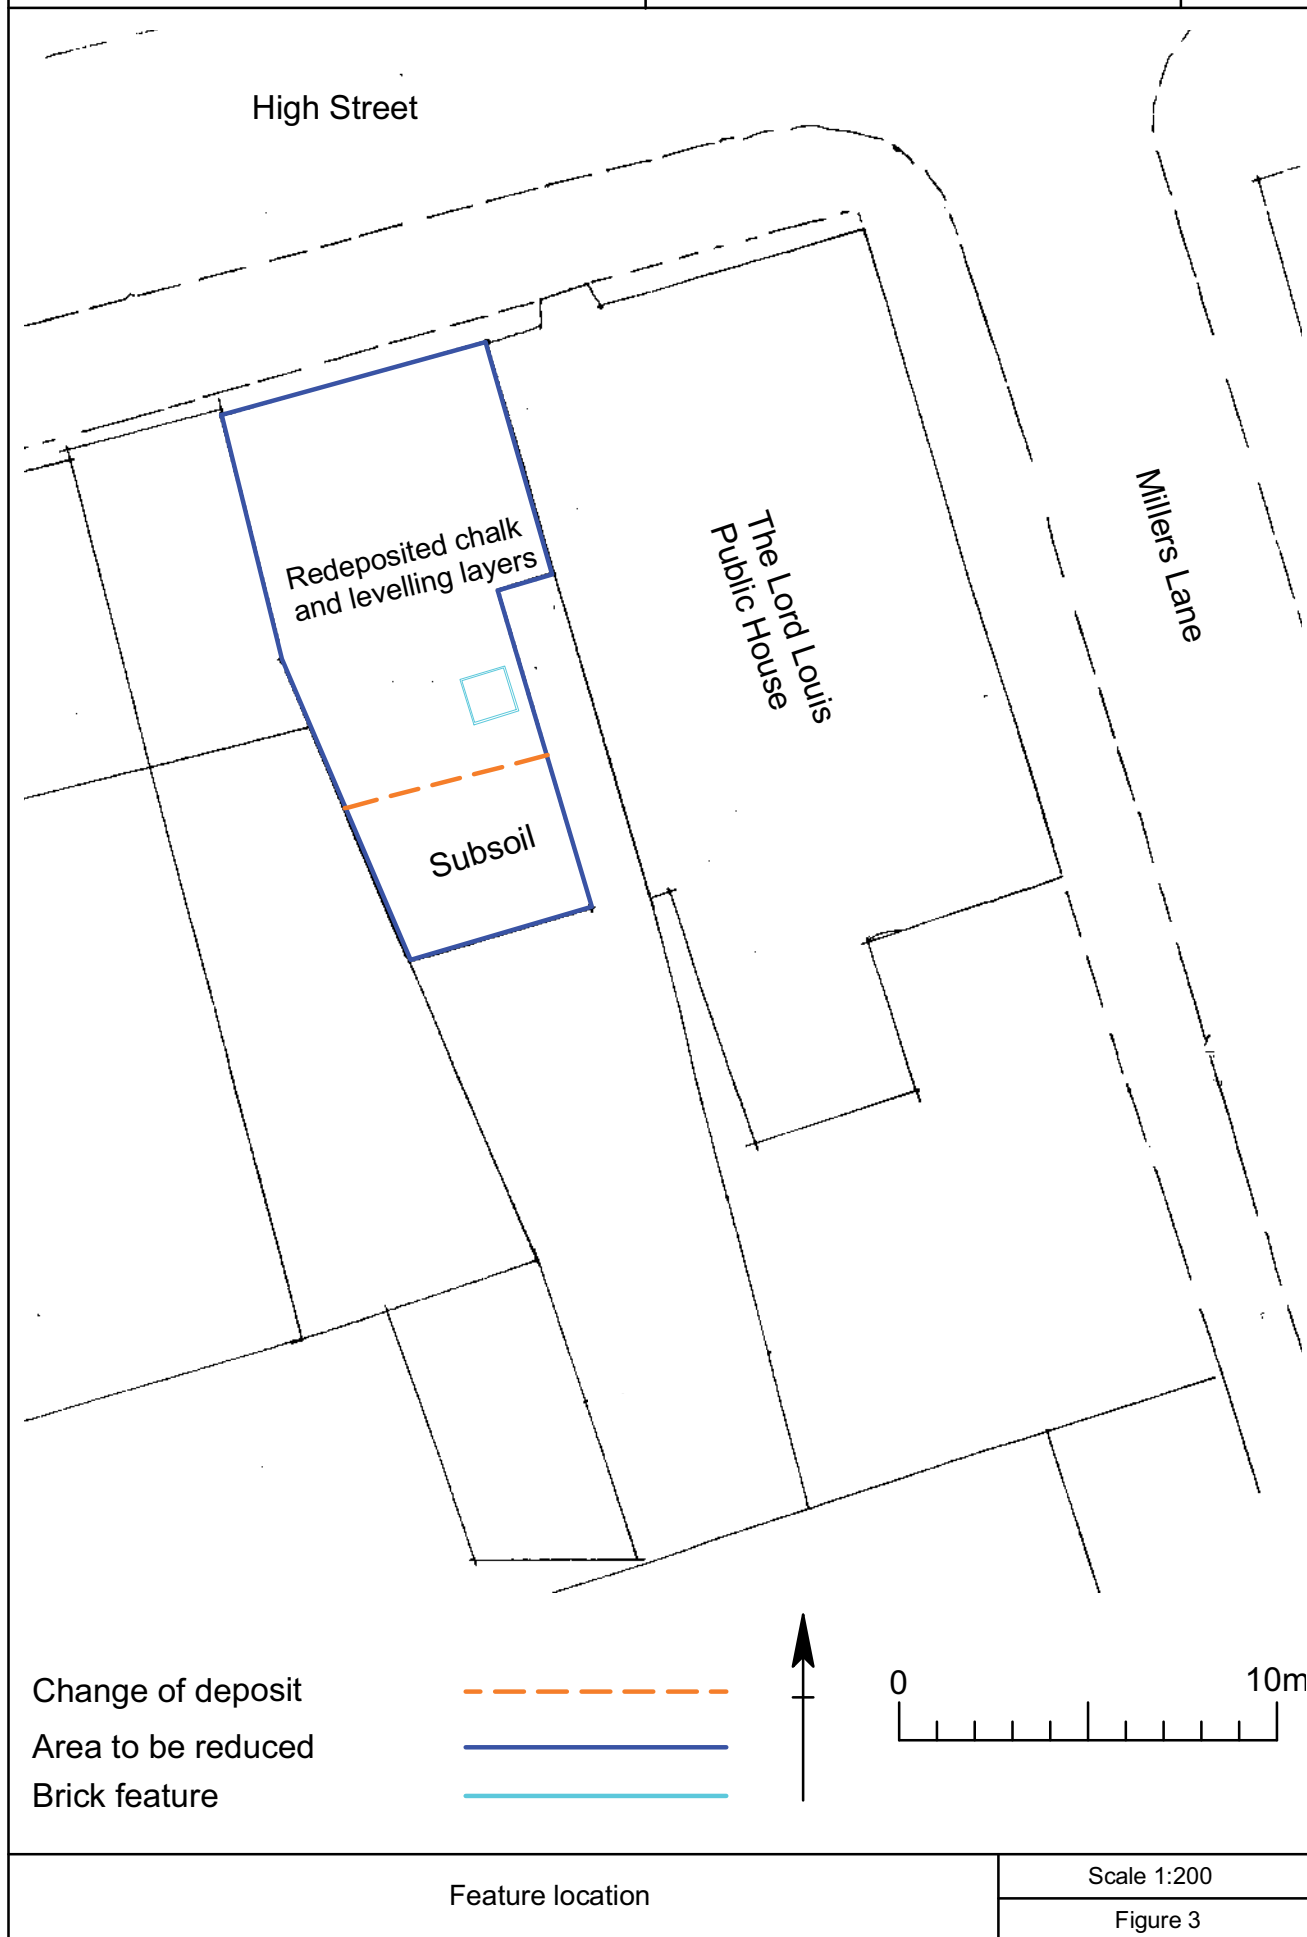
Figure 3 Feature Location

2.9 Feature [07] was observed cutting into layer (09) close to the south-eastern edge of the site (Figure 3, Plates 3 and 4). It was square in plan and measured 1.25m by 1.25m. A brick lining, one brick (0.10m) wide and surviving to at least 3 courses deep, was observed around the entire feature. No bonding material was seen between the bricks. It contained a very dark grey (10YR

2.11 Layer (09) ended approximately 11.00m south of the northern site limit (Figure 3). To the south was a layer of black (10 YR 2/1), very loose, silty clay, topsoil containing frequent stone, up to 2 cm in diameter, and a large quantity of animal bone, 0.40m in depth. Beneath this was a 0.25m+ thick, very dark grey (10YR 3/1) very loose, silty clay subsoil containing moderate amounts of stone no greater than 2cm in diameter.

3.5 A small brick feature [07] represents the only archaeological remains encountered in the course of the groundworks on the site. This probably represents a small Victorian outhouse, associated with the building previously occupying the site. Examination of the brick showed that it was handmade and was of poor quality. It is likely to have been locally made between 1850 and 1860 (T. Doig, pers. comm.). As this feature lay below the impact level of the present works it was not fully excavated and remains preserved in situ.

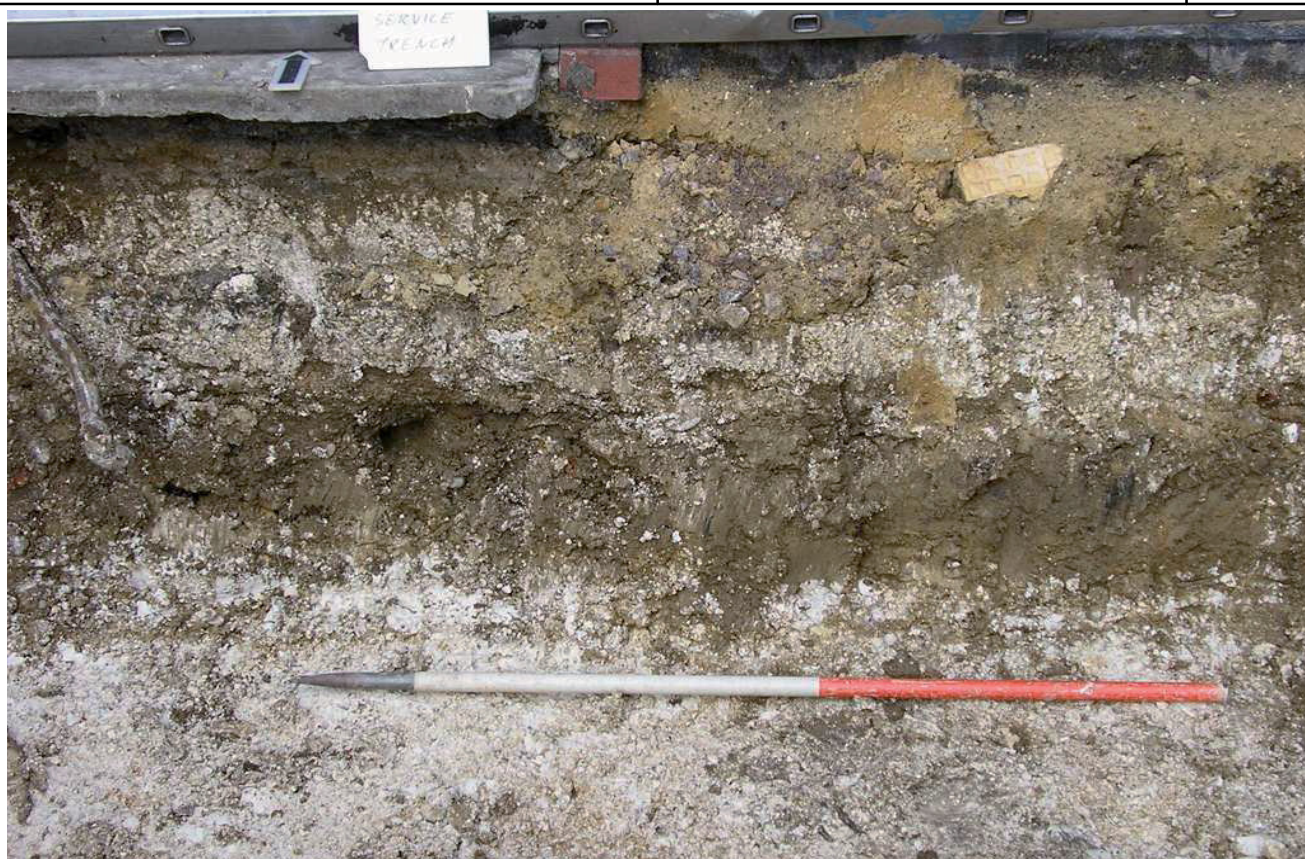
2.6 The general stratigraphy was highly disturbed across the site. A brick floor surface, context [01], measuring 0.06m in depth, was located at the northern edge of the site and probably related to the previous building. This overlay context (02), a layer of brownish yellow (10YR 6/8) sand, 0.08m in depth. Beneath this was context (03), a layer of very dark grey (7.5YR 3/1) silty sand with frequent gravel and chalk inclusions.

Plate 1: Stratigraphy along northern boundary of site

2.5 The ground level across the area of the new building was reduced by a depth of approximately 0.5m below the existing surface level (Plates 1 and 2). All drainage trenches which were of a depth considered likely to breach the overburden were monitored.

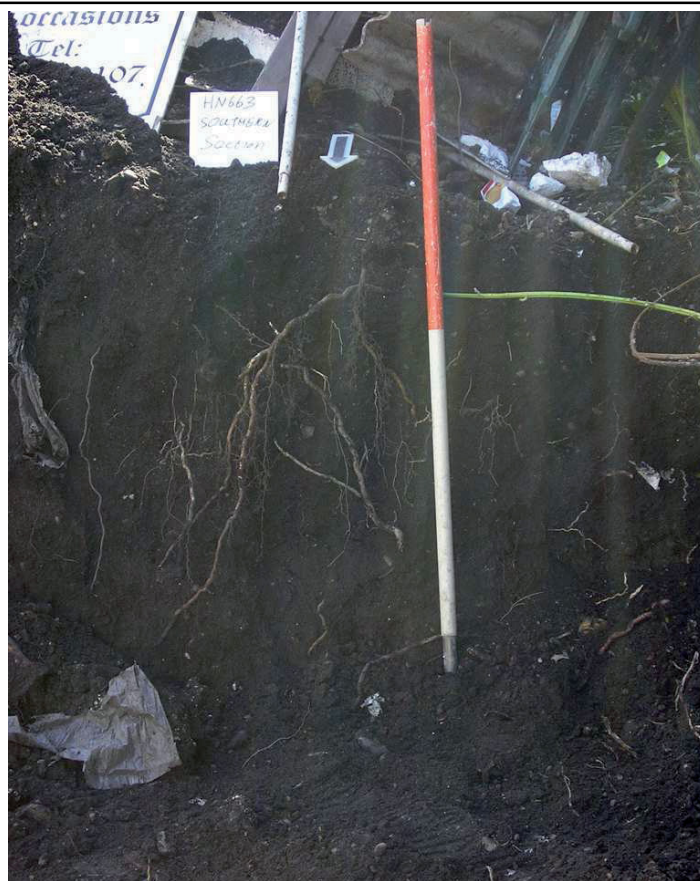
Plate 2: Stratigraphy along southern boundary of site

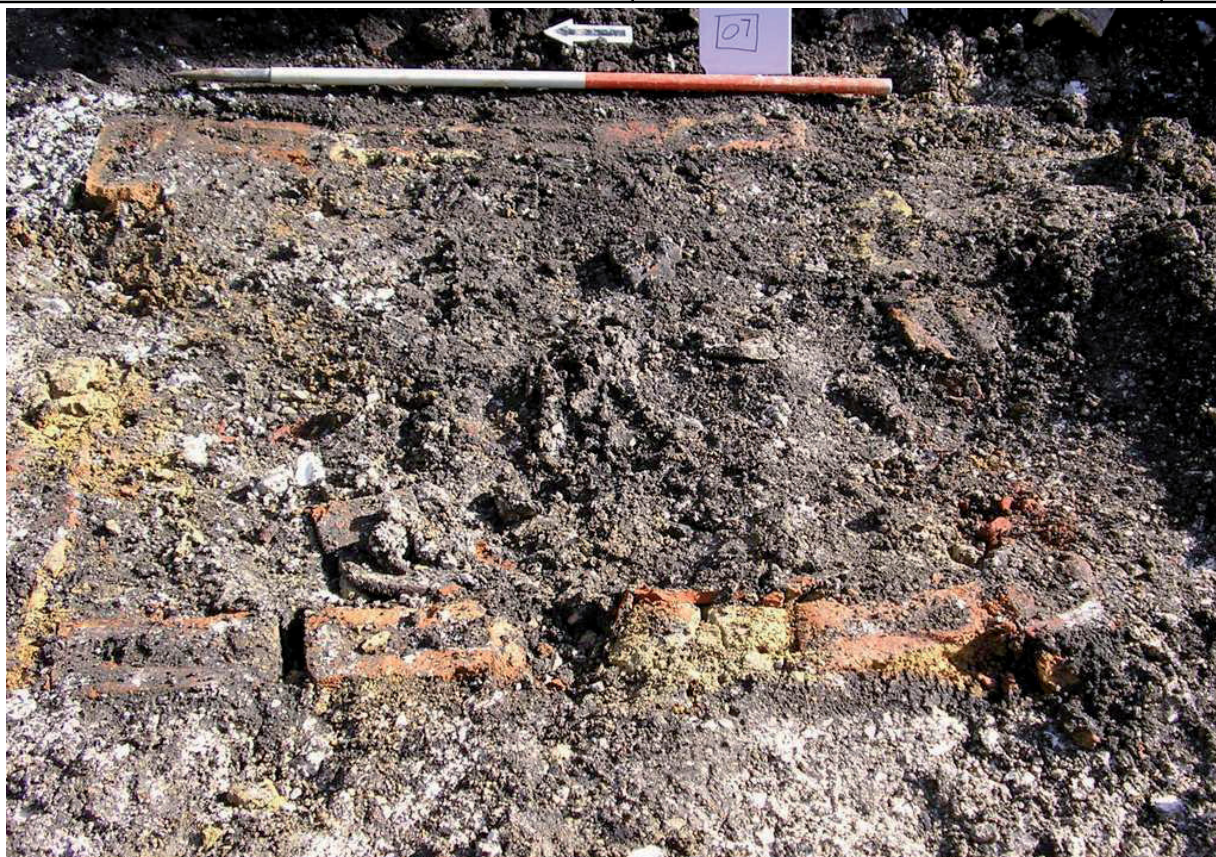
3/1), loose, silty clay fill, context (08), with frequent tile and chalk inclusions. The cut was packed with a dark grey (10YR 4/1), loose, silty clay, context (12).

2.10 The brick lining consists of poor handmade frogged bricks, measuring 230mm in length, 105mm in width and 65mm in depth. The fabric is an overfired pale orange red in colour, with sand and occasional slag inclusions. The brick has been dated to approximately 1850-1860.

Plate 3: Brick Feature [07]

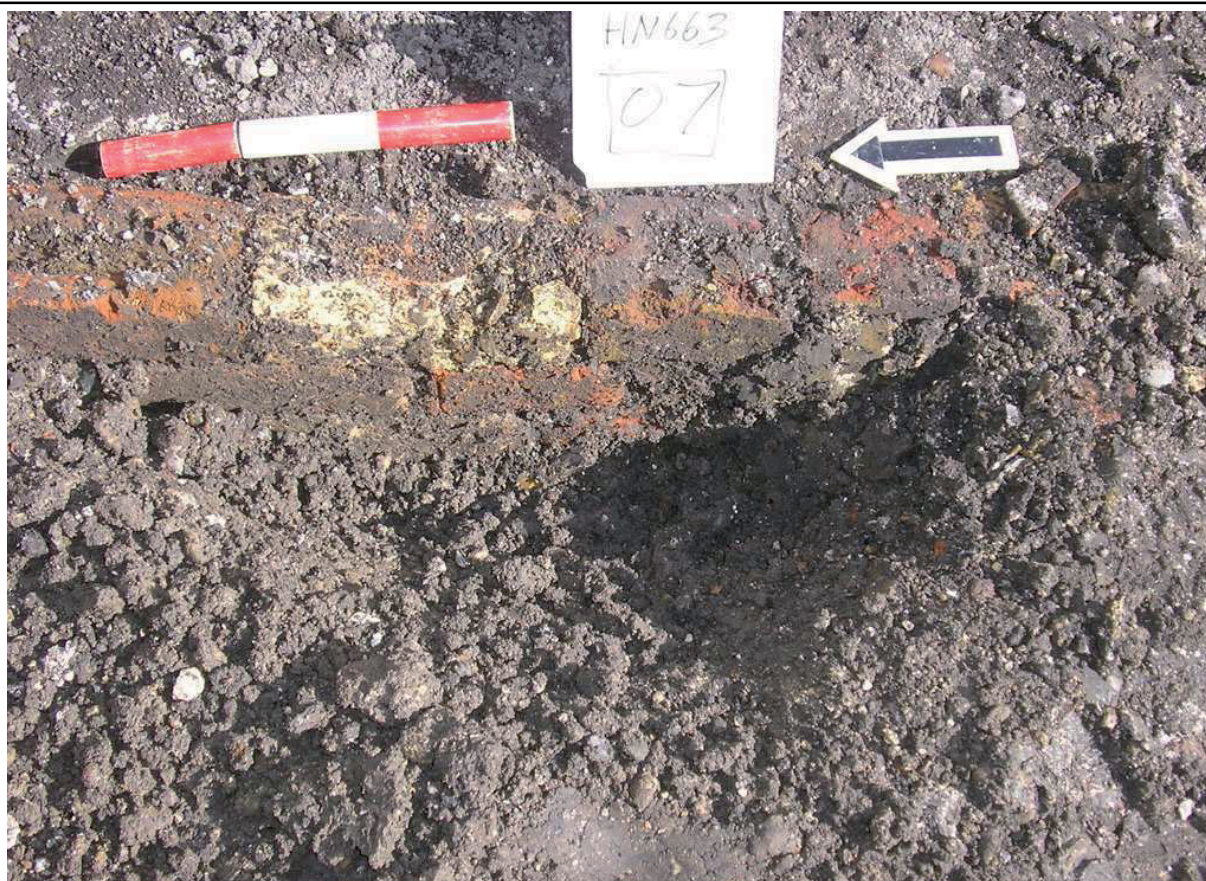
Plate 4: Brick Feature [07] detail
