MOUNT COTTAGE **Hare Street, Buntingford, Herts.**

HN650

Archaeological Monitoring Report

Prepared on behalf of Classic Window and Conservatory Co Ltd

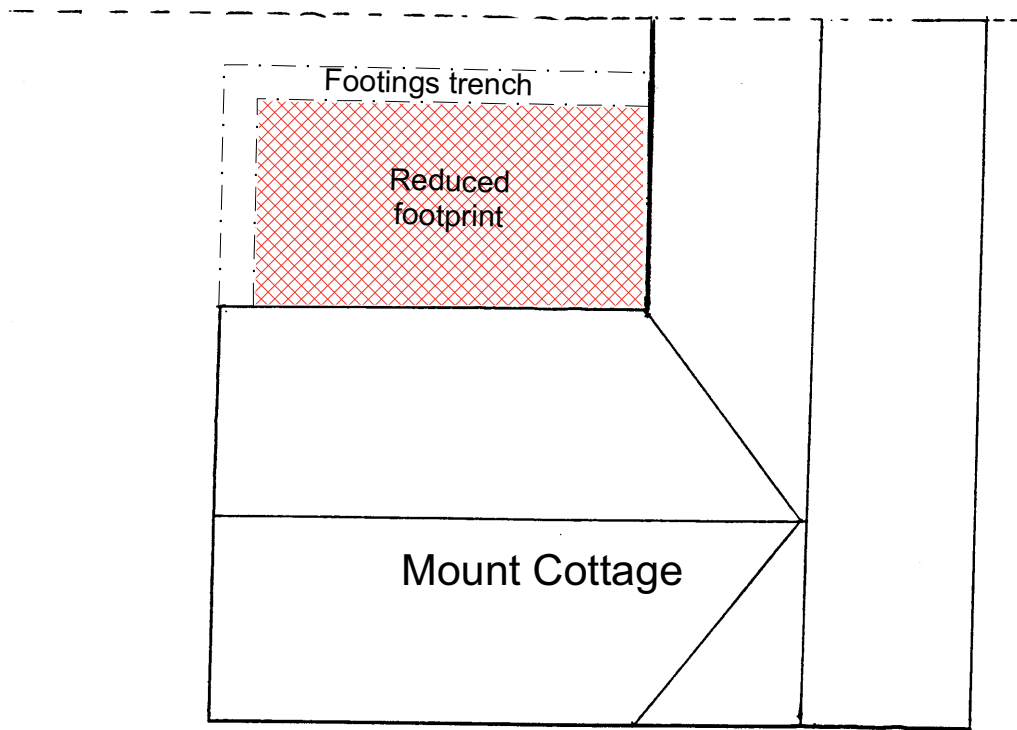
Figure 2

Site layout

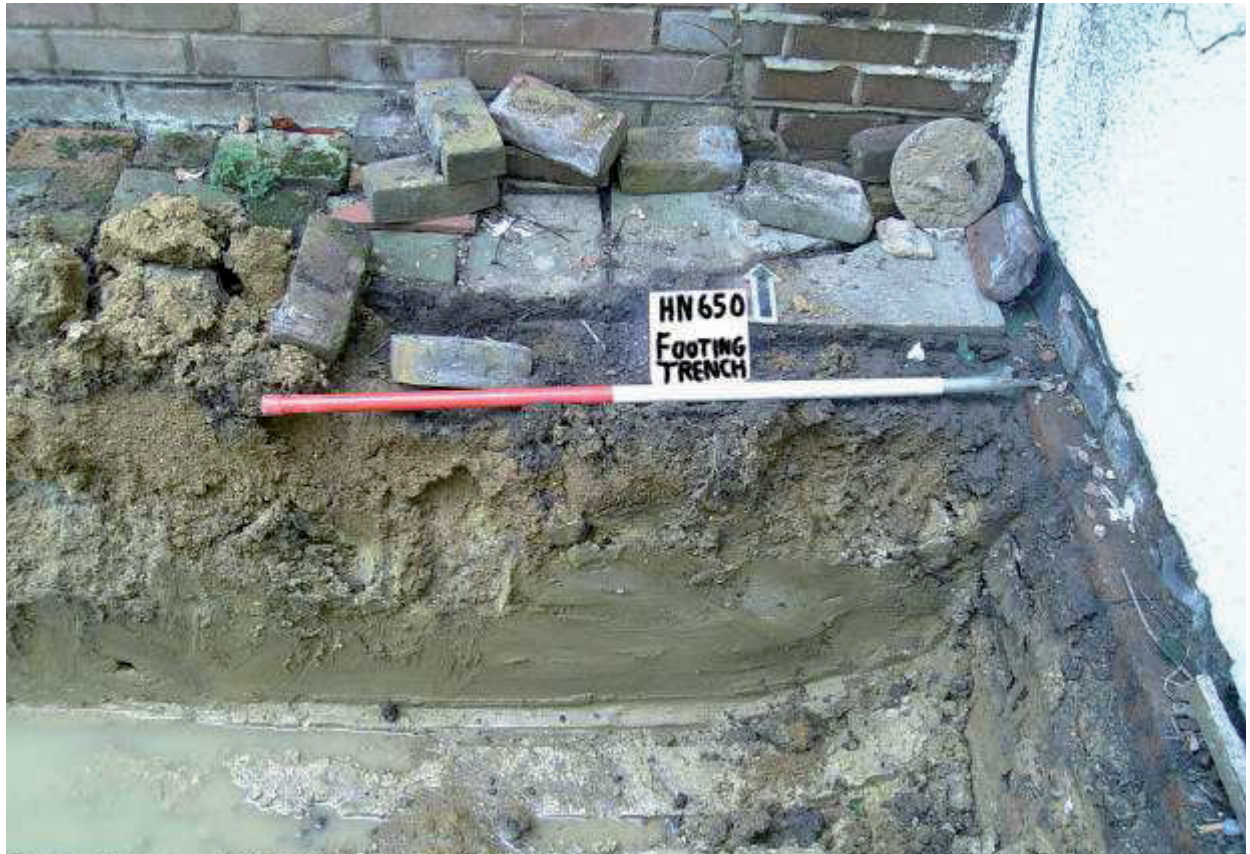
Plate 1: Stratigraphy in footings trench

2.6 The stratigraphy was consistent across the site and consisted of a layer of modern concrete slabs forming the existing patio over a layer of soft, yellowish brown (10YR 5/8) sand, imported to provide a base for the patio. Beneath this was the underlying natural geology of firm, olive brown, clay with occasional chalk fragments.

2.9 A single 'L' shaped footings trench was excavated along the exterior wall of the new conservatory. The footing measured approximately 0.45m wide by 0.6m deep.

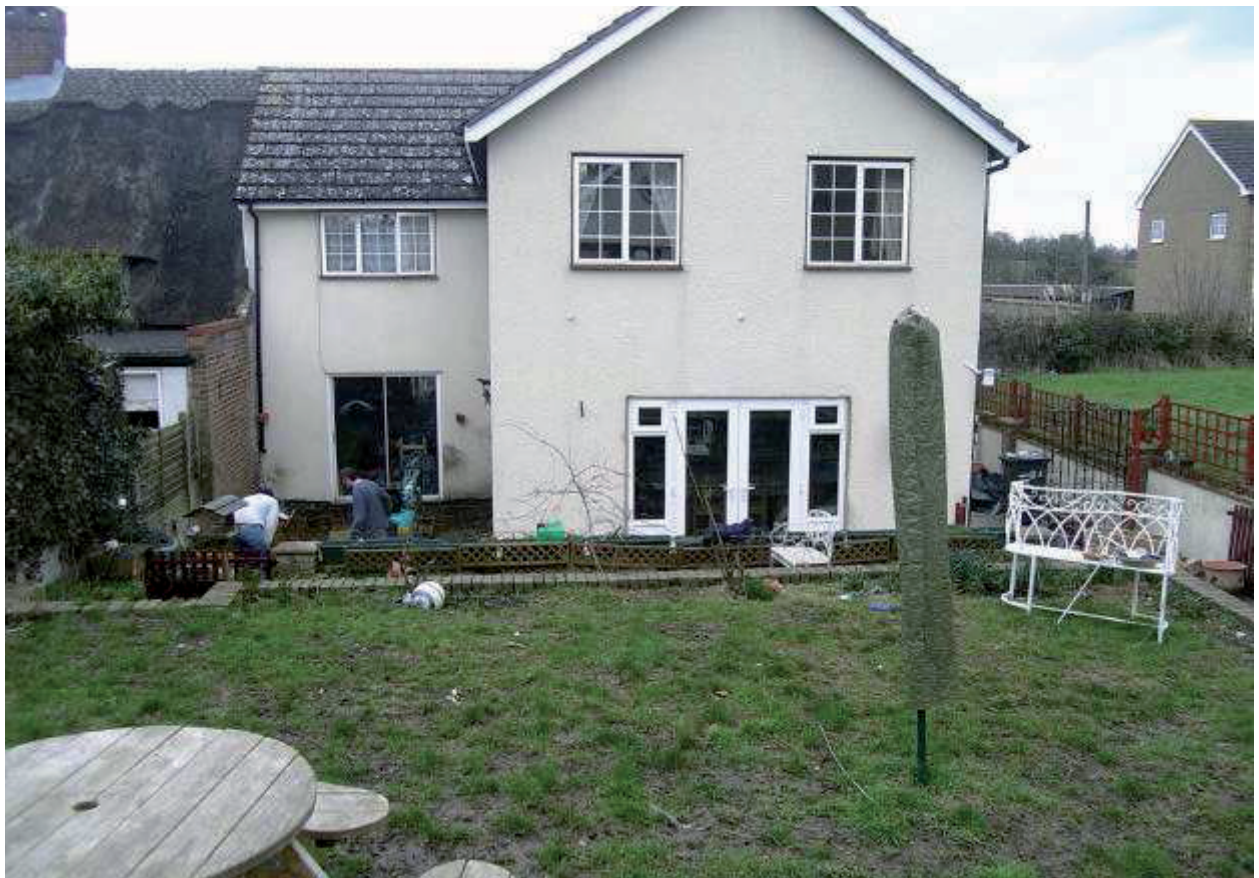
Plate 2: Photograph illustrating extensive terracing in rear garden

3.3 Mount Cottage appears to be constructed on land terraced into the hillside which rises steeply on the western side of the B1368. The terracing may have been undertaken during the construction of an extension to the western elevation of the house during the second half of the 20th century. No evidence of stratigraphy predating this period was observed, suggesting that the terracing was extensive enough to remove any earlier archaeological deposits which may have been present.
