ROTTEN ROW FARM

Furneux Pelham, Hertfordshire

Report No. 1025

In response to a condition on planning consent for the installation of an equine arena (manège) on land at Rotten Row Farm, Furneux Pelham (Figure 1), the Heritage Network was commissioned by the owner to undertake a programme of archaeological monitoring of the development groundworks. Planning permission for the development (3/16/1416/FUL) was granted by East Herts District Council (EHDC), subject to a standard archaeological condition issued under the provisions set out in the Department of Communities and Local Government's *National Planning Policy Framework* (NPPF). A full specification for the work carried out is contained in the Heritage Network's approved *Project Design* dated September 2016.

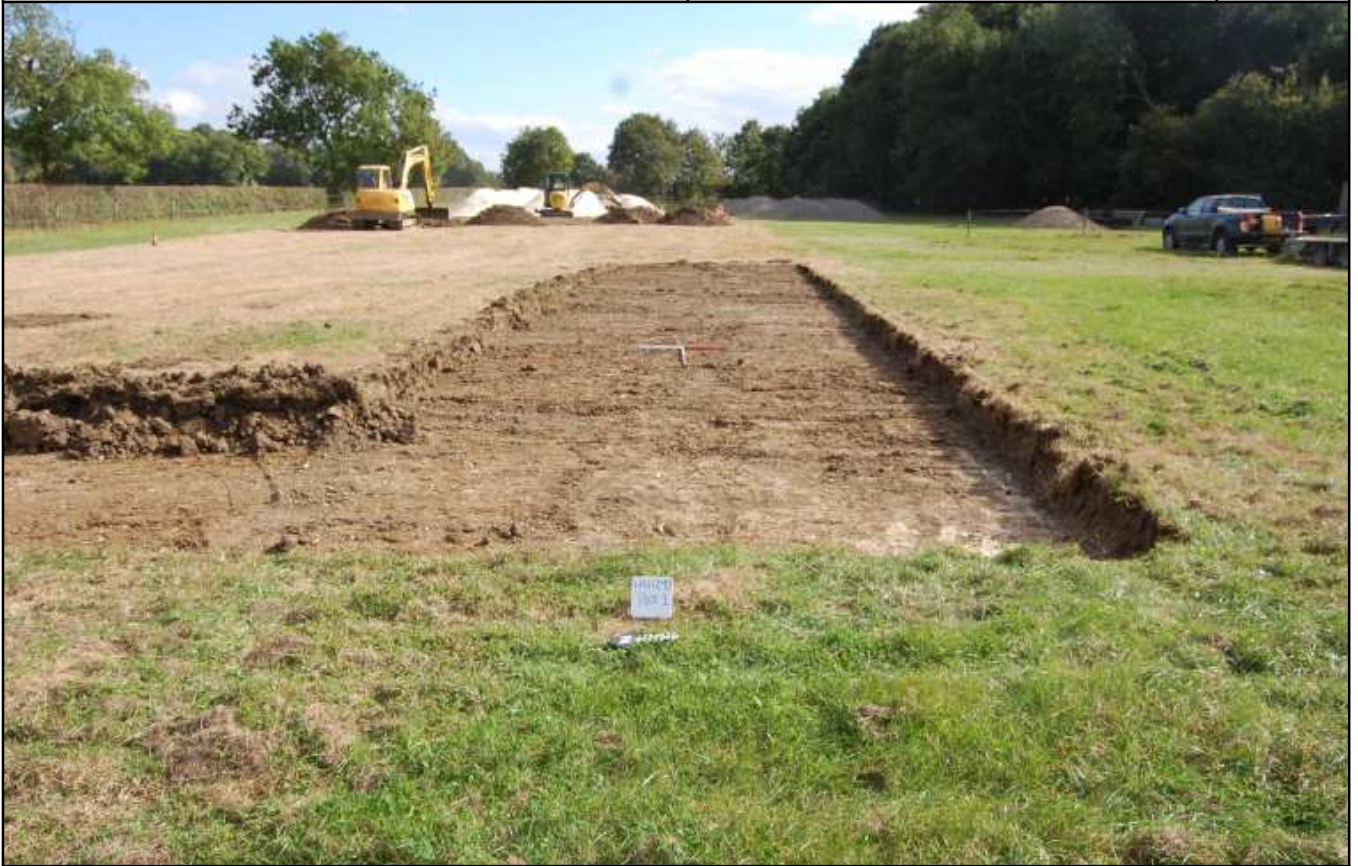
Plate 3: Stripped transect for manège, looking east

Two transects were excavated along the width and length of the excavated plot to the impact depth of the groundworks (Plate 3 & 4). These demonstrated a stratigraphy that consisted of a grass covered firm very dark greyish brown (10YR 3/2) silty clay topsoil, 0.3m thick. This overlies a friable brown (10YR 4/3) silty sandy clay subsoil, 0.04m thick (Plate 5).

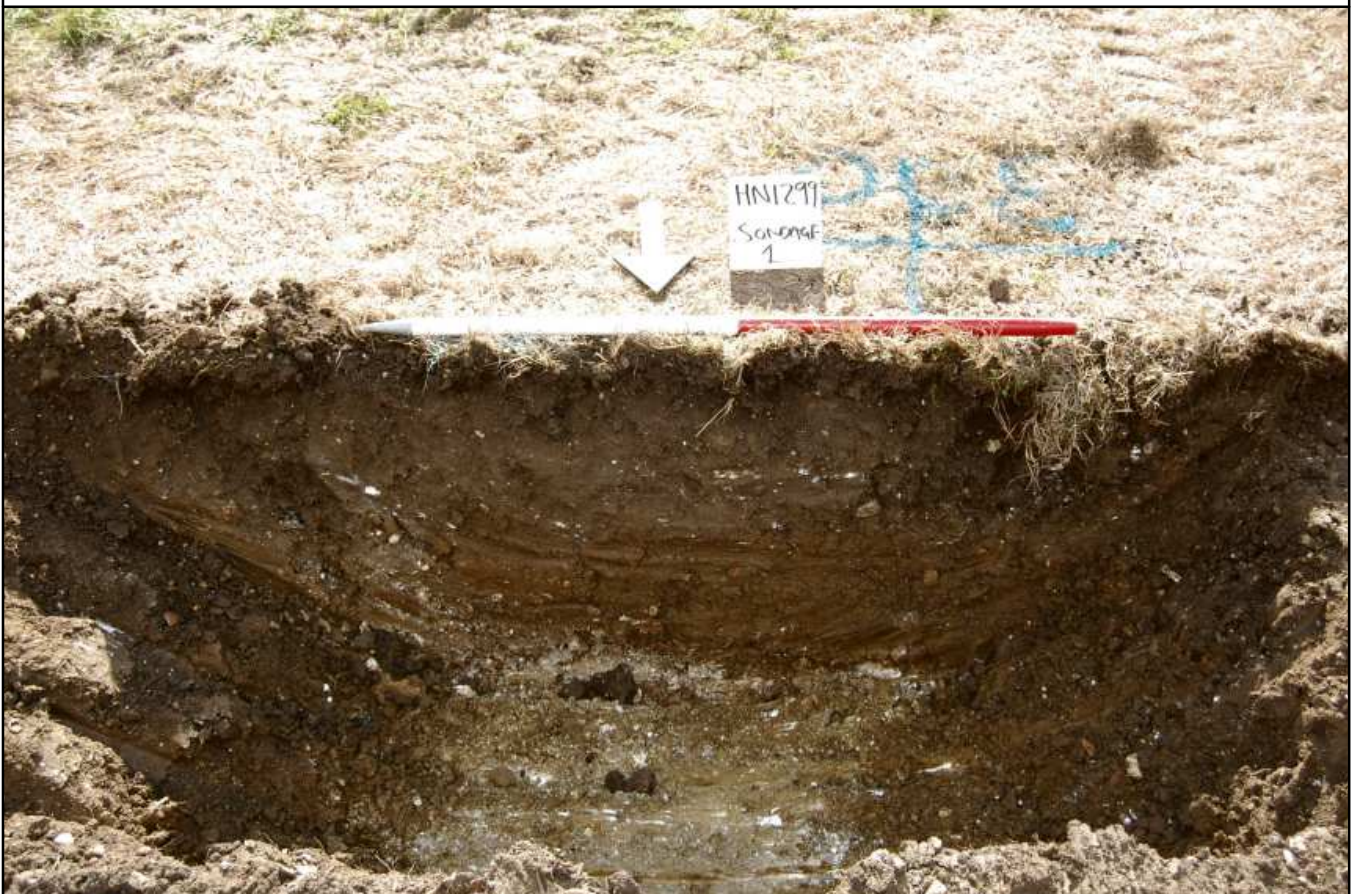
Plate 6: Sondage to expose natural substrate, looking south

The maximum impact depth of the ground reduction did not breach the subsoil and, on this basis and with the agreement of the Historic Environment Team at Hertfordshire County Council, it was agreed that the full extent of the ground reduction would not require monitoring. Nevertheless, in order to establish the nature and depth of the natural substratum, two small sondages were excavated (Figure 2, Plate 6). They demonstrated a maximum thickness of the subsoil of 0.4m, and that this overlies a natural compact yellowish brown (10YR 5/4) silty clay.

The monitoring of the development groundworks at Rotten Row Farm, Furneux Pelham, demonstrated a stratigraphic sequence consisting of topsoil and subsoil. The undisturbed natural substrate was revealed within two sondages excavated within the stripped area. Despite the proximity of the site to areas of known archaeological activity, particularly relating to the medieval and post-medieval periods, no features, deposits or finds of archaeological significance were exposed during the works and any such remains, should they be present, will remain undisturbed beneath the manège.
