56B PARK ROAD Ware, Hertfordshire

HN1301

Report No. 1061

Site name and address:	56b Park Road, Ware, Hertfordshire, SG12 0AN		
County:	Hertfordshire	District:	East Hertfordshire
Village/town:	Ware	Parish:	Ware
Planning reference:	3/15/1745/HH	NGR:	TL 35239 14607
Client name and address:	Mr David Vigus Esq, Westmill Farm, 56B Park Road, Ware, Hertfordshire, SG12 0AN		
Nature of development:	Residential development	Previous land use:	Single storey building extension
Site Status:	Area of Archaeological Significance no.117 (AAS117)	Reason for investigation:	Direction of local planning authority (NPPF)
Position in planning process:	After determination, as a condition	Project brief originator:	Local authority
Size of affected area:	c.330m ²	Size of area investigated:	19m ²
HN Ref:	HN1301	HER consultation:	189/16
Organisation:	Heritage Network	Site Director:	David Hillelson
Project type, methods etc.	Monitoring	Archive Recipient:	Ware Museum
Start of work	24/02/2017	Finish of work	24/02/2017

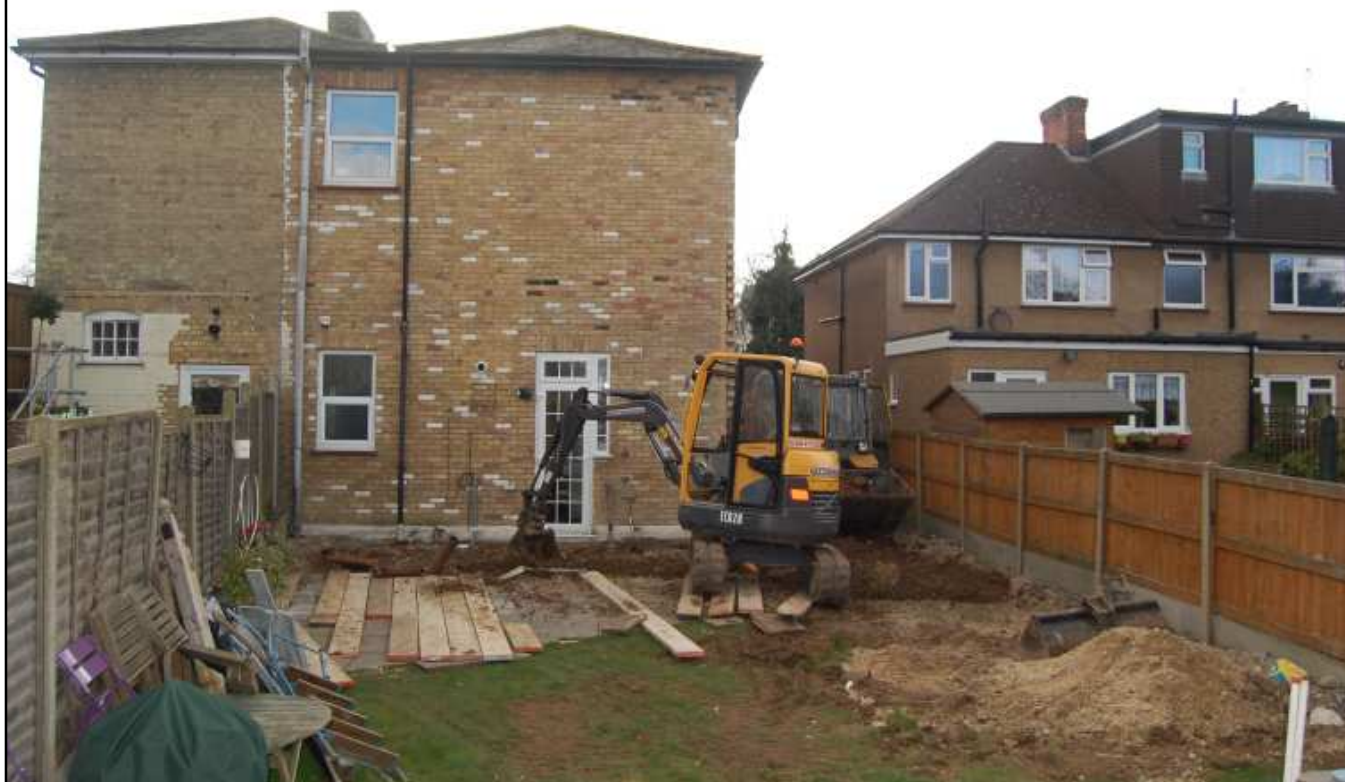
Plate 1: Development site, looking S

The proposed development entailed the construction of a single storey extension to the rear of the house (Figure 2). The present investigation involved the monitoring of the groundworks associated with the development (Plate 1).
