GARDEN HOUSE **Tewin Water, Welwyn, Herts.**

ARCHAEOLOGICAL MONITORING REPORT

GARDEN HOUSE Tewin Water, Welwyn, Hertfordshire

Project ref.: HN1307
Planning ref: 3/14/1792/FP
HER enquiry no: 207/16

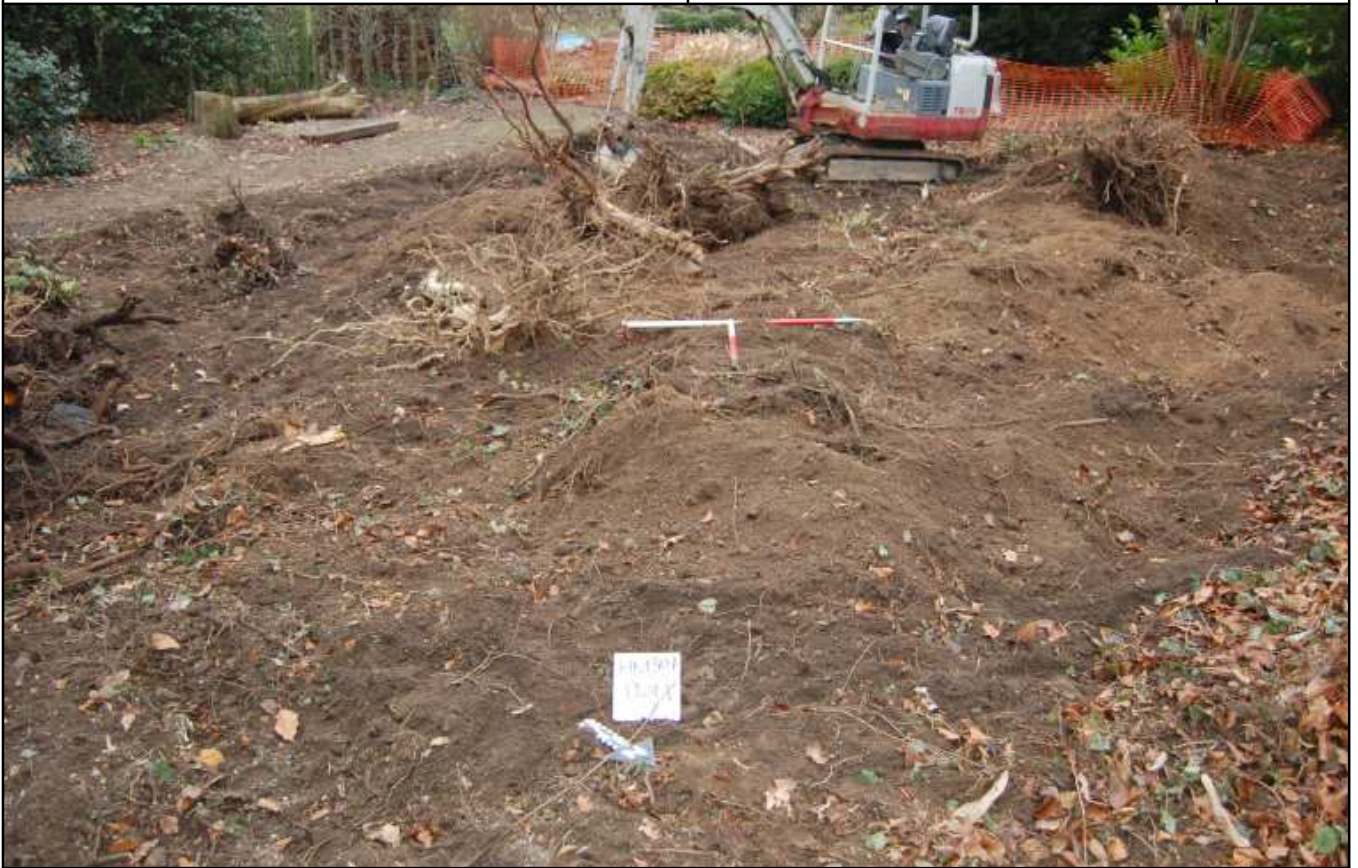
Plate 1: Area of tree removal, looking south-west

2.9 The trees having been cut down previously, the removal of several tree boles, occupying the footprint of the new garage and its access, was monitored. In places the subsoil was exposed but this was not breached. No archaeological features, deposits or finds were observed during this phase of work.

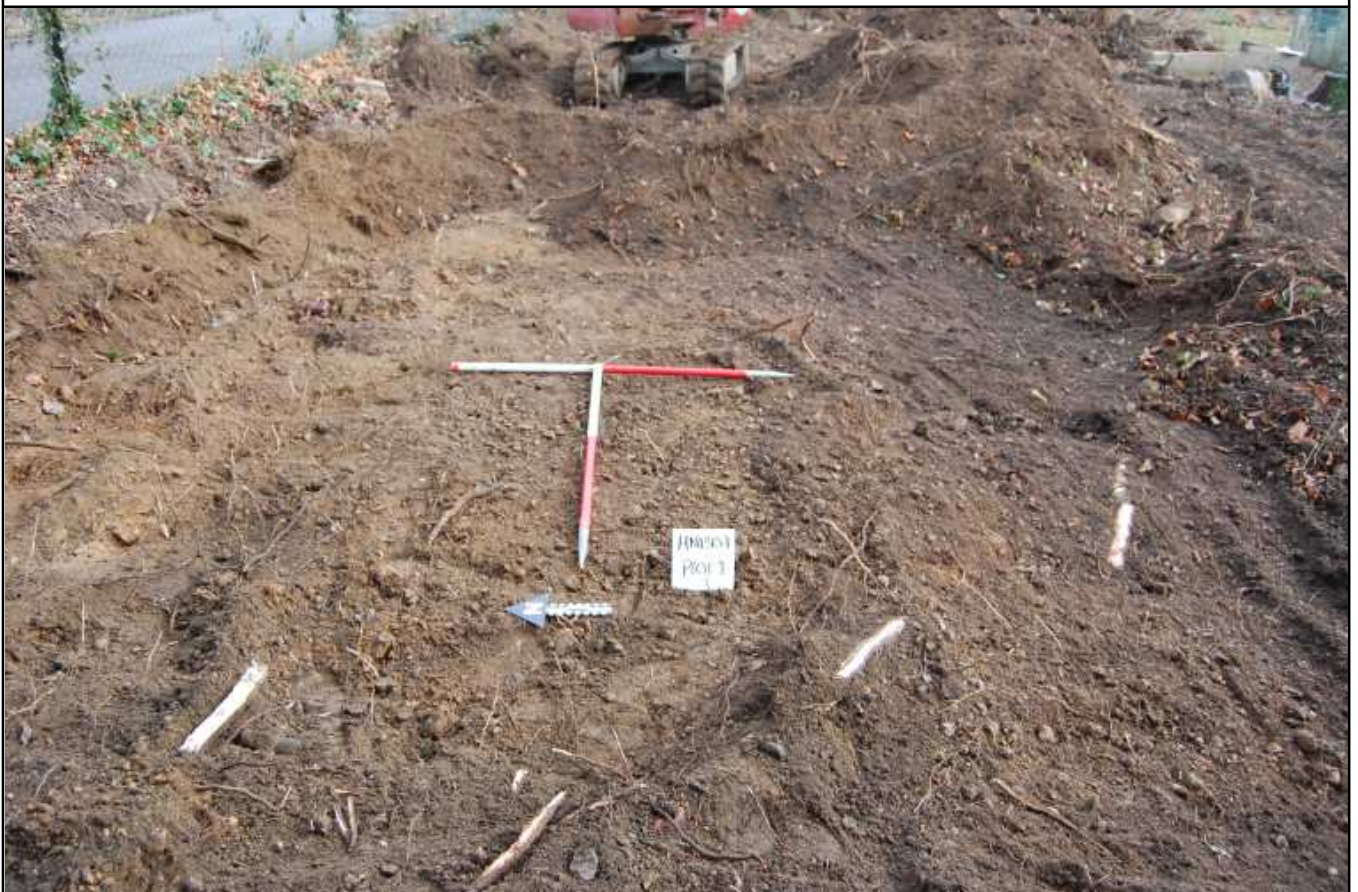
Plate 2: Ground reduction in north-west corner of garage plot, looking east

2.10 The footprint of the new garage and its associated area of hardstanding, which measured in total approximately 17m in length by 12.3m in width, was reduced in depth by c.0.2m. This work did not breach the subsoil and no archaeological features, deposits or finds were observed.

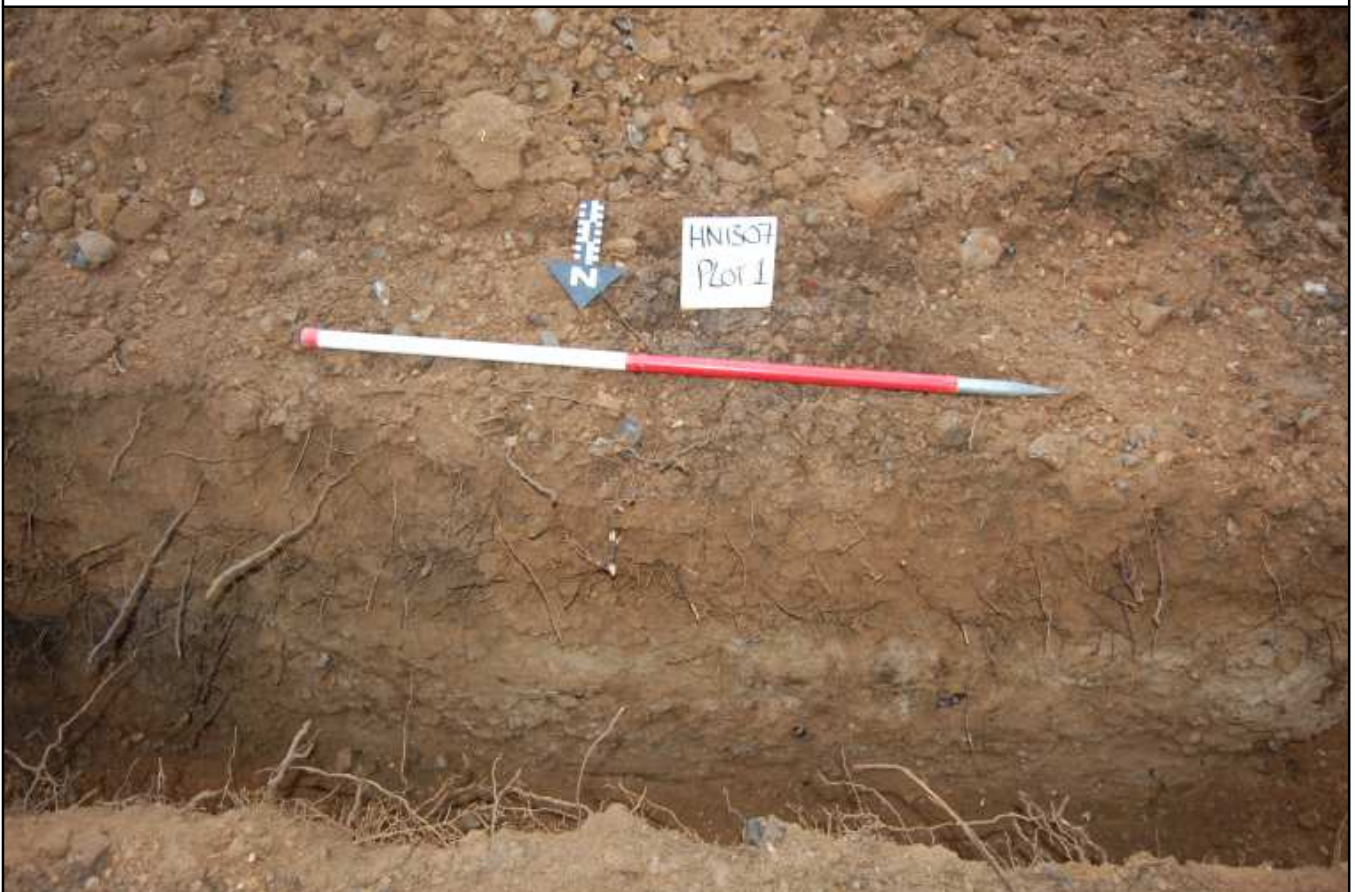
Plate 4: Stratigraphy in footing trench, looking south

2.12 The stratigraphy revealed in the trench sections comprised a layer of friable very dark greyish brown (10YR 3/2) silty clay topsoil, with frequent rooting and occasional small sub-rounded stone inclusions, 0.2m thick, above a friable strong brown (7.5YR 4/6) silty clay subsoil with moderate small sub-rounded stone inclusions, 0.3m thick. This overlay the natural substratum of compact yellow (10YR 7/8) silty sandy clay, which was encountered at a depth of 0.5m below the existing ground level (Plate 4).

2.13 No archaeological features, deposits or finds were observed during this phase of work.
