## **ALPEN HOUSE, 178 NORTON WAY NORTH Letchworth Garden City, Herts.**

HN640

***Historic Building Record &  
Archaeological Evaluation Report***

Report no. 405

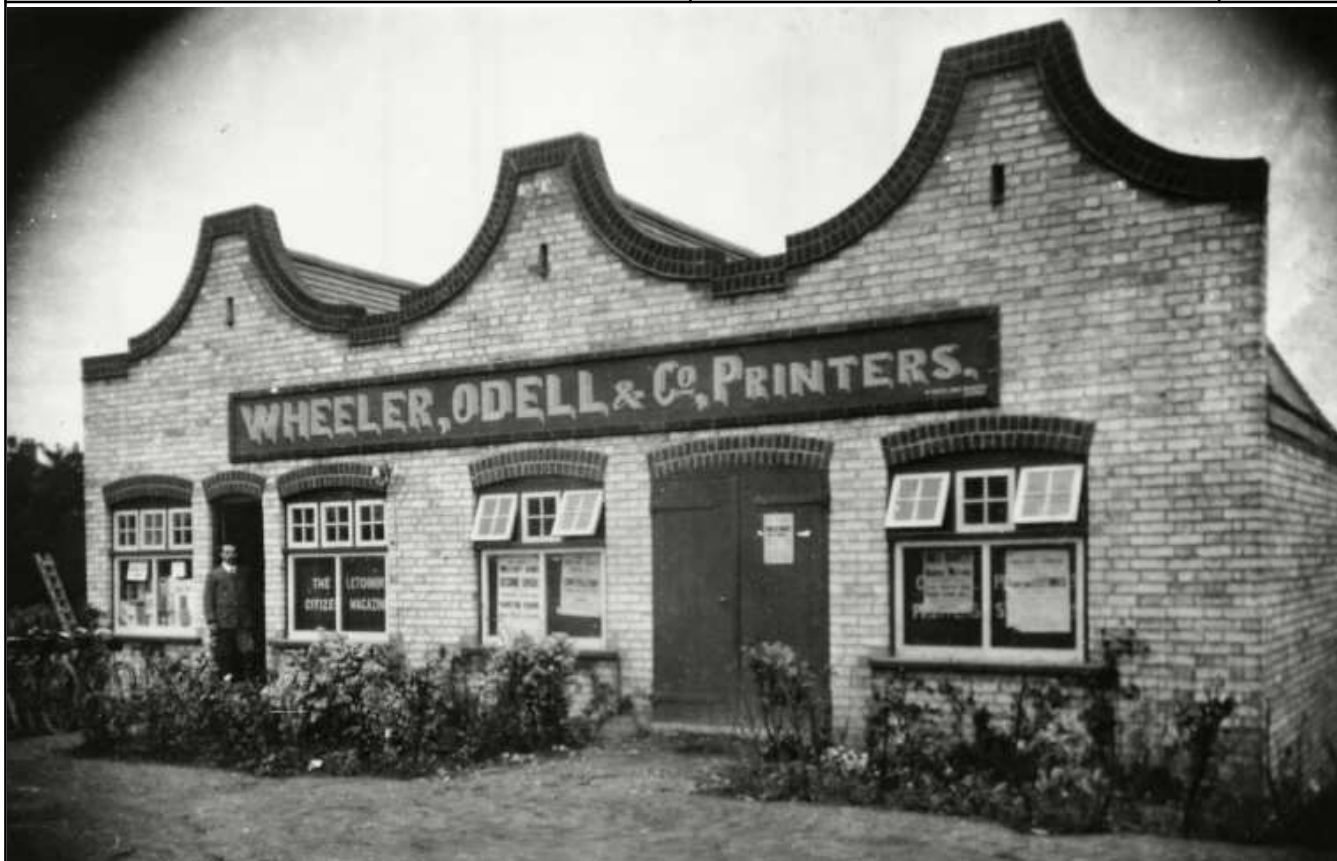
Plate 1: Front elevation, c.1907

**2.3** The front block dates to c.1907 and represents an early example of a Garden City industrial building. It was originally built as a print works and a contemporary photograph, from the collections of the First Garden City Heritage Museum, shows it to be occupied by Wheeler, Odell and Company (Plate 1). According to a series of Letchworth Garden City development maps, the front block had been extended to the rear by 1918, with the addition of a twin-aisle factory block reaching as far as the eastern bank of the Pix Brook. By 1922, a single aisle factory block had been added to the north, and by 1950, the original extension had been extended west by four bays, to cross the former line of the Pix Brook (Figure 3). After 1960, the front block was extended by one and a half bays north, in a matching style, and the factory unit in the yard to the rear was constructed (Figure 6).

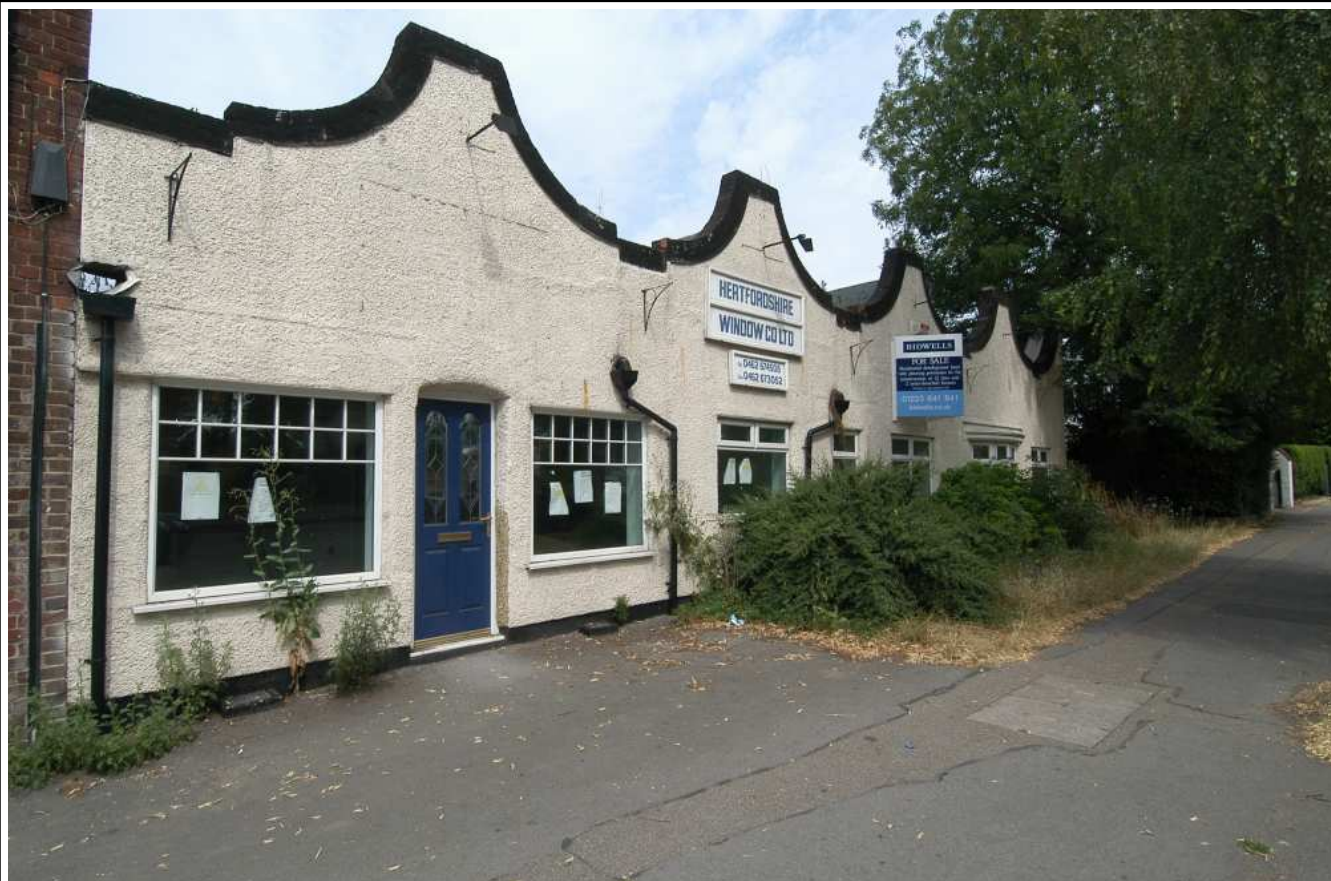
Plate 2: Front elevation, 2006, looking NW

**2.5** In its final form, the front block had been extended by one and a half bays to the north, the extension being flat-roofed behind matching gables (Plate 4) and the whole frontage had been rendered in roughcast. All the original windows and door had been replaced in uPVC, probably by the last occupant of the building, which was a replacement window company (Figure 4; Plates 2 & 3). The three pitched roofs of the original block had been covered in roofing felt (Plate 5).

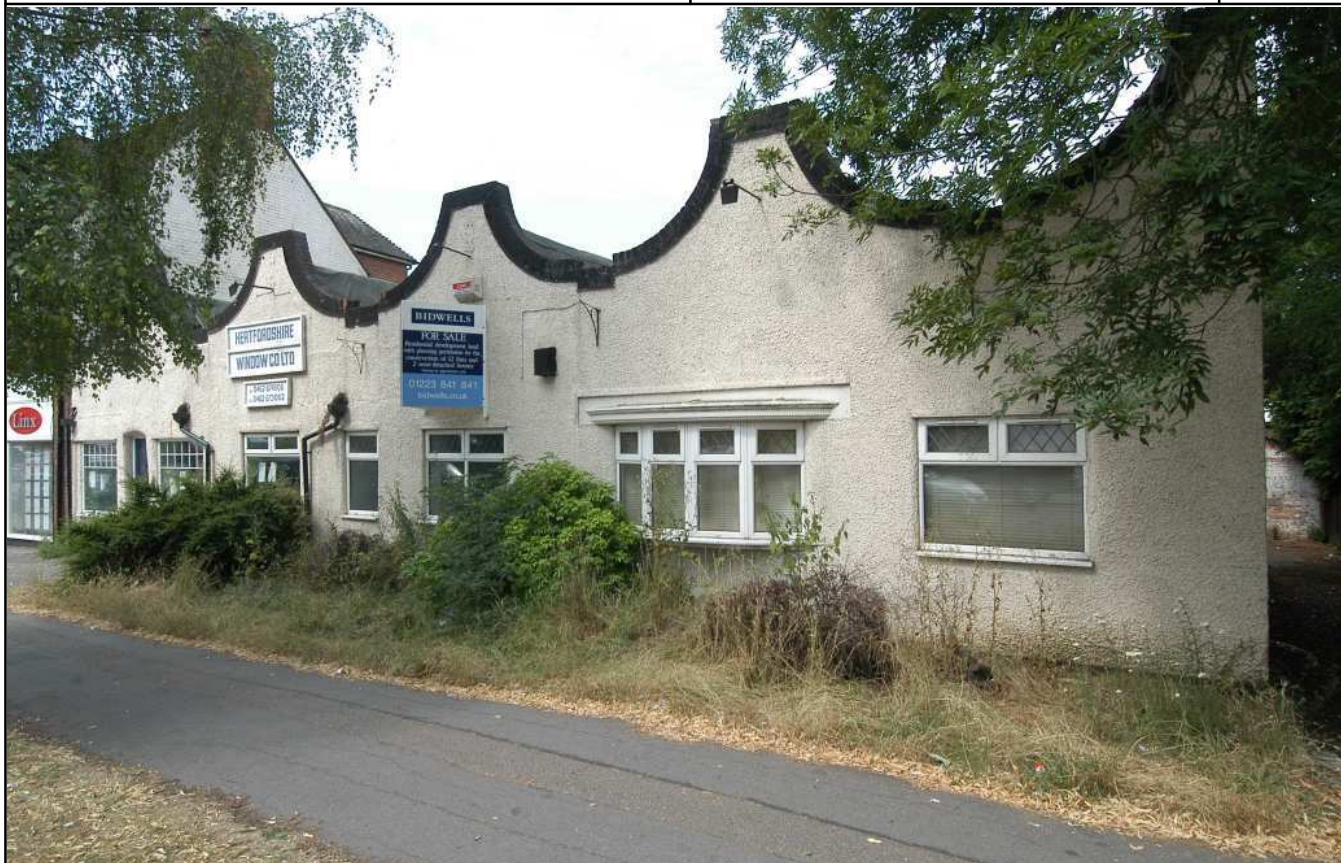
Plate 3: Front elevation, 2006, looking SW

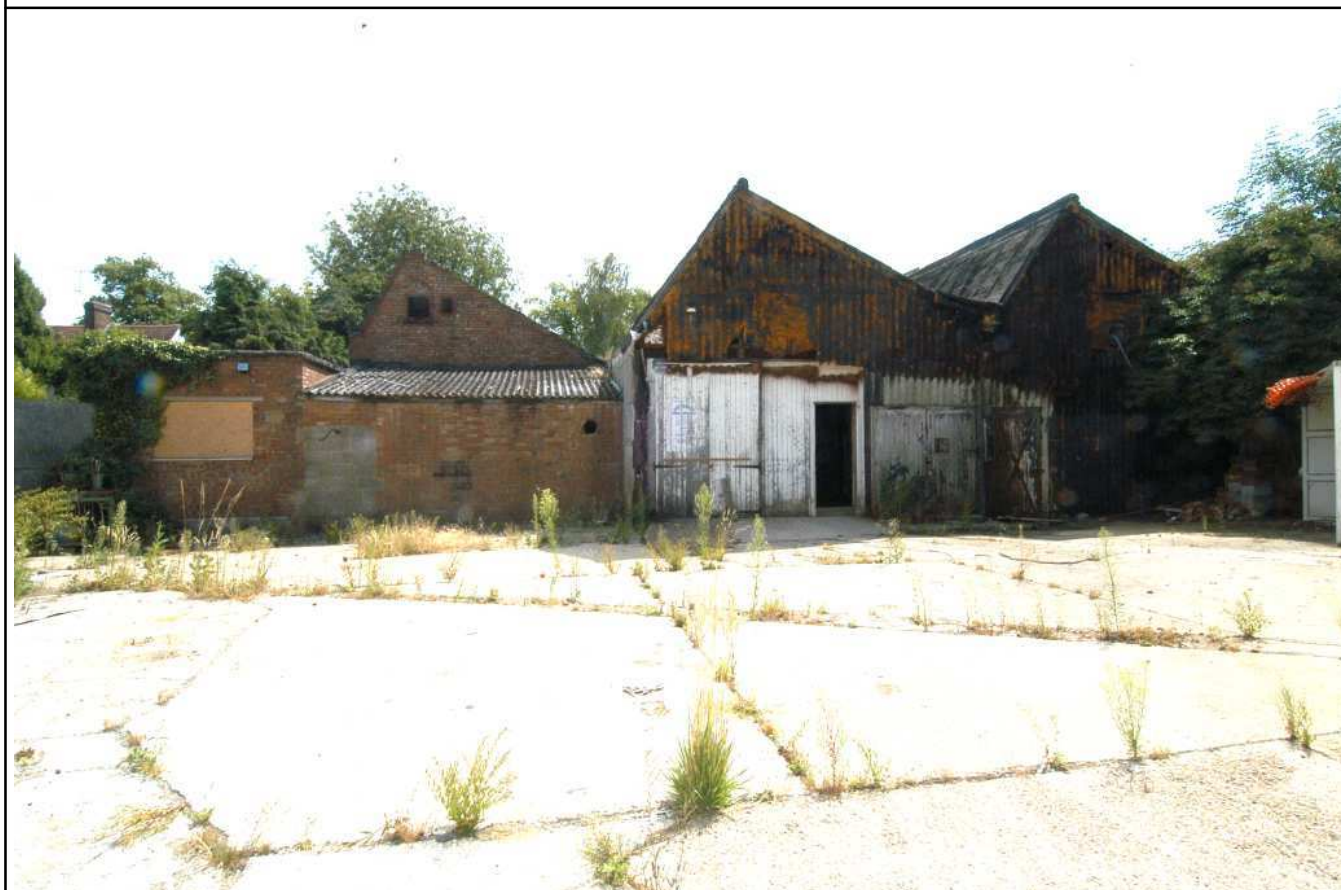
Plate 4: Rear elevation, 2006, looking E

**2.8** The western extension may date to the Second World War or may be a post-war construction. It was certainly in place by 1950. The southern brick elevation was extended, but was not intended to be structural as it incorporated steel stanchions to support the riveted fan trusses of the roof structure. The western gable end was formed of corrugated cement asbestos, and incorporated double hinged goods doors in the northern aisle (Plate 4).

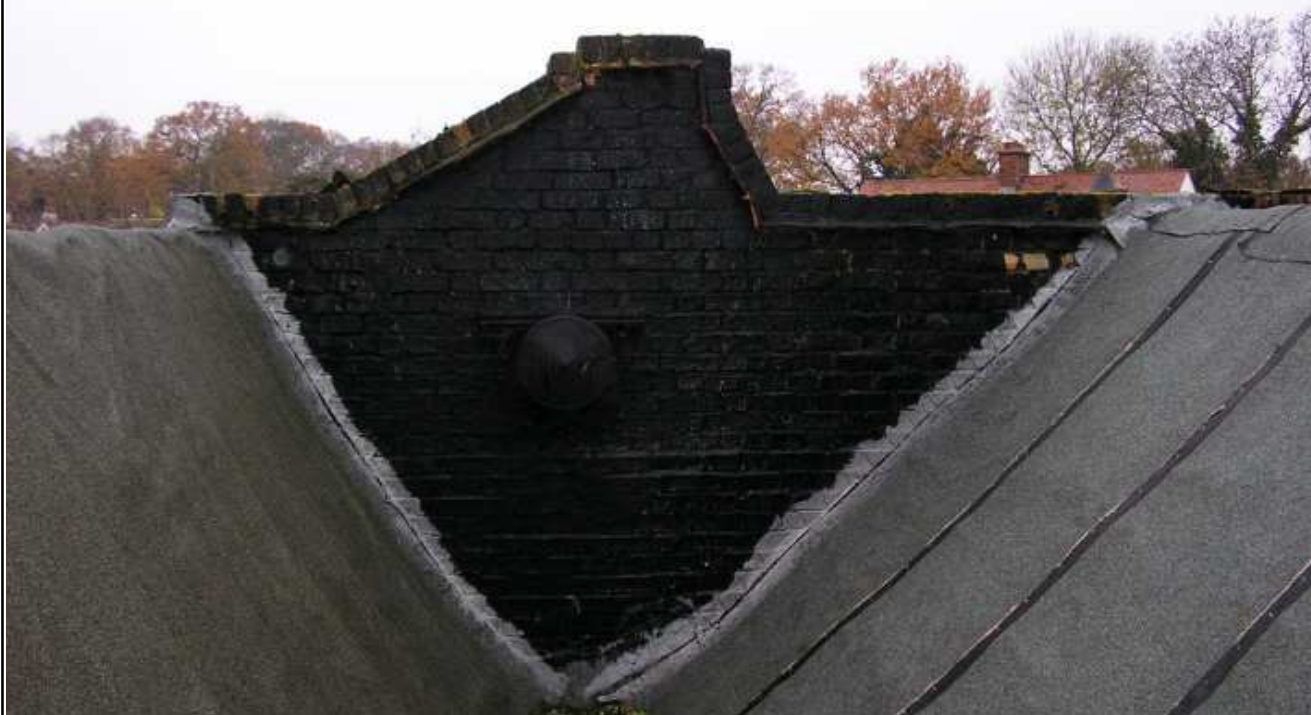
Plate 5: Front block, valley between Bays 1 & 2

**2.4** In its original form, the front block consisted of three bays each with a shaped gable, formed from concave quadrants linked with a flat top, concealing an unevenly pitched tiled roof (Figure 5, Section A-A<sup>1</sup>; Plate 5). The roofs may have been glazed, or part-glazed, on their northern slopes. The block is constructed of white bricks, laid in monk bond, with on-edge brick coping to the gables, and six segmental arched openings in the front elevation for windows and doors. In Bay 1 (to the south) a personnel door in the centre was flanked by two five light windows (three above two), the upper lights being of four panes each, and the outer pair being top-hinged to open outwards. Similar windows occupied the centre of Bays 2 and 3, with a double goods door, hinged to open outwards, occupying the space in between. A sign board was located above the arched openings, framed by a shallow projecting band of dark bricks.

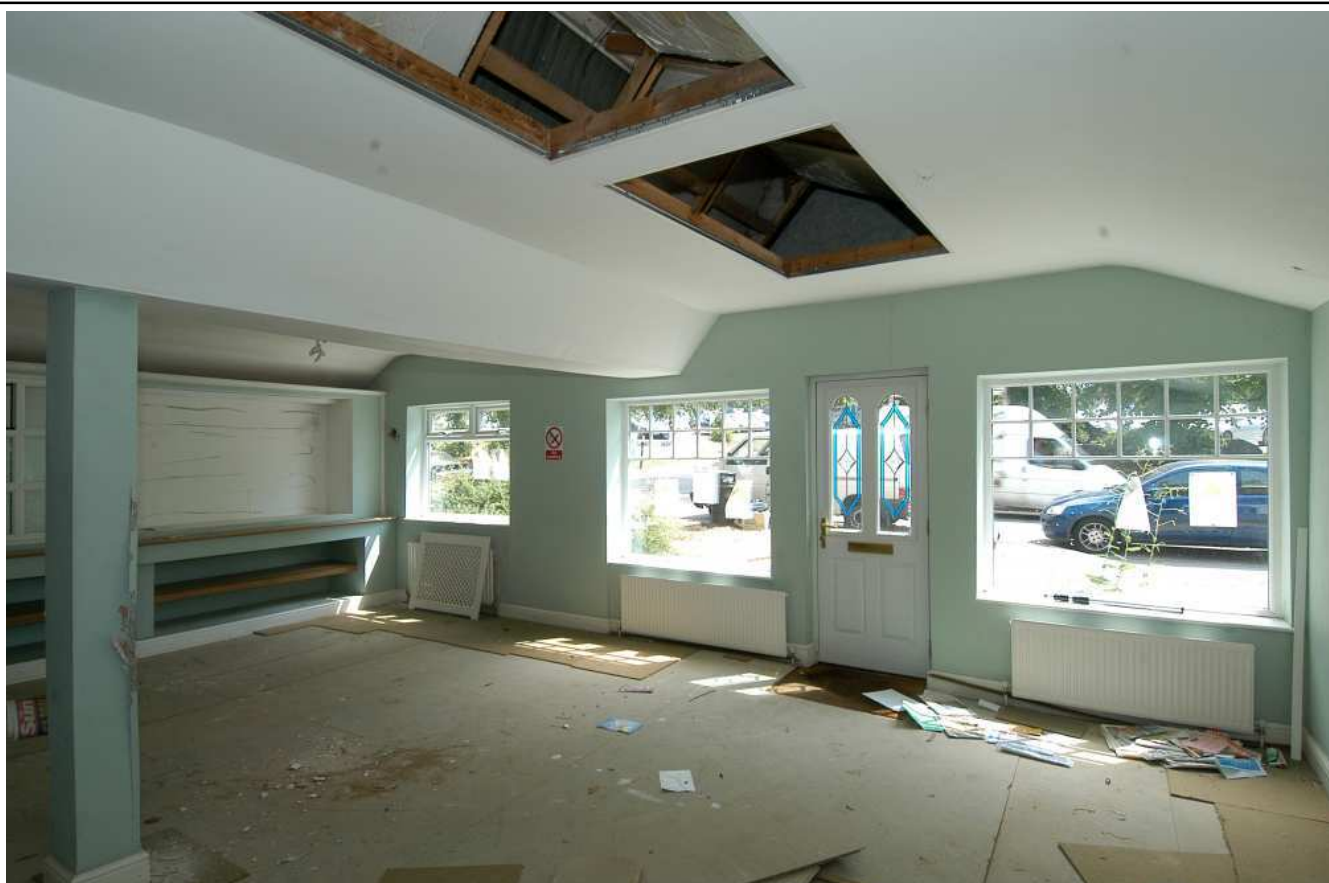
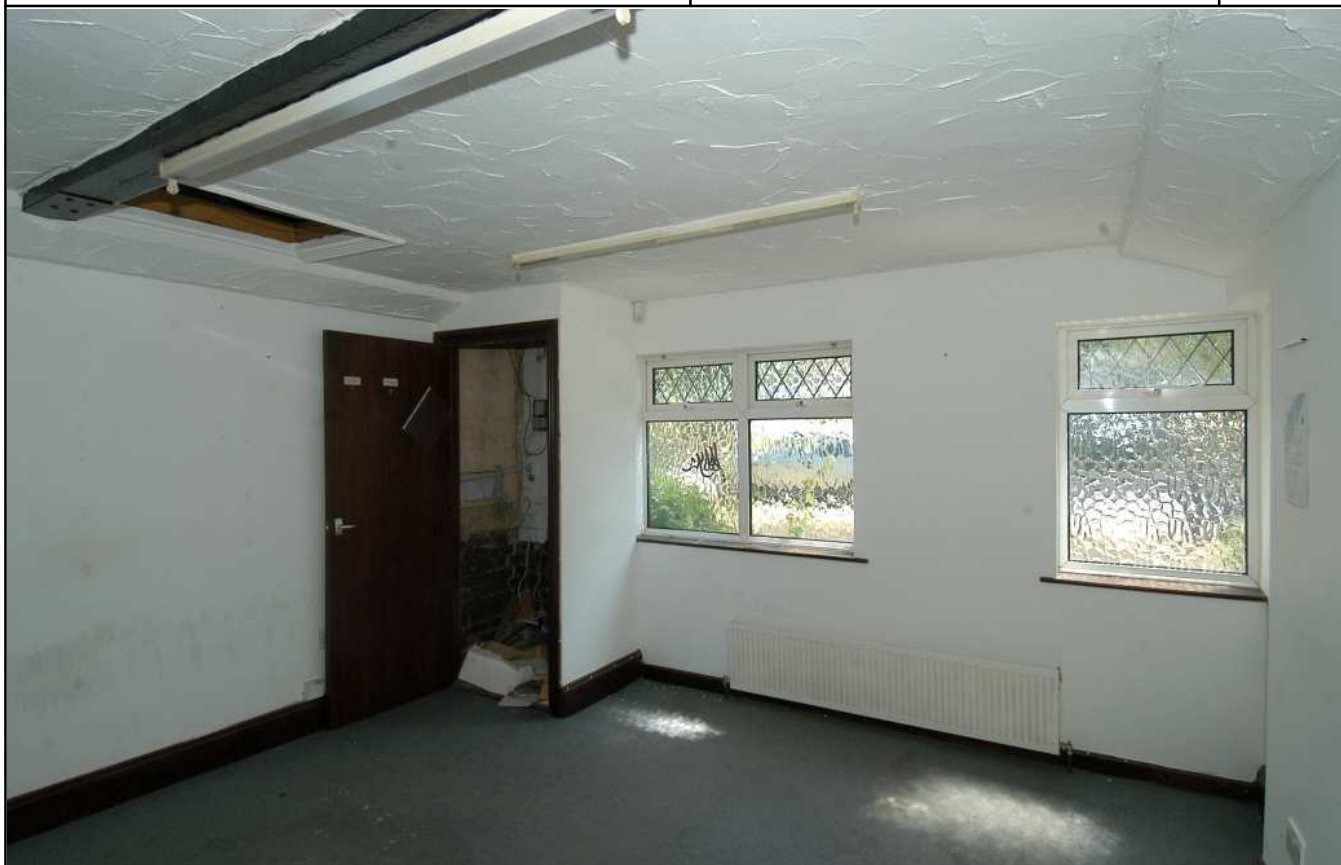
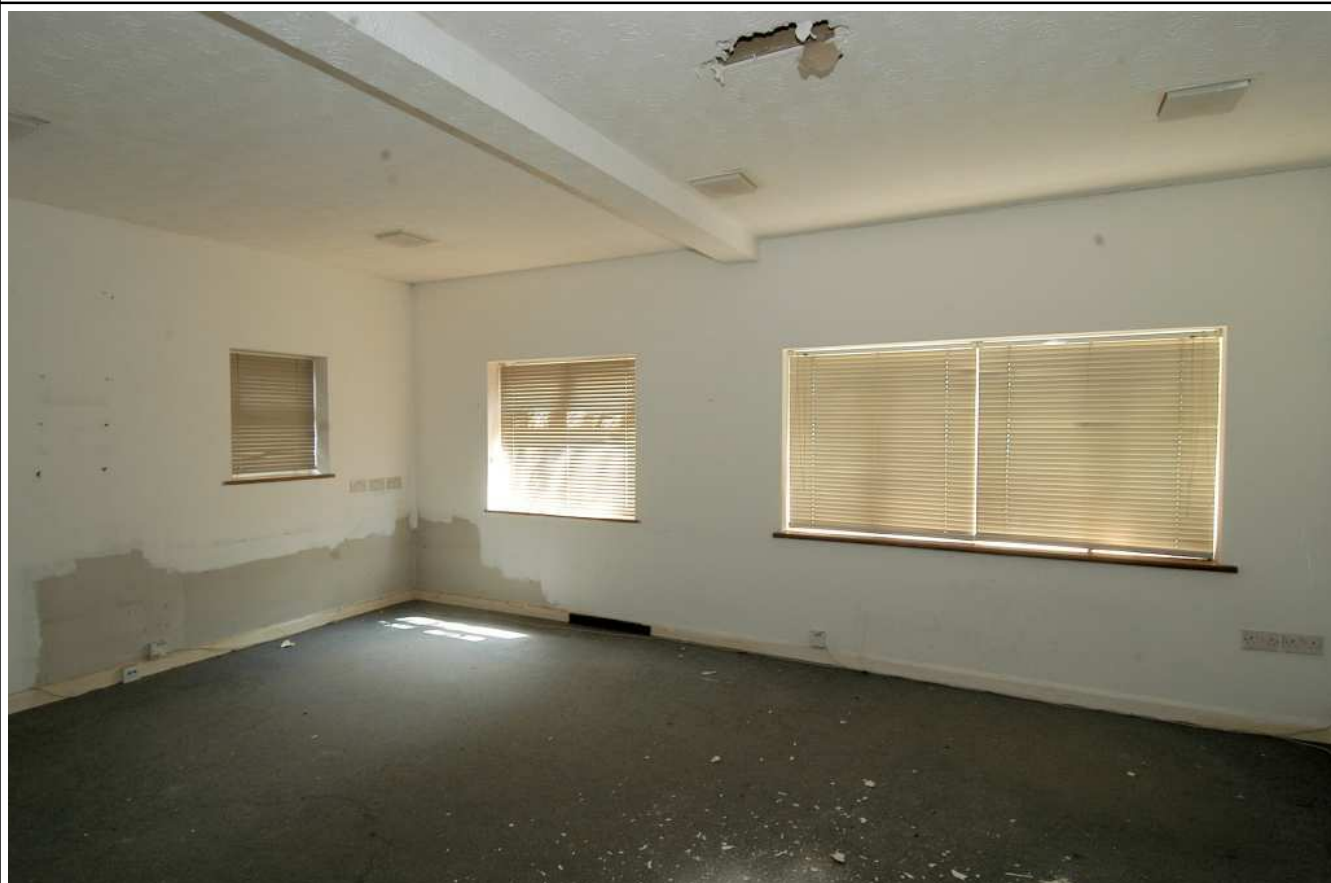
Plate 6: Front block, Bays 1 & 2, interior looking NE

Plate 7: Front block, Bay 3, interior looking NE

Plate 8: Front block, northern extension, interior looking NE

**2.6** No original features were observed in the interior of the front block, which was divided into offices and a showroom area (Plates 6-8), although some tongue and groove panelling was noted in the roof space, which may have formed part of the 1907 structure.

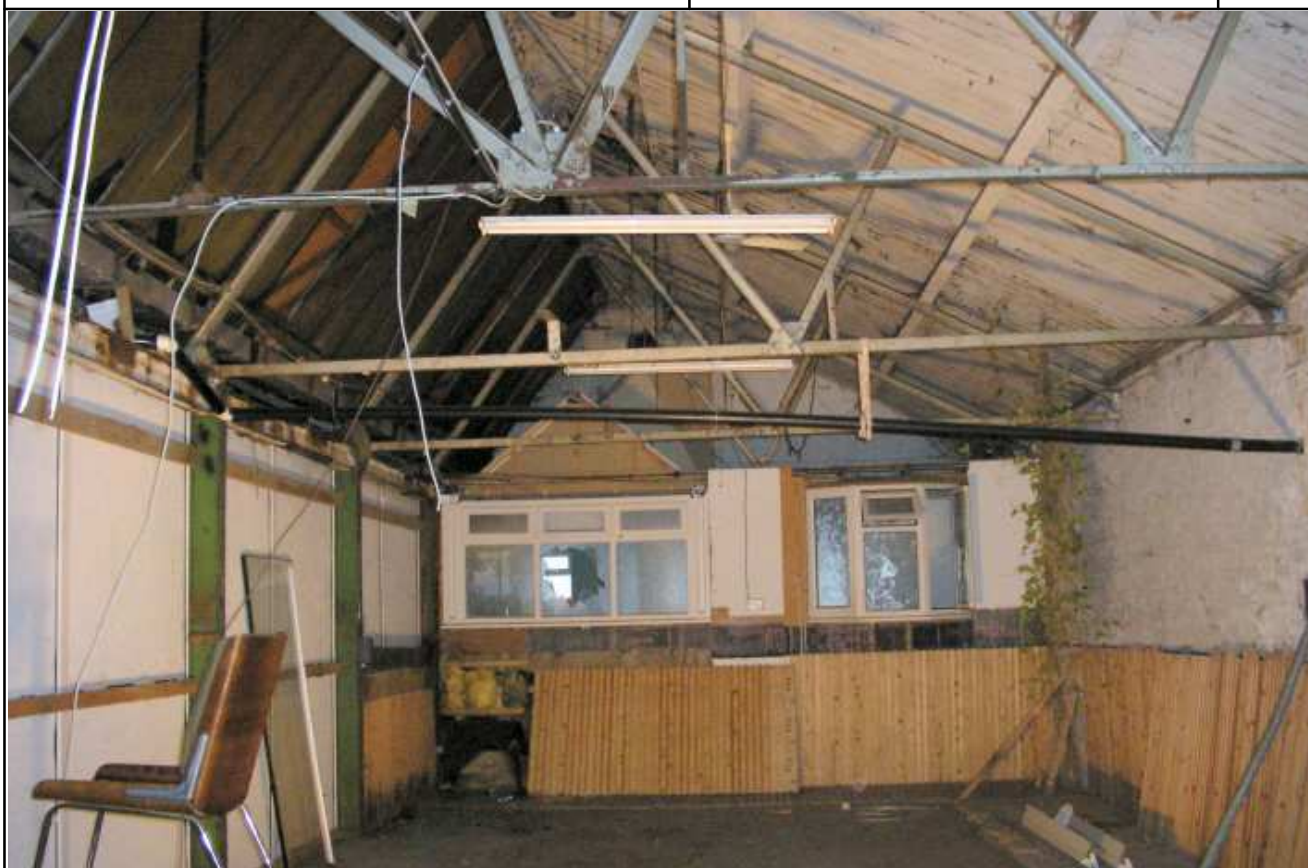
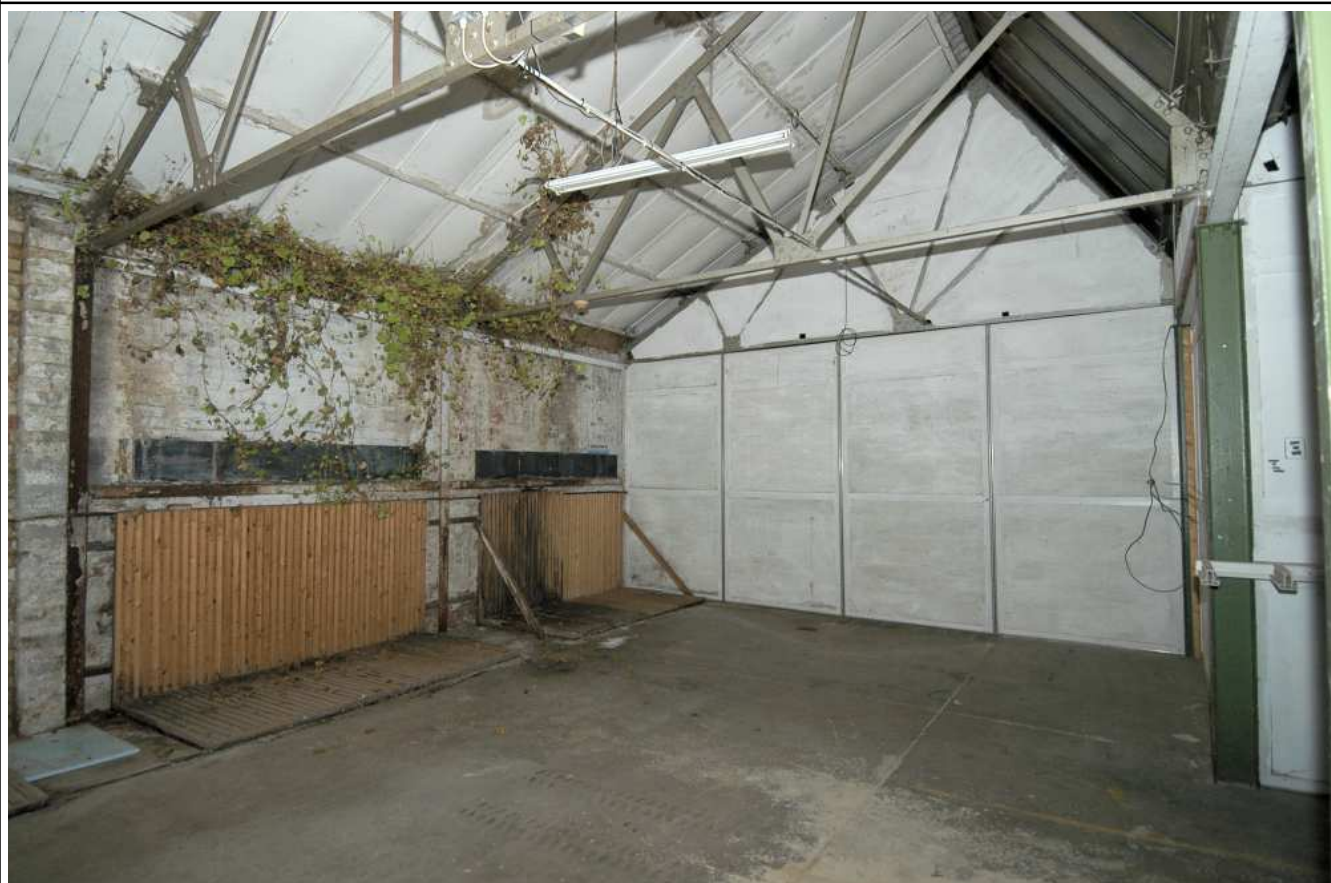
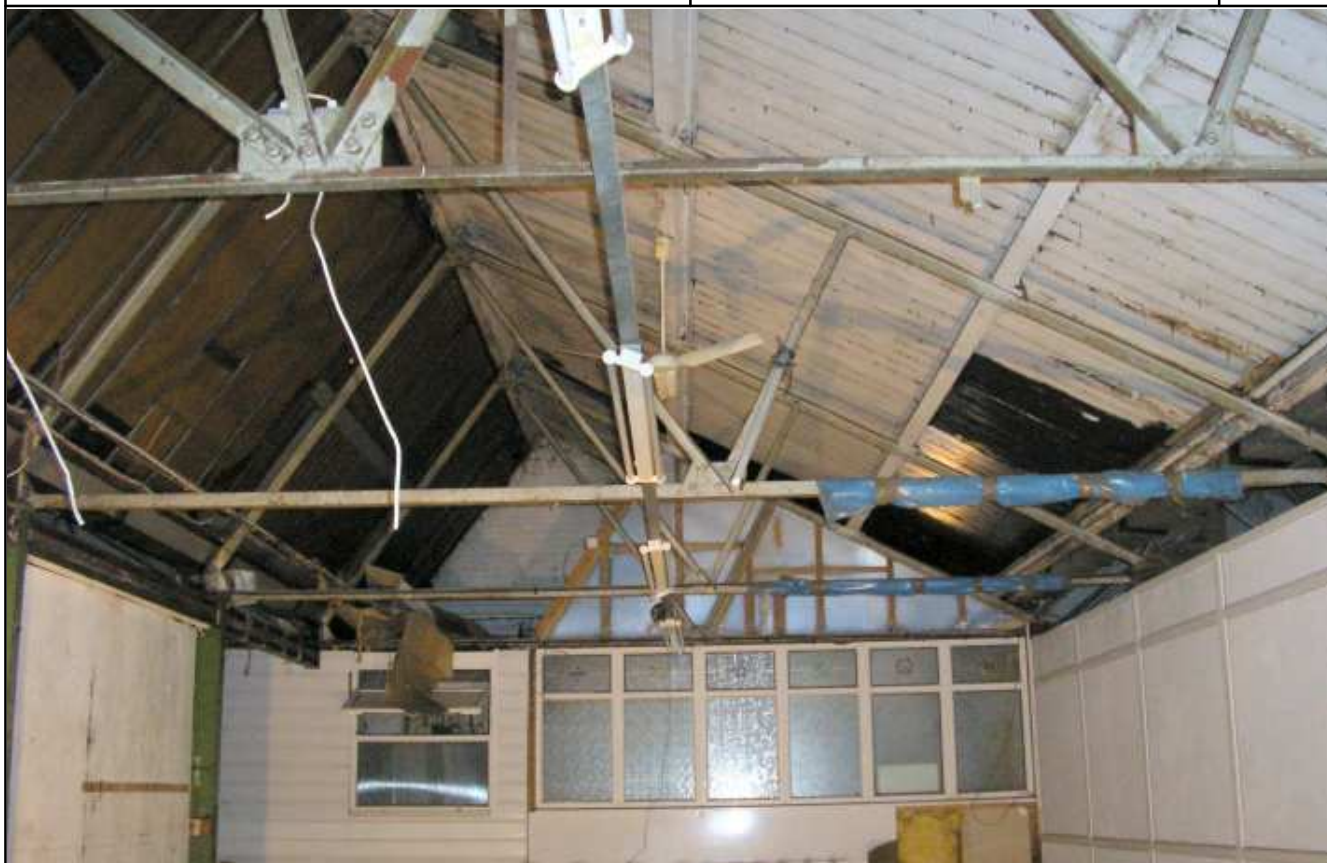
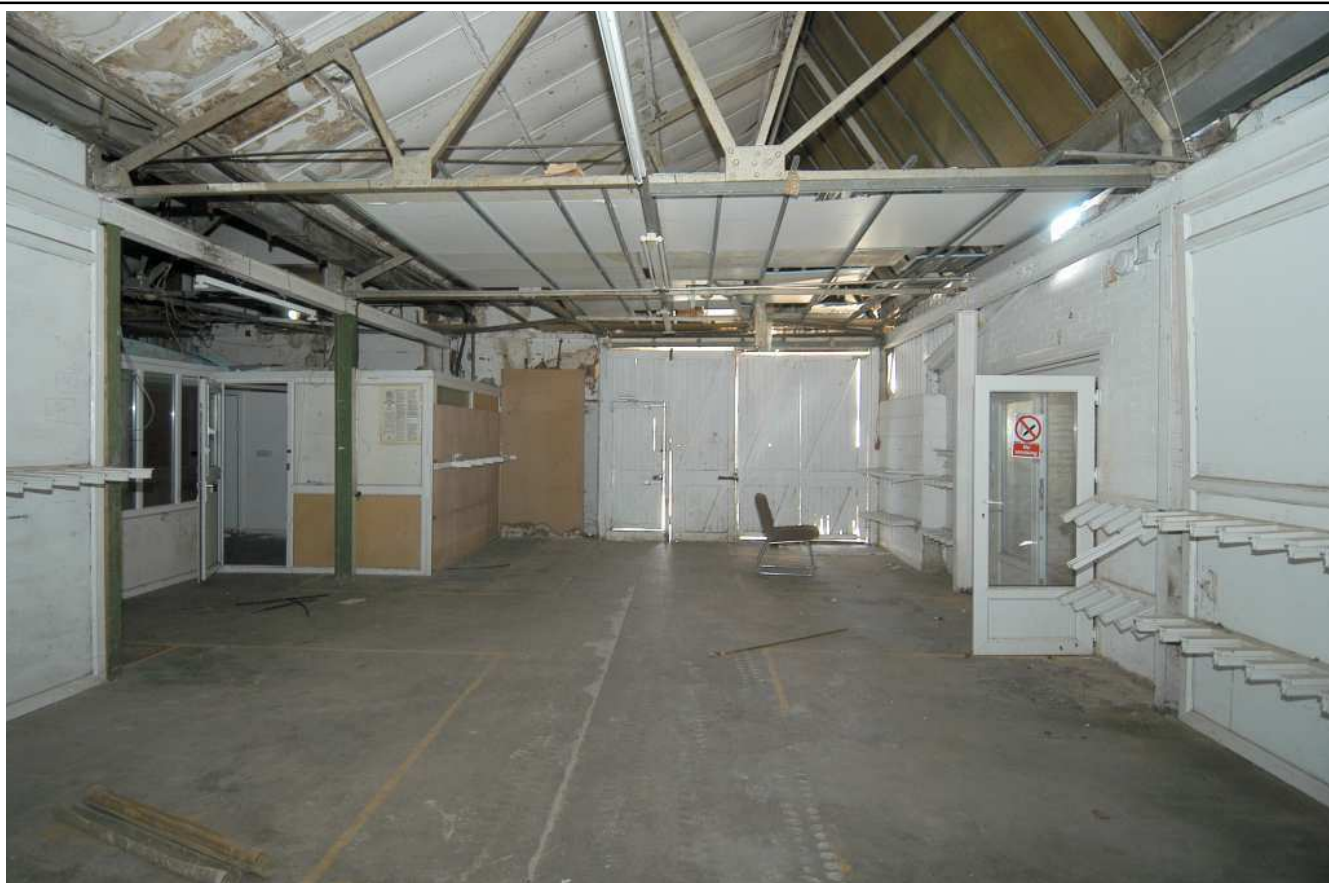
Plate 9: Rear block, S aisle, Bays 1-4 looking N

Plate 10: Rear block, Bays 5 & 6 looking SW

Plate 11: Rear block, middle aisle, Bays 1-3 looking N

Plate 12: Rear block, middle aisle, Bays 6-8 looking S

**2.9** No original fixtures and fittings were observed in the interior of this block (Plates 9 – 12). A recent extension to the window showroom had, however, been built into the eastern end.

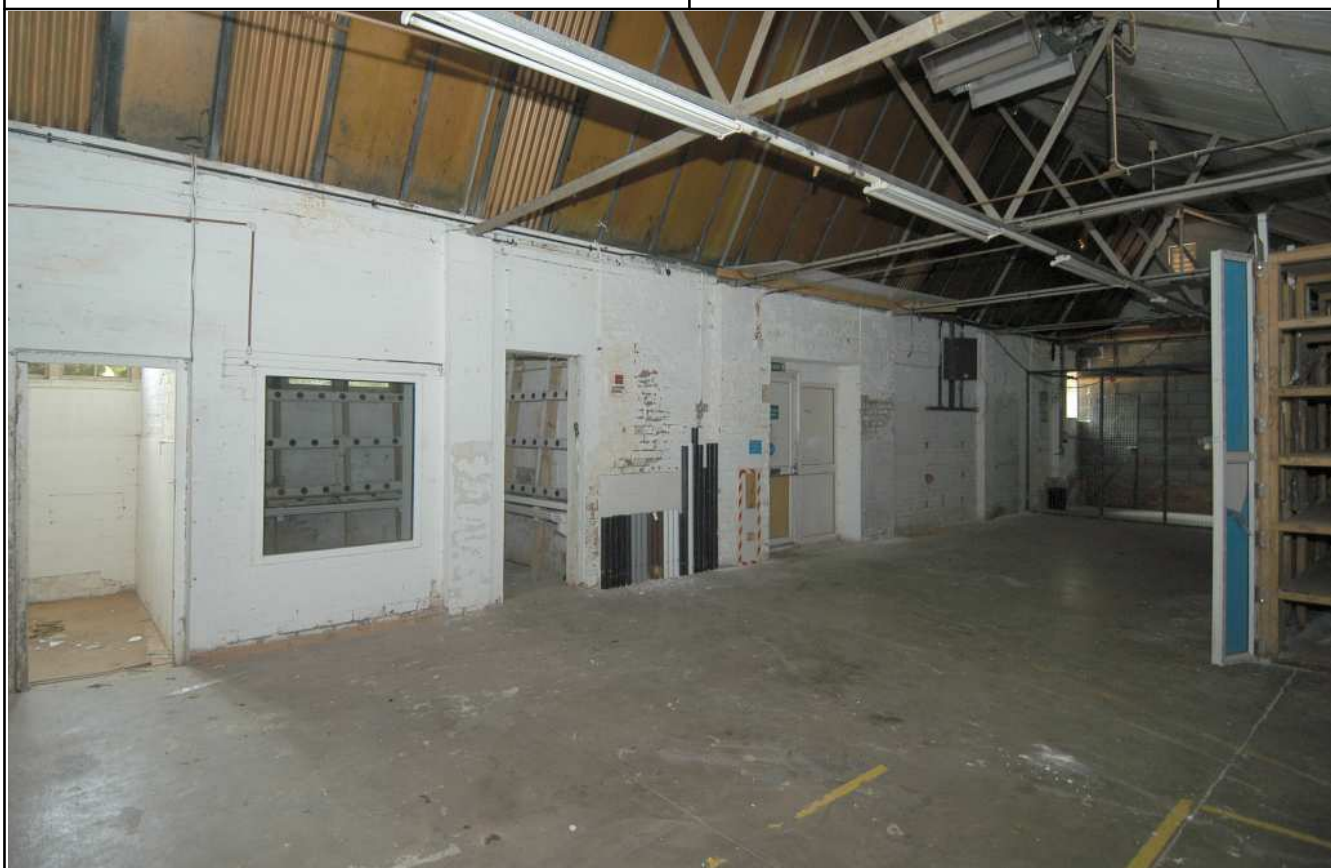
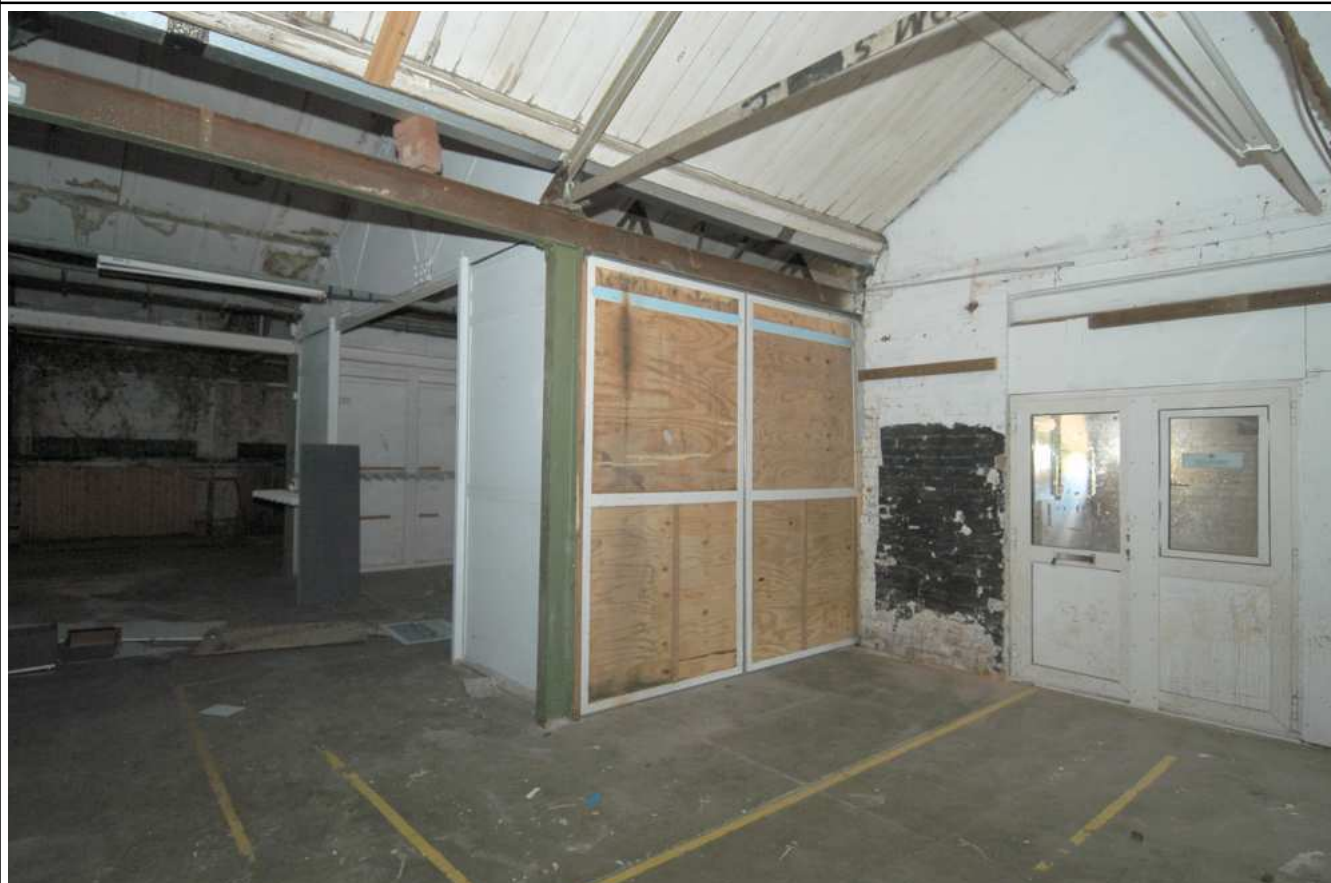
Plate 13: Rear block, Bays 1-6 looking NE

Plate 14: Rear block, Bays 5 & 6 looking SW

**2.11** No original fixtures and fittings were observed in the interior of this block (Plates 13 & 14). A recent toilet block and office had, however, been built into the eastern end.

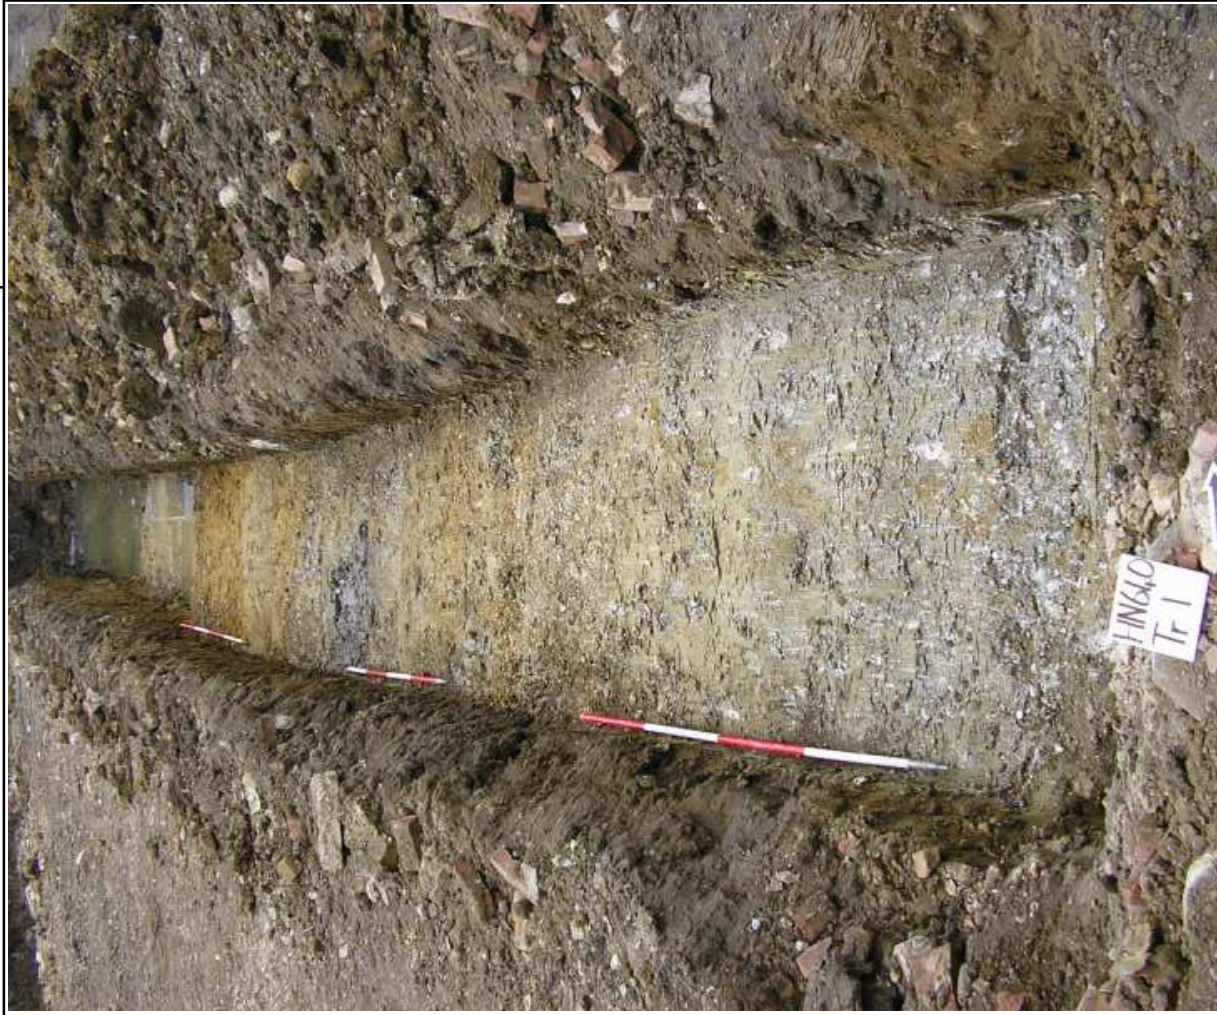
Plate 17: Trench 1 looking west

**3.8** Trench 1 was located in the eastern half of the site through the centre of the proposed block of 12 flats and was orientated east-west. The made ground consisted of a layer of dark, yellowish brown firm clay (10YR 4/6) with frequent building debris. Beneath this was a layer, at the western end of the trench, was a dark greenish grey (Gley 1 4/10Y) alluvial deposit. No archaeological cut features or deposits were identified (Figure 8; Plate 17).

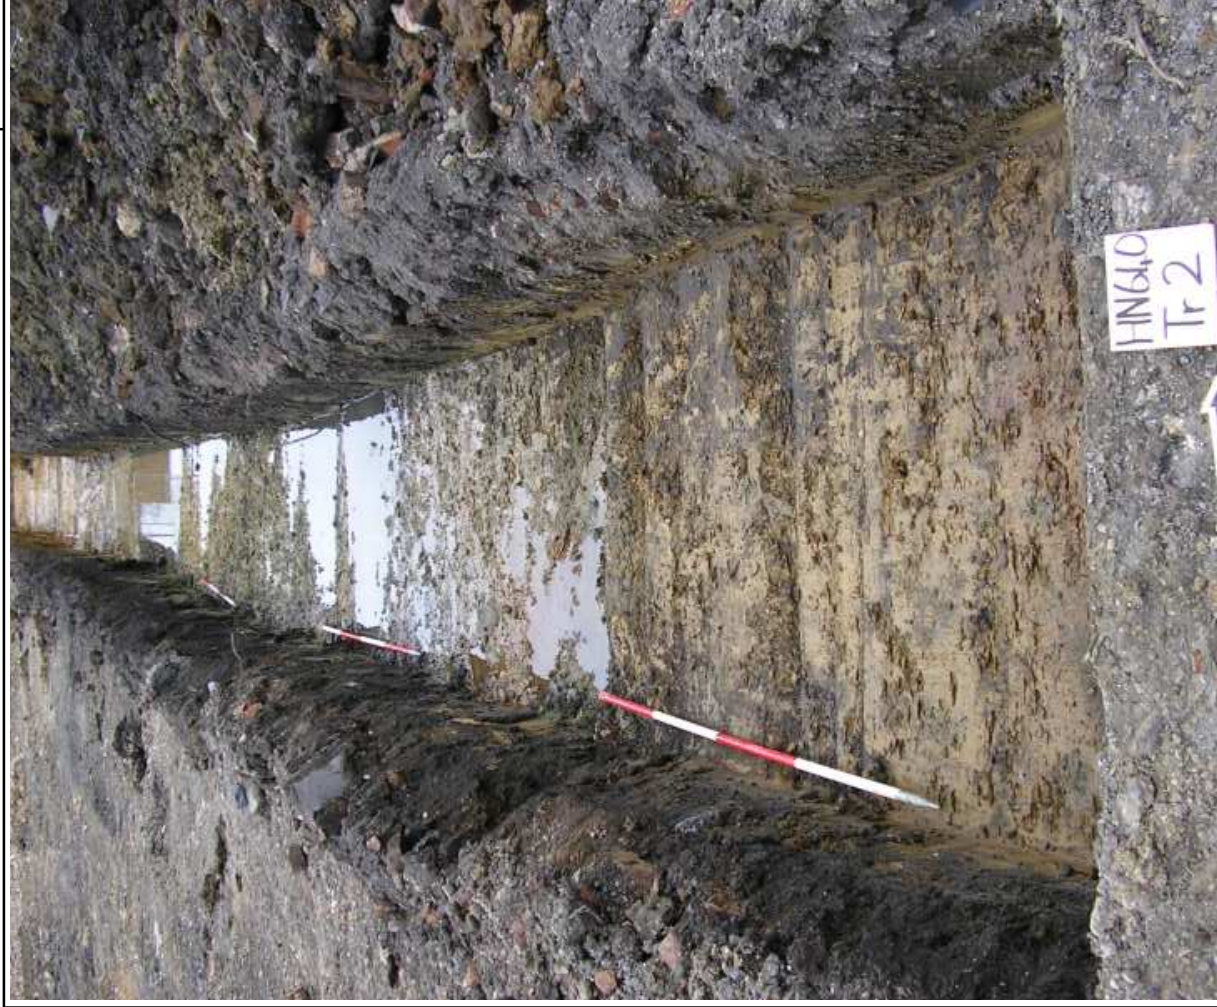
Plate 18: Trench 2 looking west

**3.9** Trench 2 was located in the western half of the site through the centre of the proposed semi-detached bungalows and was orientated northeast-southwest. Beneath the made ground was a substantial, dark greenish grey (GLEY1 4/10Y) alluvial deposit (202) (Figure 7). The natural geology consisted of mottled brown and red (10YR 4/4) clay at the northeast end of

the trench, and a yellowish brown (10YR 5/8) gravel with chalk inclusions at the southwest end. Between the two was a band of yellowish brown (10YR 5/8) gravel approximately 18m in length. It coincided with the presence of the alluvium. No archaeological cut features or deposits were identified (Figure 8; Plate 18).
