**112 BUTTERFIELD GREEN ROAD  
Luton, Beds.**

HN652

*Archaeological Monitoring Report*

*Prepared on behalf of Conack Homes Ltd*

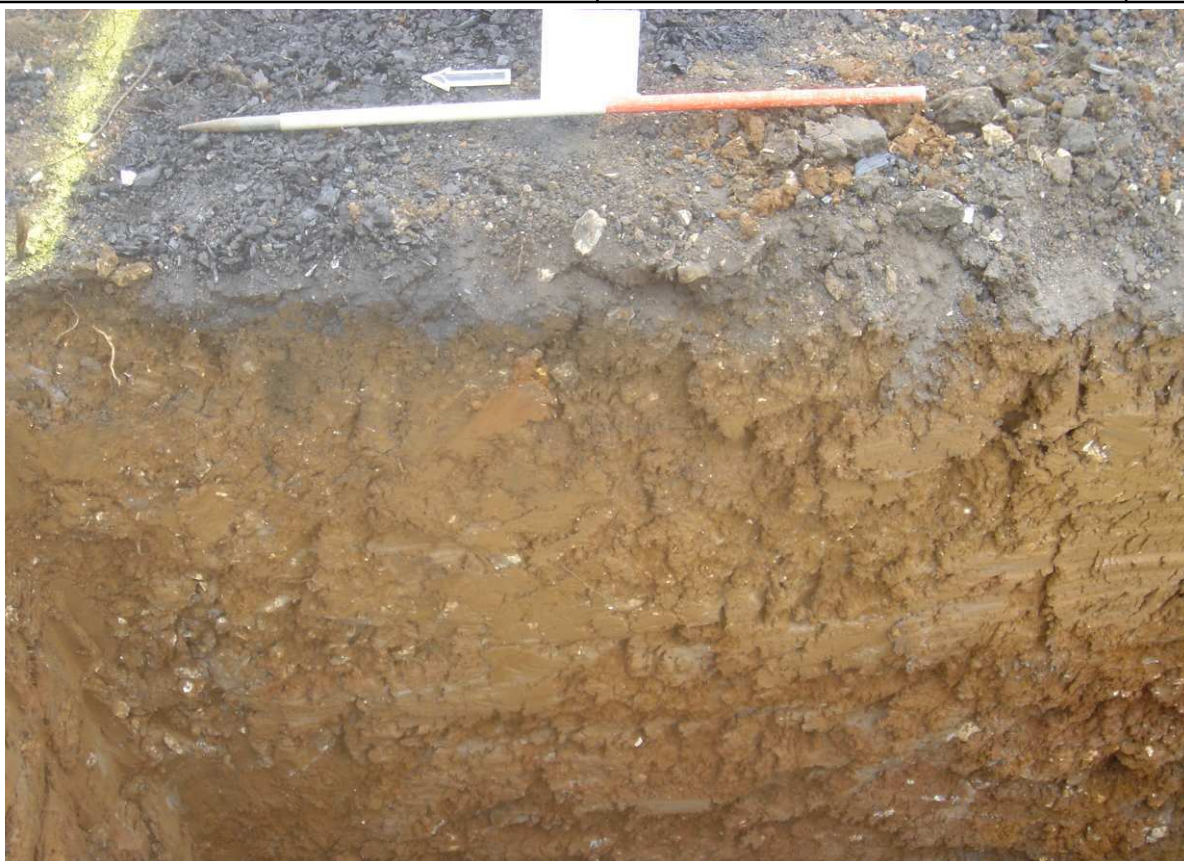
**2.5** The stratigraphy was consistent across the site and consisted of a crumbly, very dark grey (10YR 3/1) silty clay layer of topsoil containing a moderate amount of stone inclusions. At the southern end of the site this overlay a firm, very dark greyish brown (10YR 3/2) silty clay subsoil which contained a moderate amount of stone inclusions. Below this was a firm yellowish red (5YR 5/8) silty clay natural which contained a moderate amount of chalk inclusions (Figures 1 and 2).

Plate 1: Stratigraphy in footings trench (see Figure 2)

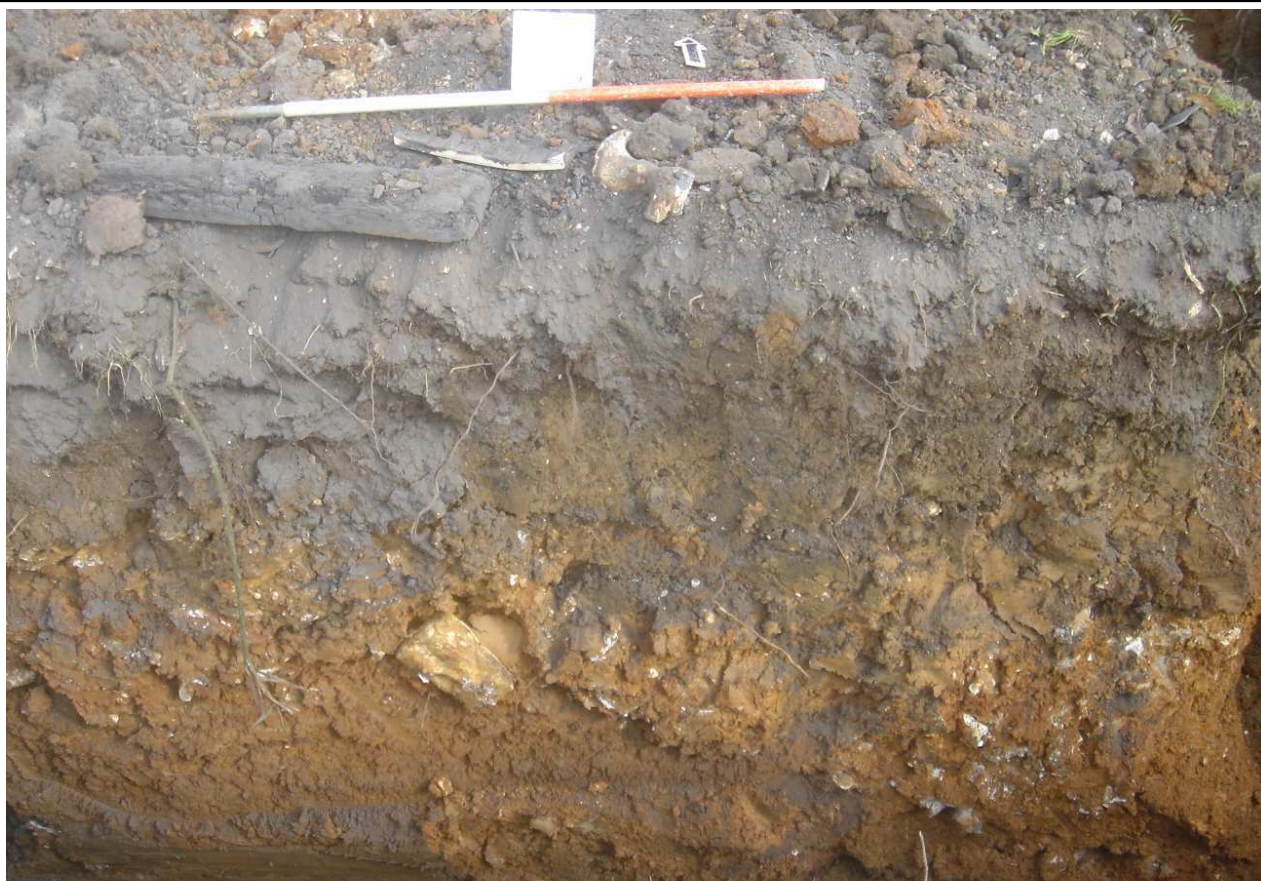
Plate 2: Stratigraphy in footings trench (see Figure 2)
